LIMITED ASBESTOS SURVEY REPORT

**RENOVATIONS TO ACCOMMODATE
COLLOCATION OF SIX (6) METROPOLITAN POLICE DEPARTMENT
UNITS AT 2850 NEW YORK AVENUE, NE
WASHINGTON, DISTRICT OF COLUMBIA**

**STV Project Number 3015141
May 27, 2011**

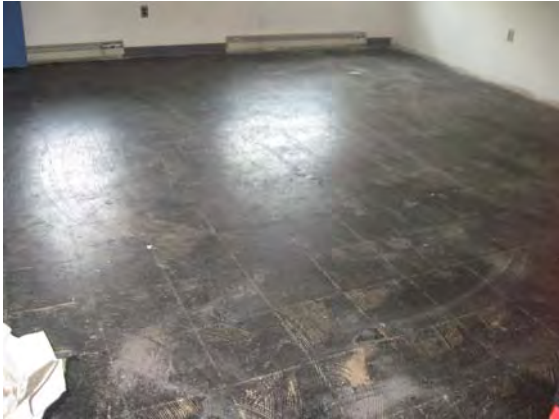
Photograph 1: Asbestos-containing remnant black floor tile mastic

| TABLE 4 HAZARDOUS MATERIALS RECOMMENDATION TABLE | | | | |
|---|--|--|--|--|
| 1 | Exterior and Warehouse Mezzanine Offices | Asbestos-containing expansion joint caulk on building exterior, remnant black floor tile mastic in warehouse mezzanine offices, and suspect asbestos-containing metal fire doors on building exterior. | EPA National Emission Standard for Hazardous Air Pollutants (NESHAP) | These materials can be left in place under an Asbestos Operations & Maintenance (O&M) Program provided that these materials remain undamaged and are not impacted by renovation/demolition activities. If these materials become damaged or are to be impacted by renovation/demolition activities they should be removed by a District of Columbia Licensed Asbestos Abatement Contractor. |

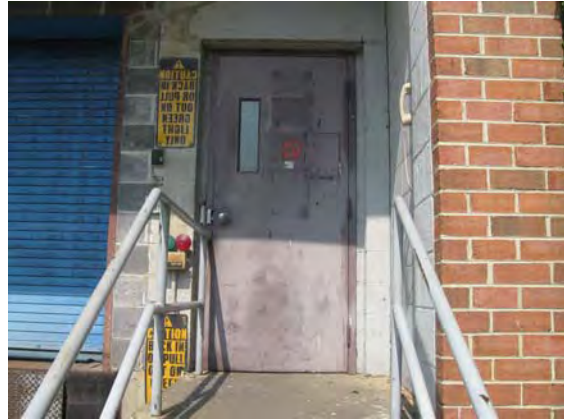
Photograph 2: Suspect asbestos-containing exterior fire door

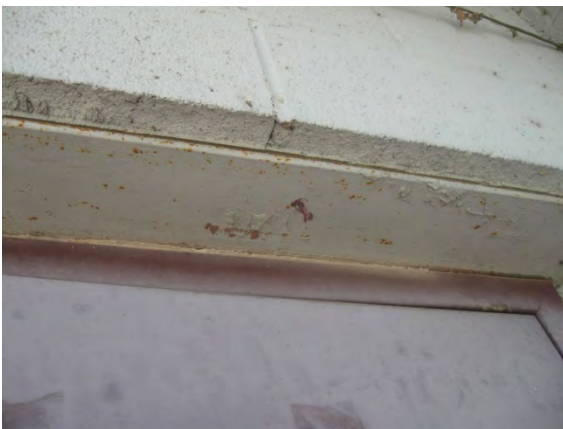
Photograph 3: Metal window lintel with lead-based paint.

| TABLE 4 HAZARDOUS MATERIALS RECOMMENDATION TABLE | | | | |
|---|--|--|--|--|
| 2 | Throughout | Lead-based paint was identified on metal I-Beams throughout, metal window lintels throughout, and white ceramic wall tiles in the warehouse 2 nd floor offices. | EPA Resource Conservation and Recovery Act (RCRA)/OSHA Lead in Construction Rule | These materials can be left in place under a Lead Operations & Maintenance (O&M) Program provided that the paint/glazing on these surfaces remains in an undamaged condition. Should the paint or glaze on these surfaces become damaged these components should be repaired or replaced by a District of Columbia Licensed Lead Abatement Contractor. Any contractor impacting these surfaces during renovation or demolition activities should follow all worker protection requirements under the OSHA Lead in Construction Rule. |

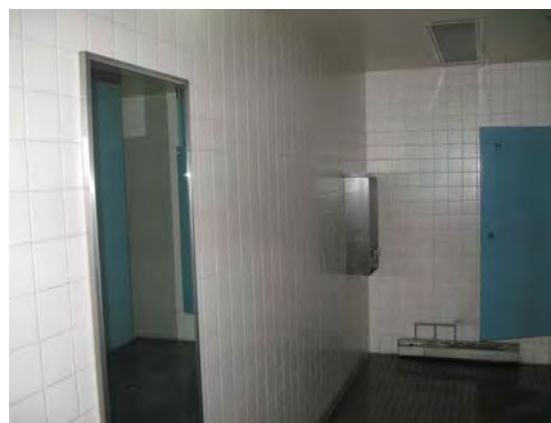
Photograph 4: Ceramic wall tile with lead-based glazing.

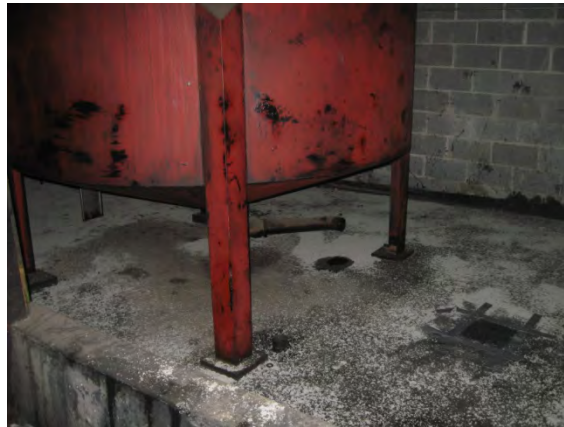
Photograph 5: Ink mixing tank berm with standing pools of ink.

F&R recommends that all areas of standing ink and sludge be remediated by a licensed hazardous waste contractor. The effectiveness of these efforts should be evaluated utilizing clearance through surface wipe sampling. Furthermore, F&R recommends that air sampling in this space be conducted prior to occupancy to determine if the printing operations have resulted in off-gassing of such contaminants as Volatile Organic Compounds (VOCs).

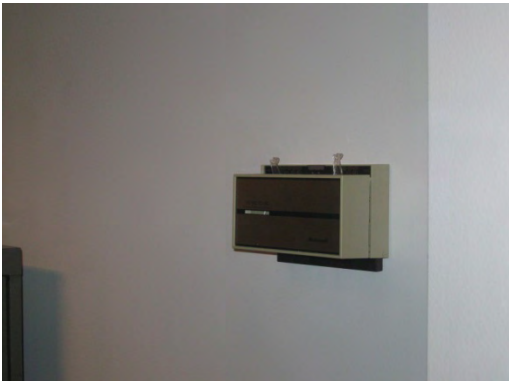
Photograph 6: Thermostat with mercury-containing switches.

The mercury-containing building components that are to be impacted as part of renovation/demolition activities should be removed, disposed of and/or recycled according to Federal and District of Columbia hazardous waste disposal guidelines by an appropriately licensed/certified contractor.

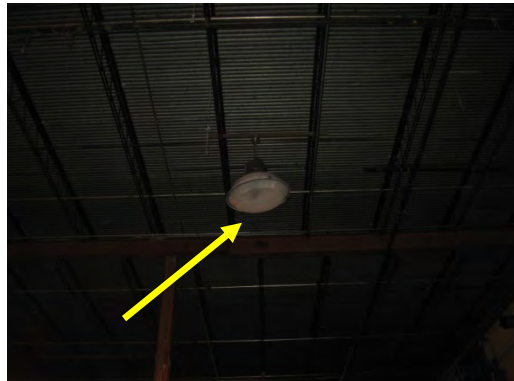
Photograph 7: Mercury-containing HID lamp.

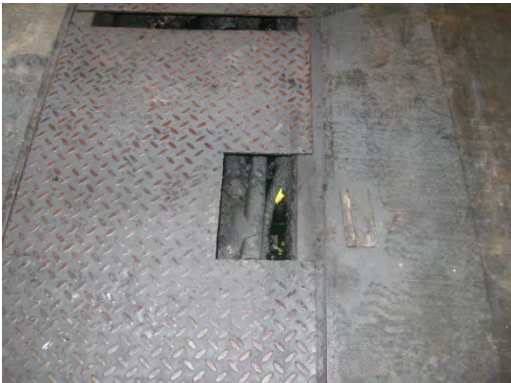
Photograph 8: Piping troughs with standing sludge in main warehouse.

Areas of the building with standing ink or sludge, specifically the ink tank mixing area, the photo processing room in the northwest corner offices, and the piping troughs located in the main warehouse area, should be remediated by a District of Columbia Licensed Hazardous Waste Contractor. The effectiveness of these efforts should be evaluated utilizing clearance through surface wipe sampling. Air sampling is recommended before the next tenant moves into this space to determine if the printing operations have resulted in off-gassing of such contaminants as Volatile Organic Compounds (VOCs).

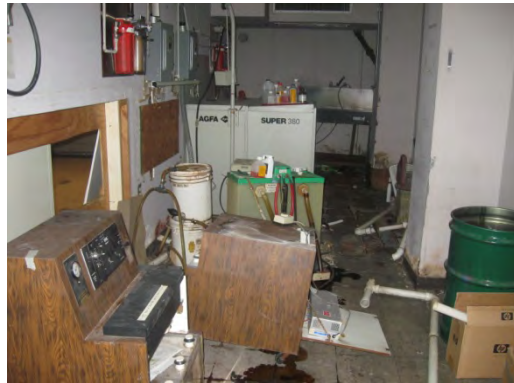
Photograph 9: Photo processing room in northwest corner offices.

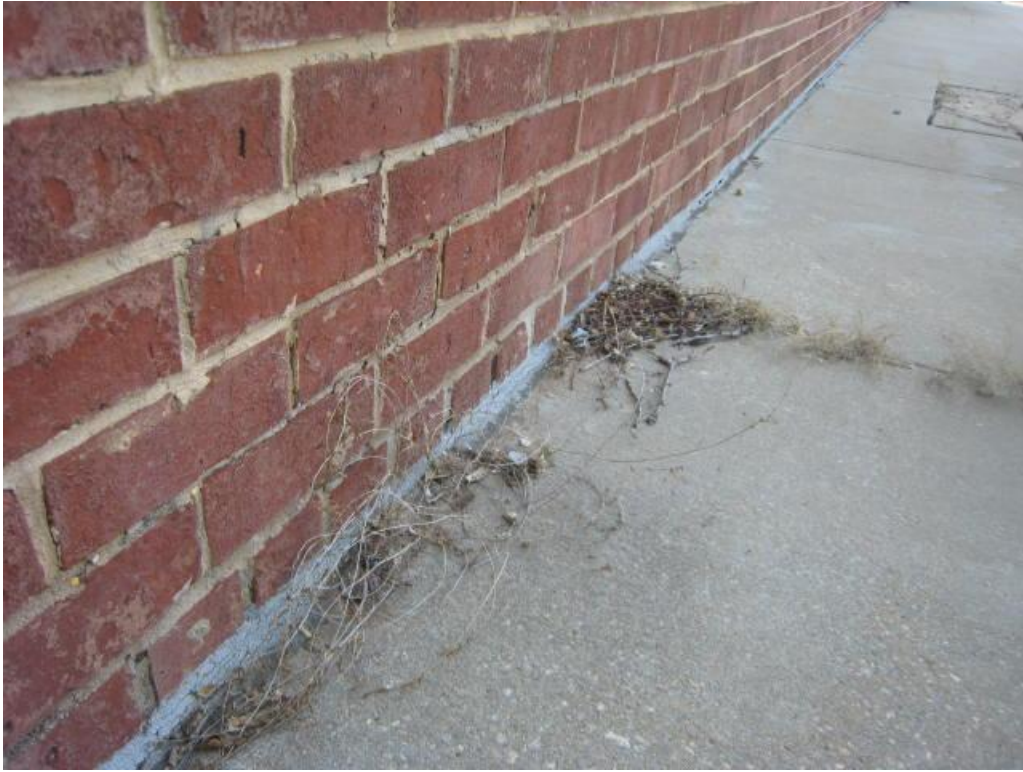
Photo 1 –View of Asbestos Expansion Joint Caulk Previously Sampled

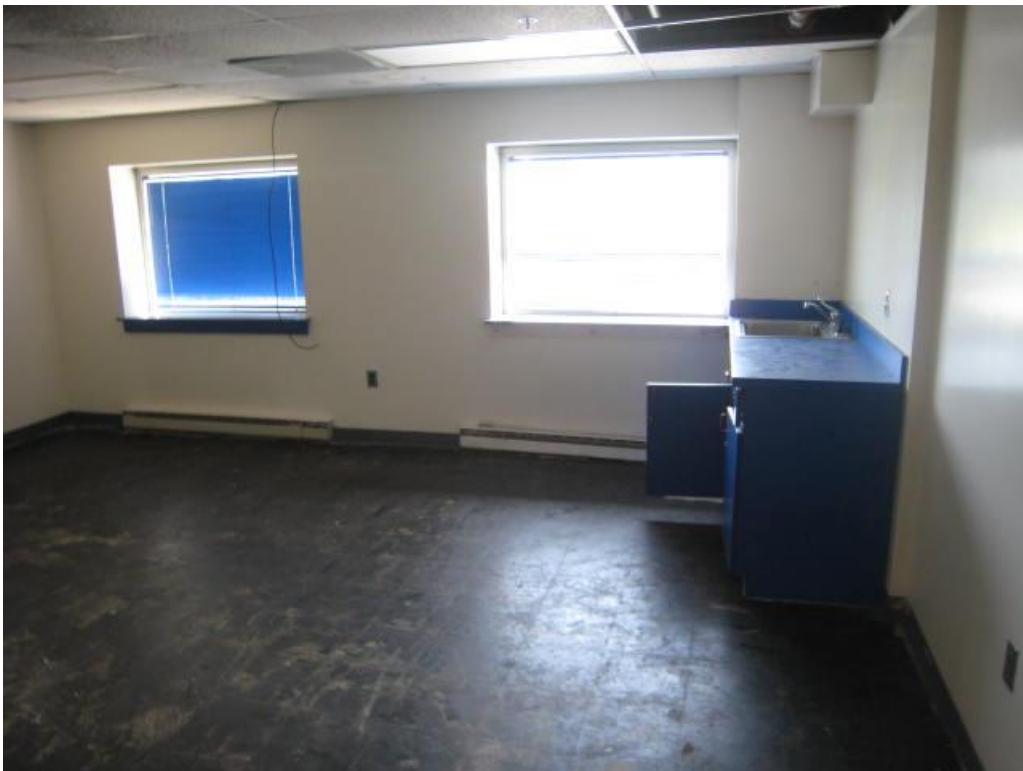
Photo 2: View of Asbestos Remnant Black Floor Tile Mastic Previously Sampled

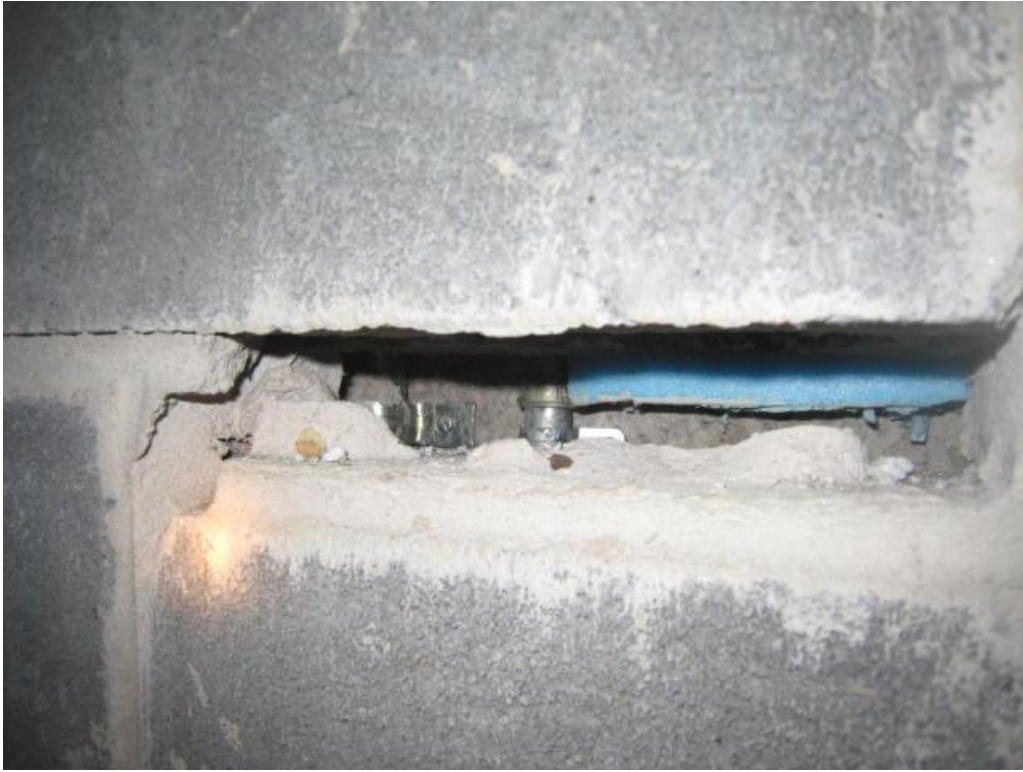
Photo 3 –View of CMU Mortar Sample 2850-0512-01

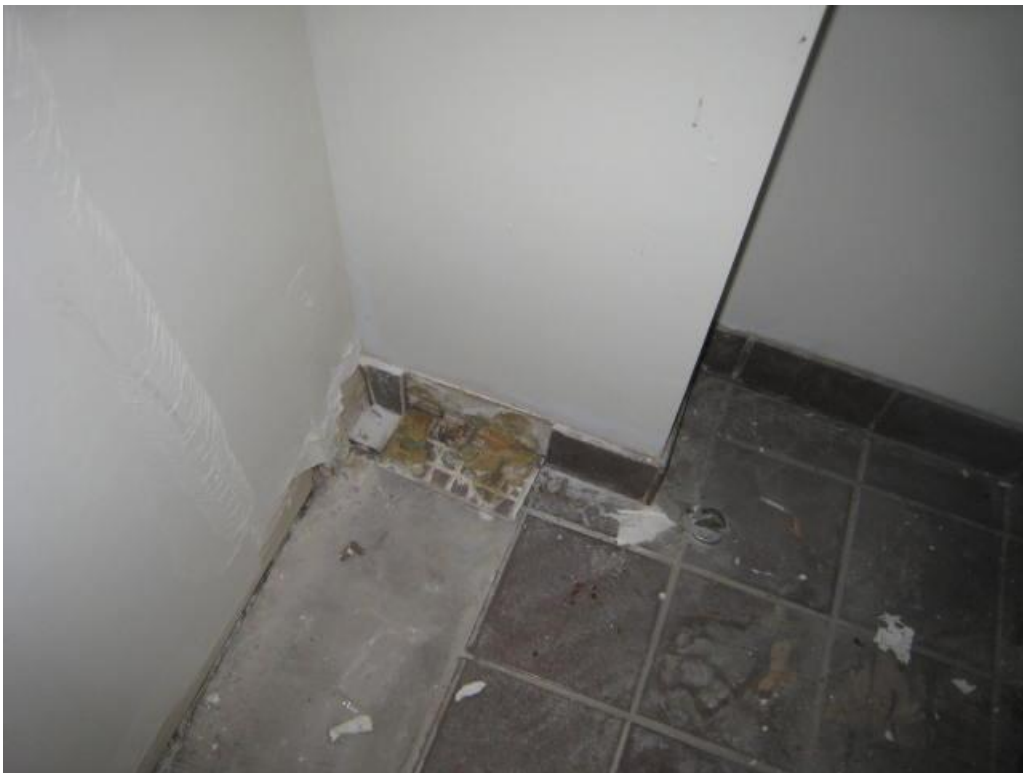
Photo 4 –View of 6"x6" Brown Ceramic Floor Tile Sample 2850-0512-07

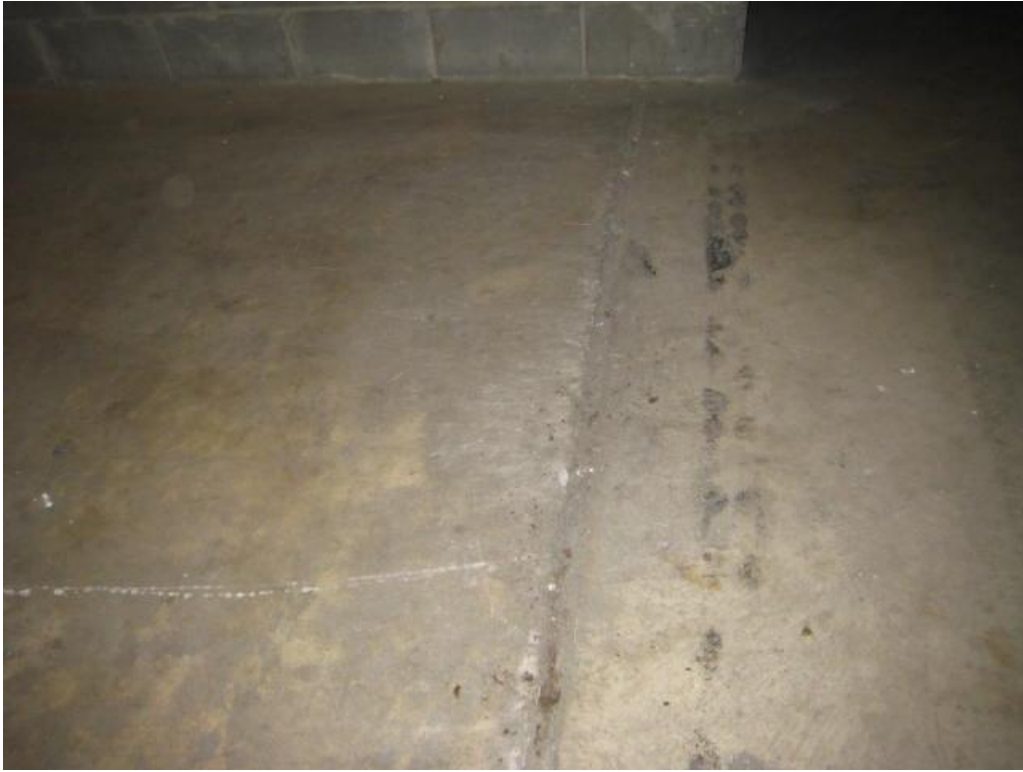
Photo 5 –View of Expansion Joint – Floor Sample 2850-0512-13

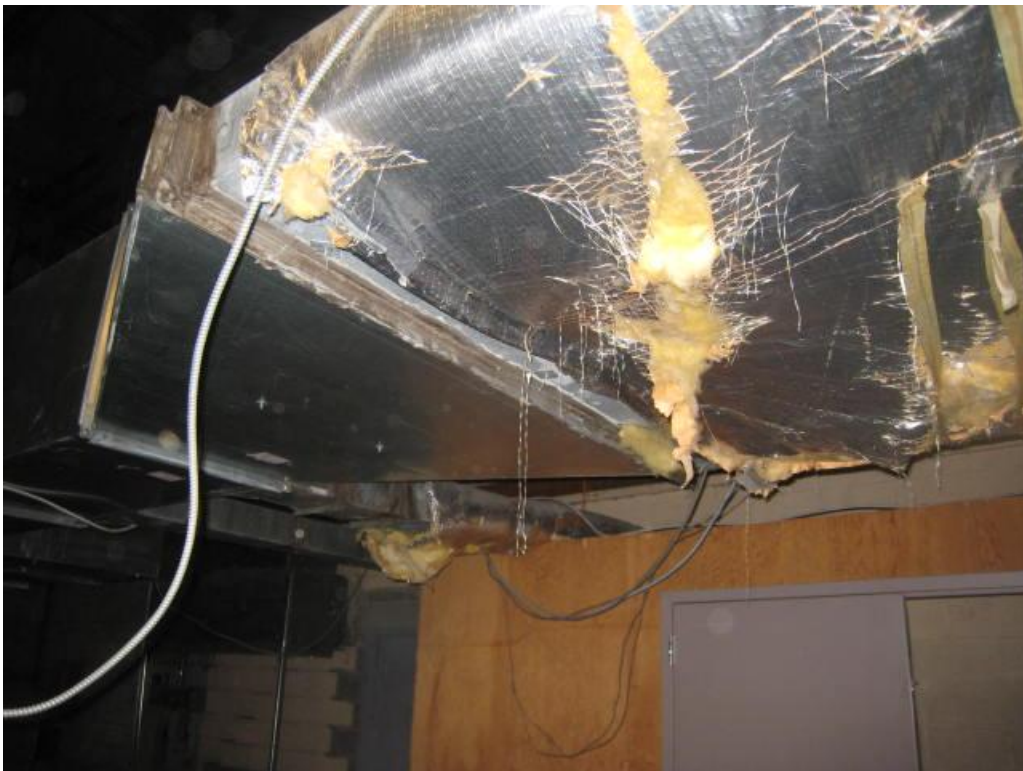
Photo 6 –View of Paper Covering Over Fiberglass Duct Insulation Sample 2850-0512-16

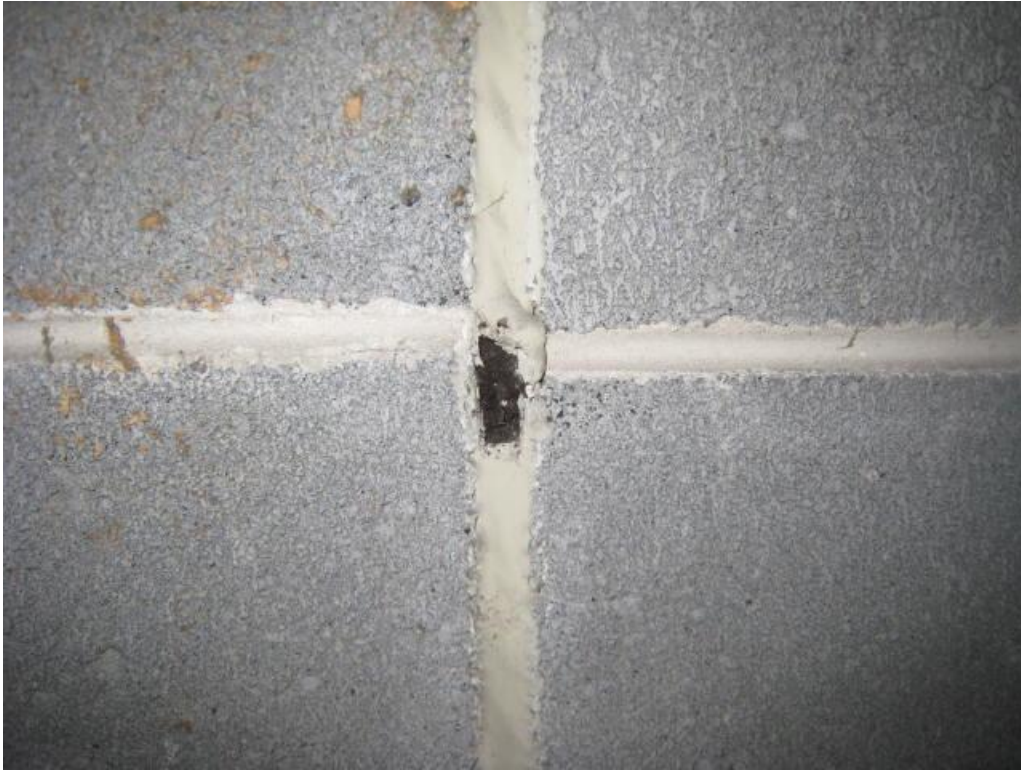
Photo 7–View of Expansion Joint - Wall Sample 2850-0512-19

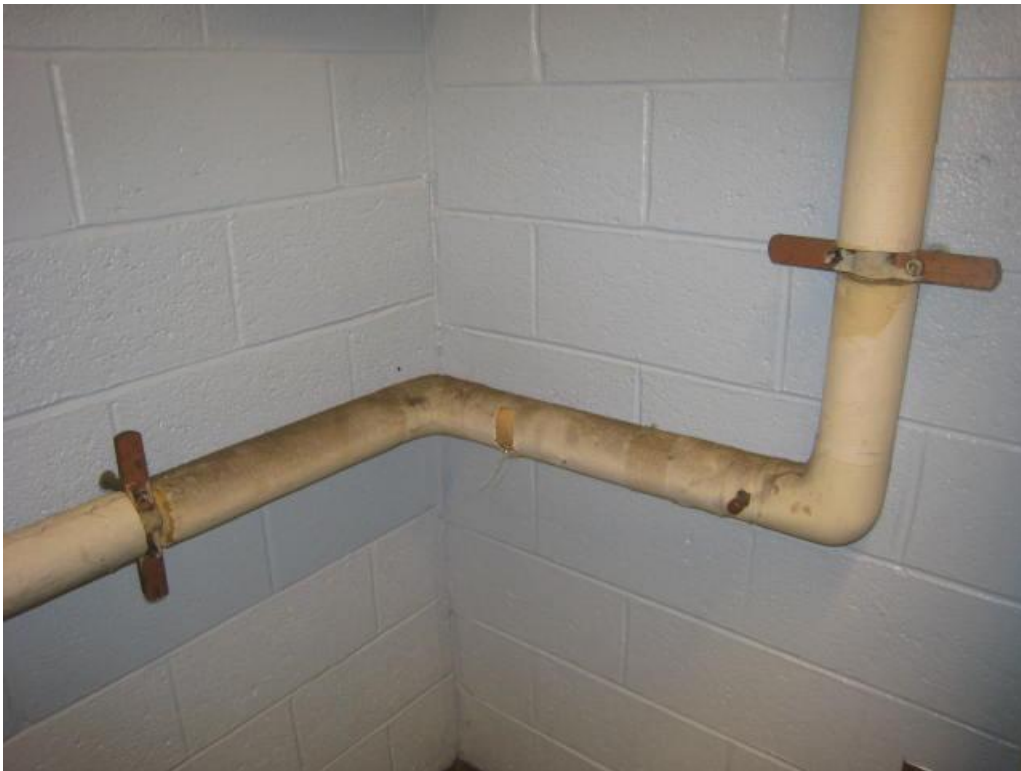
Photo 8–View of Paper Covering Over Fiberglass Pipe Insulation Sample 2850-0512-22

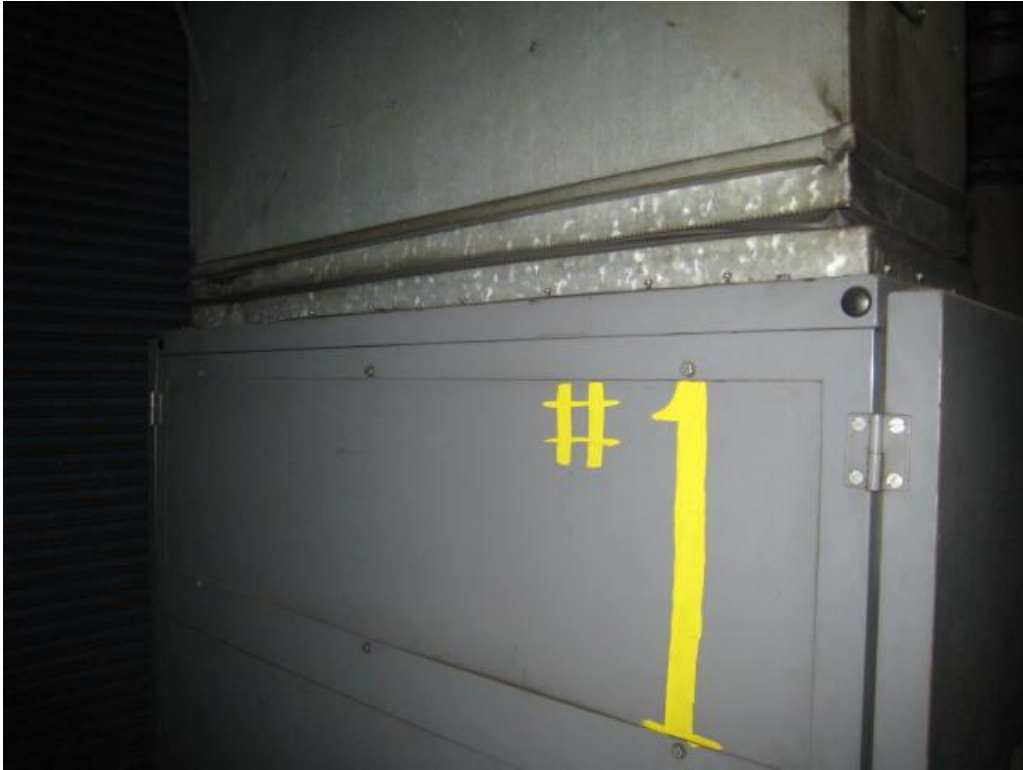
Photo 9–View of Black Vibration Cloth Sample 2850-0512-25

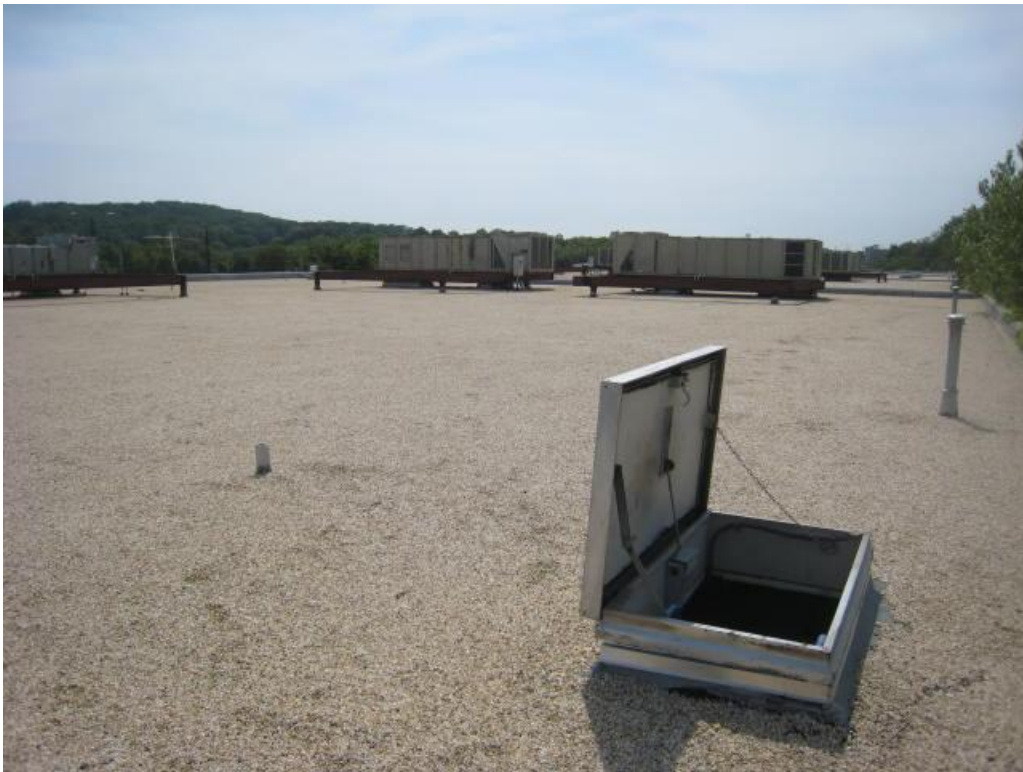
Photo 10–View of Assumed Asbestos Roofing Materials
