**Center for Therapeutic Recreation Program
Development and Associated Services**

3030 G Street SE
Washington, DC 20019

Building Conditions Assessment Report

December 10, 2014

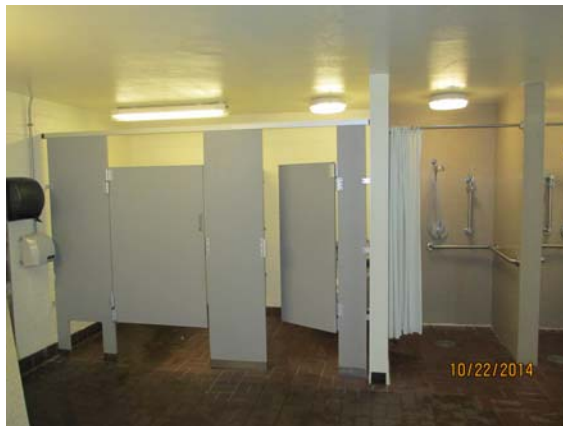
Locker Rooms: The locker rooms, though recently renovated to address wheel chair accessibility, has not addressed all issues. Though both the locker rooms have been modified since the report in 2011, to include addition showers and revised entry sequences, all items have not been fully addressed with regards to dealing with maneuverability and accessibility of clearance requirements.

Locker Room Shower/ Toilet

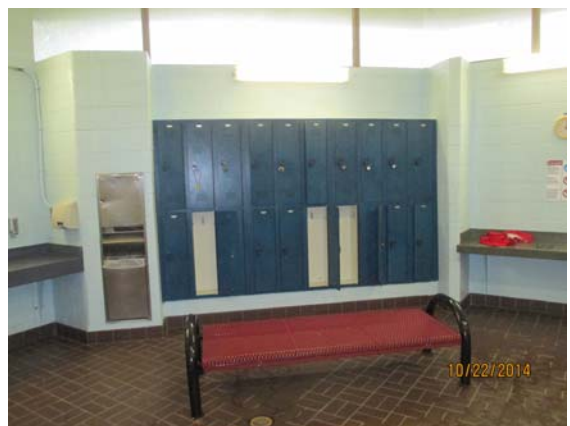
Locker Room Changing Area

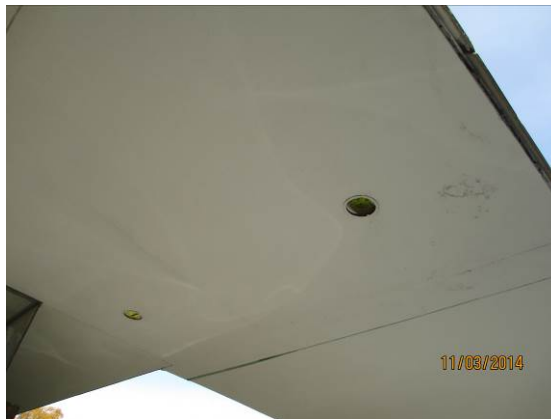
The membrane appears sound without evidence of cracking or other deterioration. The siding along the mansard roof needs a good clearing and is clearly worn but there were no observations of cracking and missing planks. Mechanical units are installed off of the roof with supports. Below the roof eve outside of the swimming pool the underside of the gypsum board soffit has been replaced multiple times. Visible water damage was observed. The source of the leak was not identified.

Eave Outside Pool

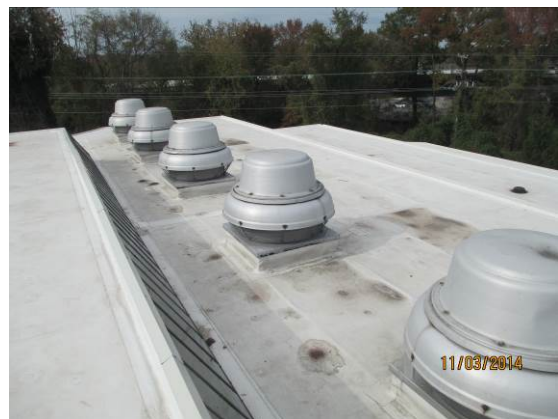
Roof: The main roof is a single ply system. It appears to have been installed recently, though not confirmed with DPR. It is difficult to determine the age of the roofing system. The roof surfaces are sloped to roof drains. After reviewing both roofs of the building, visual inspection reveals the roof appears to be properly installed, there were visible holes or gouges observed, though, there was standing water in some places. However, it is evident that there is a water problem due to the multiple locations of water damage throughout the ceiling of the building. There were multiple blisters throughout the roofs surface.

Stepped Roof Above Pool

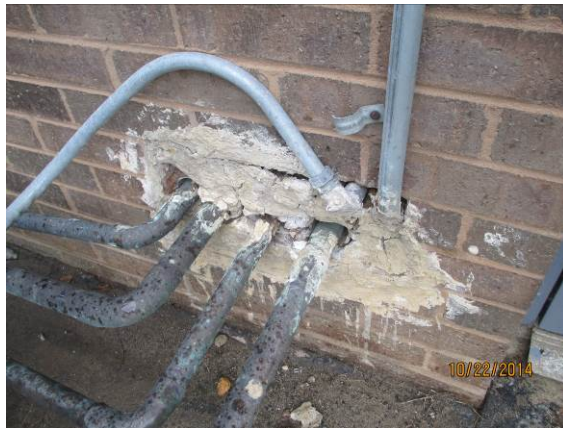
Masonry: The exterior masonry wall appears to be in fair condition and is in reasonably good shape with only very localized and limited damage in places. There are areas that did appear to have the remnants of graffiti removed. Grout joints also appear to be in good condition for the age of the building. There are several areas where penetrations need repairing to include areas where utilities penetrate the building. There are portions

Utilities at building

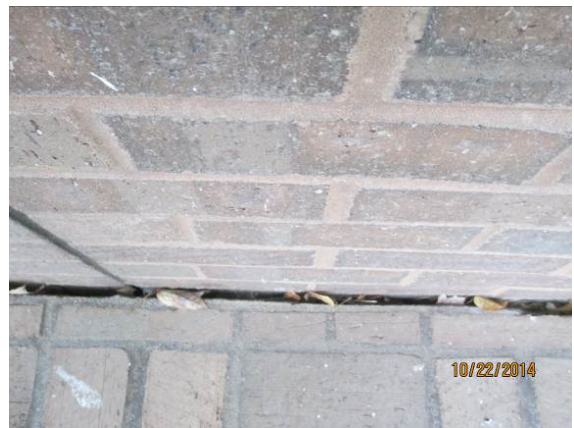
of the masonry pavers along the walkway and building perimeter that have been recently replaced. The seals between the building masonry and perimeter should be recaulked.

Masonry pavers at walkway

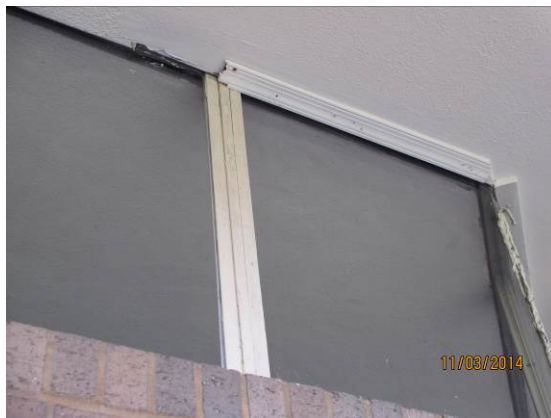
Exterior Windows: Windows appear to be original to the building and are in fair to poor condition. A few windows were closely observed where the perimeter seal or gaskets have failed and have been “manually” fixed with duct tape in an attempt to mitigate heat loss/gain and limit water infiltration. A temporary solution could be to recaulk the window frames and joints, but it is recommended that a more energy efficient glazing system be used moving forward.

Windows at Pool

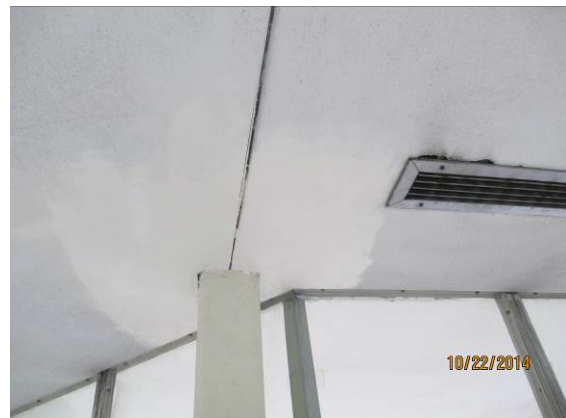
Windows at Pool (Interior)

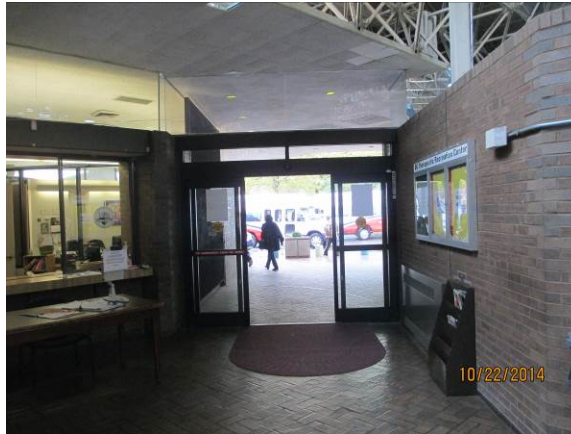
Exterior Doors: There are several types of doors that allow access to the building. Most notable are the automated sliding bi-parting doors at the main entry to the building the doors range in size but are similar in function. The smaller building has a single sliding automated door. Though these doors continue to function as designed, there is not a vestibule. This renders the doors inefficient in regards to air infiltration. The rear pair of doors were observed to have broken glass and missing weather stripping adding to the inefficiency of the conditioned space.

have a steel security gate it has been noted that this is a heavy, cumbersome gate that must be manually operated.

Main Entry Doors

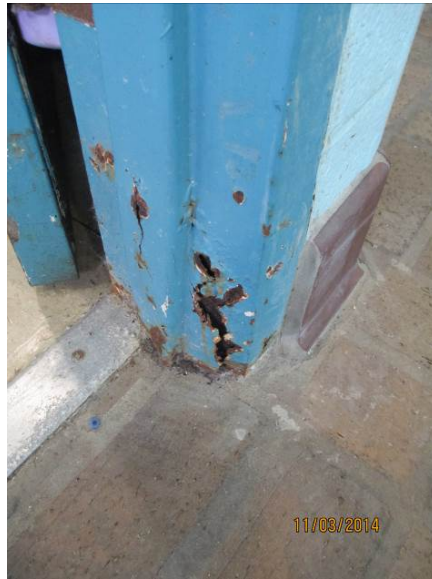
Door Frame in Pool

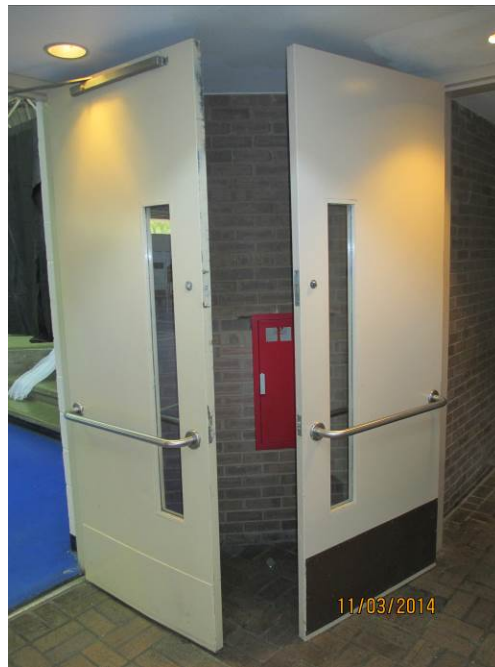
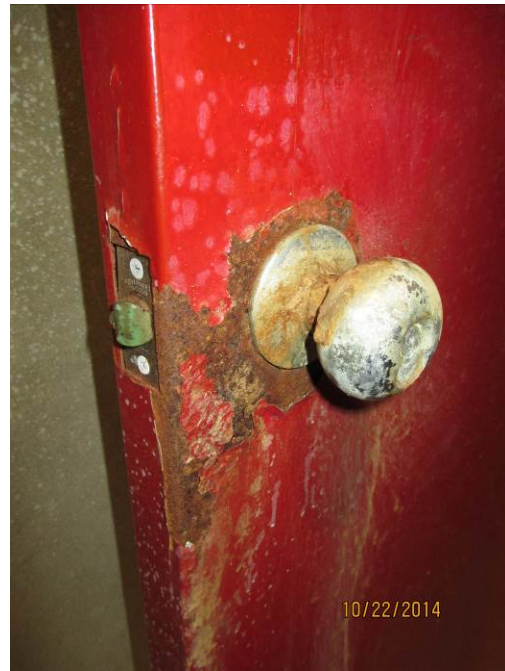
The hollow metal doors and frames that serve the building are beginning to show rust and signs of general deterioration. The existing door hardware in general needs to be replaced throughout the building. The majority of the doors have grab bars on them with thumb locks located higher than standard levels. Several emergency egress doors in the gym have latch bolts and are locked. They do not release with the panic hardware. Closers and latches do not fully function or are broken or not present. A few doors operated by closers require opening forces greater than the maximum allowable.

Door Hardware

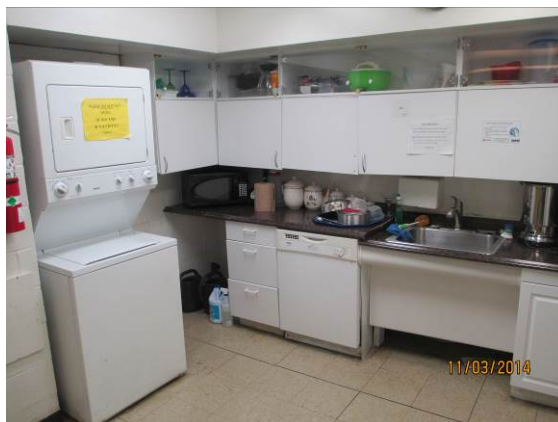
The galley kitchenette has been upgraded in recent years, but high frequency of use has worn out the residential surfaces and equipment. Currently the space contains a residential grade electric stove and oven, dishwasher, microwave, and stackable washing machine and dryer. There is an exhaust hood but it is not vented. All kitchenette equipment is in need of an upgrade. The layout is rather disorganized with very little preparation surface. The P-lam is worn on the countertop and beginning to delaminate; the cabinet doors are missing hardware and some doors need to be tightened. The VCT flooring should be replaced around the work area. The pantry around the corner has shelves for storage, but adds to the chaotic layout by not being accessible for food preparation. Finally, the kitchen space has a ceiling mounted accordion door that further separates the open space adjacent to it.

Kitchenette

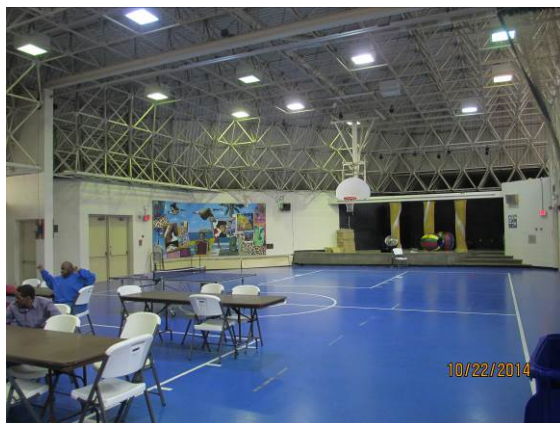
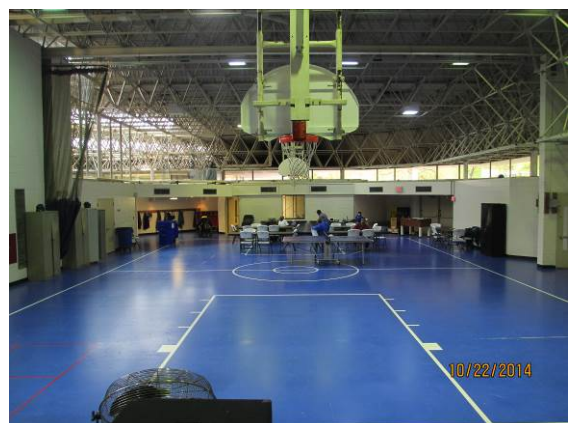
The gym is a large space that doubles as a multipurpose room. The space is divided by a manually operated curtain. There is a concrete stage at one end of the space and a manager's office opposite the stage. The basketball court is not a regulation size and space is limited around the perimeter for spectators during games. The flooring finishes appear to be in fair condition for the multitude of uses. In discussions with the user it was communicated that there are several areas in the ceiling that leak water.

Gymnasium View of Stage

Gymnasium View from Stage

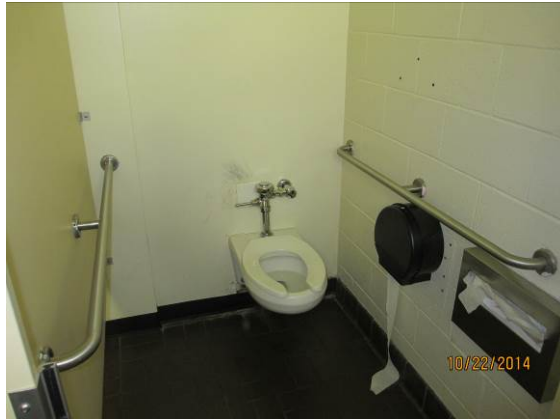
The main men's and women's toilets that serve both buildings are not ADA compliant. The accessible stalls do not have sufficient clearance for transfer to the toilet seat. The spaces do not meet the required circulation for wheel chair maneuverability as well as appropriate grab bar supports. Thermal insulation is not provided under the sink to avoid a scald hazard to wheelchair bound persons. The finishes in these areas are worn and need updating.

HC Stall

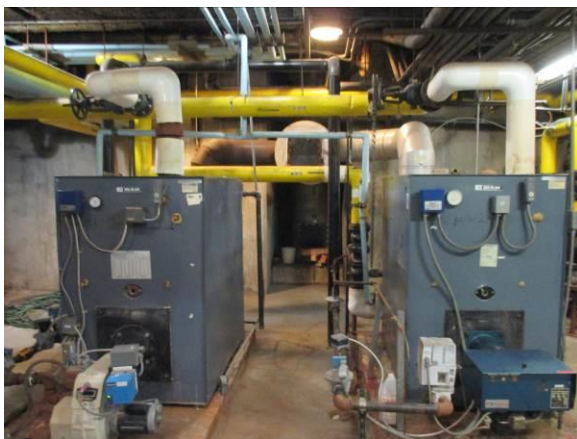
Photo 3.5.1-1: Hot Water Boilers

The majority of the existing hot water heating is in average condition, including boilers, pumps, chemical feeder, expansion tank, and air separator. The existing hot water boiler, B-1, is approximately 7 years old and B-2 is approximately 13 years old. The existing hot water pumps are approximately 13 years old.

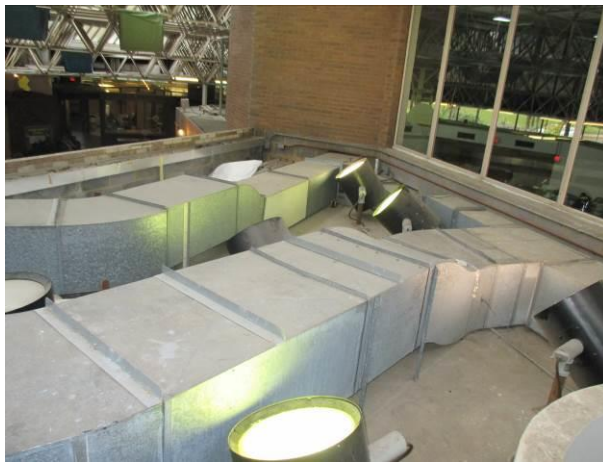
Photo 3.5.4-1: Ductwork

The existing ductwork is installed without insulation, and the ductwork is showing signs of aging. The existing hot water and chilled water piping are insulated with fiberglass. The piping and the insulation are in poor condition and it has surpassed the expected service life defined by ASHRAE.

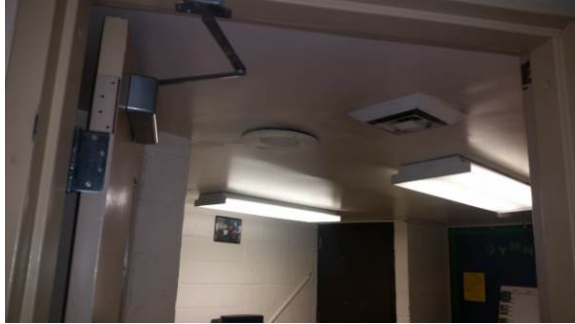
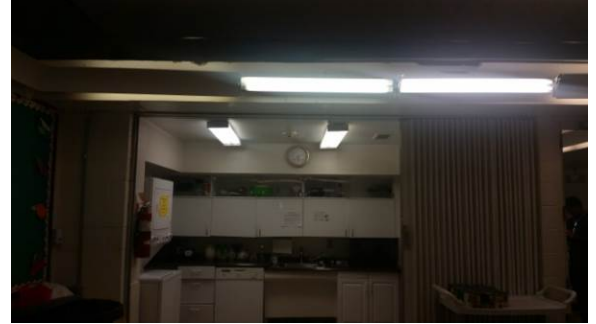
Photo 3.6.1-3 & 4: Typical Light Fixtures in Kitchen and Office Spaces

that were not working and the rooms were dark. Lighting foot-candle levels in some areas are inadequate. They do not comply with the lighting level requirements in the Illuminating Engineering Society of North America (IESNA).

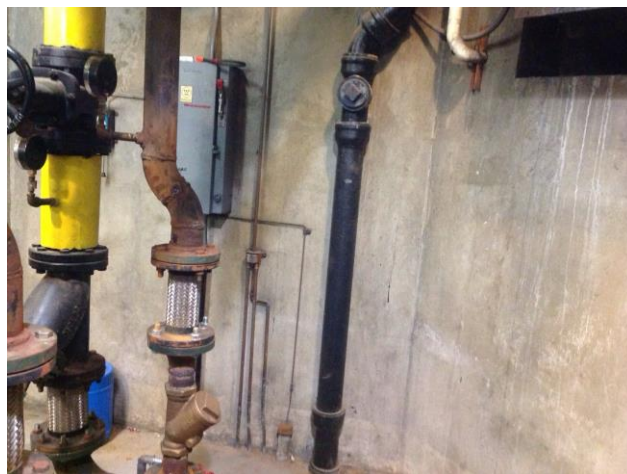
Photo 3.7.3-1: 4-inch Sanitary Building Drain

The sanitary drainage piping within the building is predominately hub and spigot cast iron. The 4-inch sanitary building drain exits the building below the basement slab and leaves to the front of the building. Most of the sanitary drainage system is not exposed for observation but what could be observed does not show significant signs of wear or damage. The existing sanitary building drain system should be inspected internally by video scoping to determine interior condition.

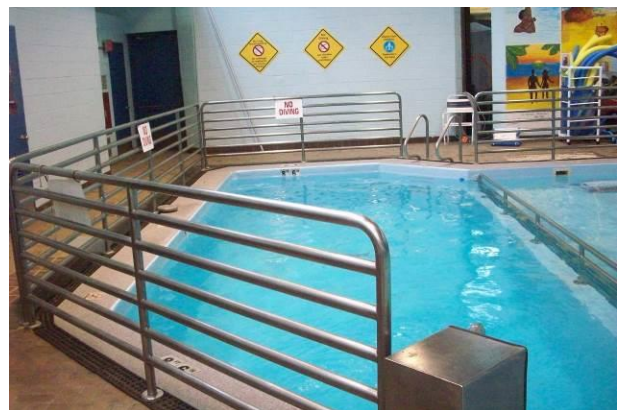
Restricted Deck Access at Deep Area of Pool

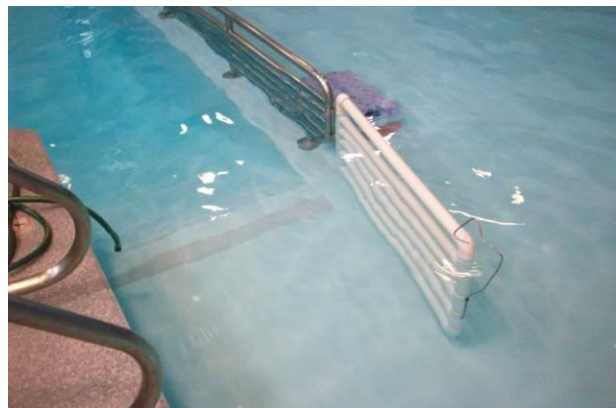
Underwater Gate Access to Deep Area of Pool

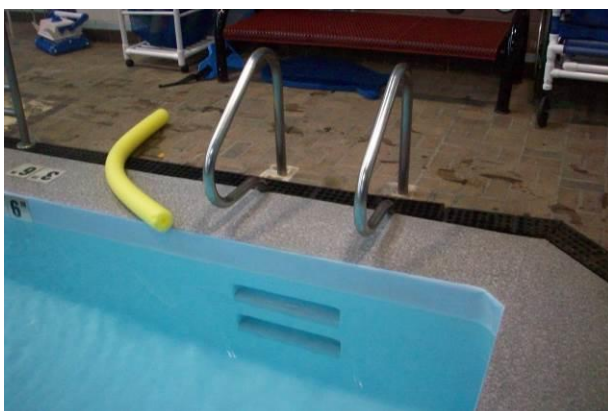
Non-Compliant Recessed Steps

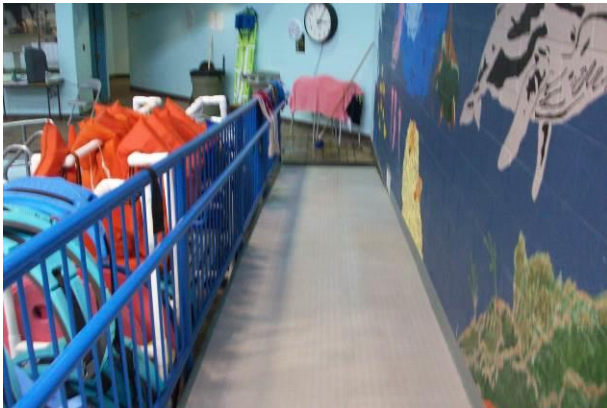
Pool: The ramp to the whirlpool is not ADA compliant. Furthermore, the ramp is constructed of plywood and due to the water pooling in certain areas it may be deteriorating faster than anticipated. Railings are provided only on one side of the ramp. There is also not adequate clearance for wheel chair access to navigate the pool deck.

Ramp to Spa – Not ADA Accessible

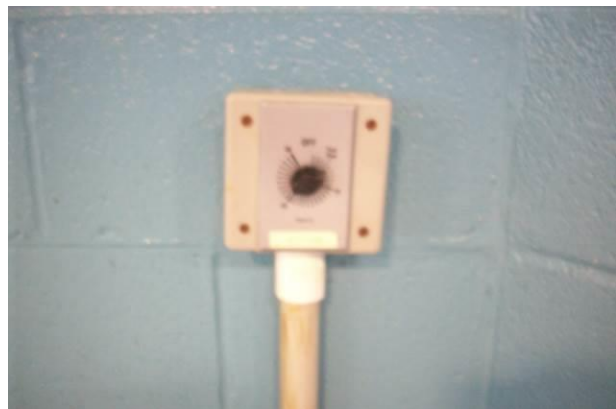
Spa Timer, No Emergency Stop

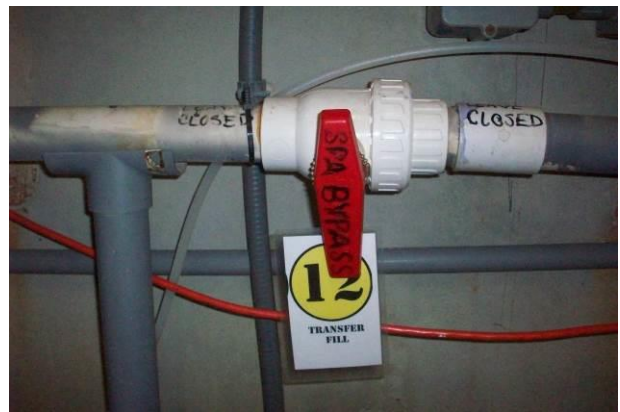
Spa Fill – Cross Connection with Pool

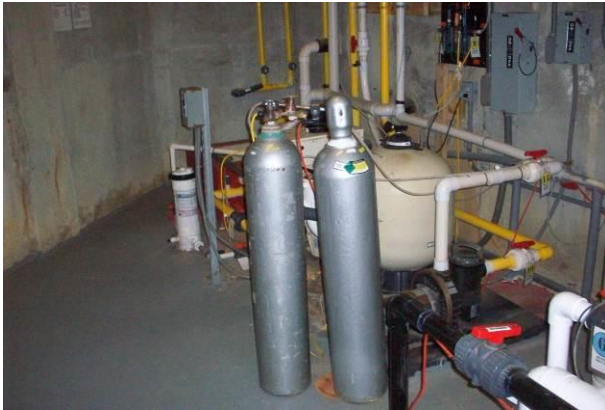
Carbon Dioxide – Unsecured

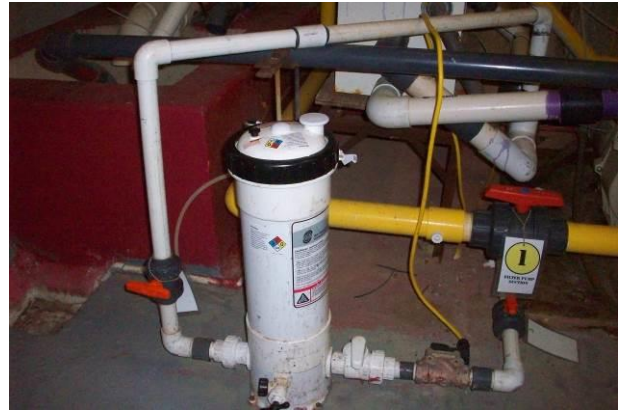
Spa Erosion Bromine Feeder

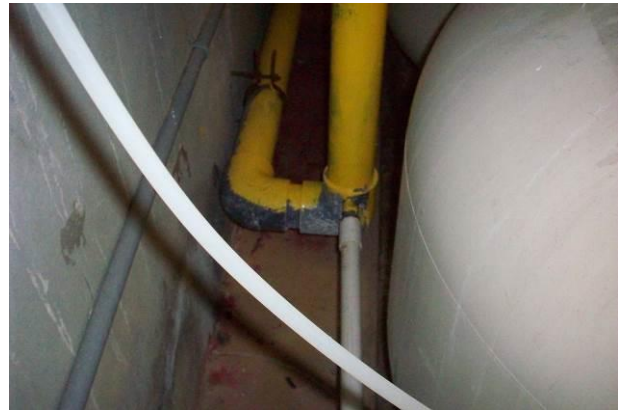
Bromine Feed to Suction Side of Recirc Pump
