Engine House 23 Renovation

ATTACHMENT J.1.13

Engine 23 - FY19  
2119 G St NW  
Washington, DC 20037

***Inspection Date:*** Friday, December 7, 2018

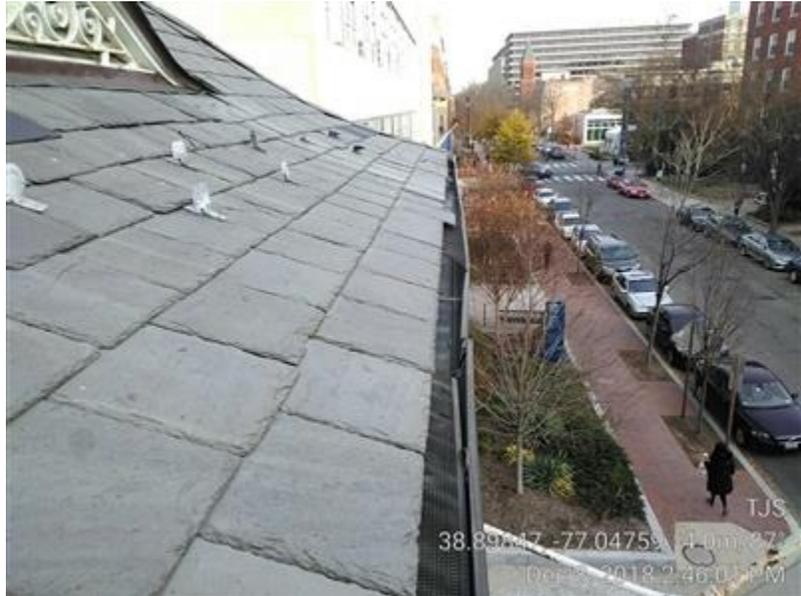
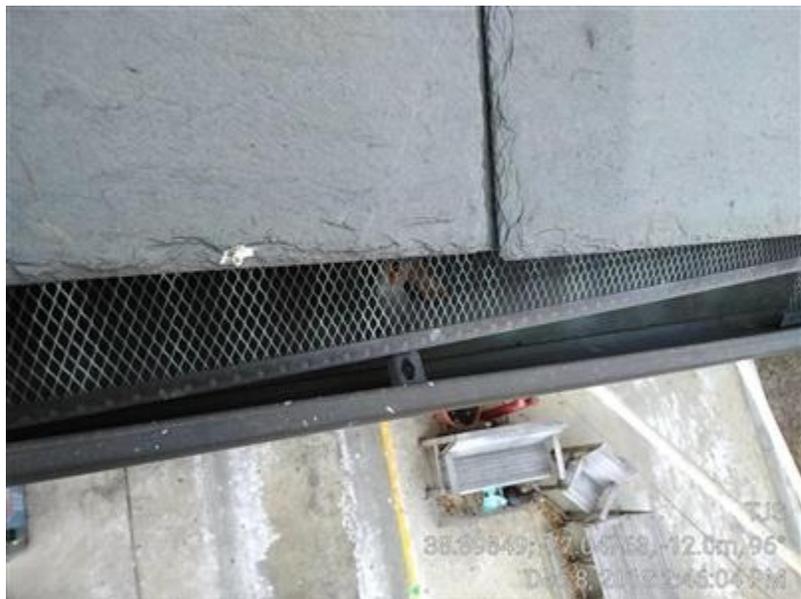
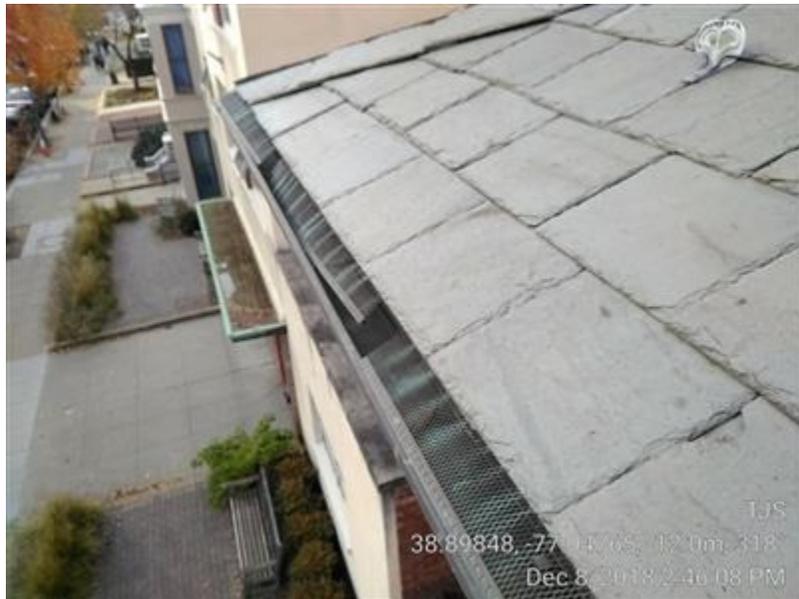
### Defect #8 - Field defect

**Defect:** Point defect - see notes.

**Severity:** See notes (EA) - Low severity.

**Recommendation:** Straighten and reseal damaged section of gutter and reposition gutter screens.

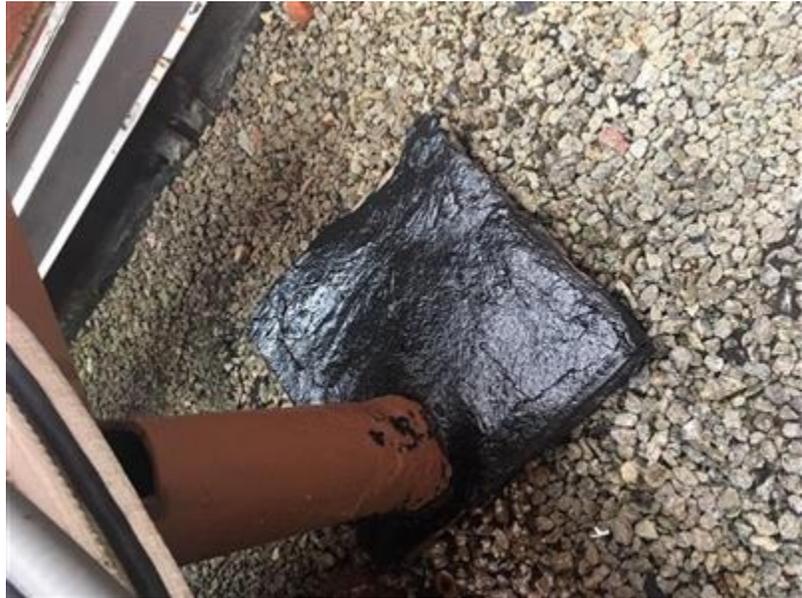
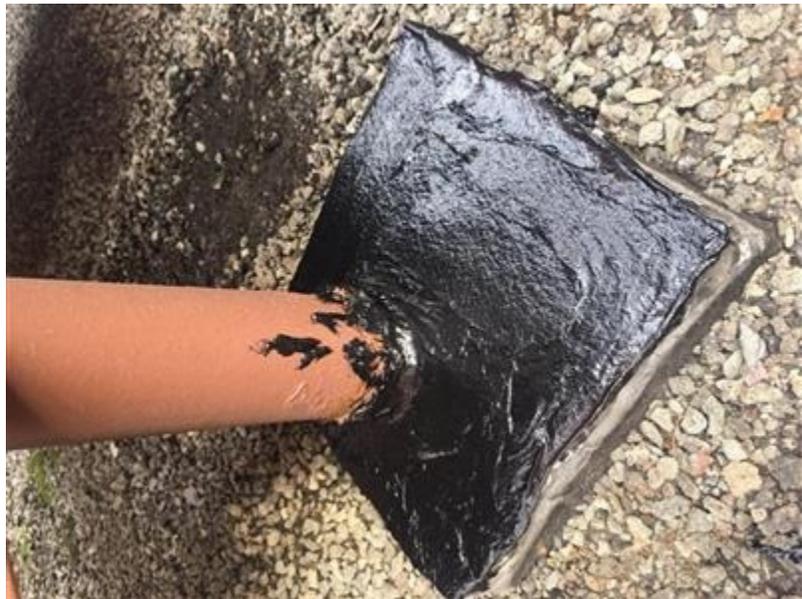
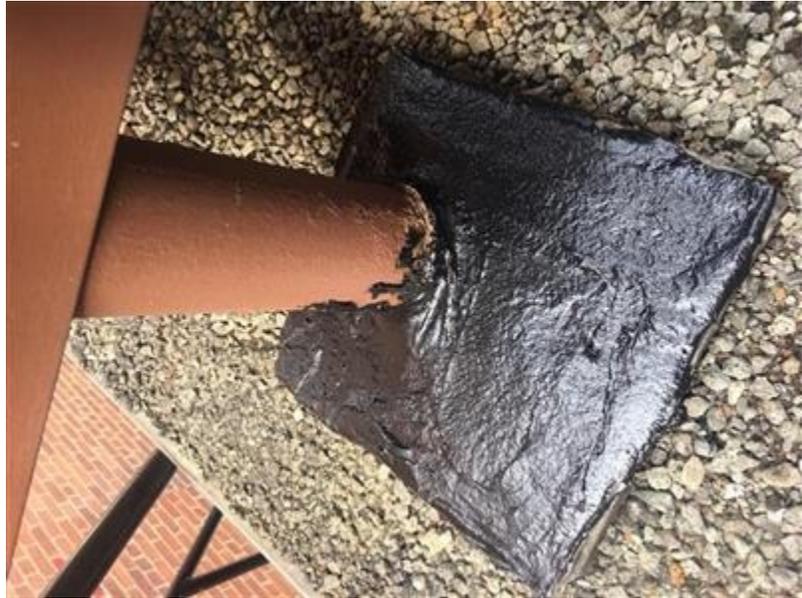
### Defect #1 - Field defect

**Defect:** Pitch pan defect.  
**Severity:** Pitch pan sealer is cracked or separated from the pan or penetration.  
**Status:** Repaired

**Recommendation:** Add pourable sealant and crown for positive drainage. Typical of 4.

**Notes:** 4 Pitch Pans re-sealed and crowned.

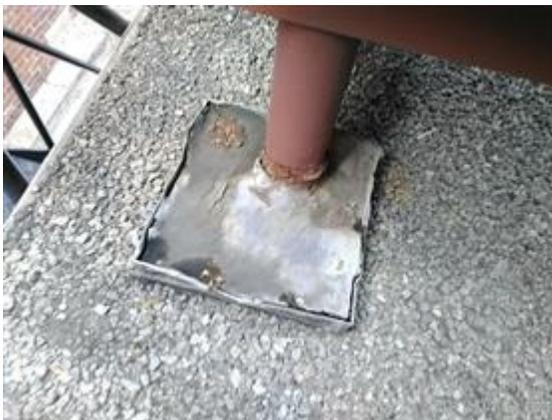
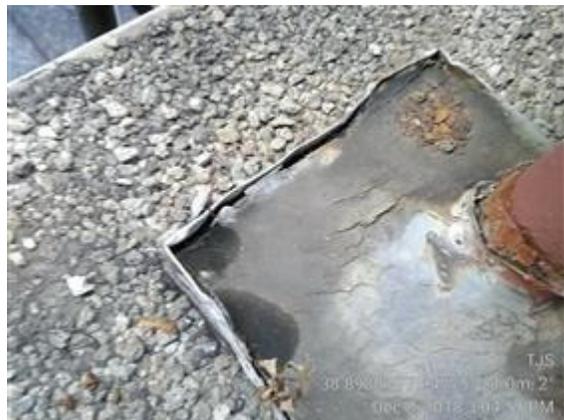
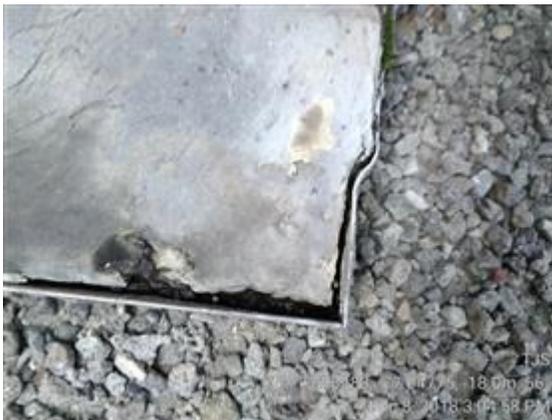
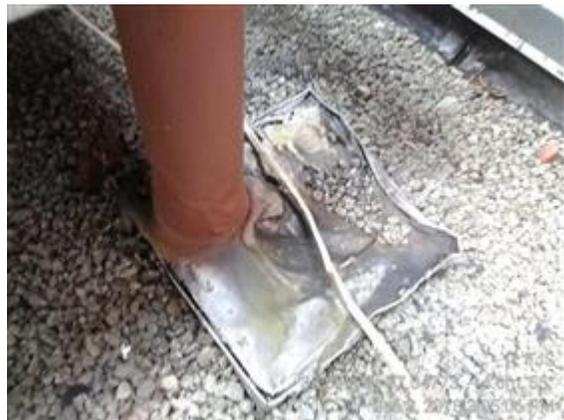
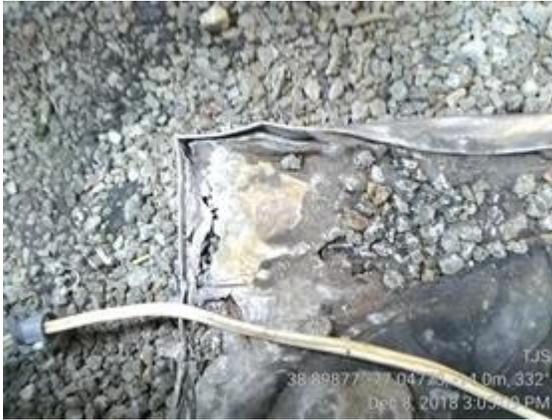
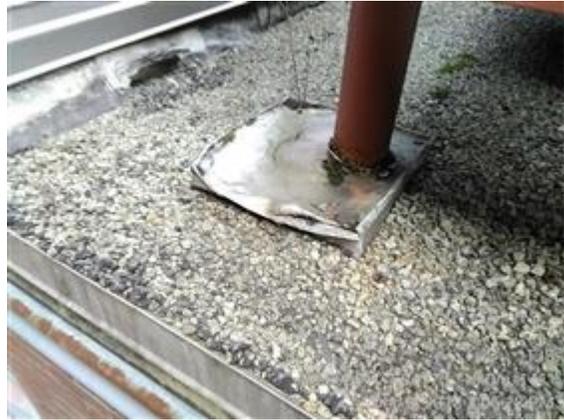
Defect #1: Pitch pan defect

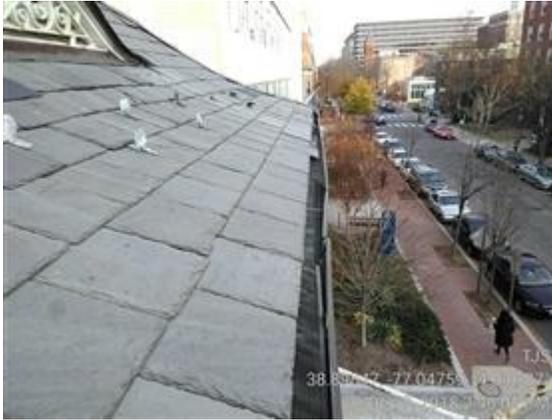
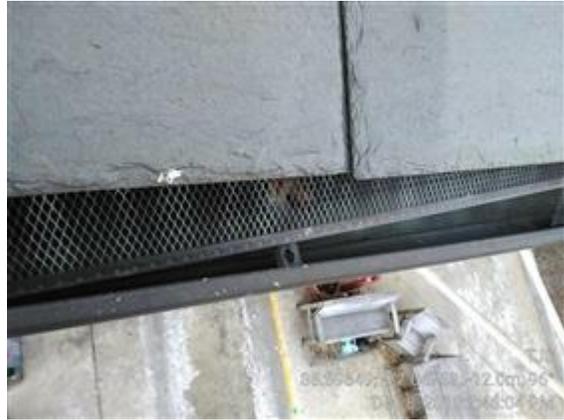
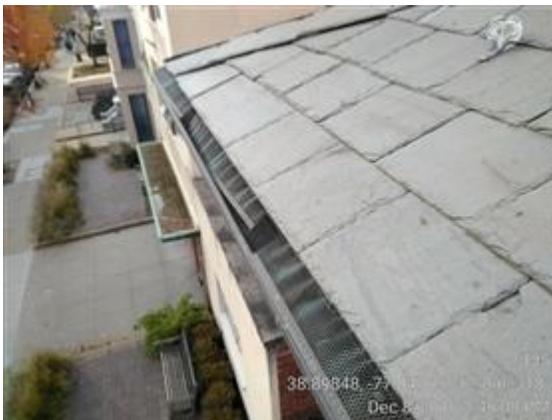
Defect #8: Point defect - see notes
