G-MAX Test and Field Inspection Report

Report No.: 19-013-1

Date of Test: 6/30/2019 (hot, sunny, breezy)

Project Name: Deanwood Recreation – Softball Field
Project Address: 1350 49th Street NE, Washington, D. C.
Contact Name: Will Johnson, FieldTurf - Sr. FieldCare Specialist
Contact Phone: c 302-507-6671
Contact Email: Will_Johnson@fieldturf.com

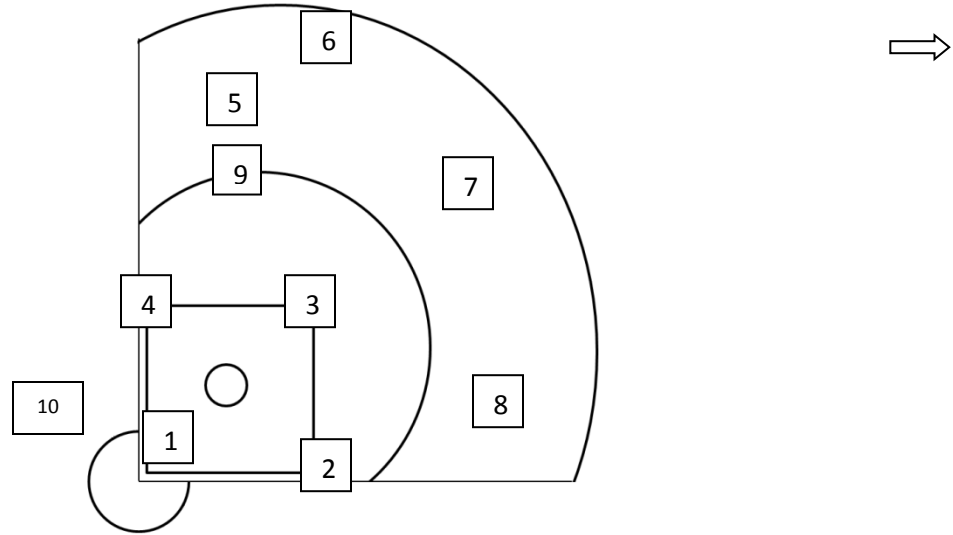
Test Point Location Diagram (Baseball/Softball Field)

Test No.	Test Point Location Description
1	25 ft from the tip of Home Plate to the center of the Pitcher's Mound
2	6 ft. from 1 st Base to 2 nd Base
3	3 ft. from 2 nd Base to 1 st Base
4	4 ft. from 3 rd Base to 2 nd Base
5	Perpendicular to the Mid-Point of 3 rd Base Line, Half the Distance from the Base Line to the Left Field Fence or Boundary Line
6	20 ft from the Left Field Fence or Boundary line toward 2 nd Base, in line with 1 st Base
7	Halfway from 2 nd Base to the Center Field fence or Boundary Line, in line with Home Plate
8	Perpendicular to the Mid-Point of 2 nd Base Line, Half the Distance from the Base Line to the Right Field Fence or Boundary Line
9	Midpoint from 2 nd base to 3 rd base, perpendicular from the baseline to the outside of the colored arc
10	Walkway from on deck area to batter's box
