D.C. DEPARTMENT OF GENERAL SERVICES
WASHINGTON, D.C.

BUILDING ASSESSMENT

LINCOLN THEATRE
1215 U STREET, N.W.
WASHINGTON, D.C.

MARCH 7, 2012

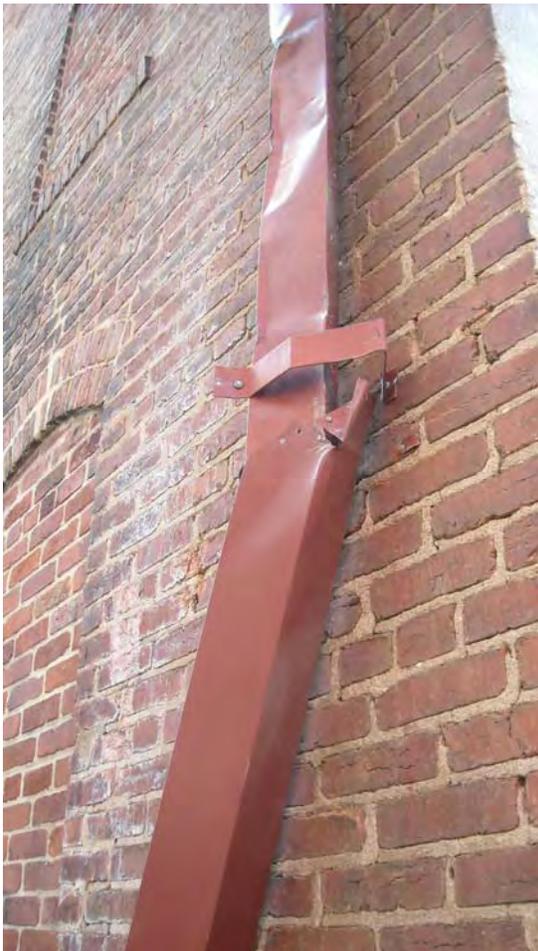
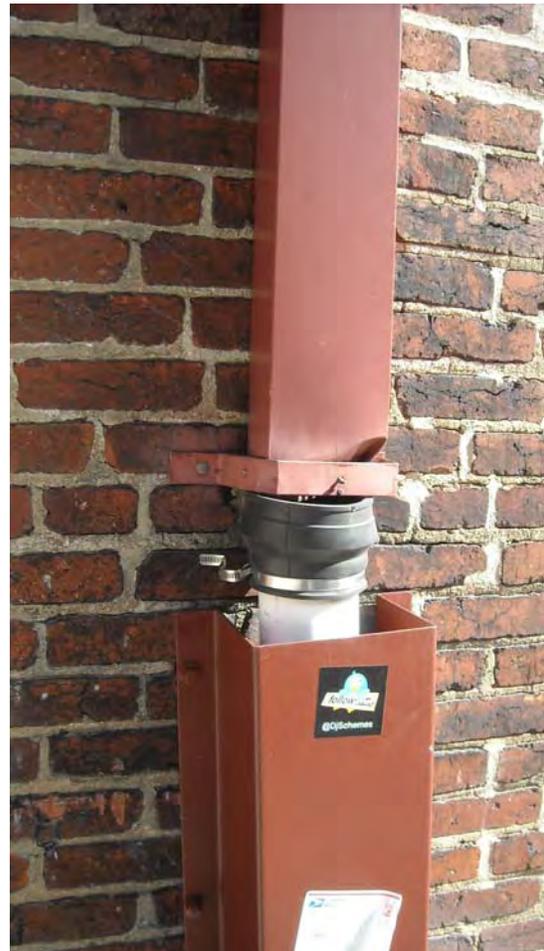
DEFICIENCY NUMBER: A-1

Damaged downspouts spill uncontrolled water onto the Theatre exterior walls and where the building meets the alleyways. This causes water infiltration due to continuous water flow onto the exterior building face, which finds its way into the building. See Deficiency A-1.

DEFICIENCY TITLE: Damaged Downspouts

DEFICIENCY DESCRIPTION:
Damaged downspouts / clogged drain

1. Repair three (3) damaged downspouts.
2. Replace missing downspout.
3. Unclog drain boot.

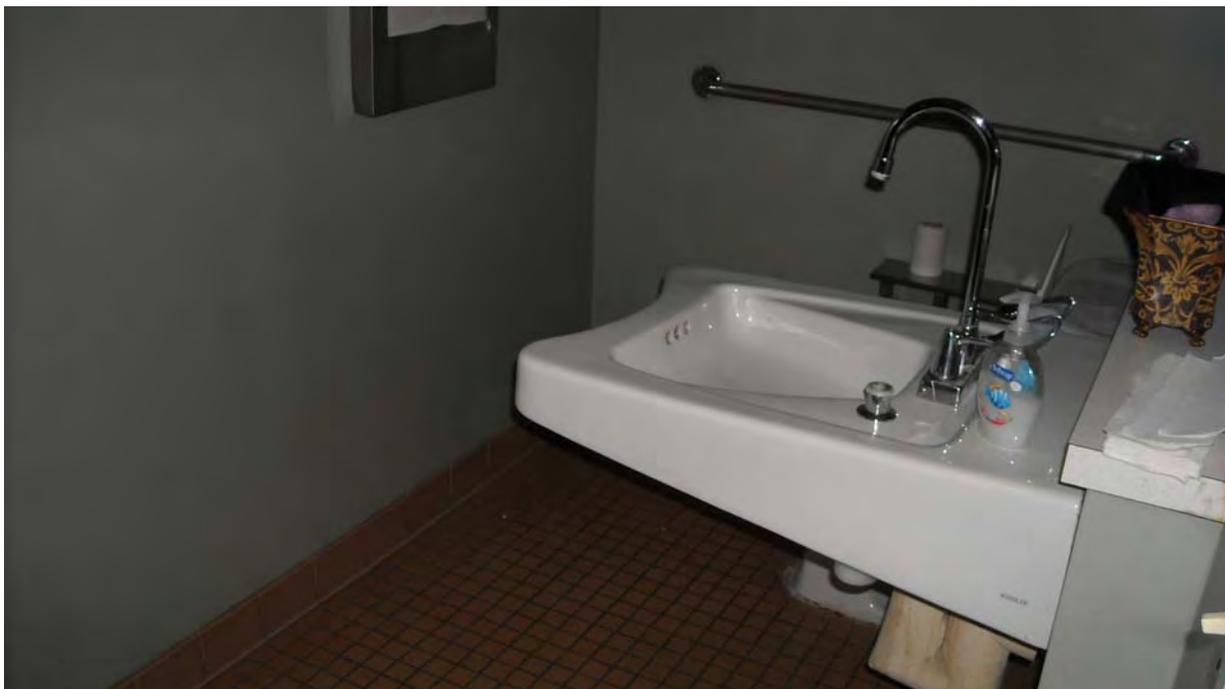
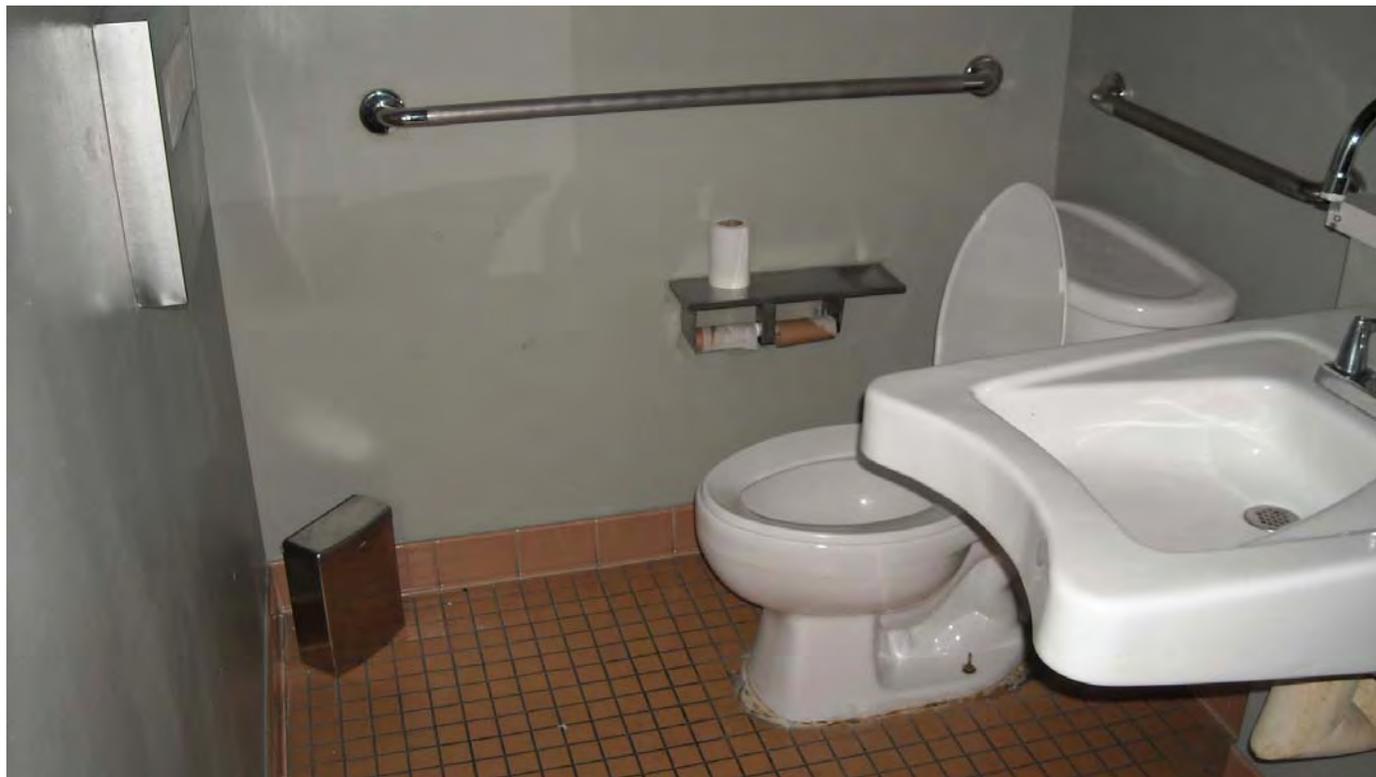
DEFICIENCY NUMBER: A-2

There presently are a gang of men's and women's bathrooms marked accessible just off the main lobby, and appear handicapped accessible. There is also a unisex bathroom marked handicapped on the Theatre level between the lift and main auditoriums, however, the layout of the bathroom is not accessible. This bathroom will either need to be redesigned to accommodate proper access per code or the placard needs to be removed, and be a non-handicapped accessible bathroom, as there is reasonable bathroom access/accommodate off the lower lobby. See Deficiency A-2.

DEFICIENCY TITLE: Non-Compliant Restroom

DEFICIENCY DESCRIPTION:
Remove non-compliant restroom

Option 1: Remove signage and fixtures. Convert to storage.

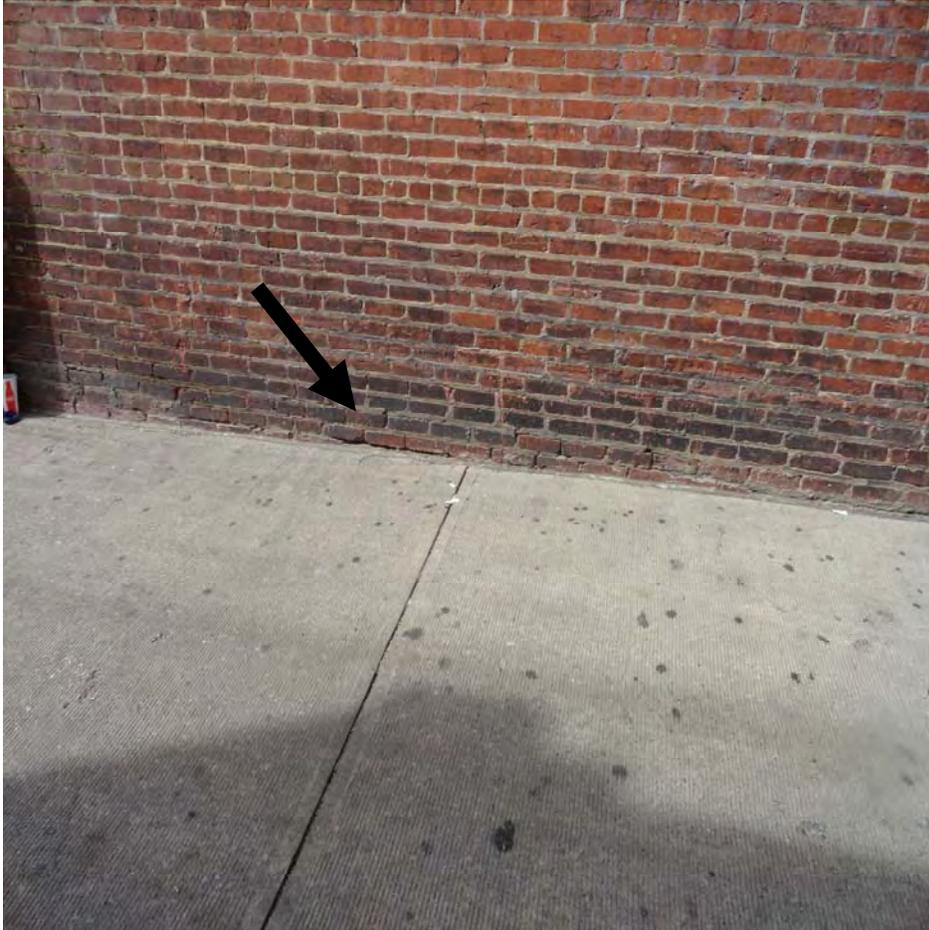
Photo P-1

Grout damage was observed at some locations along the alleys that go full length of the building on both the east and west sides. Three to four courses of the brick veneer located above the alley slab, are eroded. The loss of grout in some cases extends to half the depth of the brick. See Photo 1.

*Deteriorating
brick veneer
and loss of
grout along
alley slab.
Occurs on west
and east alleys.*

Repointing of eroding mortar joints and grouting of existing cracks should proceed immediately to stem any further deterioration of the wall. On the interior, the repairs are more architectural than structural. See Architectural Deficiency A-4 for estimated costs.

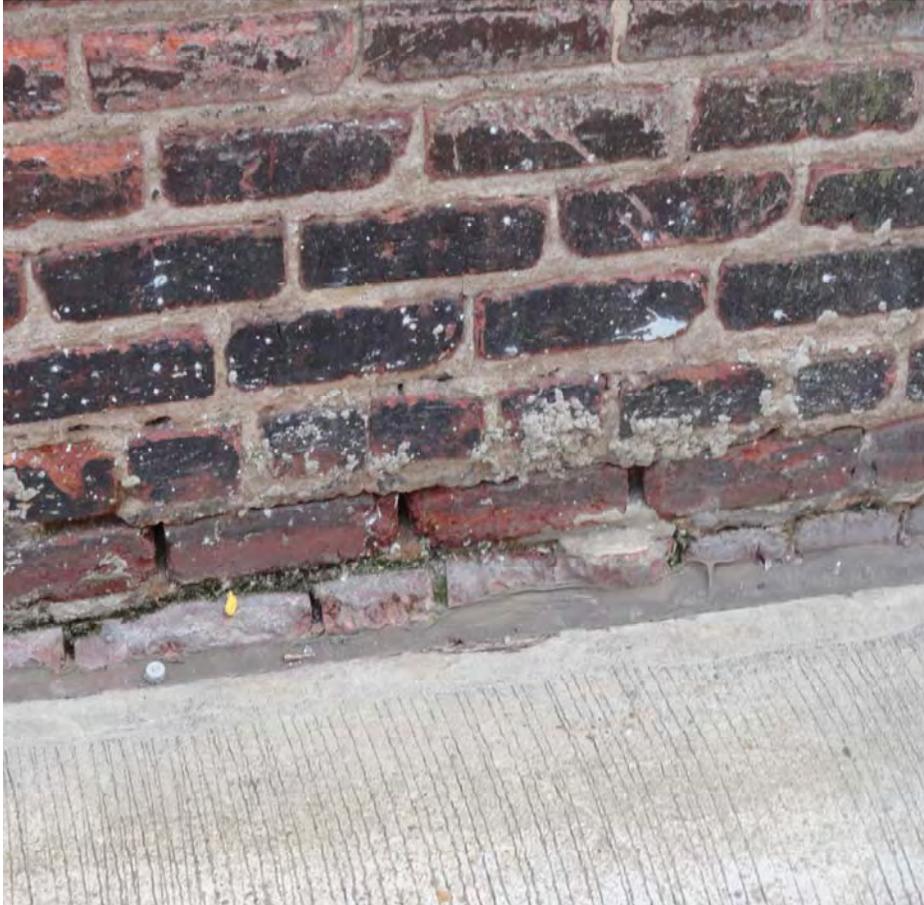
Photo P-2

*Close-up of
deteriorating
brick veneer
and loss of
grout along
alley slab.
Occurs on west
and east alleys.*

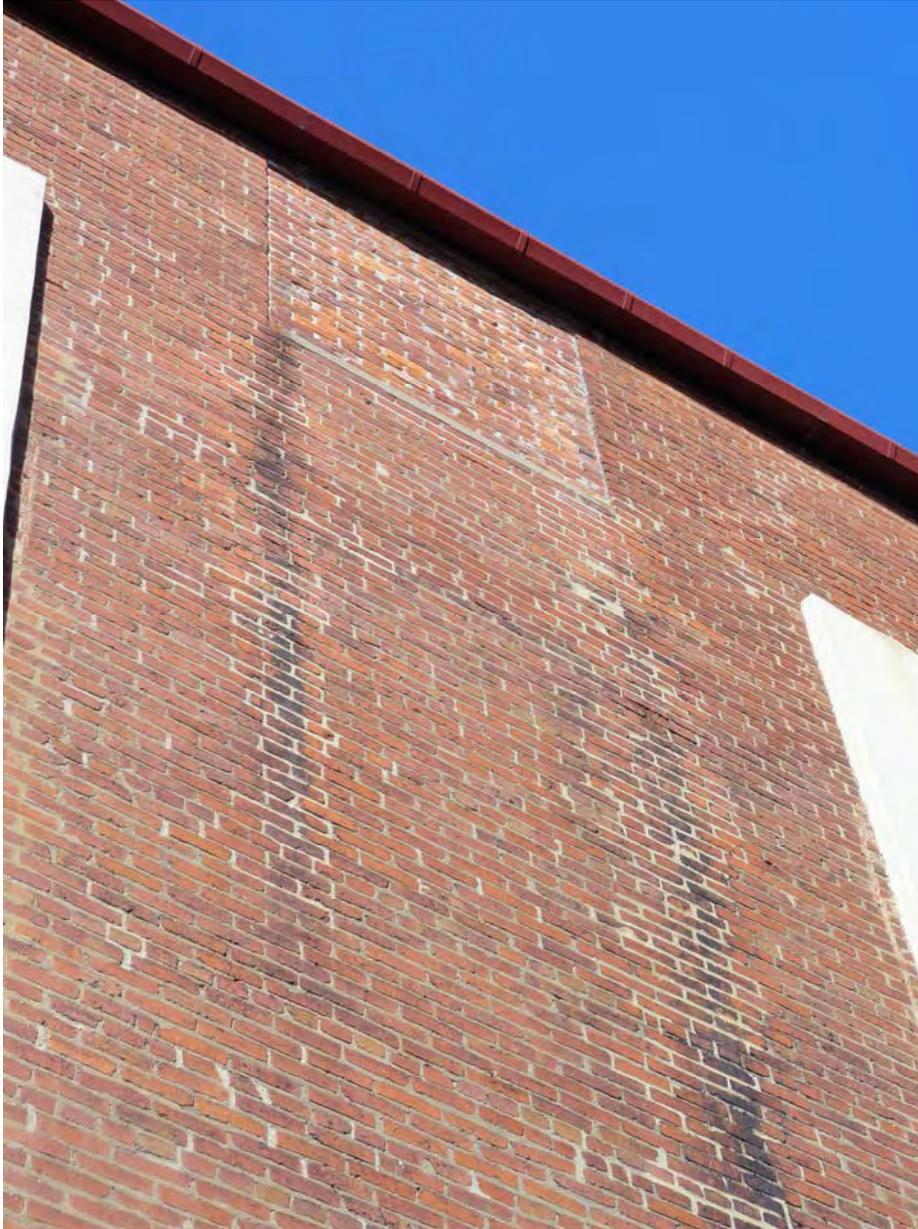
Photo P-3

In-fill of original window. Note recess of new veneer and dark staining where water drains from the recess.

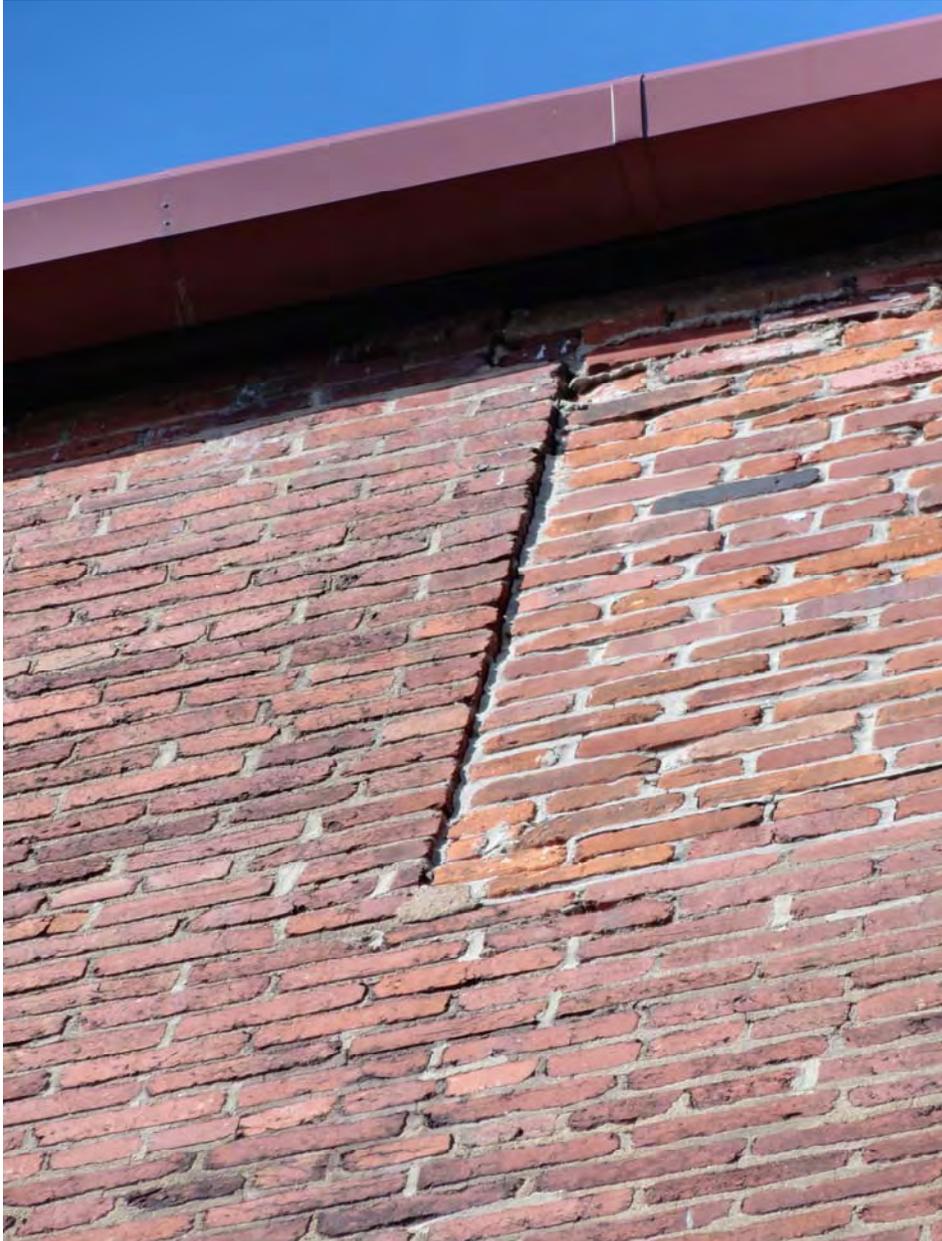
Photo P-4

*Top of in-filled
opening
showing mortar
deterioration.*

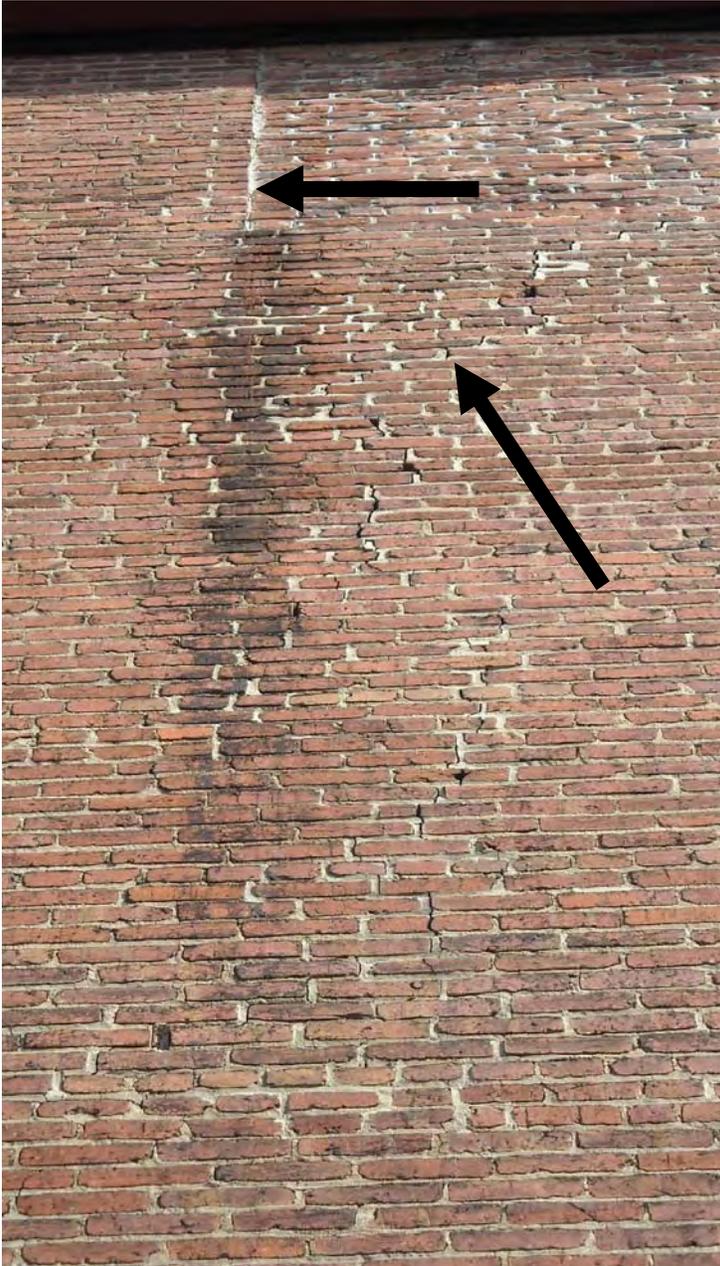
Photo P-5

A stepped crack was discovered in the west wall. See photo 5 and Photo 6. The crack extends from the base of the wall at the alley level up to the corner of an in-fill window opening. Another crack was discovered at the corner of the cornice at the southwest corner of the building.

The cause of these cracks is due to minor settlement in the footing along the west side and could have been made worse by the seismic event of August 2011.

Stepped crack in the west side exterior brick wall.

The crack is below the in-fill of a former fire escape stair doorway.

Arrow indicated the in-fill line of the former door opening.

The distress noticed in the exterior wall of the original building will require a detailed structural investigation. This investigation will require inspection by temporary scaffolding or drops using swing stages.

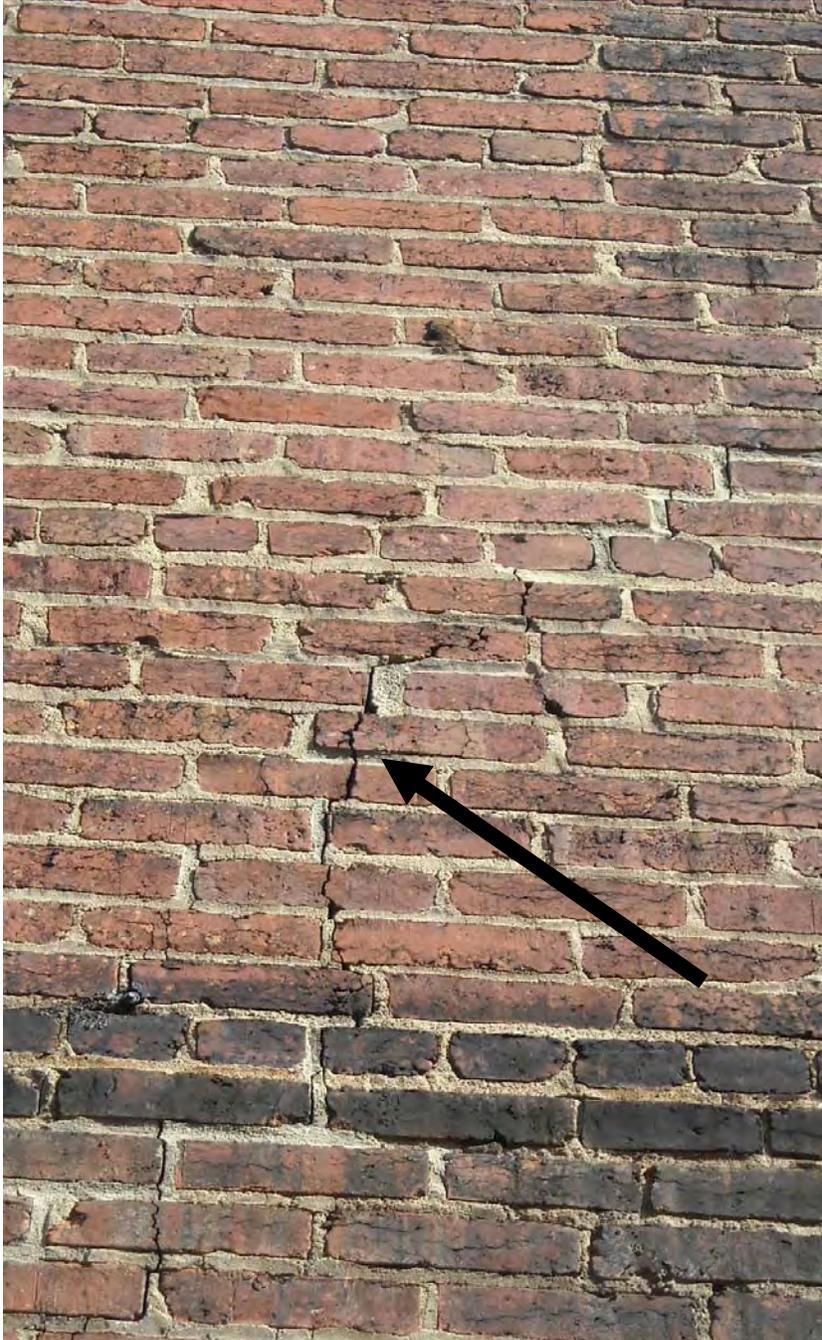
Photo P-6

*Stepped crack in the
west side exterior
brick wall.*

*Arrow indicated
where the crack goes
thru mortar and
brick.*

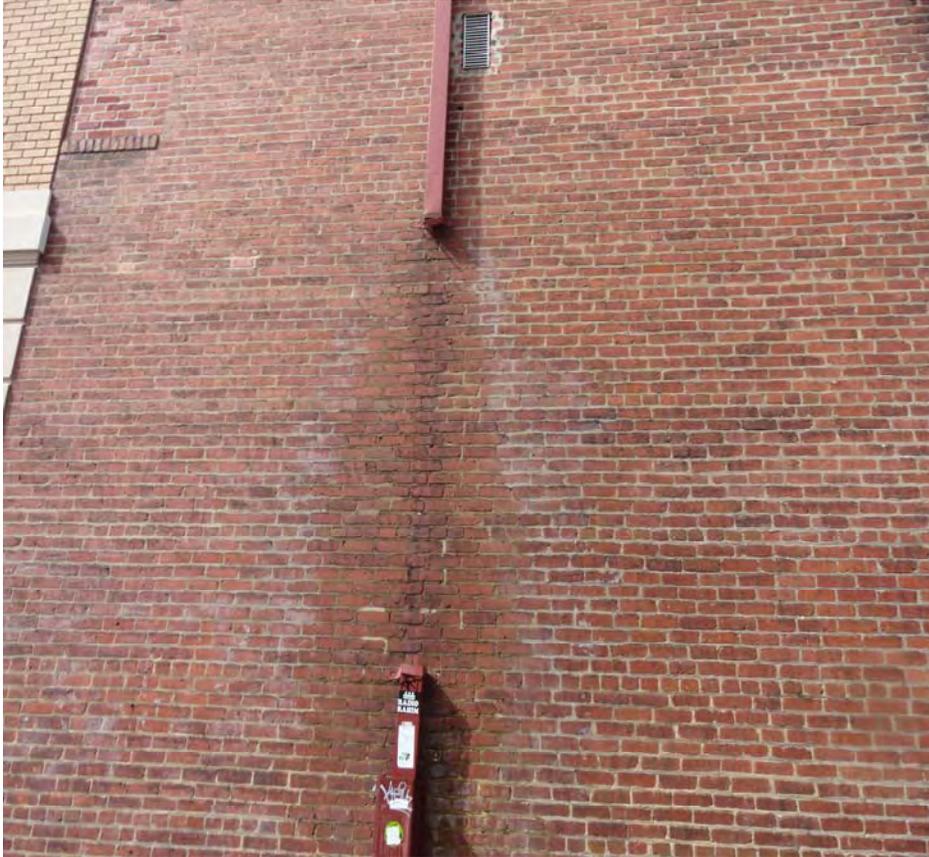
Photo P-7

*Deteriorating
brick veneer
and loss of
grout at
missing
damaged
downspout..*

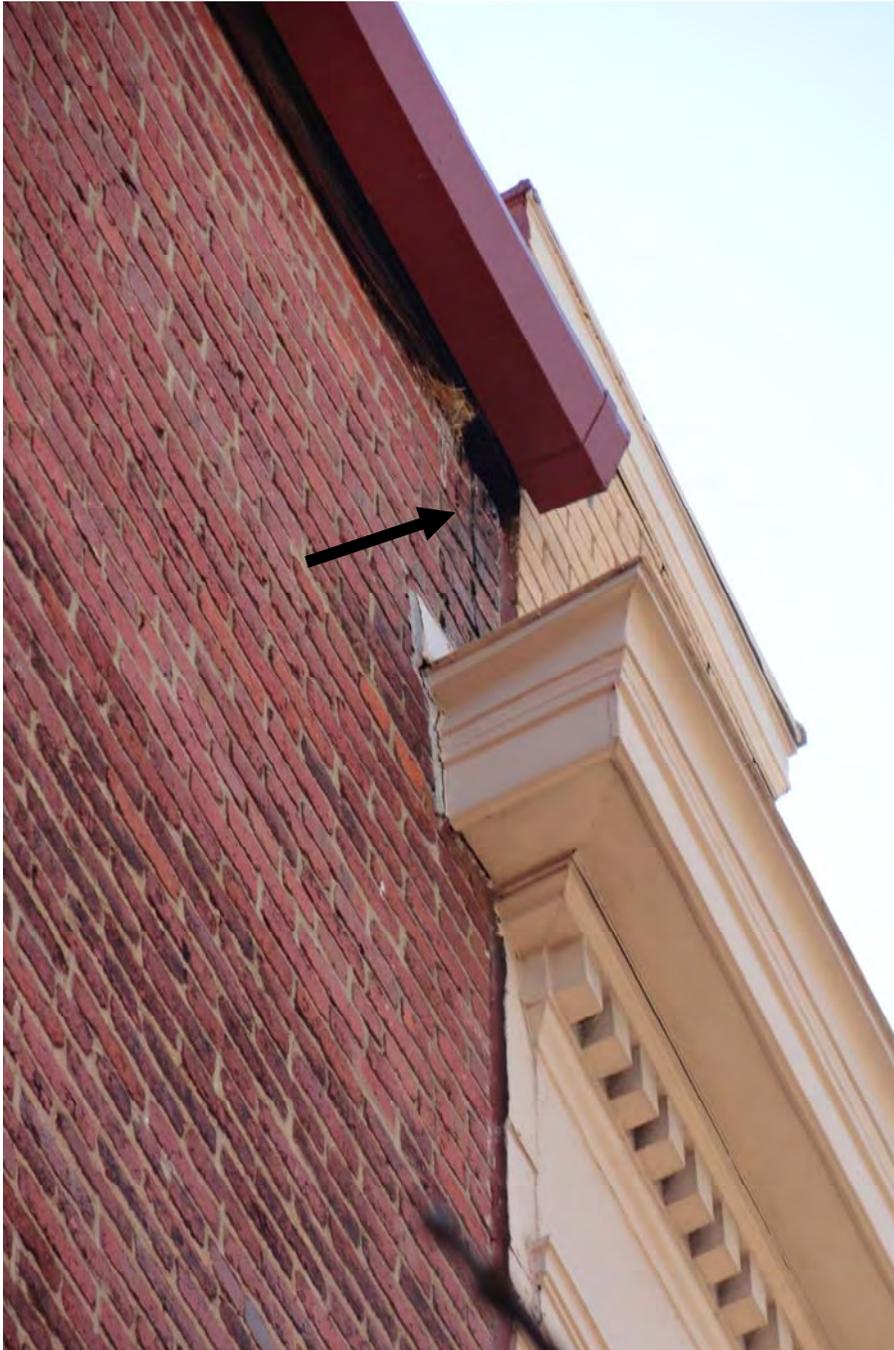
Photo P-8

Deterioration and cracking veneer at top of west wall. Note the vertical crack below gutter.

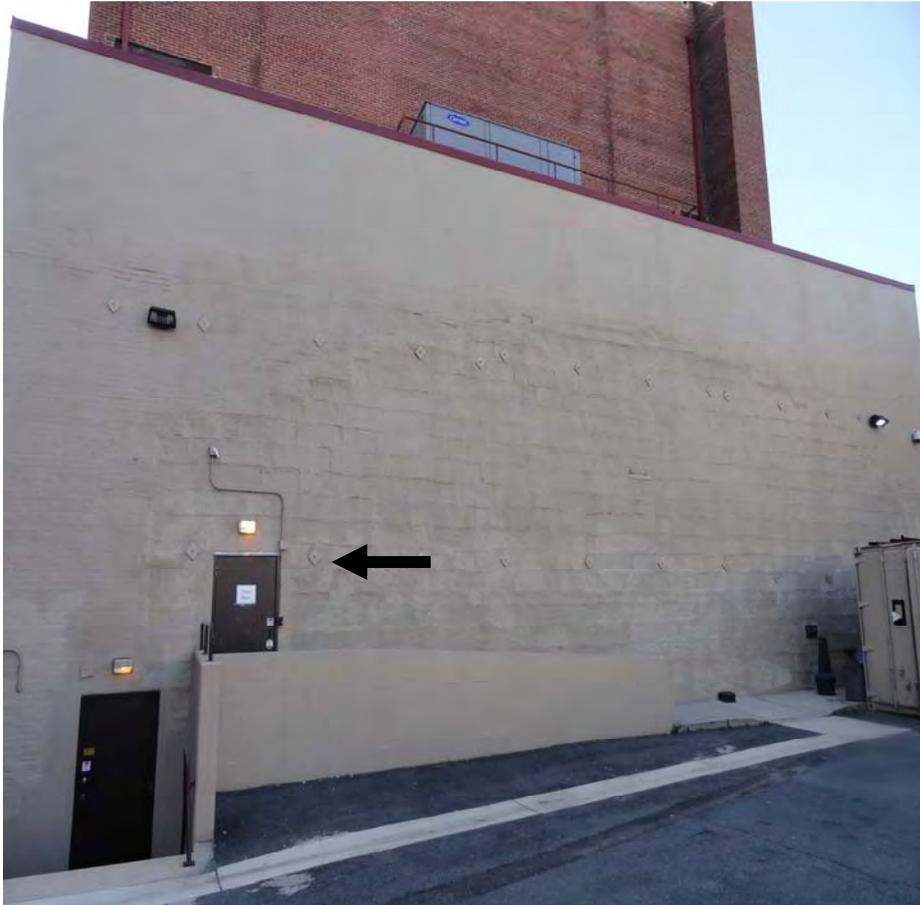
Photo P-9

*Rear wall of
addition at rear
of property.
Note the spread
plates and
through bolts.*

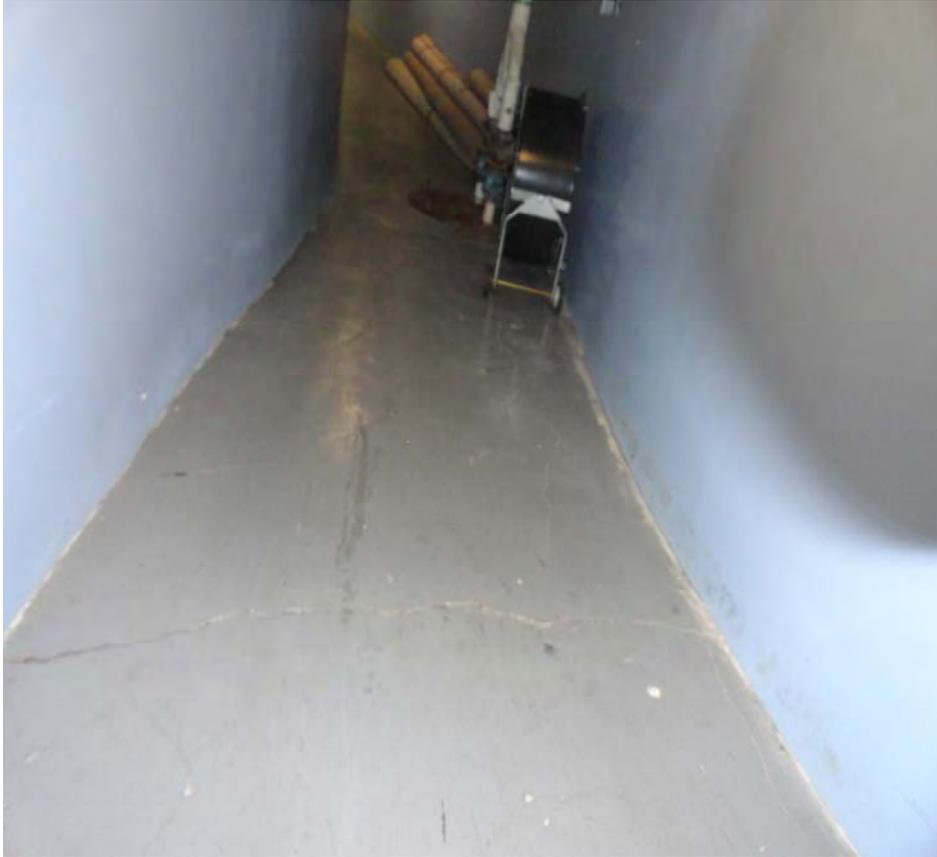
Photo P-10

*Crack in slab
on grade of
corridor at
Basement level.*

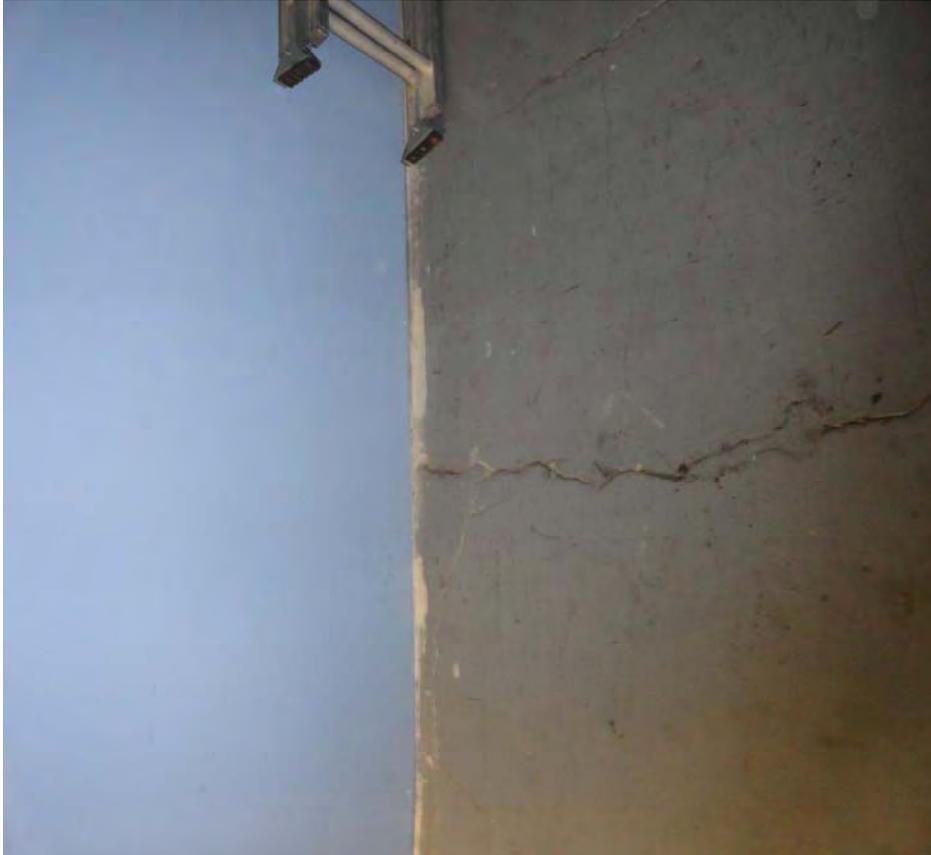
Photo P-11

*Crack in slab
on grade of
corridor at
Basement level.*

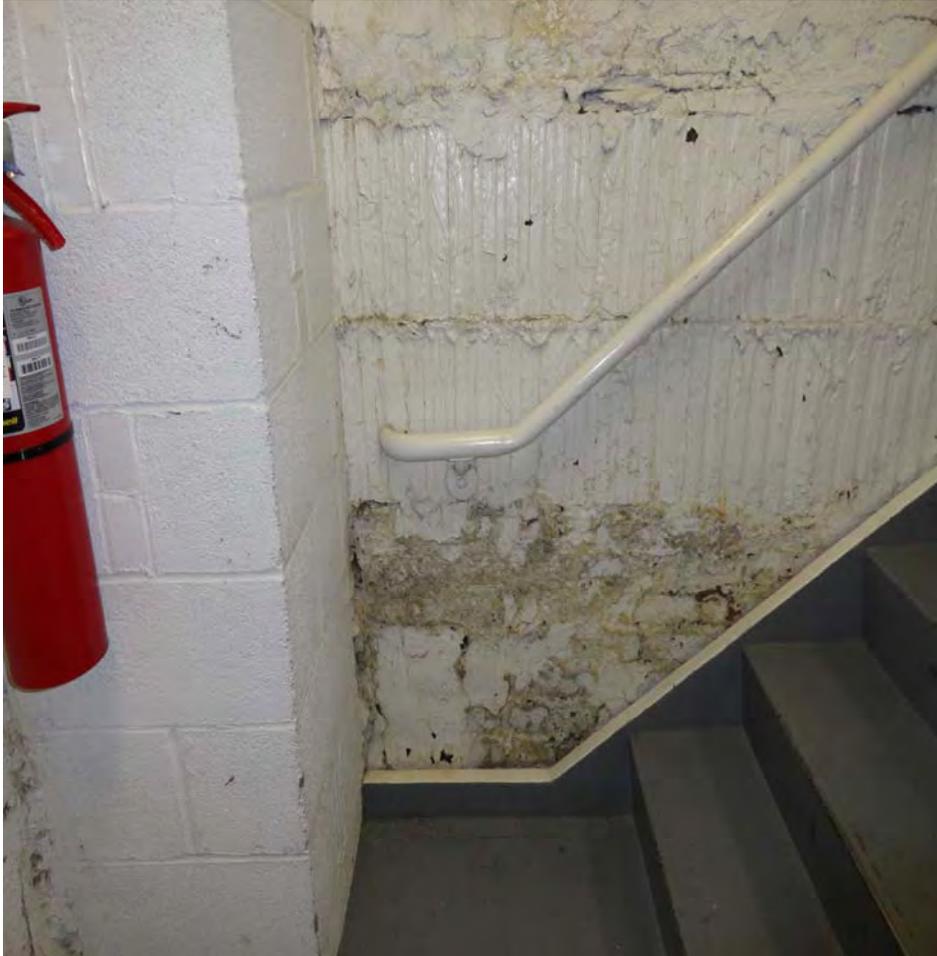
Photo P-12

*Peeling paint
on interior
face of
Basement wall
in the stairwell.*

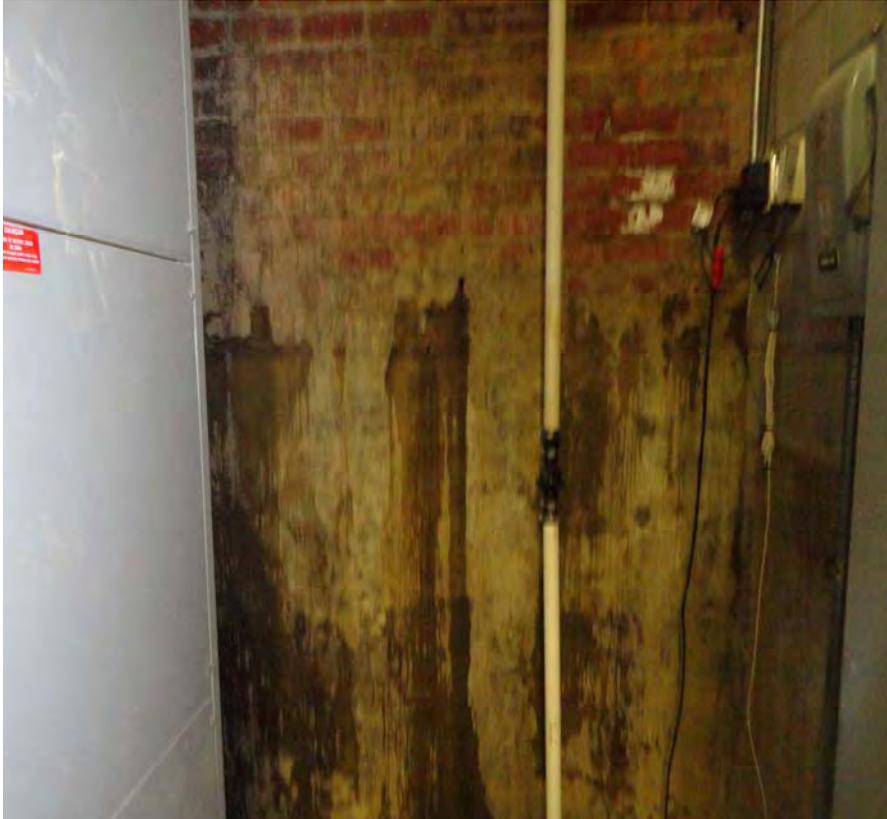
Photo P-13

Wetness and water infiltration was observed at several locations along the exterior walls. In the electrical room in the basement on the west side of the building, water infiltrates through the wall. The water travels down the inside face of the wall and drain into a trough that has a sump pump. At several other locations, the interior paint of the wall shows sign of powdering from moisture traveling through the wall.

Evidence of water infiltration in the Basement Electrical Room.

Pipe is to a sump pump at the floor line.

Water enters from the Alley on the west side of facility.

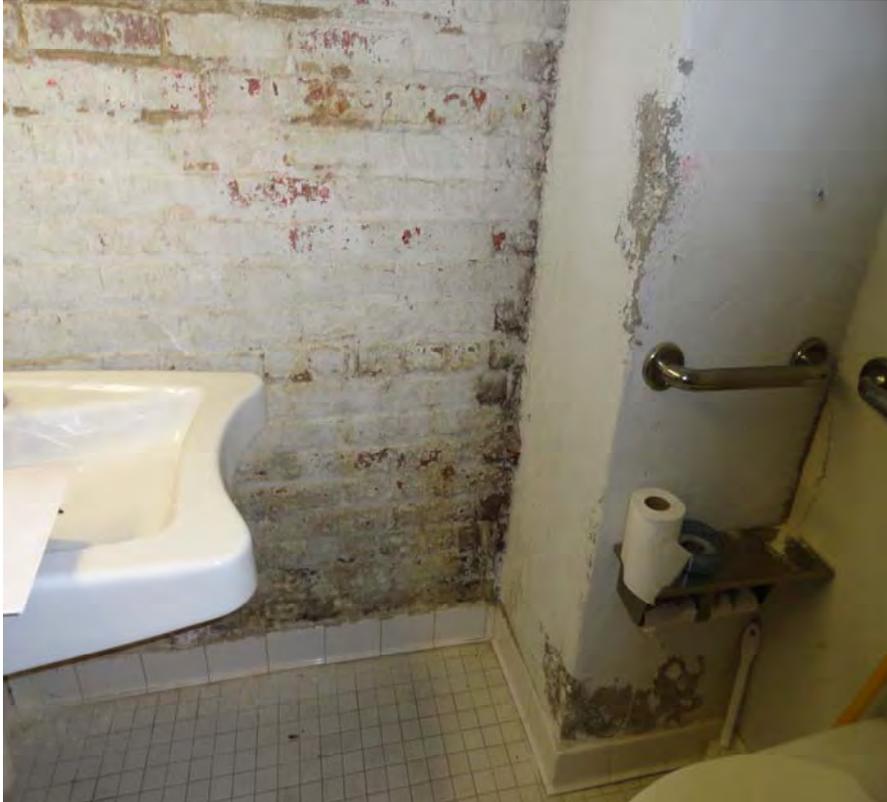
Photo P-14

*Peeling paint on
interior face of
Basement wall.*

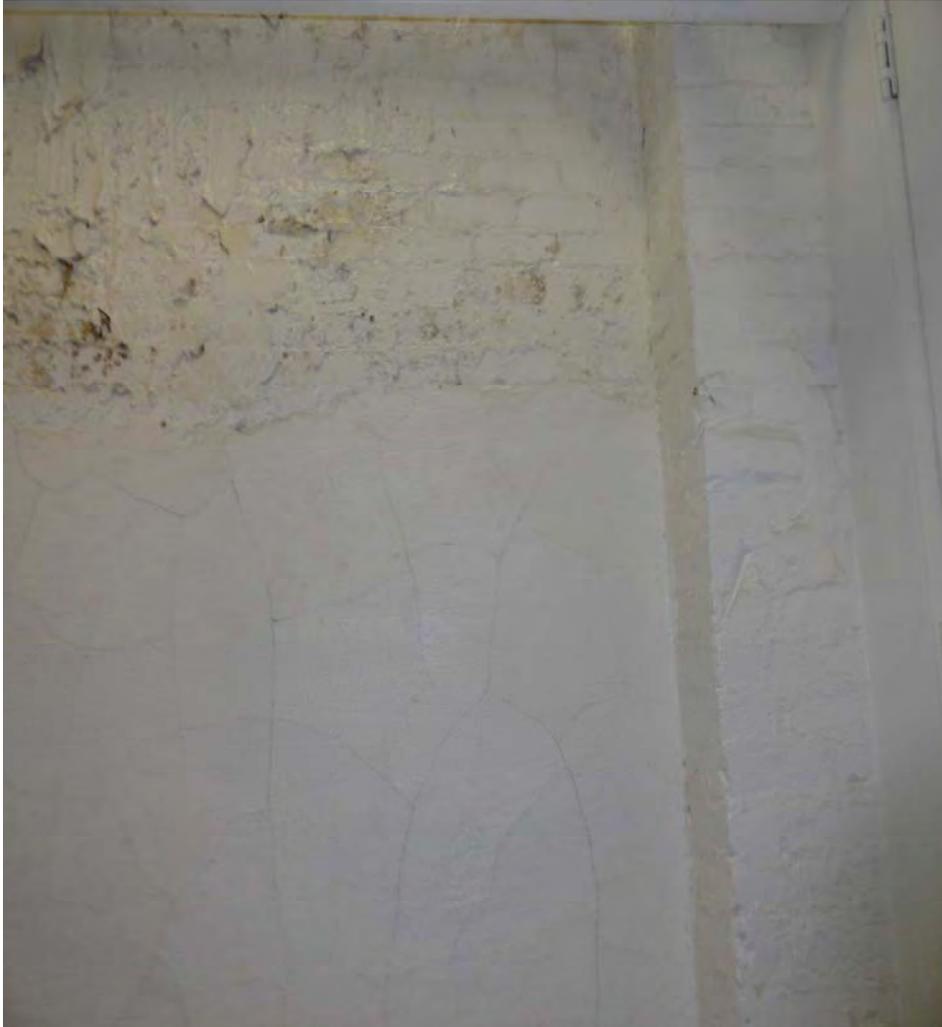
Photo P-15

*Peeling paint
on interior
face of
Basement wall.
Note the
"alligatoring of
the finish below
the exposed
brick.*

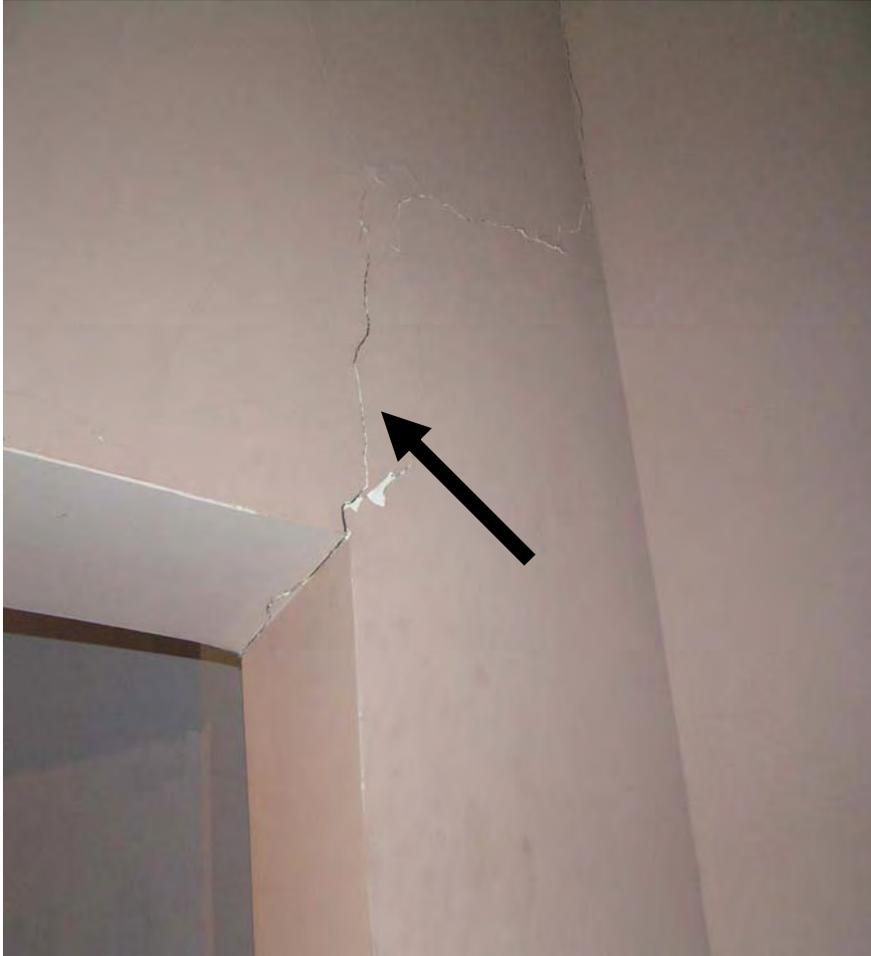
Photo P-16

Crack through the plaster finish at the in-fill doorway of the west side stairwell.

This crack occurs is reflected in the exterior face of the west side wall.

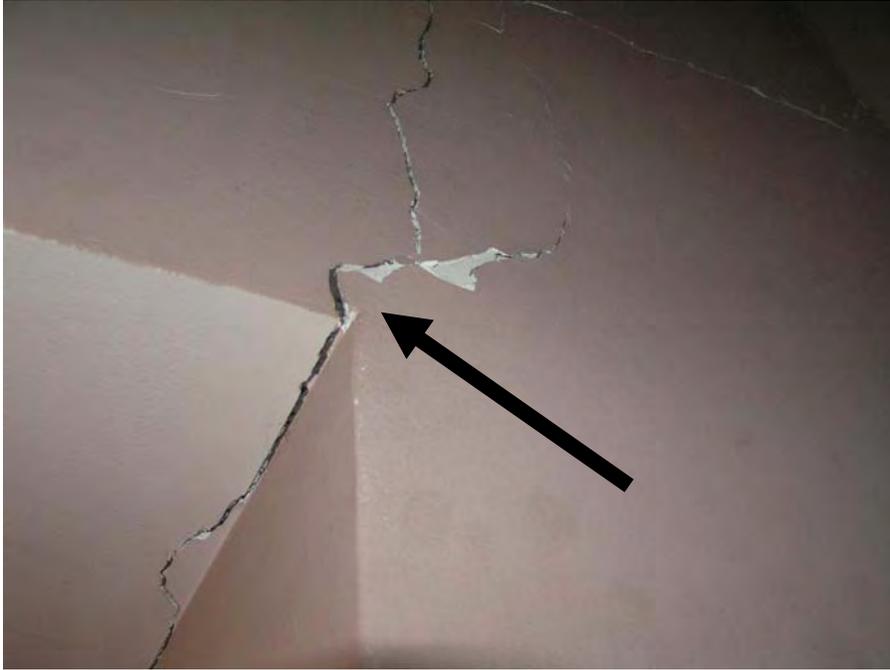
Photo P-17

*Detail of Crack
through the plaster
finish at the in-fill
doorway of the west
side stairwell.*

*This crack is reflected
in the exterior face of
the west side wall.*

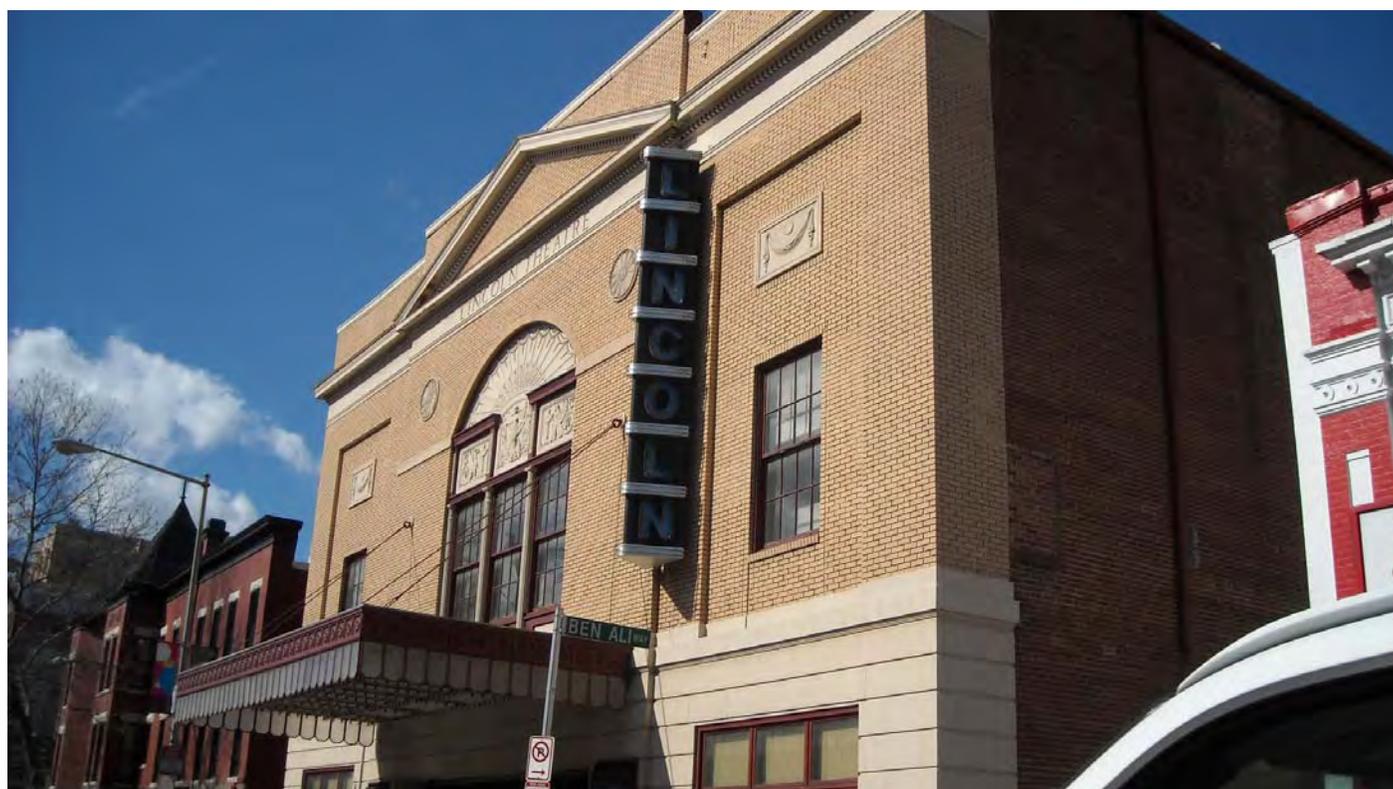
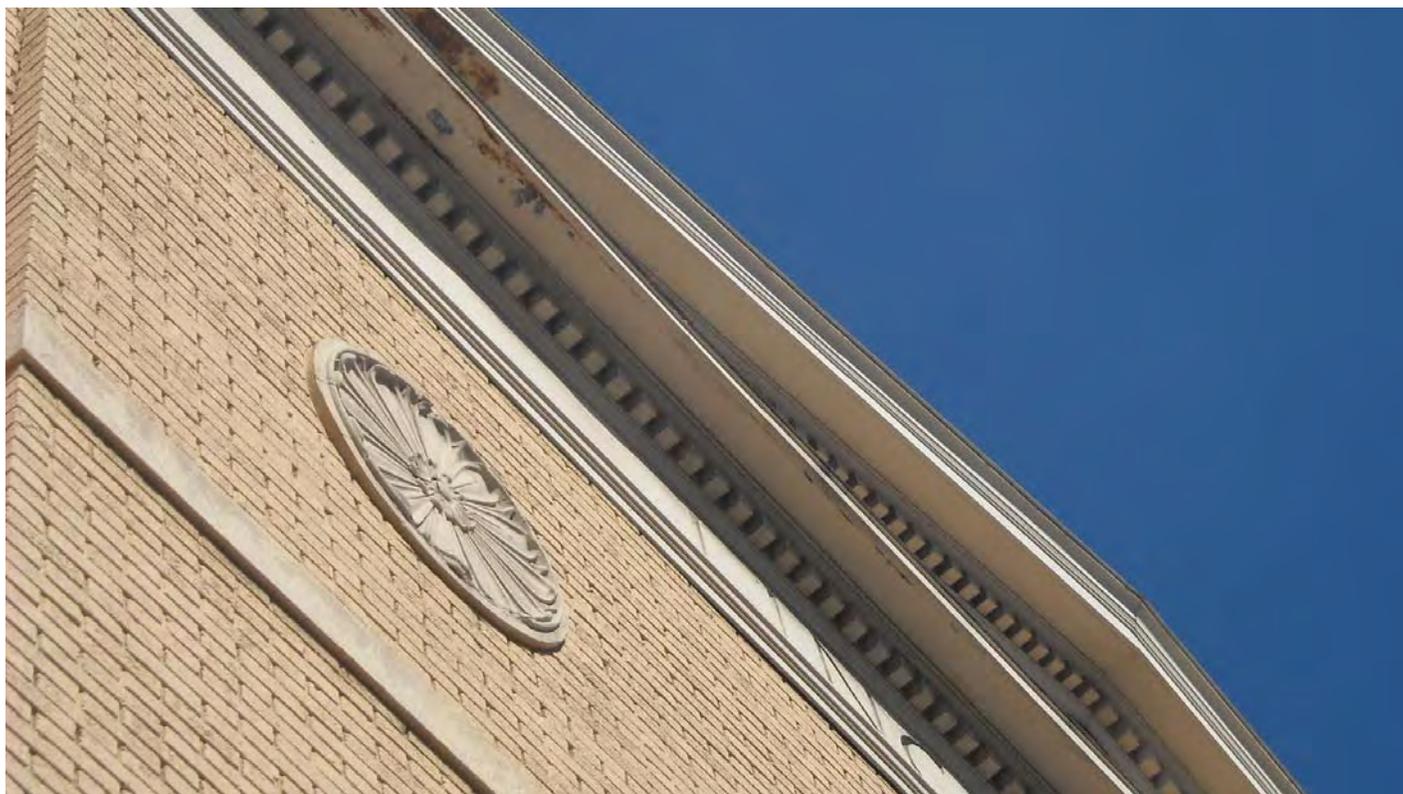
DEFICIENCY DESCRIPTION:
Replace leaking ornamental metal

Perform leak test. Test existing metal for adequate thickness. Remove rusted sections and replace in-kind. Install avian deterrent – repaint.
