D.C. DEPARTMENT OF GENERAL SERVICES
WASHINGTON, D.C.

BUILDING ASSESSMENT

LINCOLN THEATRE
1215 U STREET, N.W.
WASHINGTON, D.C.

MARCH 7, 2012

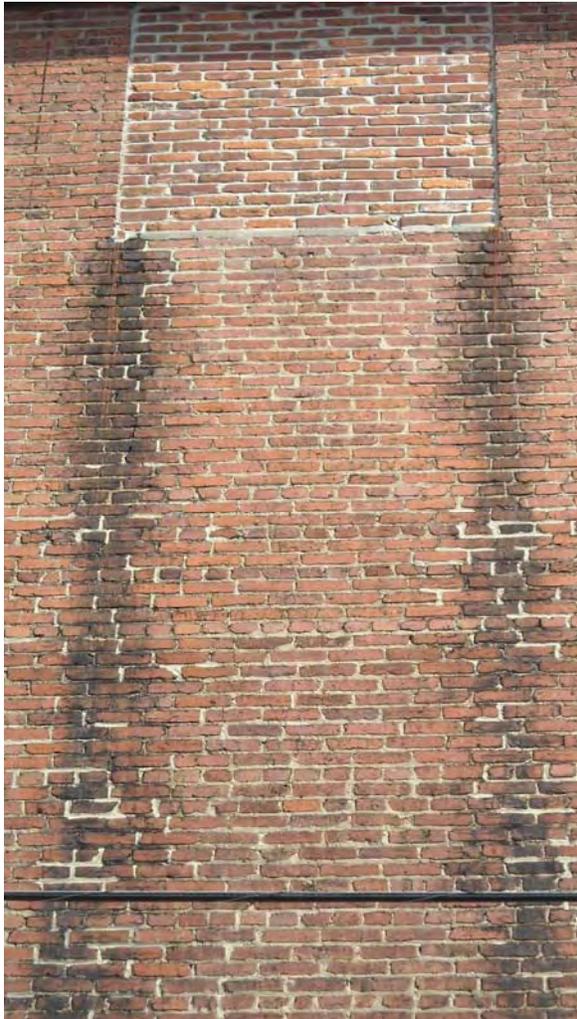
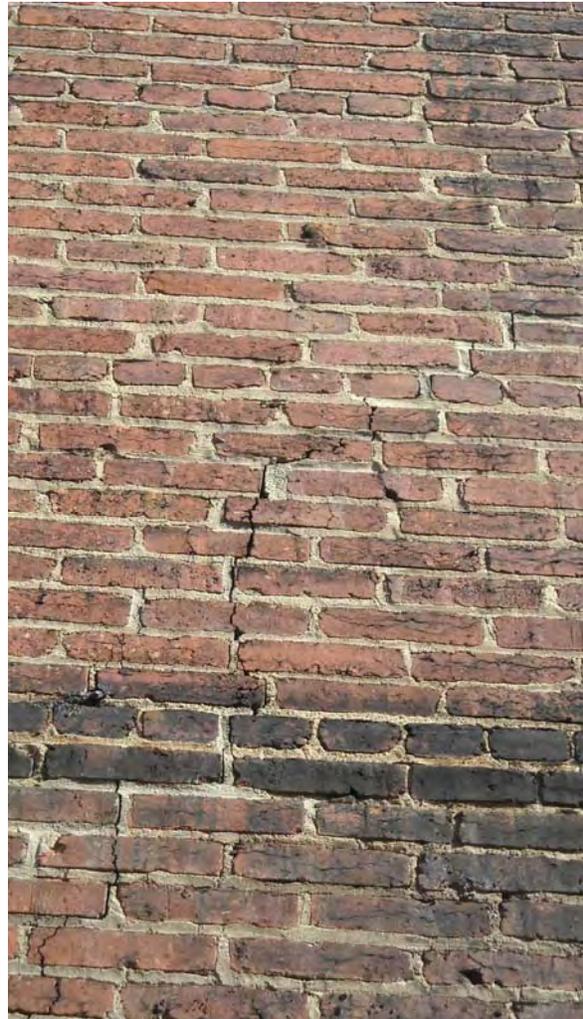
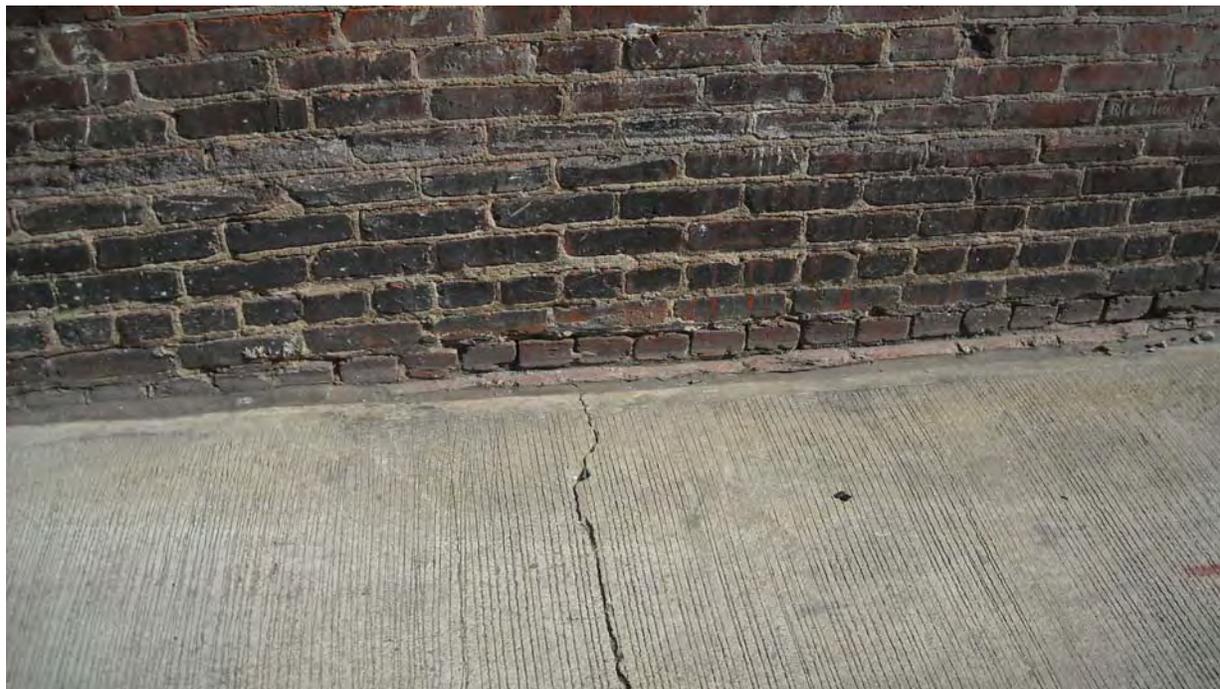
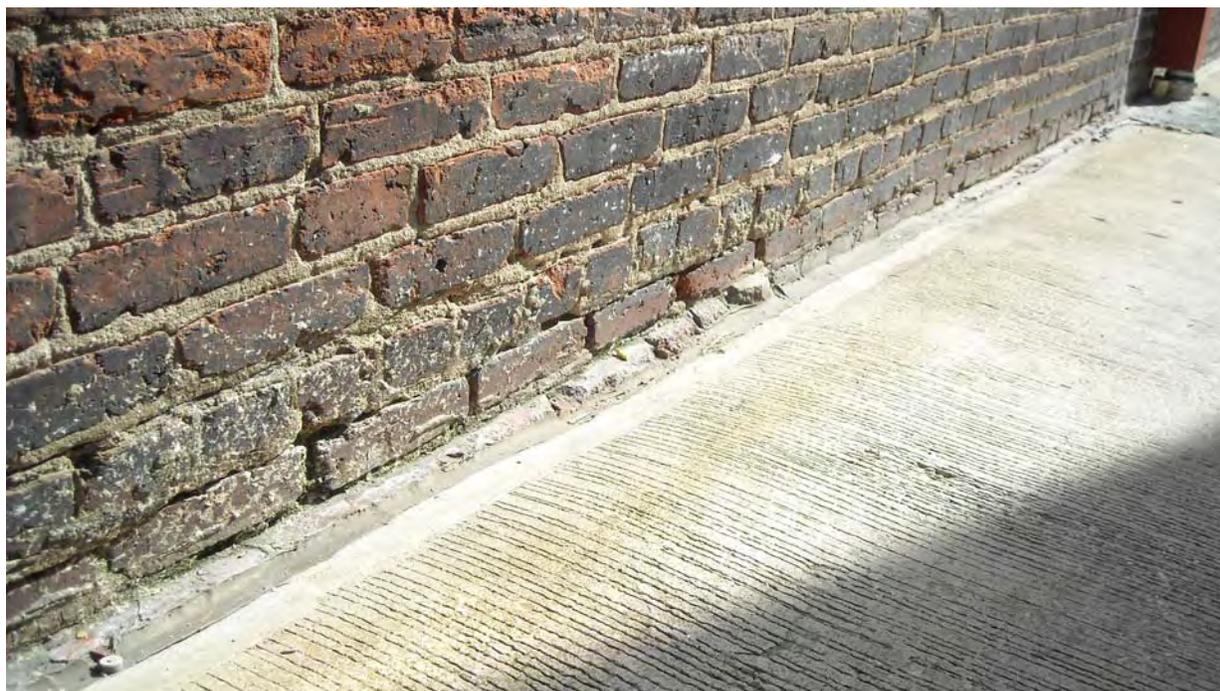
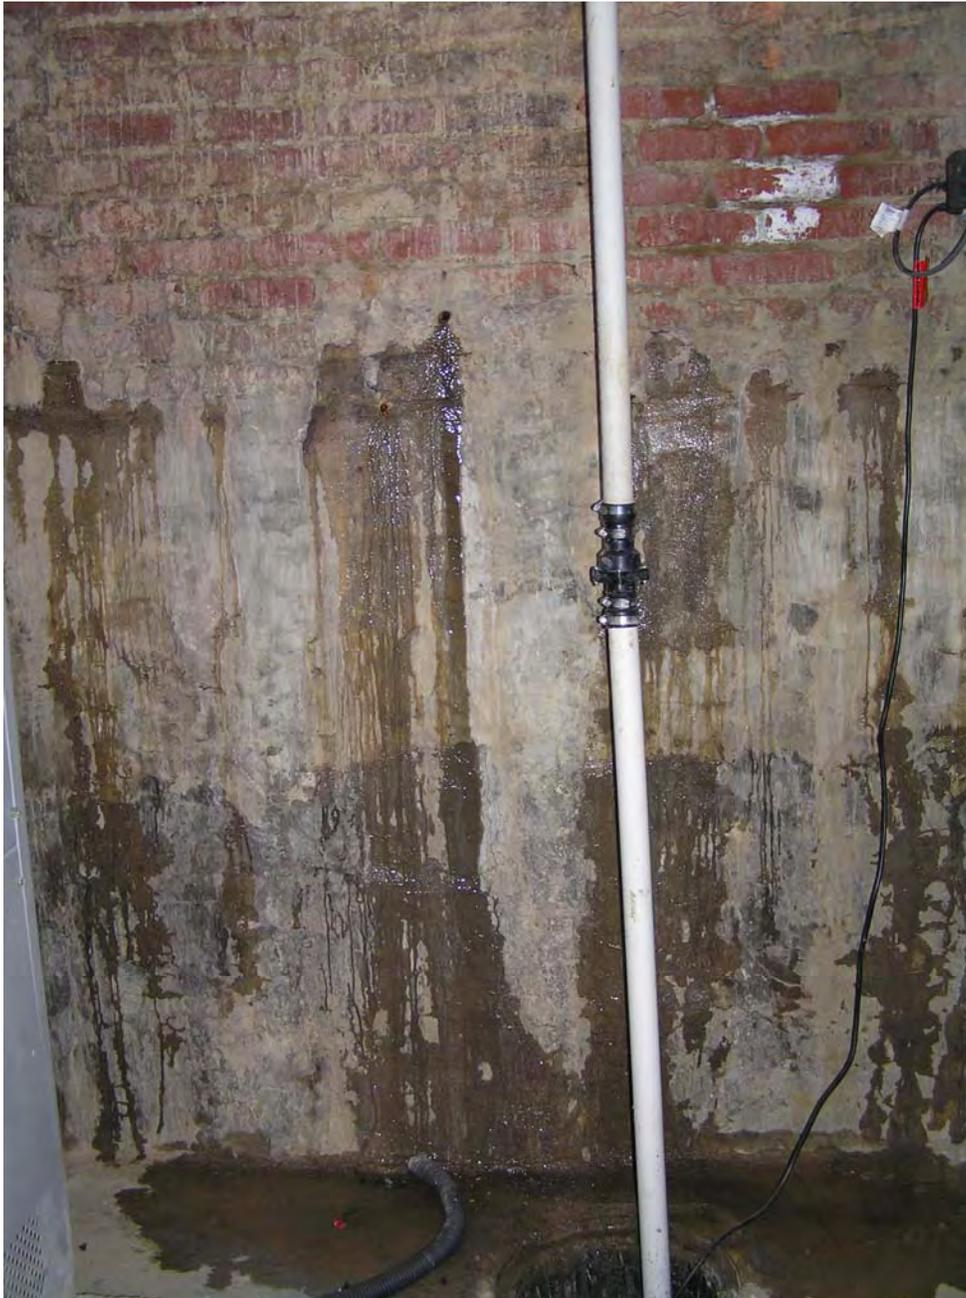
Open joints and cracked bricks throughout exterior

- Provide leak/water infiltration flood testing
- Replace sealant between alley and wall
- Tuck-point all mortar joints
- Repair cracked bricks
- Install sheet metal flashing with reglets and drips at brick infills not flush with façade
- Seal all façades with clear masonry sealant / water repellent

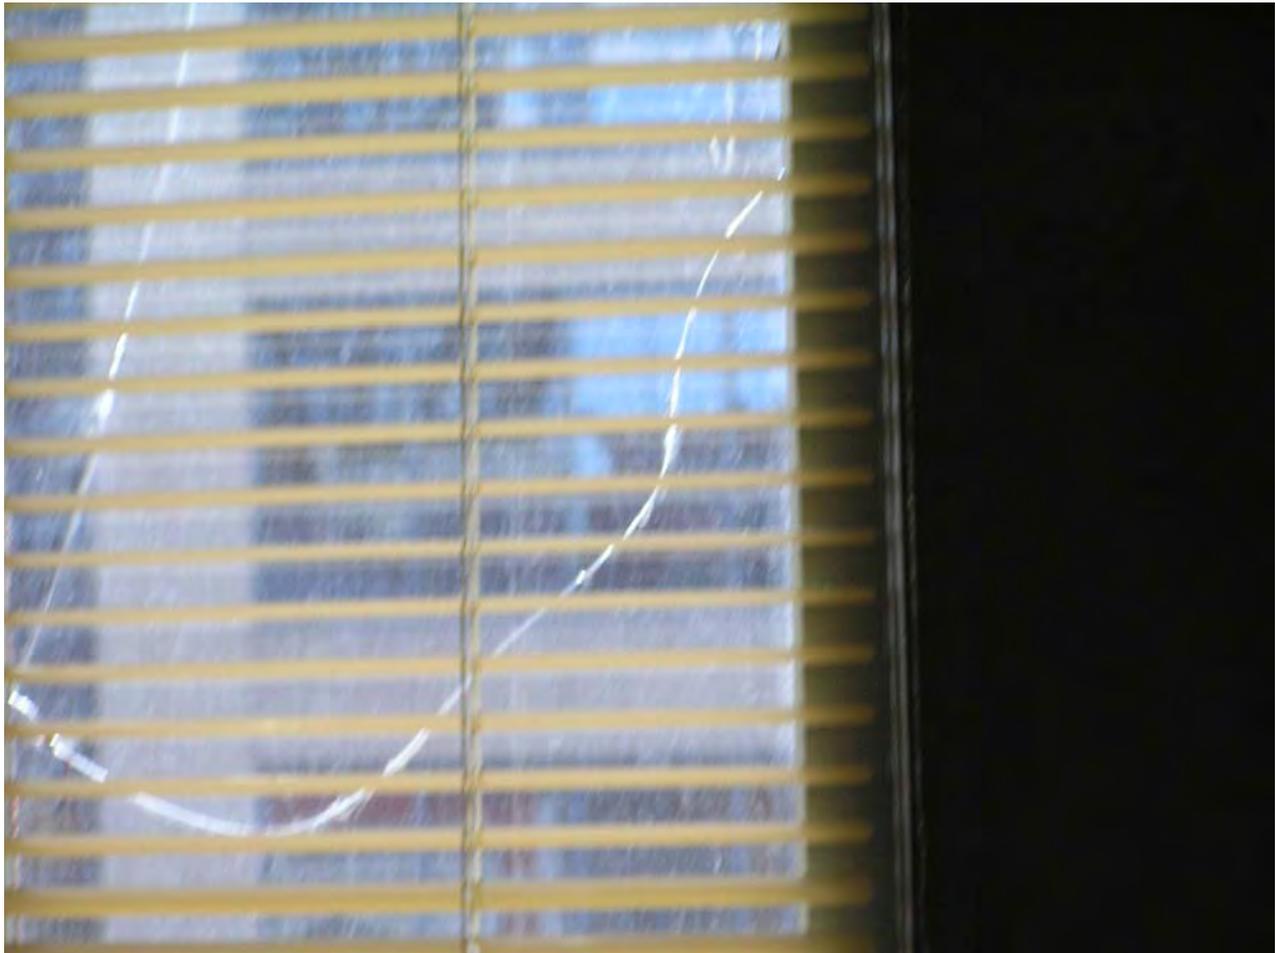
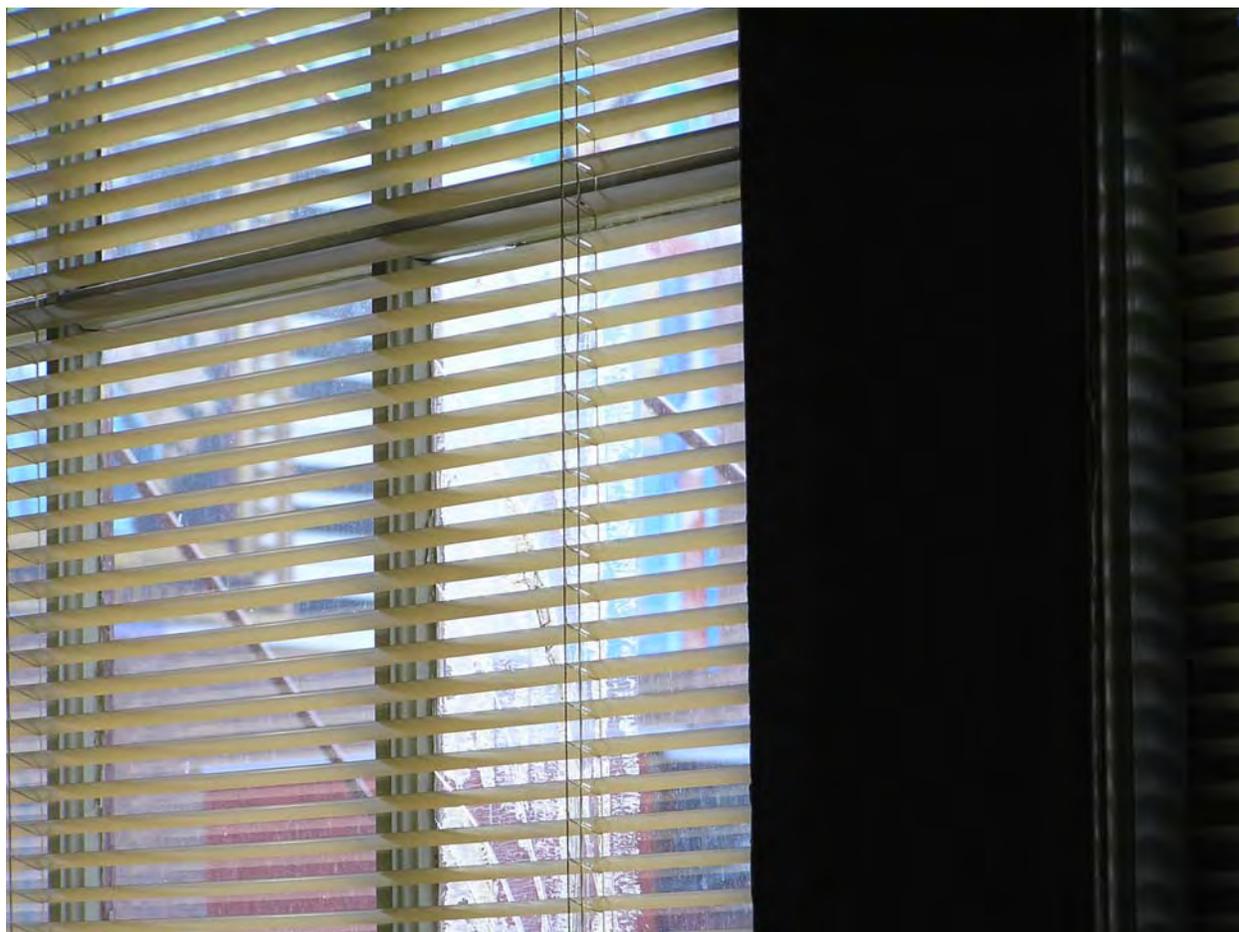
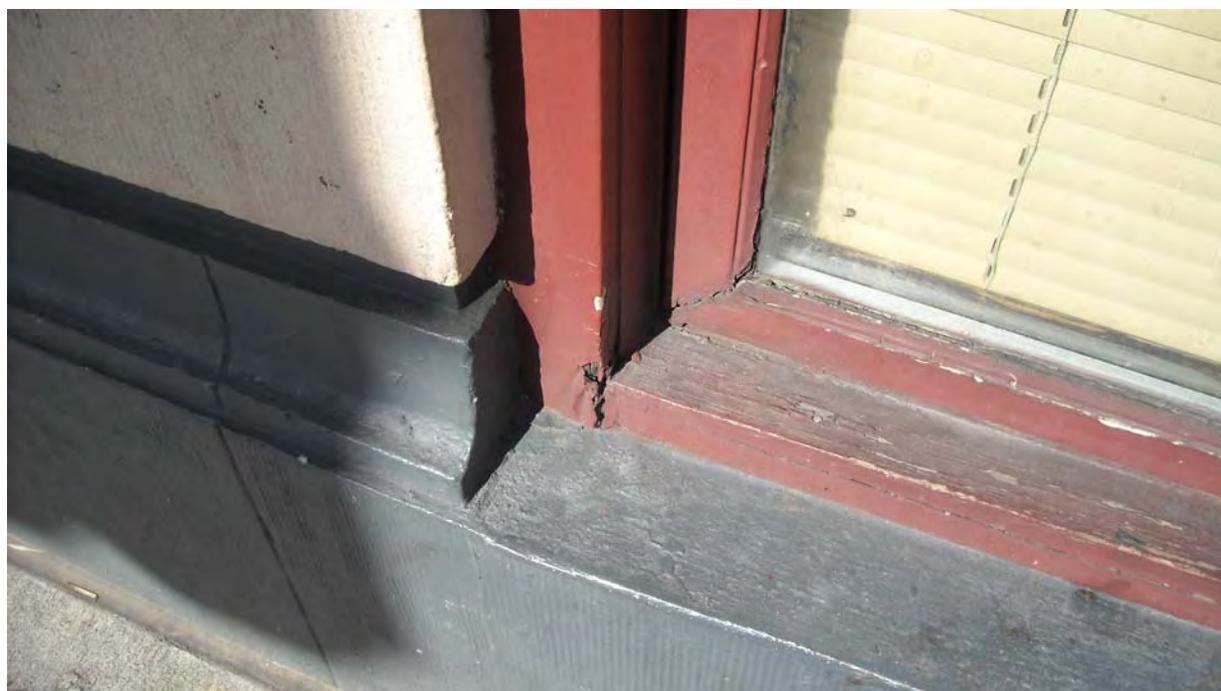
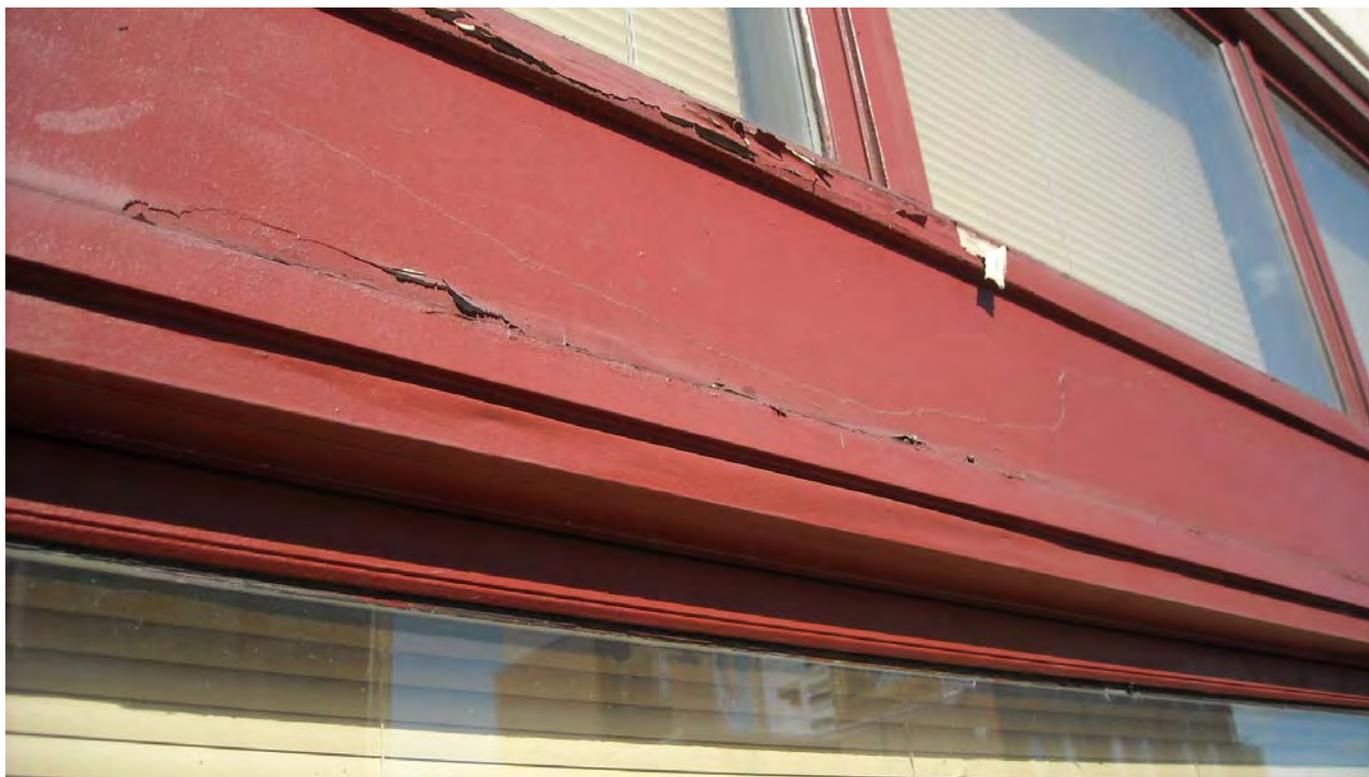
Replace broken glass – repaint/consolidate rotted wood window frames.

Strip paint, restore rotted wood – consolidate/shape with epoxy wood filler – shape to match sound molding. Replace broken window panes – repaint exterior side of windows.

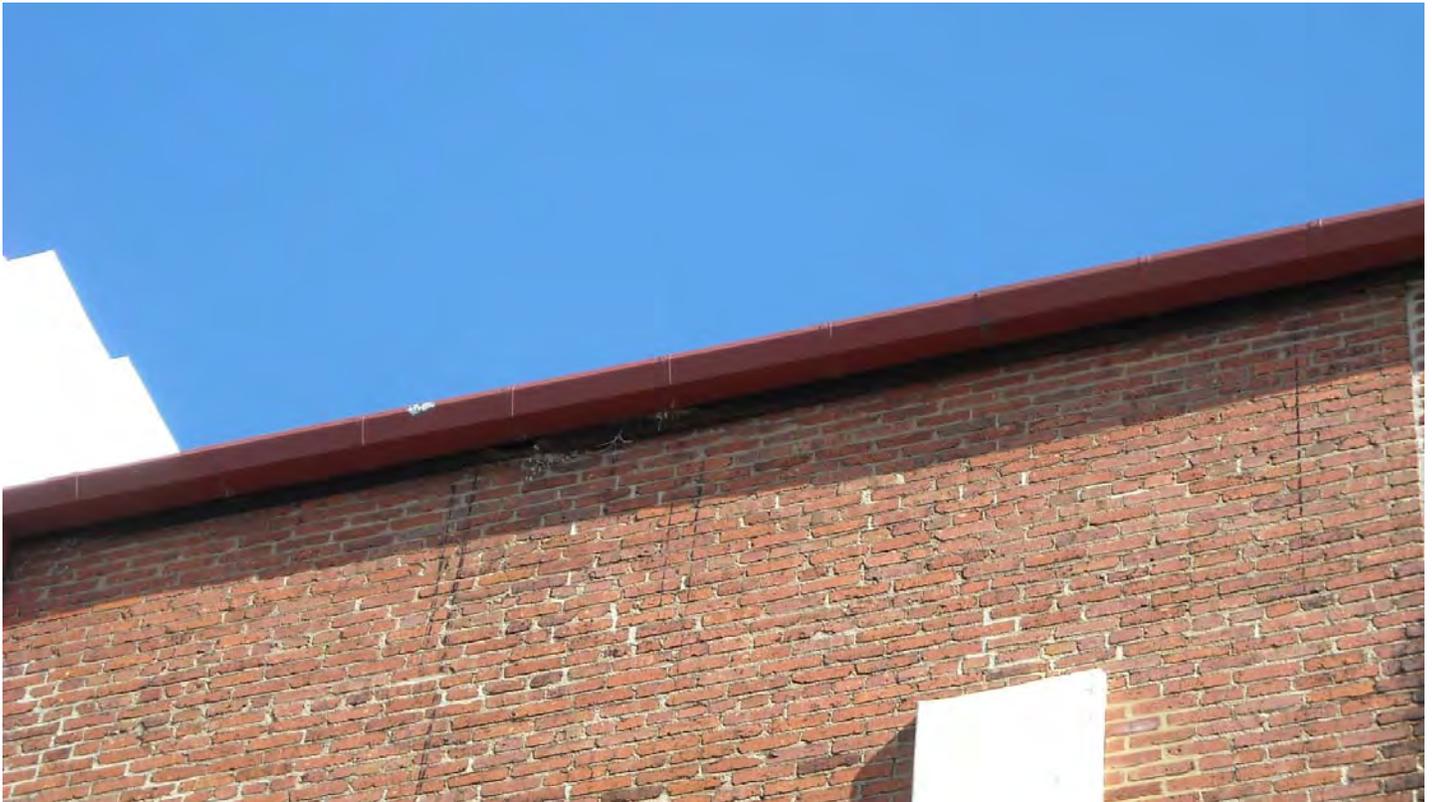
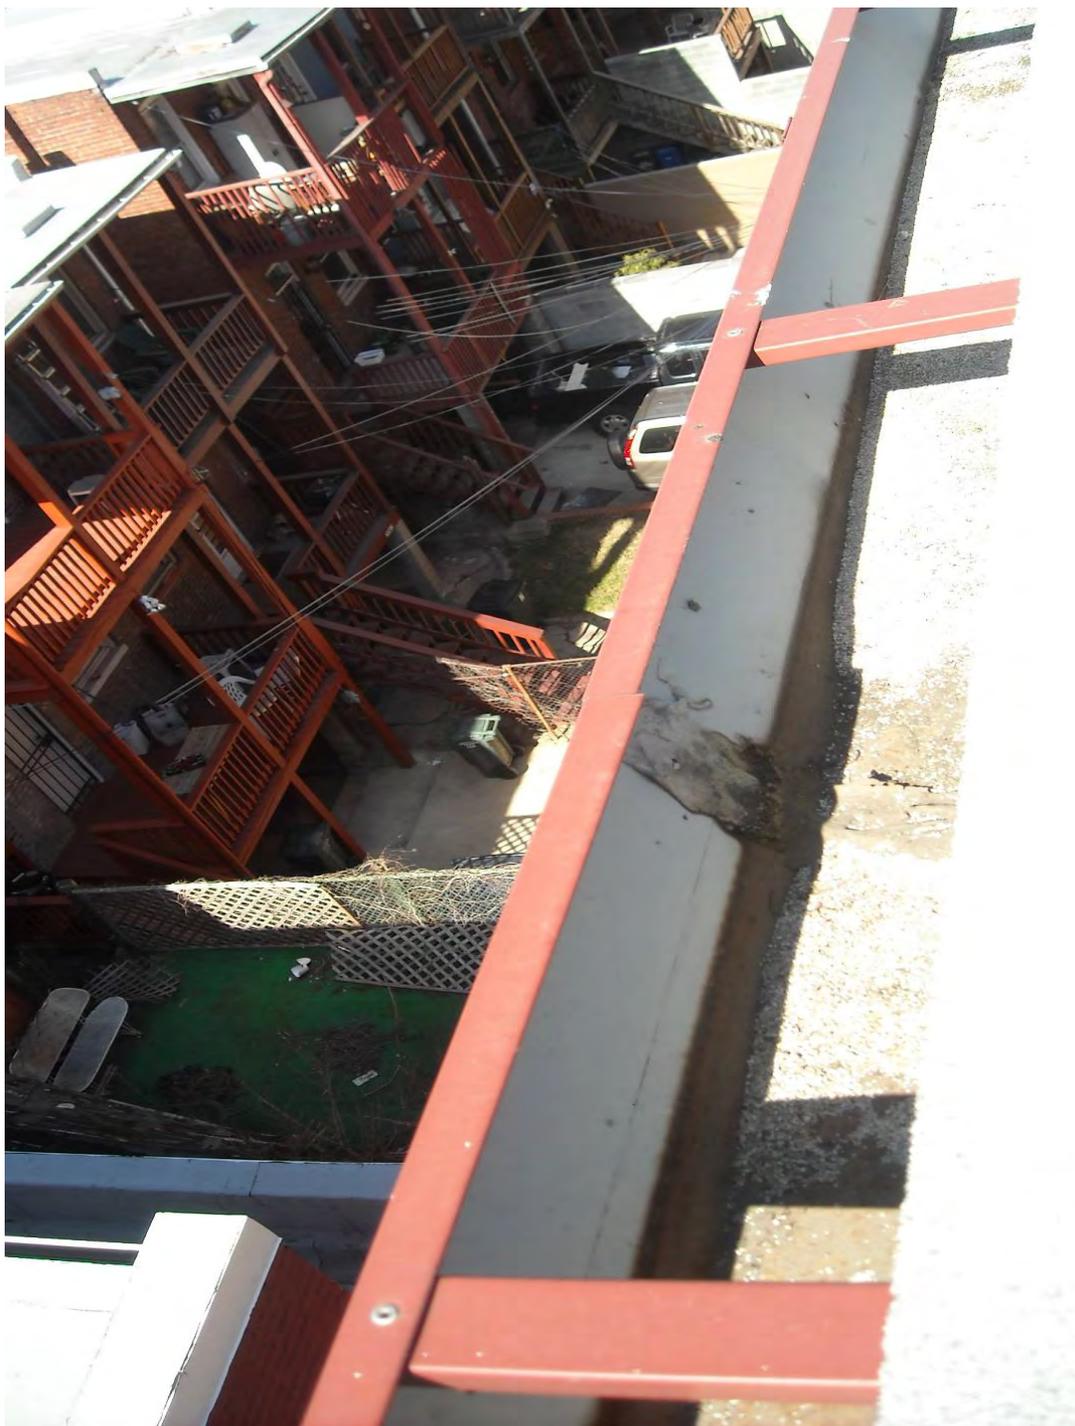
DEFICIENCY DESCRIPTION:
Replace eave / repair gutters

Remove gutter fascia and eave. Reinstall gutter, replace fascia and eave.

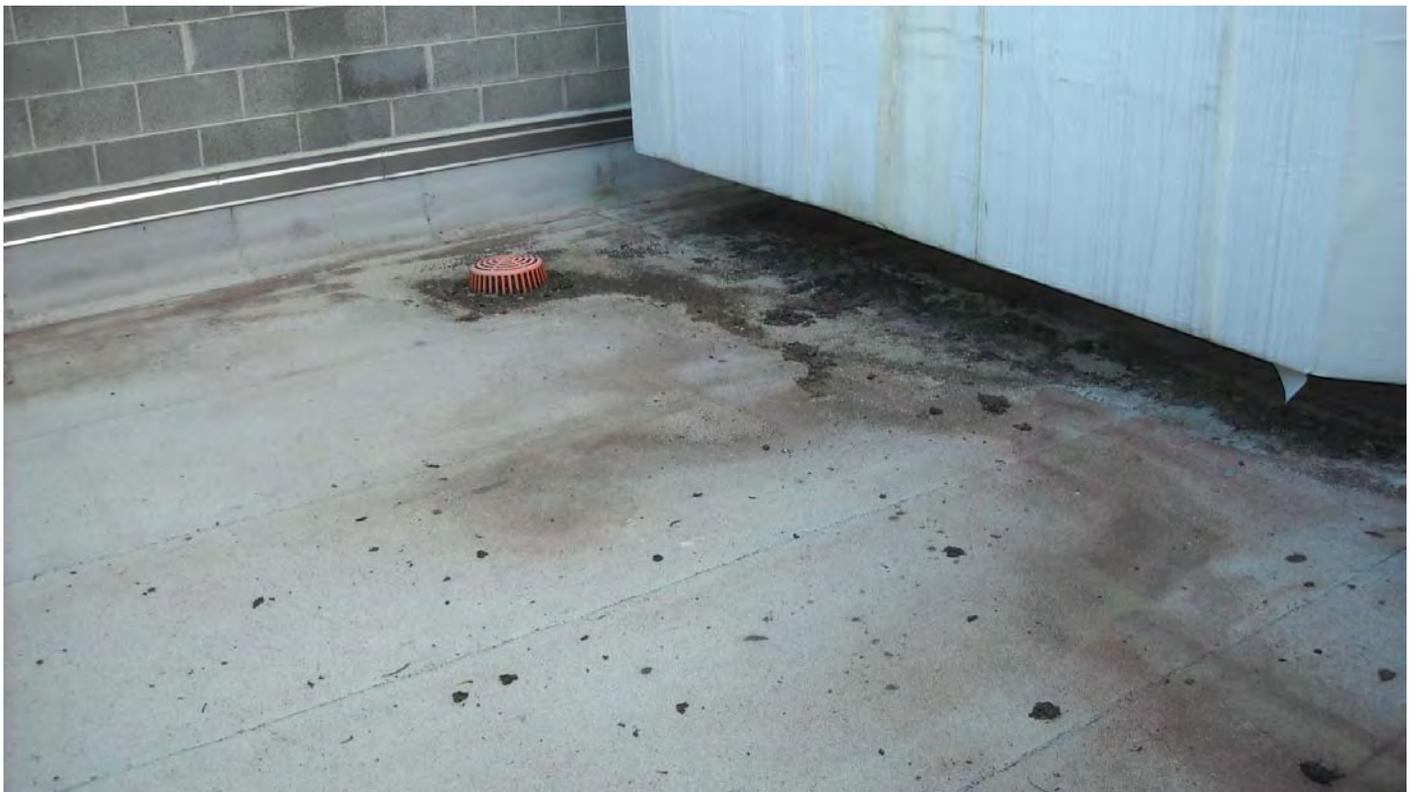
DEFICIENCY DESCRIPTION:
Relocate roof drains.

SUGGESTED SOLUTION :
Relocate roof drains. Reslope and reroof flat roof.

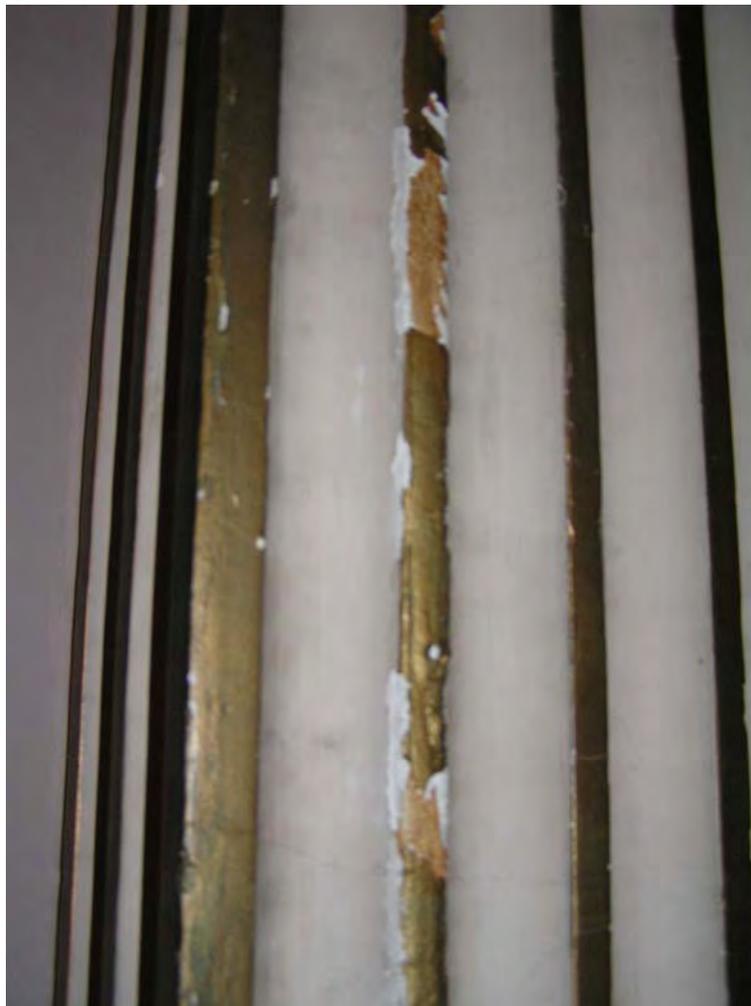
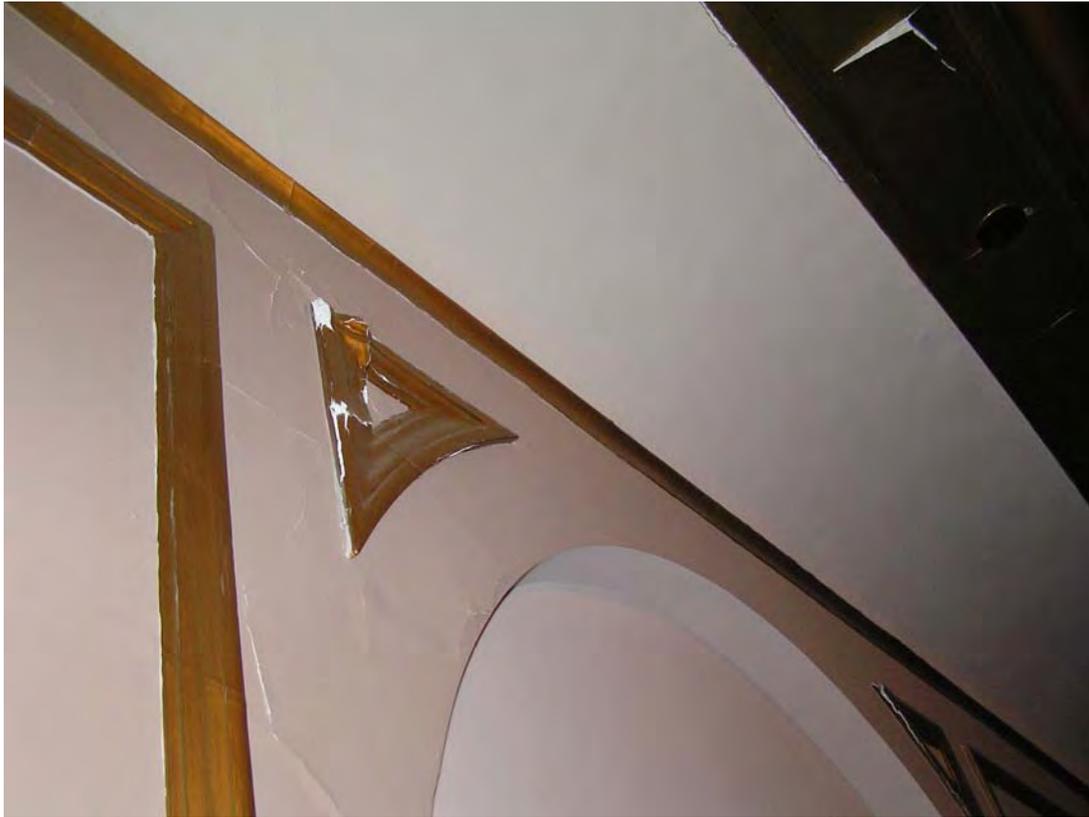
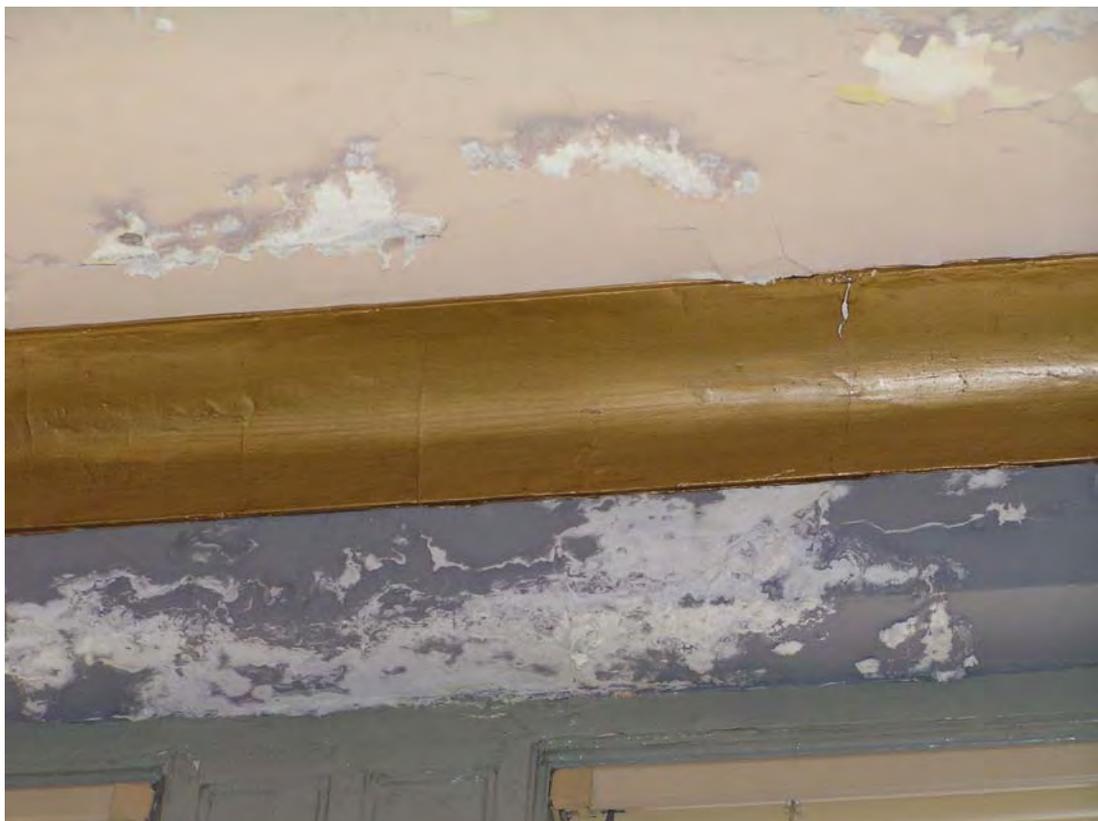
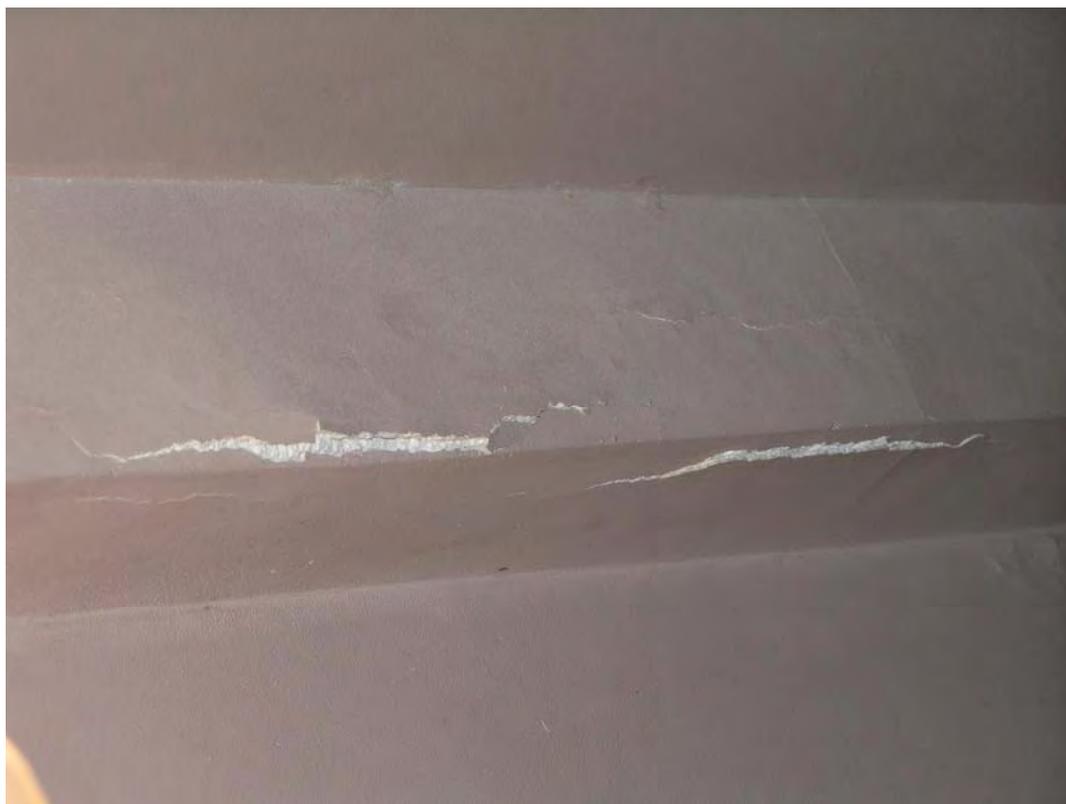
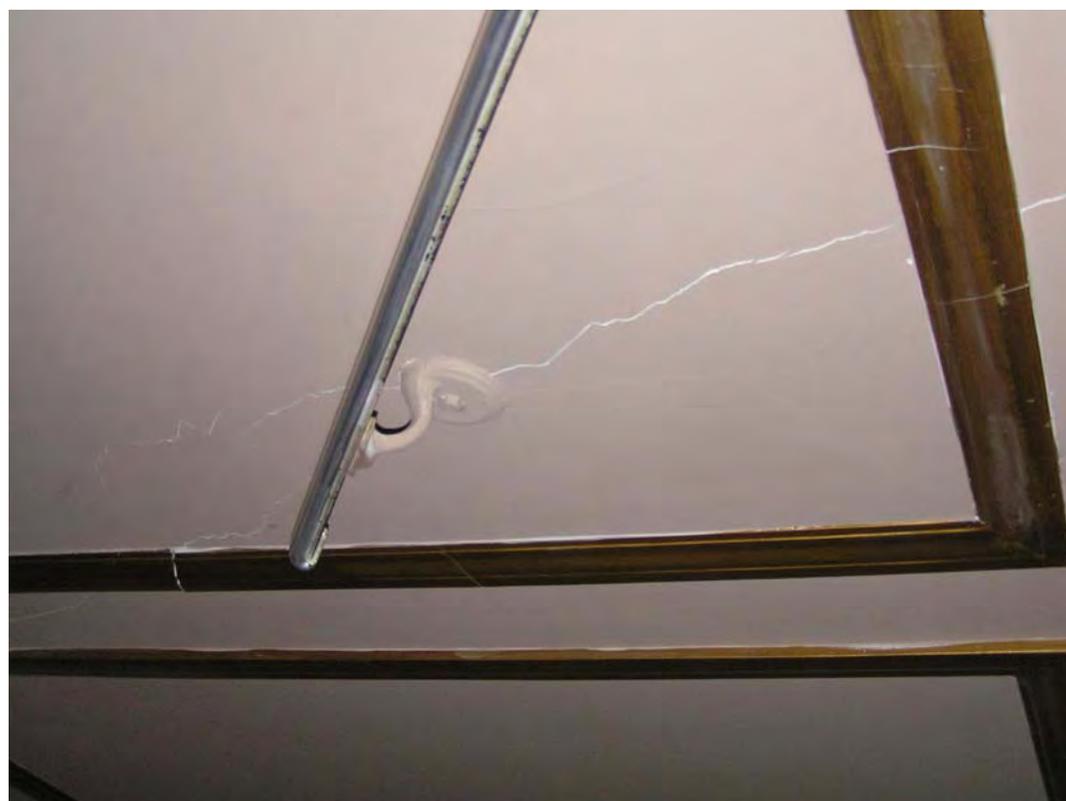
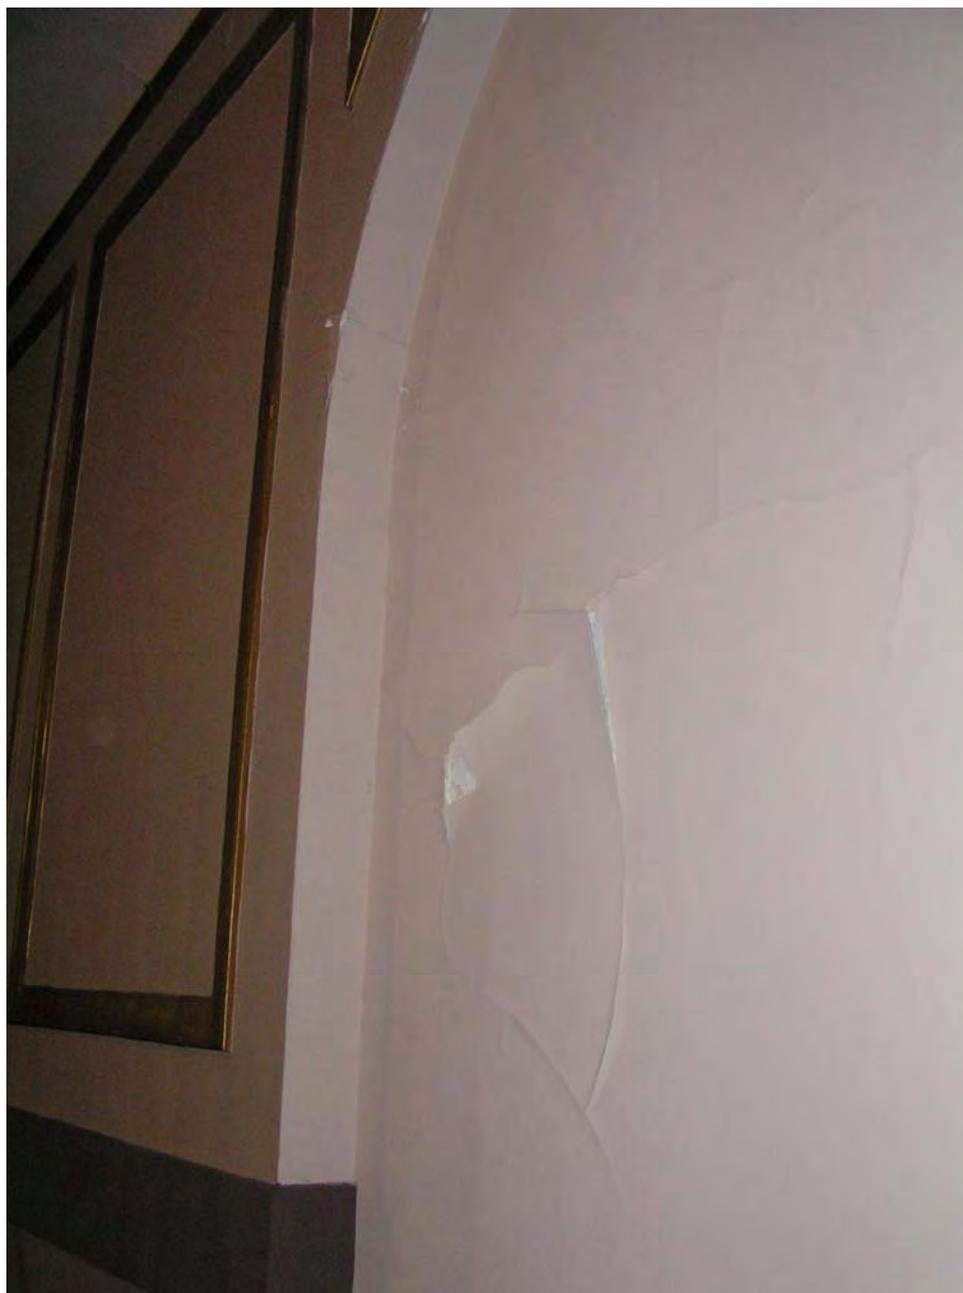
Repair smooth and ornamental plaster – historic areas – walls.

Prepare walls – remove loose / spalling paint and plaster. Patch and restore. Repaint with original theatre color palette.

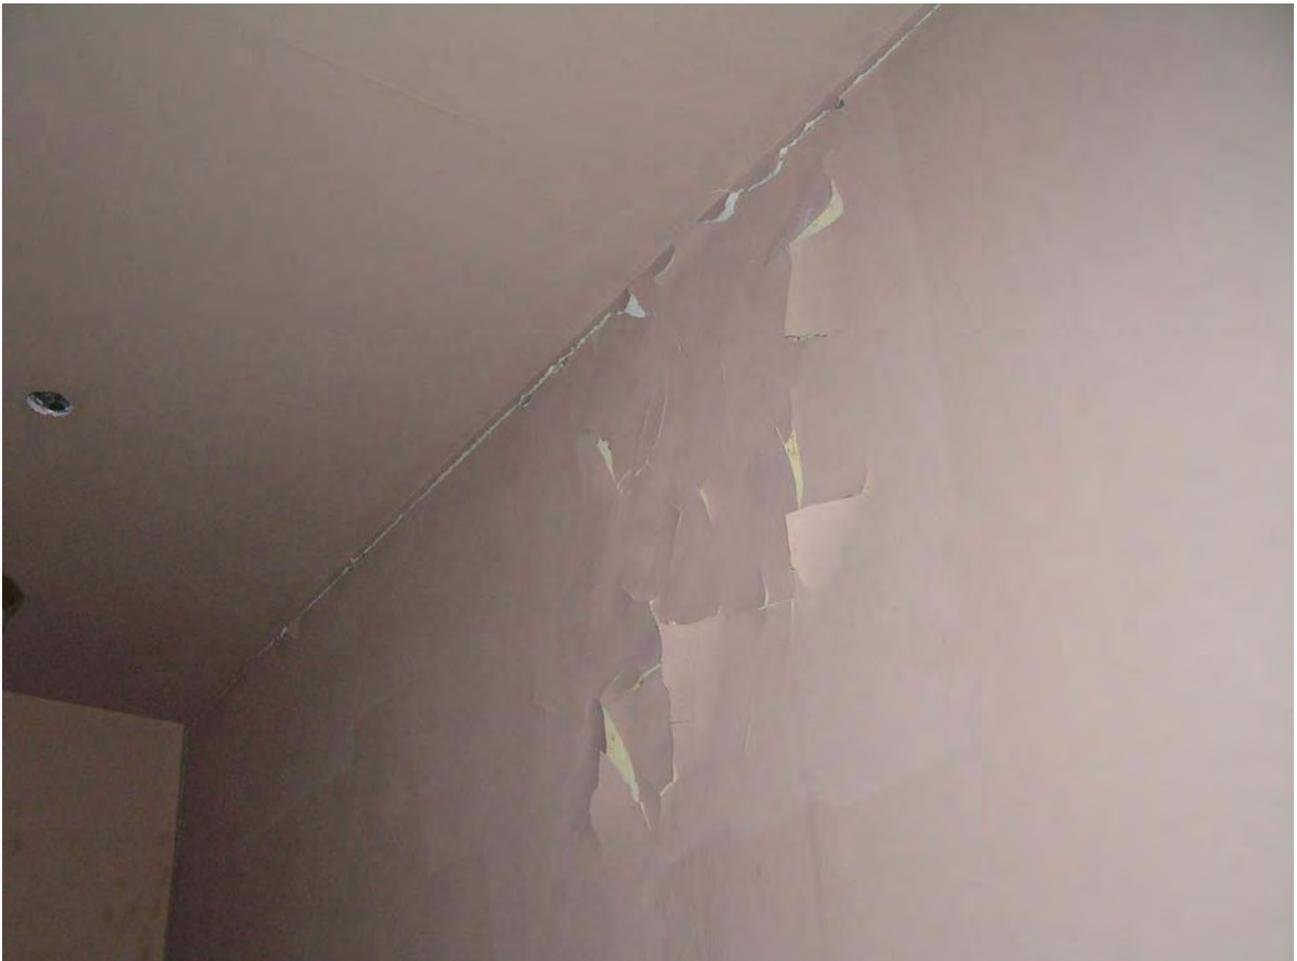
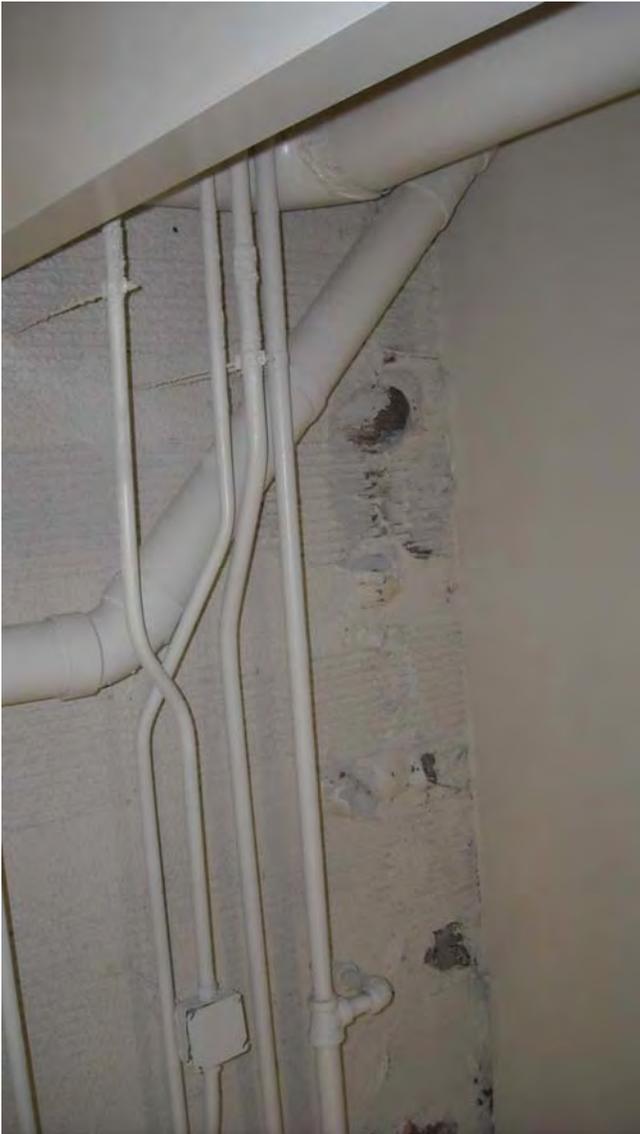
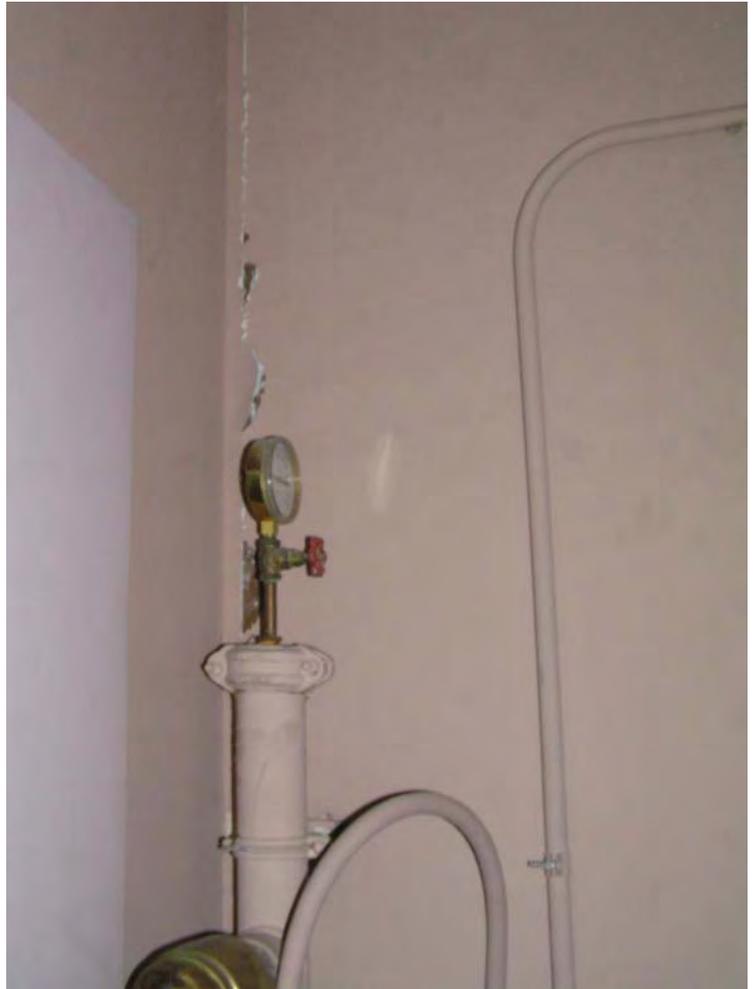
Patch repair "back-of-house" water damaged GWB and plaster.

SUGGESTED SOLUTION :
Scrape / prepare surfaces – repaint.

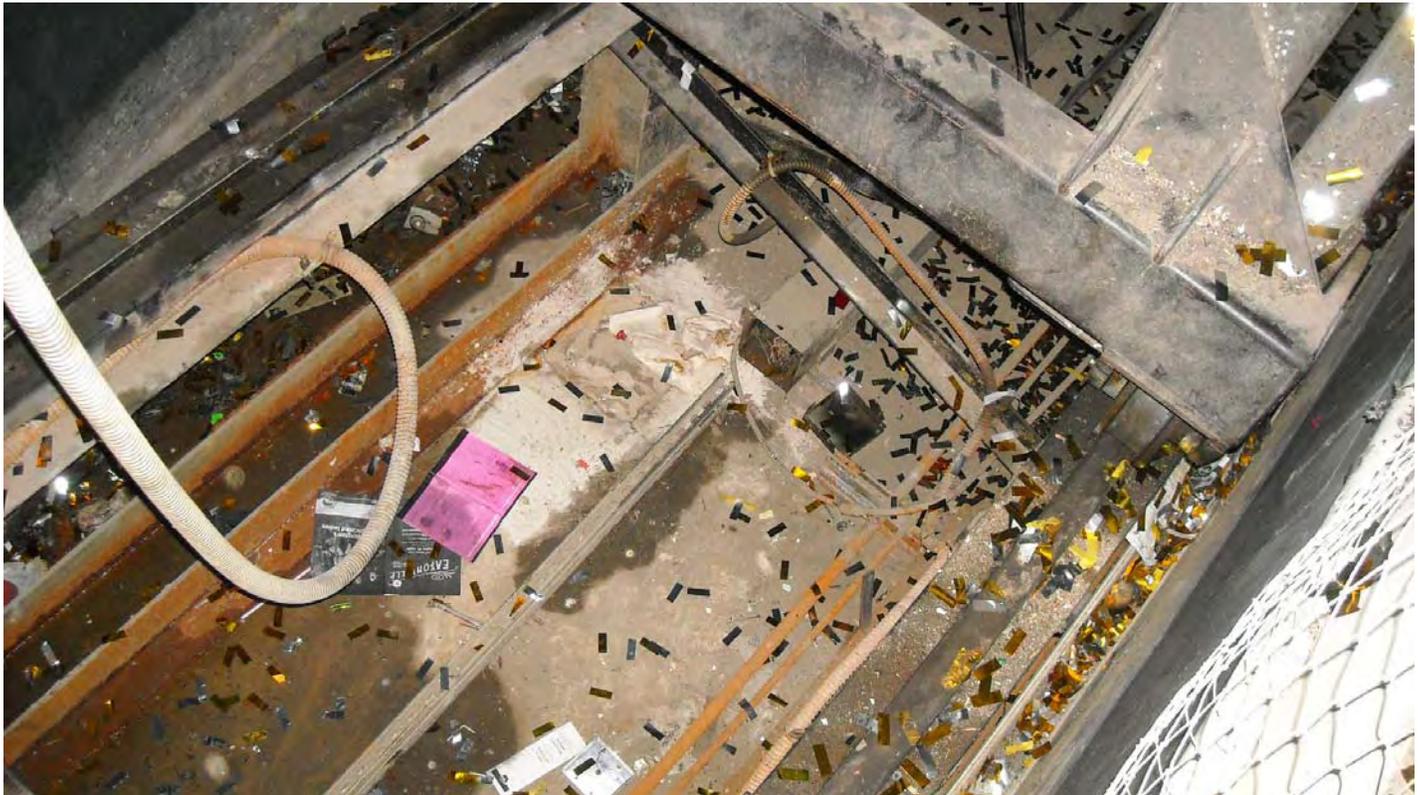
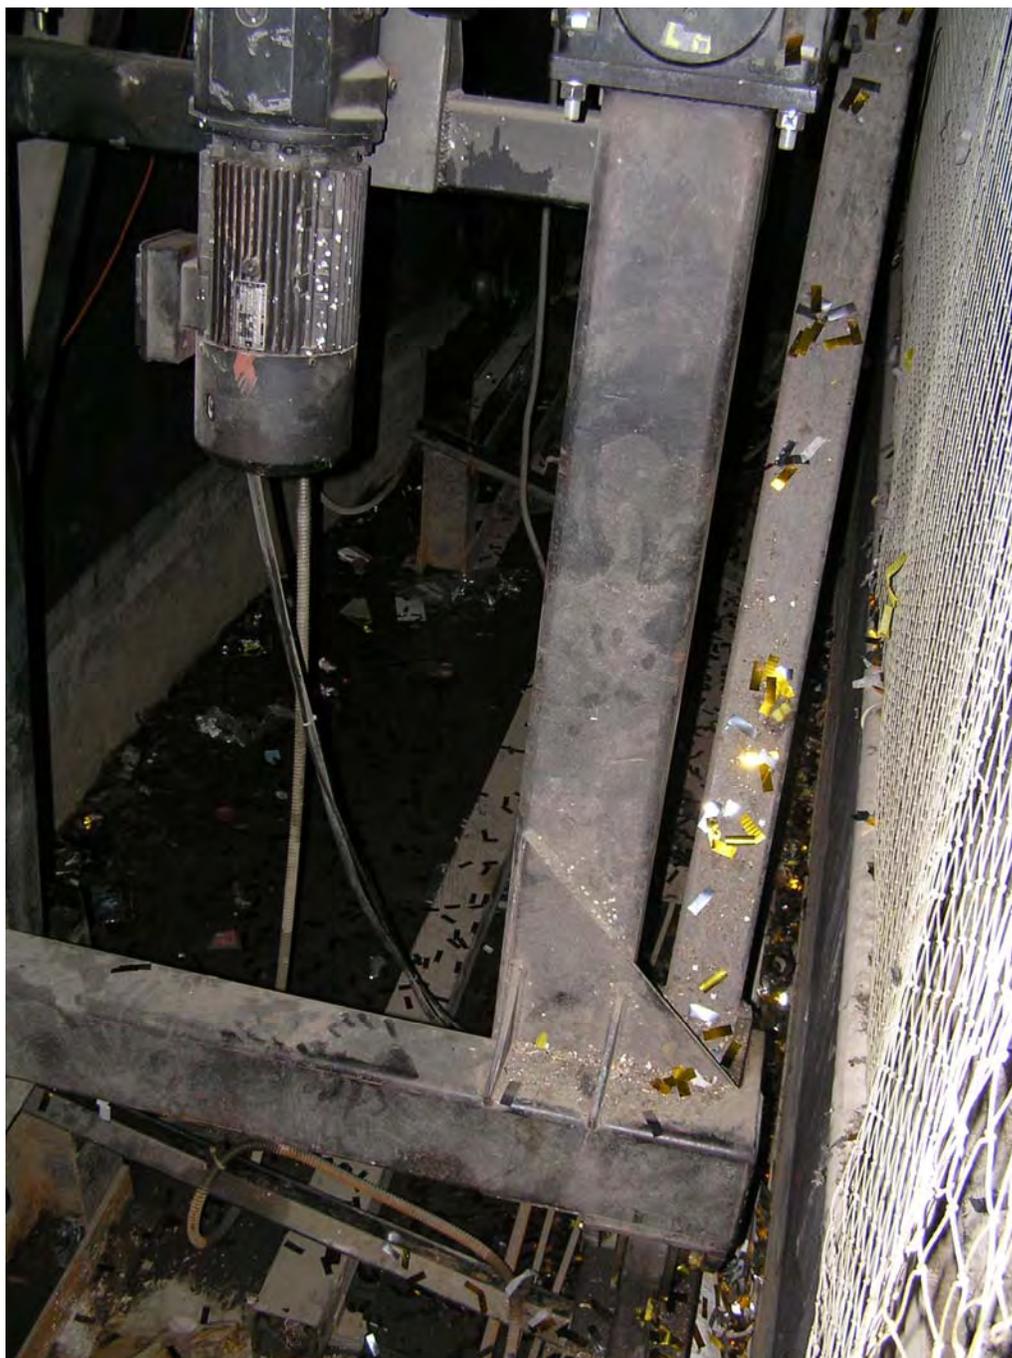
DEFICIENCY DESCRIPTION:
Fall hazard at Orchestra Pit

SUGGESTED SOLUTION :
Install removable steel railing across pit.
