D.C. DEPARTMENT OF GENERAL SERVICES
WASHINGTON, D.C.

BUILDING ASSESSMENT

LINCOLN THEATRE
1215 U STREET, N.W.
WASHINGTON, D.C.

MARCH 7, 2012

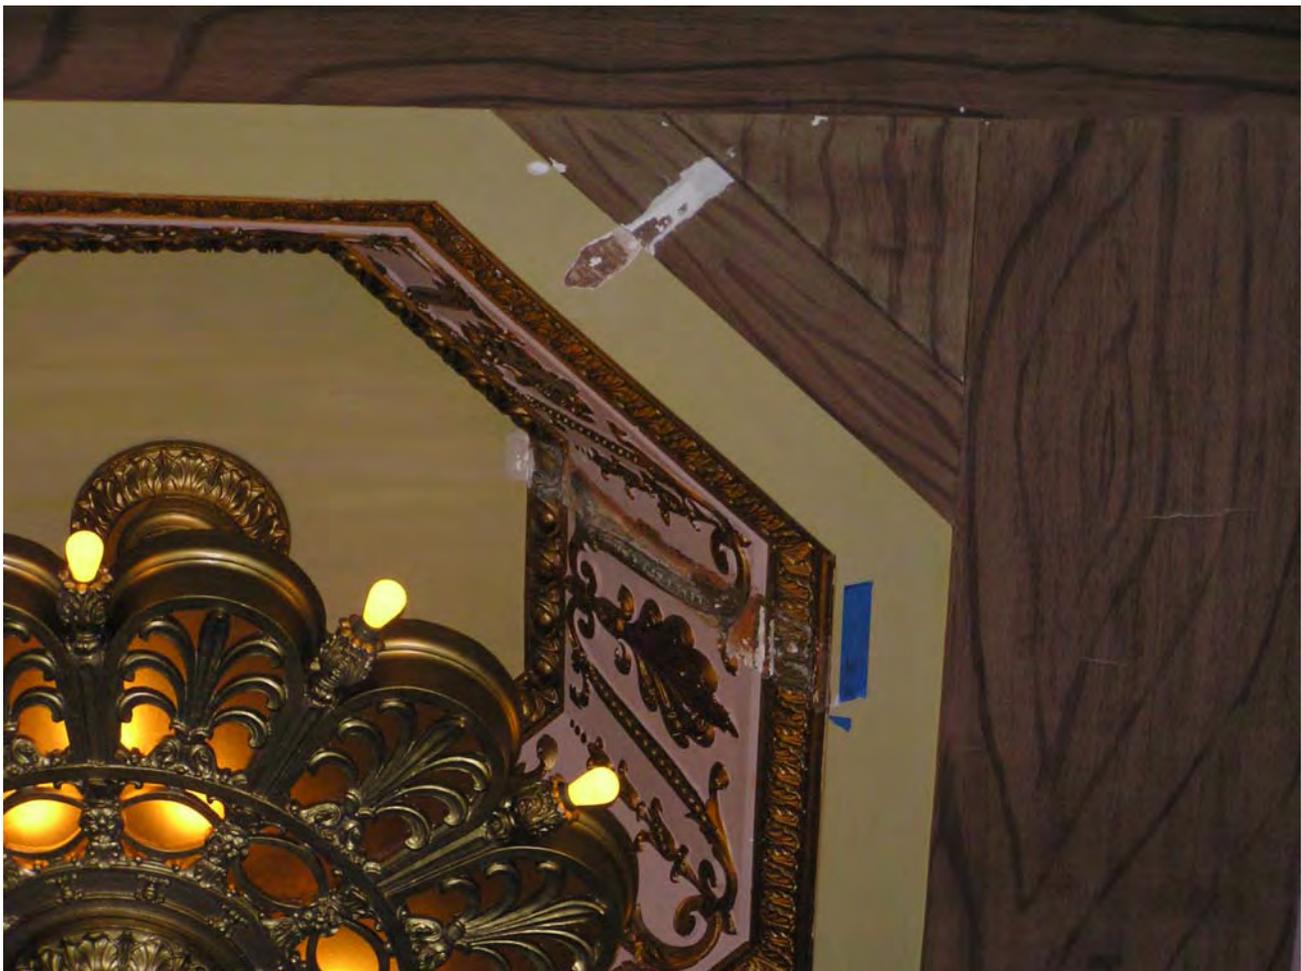
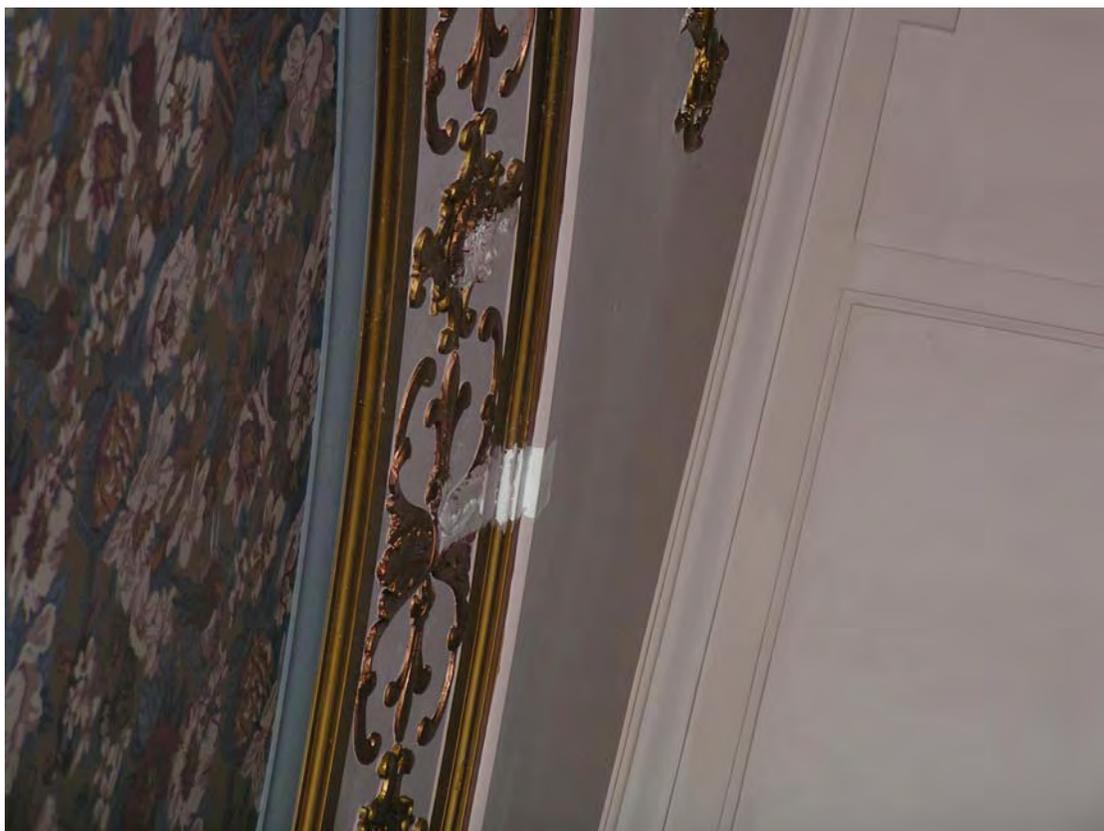
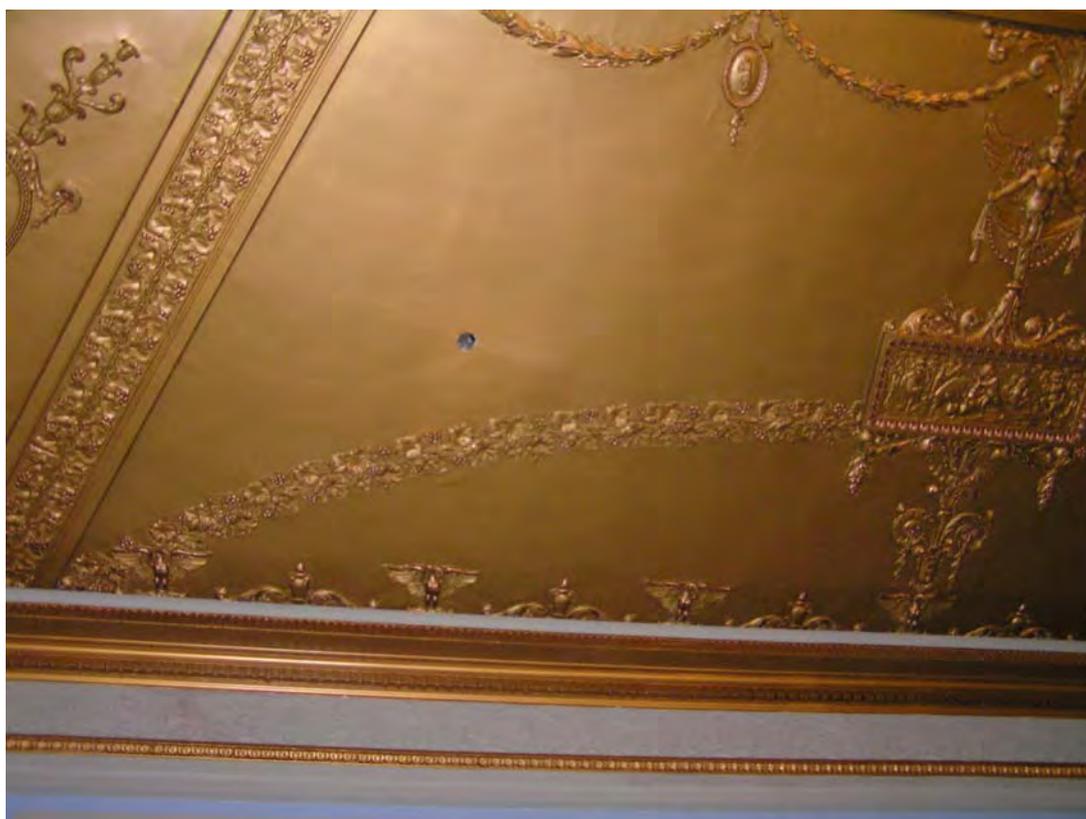
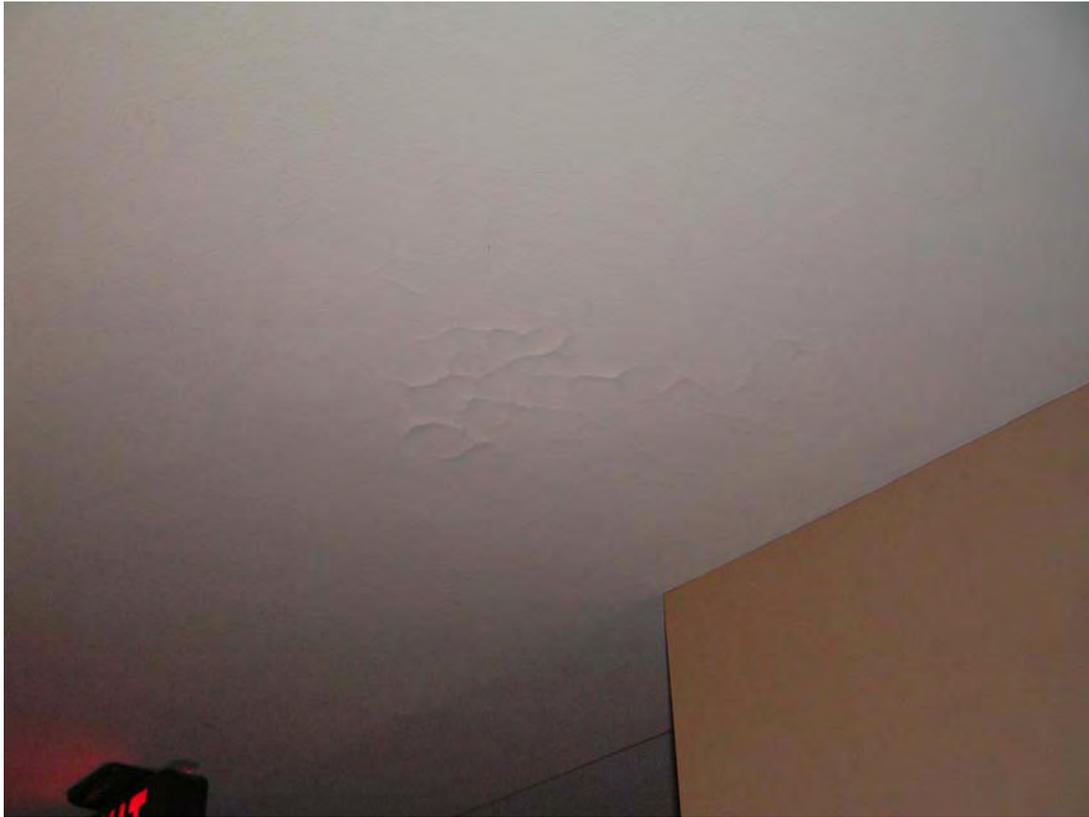
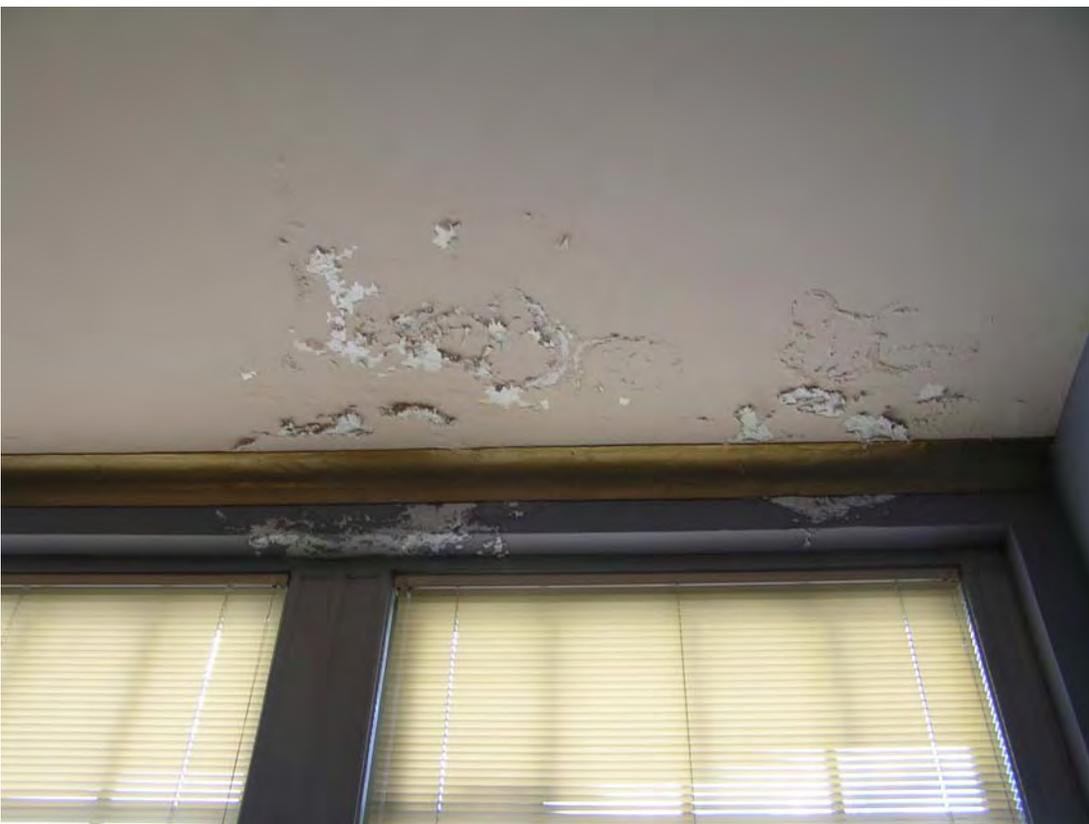
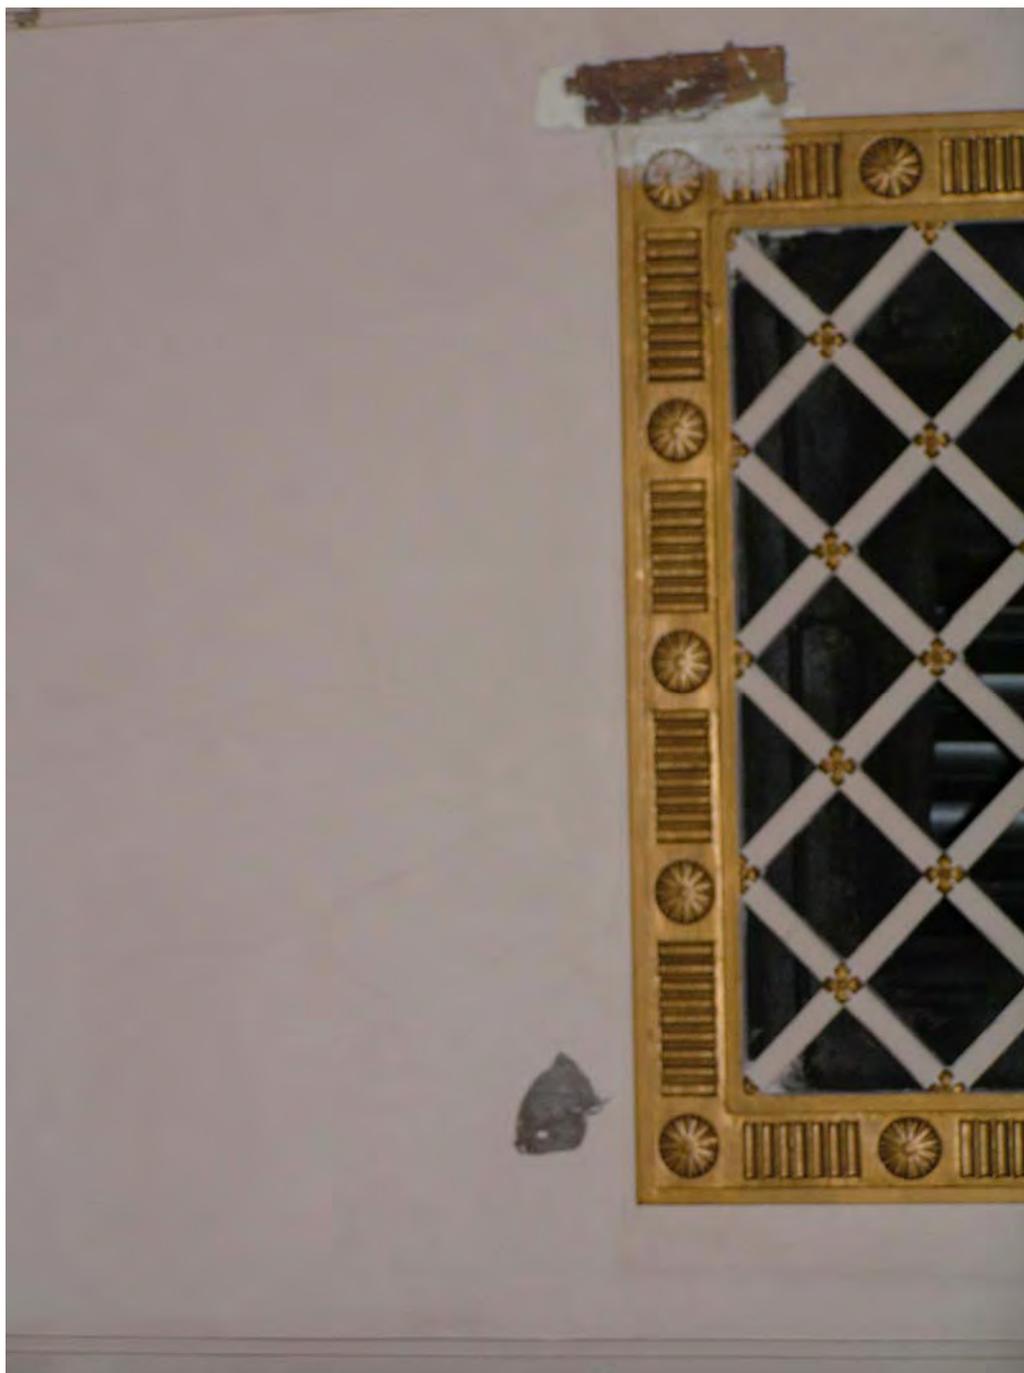
DEFICIENCY DESCRIPTION:
Repair historically significant ceilings.

Prepare ceiling – remove loose / spalling paint and plaster. Patch and restore. Repaint with original color palette.

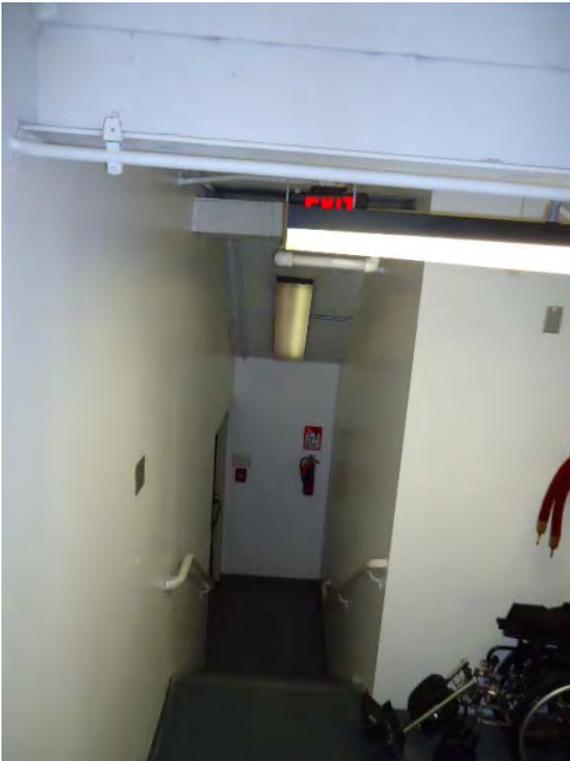
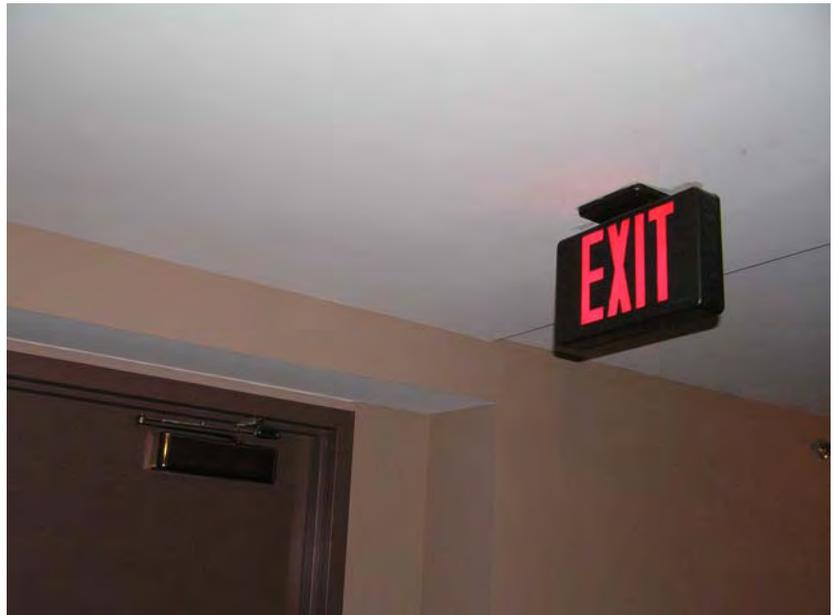
Exit signs throughout the building are non-compliant with the current codes. Many are missing directional arrows and there are locations where exit signs should be located but are not. There are also exit signs that are difficult to see from their current location and should be relocated.

Replace and relocate exit signs so as to comply with NFPA requirements. In some instances, arrow plates may just need to be removed from the plastic frame.

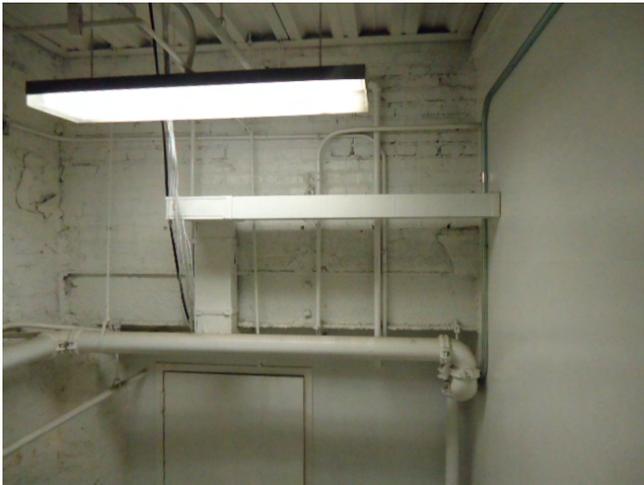
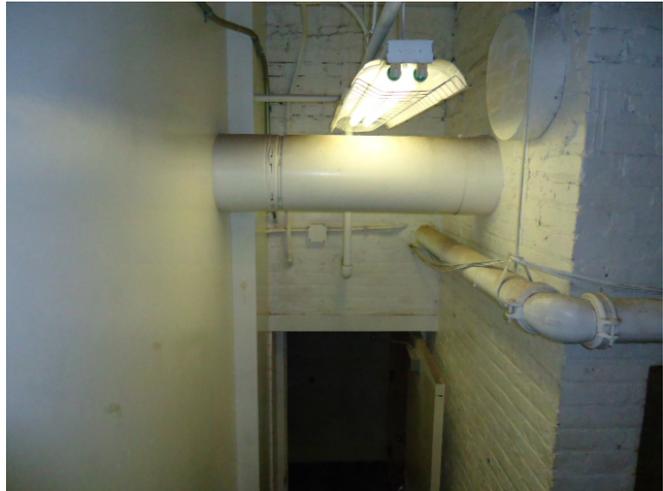
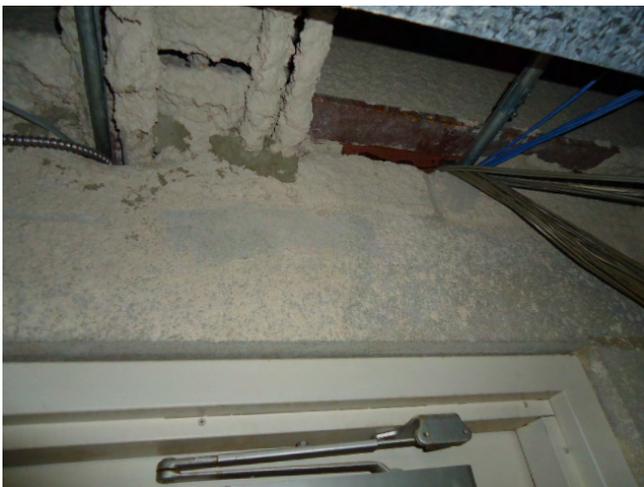
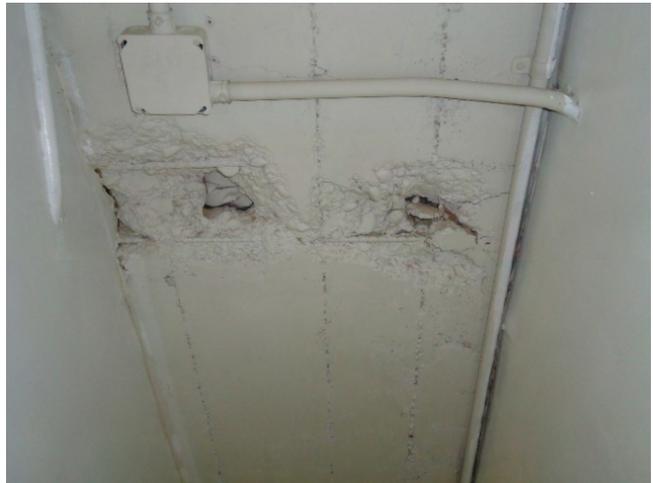
Fire-proofing in the 1 hour exit enclosures (stair #1, 2, 3, 4) is significantly deteriorated. Conduits, ducts, pipes, and wires that service areas other than the stairwell penetrate the stairwells.

Properly fire-stop penetrations or reroute penetrations outside of the stairwells. Reapply fire-stopping as necessary. Replace access doors.

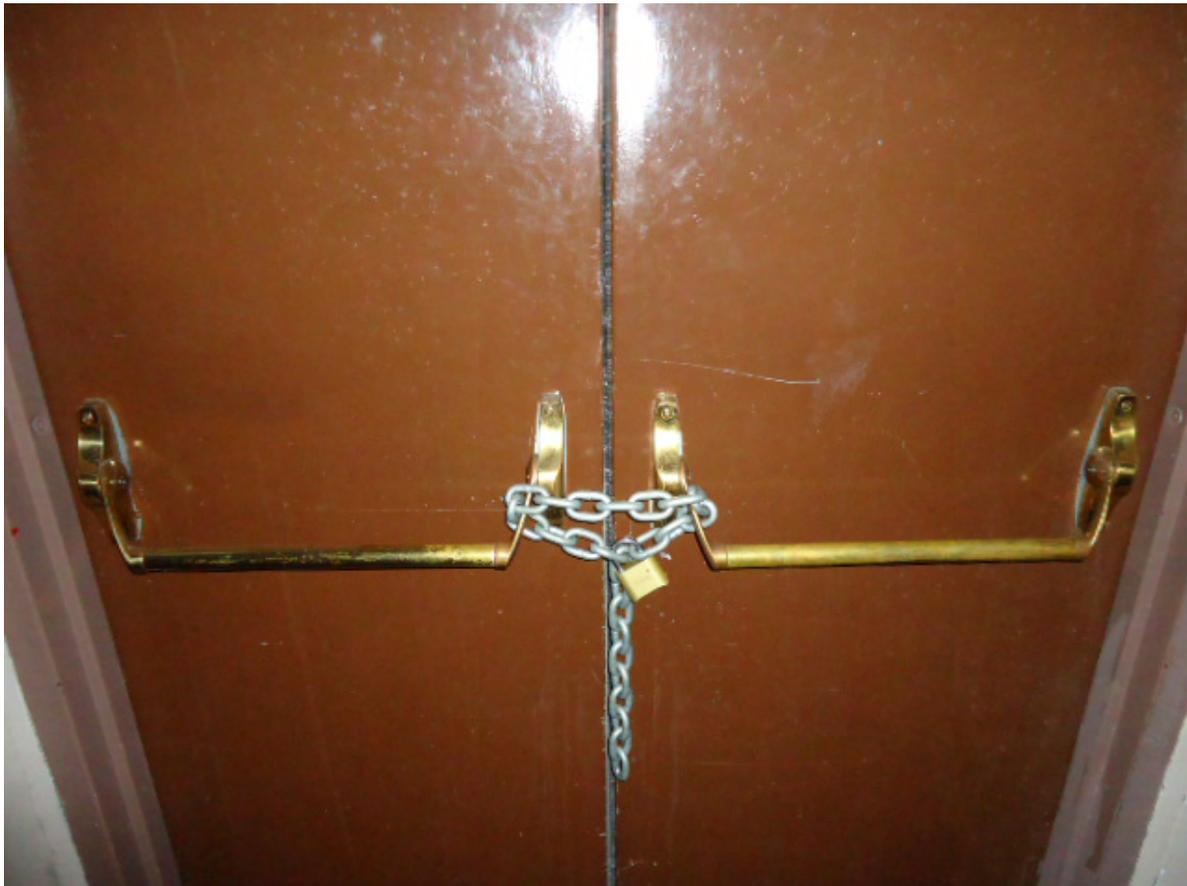
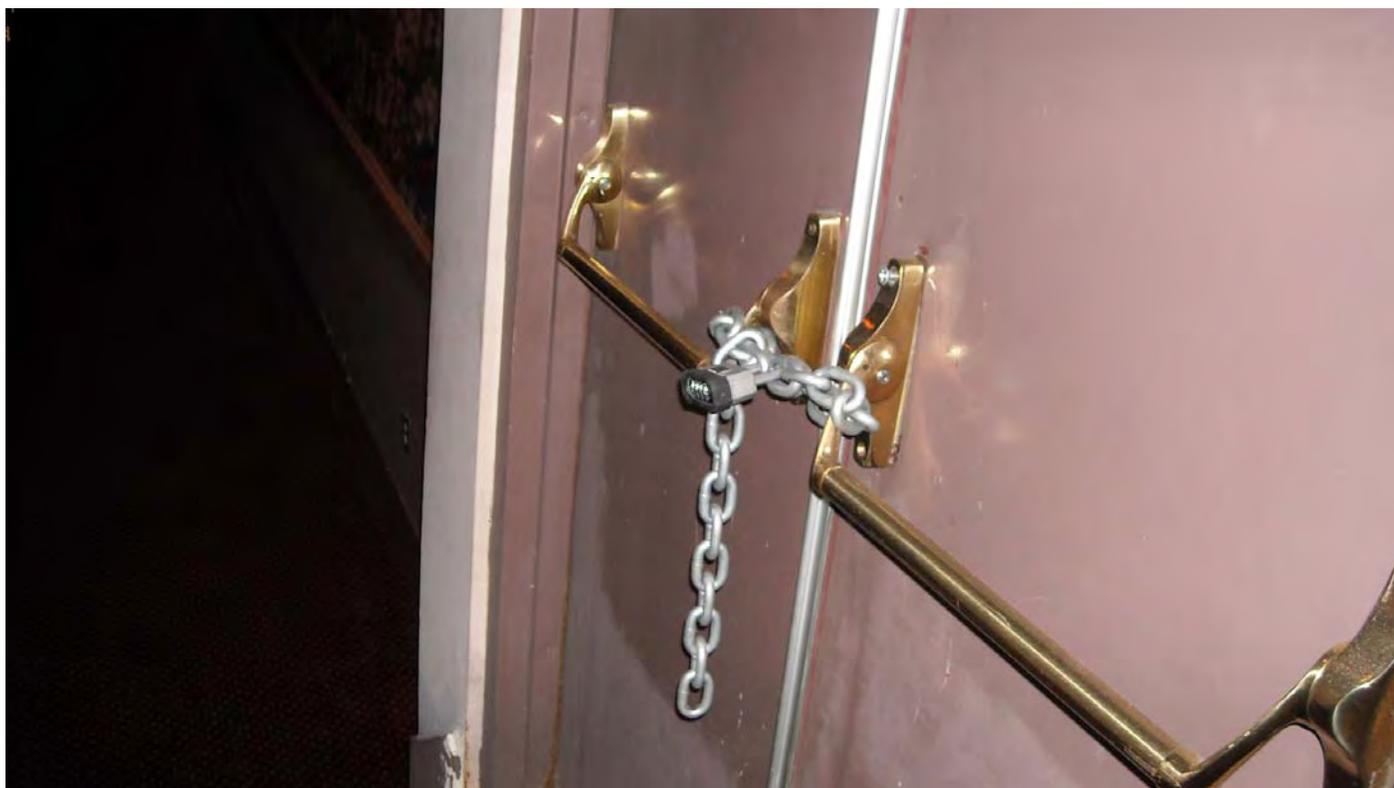
Multiple required means of egress are currently chained shut.

Remove chained locks and replace panic hardware with locking panic hardware.

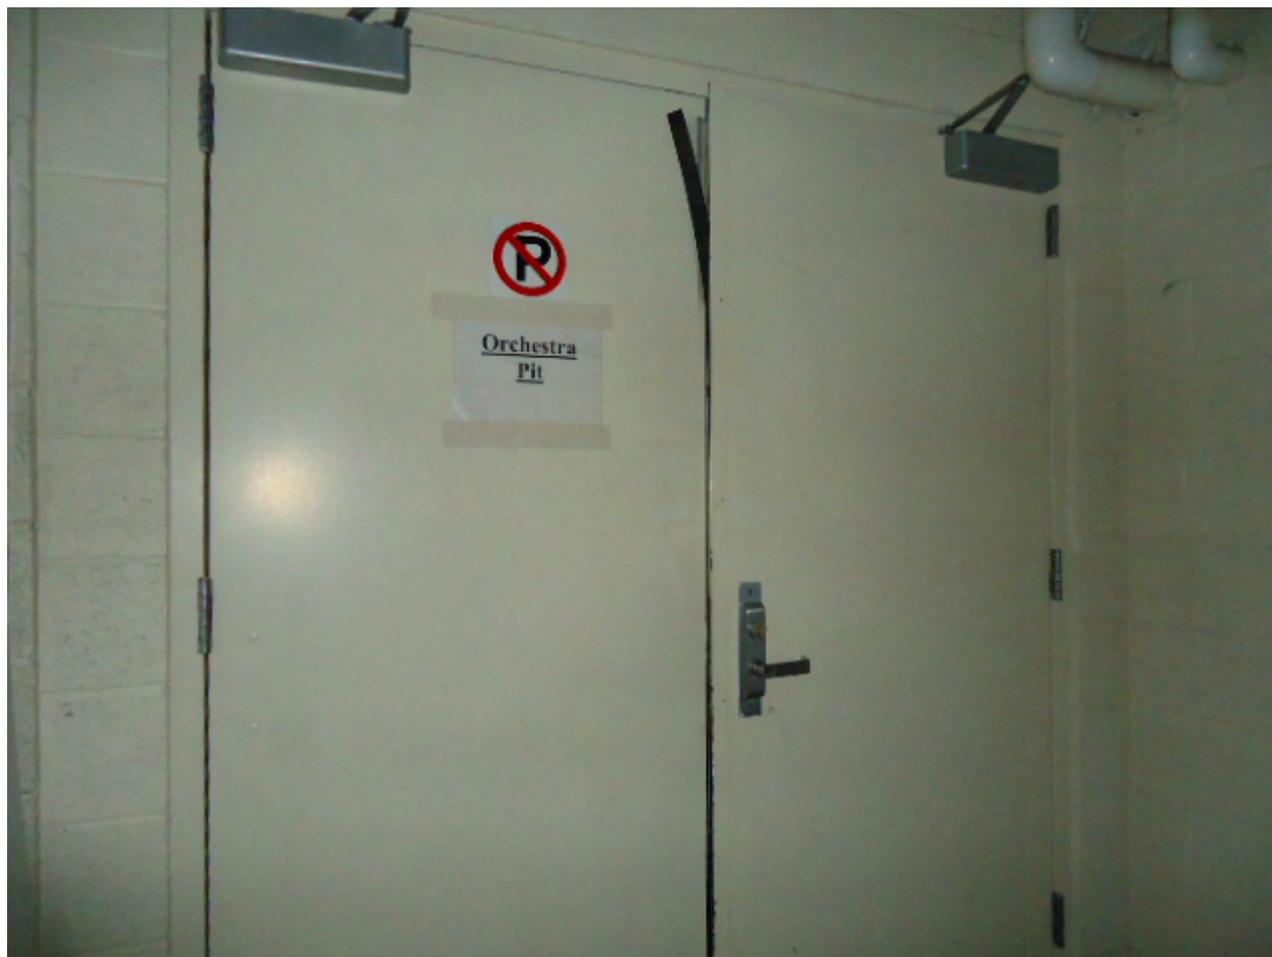
Existing coordination device is not operational. Door seal needs to be replaced.

Replace existing coordination device and door seal.
