ATTACHMENT A-1

DC DGS Patricia Handy HVAC Assessment

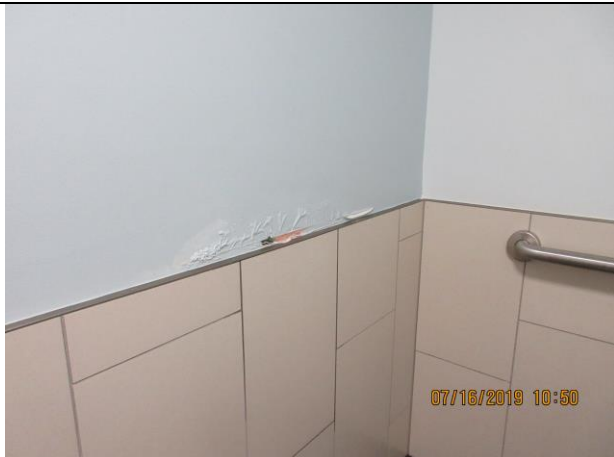
Description: Damaged wall from leaking fan coil above.

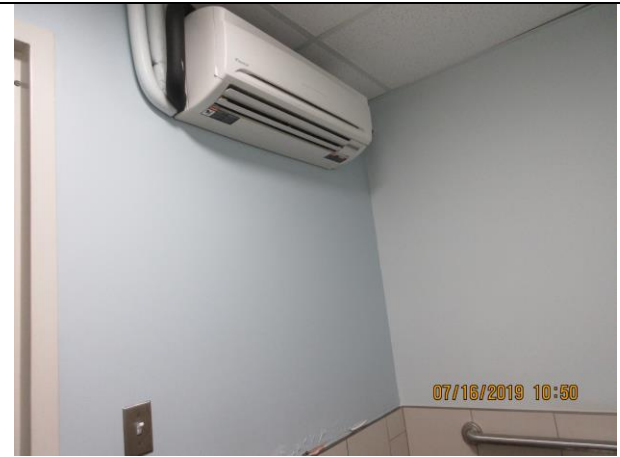
Description: Fan coil's drain pan is clogged and condensate is overflowing.

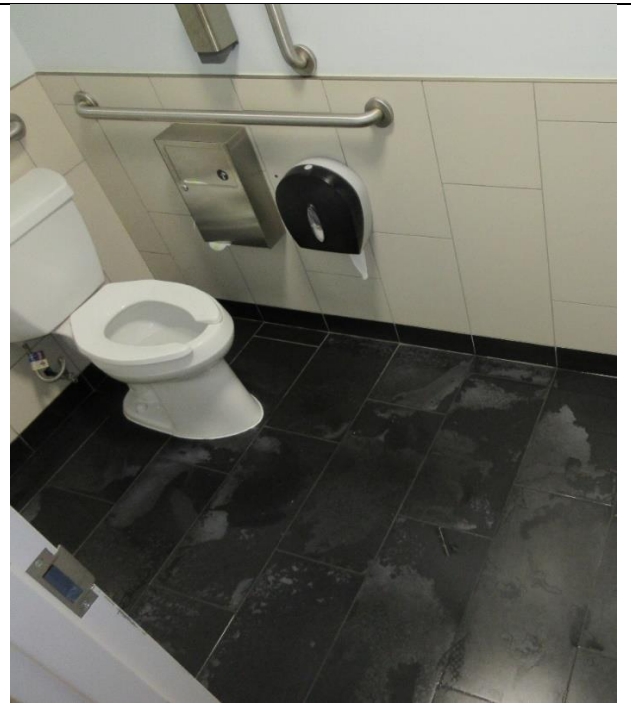
Description: Wet floor from leaking fan coil above.

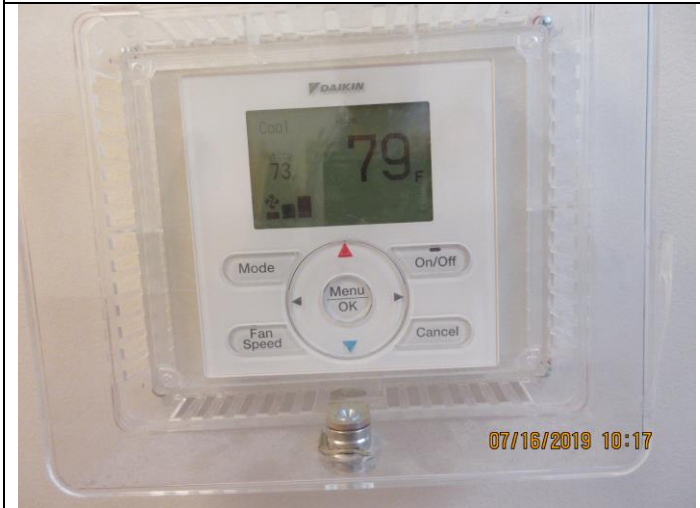
Description: T-Stat set to 73°F with room temp at 79°F.

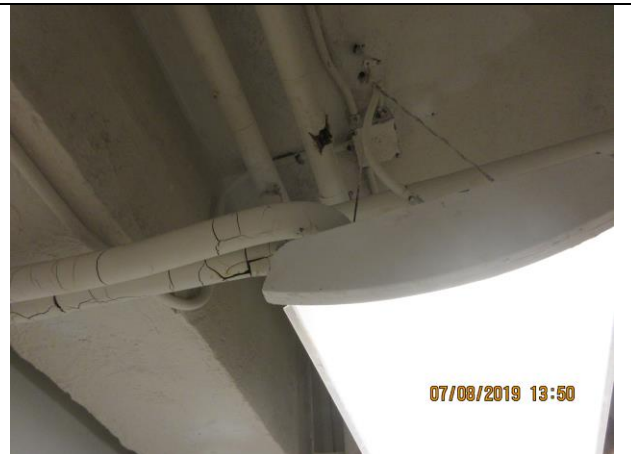
Description: damaged pipe insulation due to high humidity.

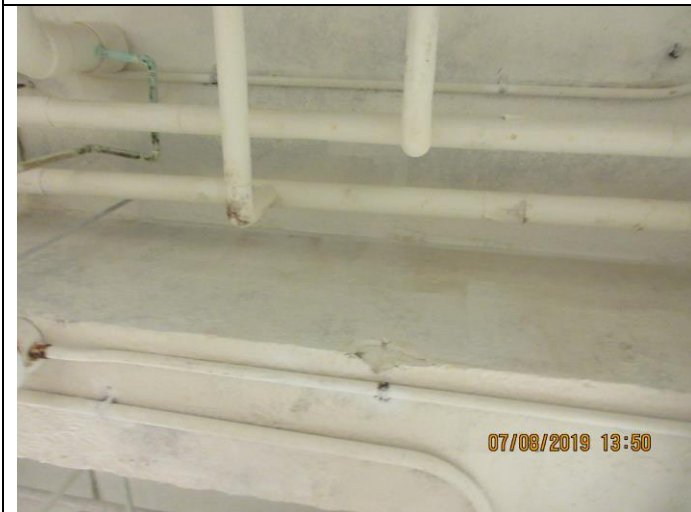
Description: damaged pipe insulation due to high humidity.

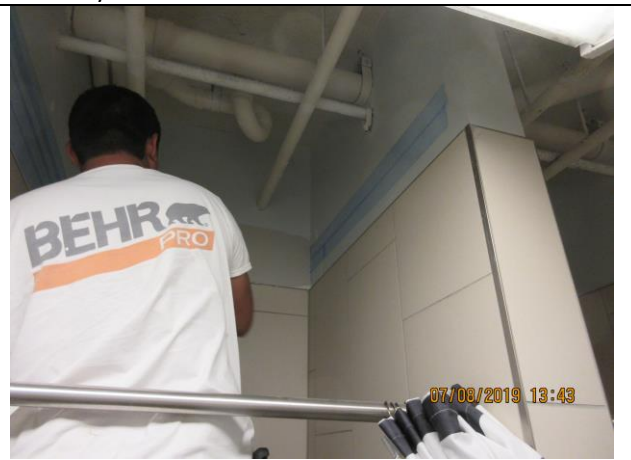
Description: crew repairing damaged wall

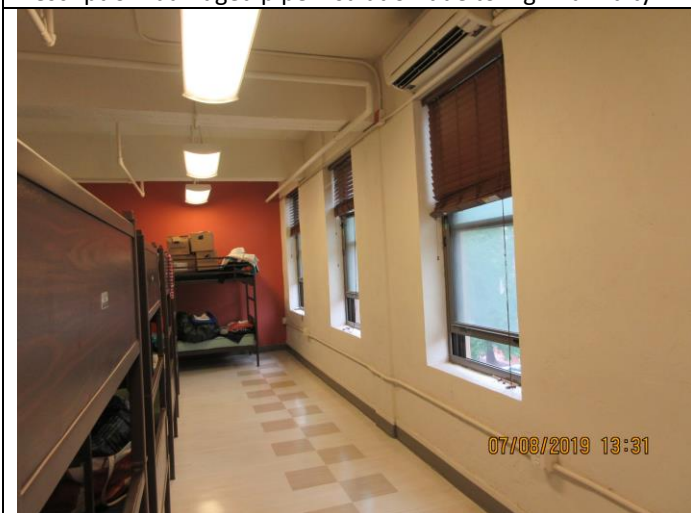
Description: view of a dorm room with a fan coil unit.

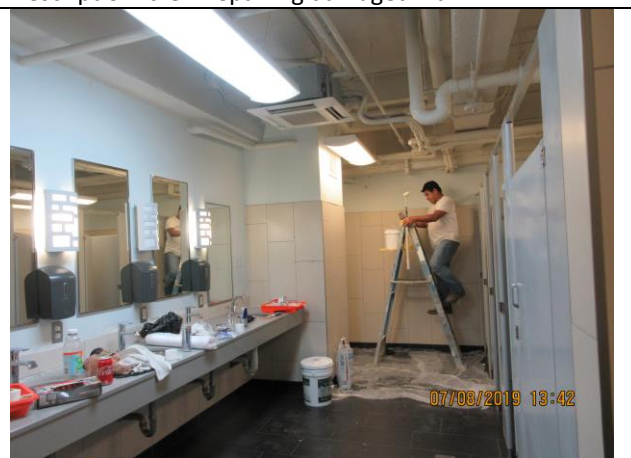
Description: crew painting damaged wall boards.

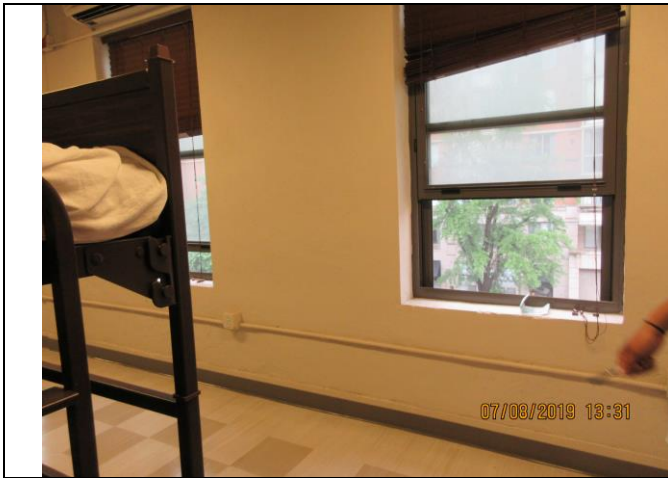
Description: windows left open.

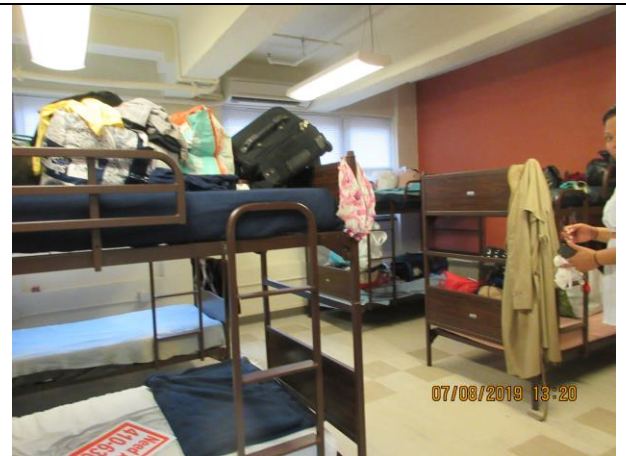
Description: piles of clothing and bathrobe contributing to high humidity levels.

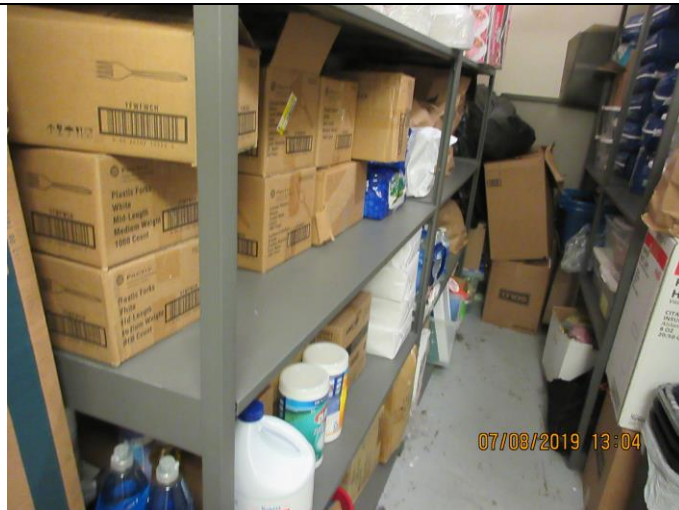
Description: Metal shelves should be replaced with wired shelves and cardboard boxes should not be on the floor.

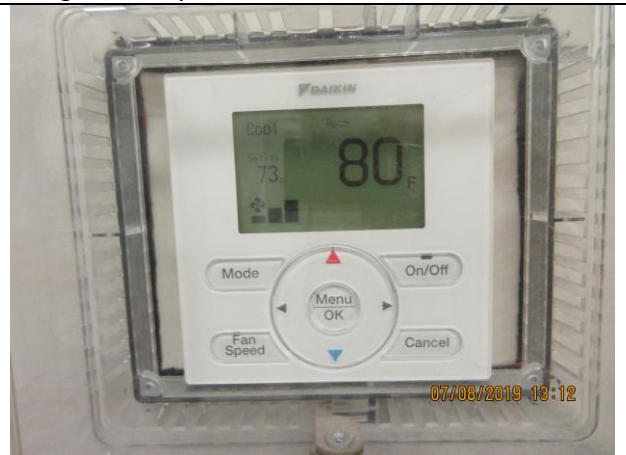
Description: T-Stat is set to 73°F with room temp at 80°F.

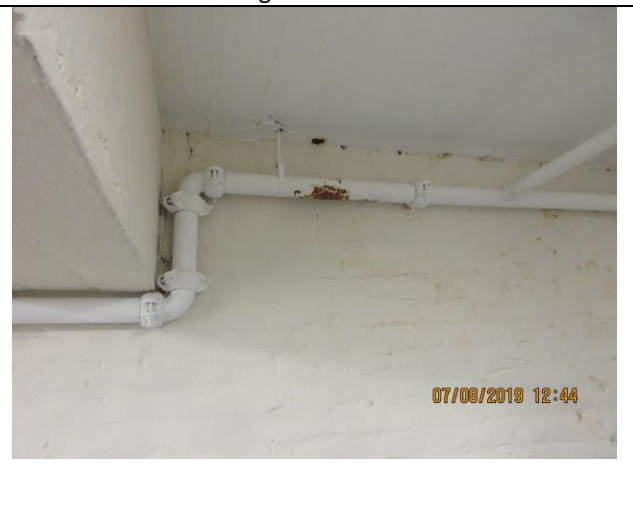
Description: water leak from basement ceiling and damaged pipe.

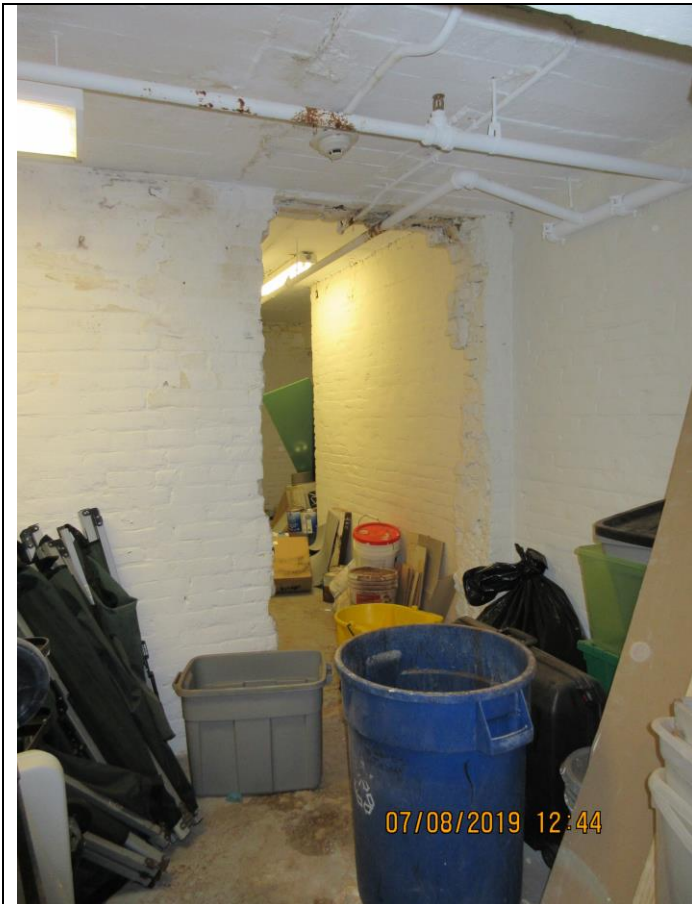
Description: water intrusion at basement ceiling

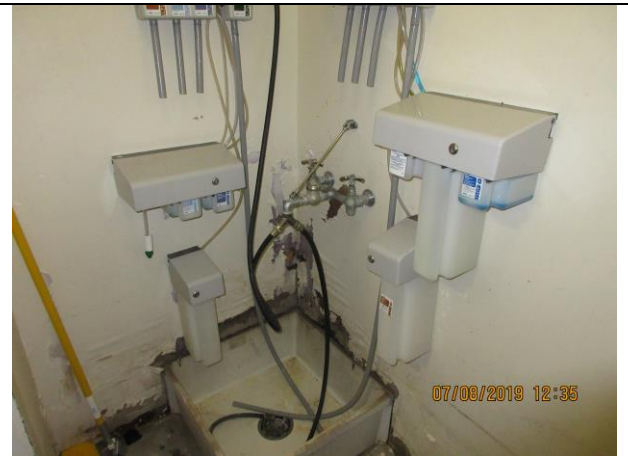
Description: damaged drywall at the mop basin.

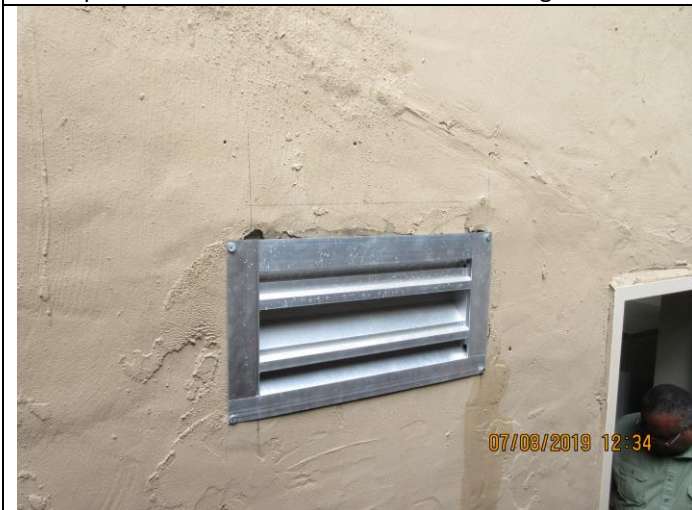
Description: exterior louver frame missing caulk.

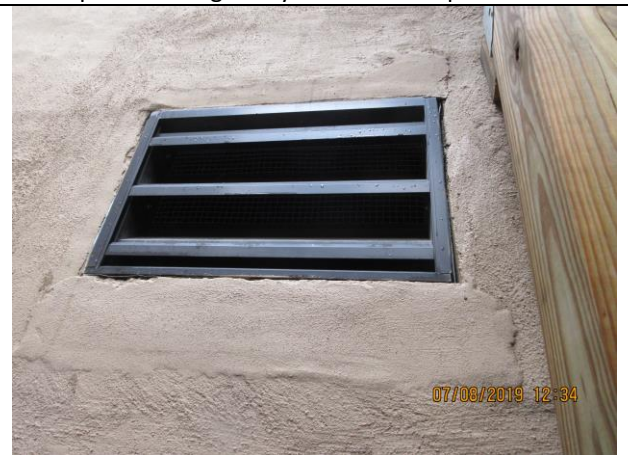
Description: exterior louver frame missing caulk.

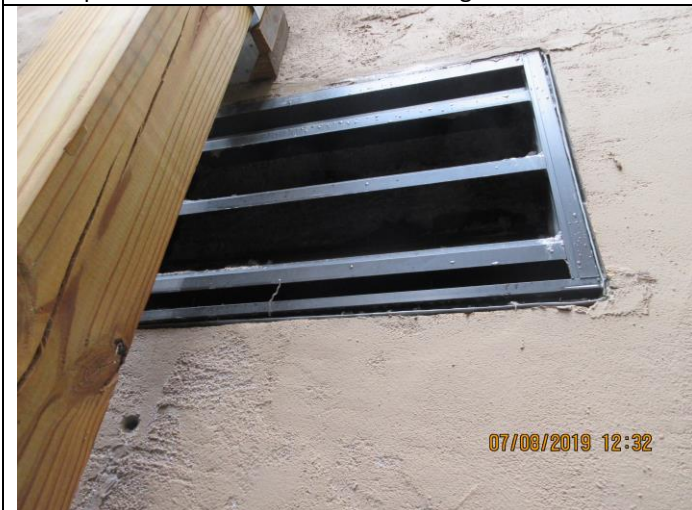
Description: exterior louver frame missing caulk.

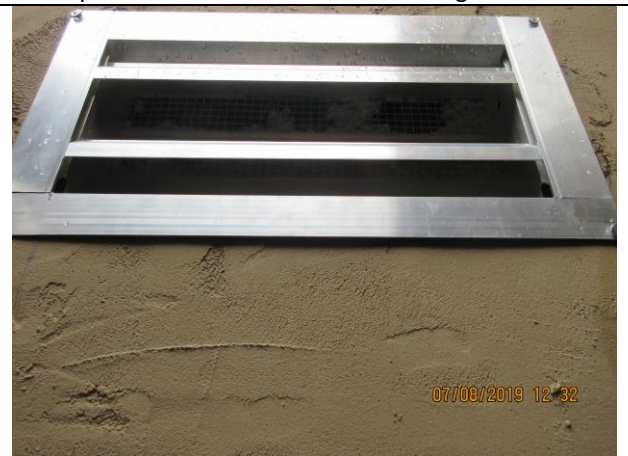
Description: exterior louver frame missing caulk.

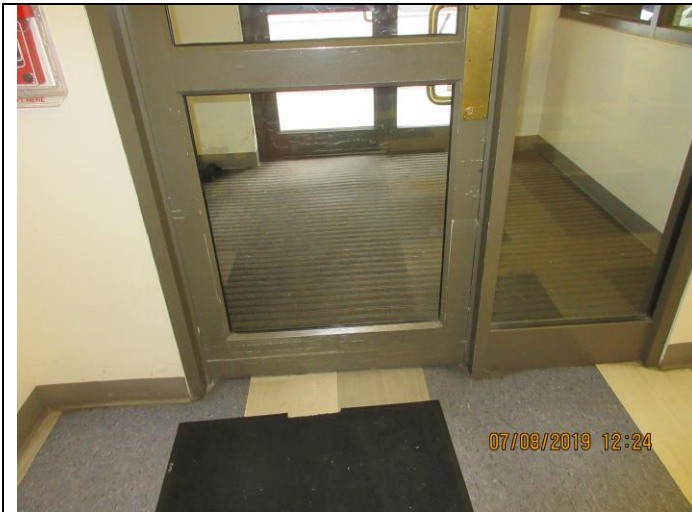
Description: Front entry foyer rug harboring water and dirt.

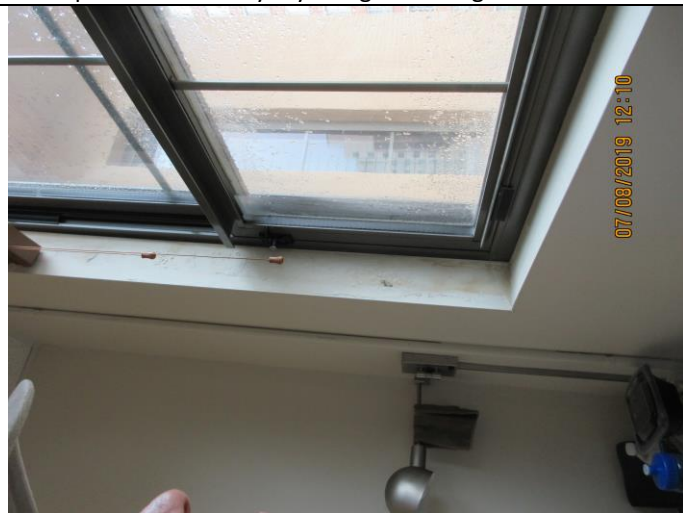
Description: damage to window sill from water intrusion.

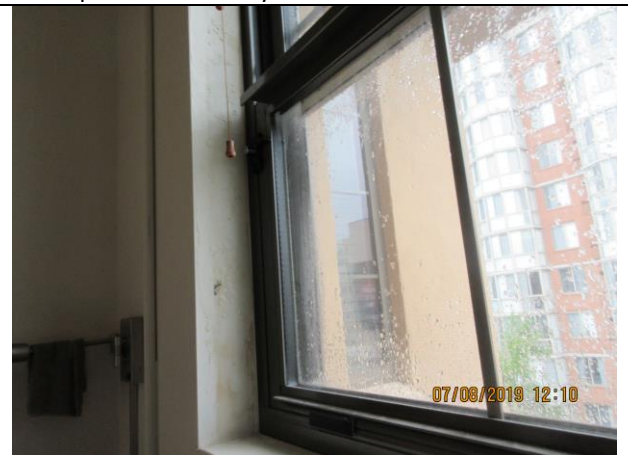
Description: damaged window frame from water intrusion.

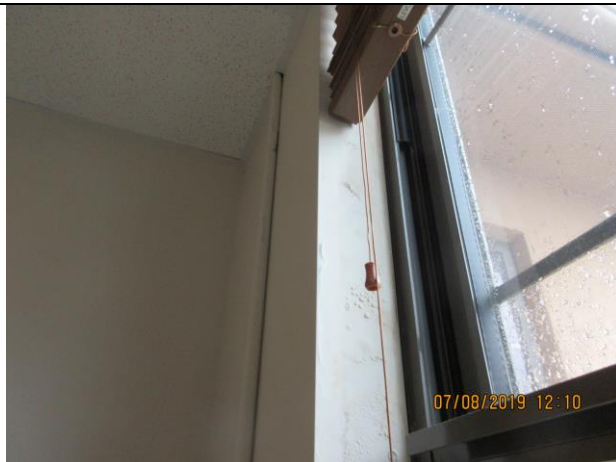
Description: damaged window frame from water intrusion.

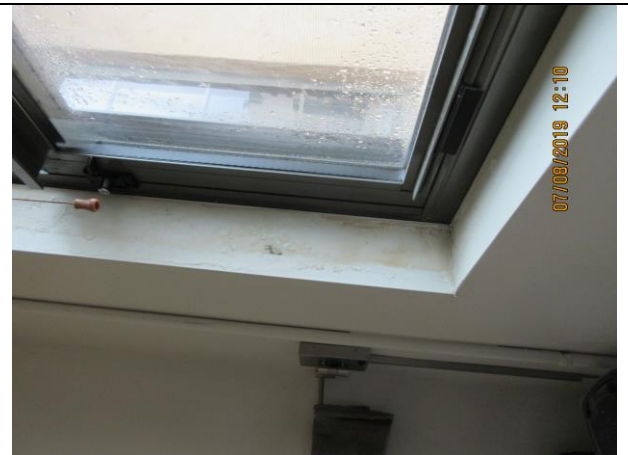
Description: damage to window sill from water intrusion.

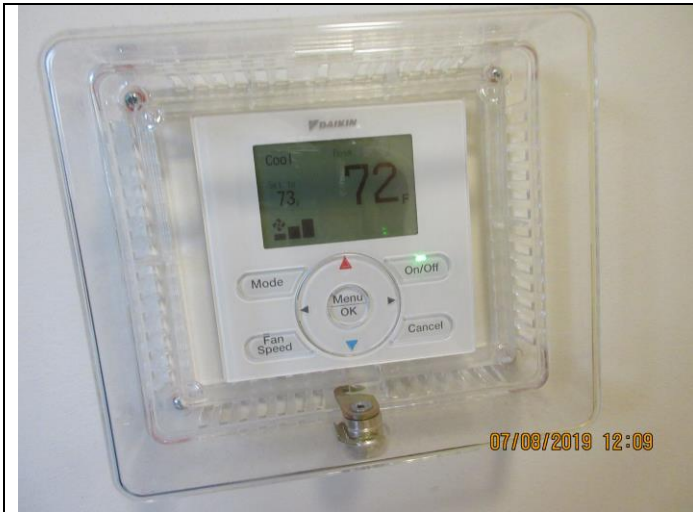
Description: T-Stat set at 73°F with room temp at 72°F.

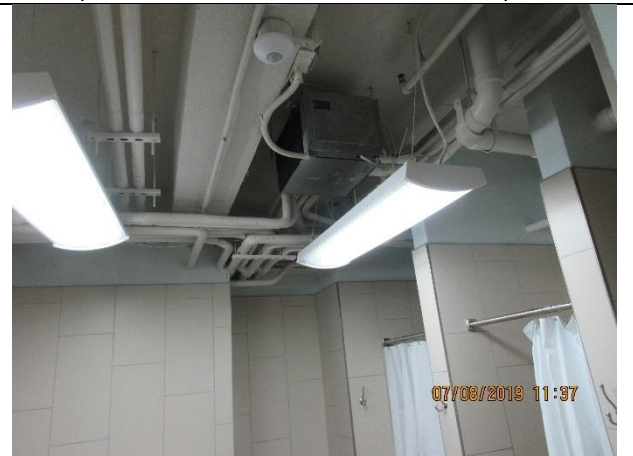
Description: gang shower rooms missing ceiling.

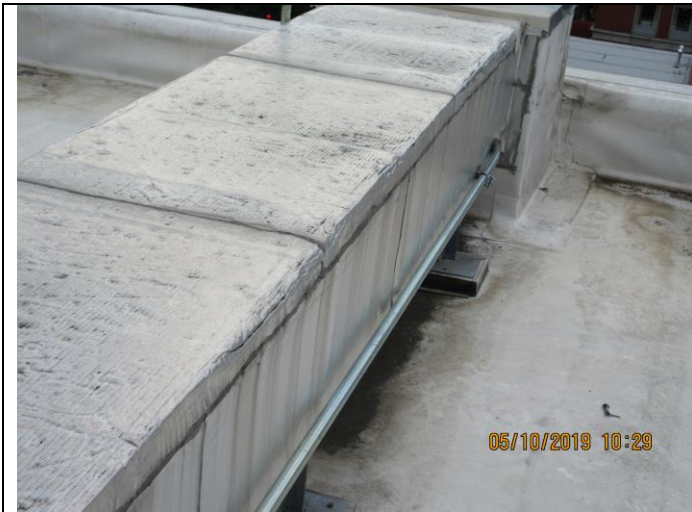
Description: ductwork on roof subject to damage.

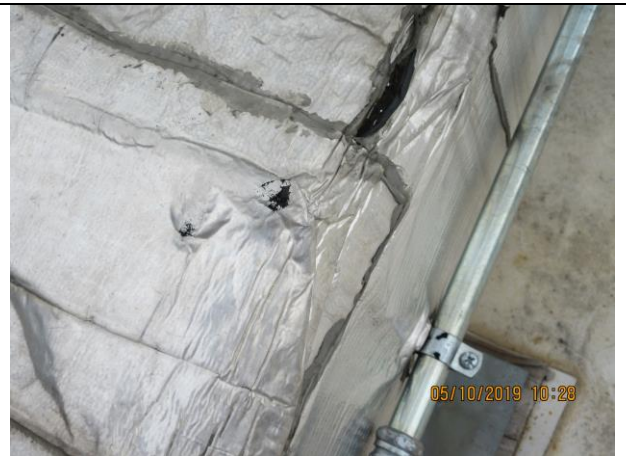
Description: damaged insulation on roof ducts

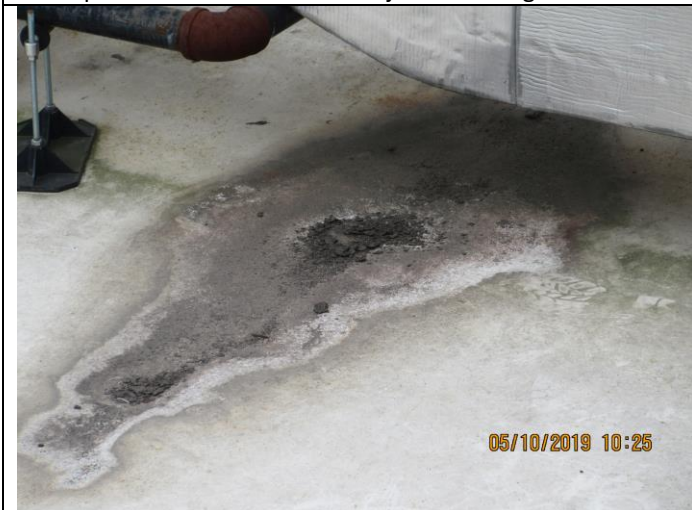
Description: water collected under ducts.

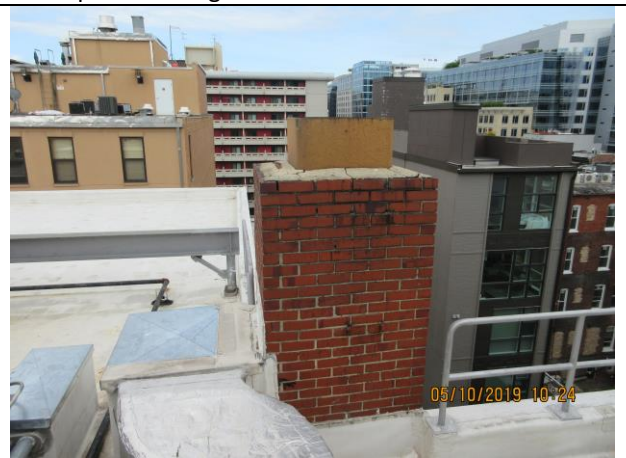
Description: masonry in need of repair.

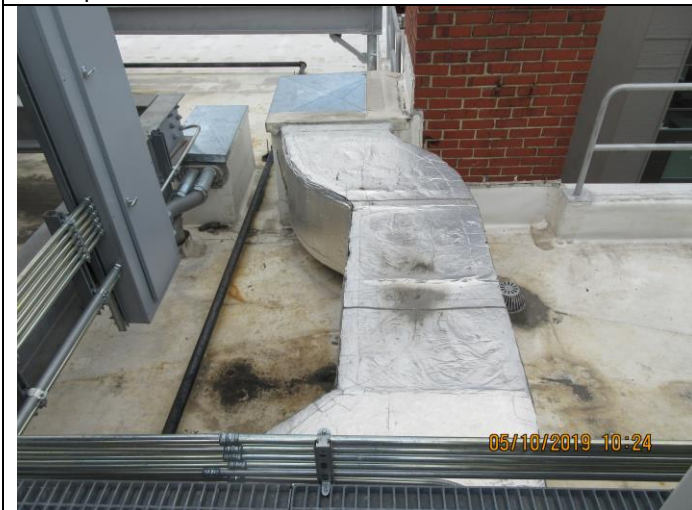
Description: roof level ducts exposed to elements.

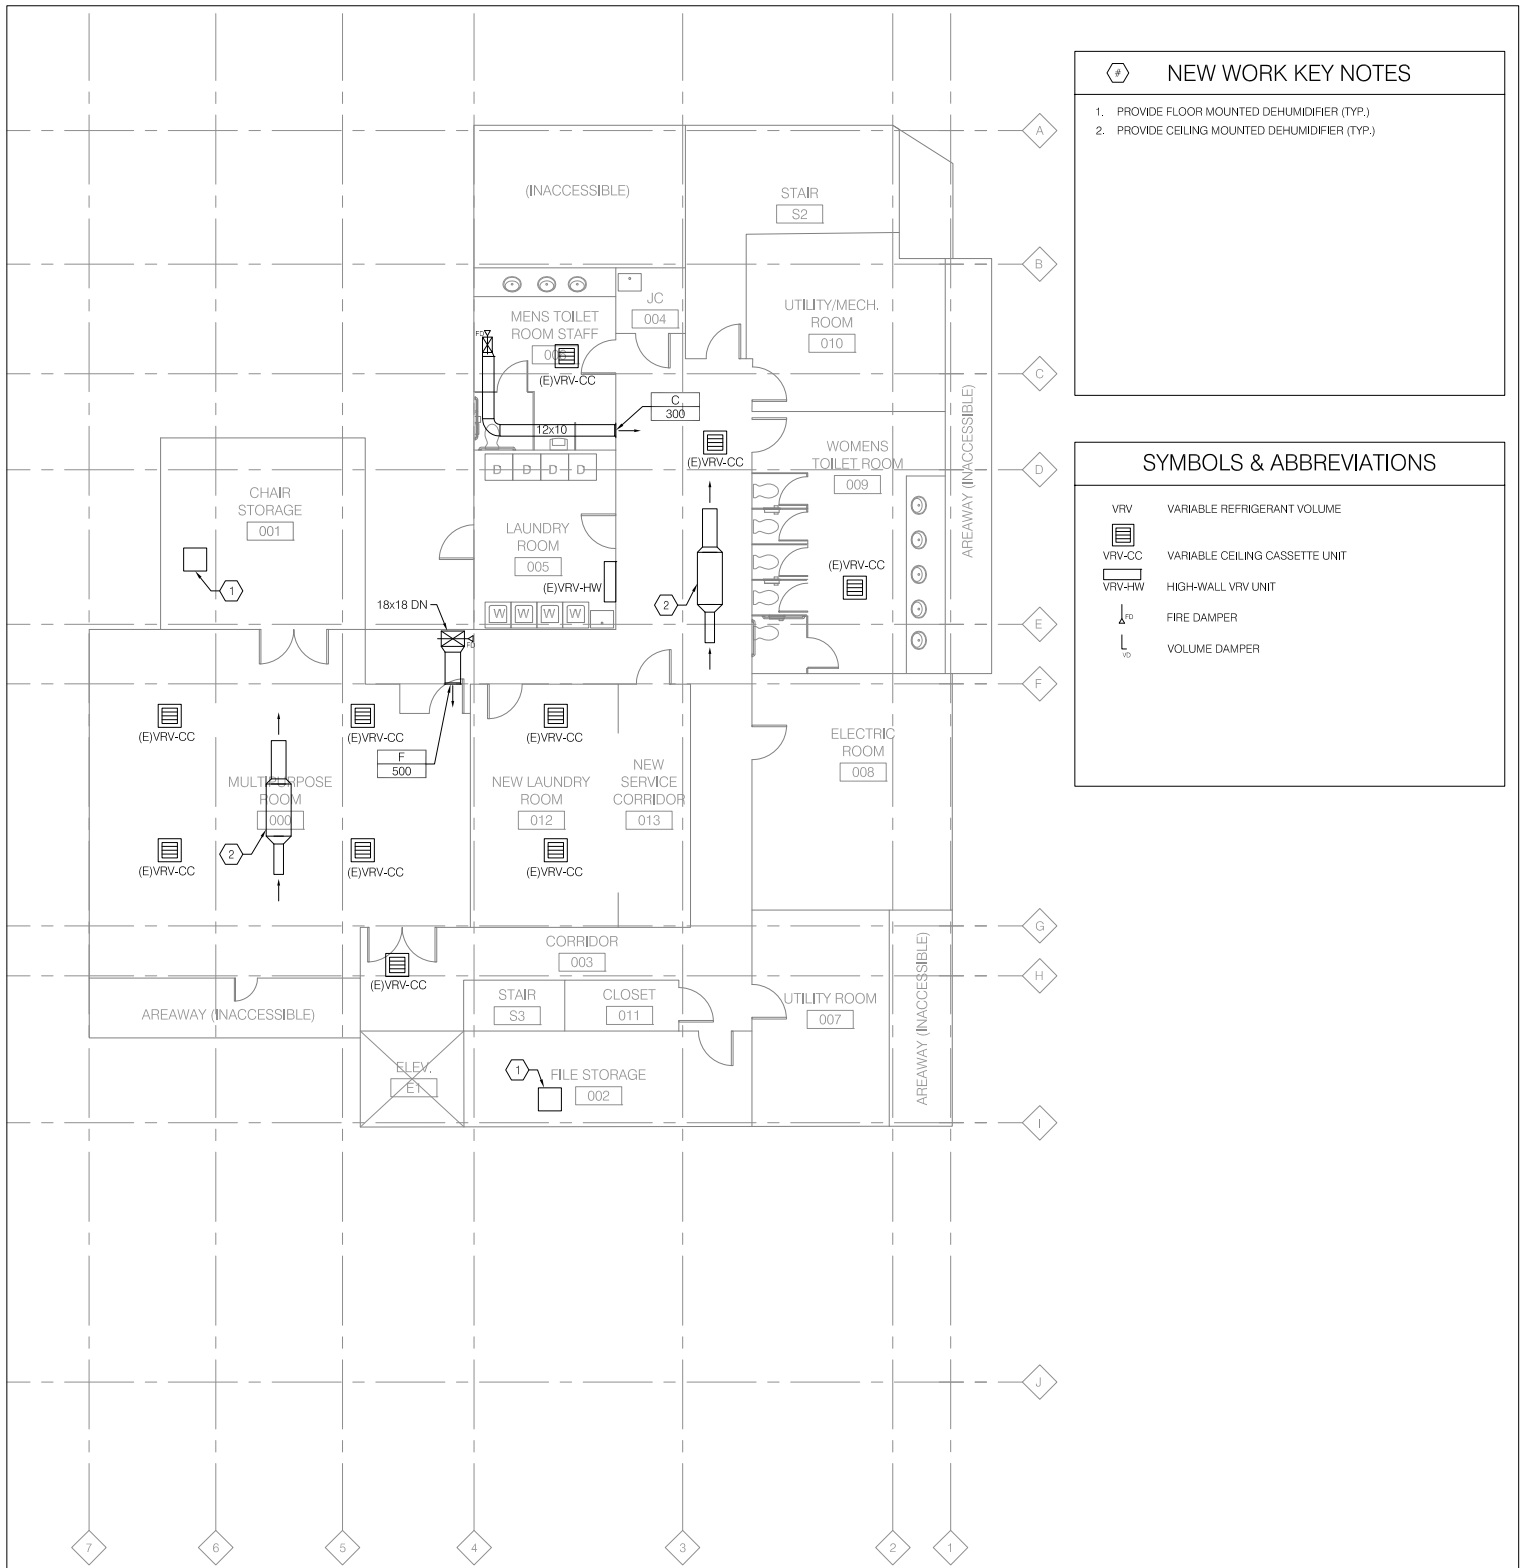
Abbreviations	Description
ABD	Automatic Balancing Damper
AC	Air-Conditioning
CFM	Cubic-Feet per Minute; a measure of the flow-rate of air
DOAS	Dedicated Outdoor Air System; the system is responsible for providing ventilation air at “neutral conditions”, and is largely responsible for dehumidifying the air introduced to the space.
FCU	Fan Coil Unit
HVAC	Heating, Ventilation, and Air Conditioning
OA	Outdoor Air
PPD	Pints Per Day; the rate of water condensed out of the air
RH	Relative Humidity
T-Stat	Thermostat
TAB	Testing and Balancing
VRV	Variable Refrigerant Volume; an air-conditioning system that relies on varying the amount of refrigerant between an outdoor condensing unit and individual indoor units to heat or cool as required.

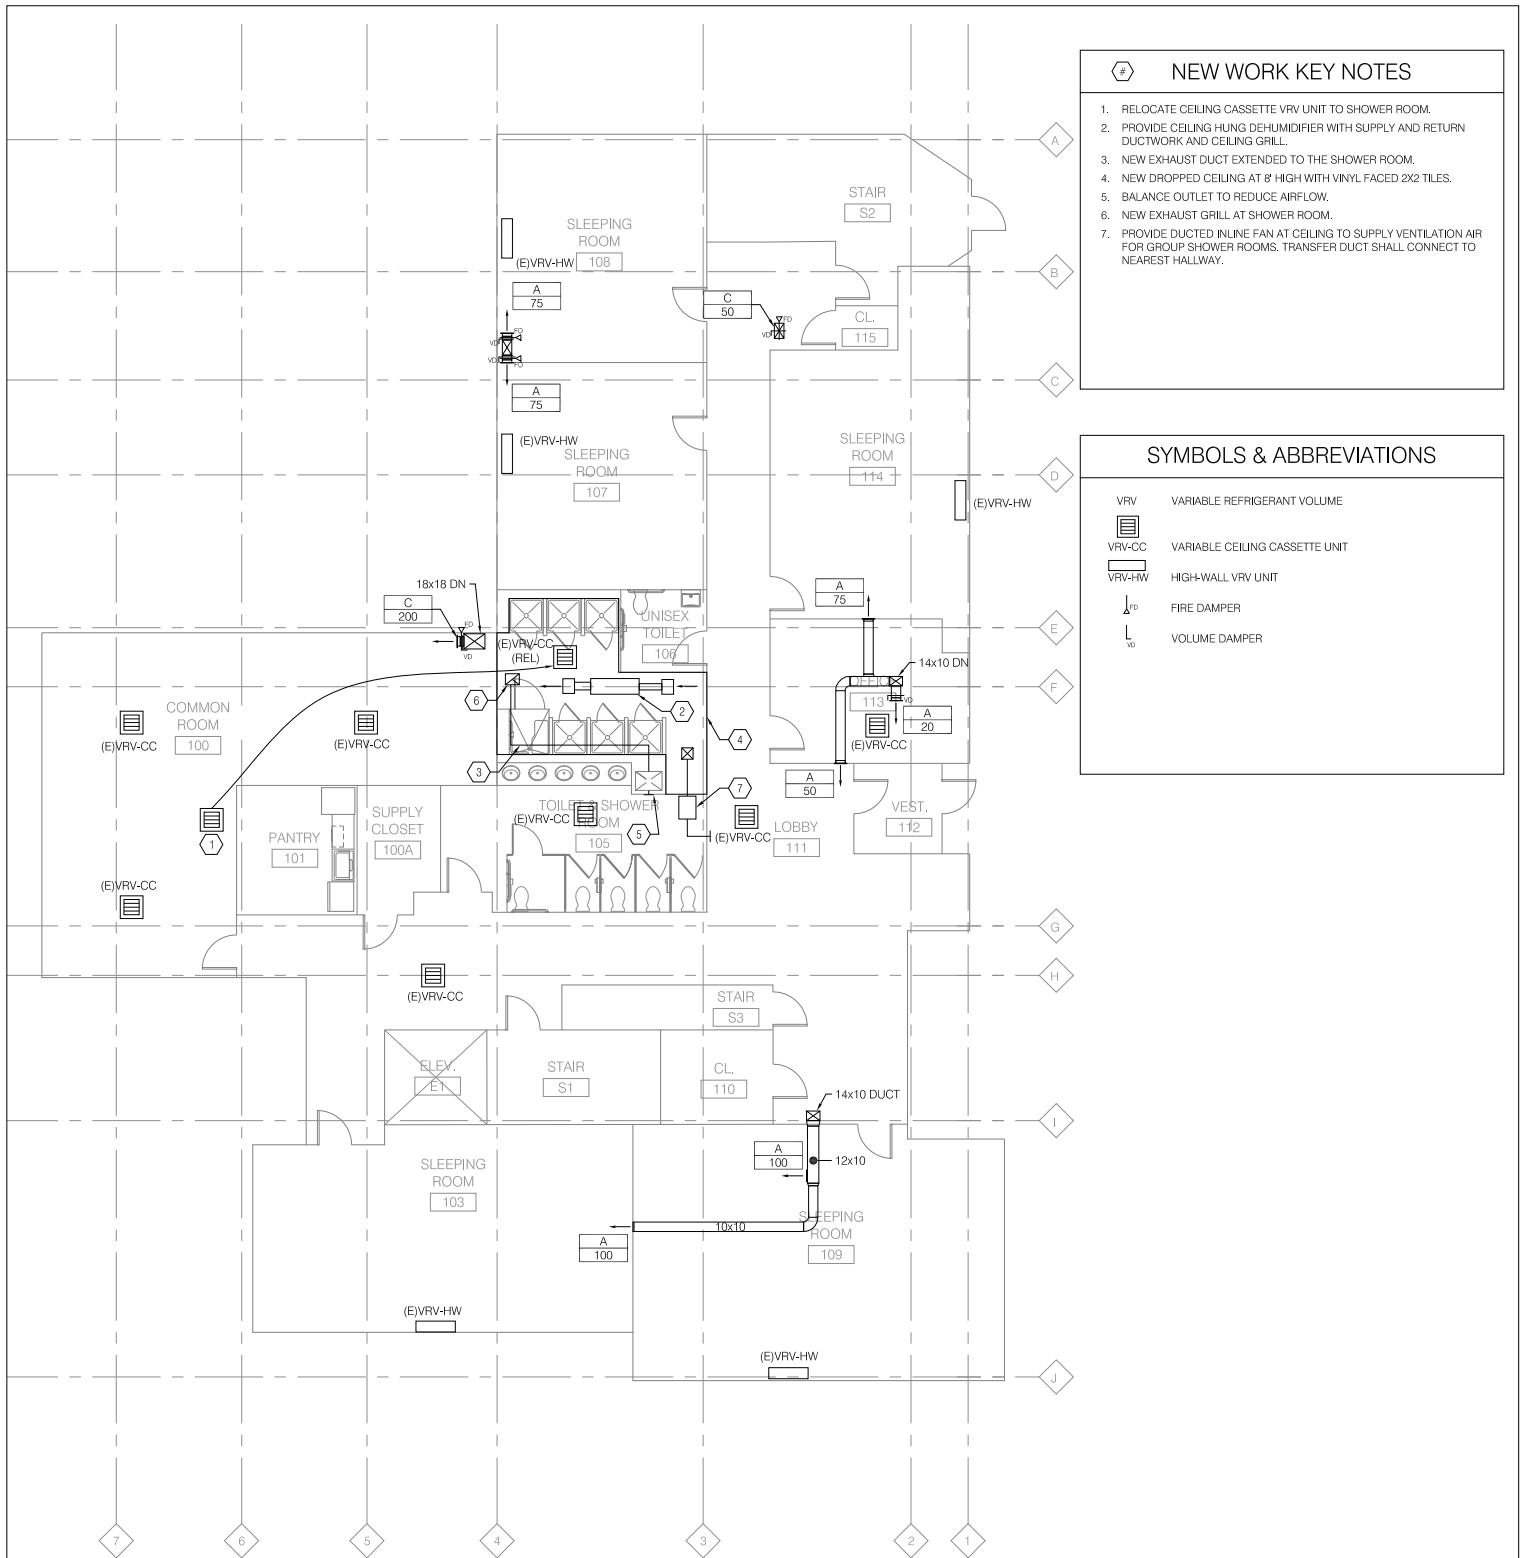
- ### NEW WORK KEY NOTES
1. RELOCATE CEILING CASSETTE VRV UNIT TO SHOWER ROOM.
 2. PROVIDE CEILING HUNG DEHUMIDIFIER WITH SUPPLY AND RETURN DUCTWORK AND CEILING GRILL.
 3. NEW EXHAUST DUCT EXTENDED TO THE SHOWER ROOM.
 4. NEW DROPPED CEILING AT 8' HIGH WITH VINYL FACED 2X2 TILES.
 5. BALANCE OUTLET TO REDUCE AIRFLOW.
 6. NEW EXHAUST GRILL AT SHOWER ROOM.
 7. PROVIDE DUCTED INLINE FAN AT CEILING TO SUPPLY VENTILATION AIR FOR GROUP SHOWER ROOMS. TRANSFER DUCT SHALL CONNECT TO NEAREST HALLWAY.

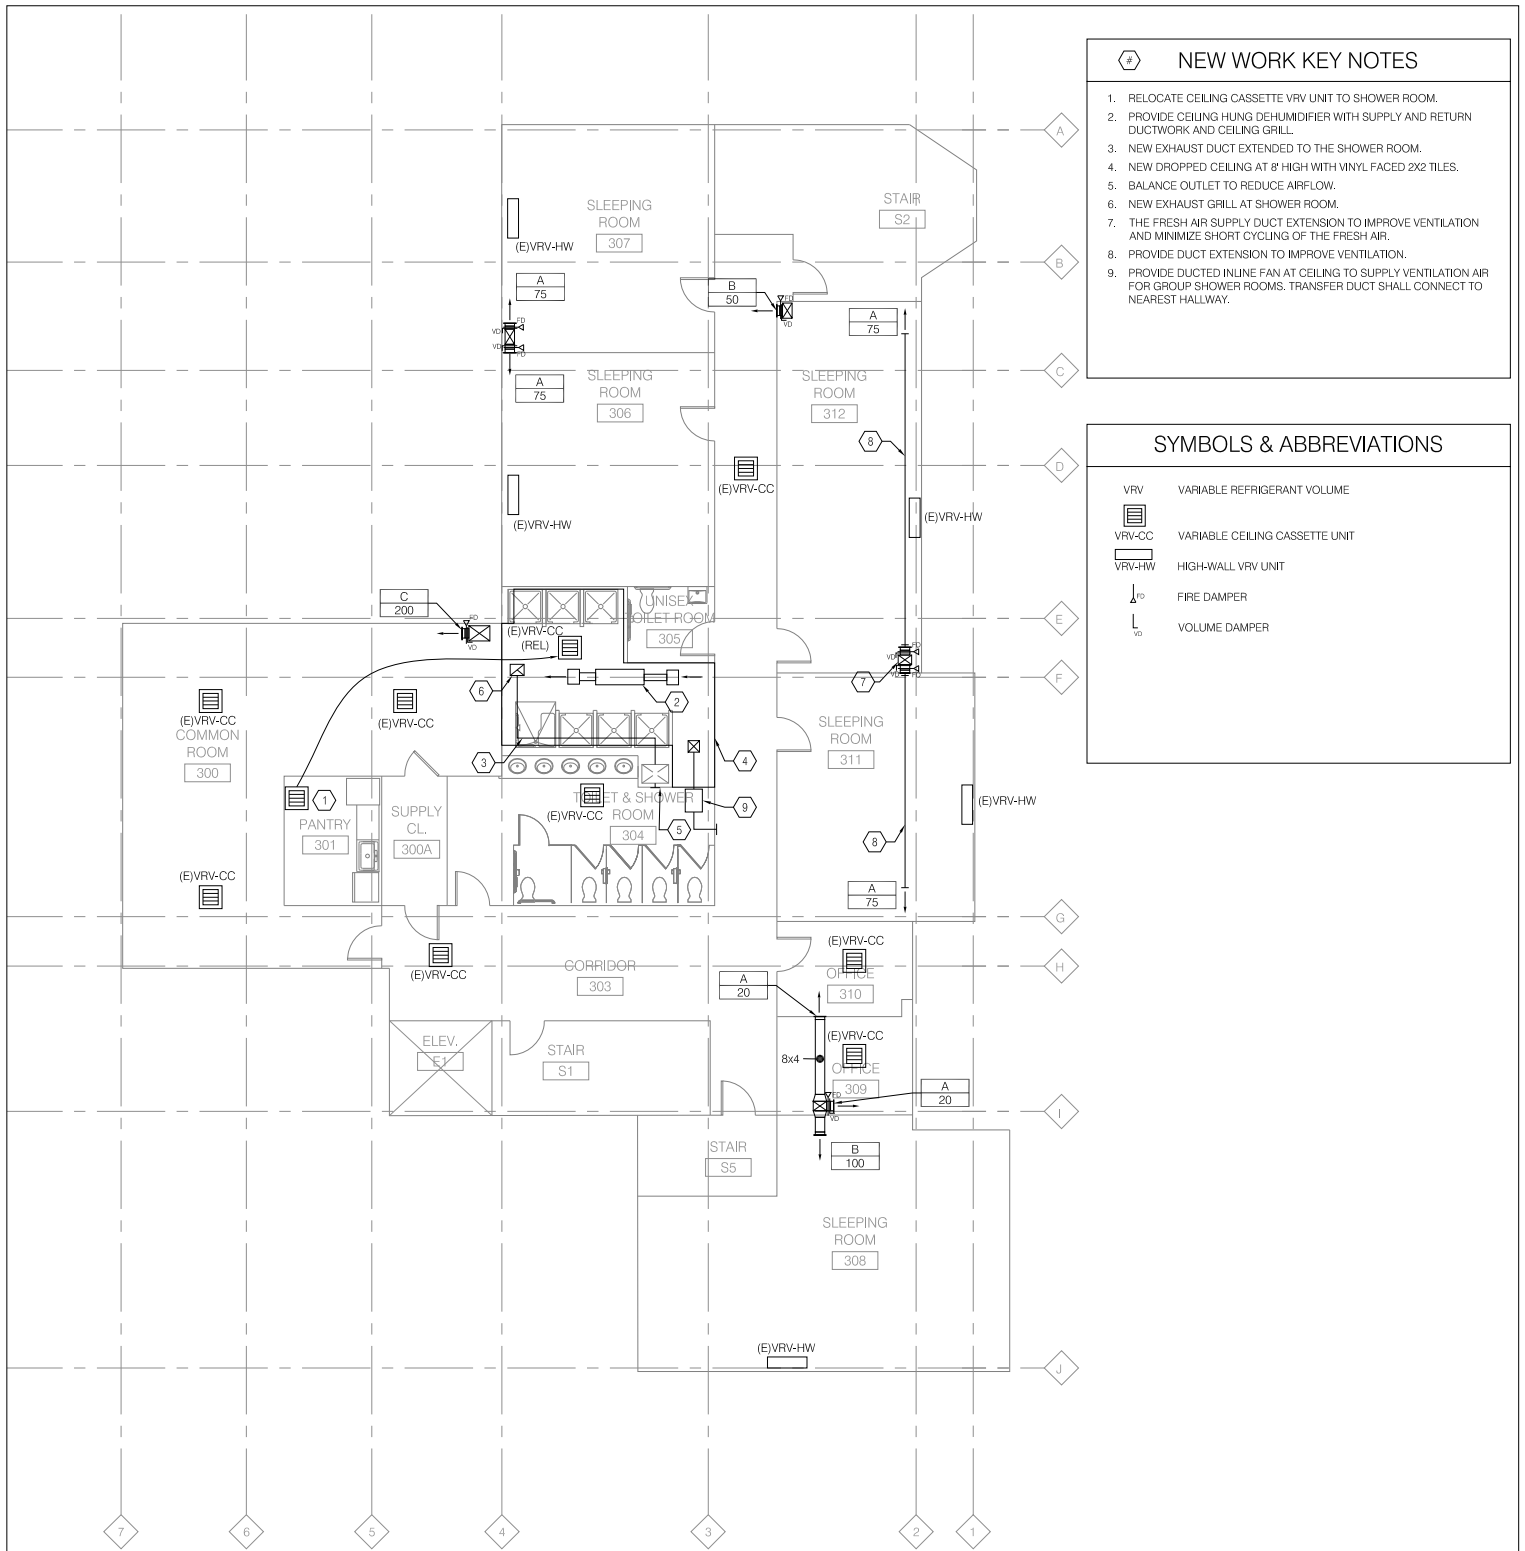
- ### NEW WORK KEY NOTES
1. RELOCATE CEILING CASSETTE VRV UNIT TO SHOWER ROOM.
 2. PROVIDE CEILING HUNG DEHUMIDIFIER WITH SUPPLY AND RETURN DUCTWORK AND CEILING GRILL.
 3. NEW EXHAUST DUCT EXTENDED TO THE SHOWER ROOM.
 4. NEW DROPPED CEILING AT 8' HIGH WITH VINYL FACED 2X2 TILES.
 5. BALANCE OUTLET TO REDUCE AIRFLOW.
 6. NEW EXHAUST GRILL AT SHOWER ROOM.
 7. THE FRESH AIR SUPPLY DUCT EXTENSION TO IMPROVE VENTILATION AND MINIMIZE SHORT CYCLING OF THE FRESH AIR.
 8. PROVIDE DUCT EXTENSION TO IMPROVE VENTILATION.
 9. PROVIDE DUCTED INLINE FAN AT CEILING TO SUPPLY VENTILATION AIR FOR GROUP SHOWER ROOMS. TRANSFER DUCT SHALL CONNECT TO NEAREST HALLWAY.
