District of Columbia Dept. of General Services

FACILITIES SUPPLEMENTAL ASSESSMENT REPORT

Final Report Submittal 4-8

Takoma Community Center and Aquatic Facility
6500 3rd Street, NW, DC 20011

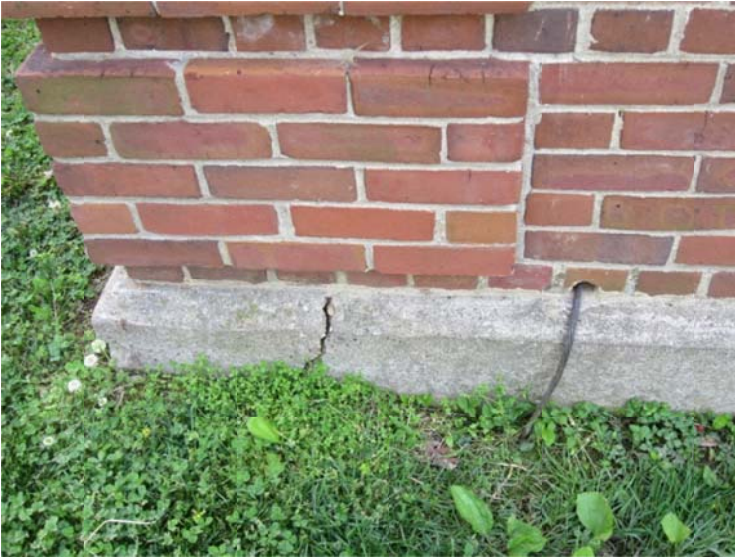
Photograph 4-8.1 (Community Center)
Damaged foundation at building corner, anchoring in place.

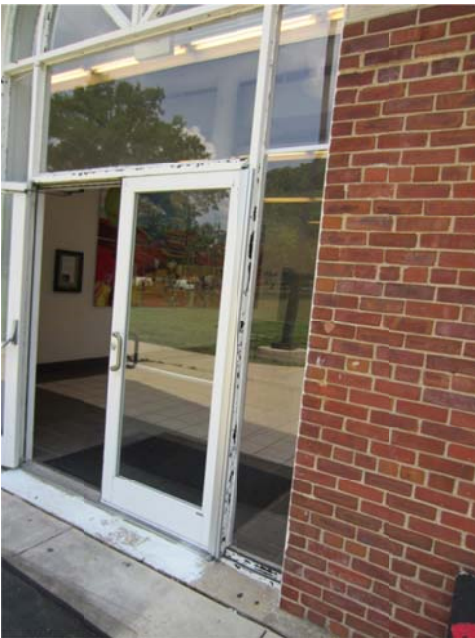
Photograph 4-8.2 (Community Center)
Rusted and chipped entry door.

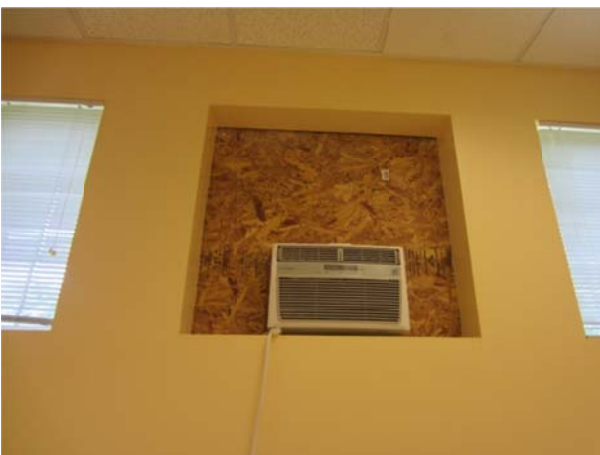
Photograph 4-8.3 (Community Center)
Boarded up window with AC unit.

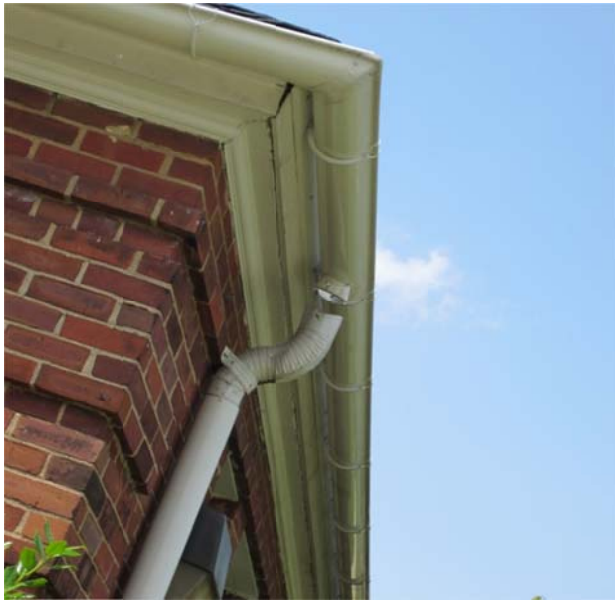
Photograph 4-8.4 (Community Center)
Detached roof drain from gutter.

14	Replace broken garbage disposal in Kitchen/Pantry	\$ 450.00	1	LS	2		✓	\$450	
	22	Re-attach and secure downspout	\$ 100.00	1	LS	2	✓		\$100

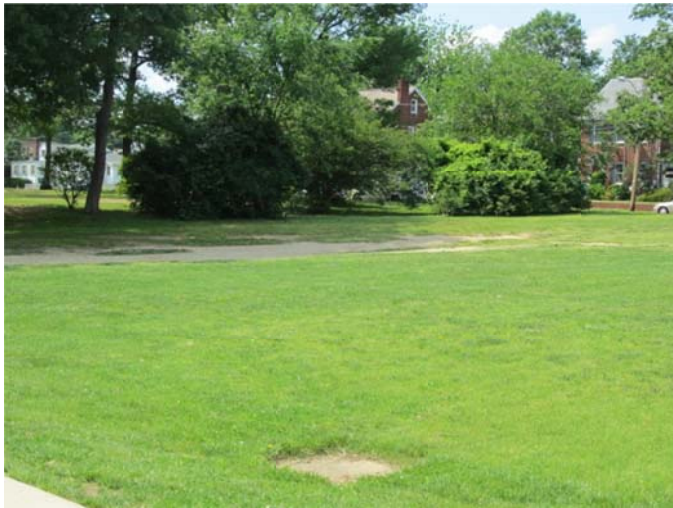
Photograph 4-8.5 (Community Center)
Patches of dirt in grounds around facility.

G10	Site Systems								
23	Re-seed or sod bare patches in grounds - Allowance	\$ 1,000.00	1	EA	2	✓		\$1,000	
51	Repair or replace broken lamp post at CC Entrance	\$ 2,500.00	1	EA	2	✓		\$2,500

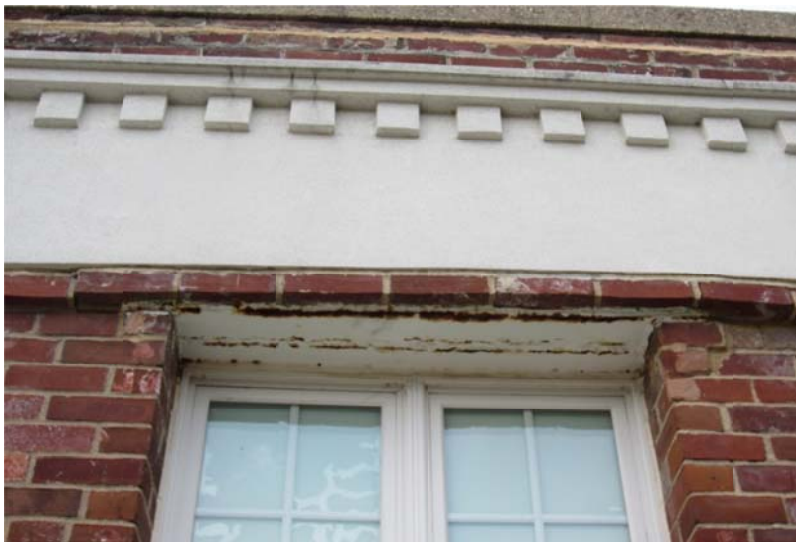
Photograph 4-8.6 (Community Center)
Rusted and damaged window head.

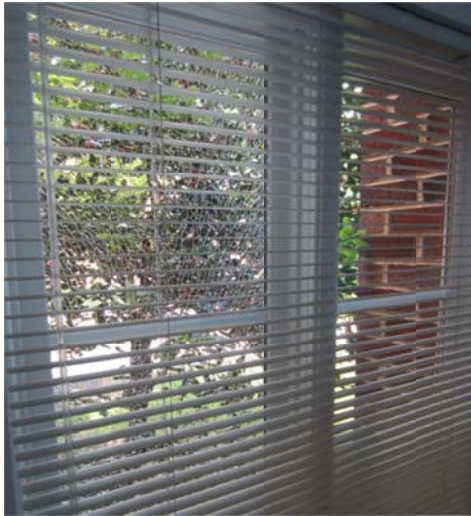
Photograph 4-8.7 (Community Center)
Broken Glass.

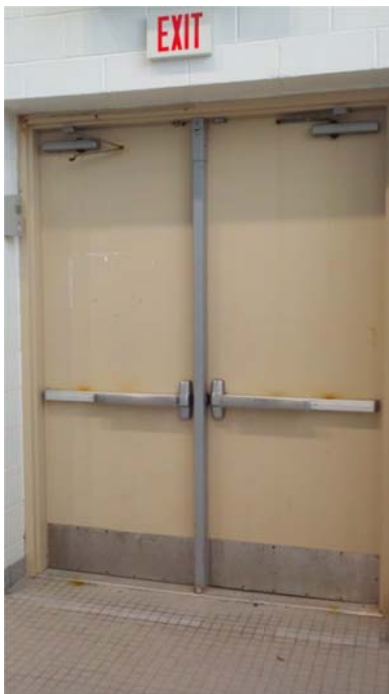
Photograph 4-8.8 (Aquatic Center)
Damaged egress door.

34	Repair damaged egress door and replace any broken hardware	\$ 2,000.00	1	PR	2	✓		\$2,000	
	45,48	Remove rust, treat and re-paint roof beams & trusses over pool and at high windows (Pool)	\$ 10.00	22,470	SF	2	✓		\$224,700	
B30		Roofing								
	17,18,1	Check/Inspect roof and drainage systems for leaks and make repairs accordingly.	\$ 5,000.00	1	EA	2			\$5,000	
	17,18,1	Provisional Allowance for roof and drainage repairs as a result of investigation above	\$ 2.50	38,135	EA	2	✓		\$95,338	
C INTERIORS										\$45,691
C10		Interiors								
	3	Replace waterlogged/damaged drywall	\$ 2,000.00	1	LS	1	✓		\$2,000	
	4	Treat/abate molded/mildewed surfaces in Women's Locker Room (say = 50%)	\$ 5.00	263	SF	1		✓	\$1,315	
	4	Cut out and repair/replace mold damaged drywall/ceiling in Women's Locker Room (allow 50%)	\$ 10.00	263	SF	1		✓	\$2,630	
	4,44	Repaint walls and ceilings (Women's Locker Room)	\$ 2.00	6,028	SF	1		✓	\$12,056

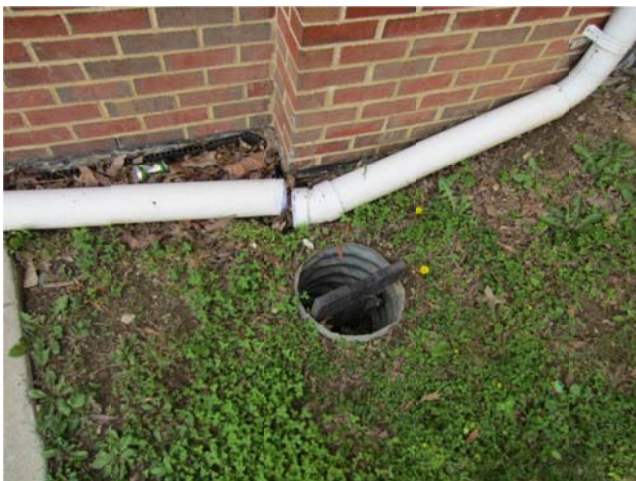
Photograph 4-8.9 (Aquatic Center)
Detached rain leader and opened and clogged drain.

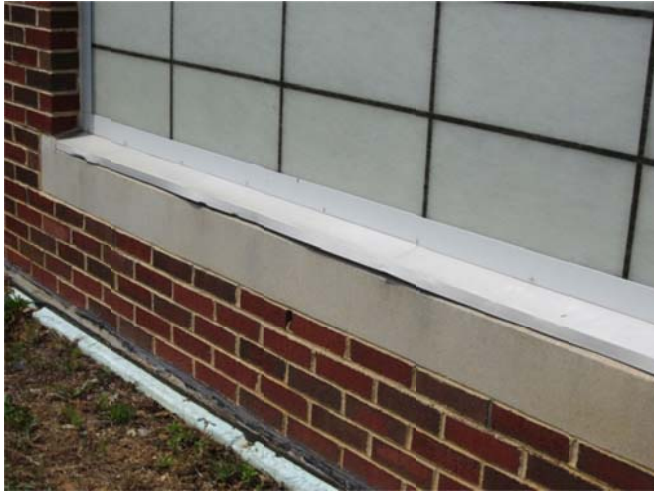
Photograph 4-8.10 (Aquatic Center)
Damaged flashing at base of window,
exposed insulation at foundation below.

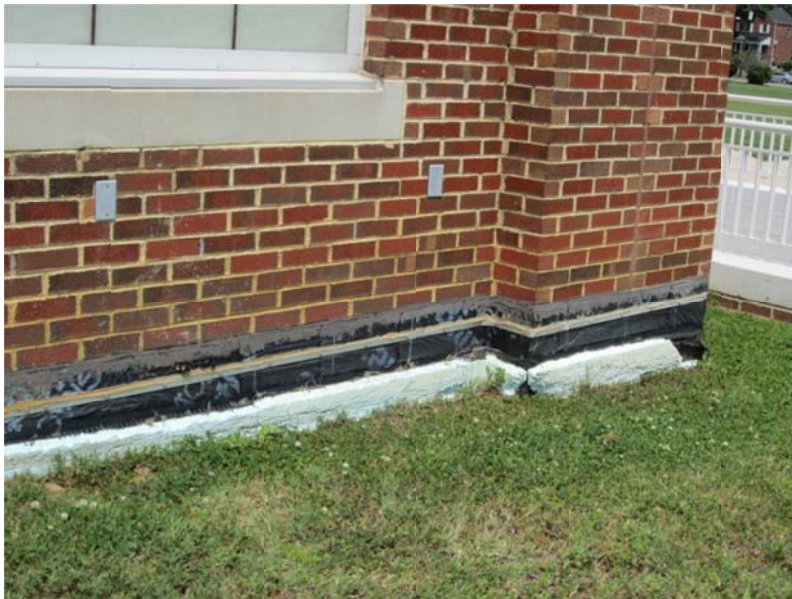
Photograph 4-8.11 (Aquatic Center)
Exposed and damaged water
barrier and insulation at
foundation along exterior of
building.

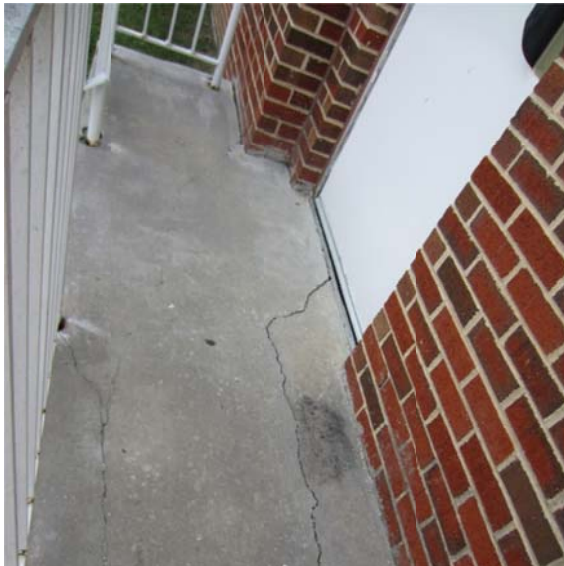
Photograph 4-8.12 (Aquatic Center)
Cracks in exterior landing at egress.

13	Repair broken storm drain pipes and clear blocked drains	\$ 2,000.00	1	LS	2		✓	\$2,000
14	Demolish and replace concrete landing adjacent East side egress door	\$ 20.00	100	SF	2		✓	\$2,000
14	Strip cracked and peeling paint from railing balusters. Treat with rust remover/primer and repaint.	\$ 250.00	1	LS	2		✓	\$250
49	Re-seed or sod bare patches in grounds - Allowance	\$ 2.50	24,955	SY	2		✓	\$62,388
50	Remove, resurface and repaint rear wall at tennis court - Allowance	\$ 500.00	1	LS	2		✓	\$500

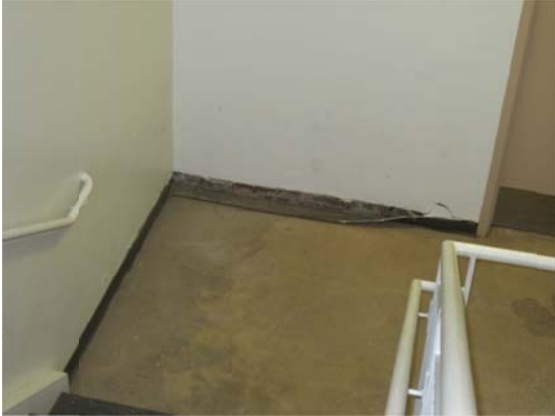
Photograph 4-8.13 (Aquatic Center)
Loose base trim in stairwell.

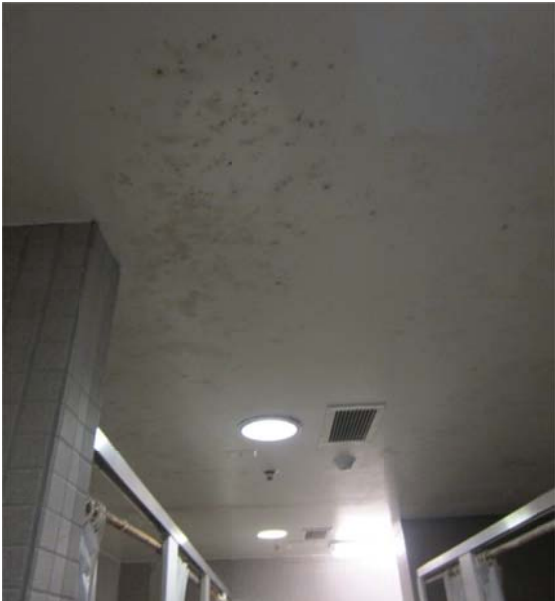
Photograph 4-8.14 (Aquatic Center)
Mold growing along ceiling and walls in shower area of Women's Locker Room.

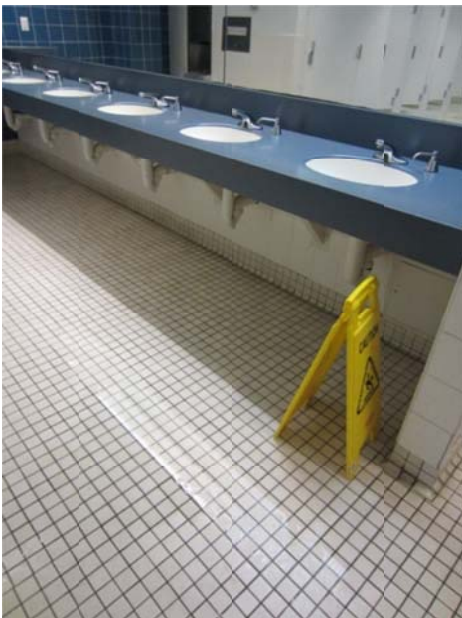
sound could be heard within the wall cavity. Although the source of the water could not be determined, the water has been leaking through the wall and into the hallway at the tile base. Facility staff indicated that the water puddles into the hallway and returns every few hours each time it is mopped up. As the water is a continuous leak into the wall, this is an issue that will prove to be costly to repair if not addressed immediately. The conditions in the women's locker room are very humid, likely due to this leak and mold is apparent on the gypsum ceiling in much of the nearby area. Also, in the pool area of the facility, many of the metal surfaces have rusted from constant exposure to moisture. The egress doors on the east and west ends of the pool area have faded signage difficult to read from a distance during an emergency and have disconnected closers attached to the doors.

Photograph 4-8.15 (Aquatic Center)
Puddle of water in Women's Locker Room from leak into wall near shower area.

1,2	Effect repairs as determined by investigation above	\$ 5,000.00	1	LS	1	✓		\$5,000

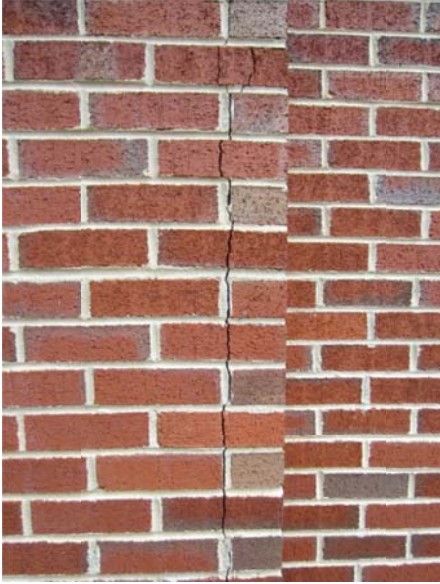
Photograph 4-8.16 (Aquatic Center)
Crack in exterior brick.

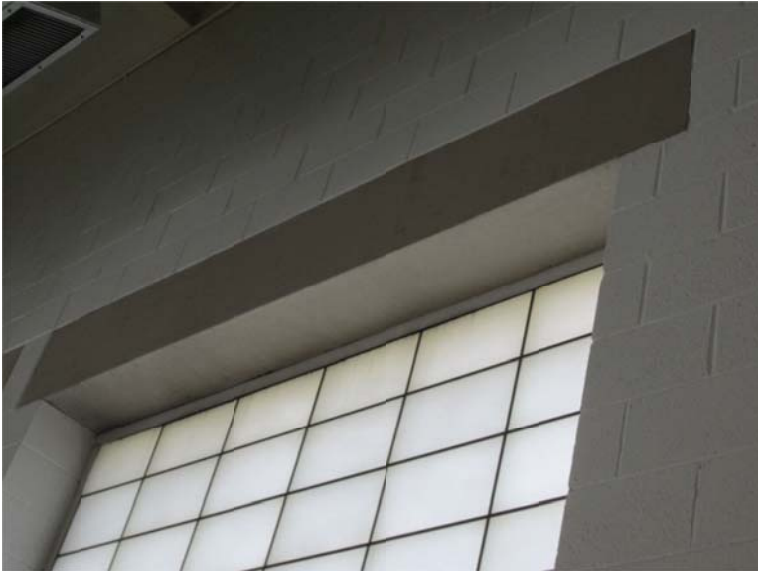
Photograph 4-8.17 (Aquatic Center)
Water marks along high windows in pool area.

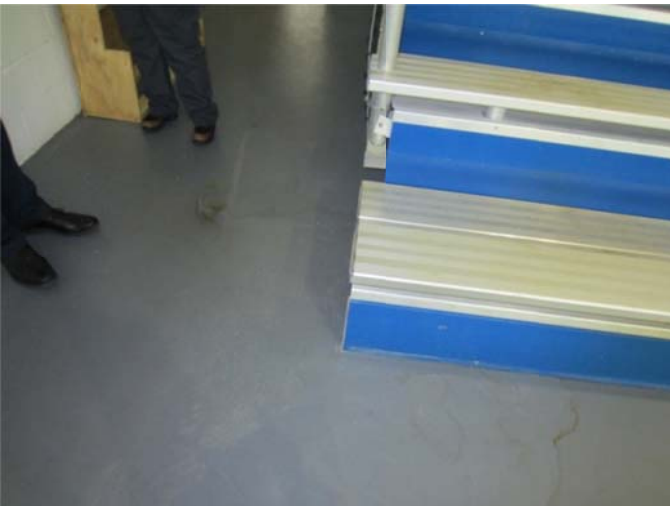
Photograph 4-8.18 (Aquatic Center)
Water damage on floor on pool observation deck from apparent roof leak.

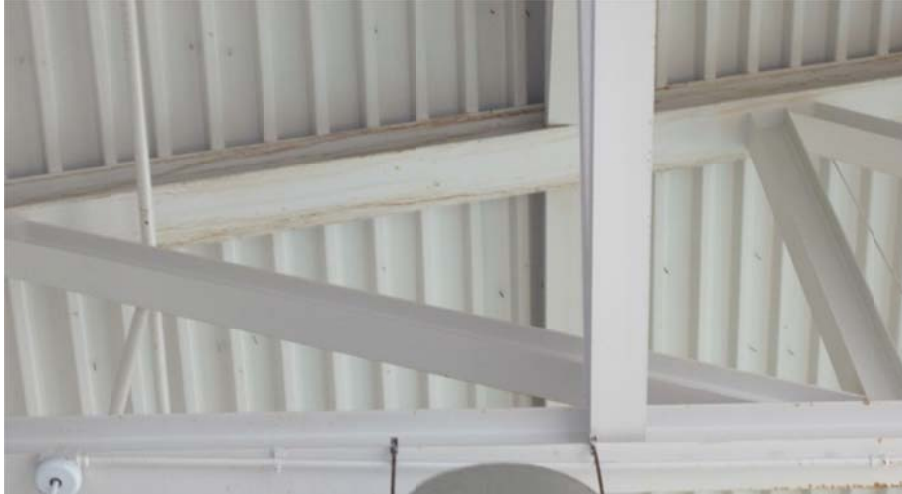
- Pool: water appears to be leaking from point in the roof. Noticeable rust along roof beams and trusses as water travels down. Water from leak flows both north and south on the west end of the pool with rust and water stains more apparent on northwest end.

Photograph 4-8.19 (Aquatic Center)
Water damage and rust along roof beams and truss over pool.

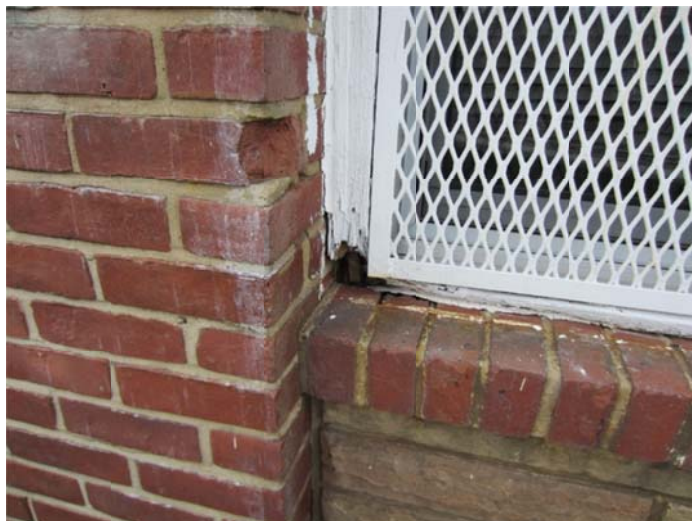
Photograph 4-8.21 (Field House)
Damaged wooden exterior window sill.

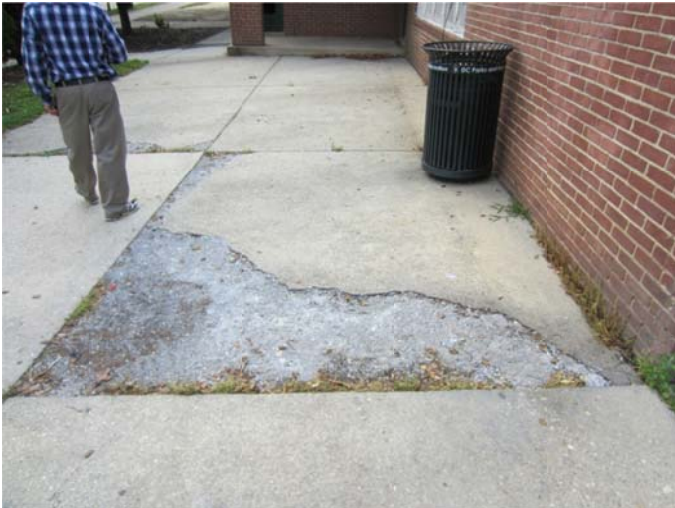
Photograph 4-8.22 (Field House)
Damaged exterior paving.

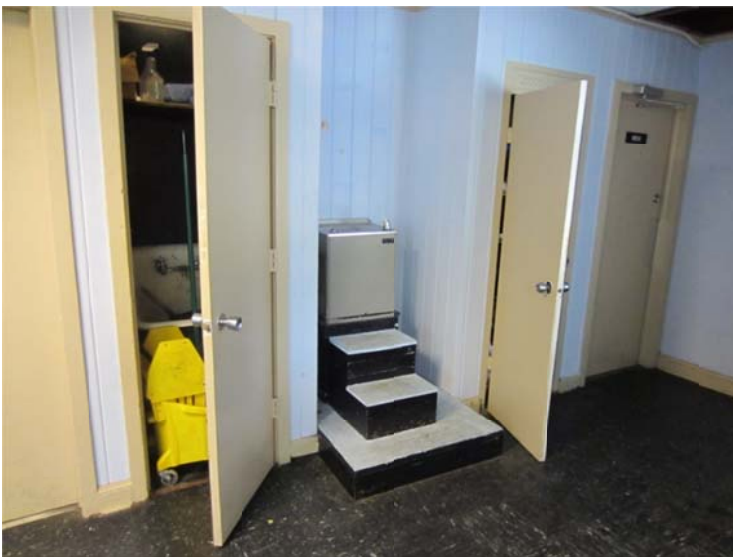
Photograph 4-8.23 (Field House)
Non-ADA accessible fixtures.

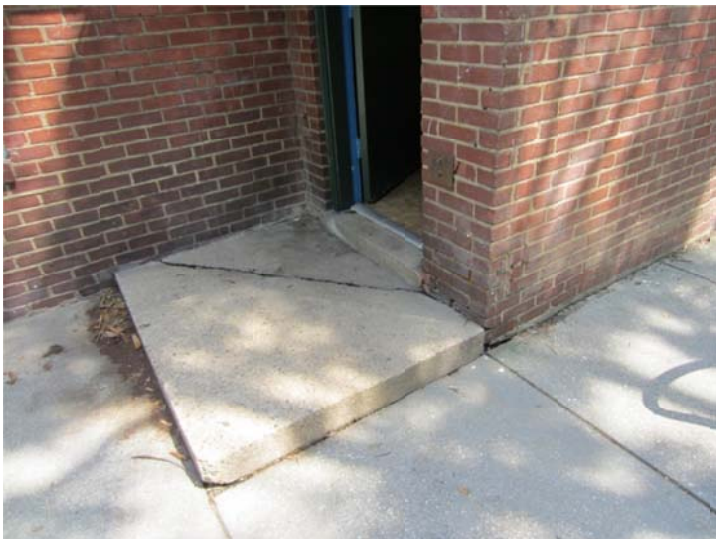
Photograph 4-8.24 (Field House)
Damaged exterior landing at restrooms. Not ADA accessible.

H10	Site Improvements						
2	Property is not ADA accessible, augment front and rear entrance steps with ADA compliant ramps.	\$ 1,000.00	1	LS	1	✓	\$1,000
2,21	Remove existing concrete step at exterior toilet and replace with new step that is also ADA compliant	\$ 15.00	25	SF	1		\$375
