Protective Services Division
(PSD) Security Survey

300 & 301 Van Buren
Street, NW

Date: August 8, 2019

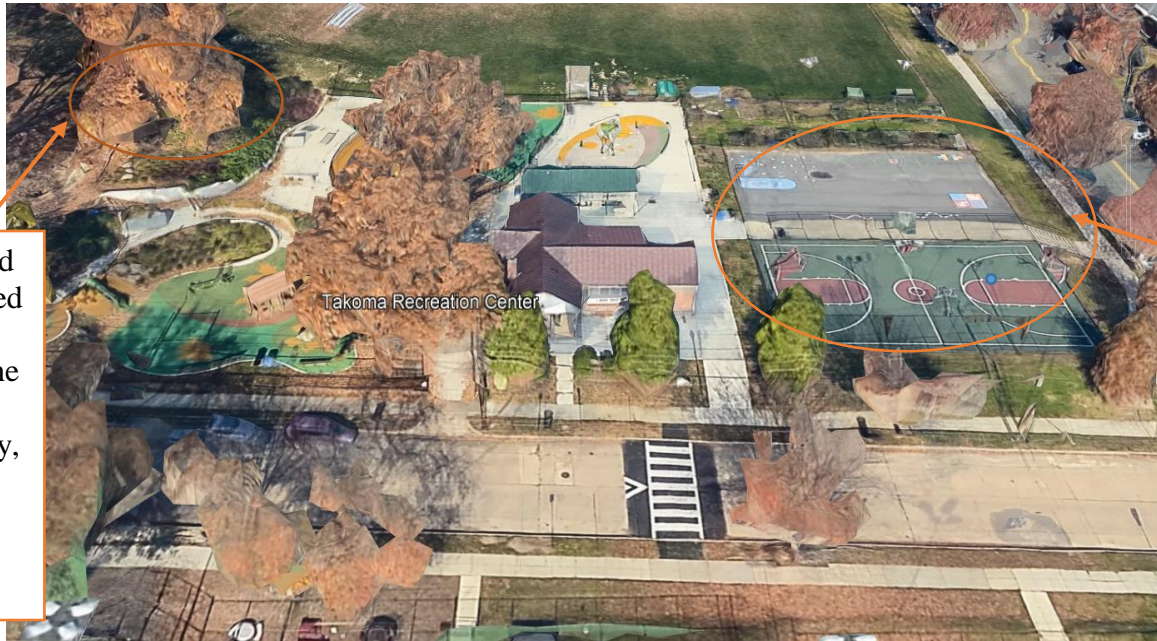
Tacoma Recreation Center

Closed Circuit Television (CCTV) There are no cameras on the exterior of the recreation facility.

Lighting and cameras need to be added alongside the walkway. Additionally, the brush needs to be cut down.

Cameras need to be placed on the flood light poles, and additional lighting is also needed.

- Recommendation: Cameras need to be placed on 14-foot poles, along the walkway, at the rear of the recreation facility, and on the flood lights around the basketball court. The cameras should have vandal resistant domes around them.

- Recommendation
Lighting should be added along the walkway located at the rear of the recreational center, and around the basketball court. The area lacks sufficient lighting, and more lighting will provide additional safety for recreation centers visitors. It is recommended that the light poles should be at a height of 14 feet, and be protected by tough polycarbonate. The lights should be LED, which gives extra illumination and promotes a sense of security.

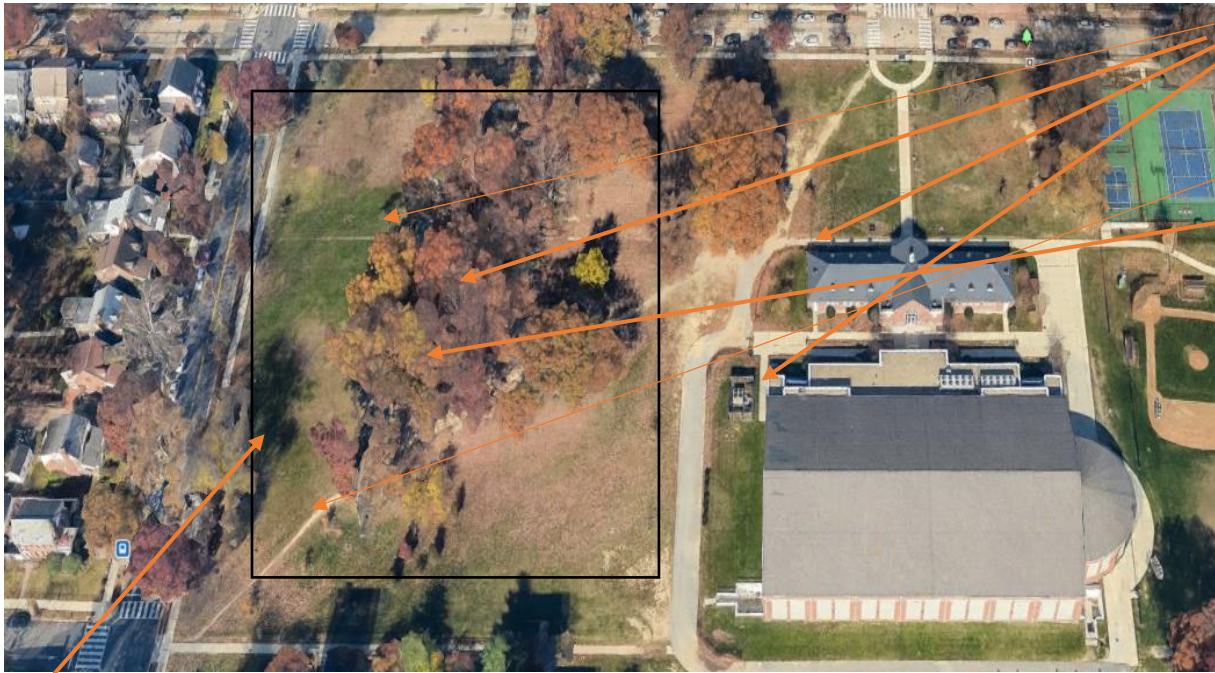
Closed Circuit Television (CCTV) There are no cameras on the exterior of the Community and Aquatic Center and along the dirt walkway, or within the wooded area.

Fencing The Community and Aquatic Center has no fencing around the adjacent wooded area.

- Recommendation: Cameras need to be placed on 14-foot poles, along the dirt walkway, and staggered within the wooded area, and placed on the lighting poles.

Lighting should be added along the dirt walkway, and the wooded area.

Add fencing around the perimeter of wooded area. The fence should be a minimum of 8 feet in height.

Cameras should be staged along the dirt walkway, on top of lighting poles, or on the roofline of the center.

An 8-foot fence should be placed around the wooded area of the Tacoma Community Center and Aquatic Center. Additionally, lighting and cameras should be installed along the dirt walkway, and in the wooded area, and on the corners of the roofline of the center.
