**Addendum No. 5**

**Architectural/Engineering Services for the MPD 7th District Headquarters  
New Facility and New Parking Structure**

# COMPREHENSIVE FACILITIES CONDITION ASSESSMENT & SPACE UTILIZATION SURVEY

DISTRICT OF COLUMBIA METROPOLITAN POLICE DEPARTMENT  
7TH DISTRICT HEADQUARTERS  
2455 ALABAMA AVENUE, SE  
WASHINGTON, D.C 20020

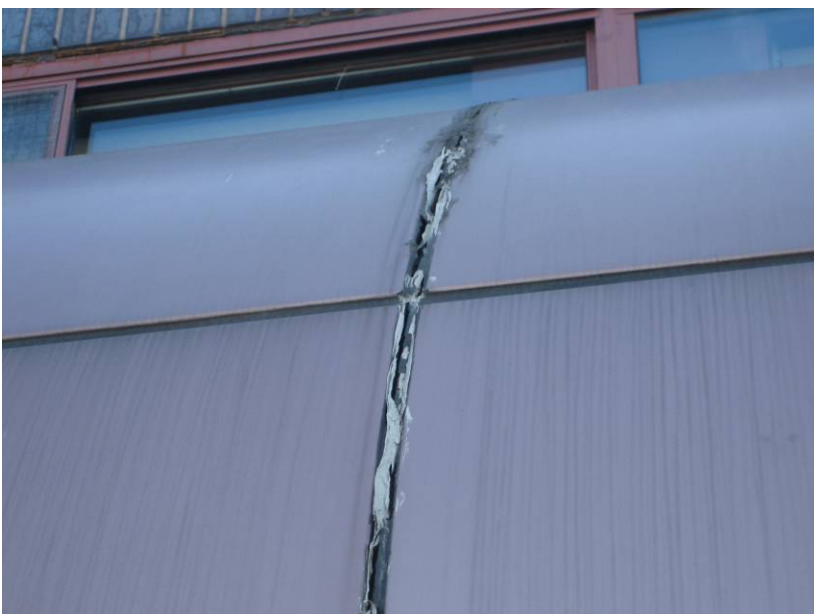
Photograph No. 9

The exterior wall system at the main building is generally in fair to good condition with no significant defects noted during our assessment. However, we noted localized deterioration of the urethane sealants provided at the first floor aluminum enclosure system. This had resulted in consequential water ingress and damage at the soffit board at the main entrance (reference Photographs 9 and 10 in Appendix C). We have recommended budgeting for the near-term replacement of the defective portion of soffit board and urethane sealants. In addition, we have recommended budgeting for the mid-term replacement of defective portions of the urethane sealant at the aluminum enclosure system, due to anticipated localized failure.

Defective Joint at Enclosure System

4. We recommend budgeting for the replacement of anticipated deteriorated urethane sealant at the aluminum enclosure system. Our opinion of the cost for this work is \$1,000 (\$5 per linear foot) in 2013.

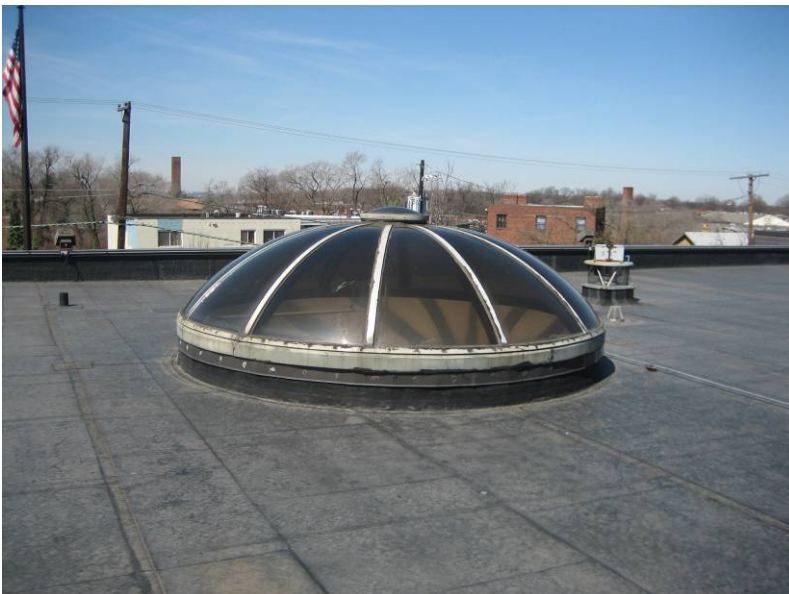
Photograph No. 15

The domed skylight provided at the main roof was in poor condition and had reportedly been recently leaking. We observed the condition of the sealant at the polycarbonate glazing and steel glazing bars and noted numerous instances of previous repairs and the sealant was generally in poor condition (reference Photographs 14 and 15 in Appendix C). We have recommended budgeting for near-term repairs to consist of raking out and replacing all of the urethane sealants between the polycarbonate glazed panels and the steel framed glazing bars.

Defective Sealant at Glazed Panels and Glazing Bars

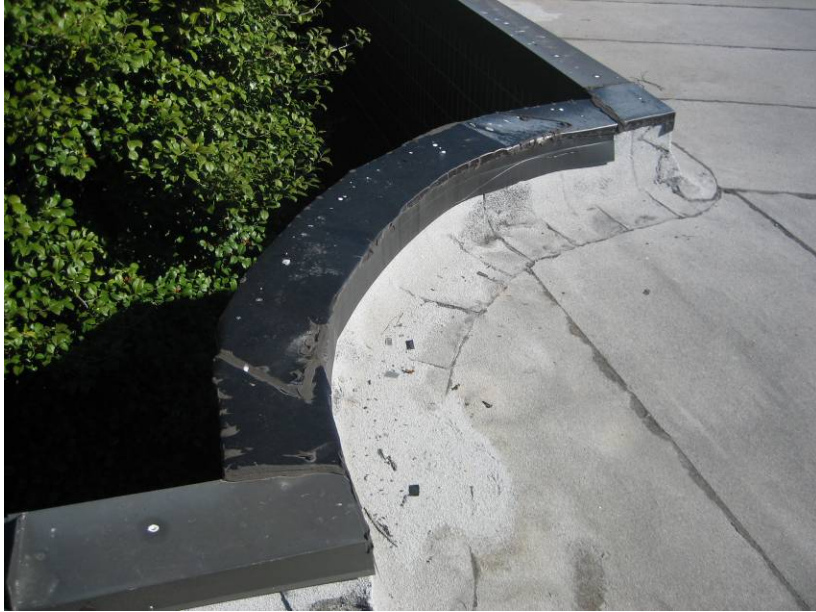
Photograph No. 16

Poor Quality Installation of Curved Portion of Cap Flashing

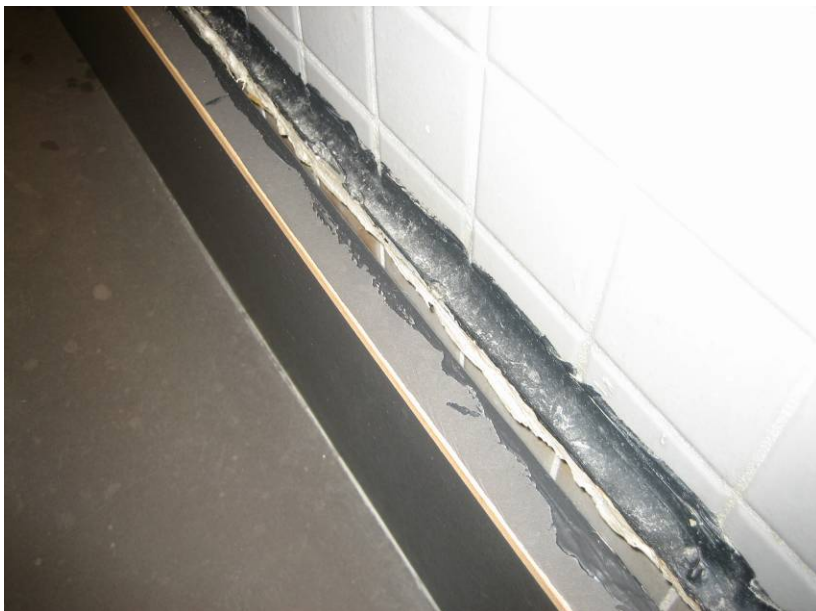
Photograph No. 21

Defective Counter Top at Restroom

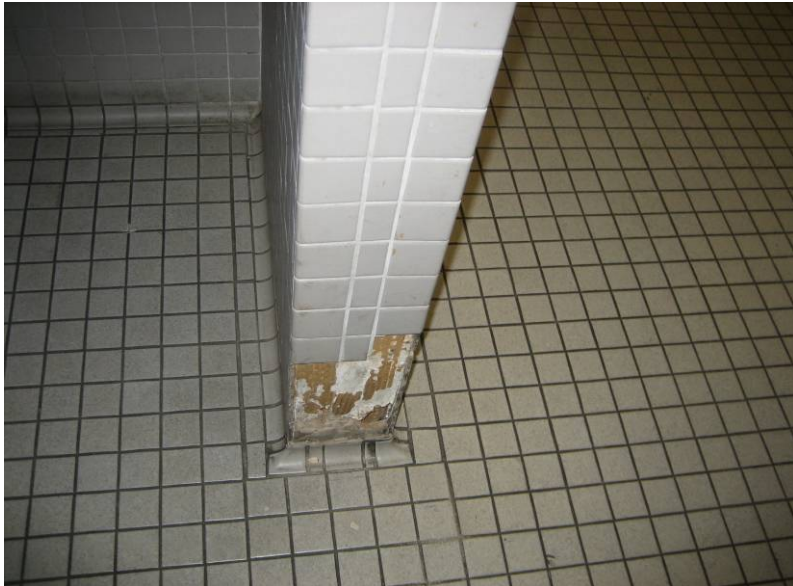
Photograph No. 22

Defective Tiles at Restroom

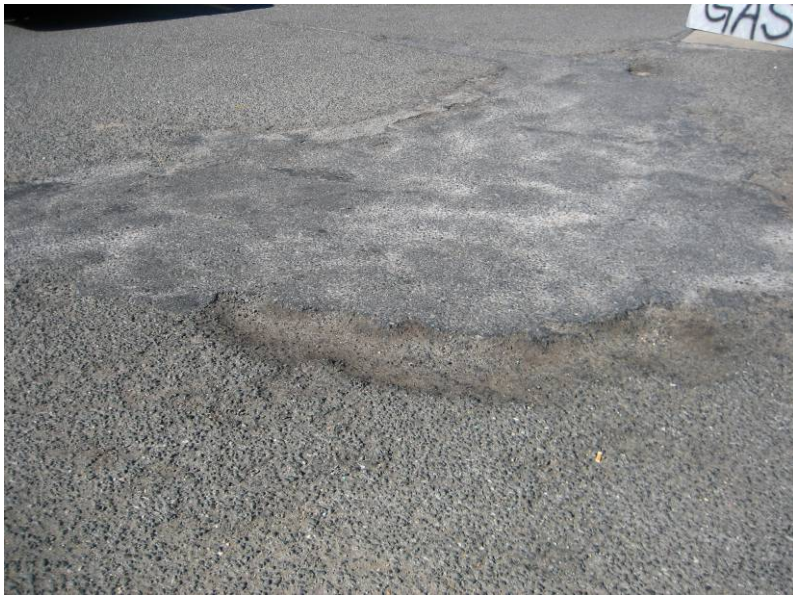
Photograph No. 31

Worn Asphalt-Paved Parking Surface

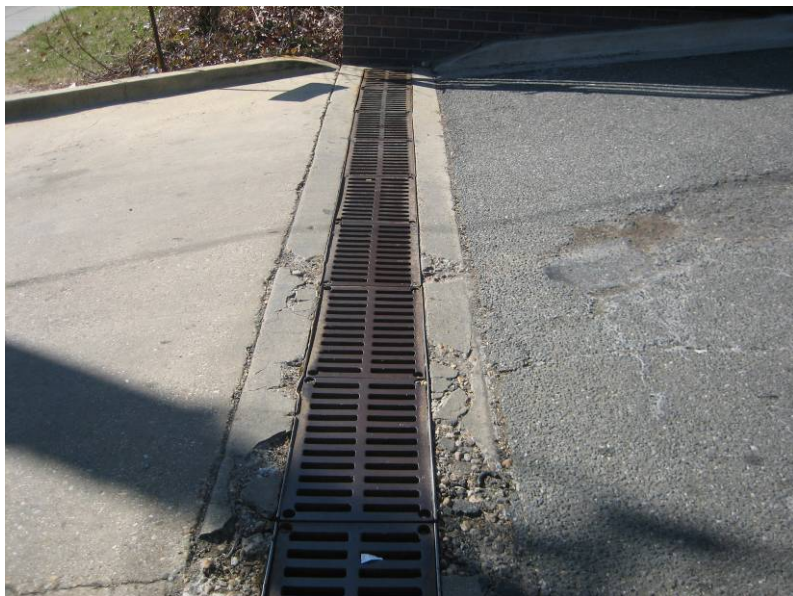
Photograph No. 32

Worn Concrete Surface at Vehicular Entrance

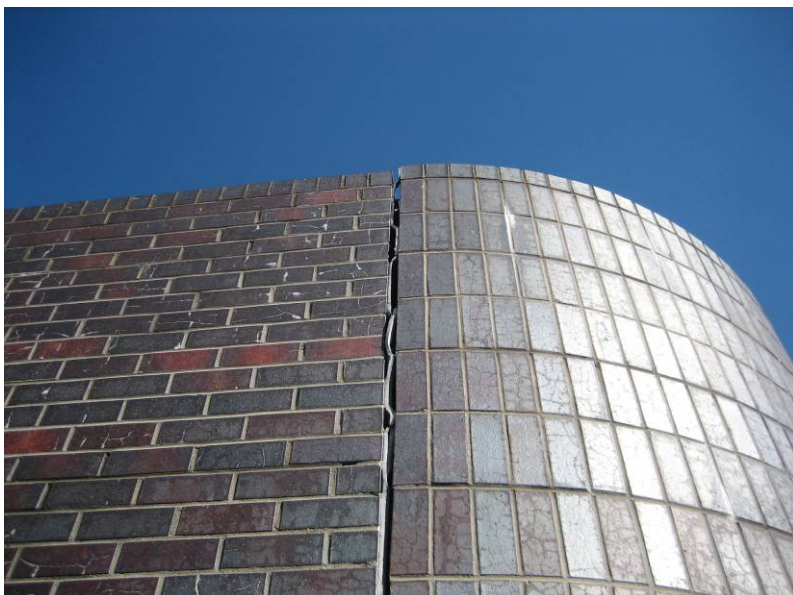
Photograph No. 33

Movement at Boundary Wall
