St. Elizabeth Hospital  
 Dix Building Hazmat Survey  
**FLOOR:1**

**PHOTOGRAPHS- ASBESTOS**  
May 5<sup>th</sup> thru 12<sup>th</sup>, 2017

**Dix building- St. Elizabeth Hospital**  
**Project No. 17-030**

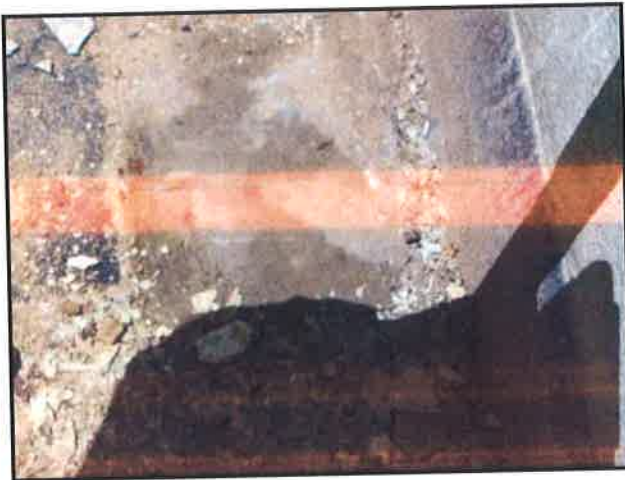
Photo 1: Tan 9"x9" floor tile with streaks (Close-up)

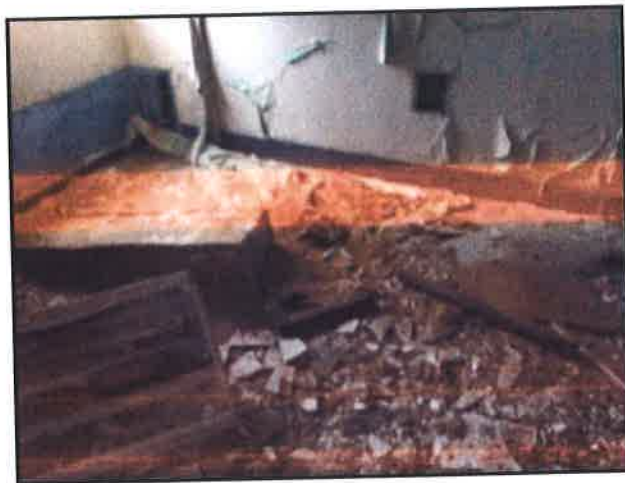
Photo 2: Tan 9"x9" floor tile with streaks (Wide angle)

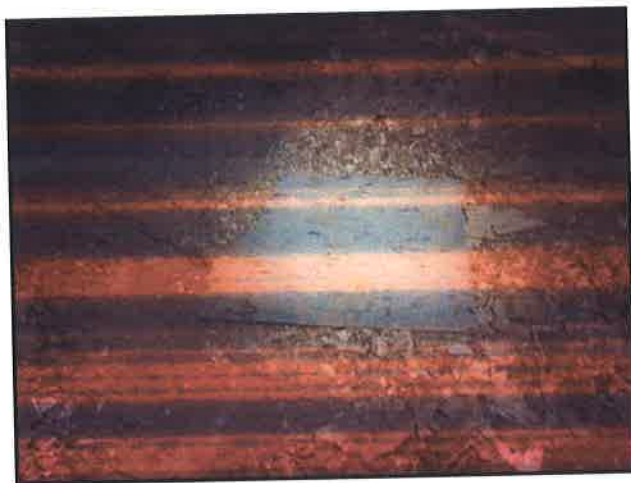
Photo 3: Lt. Blue 12"x12" floor tile with blue streaks (Close-up)

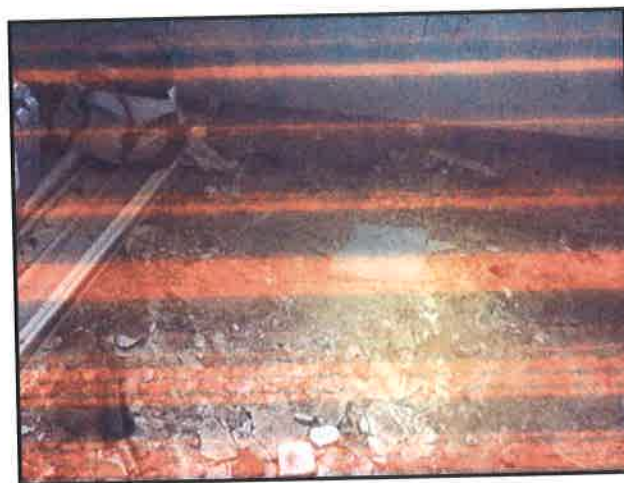
Photo 4: Lt. Blue 12"x12" floor tile with blue streaks (Wide angle)

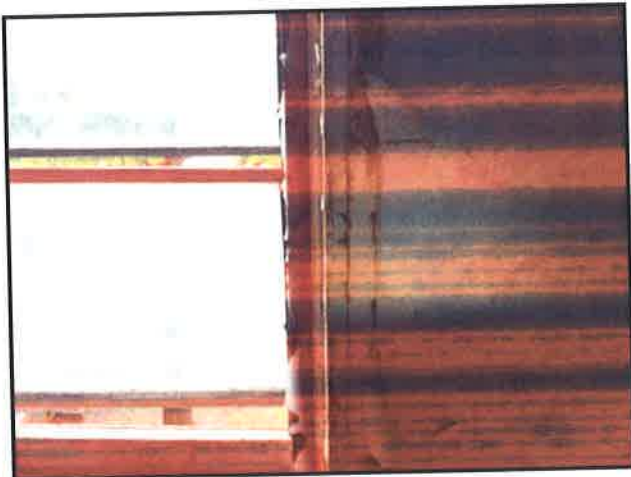
Photo 7: Gray Caulking on Windows (Close-up)

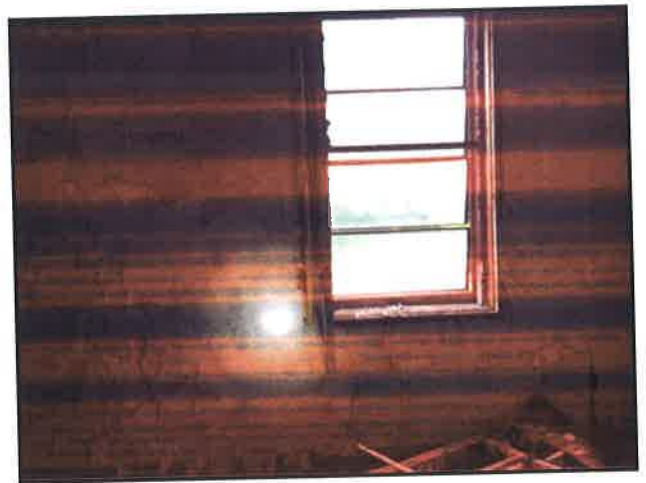
Photo 8: Gray Caulking on Windows (Wide angle)

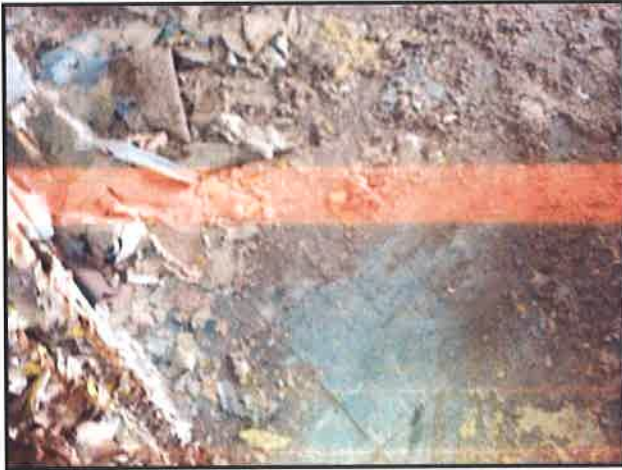
Photo 9: Green 9"x9" Floor tile with mastic  
(Close-up)

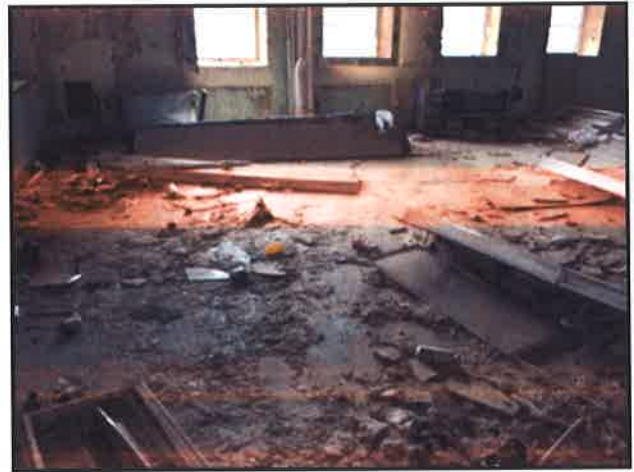
Photo 10: Green 9"x9" Floor tile with mastic  
(Wide angle)

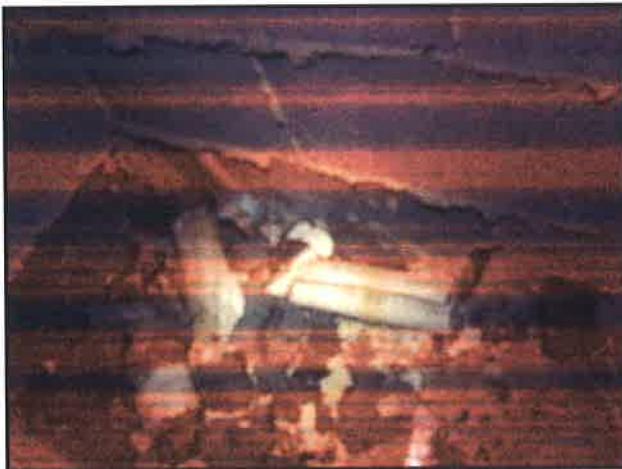
Photo 11: Corrugated paper pipe insulation  
(Close-up) inside the pipe chase

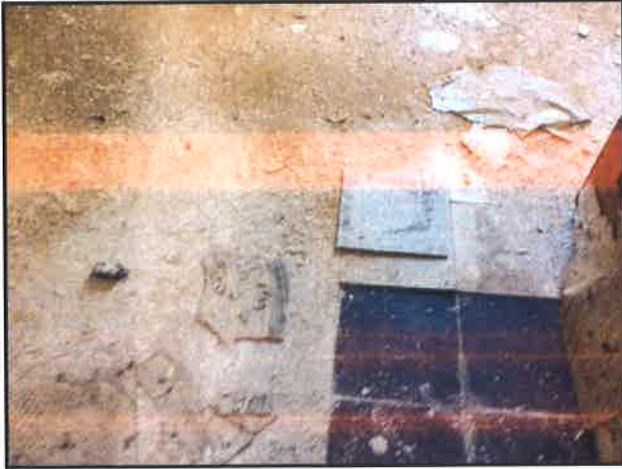
Photo 13: Off White 12"x12" Floor tile with mastic (Close-up)

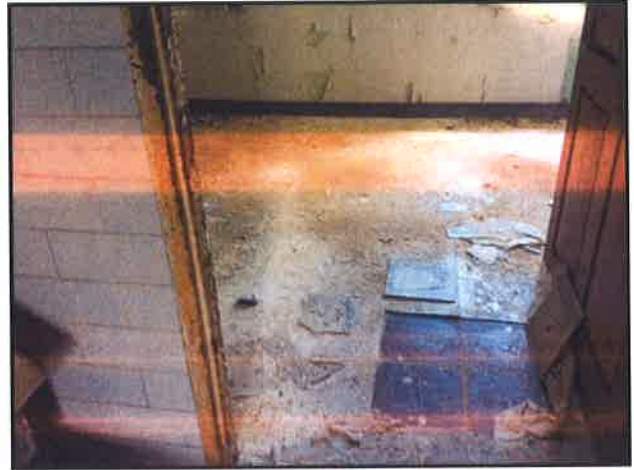
Photo 14: Off White 12"x12" Floor tile with mastic (Wide angle)

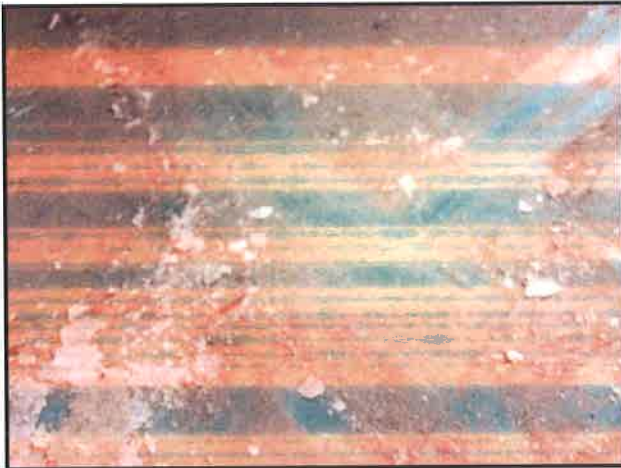
Photo 15: Green 12"x12" Floor tile with mastic (Close-up)

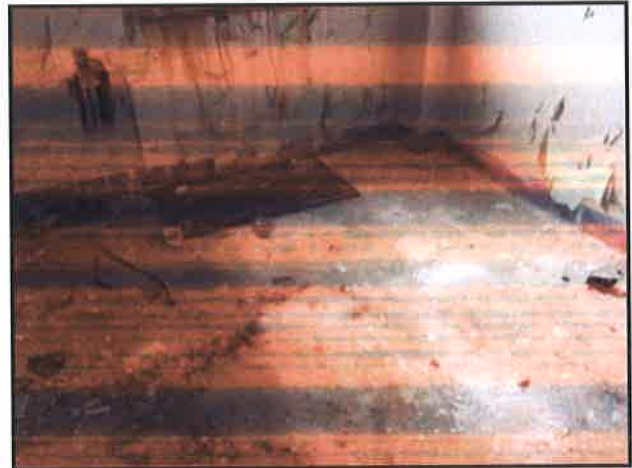
Photo 16: Green 12"x12" Floor tile with mastic (Wide angle)

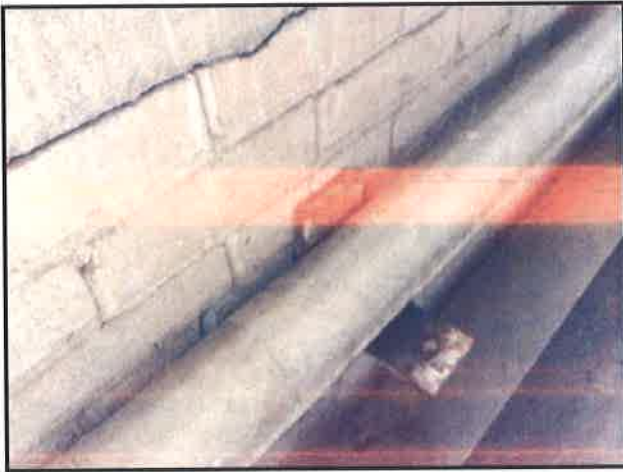
Photo 17: 4"D -6"D Pipe Insulation (Close-up)

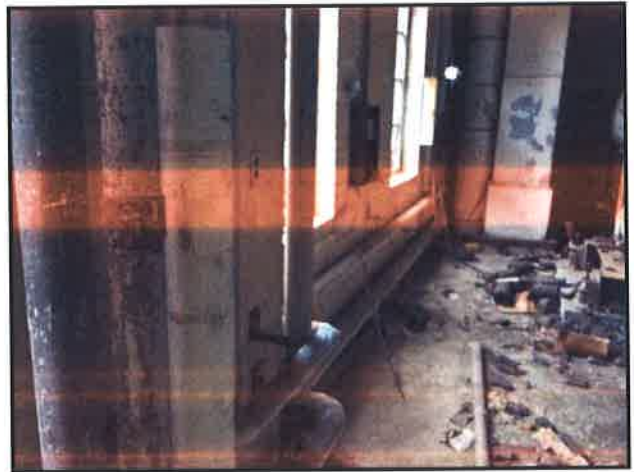
Photo 18: 4"D -6"D Pipe Insulation (Wide angle)

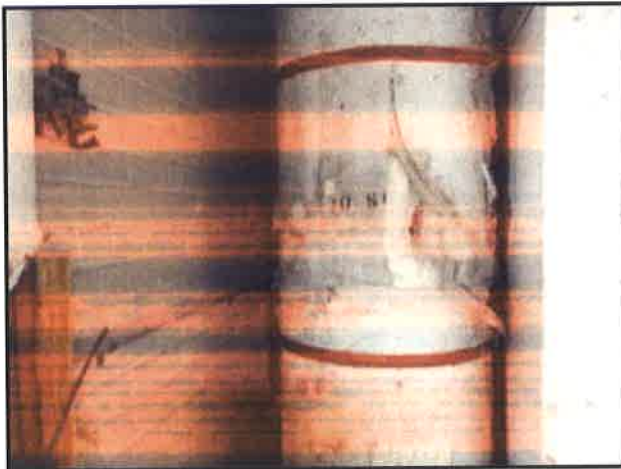
Photo 19: 12"D- 15"D Pipe Insulation (Close-up)

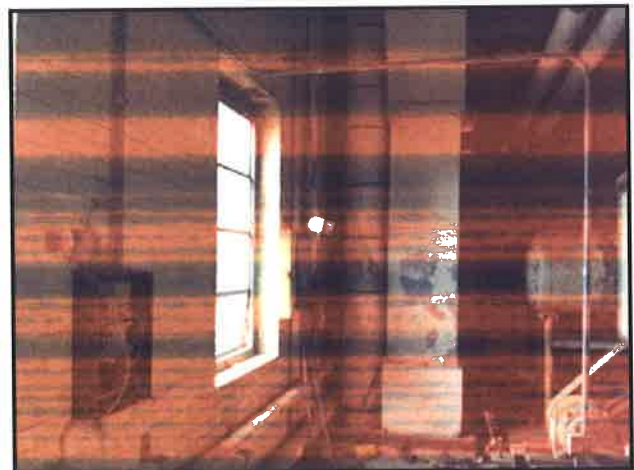
Photo 20: 12"D- 15"D Pipe Insulation (Wide angle)

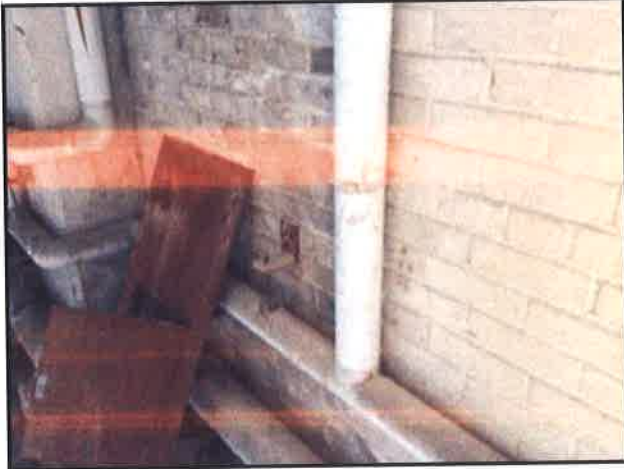
Photo 21: 2"D- 4"D Pipe Insulation (Close-up)

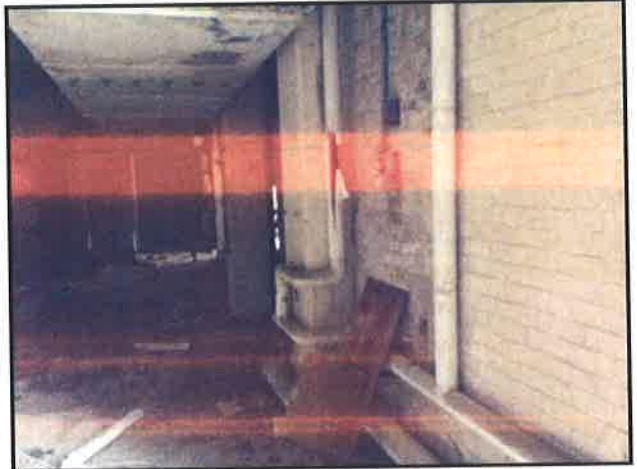
Photo 22: 2"D- 4"D Pipe Insulation (Wide angle)

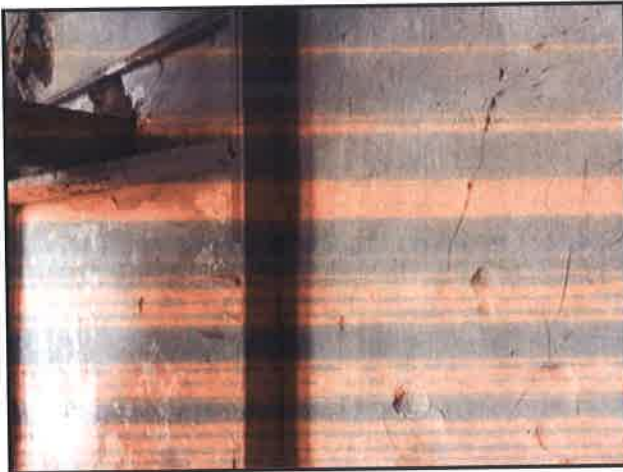
Photo 23: Duct Insulation(AHU) 7th Floor (Close-up)

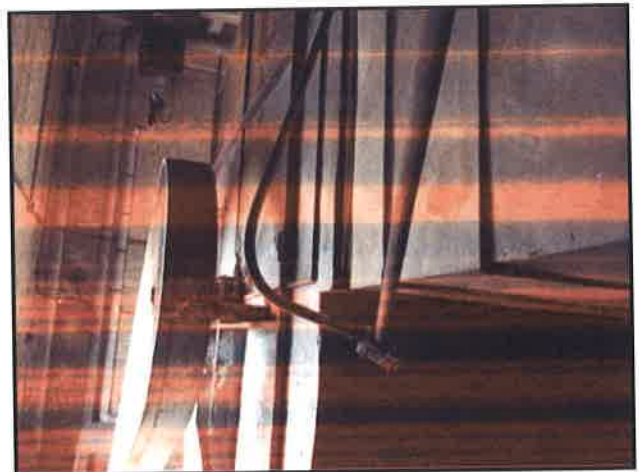
Photo 24: Duct Insulation(AHU) 7th Floor (Wide angle)

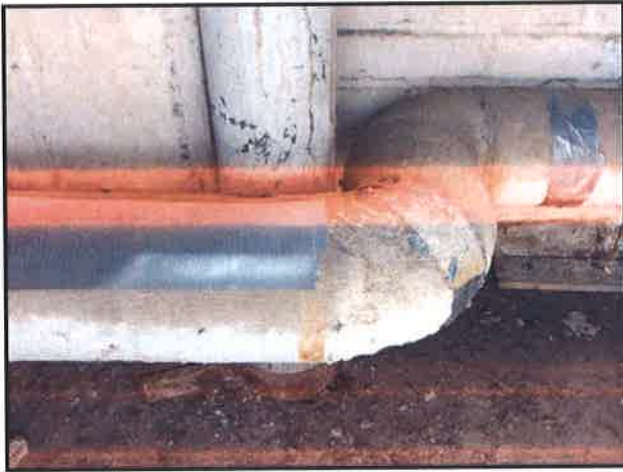
Photo 25: 4"D -6"D Pipe Fittings (Close-up)

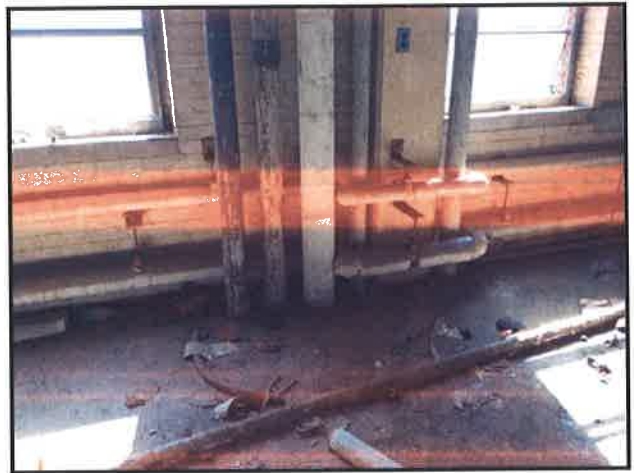
Photo 26: 4"D -6"D Pipe Fittings (Wide angle)

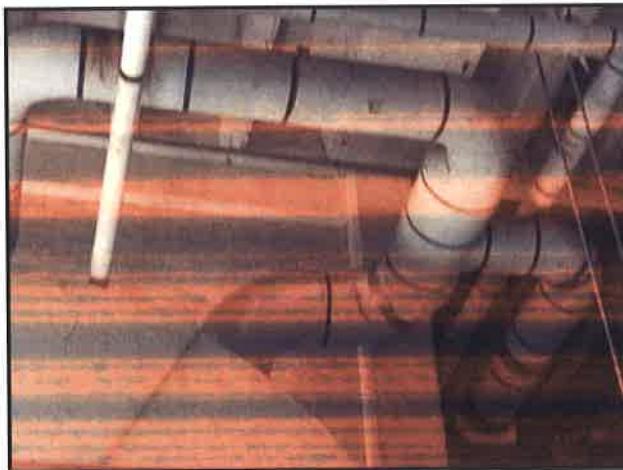
Photo 27: 12"D- 15"D Pipe Fittings (Close-up)

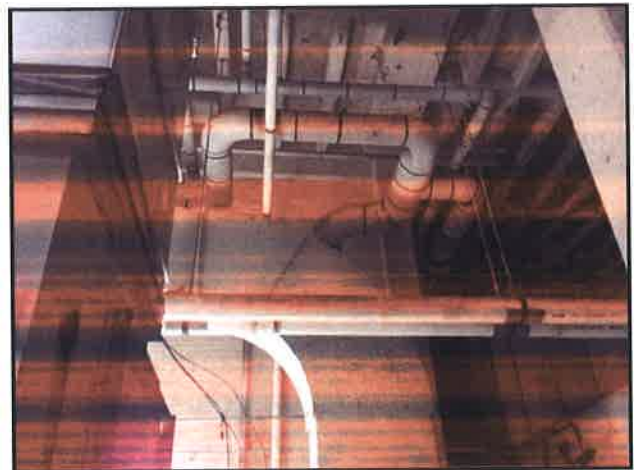
Photo 28: 12"D- 15"D Pipe Fittings (Wide angle)

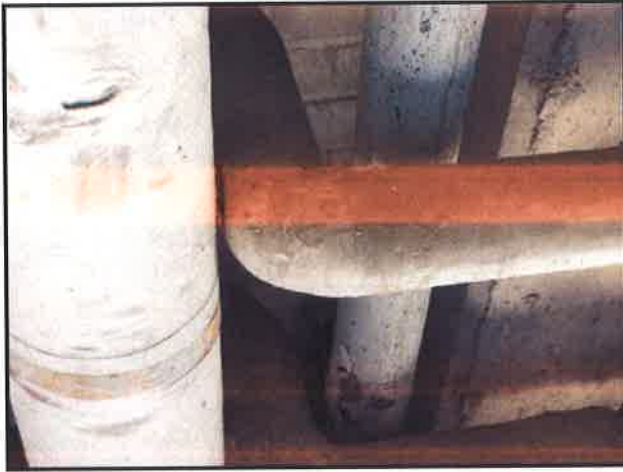
Photo 29: 2"D- 4"D Pipe Fittings (Close-up)

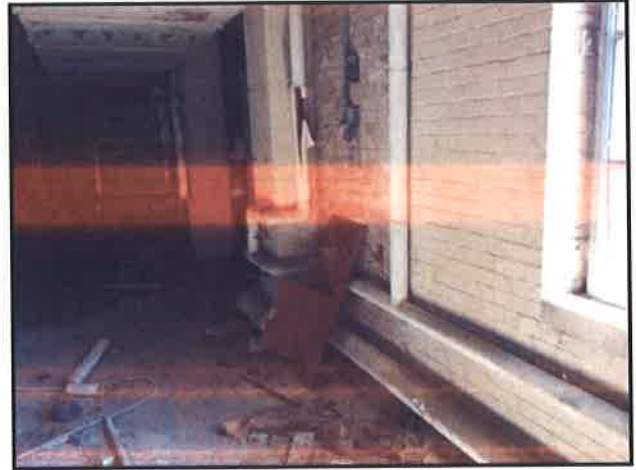
Photo 30: 2"D- 4"D Pipe Fittings (Wide angle)

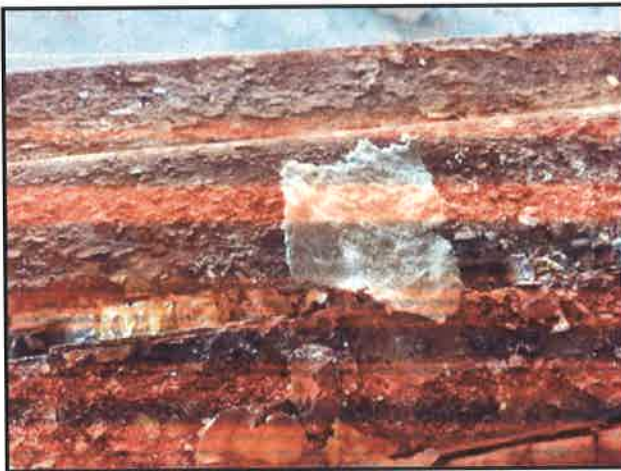
Photo 31: 1.5'x8" White Duct insulation over the hallway ceiling (Close-up)

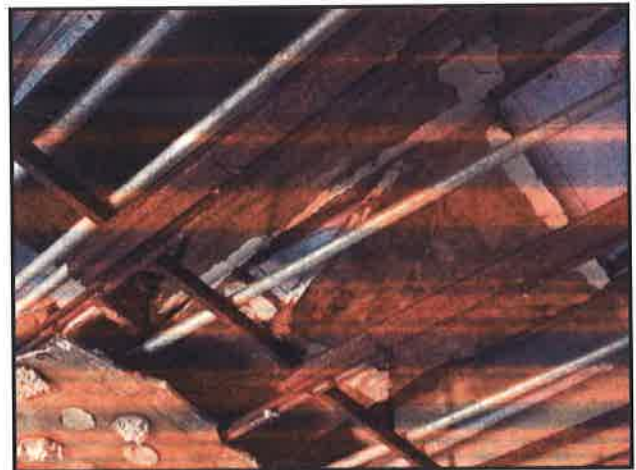
Photo 32: 1.5'x8" White Duct insulation over the hallway ceiling (Wide angle)

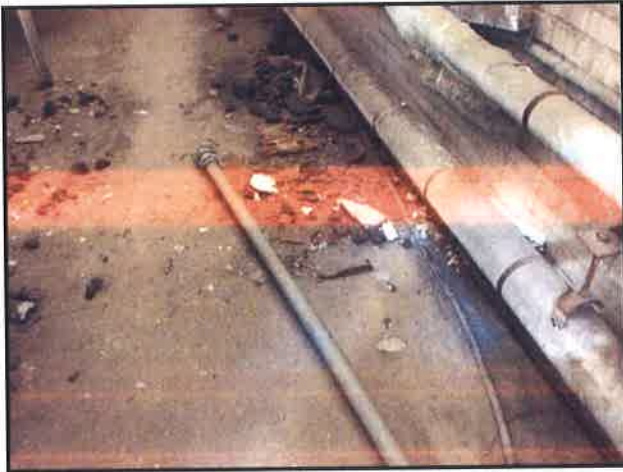
Photo 33: Debris on the 7th floor (Wide angle)

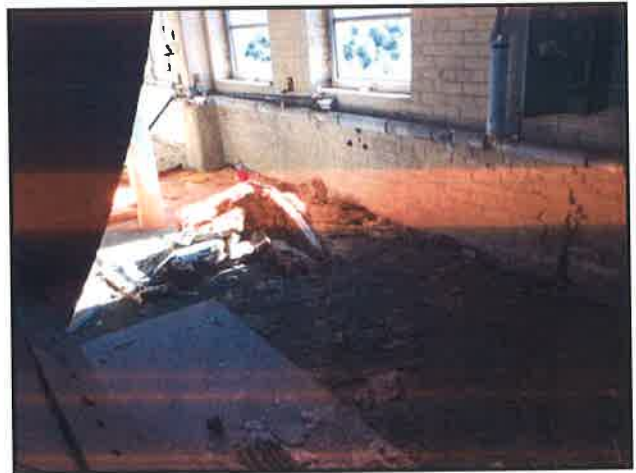
Photo 34: Debris on the 7th floor (Wide angle)

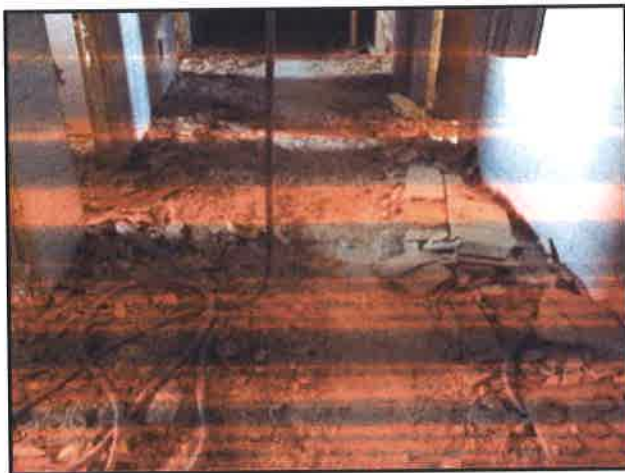
Photo 35: Debris on the floor 1-6 (Wide angle)

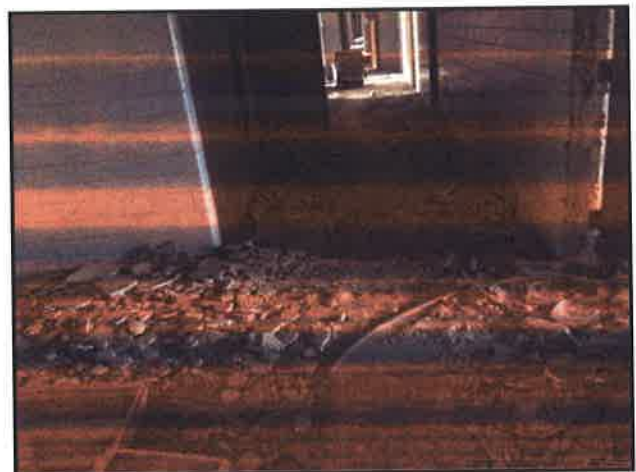
Photo 36: Debris on the floor 1-6 (Wide angle)

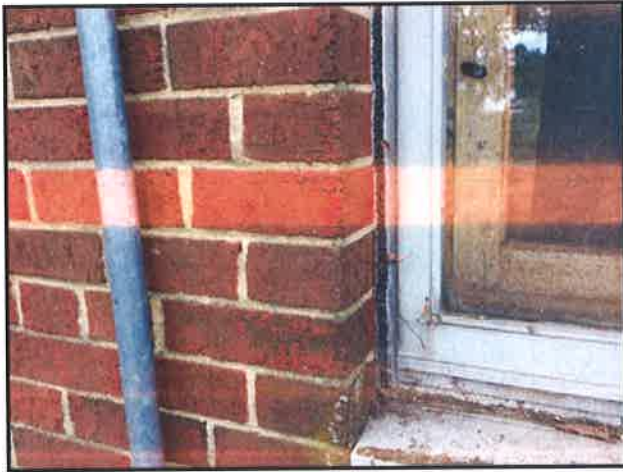
Photo 37: Gray Exterior window caulking  
(Close up)

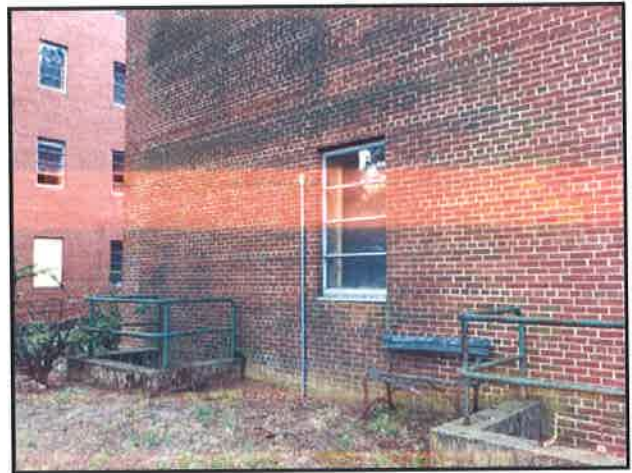
Photo 38: Gray Exterior window caulking  
(Wide angle)

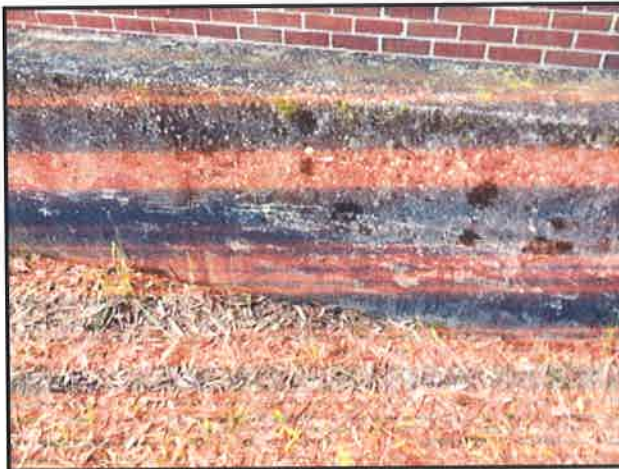
Photo 39: Black Exterior water proofing  
(Close up)

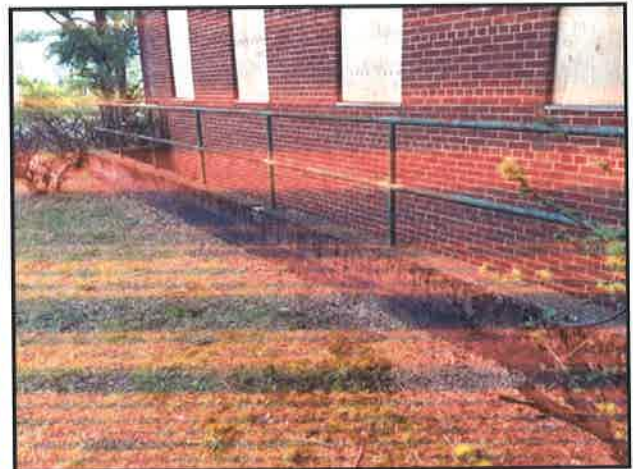
Photo 40: Black Exterior water proofing  
(Wide angle)

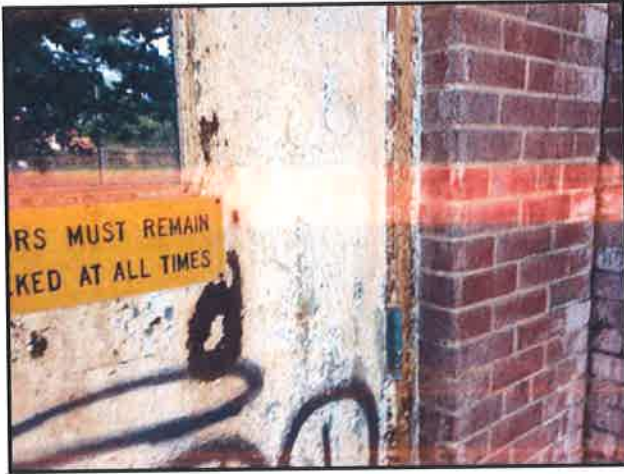
Photo 41: Gray Exterior door caulking (Close up)

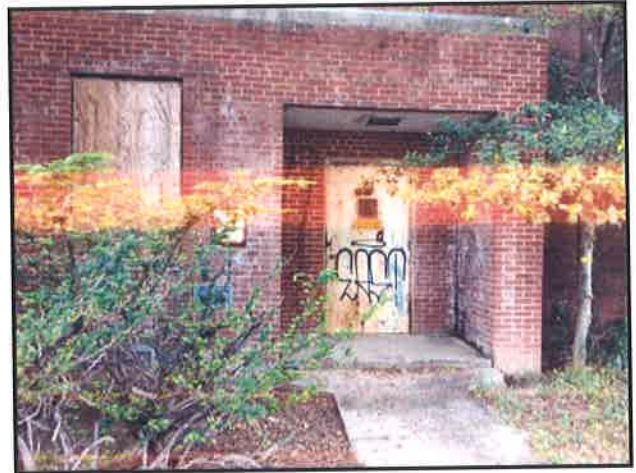
Photo 42: Gray Exterior door caulking (Wide angle)

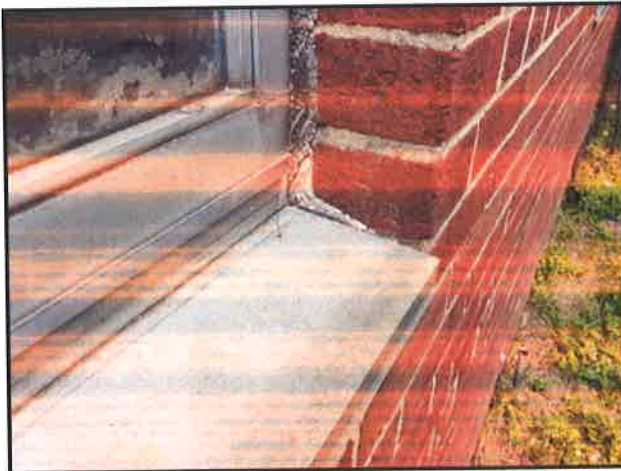
Photo 43: Gray Exterior window sill caulking (Close up)

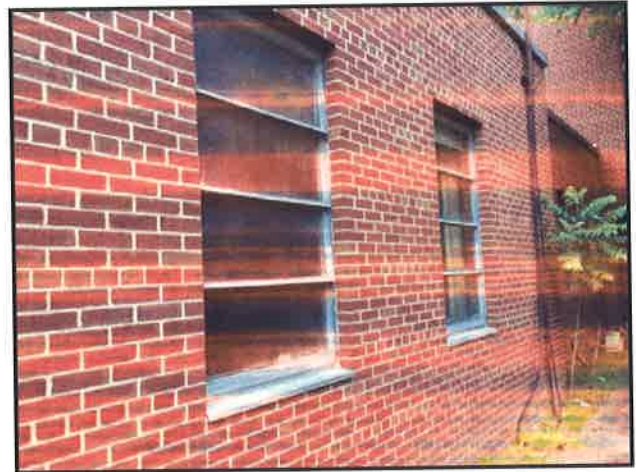
Photo 44: Gray Exterior window sill caulking (Wide angle)

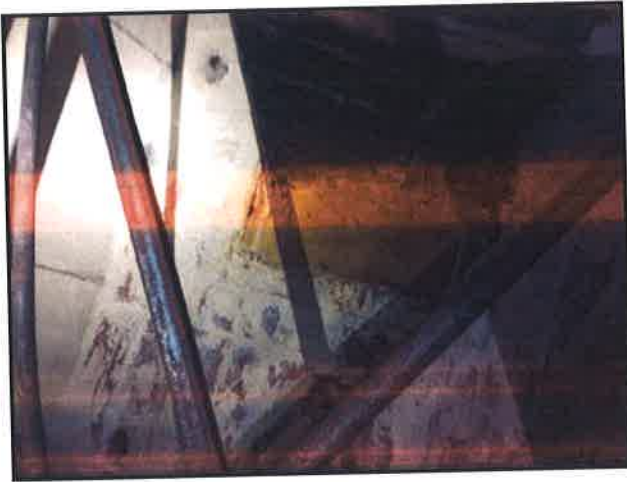
Photo 45: Black sealant (Close up)

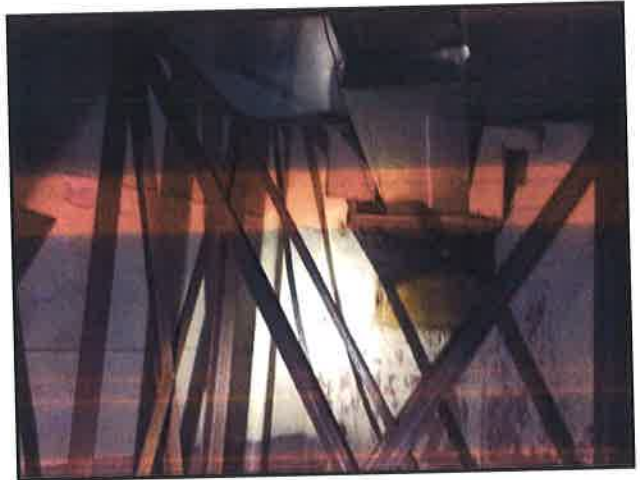
Photo 46: Black sealant (Wide angle)

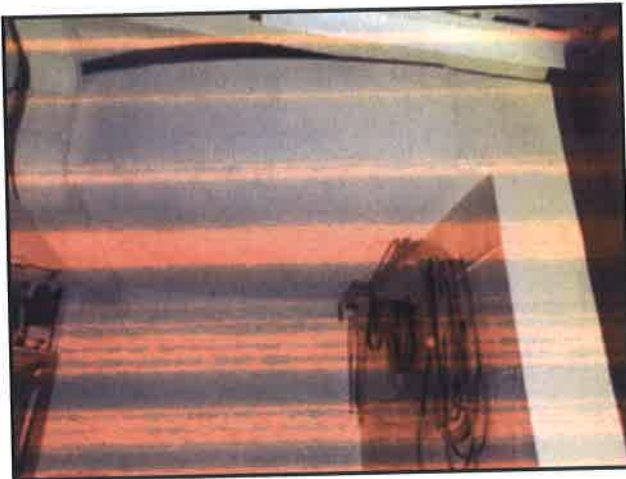
Photo 47: White duct insulation (Close up)

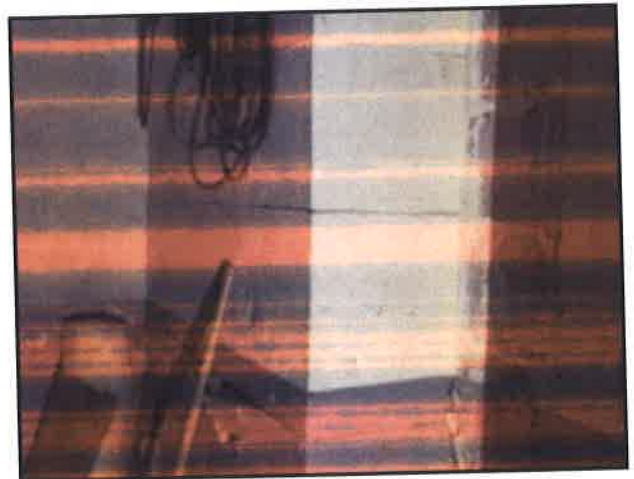
Photo 48: White duct insulation (Wide angle)

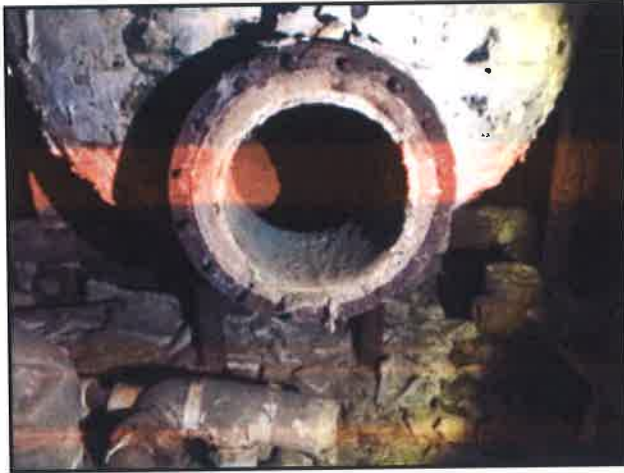
Photo 49: 12'x6' White tank insulation (Close up)

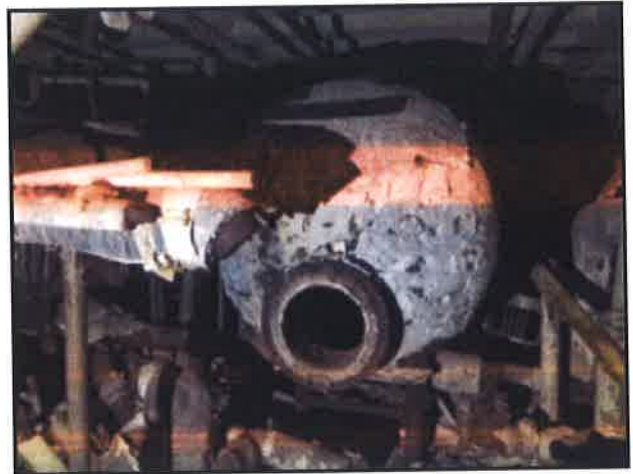
Photo 50: 12'x6' White tank insulation (Wide angle)

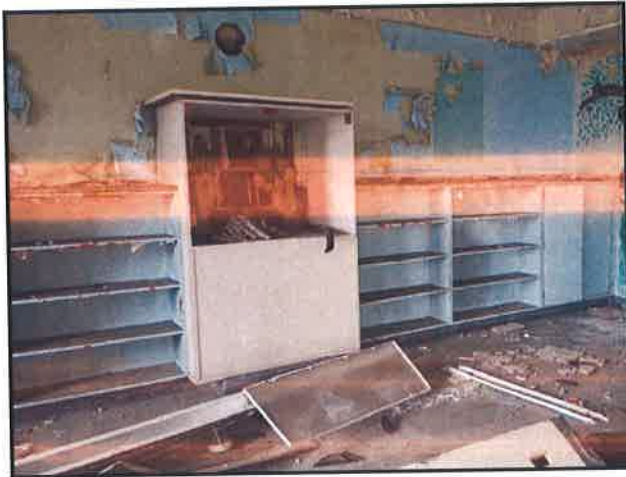
30	Cabinet	Wood	D	Deteriorated	Blue	Fourth	413a	Negative	0
31	Cabinet	Wood	D	Deteriorated	Blue	Fourth	413a	Positive	2.1
32	Door Frame	Metal	A	Deteriorated	White	Fourth	413a	Negative	0
33	Elevator Door	Metal	D	Deteriorated	Green	Fourth	Elevator Lobby	Negative	0.21
34	Elevator Door Frame	Metal	D	Deteriorated	Green	Fourth	Elevator Lobby	Negative	0.23
35	Window Trim	Metal	B	Deteriorated	Beige	Fourth	Elevator Lobby	Negative	0.02

Photo 51: 4<sup>th</sup> floor, room 413A, blue wooden shelves and cabinet

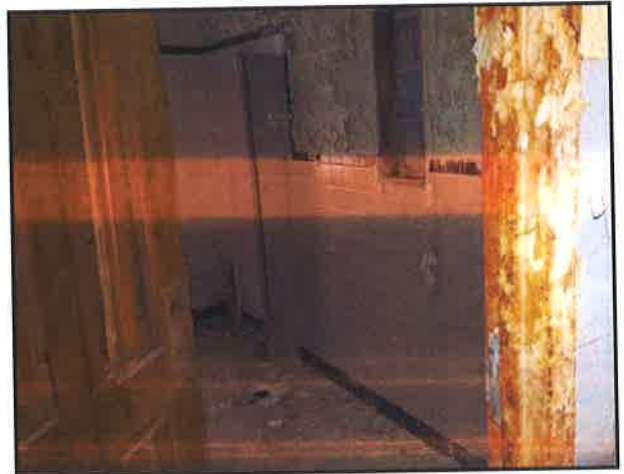
130	Wall	Ceramic Tile	B	Deteriorated	Beige	Fourth	416	Positive	4.2
131	Wall	Ceramic Tile	C	Deteriorated	Beige	Fourth	416	Positive	4.8
132	Wall	Ceramic Tile	D	Deteriorated	Beige	Fourth	416	Positive	6.6
133	Wall	Ceramic Tile	A	Deteriorated	Black	Fourth	416	Positive	4.5
134	Stall	Granite	D	Deteriorated	Beige	Fourth	416	Negative	0
135	Door(Pipe Chase)	Metal	D	Deteriorated	Beige	Fourth	416	Negative	0.01

Photo 52: 4<sup>th</sup> floor, room 416, ceramic wall tiles

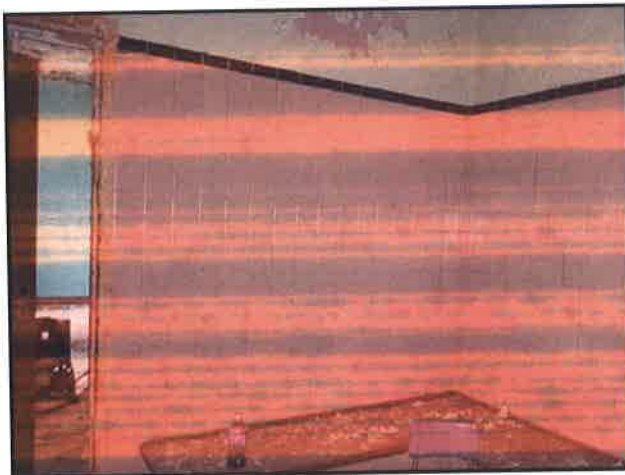
Photo 53: 4<sup>th</sup> floor, room 446B, ceramic wall tiles.

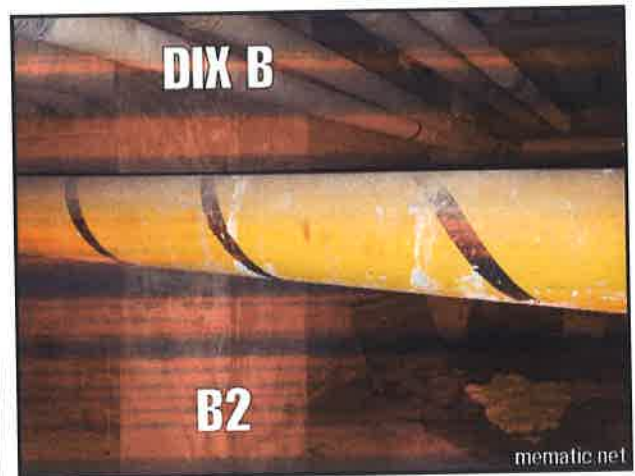
Photo 54: basement, yellow painted pipe

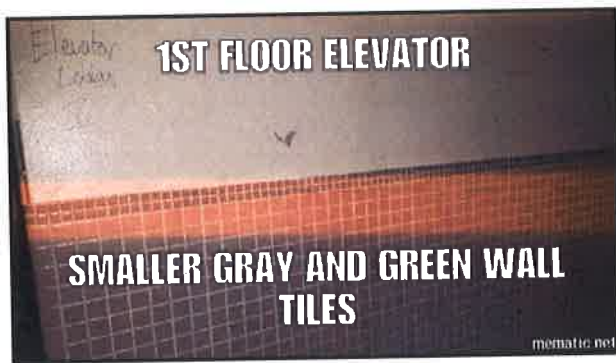
Photo 55: 1st floor, elevator lobby, ceramic wall tiles

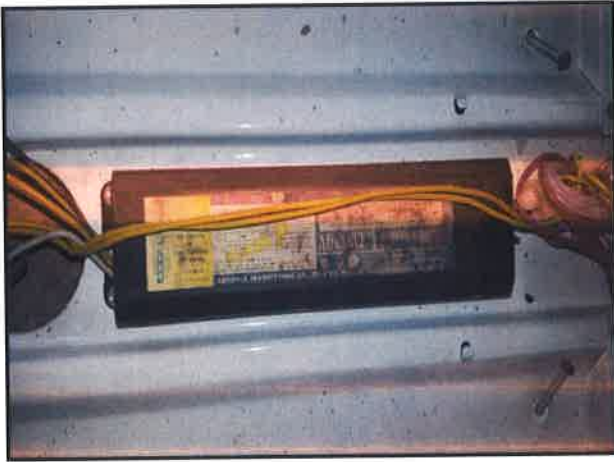
Photo 56: Light ballasts

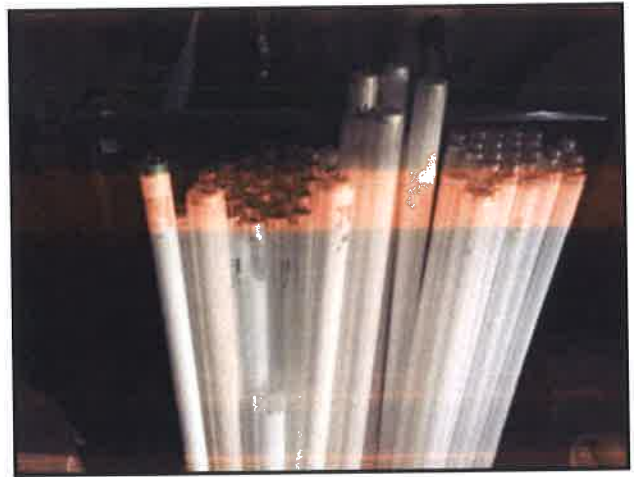
Photo 57: Fluorescent light tubes

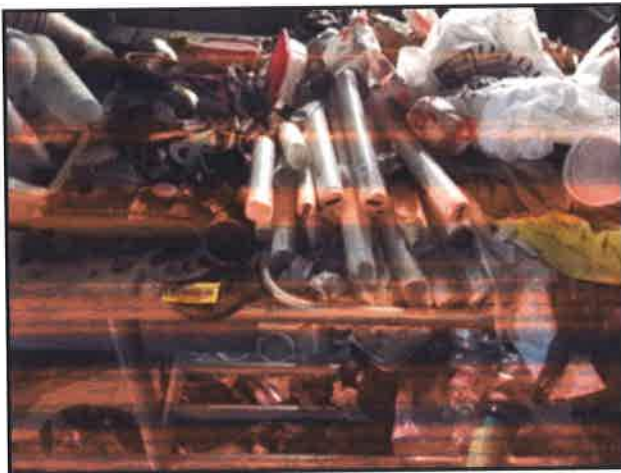
Photo 58: Broken fluorescent light tubes

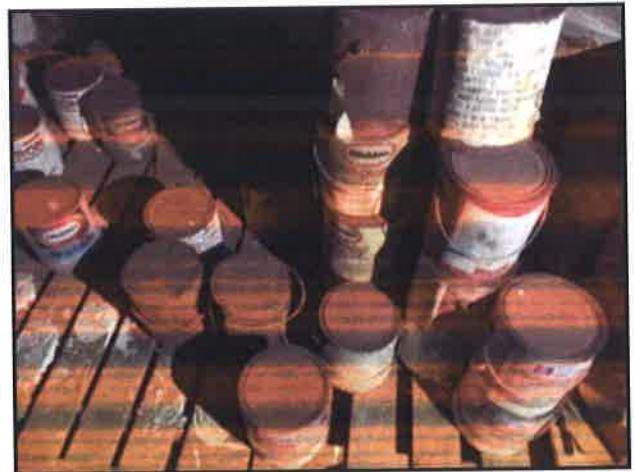
Photo 59: Paint, Putty and Solvents
