### **Structural Assessment Historical Building**

Re: Condition Assessment  
Building 83 and Building 90 at St. Elizabeths East Campus, Washington, DC  
Walter P Moore Project No. D01.14013.00

**BUILDING 83: HORSE BARN  
CONDITION ASSESSMENT**2700 Martin Luther King Jr. Ave SE  
Washington, DC 20032

**BUILDING 90: W.W. ELDRIDGE BUILDING  
CONDITION ASSESSMENT**

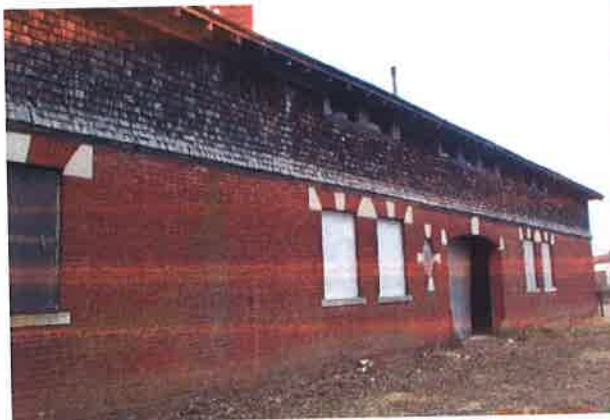
| EXTERIOR | PHOTO # |
|---|---|
| <ul style="list-style-type: none"> <li>Typically, one story of brick masonry bearing walls support an upper story framed with wood stud bearing walls. In general, walls appear plumb and stable.</li> </ul> | 1 |

Photo 1 – Typical exterior wall – North Elevation

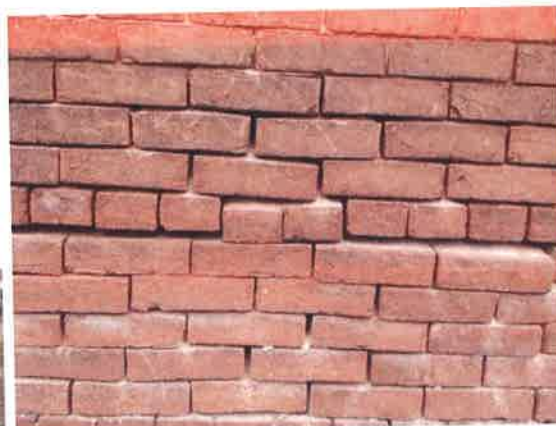
| EXTERIOR | PHOTO # |
|---|---|
| <ul style="list-style-type: none"> <li>Numerous areas of exterior brick exhibit loss and deterioration of mortar in the brick joints, as much as a full brick in depth, leading to local instability and possible wall instability.</li> </ul> | 2, 3 |

Photo 2 – Typical mortar loss in brick joints

- Repoint brick masonry, both interior and exterior in the majority of the exterior brick.
  - The majority of the repointing required is partial depth.

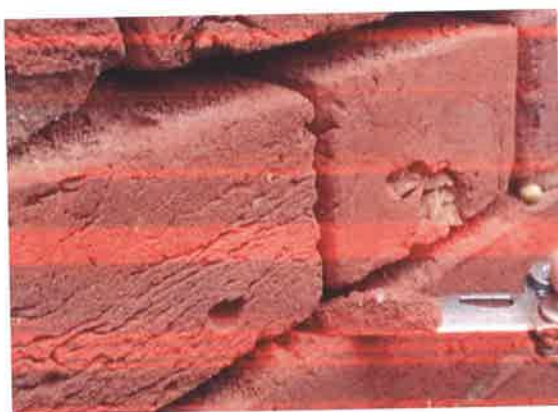
Photo 3 – Typical mortar loss and deterioration in brick joints

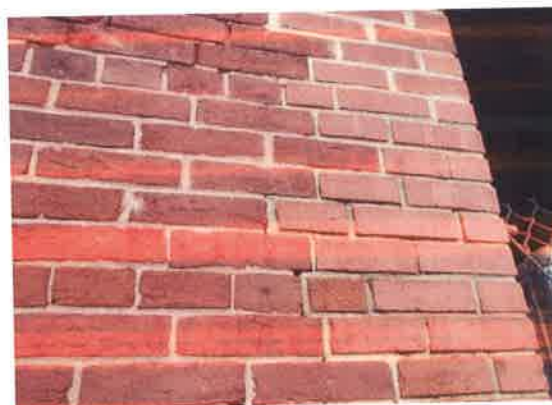
| EXTERIOR | PHOTO # |
|---|---|
| <ul style="list-style-type: none"> <li>Previous repair efforts have used modern brick and a Portland Cement-based mortar.</li> </ul> | 4 |

Photo 4 – Past repairs at west elevation (North wing)

- Testing of existing brick will allow proper specification of repair mortar.
  - Some of the areas of past repointing should be removed and reinstalled to prevent damage to brick. Investigation of this past repointing would help to better understand the potential for damage.

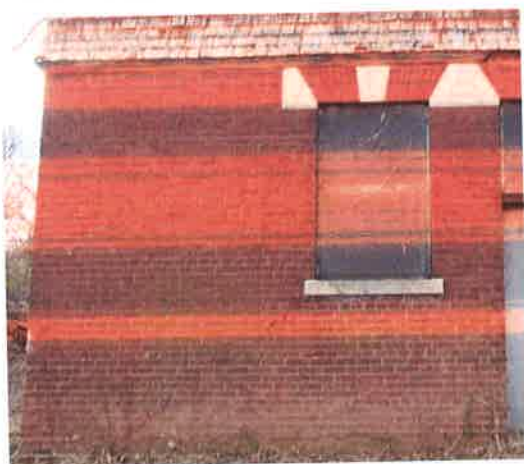
| EXTERIOR | PHOTO # |
|---|---|
| <ul style="list-style-type: none"> <li>A stair-step crack at the Northeast corner could indicate movement of brick bearing wall.</li> </ul> | 5, 6 |

Photo 5 Step crack at north elevation

- It is not clear the extent of damage at areas of the masonry, such as the foundation, therefore, further investigation should be performed in order to determine appropriate remedial steps. This could be in the form of new openings, or installing crack monitors to determine the extent and rate of ongoing movement.

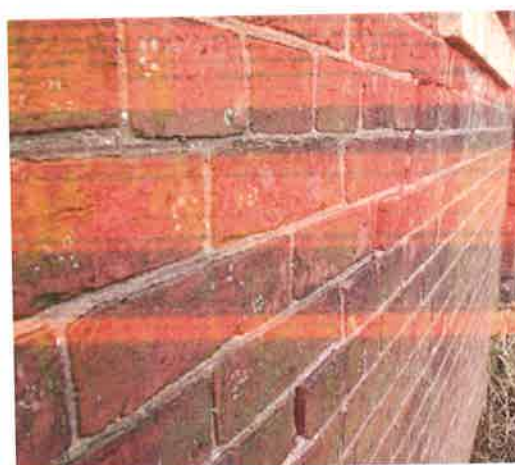
Photo 6 – Out-of-plane displacement at step crack

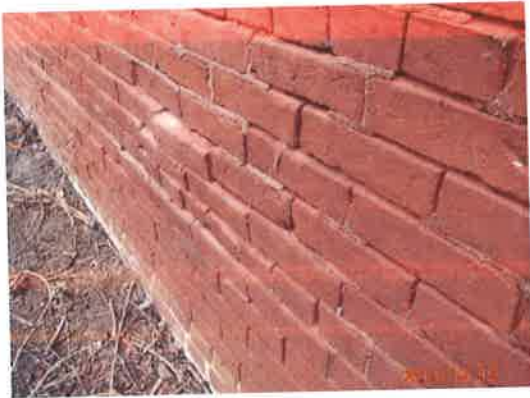
| EXTERIOR | PHOTO # |
|---|---|
| <ul style="list-style-type: none"> <li>In several areas, the base of the brick bearing wall had several courses of loose brick that are completely disconnected. It is not clear how many wythes of brick are compromised. In some areas, repairs of the brick in this condition appear to have been made.</li> </ul> | 7, 8 |

Photo 7 – Typical loose brick courses, east elevation

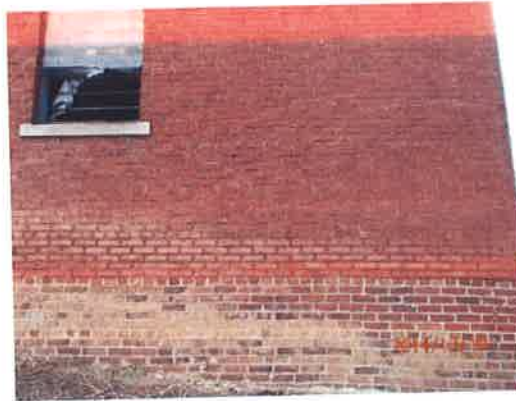
Photo 8 – Past repairs of lower brick courses, south elevation

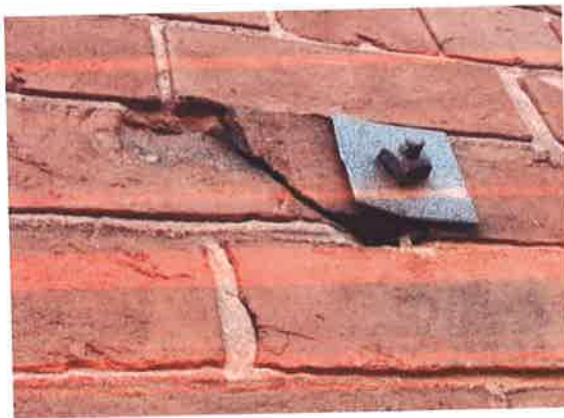
| EXTERIOR | PHOTO # |
|---|---|
| <ul style="list-style-type: none"> <li>Embedded steel items such as anchors and rings have corroded, and in many places they have initiated failure (cracking, spalling) of the adjacent brick and stone.</li> </ul> | 9, 10 |

Photo 9 – Brick spalling due to corrosion of embedded steel

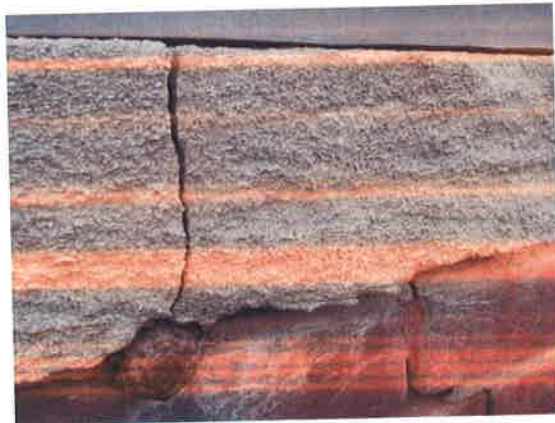
Photo 10 – Cracked limestone sill due to corrosion of embedded steel

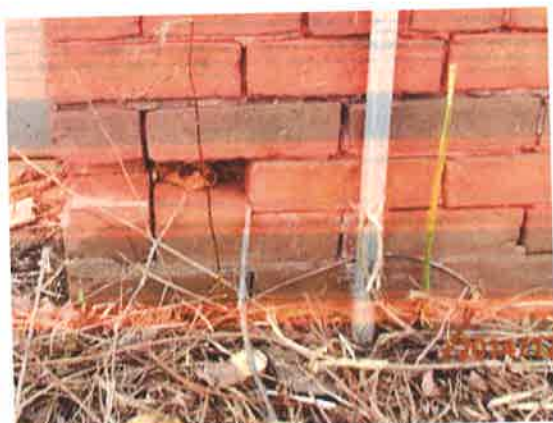
| EXTERIOR | PHOTO # |
|---|---|
| <ul style="list-style-type: none"> <li>Miscellaneous areas of damaged and missing brick.</li> </ul> | 11 |

Photo 11 – Missing brick near central entry door

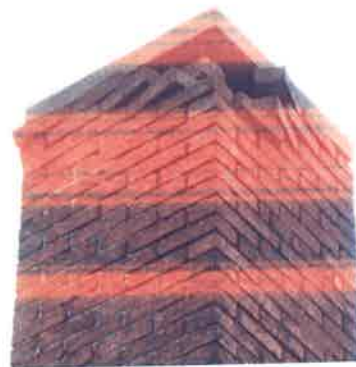
| EXTERIOR | PHOTO # |
|---|---|
| <ul style="list-style-type: none"> <li>Chimney at the north has complete loss of mortar at upper courses resulting in loose and falling bricks, a significant hazard. The chimney at the south was previously repaired; however, poor quality of repairs could result in damage.</li> </ul> | 12, 13 |

Photo 12 – Displaced bricks at north chimney

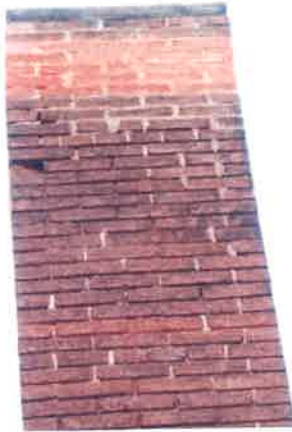
Photo 13 – Past repairs & deterioration at the south chimney

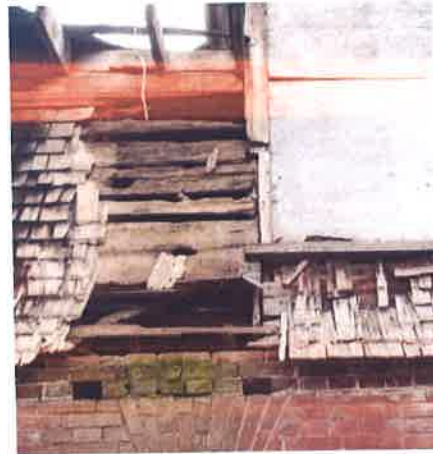
| EXTERIOR | PHOTO # |
|---|---|
| <ul style="list-style-type: none"> <li>In numerous areas, failure of the wood roofing and siding have allowed water infiltration, resulting in significant deterioration of brick as well as biological growth.</li> </ul> | 14 |

Photo 14 – Loss of roofing and siding leading to deterioration of brick and biological growth

Repairs to the building's cladding envelope, although not part of the scope of this report, will be critical as the first line of defense against the deterioration of the structure which currently compromising the structural integrity of this historic structure.

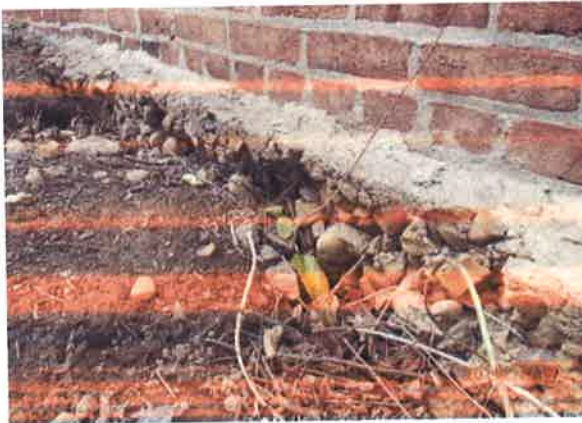
| EXTERIOR | PHOTO # |
|---|---|
| <ul style="list-style-type: none"> <li>At the southeast corner, there is repair work at the lower brick courses and concrete below the brick which appears to have been placed as part of this repair. This is indicative of repair work and possible undermining of the foundation wall.</li> </ul> | 15 |

Photo 15 – Foundation work at the southeast corner

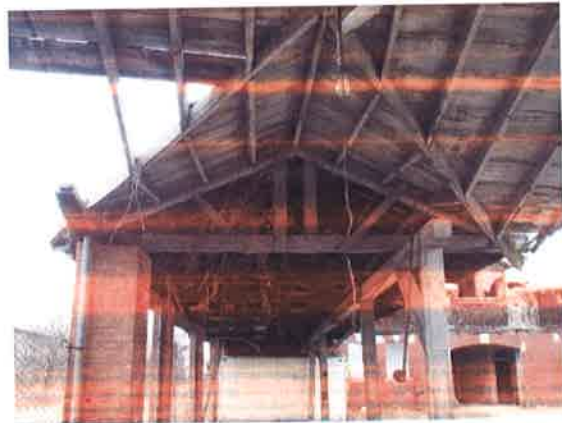
| EXTERIOR | PHOTO # |
|---|---|
| <ul style="list-style-type: none"> <li>The front covered storage area has areas of wood roof framing that are in imminent danger of failure, including the central hipped entry roof and several wood beams. The brick piers at the north portion of this storage area are relatively recent modifications which removed some of the stabilizing contribution of the brick. There is currently no good load path to provide lateral stability to this portion of the building. Although not easily apparent in the photograph, Photo 20 shows the masonry wall to the south of this storage area, which is leaning to the west, which is likely due to this lack of lateral stability.</li> </ul> | 16, 17,<br>18, 19,<br>& 20 |

Photo 16 – Failed framing over entry at front storage area

- Wood roof framing and brick walls and piers at the front storage area
- Stairs descending to basement and slab over basement area
- Wood framing at the second floor in numerous locations

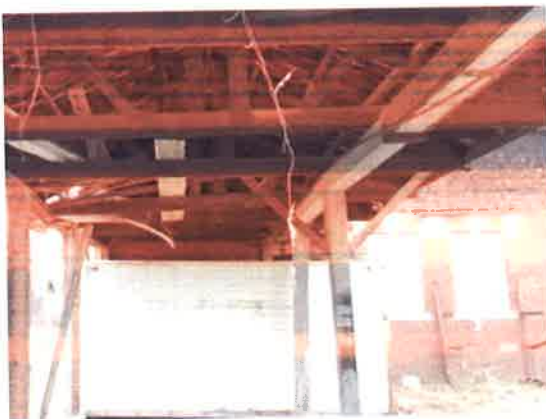
Photo 17 – Missing support posts at front storage area

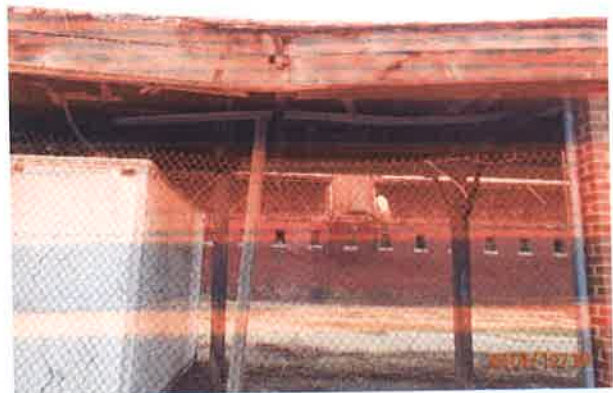
Photo 18 – Failed support beam at front storage area

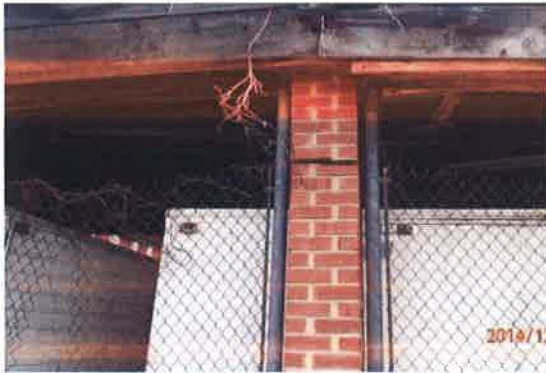
Photo 19 – Damaged brick pier at front storage area

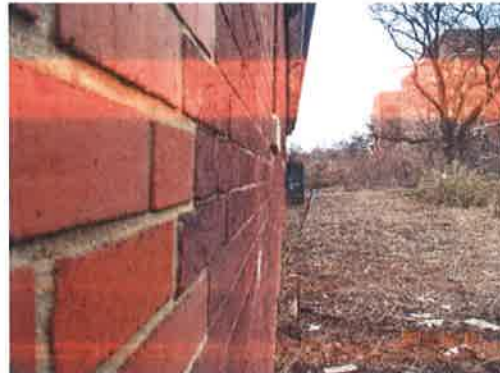
Photo 20 – Leaning brick bearing wall at front storage area

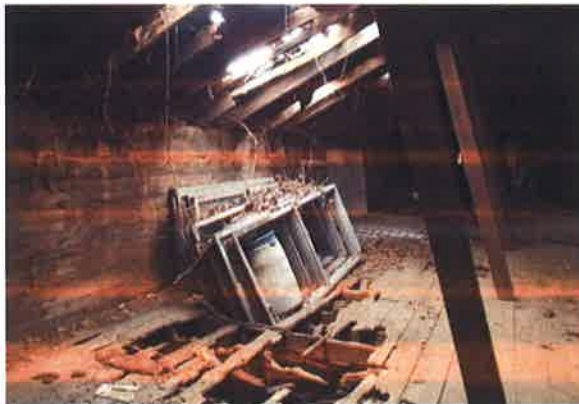
| EXTERIOR | PHOTO # |
|---|---|
| <ul style="list-style-type: none"> <li>Water infiltration through the roof and exterior wall have led to deterioration of wood rafters, joists, and decking in numerous areas. Numerous areas have failed, and due to the finishes below, it is difficult to determine the extent of failed wood framing, and therefore, which areas are safe. Photos show typical conditions that occur throughout the building.</li> </ul> | 21, 22 |

Photo 21 - Typical infiltration of water at the roof, leading to damaged roof framing and second floor framing

- Repair deteriorated floor joists and roof rafters at the two-story portion.
  - At numerous areas of where roofing has failed, the underlying rafters, second floor decking and joists have failed or are severely deteriorated. These areas should be temporarily shored and new structural members installed. Rim joists and related framing must also be replaced in a number of these areas.

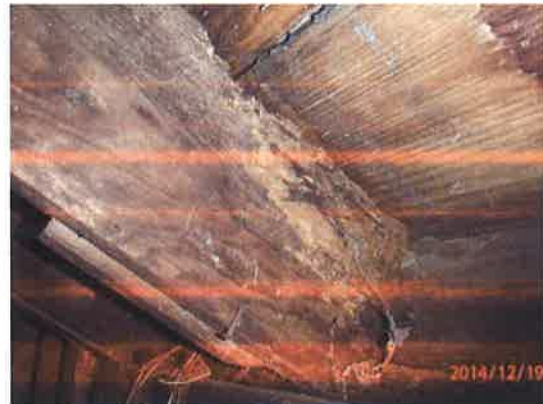
Photo 22 - Typical wood deterioration at roof rafter bearing due to water

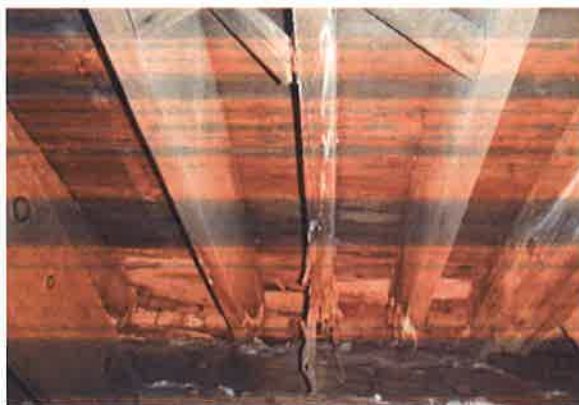
| EXTERIOR | PHOTO # |
|---|---|
| <ul style="list-style-type: none"> <li>At the basement area below the center of the building, the structural support of the slab at a number of areas has failed, compromising the structural integrity of this slab at the main entry. This is not apparent when walking on the slab, making an unsafe condition.</li> </ul> | 23, 24 |

Photo 23 – Failing floor joists at basement slab framing

- Investigation of structure and slab over the basement area is needed to design adequate stabilization. Again, as an alternate, temporary shoring could be installed in this space to allow for safe access to the structure.

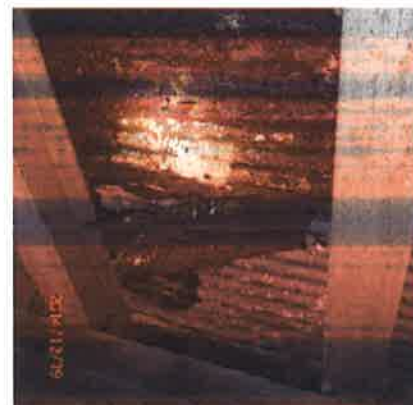
Photo 24 – Deteriorated metal deck and beams at basement slab framing

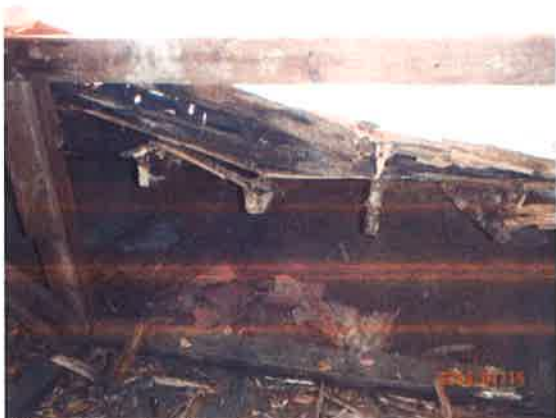
| AREA 1 | PHOTO # |
|---|---|
| • Failure of the wood framing has created an opening which allows water to enter | 1 |
| • Interior wood structural support frame has failed | 1, 2 |
| • Rafters have displaced downward at their upper bearing point | 1 |
| • Wood frame and rafters are severely deteriorated at the area of the opening | 1, 2 |

Photo 1. Area 1: Failure of wood frame

At Area 1, the structural repairs will be somewhat localized, and can be performed largely from the interior. Because the failure is due to the displaced rafters, repair work can be limited to temporary shoring and framing reinforcement to allow the rafters to be repositioned, and the roof opening closed and weatherproofed. The design for the new rafter support should take into account the capacity of the supporting concrete slab and joist framing.

- Lift and temporarily support structural rafters in the original position
- Rebuild support for rafters, either to match existing wood frame, or with a temporary knee-wall
- Reinforce deteriorated rafters with local reinforcing and full length "sister" reinforcing
- Replace deteriorated wood deck
- Repair flashing and roofing membrane (described in more detail by others)

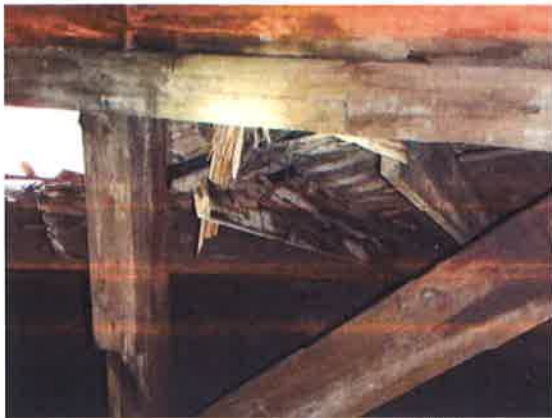
| AREA 1 | PHOTO # |
|---|---|
| • Wood decking is deteriorated and has failed in a number of areas adjoining the opening. | 2 |

Photo 2. Area 1: Deterioration of rafters and decking

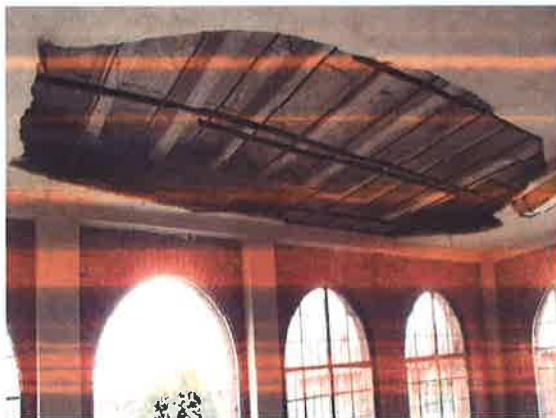
Existing structural system: This five story hospital building is built with masonry walls, concrete floor slabs (see Photo 3), and wood roof and ceiling framing. It is possible that concrete frames are concealed in the masonry walls. Interior is finished with plaster walls and ceiling. Exterior cladding is brick masonry with limestone details. Roofing is both flat and pitched, the pitched portions roofed with clay tiles. We observed flat areas to be roofed with copper.

Photo 3. Underside of Area 1 showing concrete joists

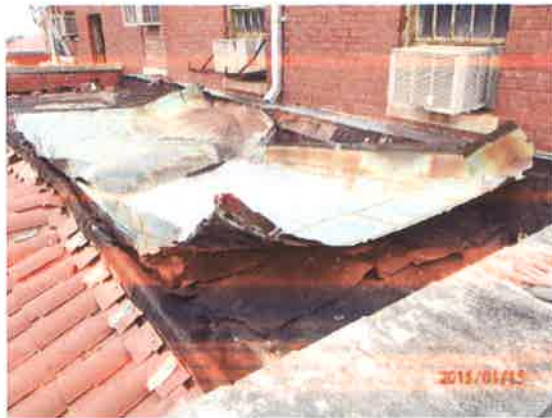
| AREA 1 | PHOTO # |
|---|---|
| • Failed area has allowed ponding which is further overloading the deteriorated framing | 4 |
| • Copper roofing at the flat roof has been removed allowing water to enter | 4, 5 |

Photo 4. Area 2: Loss of roofing and waterproofing membrane

In Area 2, the significant loss of roofing has exposed numerous roof and ceiling framing members to the elements, resulting in deterioration to many of these framing members. This framing appears to span to the exterior wall, therefore supporting not only the flat roof where failure is most evident, but also the pitched (clay tile) portion of the roof. Due to the extent of deterioration, the repair work should not proceed until the area has been made safe by temporary shoring, after which the scope of repair and replacement can be better defined with a more in-depth assessment.

- Temporarily shore framing to allow work to be performed safely
- Remove remaining ceiling plaster, roofing to allow assessment of wood framing
- Reinforcing and replacement of deteriorated wood framing may include both flat and pitched roof
- Replace deck on new/reinforced rafters
- Replace waterproofing membrane and roofing

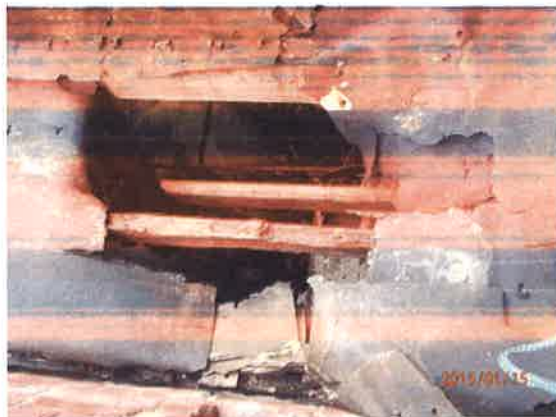
| AREA 1 | PHOTO # |
|---|---|
| • Failure of wood framing and decking has created a large opening | 5, 6 |

Photo 5. Area 2: Opening in the roofing to exposing rafters

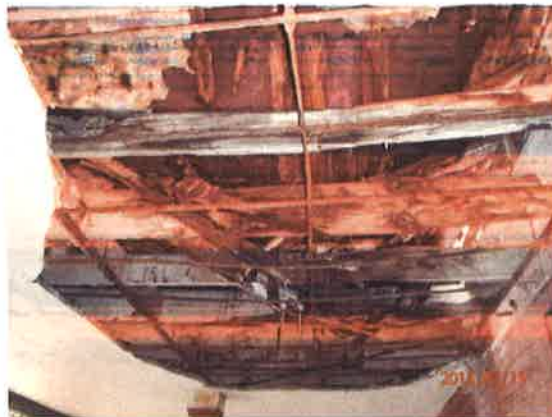
| AREA 1 | PHOTO # |
|---|---|
| • Flat framed wood rafters and ceiling supports are deteriorated and failed | 6 |
| • Metal ceiling support frame is deteriorated, and plaster has fallen in many areas | 6 |

Photo 6. Area 2: Deterioration and failure of rafters
