Building and Site Repairs at 2601 & 2603 Naylor Road SE

Solicitation No.: DCAM-16-CS-0087

**Amendment No. 3
Issued: March 18, 2016**

Naylor Road Evaluation

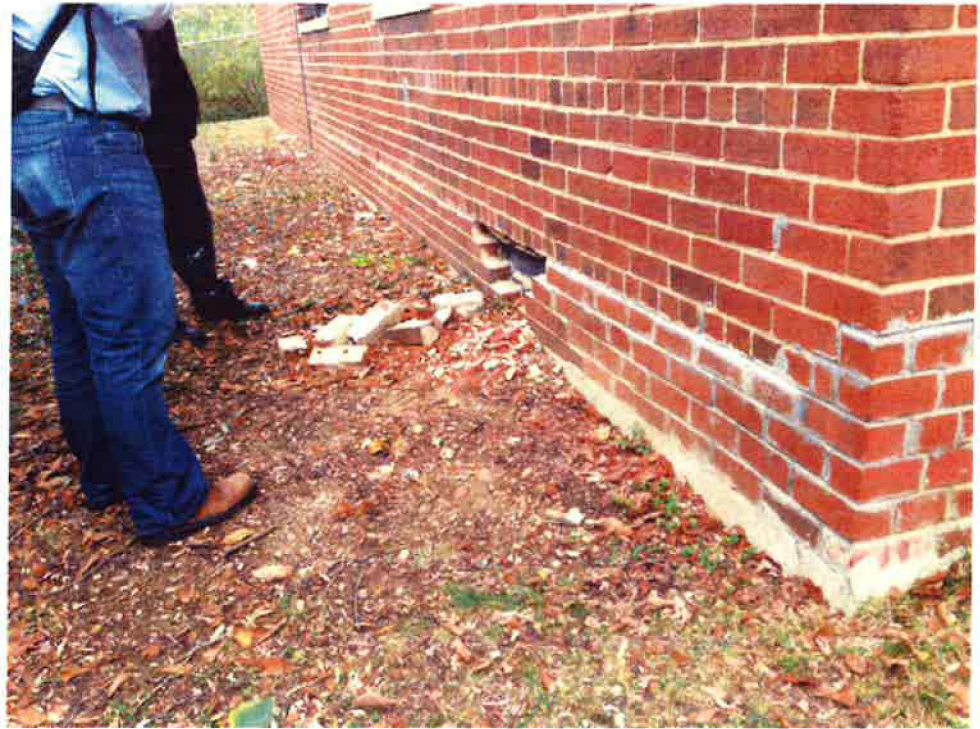
Existing Photo 1: Crack and deterioration at south wall.

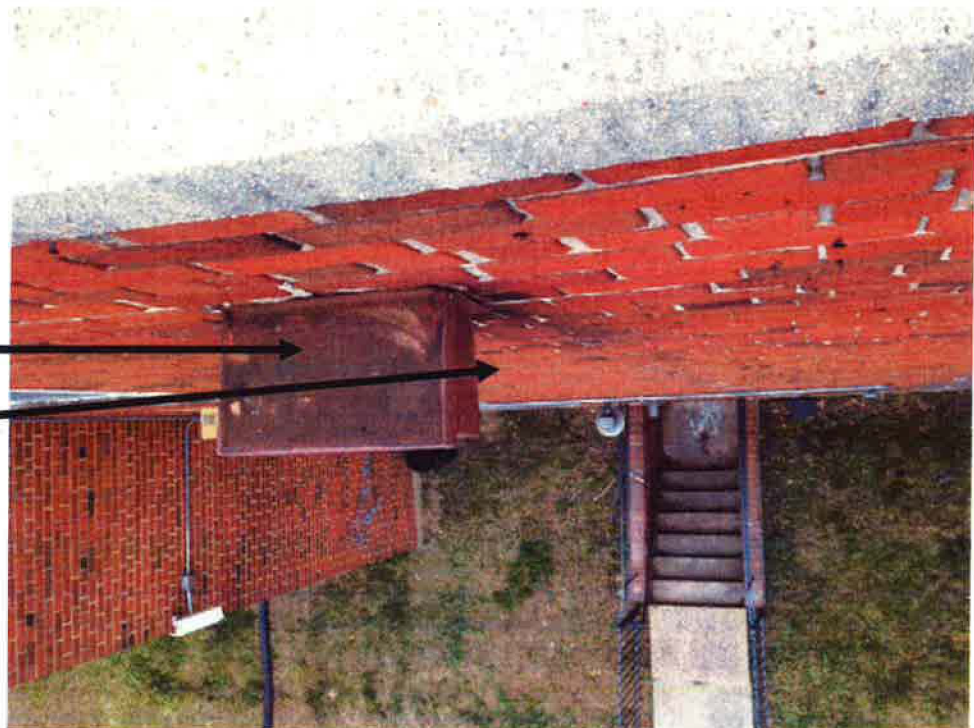
Existing Photo 2: Example of missing downspout

Existing scupper

Missing downspout

1. Install downspouts at perimeter roof drains on all sides of the building.
2. Where the brick is peeling away from the back wall, remove the brick from the location where the separation begins down to the top of the footing. Then rebuild that portion of the brick wall to cover proper water proofing. During this process the A/E should be notified so the existing footing conditions can be observed.
3. Install crack monitors on the stepped cracks on the side wall and conduct periodic monitoring to record whether any changes occur. While it is unlikely that the back wall is settling, the monitoring process will indicate movements before they become more visible and create damage to the existing structure and interior finishes.

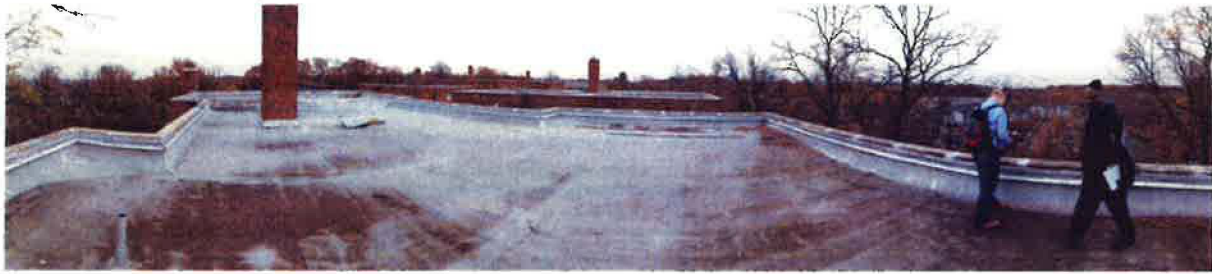
Existing Photo 3: General roof conditions

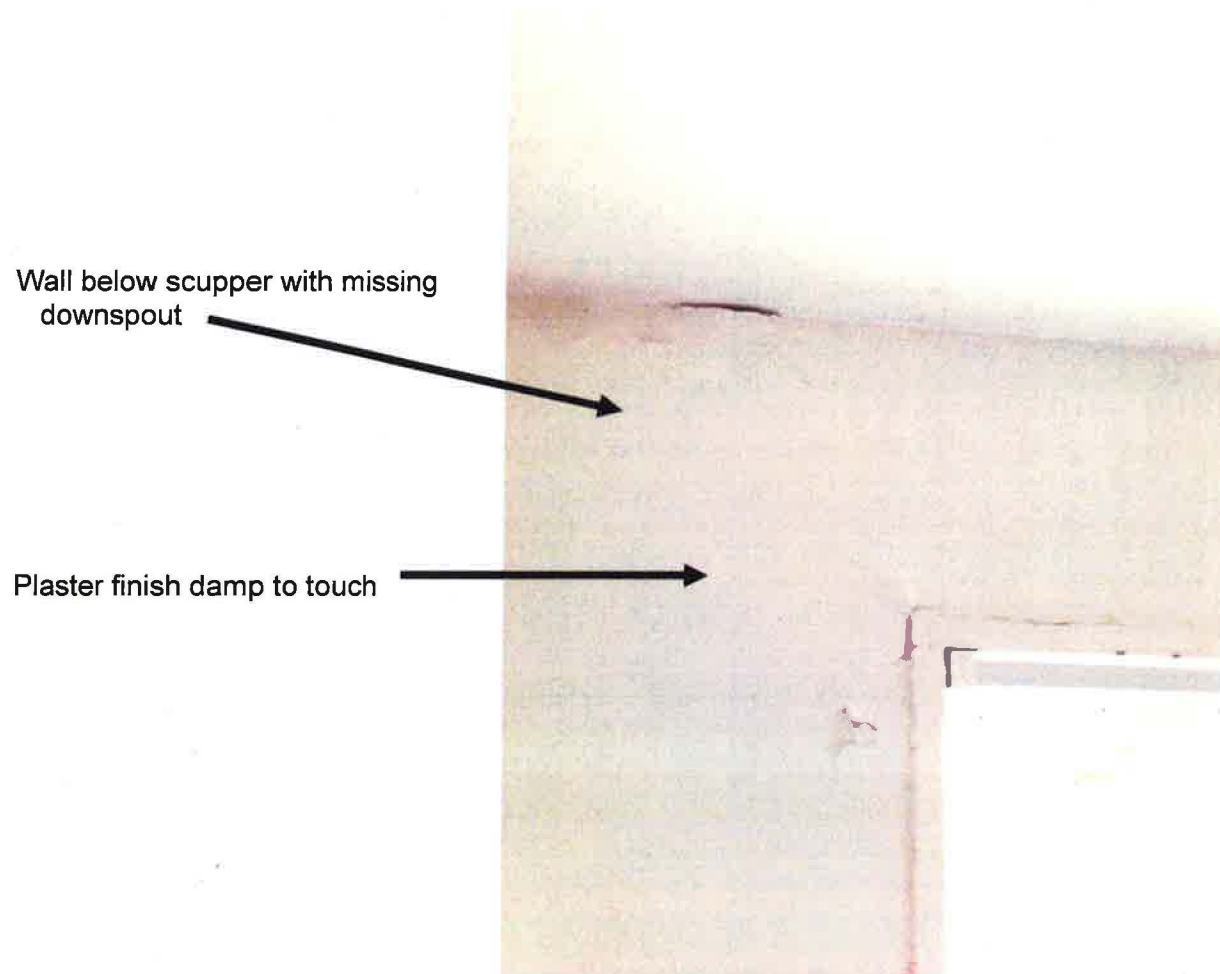
Existing Photo 4: Interior wall dampness and deterioration.

Wall below scupper with missing
downspout

Plaster finish damp to touch

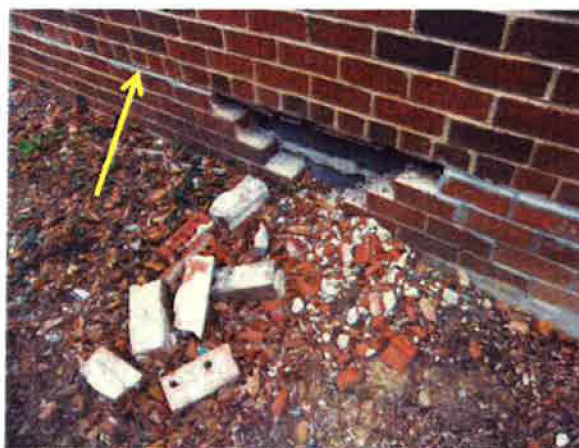
Photo 2: Long horizontal bed joint separation of brick wythe with location of fallen bricks.

brick, tying the outer wythe of brick to the inner wythe of CMU. This joint also has a water proofing paper running continuously along the joint. It is likely that water from below the basement slab on grade bled into the masonry wall, stopped at the paper, and over the years, the cycling of freeze-thaw caused the outer wythe of brick to separate.

- Where the brick is peeling away from the back wall, we recommend removing the brick from the location where the separation begins down to the top of the footing. Then rebuild that portion of the brick wall following details provided by the architect to cover proper water proofing. RSA should be notified when the top of the footing is exposed and the majority of the brick has been removed so that work and the existing footing conditions can be observed.
- Install downspouts at perimeter roof drains.
- Install crack monitors on the stepped cracks on the side wall and conduct periodic monitoring to record whether any changes occur. While it is unlikely that the back wall is settling, the monitoring process will indicate movements before they become more visible and create damage to the existing structure and interior finishes.

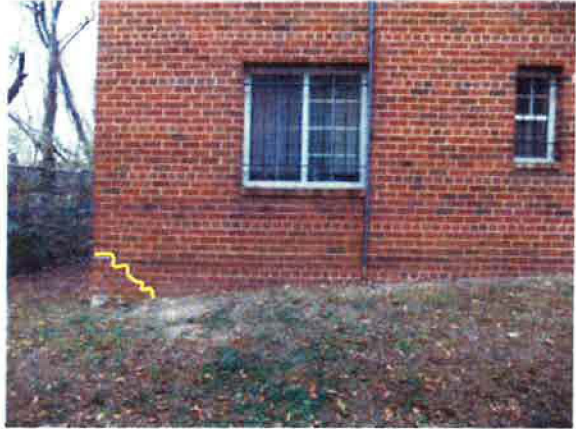
Photo 3: Stepped crack at base of exterior load bearing walls

indicates that the cracks formed prior to the separation of the interior plaster walls and correspond to an older condition unrelated to the interior plaster wall issue along the back wall. Furthermore, no parallel cracks were observed in the interior plaster walls along the sides of the building. This is not surprising as masonry cracks with much smaller movement than the plaster because the wood furring allows for small movement without stressing the plaster.

Stepped cracks can occur with vertical movement of a perpendicular wall surface. At some point the back wall may have moved down slightly. This is unlikely however masonry walls do not tend to settle uniformly. As a result, there would be many more cracks present along the back wall than were observed in the field. Loading on this back wall is also very small and a standard strip footing should be more than adequate to support the weight of the brick wall above. As a result of these observations and understanding of the existing structure, it is unlikely that the problems observed are results of foundation settlement.

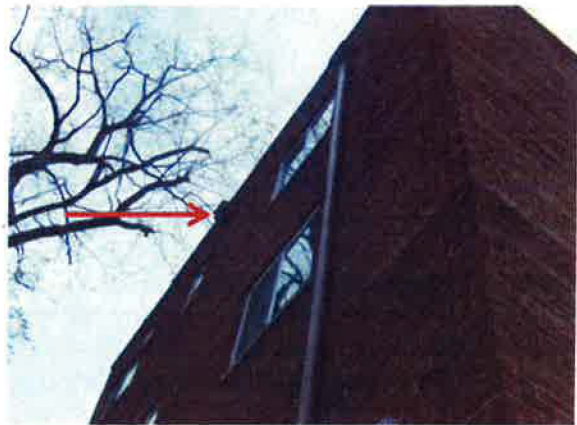
Photo 4: Existing downspout with no drain pipe

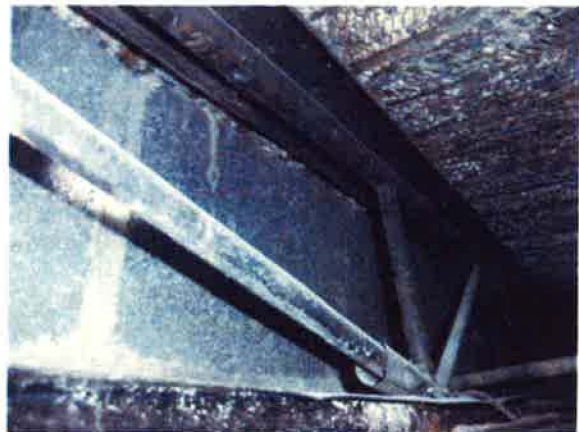
Photo 5: First floor framing. Steel bar joists with concrete slab poured over wire mesh.

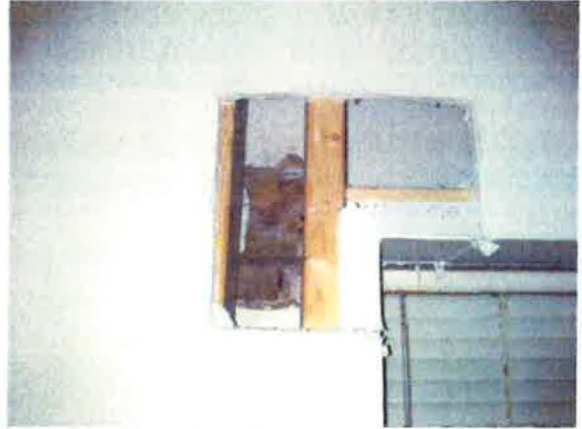
The likely culprit for the plaster separation and the brick separation is water infiltration into the back wall. The probes around the window casing uncovered water stains and cracks in the plaster centered at windows. Water likely infiltrated around the windows, soaked into the wood furring, and over time, caused the wood to decay or the anchors of the furring to the masonry wall to loosen. This weakened the anchorage of the wood furring to the back wall which led to the plaster peeling from the back wall as indicated by the tenants and maintenance staff during the site visits. Observation of this was limited as the failed plaster was removed and a new stud wall with drywall was installed along the back wall before RSA was requested to investigate the site conditions.

Photo 6: Exposed framing at corner of window on back wall. Water stains observed on furring strips around window.

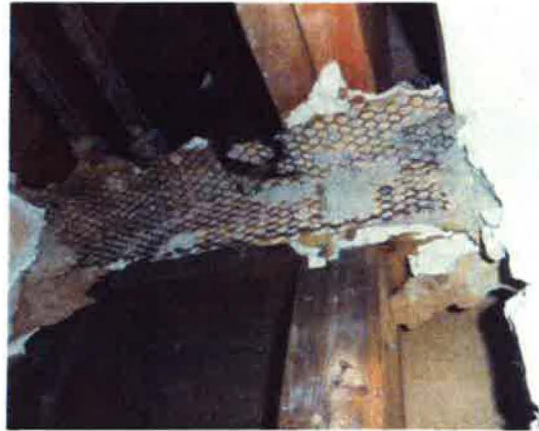
Photo 7: Second floor framing with wood joists supported on interior stud walls

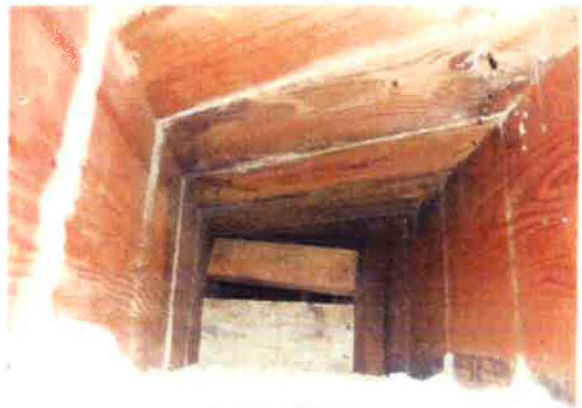
Photo 8: Floor framing detail photo taken just above apartment ceiling.

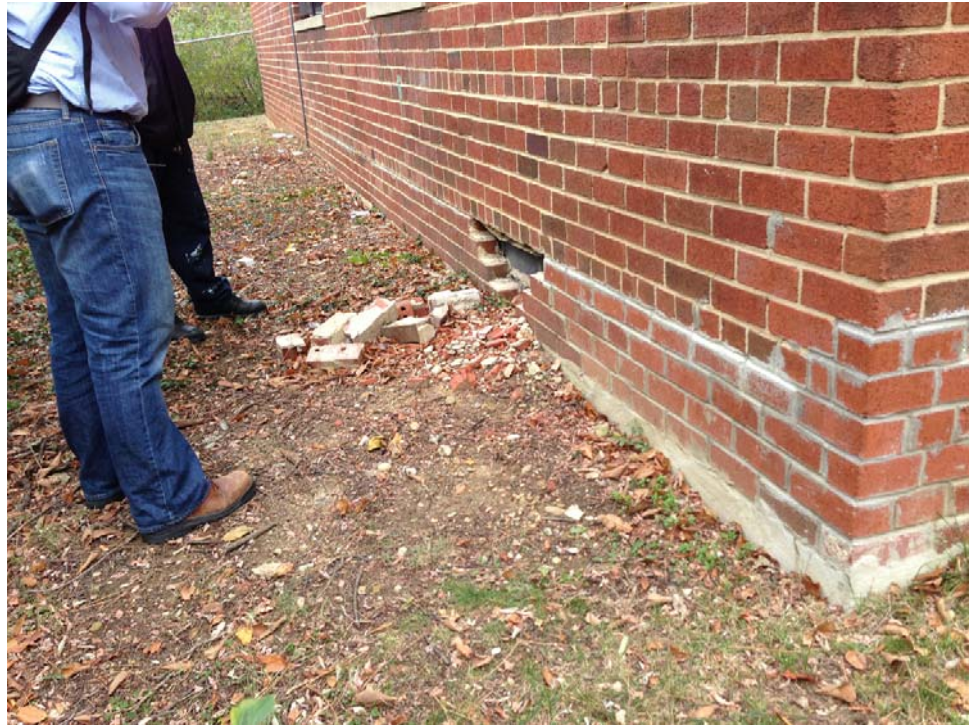
Existing Photo 1: Crack and deterioration at south wall.

3. Install crack monitors on the stepped cracks on the side wall and conduct periodic monitoring to record whether any changes occur. While it is unlikely that the back wall is settling, the monitoring process will indicate movements before they become more visible and create damage to the existing structure and interior finishes. **The movement of the bricks is continuing. The issue should be repaired.**

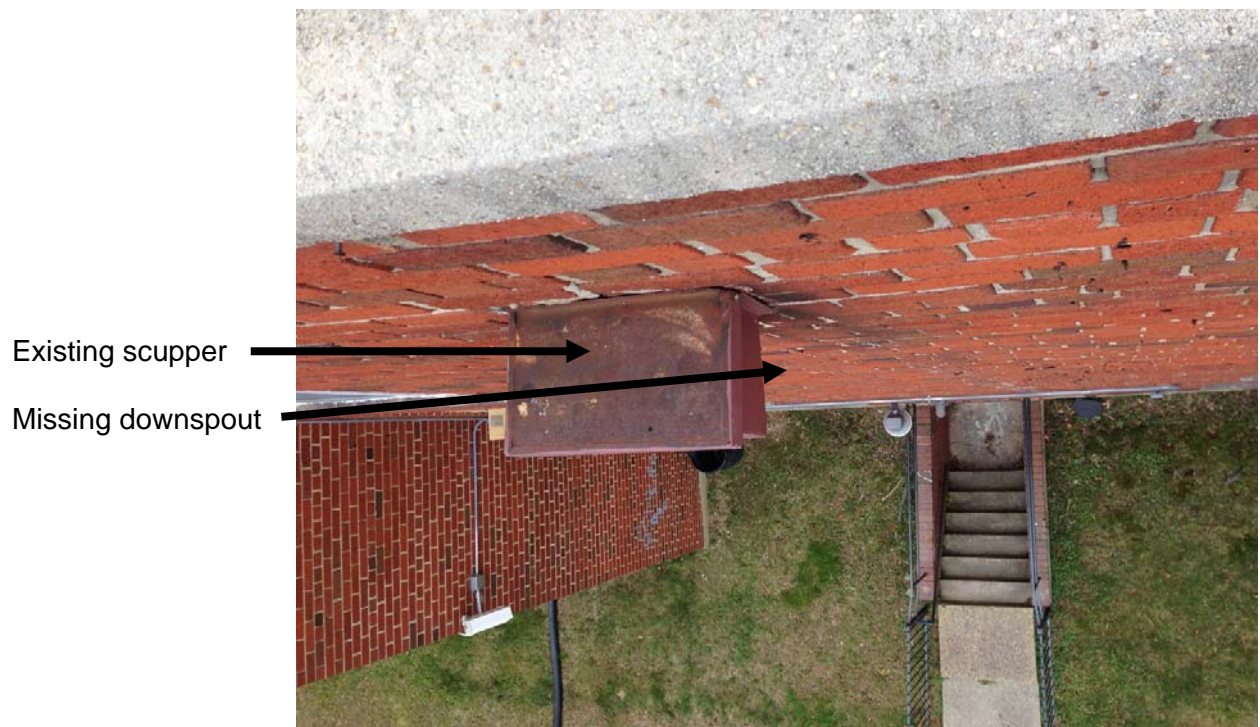
Existing Photo 2: Example of missing downspout

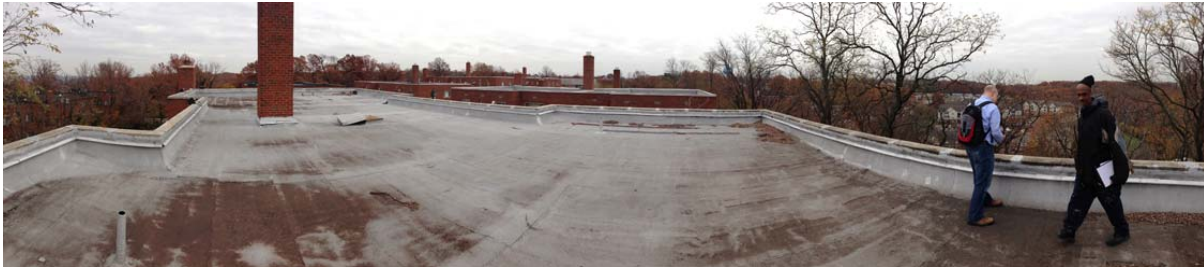
Existing Photo 3: General roof conditions

4. **The existing roof of building 2603 is not properly sloped and should be replaced with a new roof of a more more appropriate design.**
5. **The area at the south side of Building 2601 should be regraded and/or a foundation drain be installed at this location to get water away from the building.**

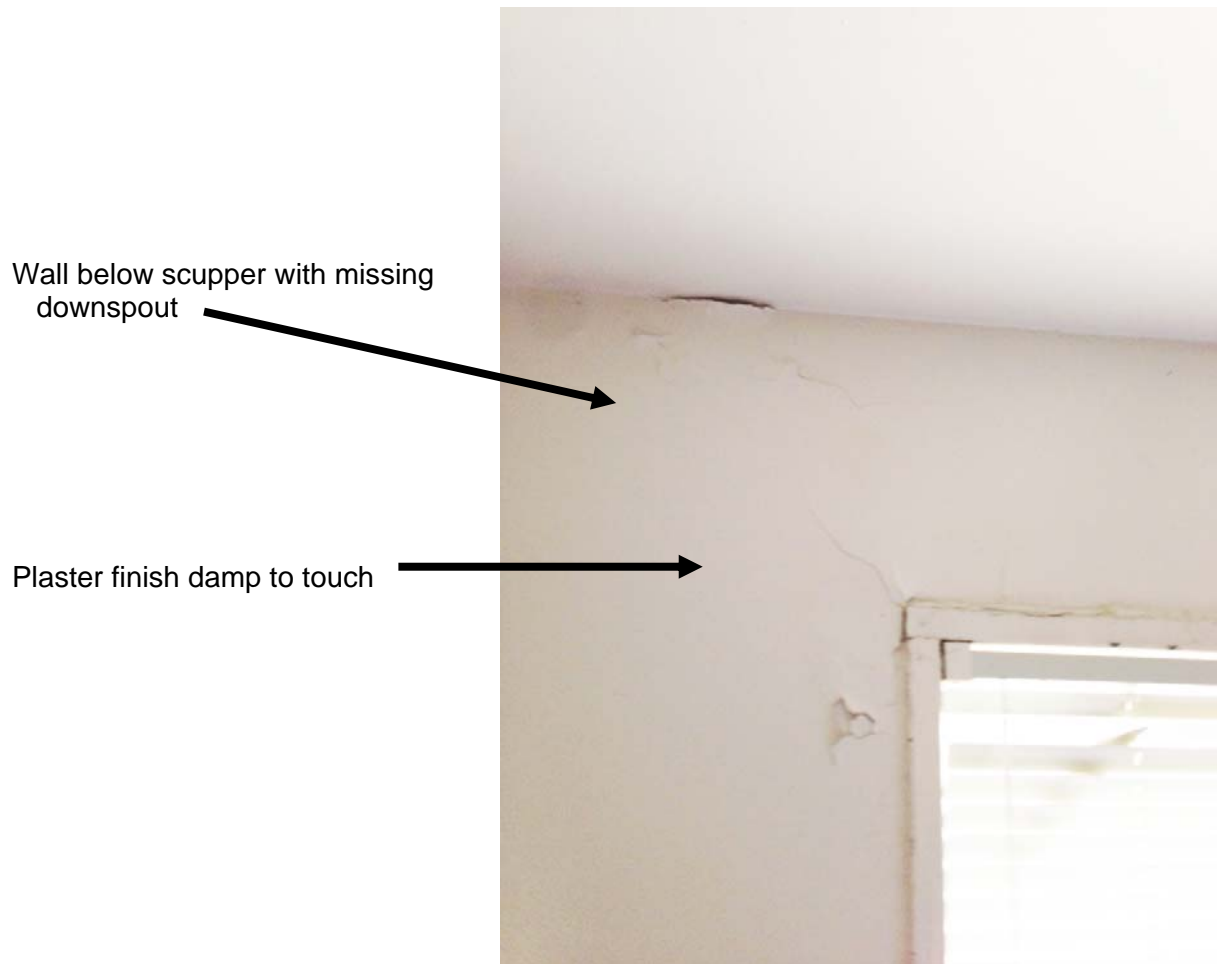
Existing Photo 4: Interior wall dampness and deterioration.

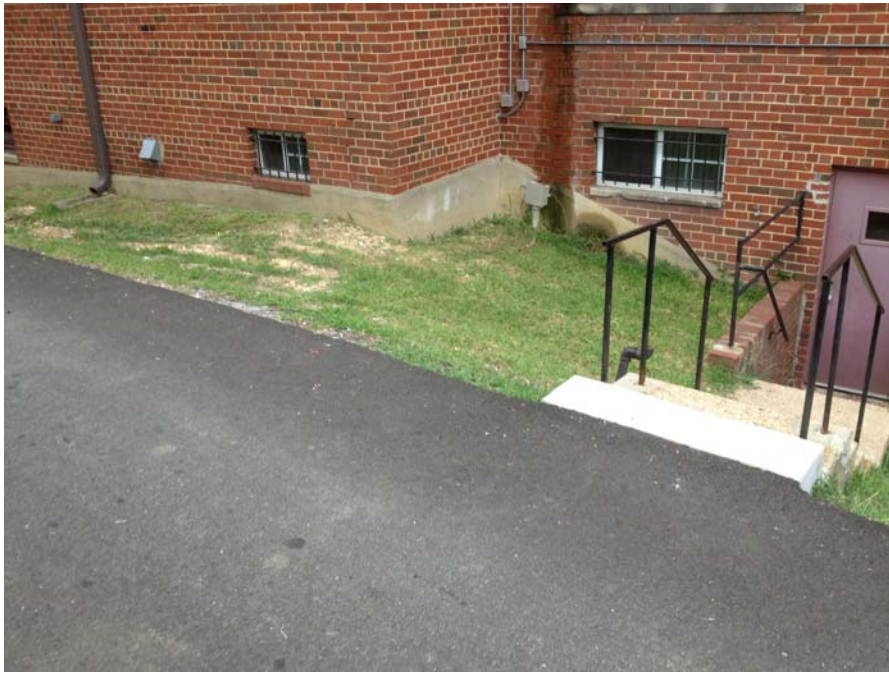
Existing Photo 5: Improperly graded area with basement stairway that fills with rain water

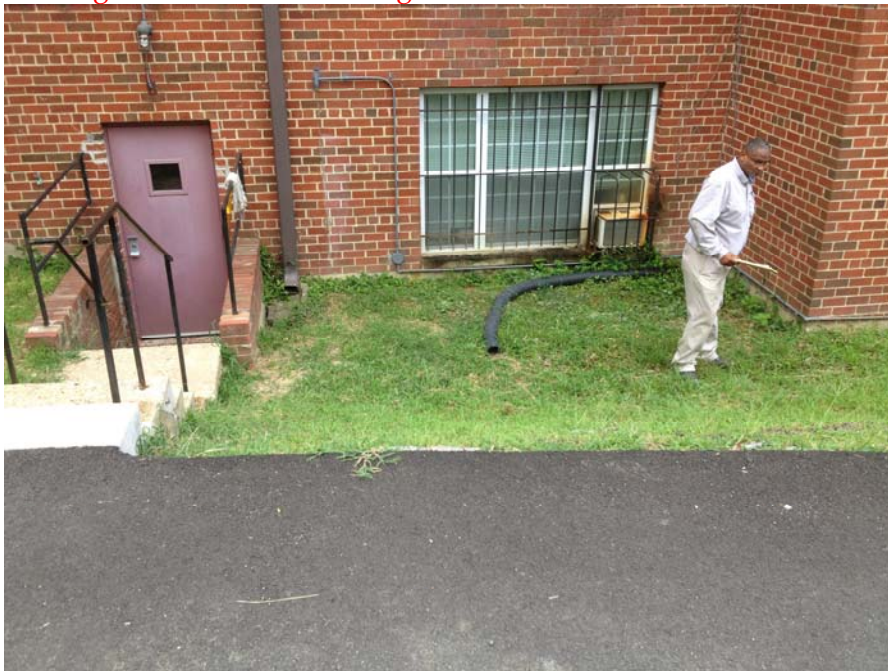
Existing Photo 6: Area to be regraded.
