**Amendment 001
Request for Proposal (RFP)**

**Design-Build Services
Adelaide Davis Elementary School Swing Space (DCAM-16-CS-0140)**

Attachment A1
2014 Roof Assessment Report

Davis Elementary School 2014*
4430 H St SE
Washington, DC 20019

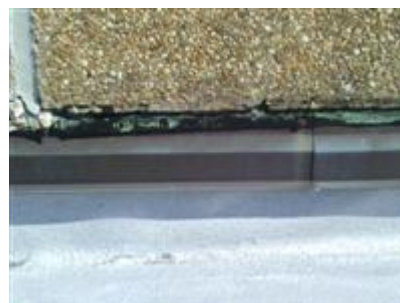
Associated Defect: #3 , #4 - Metal flashing defects (LF)

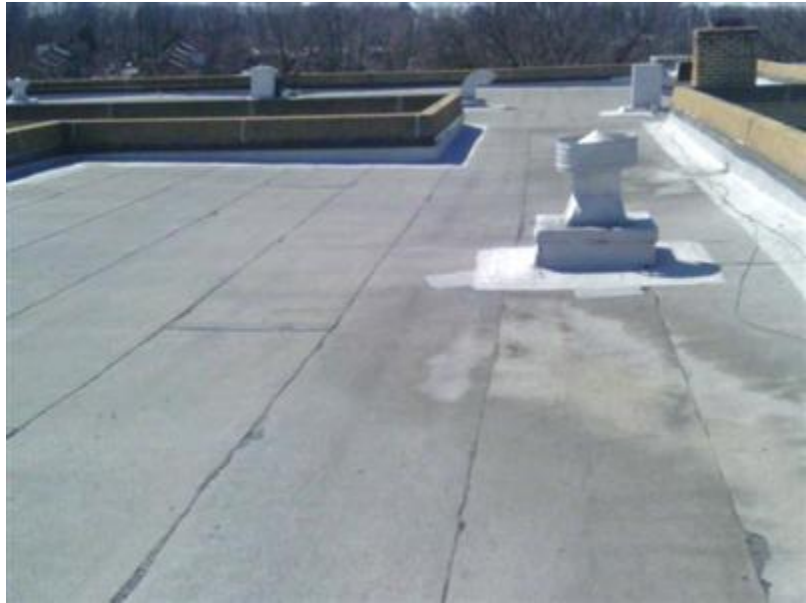
Defect #1 - BUR membrane

Defect: Suspected wet insulation.

Recommendation: Condition is indicative of deterioration. However no other repairs are necessary at this time. Continue to monitor and report any changes in condition. Keep foot traffic to a minimum.

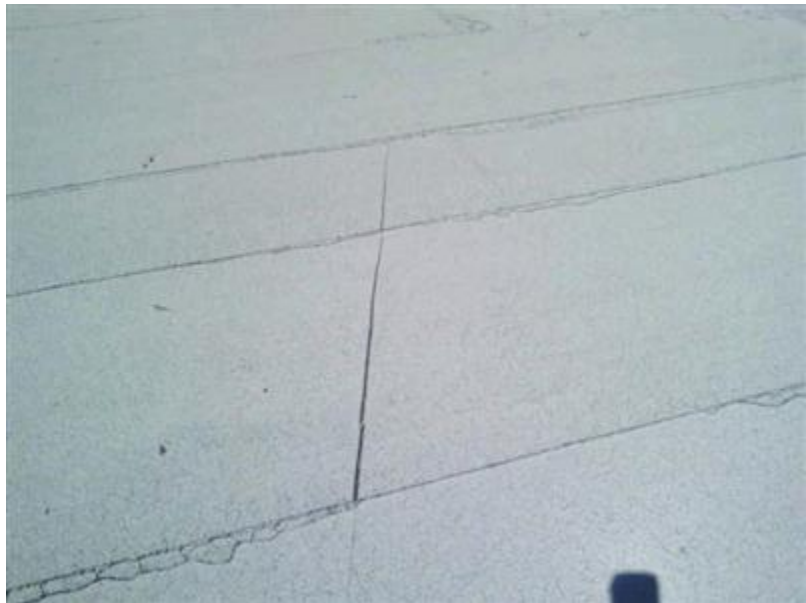
Defect #2 - BUR membrane

Defect: Membrane splits.

Recommendation: Apply a 3 course layer of an elastomeric product with fabric over affected area.

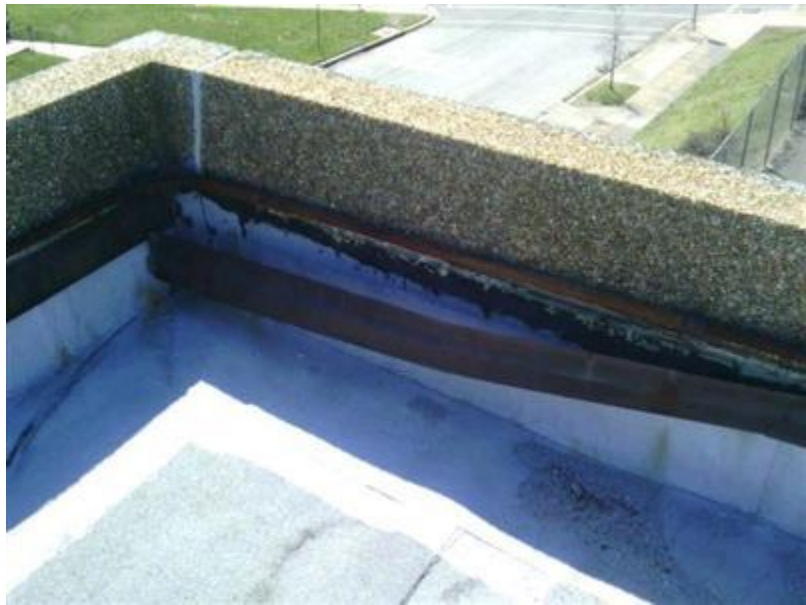
Defect #3 - Parapet counter flashing

Defect: Metal flashing defects (LF).

Severity: Missing or damaged metal joint covers, obvious water penetration.

Recommendation: New metal flashing should be fabricated to match the existing. The new flashing should be securely anchored with appropriate fasteners.

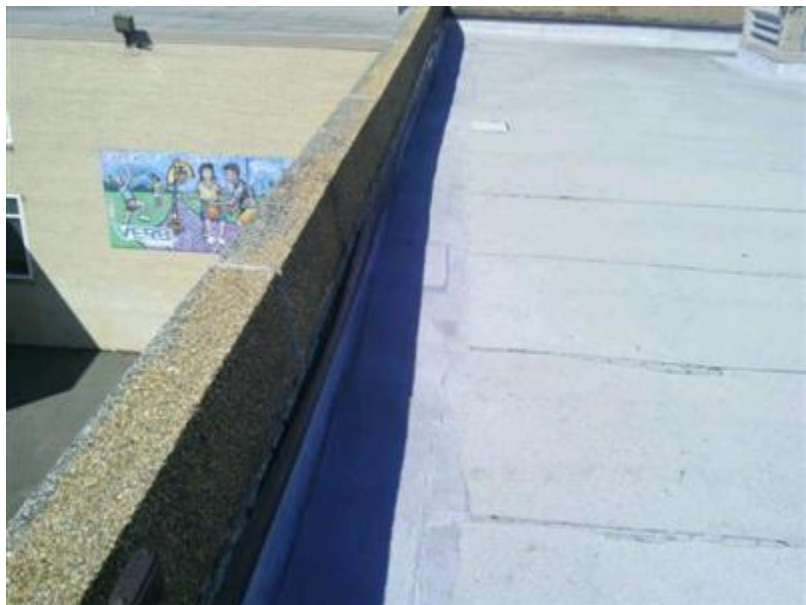
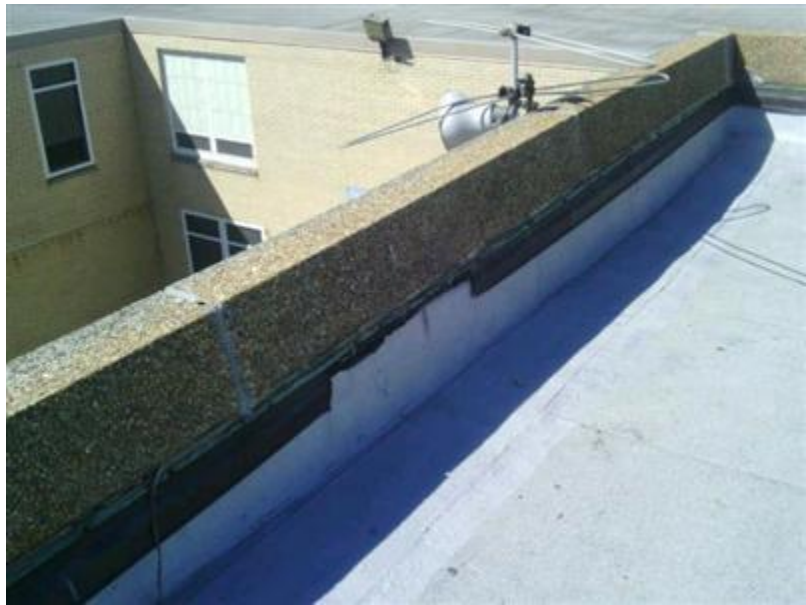
**Defect #4 - Parapet counter flashing**

Defect: Metal flashing defects (LF).

Severity: Missing or damaged metal joint covers, obvious water penetration.

Defect: Metal flashing defects (LF).
Severity: Missing or damaged metal joint covers, obvious water penetration.
Status: Proposed

Recommendation: New metal flashing should be fabricated to match the existing. The new flashing should be securely anchored with appropriate fasteners.

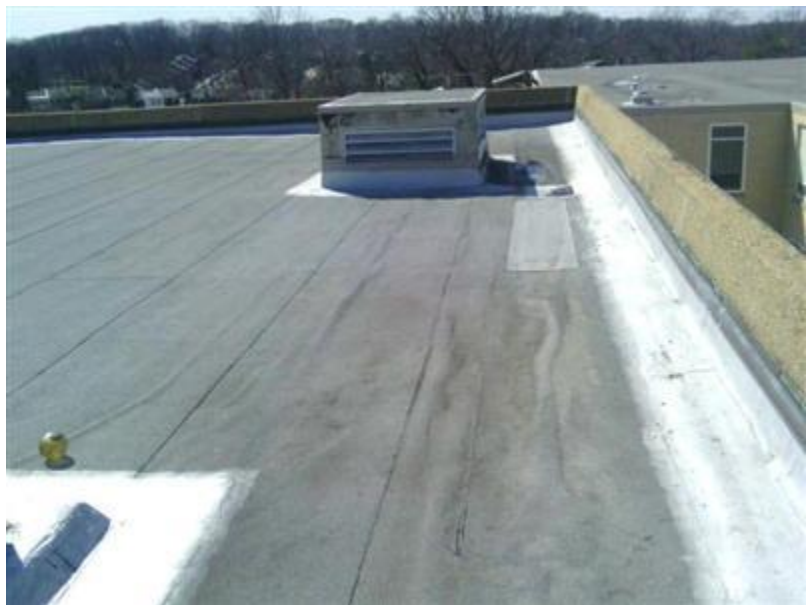
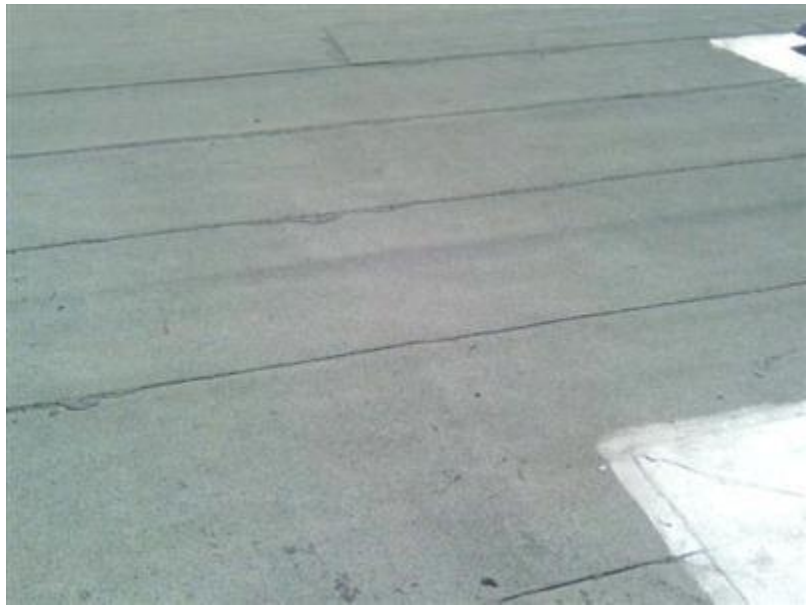
**Defect #5 - BUR membrane**

Defect: Membrane blisters (SF).
Severity: Blisters greater than 1 SF OR with surface material migrating but no exposed felts or plies.
Area: 997 SF
Status: Proposed

Defect: Membrane blisters (SF).
Severity: Blisters greater than 1 SF
OR with surface material migrating
but no exposed felts or plies.
Status: Proposed

Recommendation: Perform temporary repairs to protect this area against roof leaks until roof system can be scheduled for replacement.

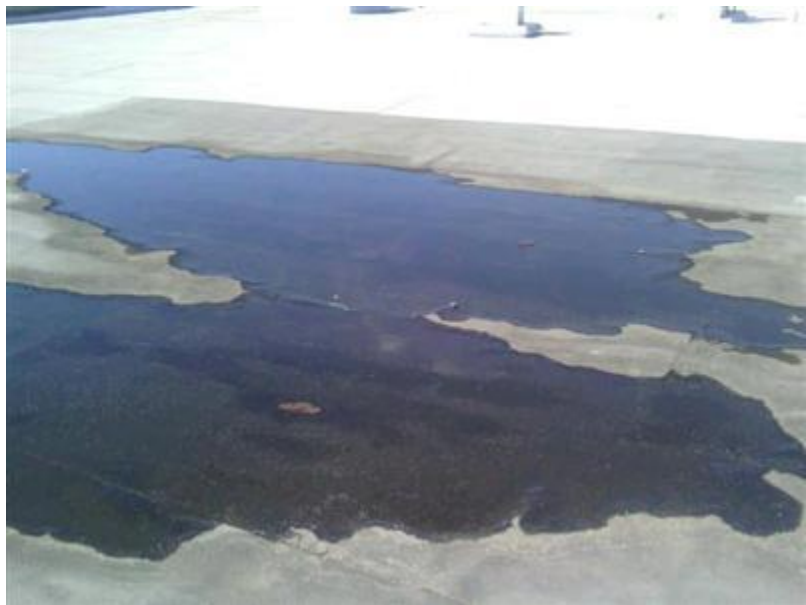
**Defect #6 - BUR membrane**

Defect: Ponding.
Severity: Ponding at the drain or drip
edge.
Area: 410 SF
Status: Recorded

Recommendation: Ponding water is
defined as water that remains
standing on roof surface 48 hours
after a rainfall. Perform more frequent
inspections to monitor and maintain
membrane surface. Consider positive
drainage at time of replacement.

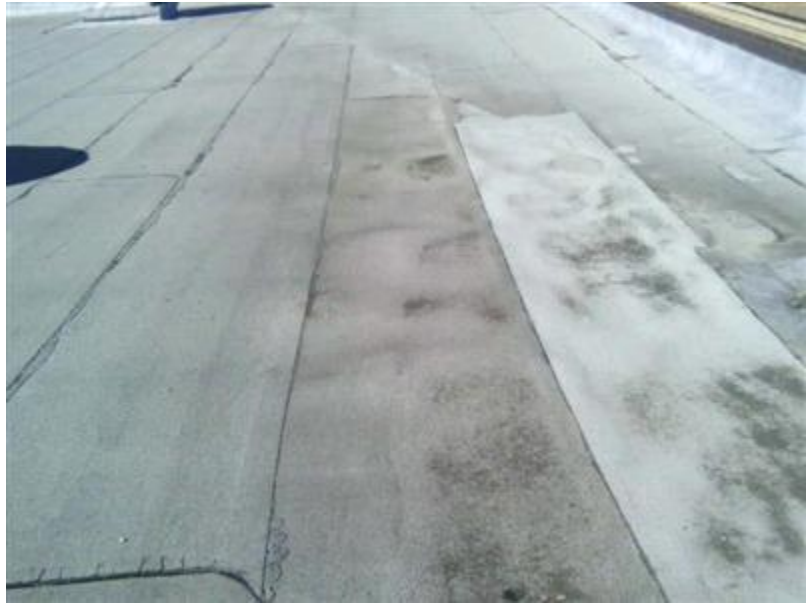
Defect #7 - BUR membrane

Defect: Suspected wet insulation.

Recommendation: An infrared survey of entire roof system is recommended. Moisture within a roof system accelerates deterioration of system and is a large source of energy loss.

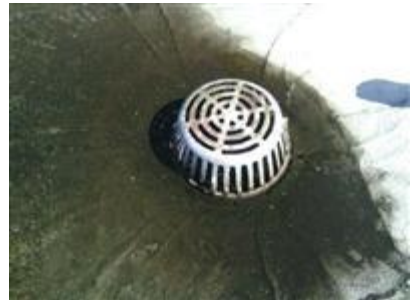
Associated Defect: #8 - Clogged drain

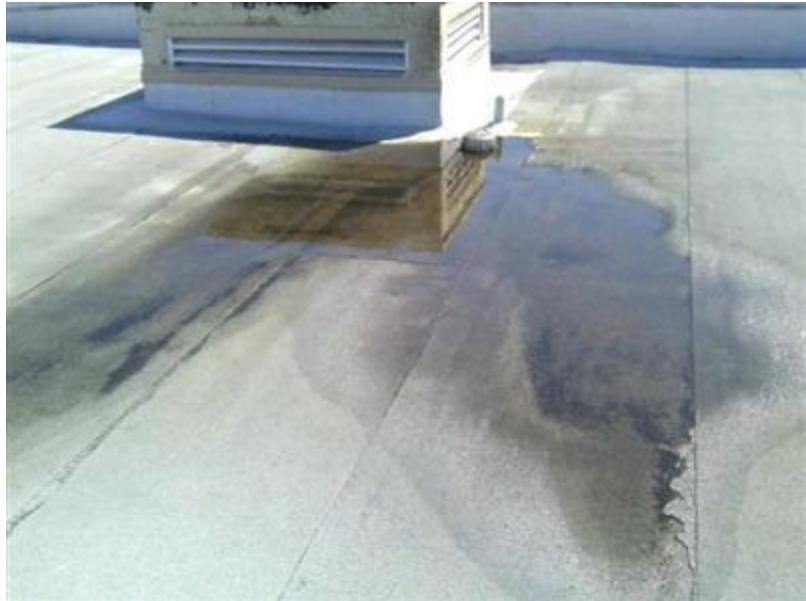
Defect #8 - Field drain

Defect: Clogged drain.

Notes: needs to be snaked.

Recommendation: Contact a plumber or roofing subcontractor to jet the drain

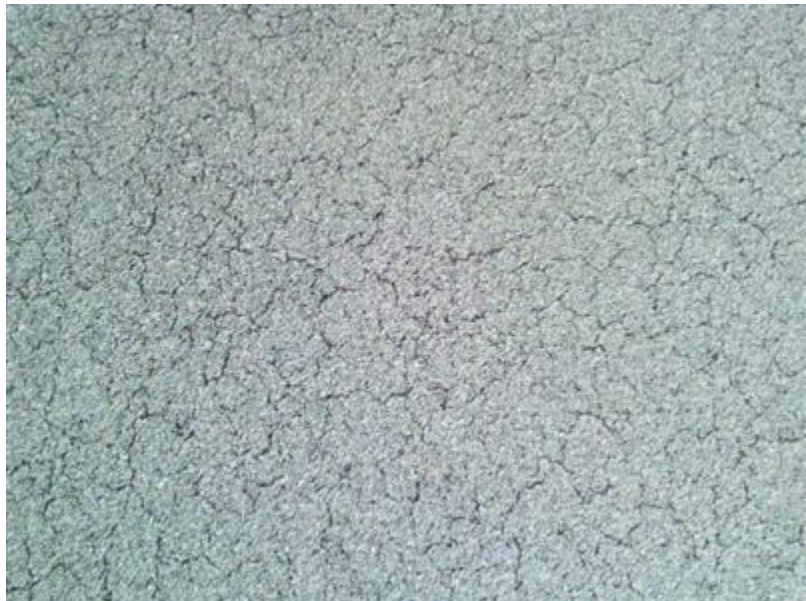
Defect #9 - Mod bit membrane

Defect: Mineral surface-cap deterioration.

Severity: Small cracks/crazing present.

Recommendation: Condition is indicative of deterioration, however no repairs are necessary at this time. Continue to monitor and report any changes in conditions. Keep foot traffic to a minimum.

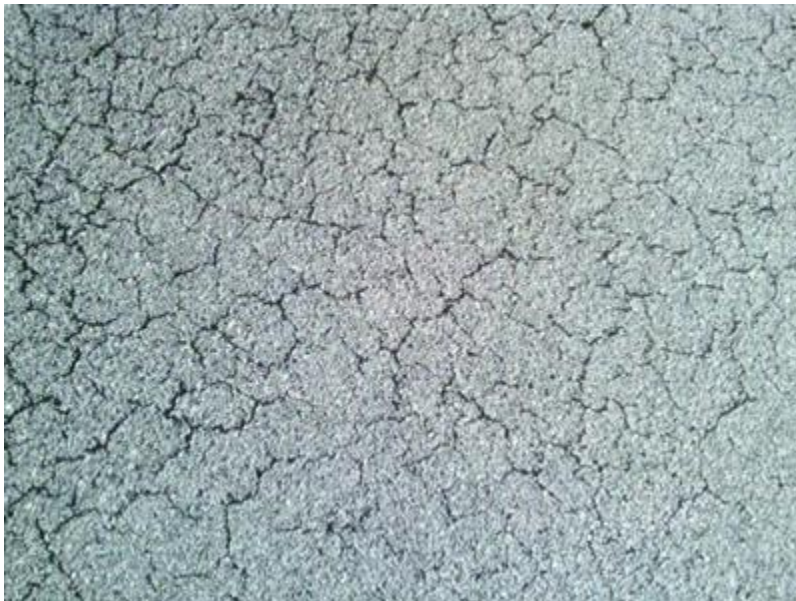
Defect #10 - Mod bit membrane

Defect: Mineral surface-cap deterioration.

Severity: Small cracks/crazing present.

Recommendation: Condition is indicative of deterioration, however no repairs are necessary at this time. Continue to monitor and report any changes in conditions. Keep foot traffic to a minimum.
