COMPREHENSIVE FACILITIES CONDITION ASSESSMENT & SPACE UTILIZATION SURVEY

DISTRICT OF COLUMBIA DEPARTMENT OF PARKS AND RECREATION
RANDALL RECREATION CENTER
820 SOUTH CAPITOL STREET, SW
WASHINGTON, D.C. 20001

PUBLISHED OCTOBER 2009, BY
DISTRICT OF COLUMBIA DEPARTMENT OF REAL ESTATE SERVICES
ROBIN-EVE JASPER, DIRECTOR
GERICK T. SMITH, DEPUTY DIRECTOR OF CONSTRUCTION DIVISION

Reference: Report of Comprehensive Facilities Condition Assessment & Space Utilization Survey
Department of Parks and Recreation
Randall Recreation Center
820 South Capitol Street, SW
Washington, D.C. 20001
Faithful+Gould Project No. 55561-10
District of Columbia Contract Number POAM-2004-C-0044-14-CA

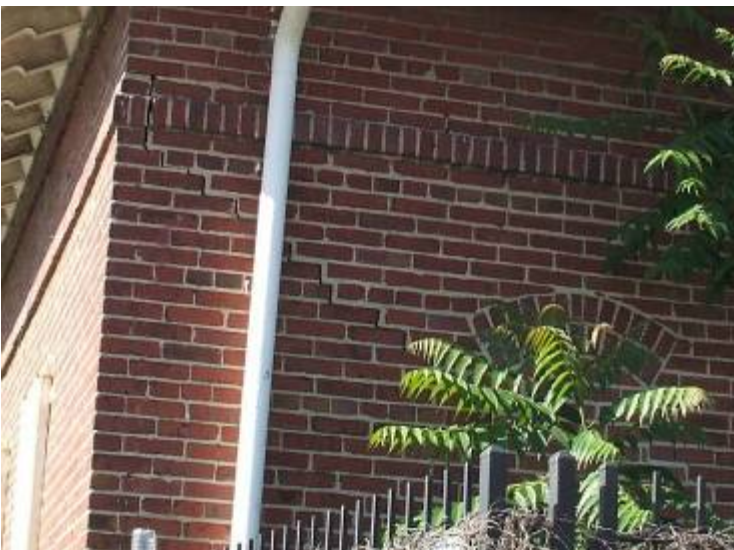
Photograph No. 3

However, we noted localized diagonal 'toothed' or stepped cracking in the brick façade at the rear of the building (reference Photograph 3 in Appendix C). This type of cracking is indicative of differential settlement within the foundations over a period of time. The cracking has resulted in diagonal cracks in the brick façade up to ¼" wide. The extent of the cracking is not significant at this time, although we recommend repairs to seal the open cracking and monitoring of the condition to ensure that further, ongoing movement within the structure is not occurring. We do not anticipate a requirement to complete significant repair or replacement of the foundation systems within the six-year study period. Repairs to the masonry façade are addressed in Section B20, Exterior Closure.

Cracking at Brick Façade

1. We recommend budgeting for repointing the cementitious mortar in the joints and the application of a water repellent solution on the exterior brick facades throughout the building. Our opinion of the cost for this work is a total of \$26,550, including \$22,125 (\$7.50 per square foot) for repointing and \$4,425 (\$1.50 per square foot) for application of water repellent, in 2010.

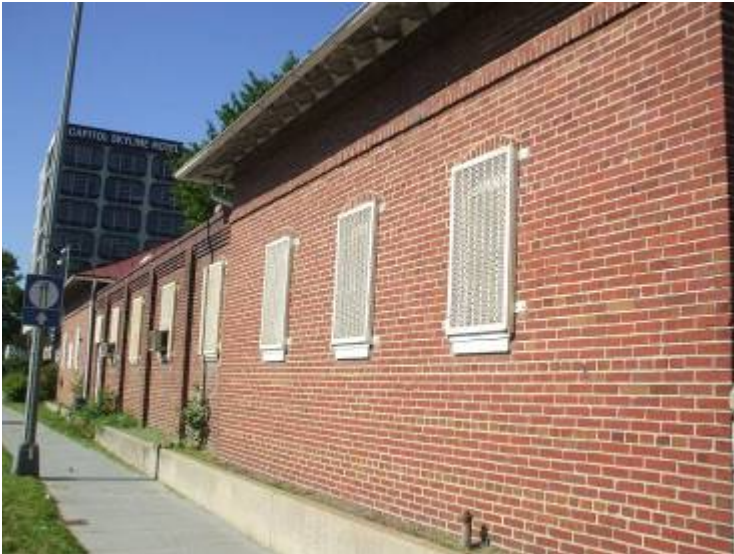
Photograph No. 5

The clay brick enclosure walls and its mortars are generally in fair to poor condition. We noted in the brickwork and mortar, widespread areas of deterioration consisting of poor quality, brittle cementitious mortar throughout the building (reference Photograph 5 in Appendix C). The joints' cementitious mortar is brittle, and contains loose or detached portions. Based on our interior assessment of the structure, it appears that the existing brickwork, including the cementitious mortar, is porous and allowing moisture ingress, contributing to interior dampness at the building. We have recommended budgeting for the near-term repointing of the exterior brickwork. We have also recommended budgeting for the near-term application of a water repellent solution to be applied to the exterior clay brick facades.

Brickwork Façade

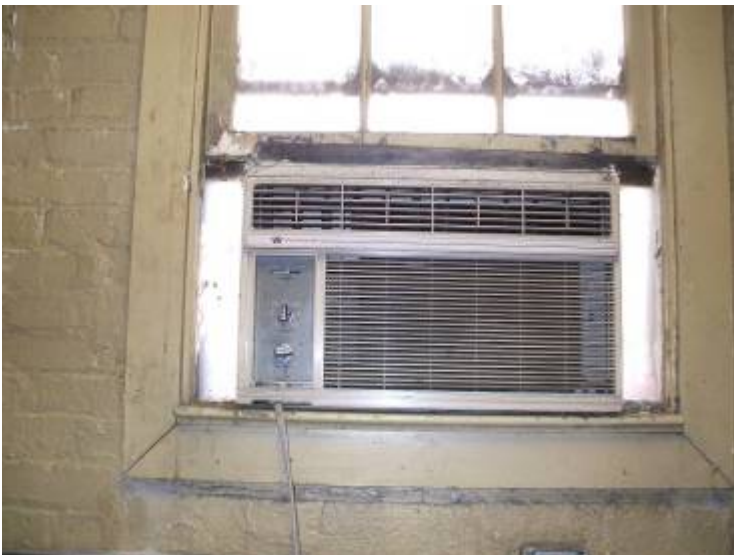
Photograph No. 6

The condition of the wood-framed slider windows varies. Some of the windows are in fair condition and may be salvageable. However, many of the windows are in poor condition, with numerous instances of water damaged and deteriorated wood noted during our assessment (reference Photograph 6 in Appendix C). We also noted evidence of water ingress at the interior of the building, adjacent to the windows. The existing wood-framed windows are single-glazed and therefore provide minimal energy efficiency, and are reportedly allow air infiltration during the colder months of the year, creating drafty and uncomfortable conditions for occupants. Based on our noted defects and the reported air infiltration throughout the facility, we have recommended budgeting for the near-term replacement of the existing wood-framed windows.

Wood-Framed Window

3. We recommend budgeting for replacing the existing wood-framed windows, installing aluminum framed thermal slider units and application of perimeter sealant. Our opinion of the cost for this work is \$35,467 (\$89.07 per square foot, plus an allowance of \$10 per square foot for the removal and reinstatement of the existing steel-framed security grilles) in 2010.

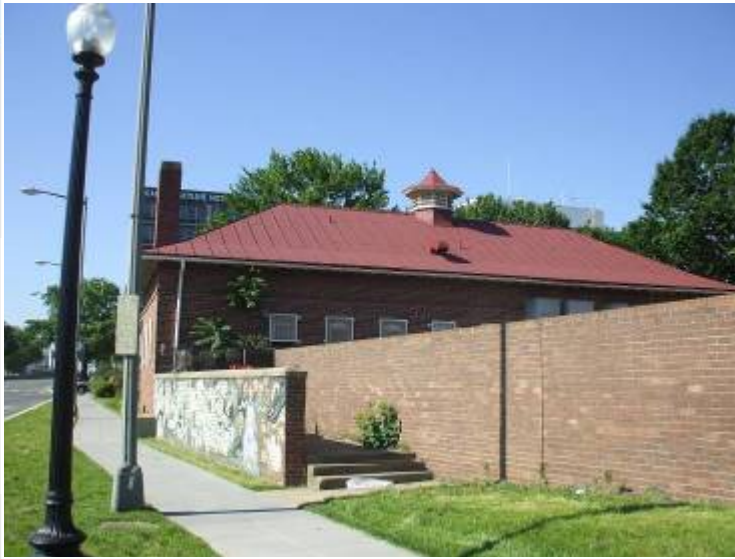
Photograph No. 7

The primary steep-slope roof is in fair to good condition with no significant defects, such as evidence of water ingress, noted during our assessment. We have recommended budgeting for the mid-term application of a protective paint to prevent ferrous metal surface corrosion and subsequent deterioration of the roof system.

Main Steep-Slope Hipped Roof

2. We recommend budgeting for cleaning and repainting the existing steep slope ferrous metal roofing system. Our opinion of the cost for this work is \$18,375 in 2012 (\$2.50 per square foot).

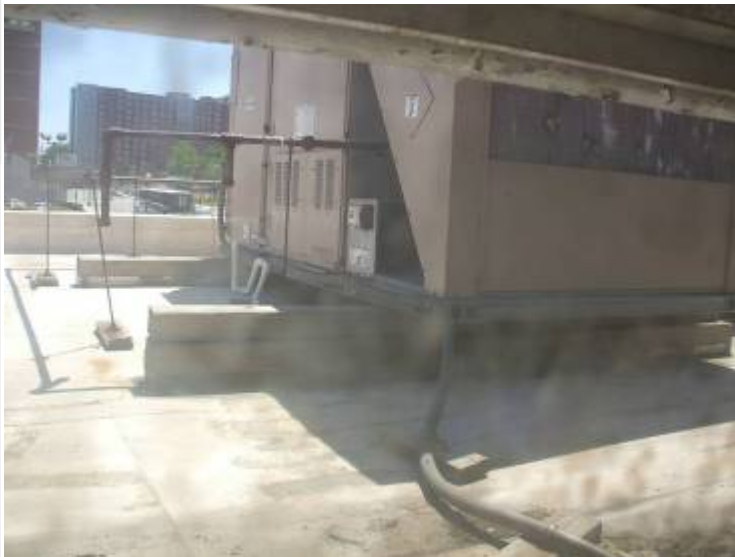
Photograph No. 8

The low-slope roof is in poor condition, with evidence of water ingress noted at the interior of the building, at the underside of the concrete floor slab. The asphalt BUR and applied coating systems appear to have reached the end of their effective useful life and we have recommended budgeting for the near-term replacement of the existing low-slope roof system.

Low-Slope Roof at Rear Elevation

1. We recommend budgeting for replacing the low-slope roof system at the South Capitol Street elevation of the main recreation building. Our opinion of the cost for this work is \$6,240 in 2010 (\$12 per square foot).

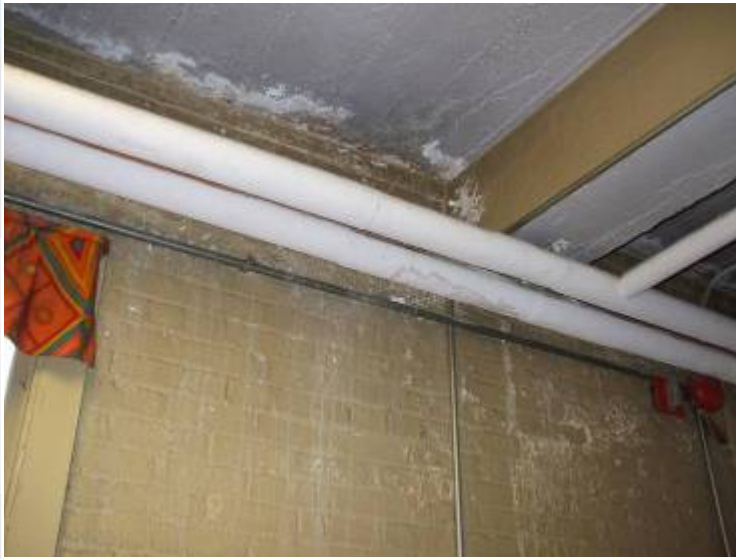
Photograph No. 13

Dampness at Interior Wall Surface

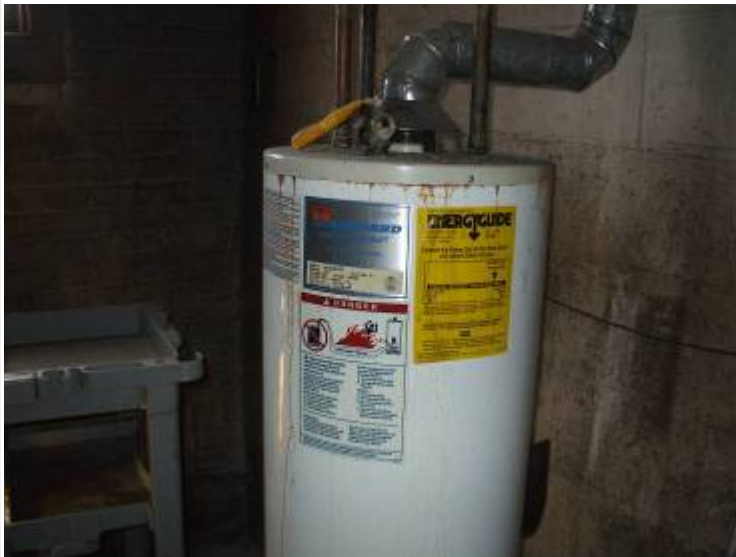
Photograph No. 14

The domestic water heater has reached the end of its effective useful life. Based upon the age of the unit, and evidence of surface corrosion, we have recommended budgeting for the near-term replacement of the water heater.

Water Heater

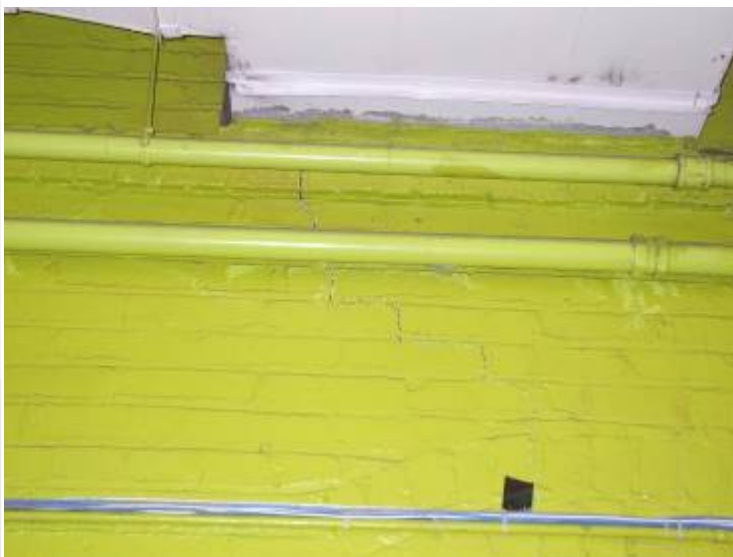
Photograph No. 18

Below an opening in the interior brick wall through which ductwork penetrates, at the north end of the building between the main hall and the lobby area, minor cracking has occurred (reference Photograph 18 in Appendix C). Based on our observations of the condition, it appears that overhead structural loading, or loading and vibration of the ductwork, has caused cracking to occur in the brick wall. Additional support may be required to reduce the loading on the brick wall, and the existing cracking should be repaired. We have recommended budgeting for the installation of additional structural support and for repairs to the damaged brick at the ductwork location.

The heating systems' package units are in good condition, having been recently installed in 2002. However, we noted a problem associated with the sheet metal ductwork. Below an opening in the interior brick wall through which the ductwork penetrates, at the north end of the building between the main hall and the lobby area, minor cracking has occurred (reference Photograph 18 in Appendix C). Based on our observations of the condition, it appears that overhead structural loading, or loading and vibration of the ductwork, has caused cracking to occur in the brick wall. Additional support may be required to reduce the loading on the brick wall, and the existing cracking should be repaired. We have recommended, within the interior construction section of this report, budgeting for the installation of additional structural support and for repairs to the damaged brick at the ductwork location.

Cracked Brickwork at Ductwork Support

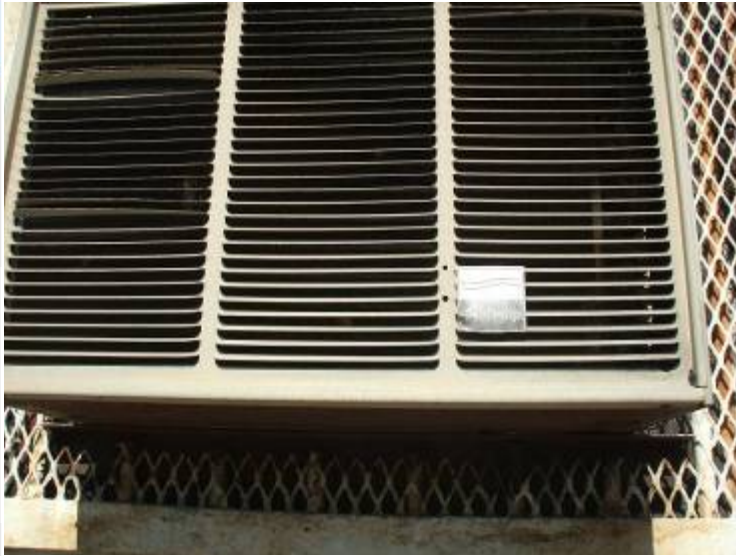
Photograph No. 19

The main cooling system used at the building is in good condition and should not require replacement within the six-year study period. However, the two window air conditioning units have almost reached the end of their effective useful life and we have therefore recommended budgeting for the near-term replacement of the two units.

Window Air Conditioning Unit

1. We recommend budgeting for replacing the two window air conditioning units. Our opinion of the cost for this work is \$1,000 in 2011 (\$500 per unit).

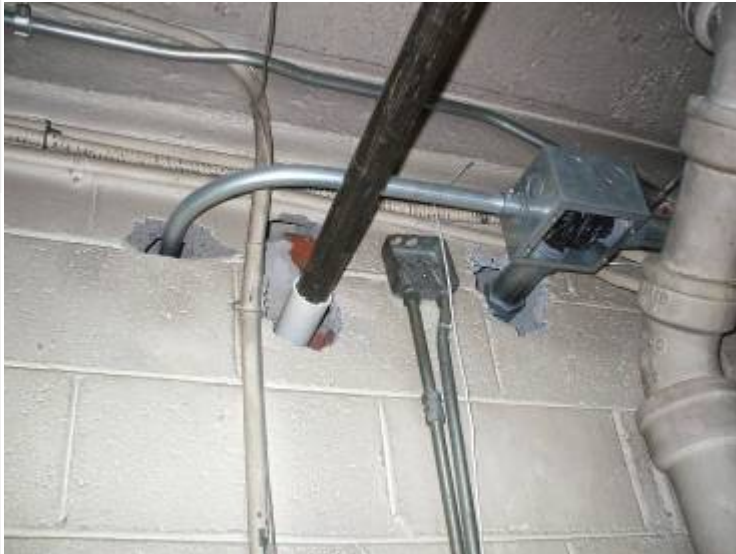
Photograph No. 20

Unsealed Penetrations at CMU Wall

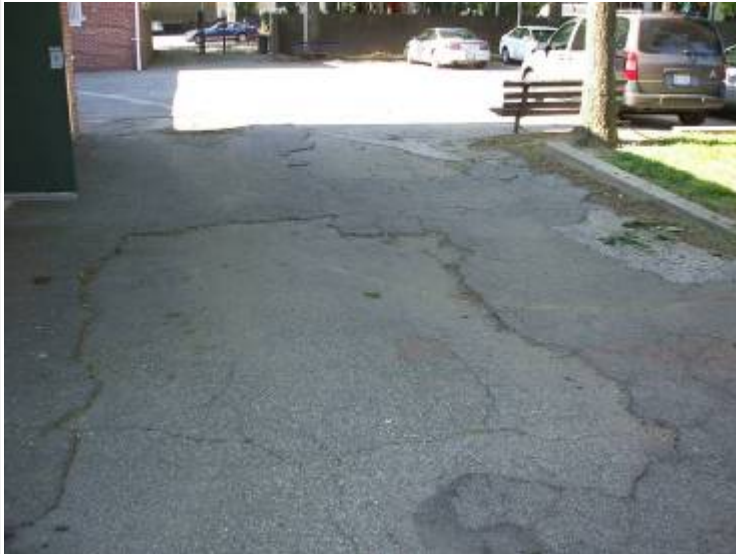
Photograph No. 26

Cracking at Asphalt-Paved Access road

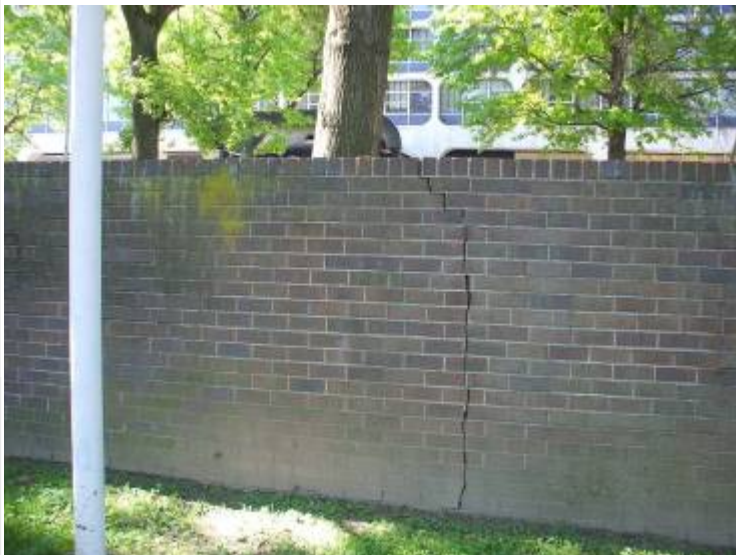
Photograph No. 27

Cracking at Clay Brick Boundary Wall

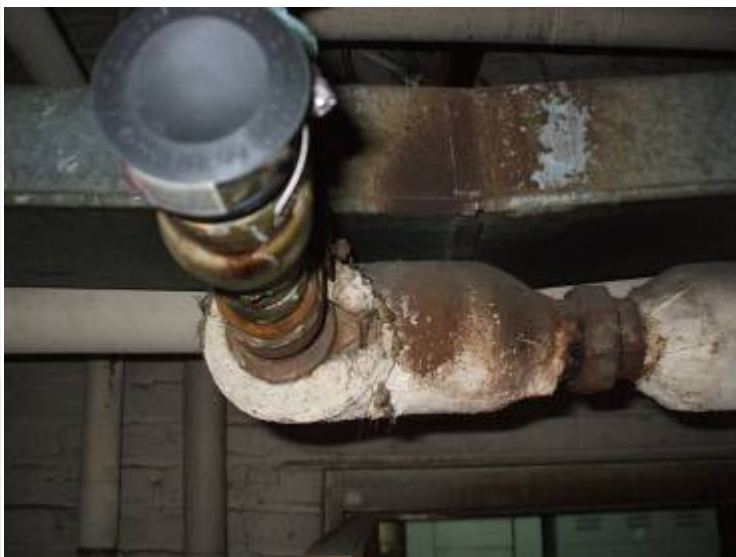
Photograph No. 30

Possible Asbestos Content at Pipe Insulation
