ADA Master Plan for the District of Columbia

September 20, 2011

Randall Park Pool

Building #51B
10 I Street, SW
Washington, DC 20024

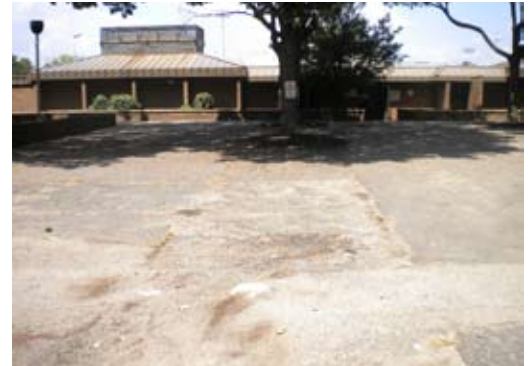
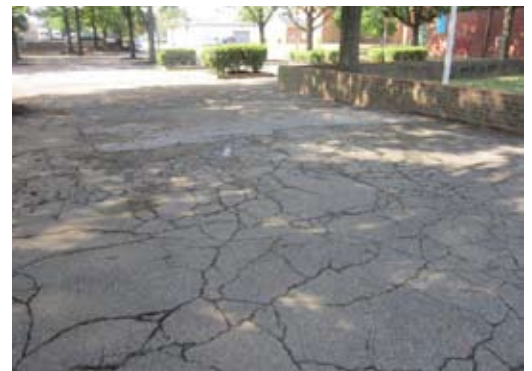
- Parking is provided in a lot in front of the bathhouse with no marked spaces or signed handicapped spaces. Generally, the asphalt surface is cracked and broken with uneven areas, which are not ADA compliant. In addition, no required van accessible space is provided (Picture 1, 2).

Action: Resurface parking area to provide level accessible surface to meet ADA requirements. Provide required amount of accessible spaces with compliant signage.

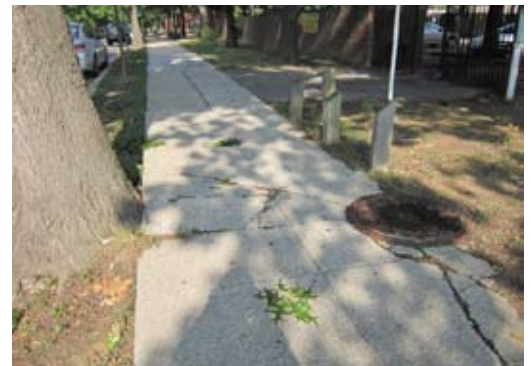
Picture 3

- Surrounding sidewalks are in fair to poor condition with uneven areas that are not ADA compliant (Picture 3).

Action: Repair concrete sidewalk surfaces to provide a level accessible walkway.

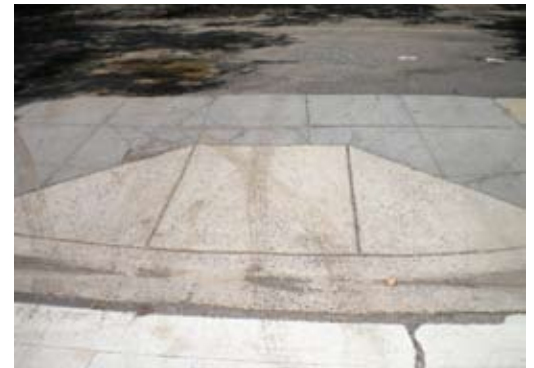
Picture 4

- Curb cuts are provided at site entrance, but no required truncated domes are included (Picture 4).

Action: Provide and install detectable warnings for ADA compliance.

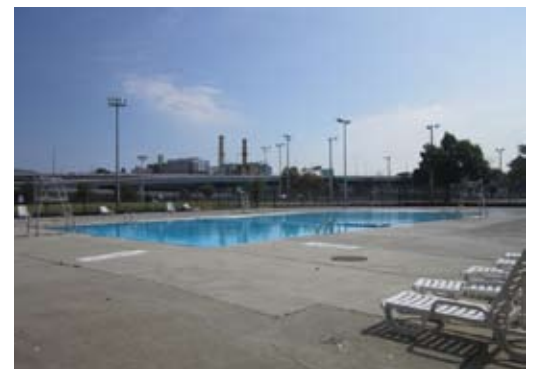
Picture 5

- The outdoor swimming pool is located within a fenced area and is accessed through the pool bathhouse building. The pool has more than 300 linear feet of water wall but does not have the required accessible means of entry (Picture 5).

Action: Provide two means of accessible entry into pool.

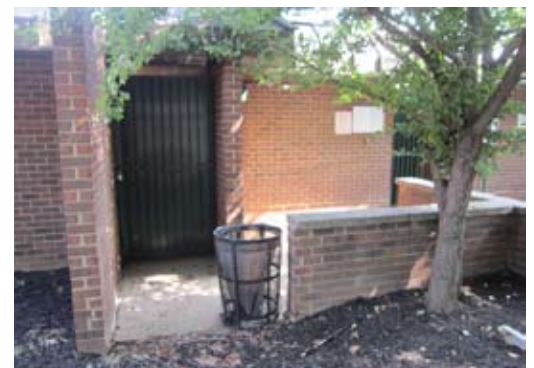
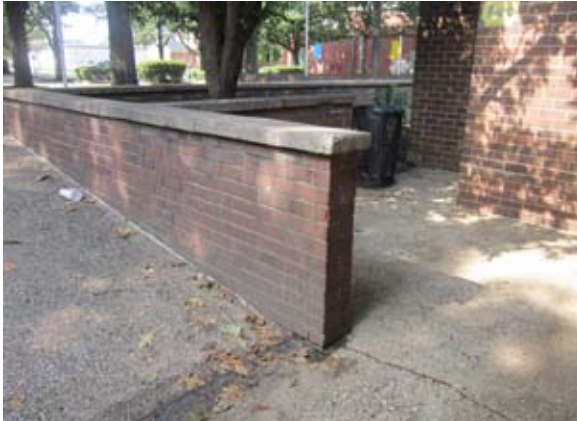
- The layout and configuration of the bathhouse entrance for both Men's and Women's changing rooms does not provide the required clearance for ADA compliance (Picture 6, 19).

Action: Significant demolition and restructuring is required to provide clearances to meet ADA requirements.

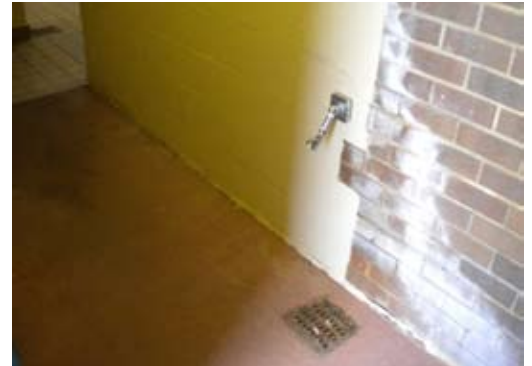
Picture 7

- Spray nozzles are provided at the vestibule entry areas leading into the pool area and they impede into the accessible route (Picture 7).
Action: Provide and install shallower spray nozzles to meet ADA requirements.

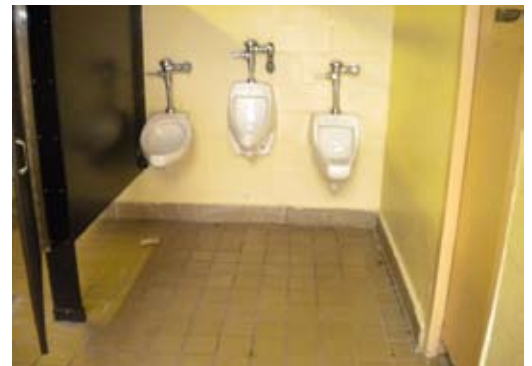
Picture 9

- Urinals in Men's Locker Room exceed the required height for compliance (Picture 9).
Action: Provide accessible urinal at corrected height.

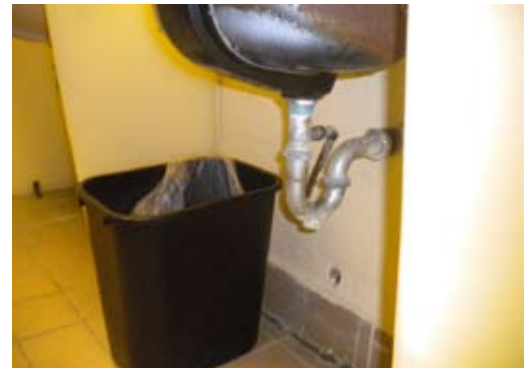
Picture 10

- The required pipe protection (insulation) under the sinks in both Locker Rooms is missing (Picture 10)
Action: Provide and install pipe padding to bring sinks into compliance.

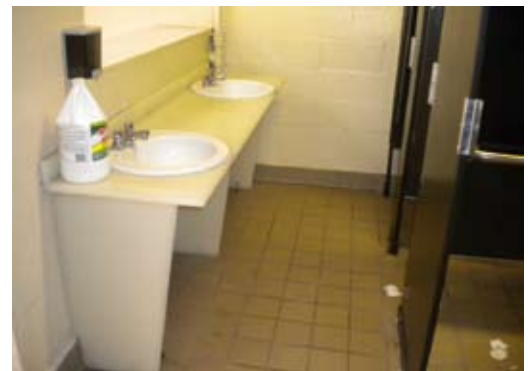
Picture 11

- Existing sinks are above allowable height for compliance (Picture 11).
Action: Remove and relocate sinks below maximum height to meet ADA requirements.

- Faucet controls in both Locker Rooms require hard grasping and turning of the wrist, which is not compliant (Picture 11).
Action: Provide ADA compliant faucet controls.

- Toilet compartment configurations at sink locations prevent the required approach dimensions for ADA compliance (Picture 11).
Action: Remove plumbing fixtures and accessories. Rebuild to provide required clearance.

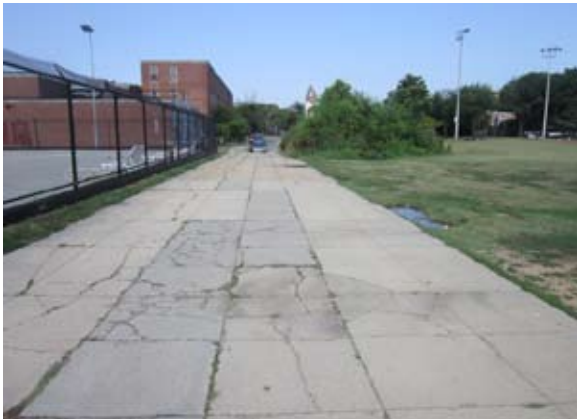
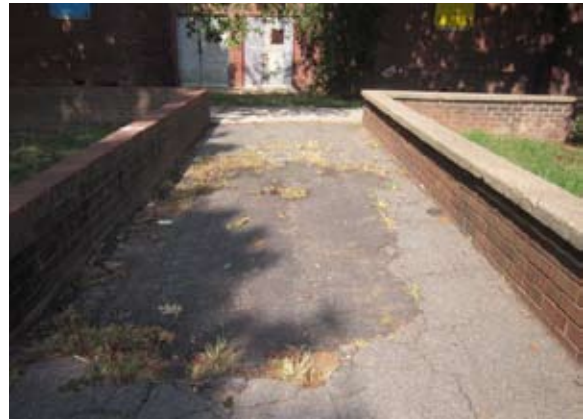
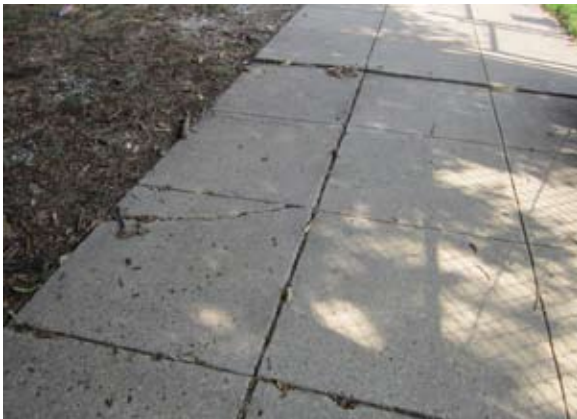
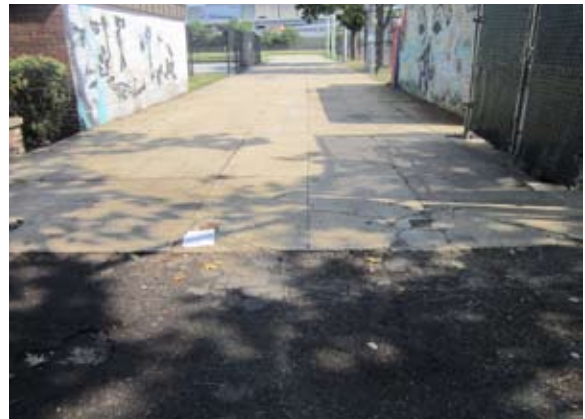
- Concrete surface walkways surrounding the bathhouse are uneven and do not provide accessible route for compliance (Picture 13, 14 15, 16).

Action: Remove concrete surfaces and provide a level accessible surface.

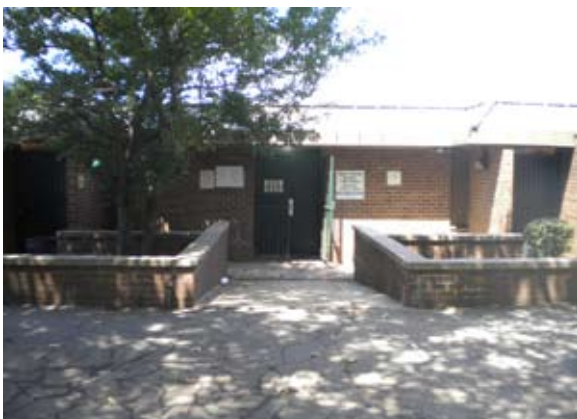
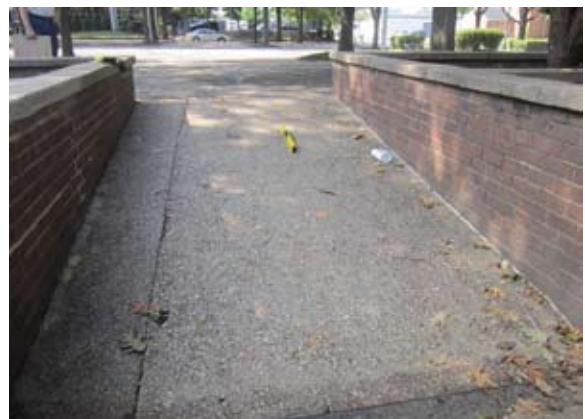
- Ramp is provided at building entrance, but the running slope is steeper than required for compliance. In addition, required handrails are not provided (Picture 17, 18).

Action: Remove concrete surface and regrade to meet ADA requirements. Resurface as required. Provide and install ADA compliant handrails with extensions.

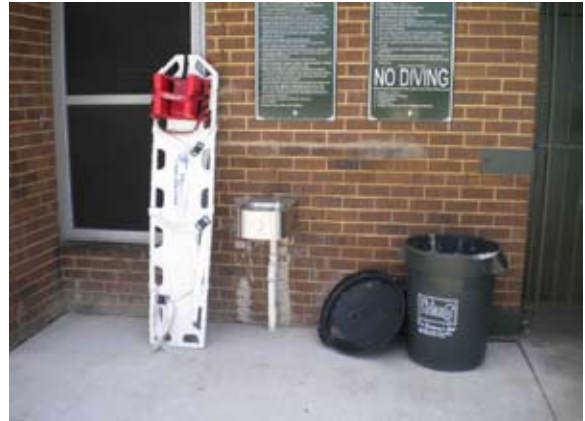
Picture 20

- Only one type of drinking fountain is provided at the Bathhouse building within the pool area, but two are required for compliance. The spout location at the drinking fountains is too shallow for compliance (Picture 20).

NOTE	ADA REF	ITEM	REQUIREMENT	COMPLIES	REPAIR	RENOVATE	STRUCTURALLY INFEASIBLE	FINDINGS AND ACTION ITEMS
BUILDING EXTERIOR: Building Façade and extending 5' from face of building								
3-536	211 / 602	Drinking Fountains						
3-537	307	Water Fountain intrusion - Protrusion Objects	4" max impingement into accessible route					
3-538	602 / 307	Accessible Fountain (adult standing)	number of fountains					Action: Provide and install drinking fountain for standing adults.
3-539	602 / 307	Accessible Fountain (adult seated)	number of fountains					
3-540	602.2 / 305.5	Forward approach only for Adults, clear floor space	forward approach clear space 48" deep x 30" wide, centered on unit; Children side ap. permitted					
3-541	602.5	Spout location	Spout 15" min. from wall or vertical support					Spout location provided is too shallow for compliance (Picture 20). Action: Provide drinking fountain with required spout location.

Action: Provide and install accessible drinking fountains for both standing and seated adults with required clearance to meet ADA requirements.

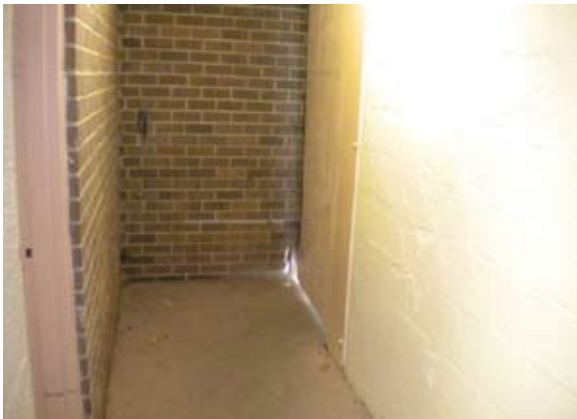
Picture 21

- The vestibule size and configuration at both changing room entries does not provide the required clearance for ADA compliance (Picture 21).
Action: Remove walls and doorways. Rebuild vestibule to provide required clearance.

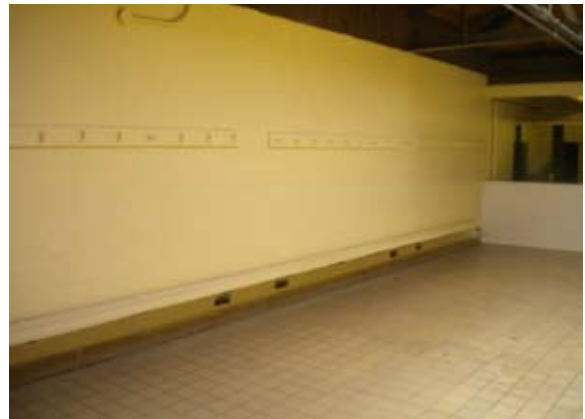
Picture 22

- Hooks are provided in the Men's Changing Area, but they are not located within the accessible range for ADA compliance (Picture 22).
Action: Remove / relocate hooks to be within allowable reach range.

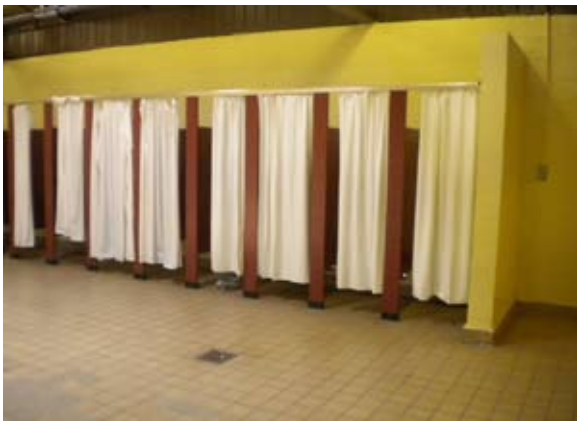
Picture 23

- Changing stalls are provided in Women's Changing Area, but no accessible stall is included (Picture 23).
Action: Provide accessible changing stall for ADA compliance.
