Introduction

This report is to fulfill the request from the DGS RFP to perform a “preliminary...structural conditions assessment report of the existing facility” and “report on the structural integrity of the building.”

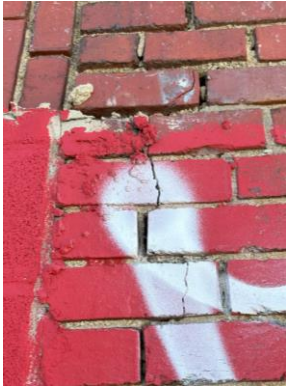
The exterior multi-wythe brick bearing wall will need to be repaired to address structural concerns. Examples of the items observed are as follows: cracked brick (Figure 1), mortar loss (Figure 2), organic growth (Figure 3 and 5), lintels covered in rust (Figure 3), and temporary repair/infills (Figure 4).

Figure 1: Exterior Wall - Cracked brick

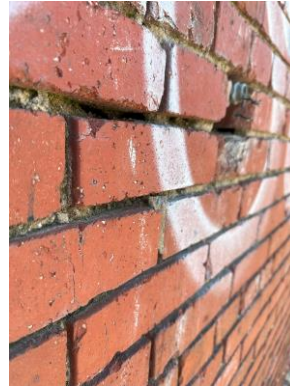
Figure 2: Exterior Wall – Mortar loss

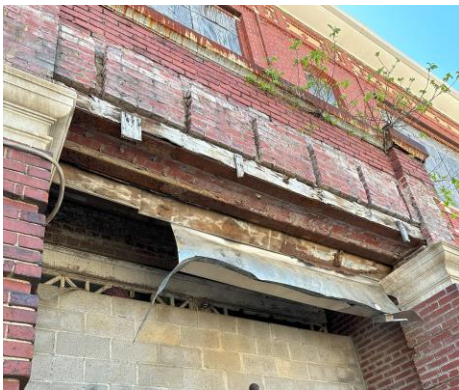
Figure 3: Lintels supporting brick over northern entrance

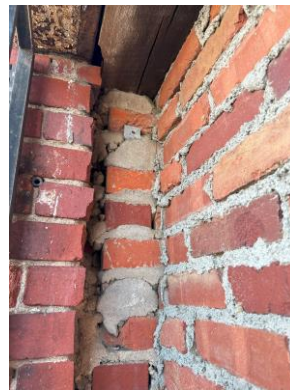
Figure 4: Temporary repair/infills

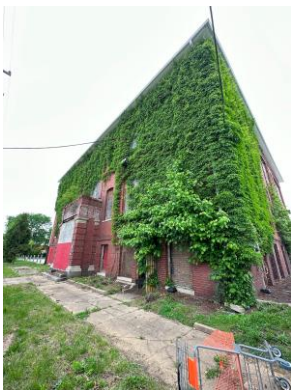
This building has one below-grade and two-above grade levels (Figure 5). Additional investigation will be required to confirm the condition of structural steel and concrete encased steel beams.

Figure 5: View of building from SE

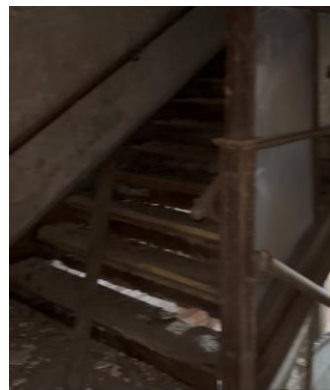
Steel pan and stringer are typical for the stairs. In some locations, there is significant material loss of the pan due to corrosion (Figure 6). The stairs and rails will need to be replaced.

Figure 6: Corroded stair pans

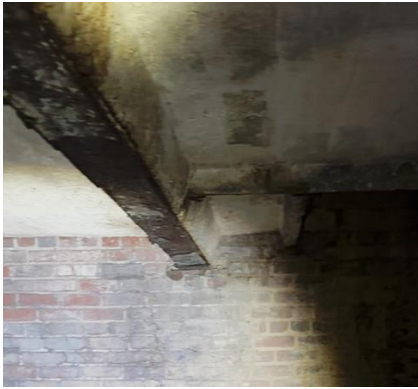
The roof of the existing coal vault is composed of concrete slabs spanning to concrete encased steel beams. In most cases, the concrete encasement has detached from the beam soffit due to corrosion of the previously encased steel beam flange (Figure 7).

Figure 7: Coal vault roof with exposed steel beam flange

The extent of corrosion is such that both encased and exposed structural steel will need to be investigated and assessed. Encased structural steel will need to be sounded to identify potential for delamination of the concrete encasement. Corroded steel will need to be cleaned, replaced where section loss is significant, and concrete encasement replaced.

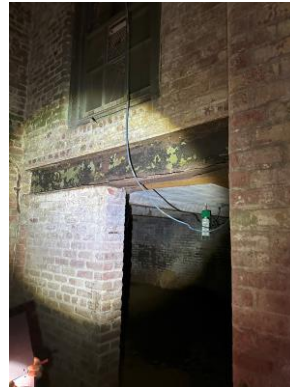
Most exposed steel, including interior lintels (Figure 8 and 9), beams, and columns (Figure 10), have rusted surfaces.

Figure 8: Rusted lintel at entry to Coal Vault

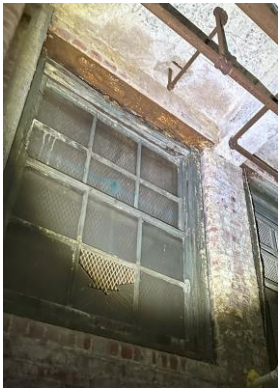
Figure 9: Interview view of lintel over window

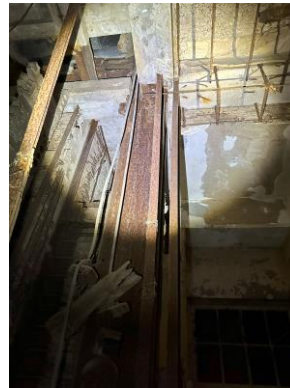
Figure 10: Interior steel column with rust

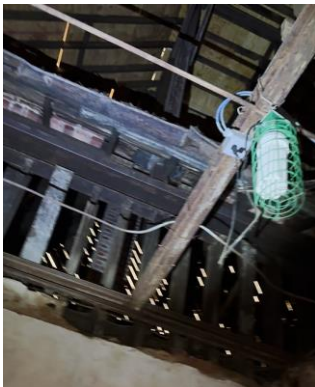
A portion of the original, from prior to the 1932 addition, north exterior wall and gutter are observable (Figure 11). The visible roof structure is composed of wood framing spanning to steel posts/beams/girders. Visual assessment of the original roof/ceiling framing was not possible because the ceiling is still intact under that area of the building.

Figure 11: Roof structure
