Facility Condition Assessment

**Anacostia High School
1601 16th Street SE
Washington, DC
20020**

Date of Report: August 31, 2018

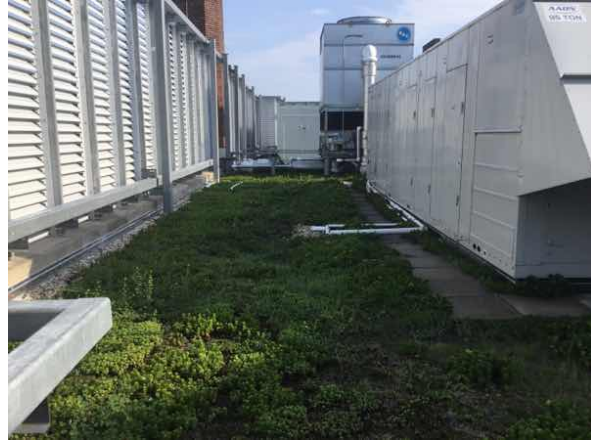
There are leakage from the Roof and need maintenance.

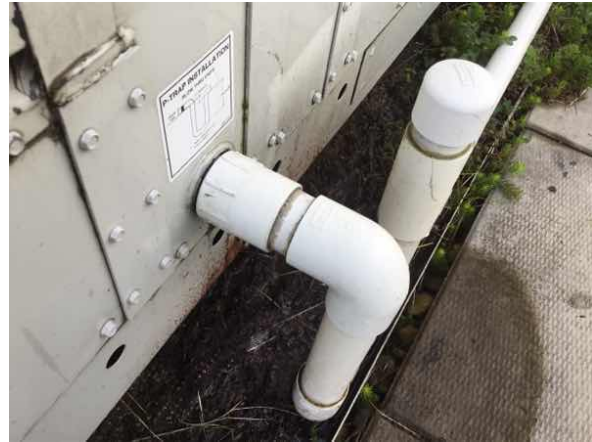
Condensate piping leaking

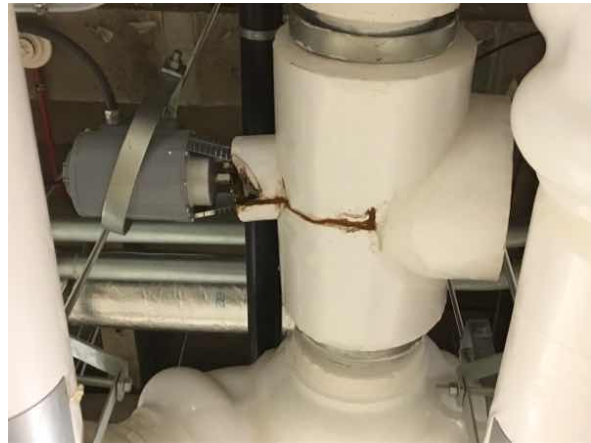
Cracked Chilled Water Piping at a Valve Controller- Leaking

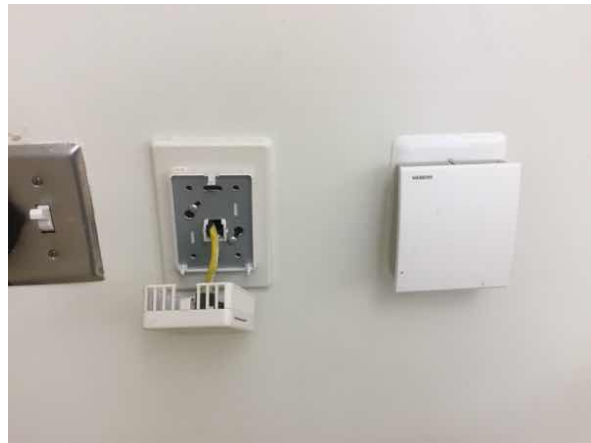
Detached Thermostat in Room 321

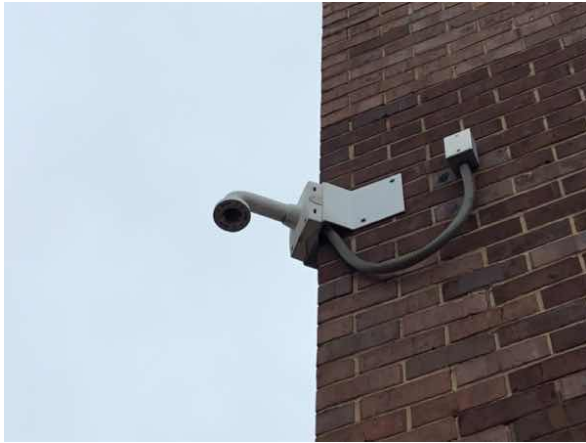
Damaged Surveillance Camera

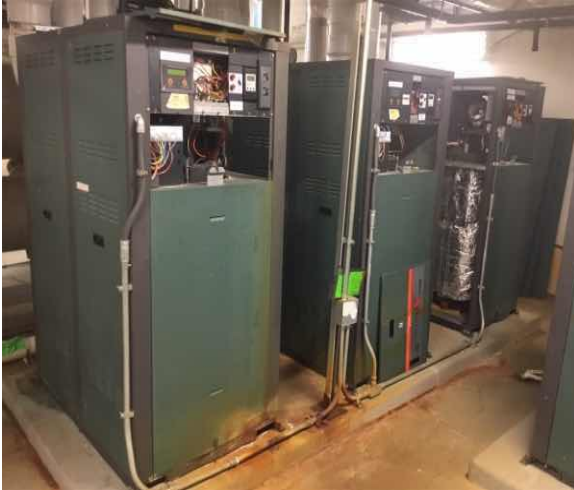
D3021 Boilers:- Flue Piping Leaking...Boiler 1

D30	HVAC																			
D3021	Repair the leak of flue piping for Boiler 1.	0	0	1	EA	\$2,000.00	Routine Maint Minor Repairs		\$2,000	\$0	\$0	\$0	\$0	\$0	\$0	\$0	\$0	\$0	\$0	\$2,000
	Replace Boiler 3, Gas-fired, 1500 Mbh (x1)	25	0	1	EA	\$55,545.00	Capital Replacement		\$55,545	\$0	\$0	\$0	\$0	\$0	\$0	\$0	\$0	\$0	\$0	\$55,545
	Replace Boiler 3, which is down.	0	0	1	EA	\$55,545.00	Capital Replacement		\$55,545	\$0	\$0	\$0	\$0	\$0	\$0	\$0	\$0	\$0	\$0	\$55,545
D3021	Repair the leak of flue piping for Boiler 1.	0	0	1	EA	\$2,000.00	Routine Maint Minor Repairs		\$2,000	\$0	\$0	\$0	\$0	\$0	\$0	\$0	\$0	\$0	\$0	\$2,000
	Replace Boiler 3, which is down.	0	0	1	EA	\$55,545.00	Routine Maint Minor Repairs		\$55,545	\$0	\$0	\$0	\$0	\$0	\$0	\$0	\$0	\$0	\$0	\$55,545
D3031	Replace Cooling Tower, 250 Ton (x2)	15	9	2	EA	\$39,762.16	Capital Replacement		\$0	\$0	\$0	\$0	\$0	\$0	\$0	\$0	\$0	\$0	\$79,524	\$79,524
D3032	Replace Condensing Unit, -5 HP	15	9	1	EA	\$5,967.18	Capital Replacement		\$0	\$0	\$0	\$0	\$0	\$0	\$0	\$0	\$0	\$0	\$5,967	\$5,967

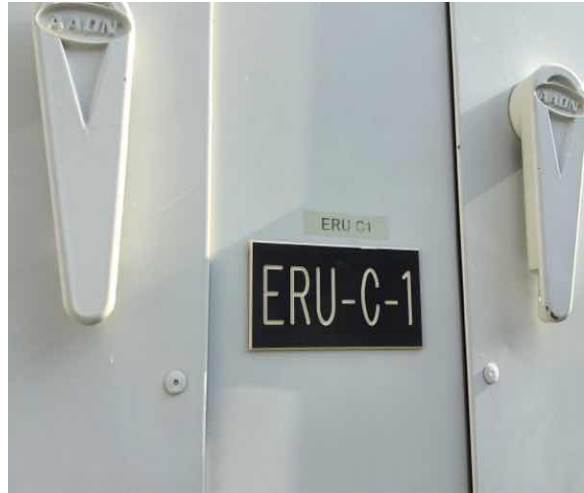
D3041 Air Distribution Systems:- Condensate piping leaking

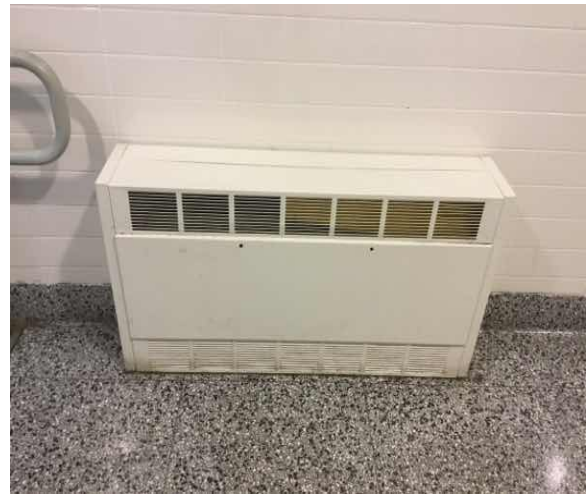
D3045 Chilled Water Distribution:- Cracked Chilled Water Piping at a Valve Controller- Leakng

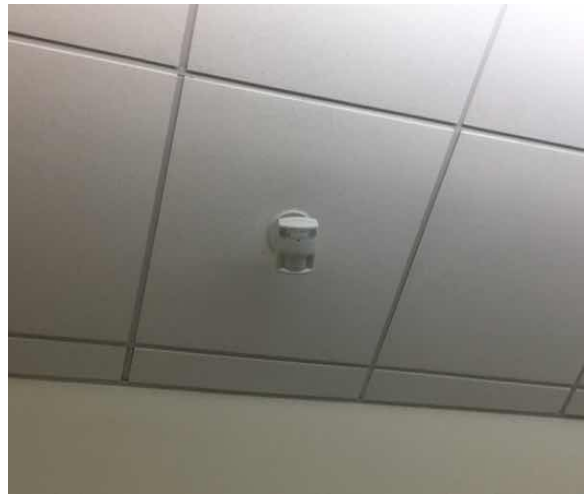
D5038 Security and Detection Systems:- Damaged Surveillance Camera
