## ***Condition Assessment Report***

CDF Master 2015  
1901 S Street SE  
Washington, DC 20003

***Inspection Date:*** Tuesday, March 17, 2015

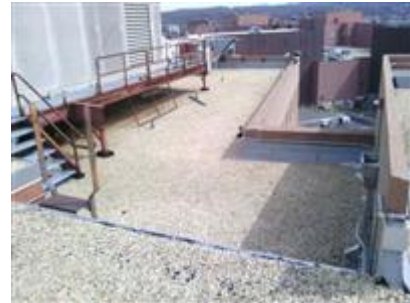
**Section ID:** A - A

**Roof Condition Score:** 48 (Unsatisfactory)

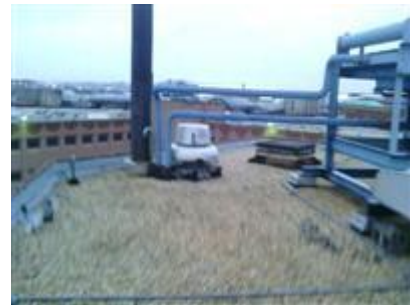
**Section ID:** CC - CC

**Roof Condition Score:** 71 (Degraded)

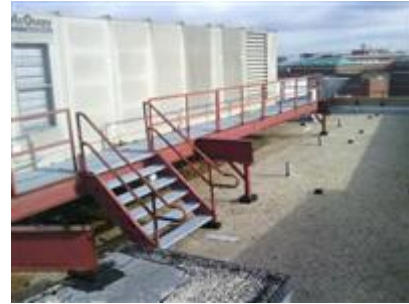
**Section ID: D - D****Area:** 3,594 SF**Roof Type:** Built-up membrane**Layers:**

**Roof Condition Score:** 66 (Degraded)**Section ID: D - D (Photo #4)****Area:** 3,594 SF**Roof Condition Score:** 66 (Degraded)

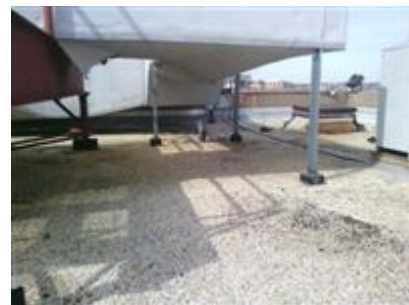
**Section ID: D - D (Photo #5)****Area:** 3,594 SF**Roof Condition Score:** 66 (Degraded)

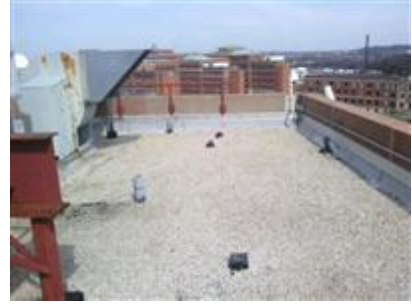
**Section ID:** D - D (Photo #6)

**Roof Condition Score:** 66 (Degraded)

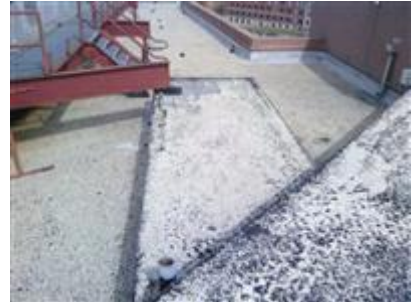
**Section ID:** DD - DD

**Roof Condition Score:** 70 (Degraded)

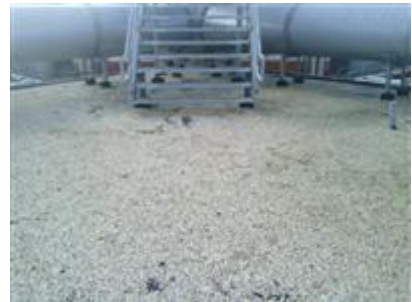
**Section ID:** E - E

**Roof Condition Score:** 66 (Degraded)

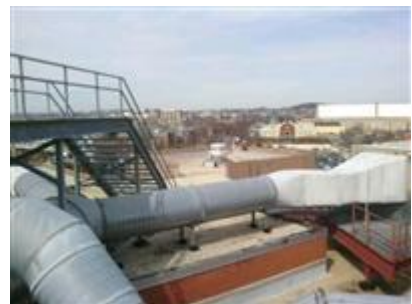
**Section ID:** E - E (Photo #2)

**Roof Condition Score:** 66 (Degraded)

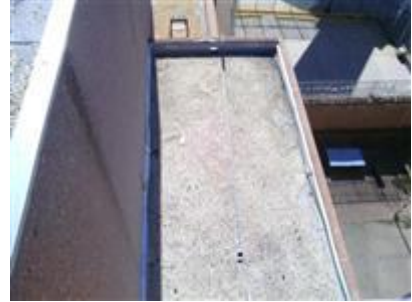
**Section ID:** EE - EE

**Roof Condition Score:** 61 (Degraded)

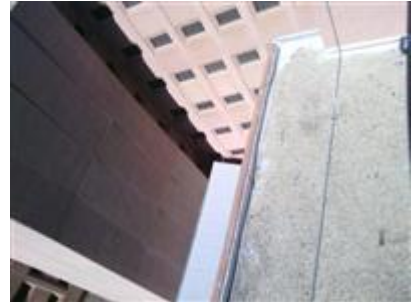
**Section ID:** EE - EE (Photo #2)

**Roof Condition Score:** 61 (Degraded)

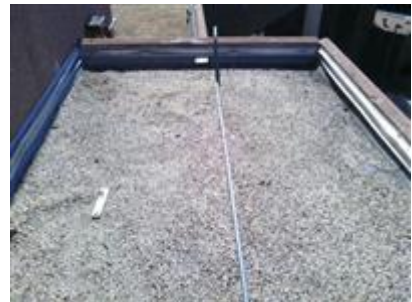
**Section ID:** EE - EE (Photo #3)

**Roof Condition Score:** 61 (Degraded)

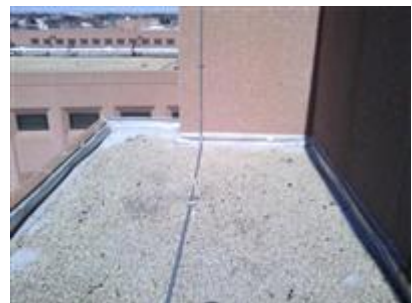
**Section ID:** EE - EE (Photo #4)

**Roof Condition Score:** 61 (Degraded)

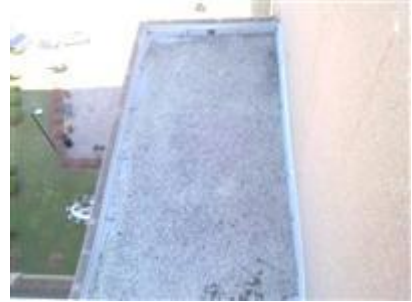
**Section ID:** FF - FF (Photo #2)

**Roof Condition Score:** 61 (Degraded)

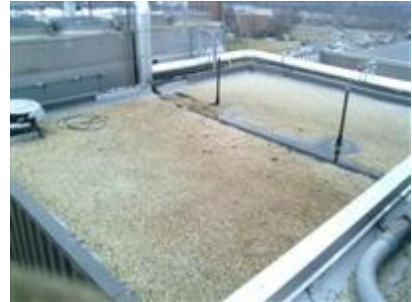
**Section ID:** G - G

**Roof Condition Score:** 60 (Unsatisfactory)

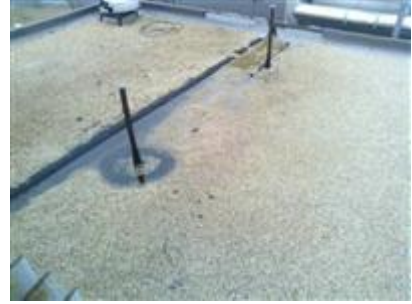
**Section ID:** G - G (Photo #2)

**Roof Condition Score:** 60 (Unsatisfactory)

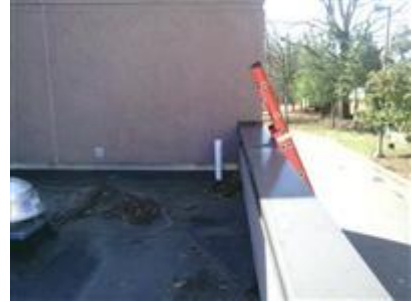
**Section ID:** GG - GG

**Roof Condition Score:** 58 (Unsatisfactory)

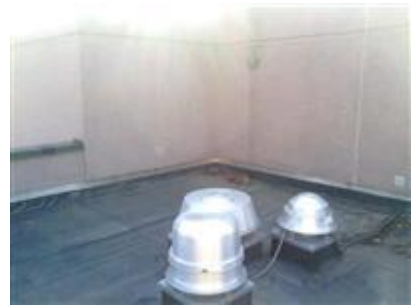
**Section ID:** GG - GG (Photo #2)

**Roof Condition Score:** 58 (Unsatisfactory)

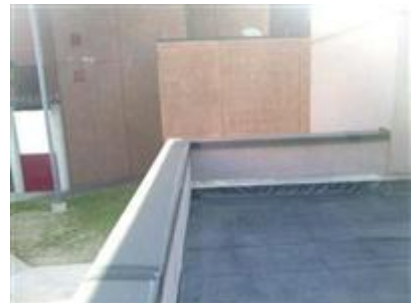
**Section ID:** GG - GG (Photo #3)

**Roof Condition Score:** 58 (Unsatisfactory)

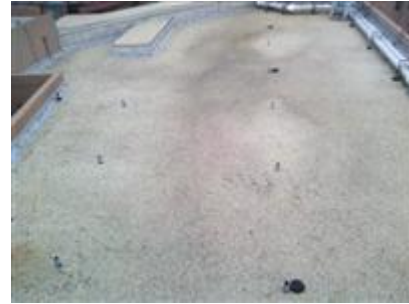
**Roof Condition Score: 34 (Unsatisfactory)****Section ID: O - O (Photo #2)****Area:** 9,506 SF**Roof Condition Score: 34 (Unsatisfactory)**

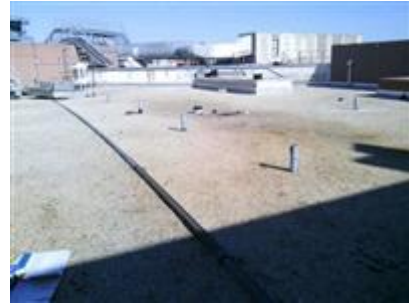
**Section ID:** O - O (Photo #3)

**Roof Condition Score:** 34 (Unsatisfactory)
