COMPREHENSIVE FACILITIES CONDITION ASSESSMENT & SPACE UTILIZATION SURVEY

DISTRICT OF COLUMBIA DEPARTMENT OF PARKS AND RECREATION
WILLIAM H. RUMSEY, SR. AQUATIC CENTER
635 NORTH CAROLINA AVENUE, SE
WASHINGTON, DC 20003

Reference: Report of Comprehensive Facilities Condition Assessment & Space Utilization Survey
William H. Rumsey, Sr. Aquatic Center
635 North Carolina Avenue, SE
Washington, DC 20003
Faithful+Gould Project No. 55561-10
District of Columbia Contract No. POAM-2004-C-0044-14-CA

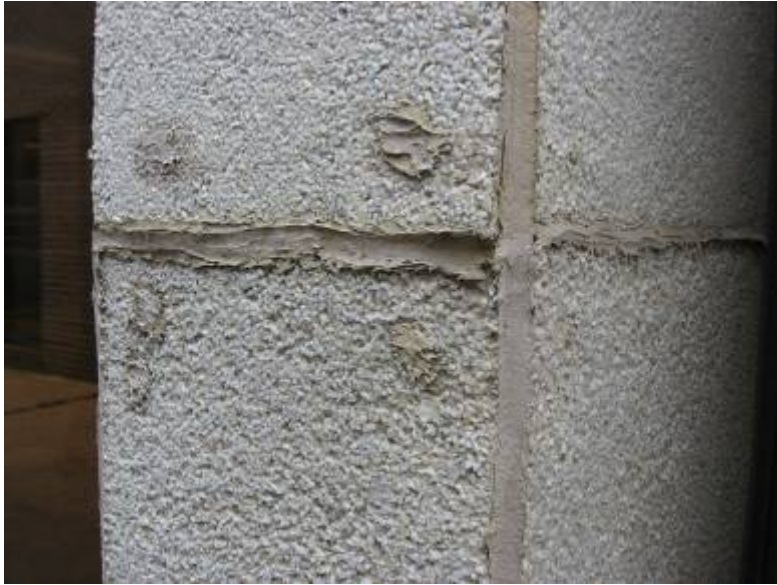
Photograph Number 7

The exterior wall systems appeared to be in good condition with no evidence of significant damage or failure noted. However, it appears that several of the aggregate panels had cracked in the past and had been repaired with an elastomeric sealant (reference Photograph 7 in Appendix C). The sealant appeared to be in generally good condition and should remain serviceable throughout the study period. We do not anticipate a requirement to complete significant repair to the exterior wall system during the study period.

Aggregate panels with elastomeric sealant

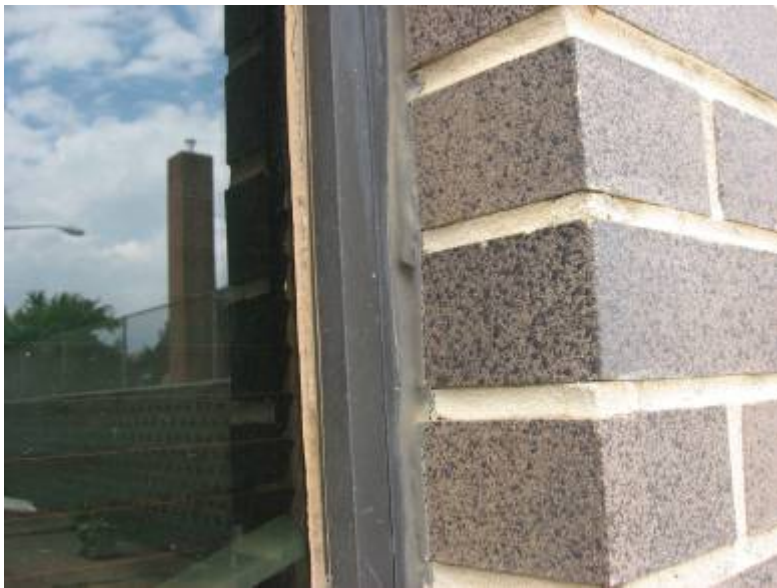
Photograph Number 8

Window systems appeared to be in generally fair condition having been installed in circa 1960. The perimeter sealants are in good overall condition (reference Photograph 8 in Appendix C). We do not anticipate a requirement to complete the replacement of the perimeter window or door sealants during the study period.

Sealant at window-to-brick joint in good condition

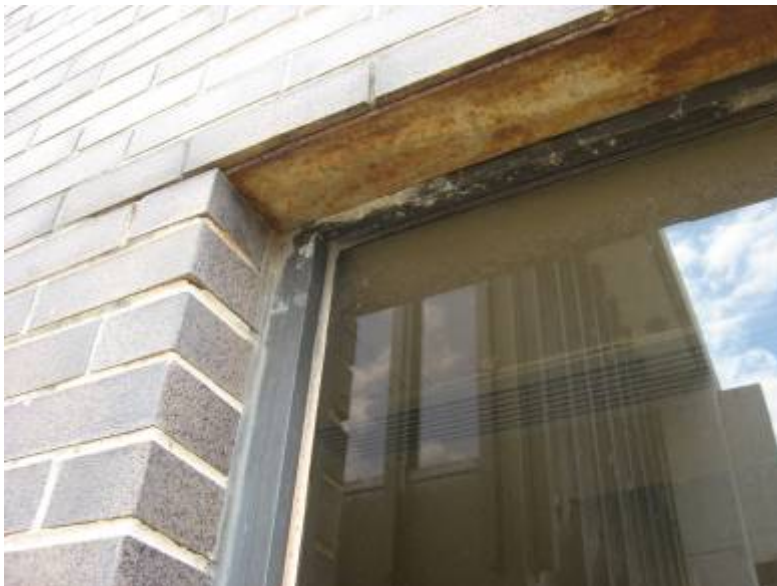
Photograph Number 9

Doors appeared to be in generally good condition with only localized instances of surface damage and corrosion noted on the steel lintels (reference Photograph 9 in Appendix C). Assuming as-needed painting and repairs, we do not anticipate a requirement to replace the doors within the six-year study period.

Rusted steel lintel in need of repainting

We have recommended budgeting for a yearly "Door and Window Life Extension Maintenance" throughout the six-year study period.

1. We recommend budgeting a maintenance allowance of \$2,500 per year for as-needed repair and life-extension maintenance of the door and window systems. Per cycle, this cost assumes the retention of two technicians for an eight hour period at a per hour / per operative rate of \$100 (\$1,600 per day) and a combined material, contingency and disposal cost of \$900.

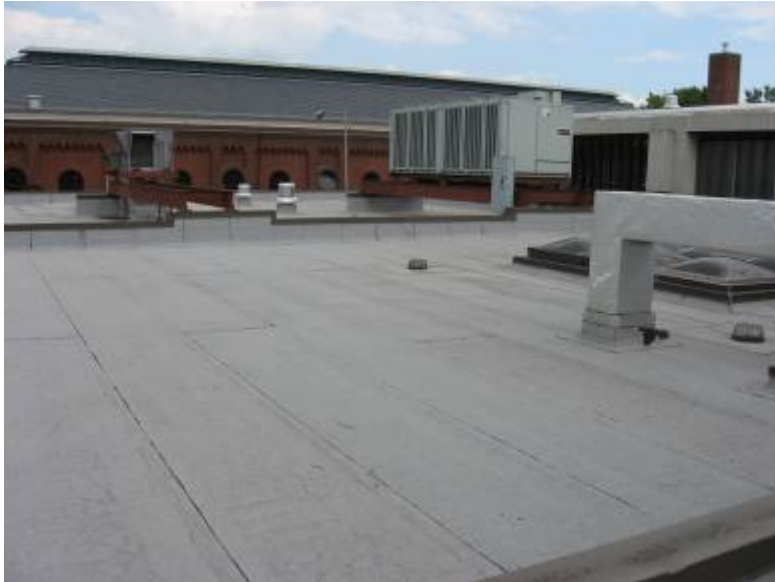
Photograph Number 10

The low-slope roof system at the lower roof area appeared to be in good condition. The modified bitumen system appeared to have been installed as a recovery system. Assuming the completion of on-going maintenance and as-needed repair, we do not anticipate a requirement to replace the lower roof system within the six-year study period.

Lower roof consisting of a three-ply asphaltic-based built-up roofing system with a hot-mopped granular-surface styrene-butadiene-styrene (SBS) modified bitumen cap sheet

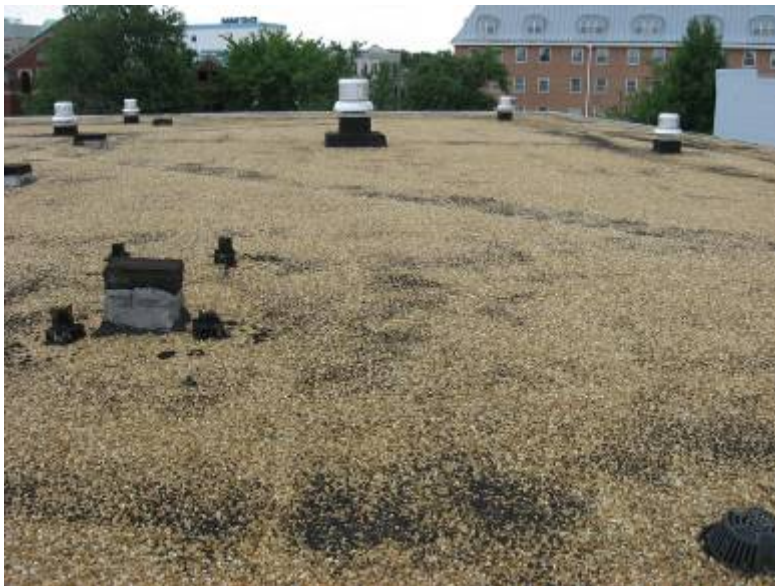
Photograph Number 11

The coal tar built up roofing system was likely original construction, and appeared to be in generally good condition with no reports or evidence of active roof leaks. However, at 49 years of age, we recommend budgeting for replacement of the coal tar roofing system on the upper roof within the six-year study period.

Upper roof over natatorium comprised of a coal tar built-up roofing system with a pea gravel surface

1. We recommend replacing the coal tar roofing system over the natatorium. Our opinion of cost for this work is \$192,000 (\$15.00 per square foot) in 2012.
2. We recommend budgeting an allowance of \$2,500 per year for as-needed repair and life-extension maintenance of the sloped and low-slope roof systems. Per cycle, this cost assumes the retention of one roof operatives for an eight hour period at a per hour / per operative rate of \$100 (\$1,600 per day) and a combined material, contingency and disposal cost of \$900.

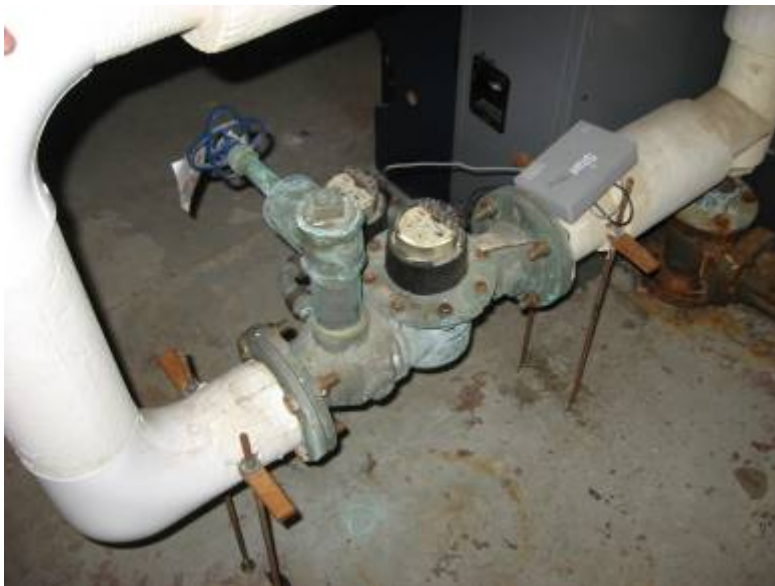
Photograph Number 17

Domestic cold water enters the building at main boiler room on the west side of the building and is fitted with a 3-inch water meter (reference Photograph 17 in Appendix C). The piping observed within the building is copper. Supply pressure is supplied from the cold water intake pressure. Domestic cold water is routed to all the plumbing fittings within the building.

3" domestic water meter

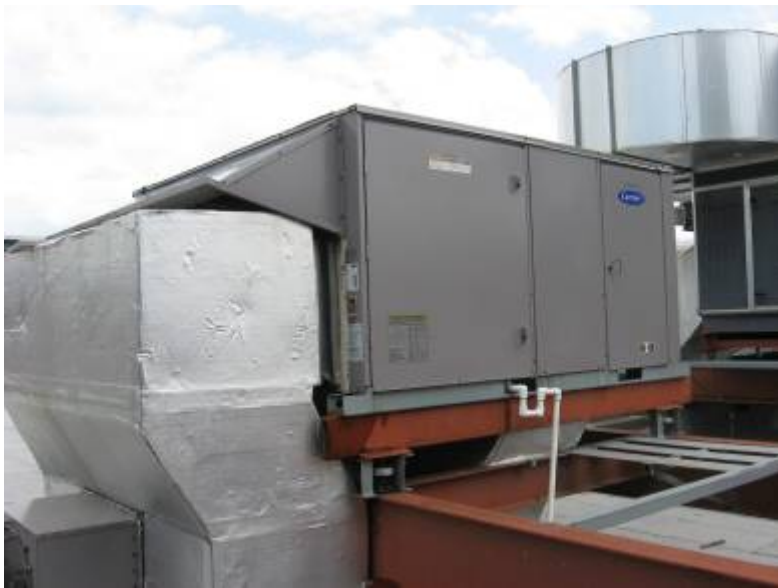
Photograph Number 20

The north wing of the building is heated and cooled by four rooftop units with electric auxiliary heating coils or natural gas furnaces (reference Photograph 20 in Appendix C). The natatorium is equipped with an air to air energy recovery dehumidification system (reference Photograph 21 in Appendix C).

Rooftop HVAC unit serving north wing of building

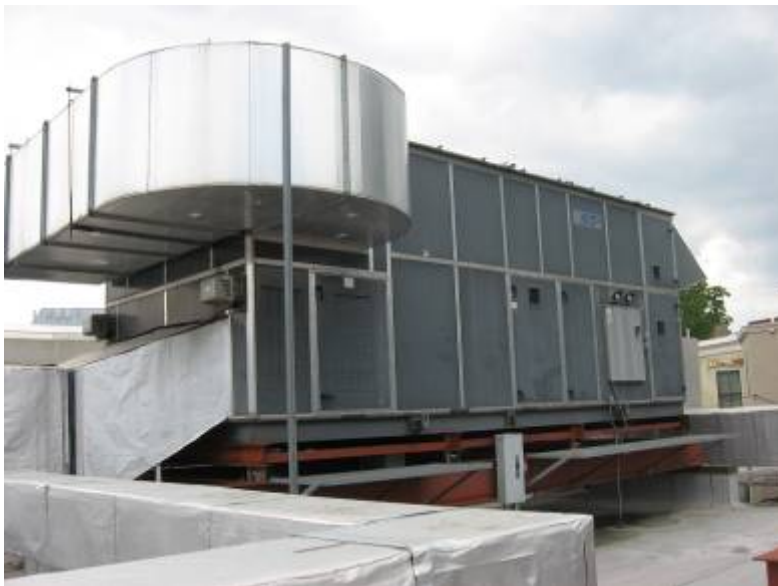
Photograph Number 21

Dehumidification system serving the natatorium
