Attachment M
Condition Assessment

**BUILDING 90: W.W. ELDRIDGE BUILDING
CONDITION ASSESSMENT**

2700 Martin Luther King Jr. Ave SE
Washington, DC 20032

Report Date	February 20, 2015
WPM Project No.	D01.14013.00

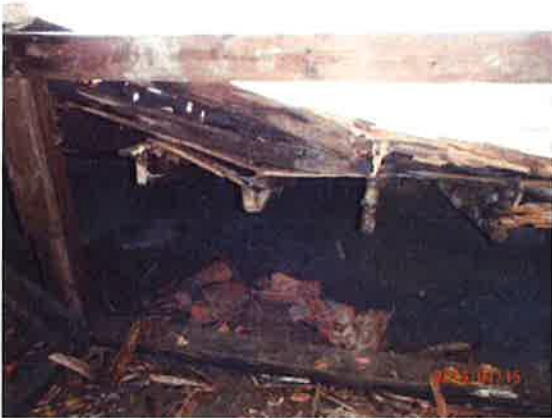
AREA 1	PHOTO #
• Failure of the wood framing has created an opening which allows water to enter	1
• Interior wood structural support frame has failed	1, 2
• Rafters have displaced downward at their upper bearing point	1
• Wood frame and rafters are severely deteriorated at the area of the opening	1, 2
• Wood decking is deteriorated and has failed in a number of areas adjoining the opening.	2
AREA 2	PHOTO #
• Failure of wood framing and decking has created a large opening	5, 6
• Failed area has allowed ponding which is further overloading the deteriorated framing	4
• Copper roofing at the flat roof has been removed allowing water to enter	4, 5
• Flat framed wood rafters and ceiling supports are deteriorated and failed	6
• Metal ceiling support frame is deteriorated, and plaster has fallen in many areas	6

Photo 1. Area 1: Failure of wood frame

At Area 1, the structural repairs will be somewhat localized, and can be performed largely from the interior. Because the failure is due to the displaced rafters, repair work can be limited to temporary shoring and framing reinforcement to allow the rafters to be repositioned, and the roof opening closed and weatherproofed. The design for the new rafter support should take into account the capacity of the supporting concrete slab and joist framing.

- Lift and temporarily support structural rafters in the original position
- Rebuild support for rafters, either to match existing wood frame, or with a temporary knee-wall
- Reinforce deteriorated rafters with local reinforcing and full length “sister” reinforcing
- Replace deteriorated wood deck
- Repair flashing and roofing membrane (described in more detail by others)

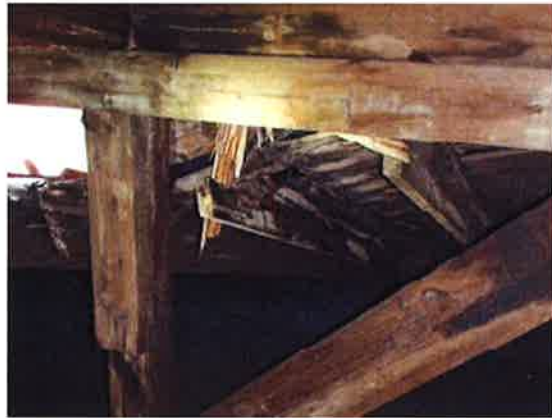
Photo 2. Area 1: Deterioration of rafters and decking

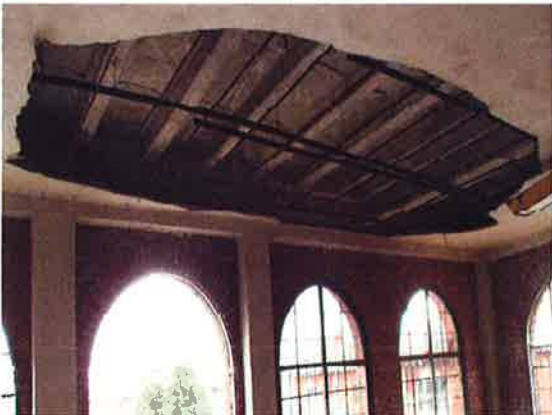
Existing structural system: This five story hospital building is built with masonry walls, concrete floor slabs (see Photo 3), and wood roof and ceiling framing. It is possible that concrete frames are concealed in the masonry walls. Interior is finished with plaster walls and ceiling. Exterior cladding is brick masonry with limestone details. Roofing is both flat and pitched, the pitched portions roofed with clay tiles. We observed flat areas to be roofed with copper.

Photo 3. Underside of Area 1 showing concrete joists

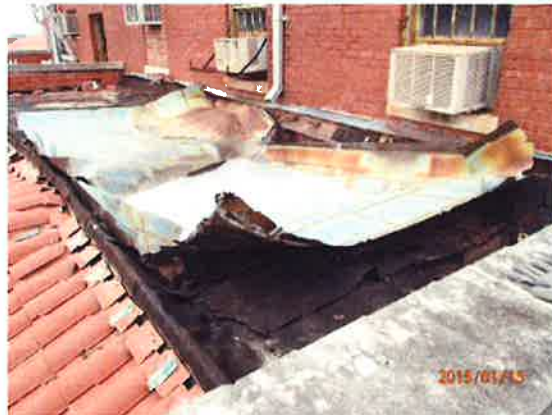
Photo 4. Area 2: Loss of roofing and waterproofing membrane

In Area 2, the significant loss of roofing has exposed numerous roof and ceiling framing members to the elements, resulting in deterioration to many of these framing members. This framing appears to span to the exterior wall, therefore supporting not only the flat roof where failure is most evident, but also the pitched (clay tile) portion of the roof. Due to the extent of deterioration, the repair work should not proceed until the area has been made safe by temporary shoring, after which the scope of repair and replacement can be better defined with a more in-depth assessment.

- Temporarily shore framing to allow work to be performed safely
- Remove remaining ceiling plaster, roofing to allow assessment of wood framing
- Reinforcing and replacement of deteriorated wood framing may include both flat and pitched roof
- Replace deck on new/reinforced rafters
- Replace waterproofing membrane and roofing

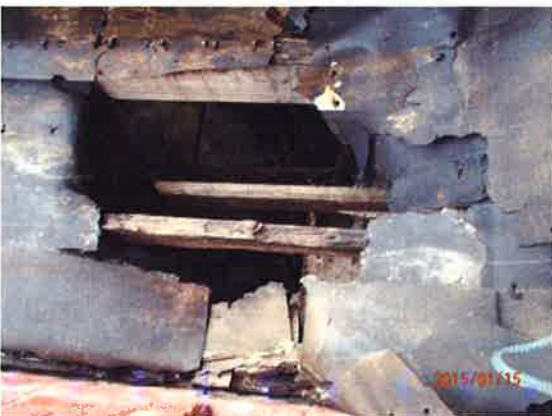
Photo 5. Area 2: Opening in the roofing to exposing rafters

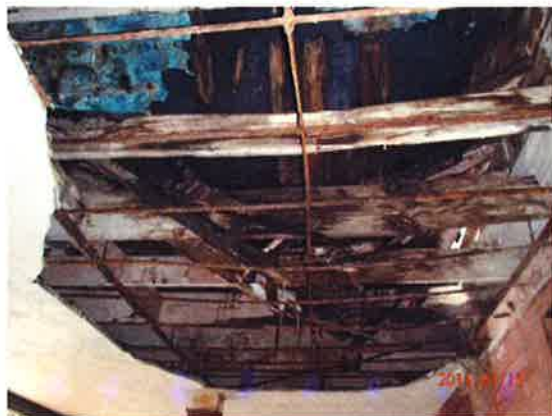
Photo 6. Area 2: Deterioration and failure of rafters
