Property Conditions Report

**MPD Youth Division
1700 Rhode Island Ave
Washington, DC**

**Comprehensive Facility Condition Assessment
And Space Utilization Study
DCAM-13-NC-0162**

October 15, 2014

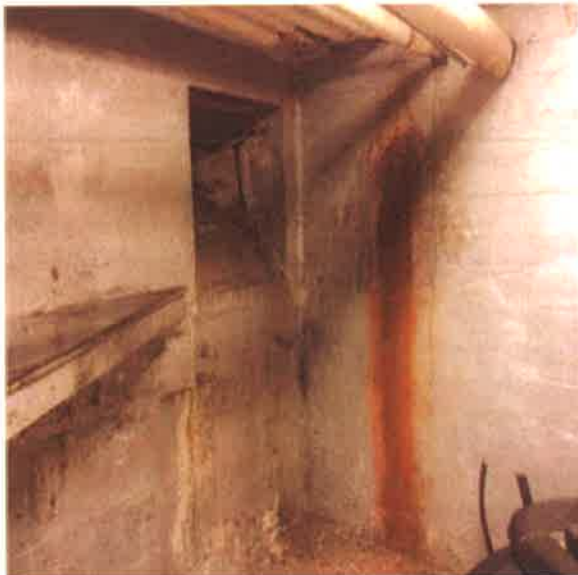
Concrete foundation Walls

The building's substructure includes cast in place concrete strip footings, foundation walls including basement walls, and spread column footings. Also included are under drains. Evidence of water ingress.

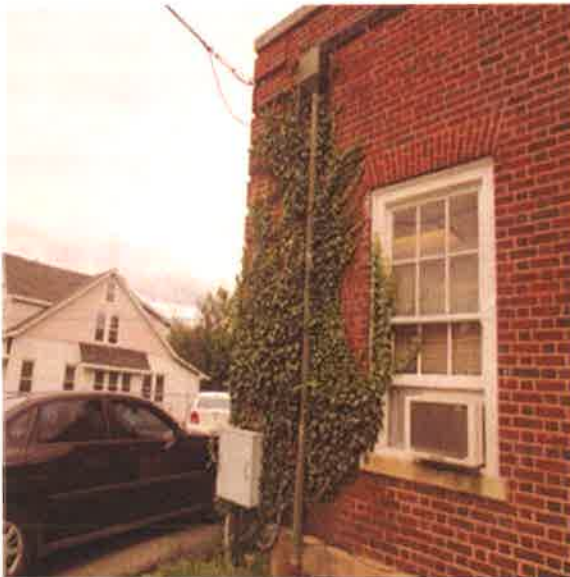
Typical Wood Framed Exterior Window

The building's fenestration is composed primarily of wood framed exterior window units. Single pane wood windows in poor condition with evidence of deteriorating wood and frames.

| Type | Component Description | Plan Type | Year | Expenditures (\$) |
|---|---|---|---|---|
| B2021 | Replace Windows, Wood Framed (per SF) | Capital Replacement | 2014 | \$27,661 |

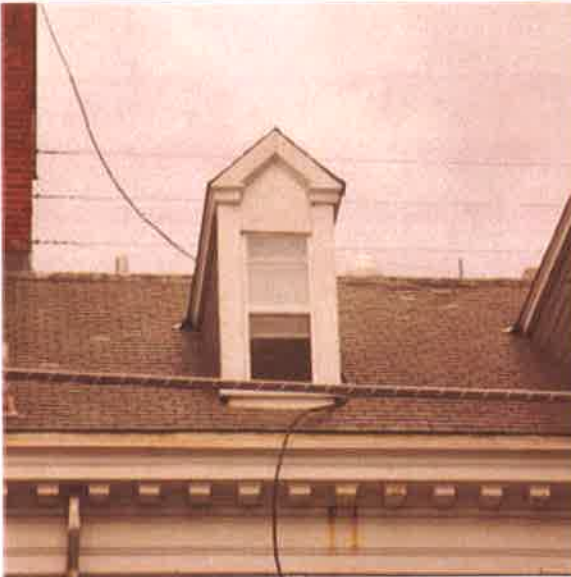
Asphalt Shingle Roof Covering

The roof coverings include asphalt strip shingles, presumably over asphalt felt sheathing paper, sheathing, and insulation. Roof was observed from the ground. Was observed and reported to be in poor condition with some reports of water ingress to the interior of the building.

| Type | Component Description | Plan Type | Year | Expenditures (\$) |
|---|--|---|---|---|
| B3011 | Replace Roof Covering, Asphalt Shingle | Capital Replacement | 2014 | \$16,652 |

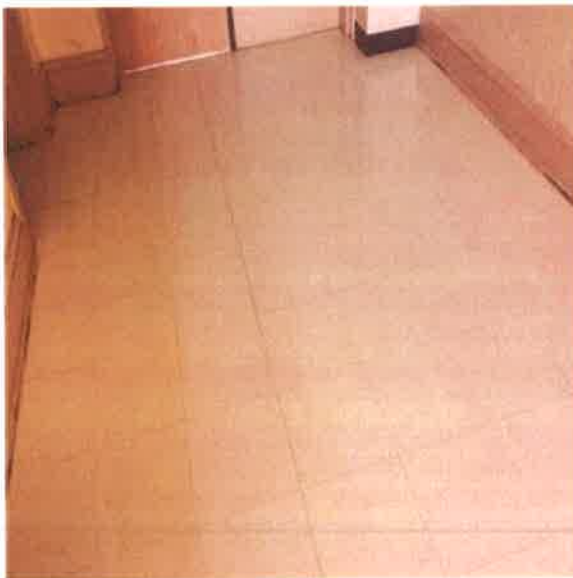
Typical Vinyl Tile Floor Finishes

Interior floor finishes include standard Vinyl Composition Tile (VCT) flooring and related base.

| Type | Component Description | Plan Type | Year | Expenditures (\$) |
|---|---|---|---|---|
| C3024 | Replace Floor Finish, Vinyl Tile | Capital Replacement | 2018 | \$27,360 |

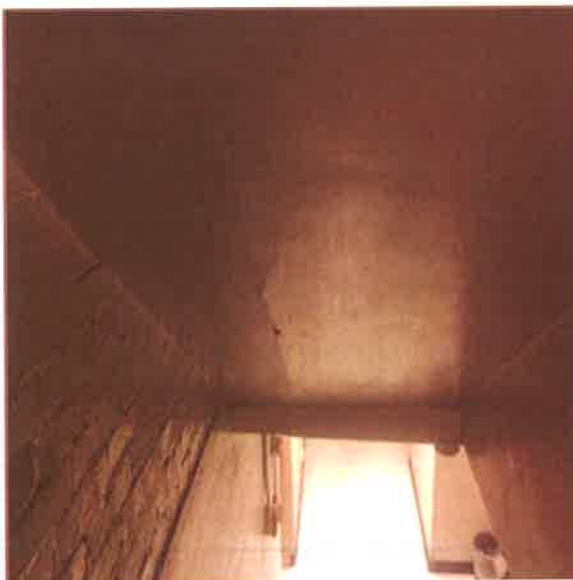
Plaster Ceilings above stairs

Interior ceiling finishes include a multi-coat plaster on metal lath (or similar). Poor condition with evidence of cracking and movement.

| Type | Component Description | Plan Type | Year | Expenditures (\$) |
|---|--|---|---|---|
| C3031 | Replace Ceiling Finish, Plaster, Painted | Capital Replacement | 2016 | \$2,513 |

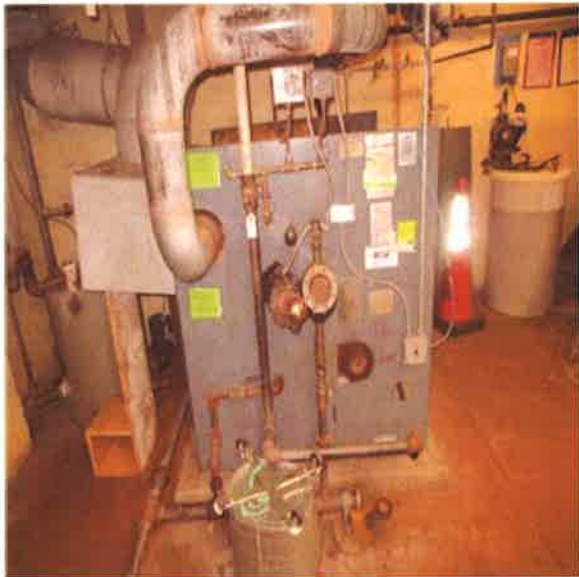
Weil McLain Boiler

Weil McLain gas boiler was undergoing refit during site visit.

| Type | Component Description | Plan Type | Year | Expenditures (\$) |
|---|---|---|---|---|
| D3021 | Replace Boiler, Gas, 1,000 Mbh | Capital Replacement | 2018 | \$23,259 |

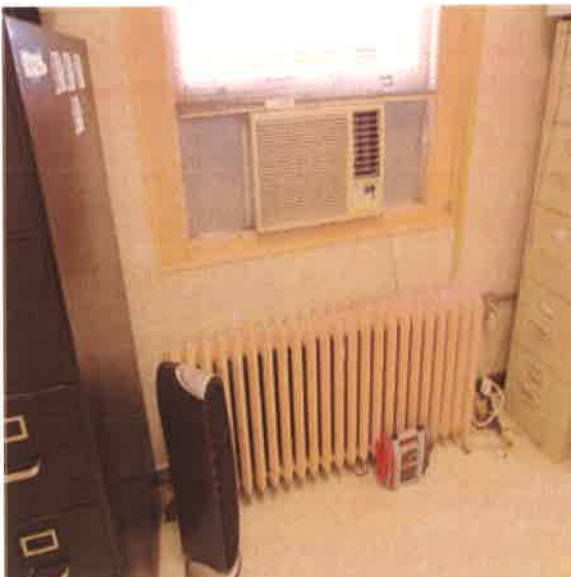
Typical Cast Iron Hot Water Radiator

HVAC in the building includes cast iron radiators with hot water distribution piping. Price per building SF. Reported heating in the winter is unreliable.

| Type | Component Description | Plan Type | Year | Expenditures (\$) |
|---|--|---|---|---|
| D3023 | Replace Heating, Cast Iron Radiators or Similar (per SF) | Capital Replacement | 2014 | \$119,860 |

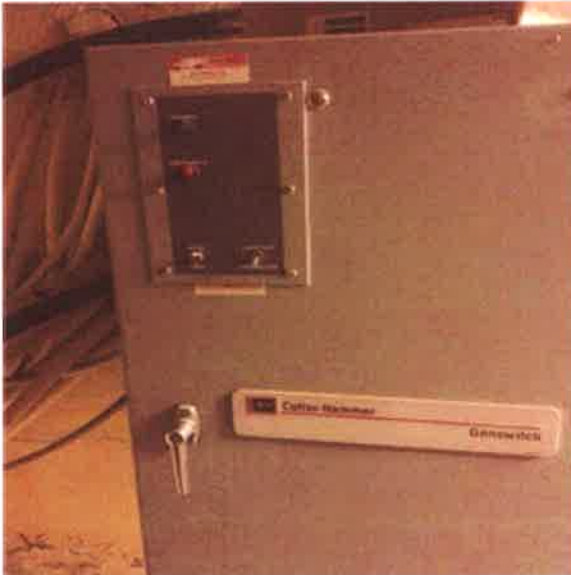
Generator Transfer Switch

Emergency electrical components include an automatic generator transfer switch. Culter Hammer Genswitch

| Type | Component Description | Plan Type | Year | Expenditures (\$) |
|---|--|---|---|---|
| D5012 | Replace Generator Transfer Switch, Auto, 208 V, 225Amp | Capital Replacement | 2017 | \$10,669 |

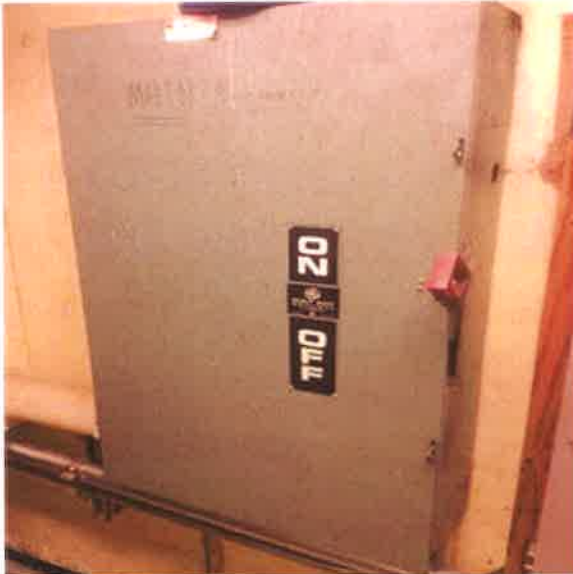
Main Electrical Disconnect

The building contains a high-voltage main electrical service, which includes incoming feeders, high-voltage switches, and associated equipment necessary to support main switches, distribution switches and a center tie. 400 Amp 240 v GE

| Type | Component Description | Plan Type | Year | Expenditures (\$) |
|---|---|---|---|---|
| D5012 | Replace Main Electrical Service, 400 Amp, w/ Main Disconnect(s), Main Distribution Switches | Capital Replacement | 2015 | \$142,920 |

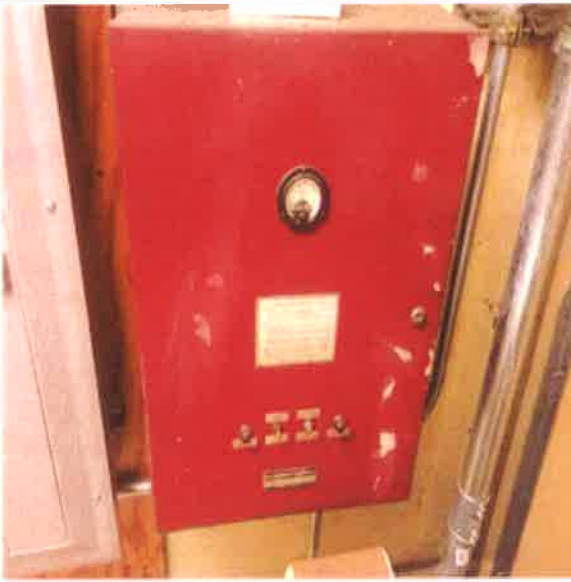
Simplex Fire Alarm

The building is equipped with a fire alarm system, including control panel, annunciator panel, detection devices, alarm devices. Price is per building SF. Alarm panel has exceeded its expected useful life and was not known by building occupants if it was linked to fire department.

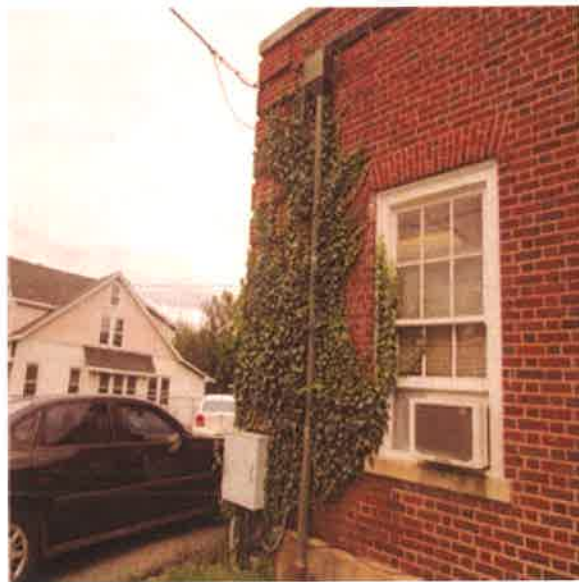
Windows, Wood Framed (per SF) :- Typical Wood
Framed Exterior Window

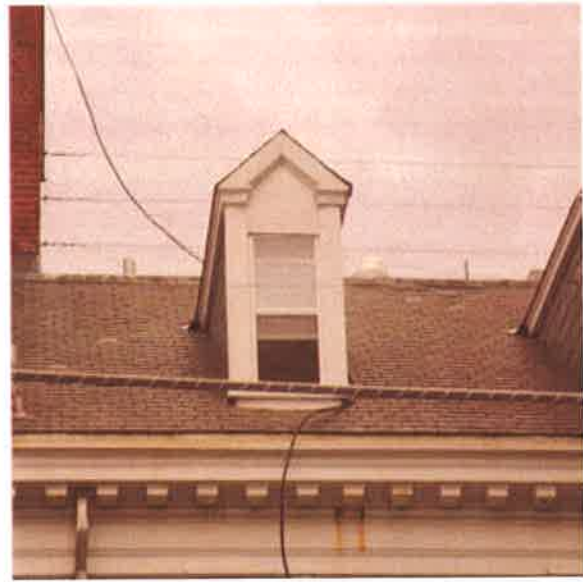
Roof Covering, Asphalt Shingle:- Asphalt Shingle
Roof Covering

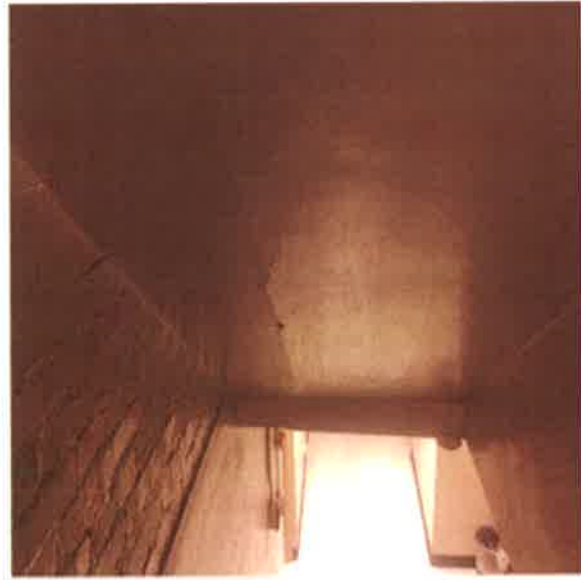
Ceiling Finish, Plaster, Painted:- Plaster Ceilings above stairs

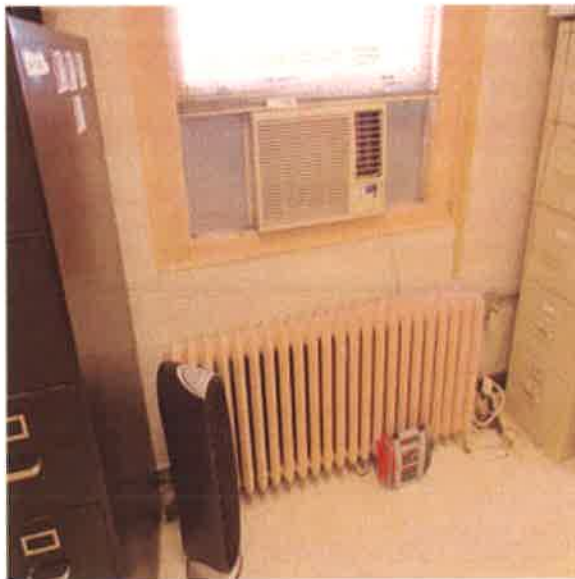
Heating, Cast Iron Radiators or Similar (per SF) :-
Typical Cast Iron Hot Water Radiator

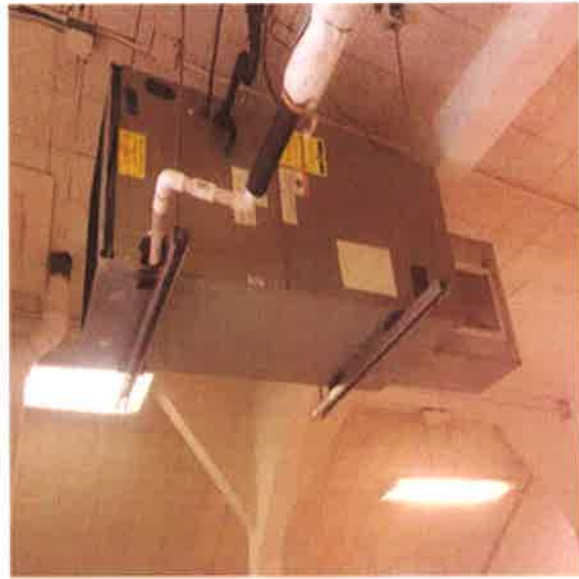
Suspended A/C Unit:- Ac Unit no longer functional

| Type | Component Description | Plan Type | Year | Expenditures (\$) |
|---|---|---|---|---|
| D3051 | Replace Suspended A/C Unit | Capital Replacement | 2014 | \$2,089 |
