**Property Condition Report**

Southwest Health Center 850 Delaware Ave SW Washington, DC

Comprehensive Facility Condition Assessment
And Space Utilization Study
DCAM-13-NC-0162

October 3, 2014

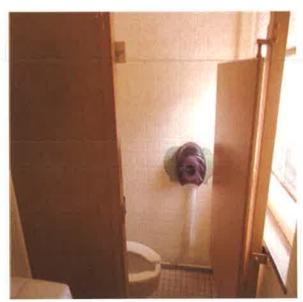
Restrooms include floor and/or ceiling mounted partitions of metal construction or similar. The units appeared to be in fair to good condition.

Typical metal toilet partitions.

Туре	Component Description	Plan Type	Year	Expenditures (\$)
C1011	Replace Toilet Partitions, Painted Metal	Capital Replacement	2018	\$10,569

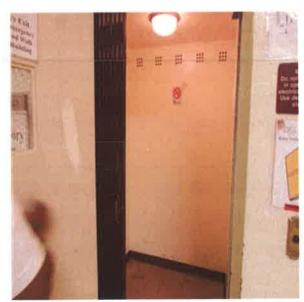
The elevator is manufactured by Otis and is original to the building. There have been reported issues with the unit and its anticipated that it will require replacement within the next year.

Elevator that service all three floors.

Туре	Component Description	Plan Type	Year	Expenditures (\$)
D1011	Replace Elevator, Passenger, Cable	Capital Replacement	2014	\$118,700

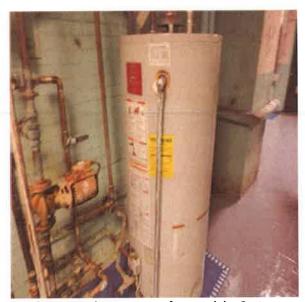
The domestic hot water is provided by a 120-gallon natural gas water heater. The unit appeared to be in fair to good condition.

Gas fire water heater manufactured by State.

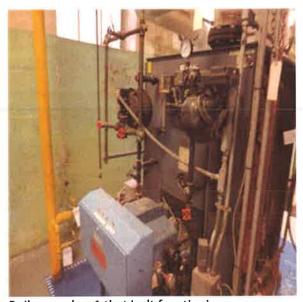
The boiler is manufactured by Weil-McLain and was reported that it broken down two years ago and has not worked since. This boiler requires replacement.

Boiler number 1 that isn't functioning.

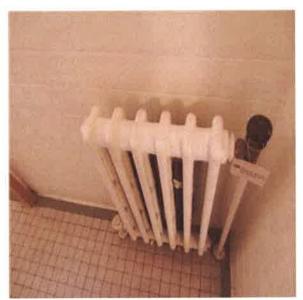
HVAC in the building includes cast iron radiators with steam or hot water distribution piping, including simplex condensate return and steam condensate meter (steam). Price per building SF.

Cast iron radiator that is found throughout the building.

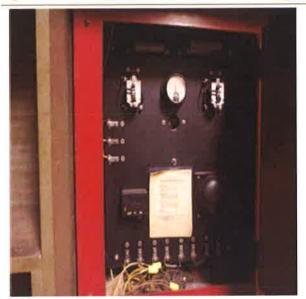
The fire alarm system includes a multi-zone fire alarm control panel. It appeared to have surpassed its theoretical expected useful life; however, the unit is still functioning, which warrants the increased life.

Fire alarm panel.

Туре	Component Description	Plan Type	Year	Expenditures (\$)
D5037	Replace Fire Alarm Control Panel	Capital Replacement	2016	\$5,000

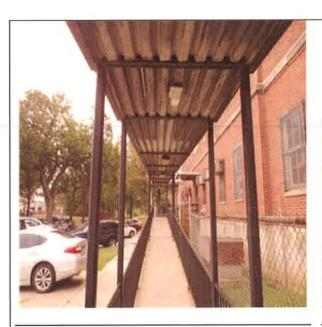
Accessible Ramp - Concrete :- The access ramp to the building.

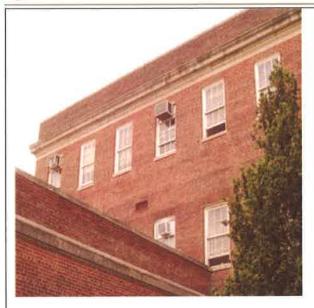
The building's fenestration is composed primarily of wood framed exterior window units with single pane glazing. Price is per square foot. The windows appeared to be in fair to poor condition as they

were reported to be original to the building; however, there are no issues of water ingress. It is expected that the units will require replacements within the next few years.

Windows, Wood Framed (per SF) :- Example of wood framed windows.

Туре	Component Description	Plan Type	Year	Expenditures (\$)
B2021	Replace Windows, Wood Framed (per SF)	Capital Replacement	2017	\$71,247

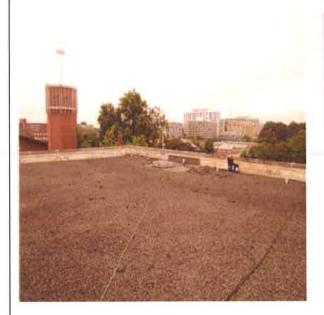
main building over the south side of the building. The roof appeared to be in fair condition and is starting to reach the end of its expected useful life.

Roof Covering, Built-up Roof :- The roof covering consists of a built up roof system.

Туре	Component Description	Plan Type	Year	Expenditures (\$)
B3011	Replace Roof Covering, Built-up Roof	Capital Replacement	2017	\$73,185

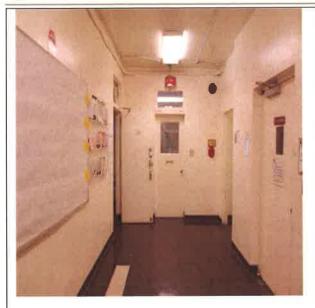
Interior Doors, Wood, Solid Core :- Typical interior door.

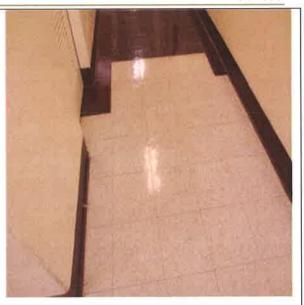
Floor Finish, Vinyl Tile - 12"x12":- Typical 12" x 12" tiles in select locations throughout the building.

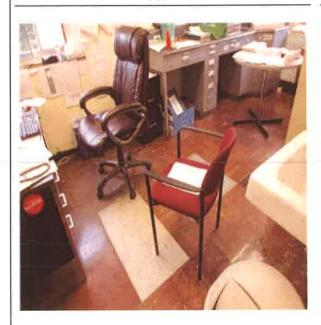
Interior floor finishes include standard Vinyl Composition Tile (VCT) flooring and related base. These vinyl tiles were reported to have asbestos containing material within the tile/substrate. The price for replacement has been increased, as their will be abatement required.

Floor Finish, Vinyl Tile - 9"x9" :- Typical 9"x9" tile with sections that have been replaced.

Туре	Component Description	Plan Type	Year	Expenditures (\$)
C3024	Replace Floor Finish, Vinyl Tile - 9"x9"	Capital Replacement	2017	\$94,058

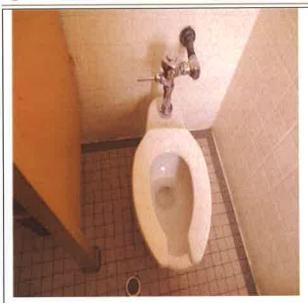
Flush Tank Water Closets :- Typical water closet throughout the building.

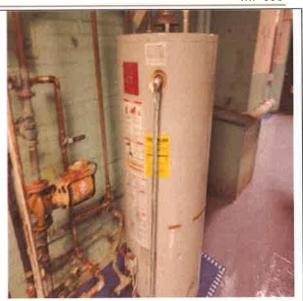
Water Heater, Domestic, Gas:- Gas fire water heater manufactured by State.

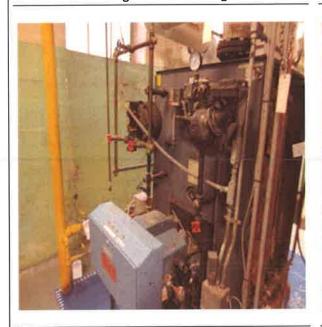
Boiler, Steam, Gas Fired, 1,000 Mbh - Boiler #1:-Boiler number 1 that isn't functioning.

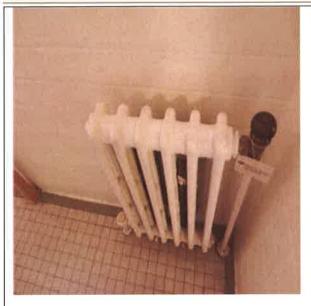
Heating, Cast Iron Radiators or Similar (per SF):-Cast iron radiator that is found throughout the building.

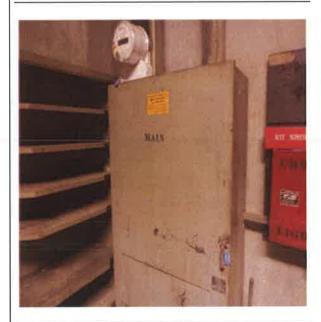
Main Electrical Service, 800 Amp, w/ Main Disconnect(s), Main Distribution Switches: - Main disconnect for the building.
