**Attachment B- Feasibility Study  
Part 1**

**DISTRICT OF COLUMBIA PUBLIC SCHOOLS**  
**JOHN EATON ELEMENTARY SCHOOL MODERNIZATION**  
**FEASIBILITY ASSESSMENT AND CONCEPTUAL DESIGN**  
**JULY 3, 2018**

# EXISTING FACILITY CONDITION ASSESSMENTS & FEASIBILITY RECOMMENDATIONS

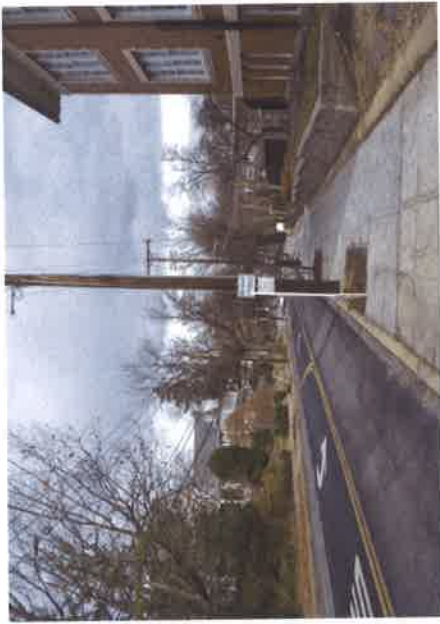
Perimeter public space hardscape in good condition

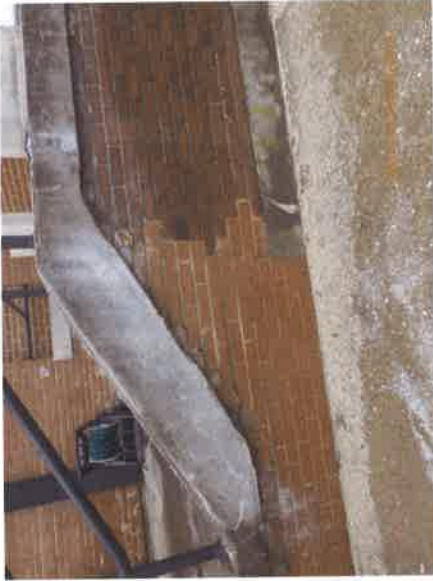
The rear pedestrian ramp in the vicinity of the vehicular entrance from 34<sup>th</sup> Street, NW was reported during the site visit to be very old. Moderate cracks and spalling were observed.

Rear pedestrian stairs and ramp showing cracking and deterioration

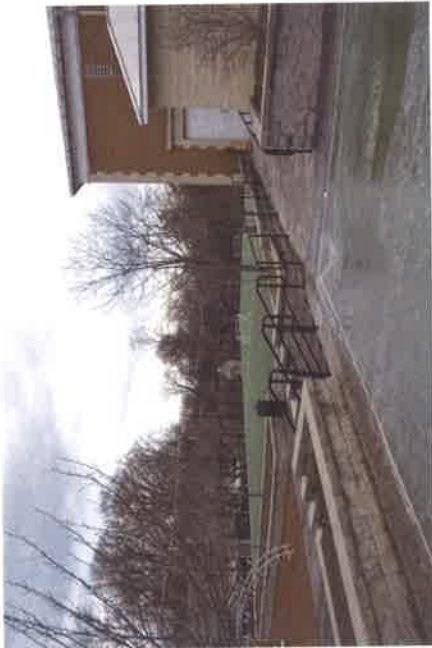
Rear hardscaping in playground area in good condition

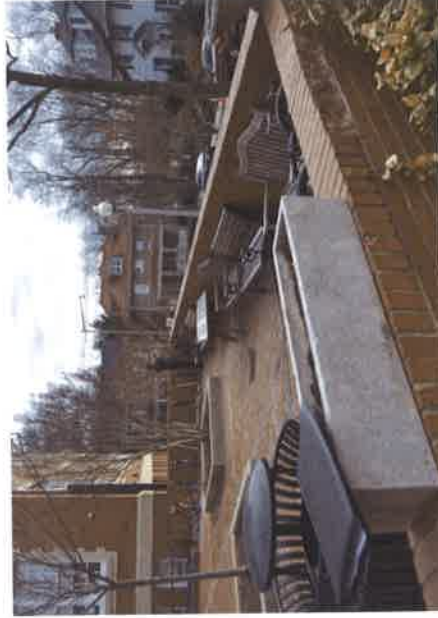
The front entrance along Lowell Street, NW is in good condition, with only isolated, minor repairs needed.

Main entrance along Lowell Street NW in good condition.

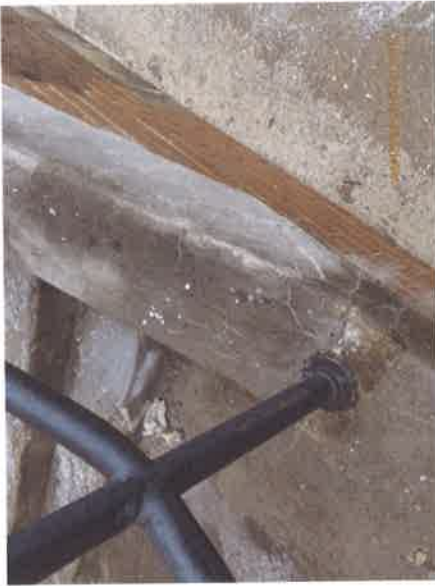
Rear pedestrian stamps and ramp showing cracking and deterioration

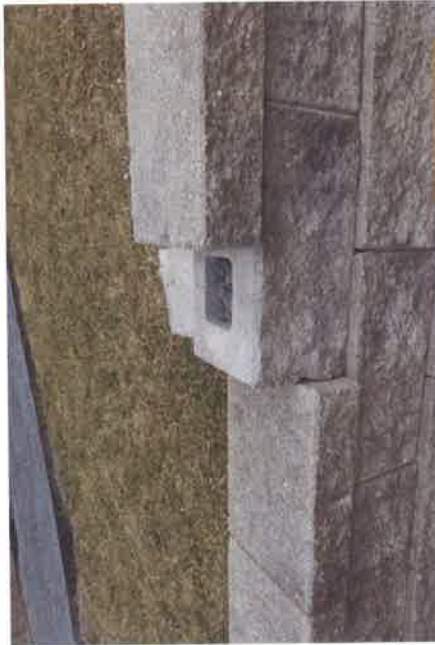
Minor, isolated exception to perimeter hardscape being in good condition

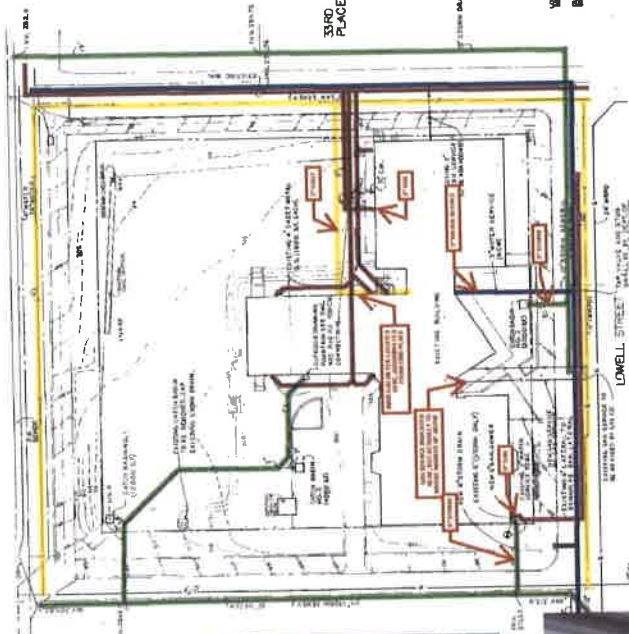
Information pertaining to the existing site conditions is limited, particularly regarding the underground utilities. Most of the information presented herein was per site visit observations and by talking with school staff familiar with the site and its maintenance issues.

Limited information pertaining to onsite utilities

A topographic and utility survey of the property should be conducted. This would allow for a more thorough analysis of the existing conditions.

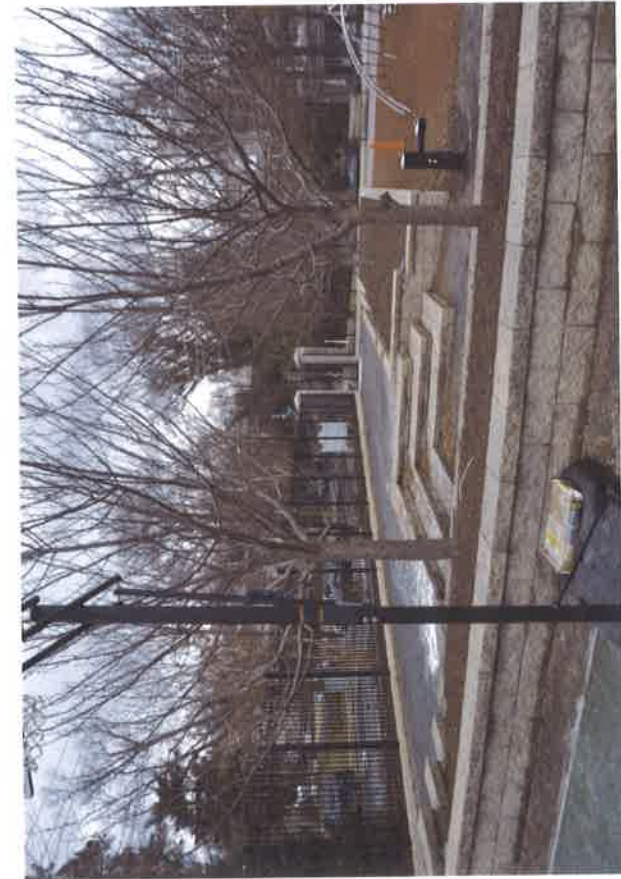
Hardscape taking up limited space in playground area

12. Limit the extent of rigidly defined hardscape to provide greater flexibility of outdoor multipurpose areas.

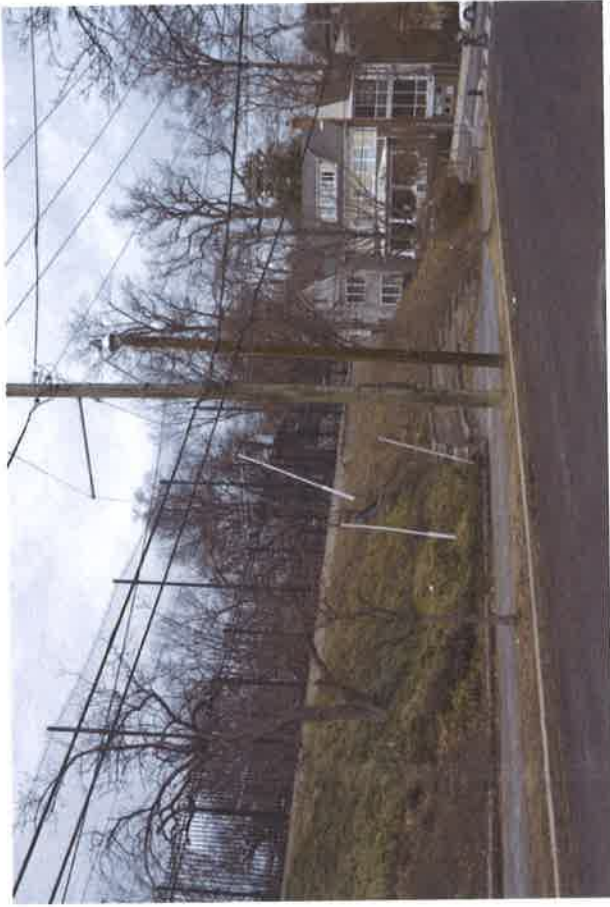
Northeast corner of site with no pedestrian access

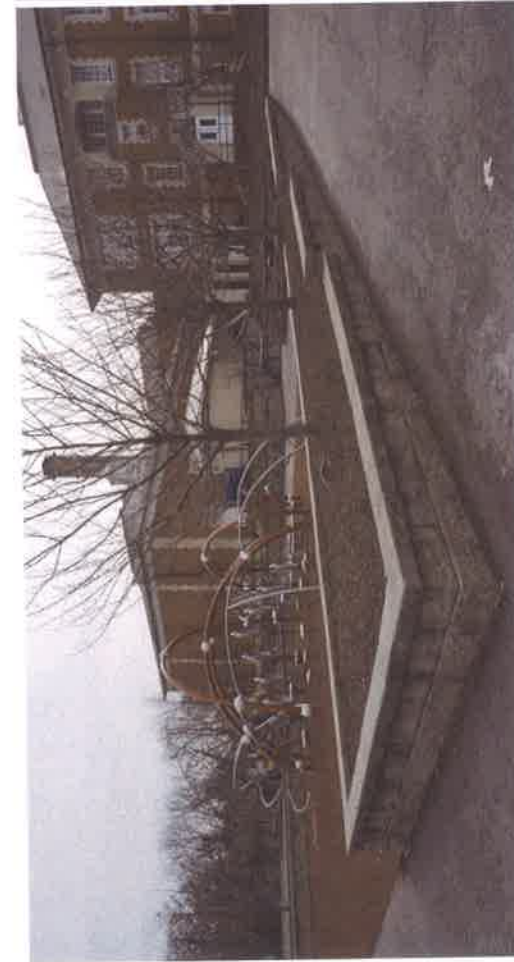
Figure 1 - Excessive and harsh hardscape, planter walls along 5-12 yr. play area

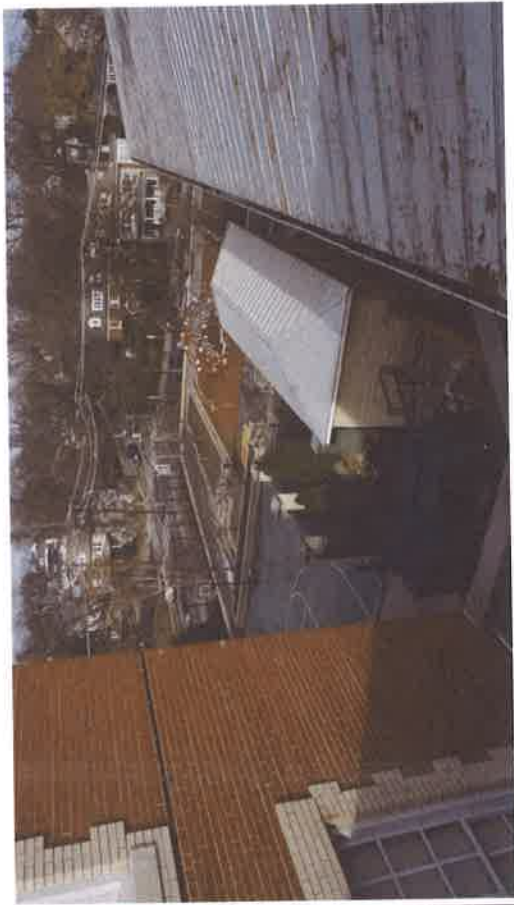
Figure 3 - Utility and storage cluster that can be organized better

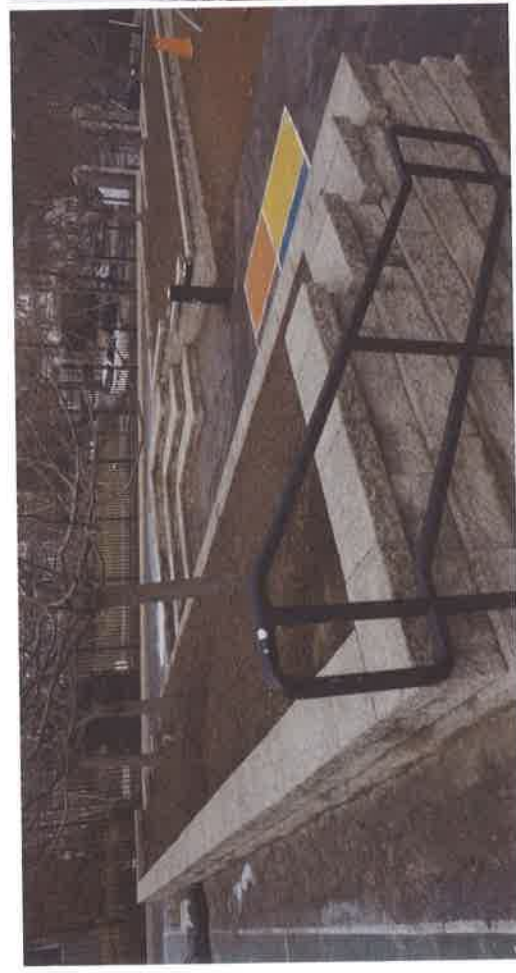
Figure 2 - -Excessive and harsh hardscape, planter walls along basketball court

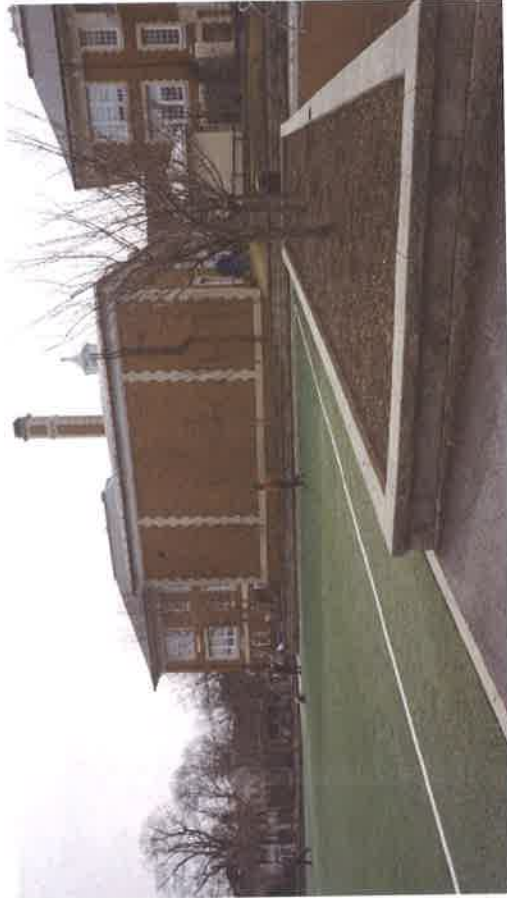
Figure 4 - Excessive and harsh hardscape, planter wall along sports field and north wall of gym

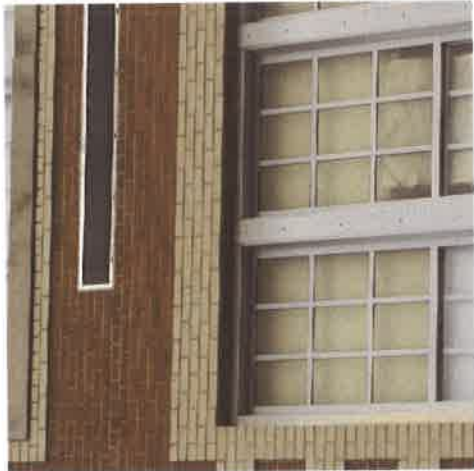
**Observations**  
We observed diagonal cracks above isolated lintels over triple-ganged windows (Figure 1).

Mass brick masonry is a porous material that readily absorbs moisture and is subject to moisture and temperature-related movement. Brick masonry is typically kiln fired and at the time it leaves the kiln has a very low moisture content. After the brick is installed and exposed to the environment (e.g. temperature, humidity, rain, etc.), the brick absorbs moisture and grows over time. Restraint of masonry expansion and contraction can cause cracking. Over time, cracks and weathering and degradation of the brick and mortar allow additional moisture into the wall exposing embedded steel and wood elements to moisture-related deterioration.

Figure 1 – Step crack at left side of window extending right.

We recommend additional assessment of the exterior masonry to identify the cause and extent of deterioration and develop recommended remedial repairs that address the cause. As part of the exterior masonry assessment hands-on survey and exploratory probes should be conducted at select locations. Locations may include but are not limited to:

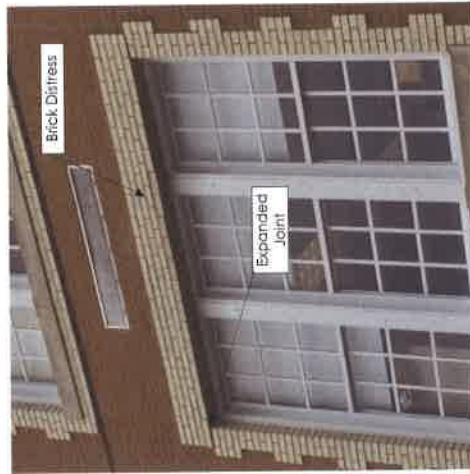
The underside of many existing lintels over masonry openings are corroded and scaling. The masonry is cracked at isolated lintel bearing locations where the lintels have visible rust scaling (Figure 2).

Corrosion, in particular rust on structural steel, is a result of moisture infiltration. The rust byproduct is several times the original volume of steel and this expansion will create internal tensile forces which act on the surrounding media in a process called rust jacking. Rust jacking is often apparent at the bearing locations of steel lintels in exterior masonry bearing walls. The growth of the structural steel opens mortar joints in the brick masonry and if left unaddressed will cause cracking of the mortar joints and adjacent brick masonry. Cracks also lead to additional bulk water infiltration, accelerating the deterioration cycle. To decrease a steel element's susceptibility to moisture distress, steel elements are commonly protected with a corrosion resistant paint or galvanizing and covered with flashings to collect and direct water from the wall. Remedial flashing installation in coordination with maintenance of protective coatings are durable and reliable options to address minor lintel deterioration. Where lintels are deteriorated beyond repair, lintel repairs or replacement may be required.

Figure 2 – Expanded joint at lintel beaming & brick distress.

- Lintel bearing where rust jacking is observed to determine condition of the existing lintels, masonry and flashings (if present).
- Interface at the top of the roof structure and masonry parapet above to review the condition of the concealed flashings and existing structural connections.

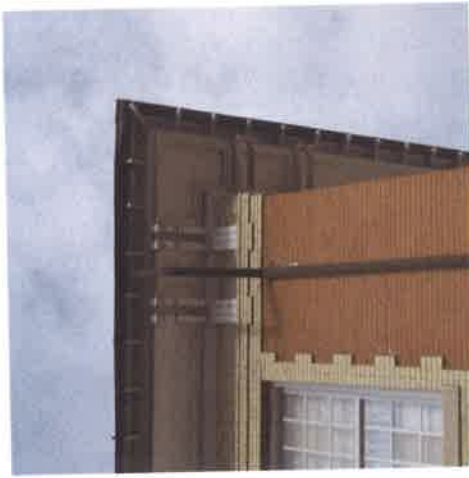
An existing gutter was observed to have displaced away from the roof line as a result of impact damage and anchorage (Figure 7).

Figure 7 – Gutter distress.

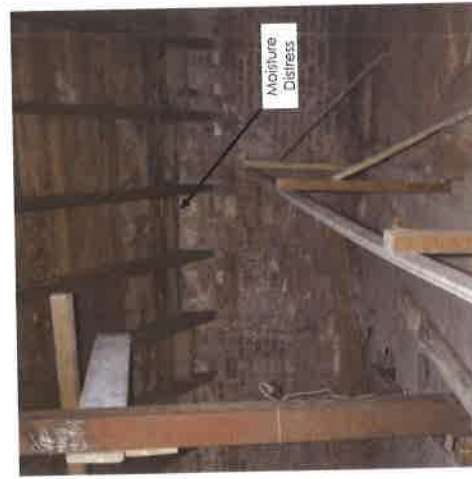
Figure 8 – Moisture distress at rafter bearing pockets slab.

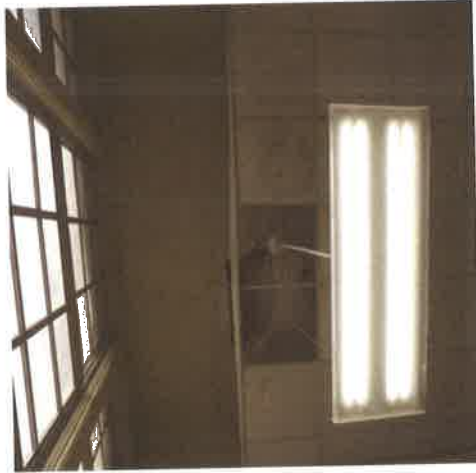
Figure 9 – 1911 Bldg: exposed rebar at underside of stairwell slab.

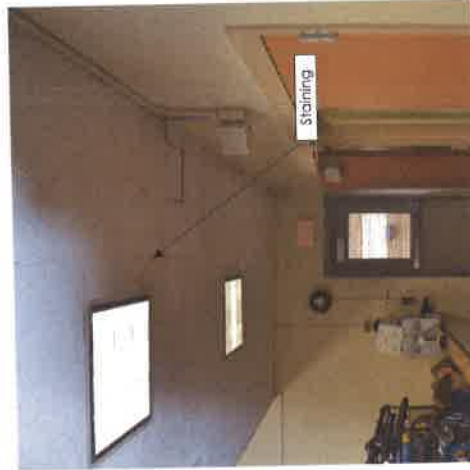
Figure 10 – Moisture distress at underside of second floor.

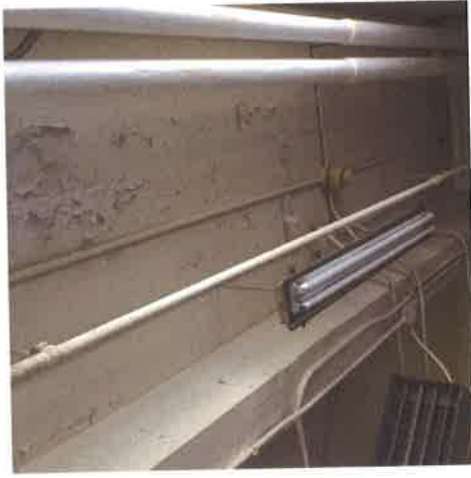
Figure 11 – Peeling paint in basement of 1930's connector.
