Reference: Phase I Environmental Site Assessment
Eastern Market MetroPark
Pubic Right -of- Way 7th, 9th and D Street, SE,
Washington, D.C

PHASE I ENVIRONMENTAL SITE ASSESSMENT REPORT

Eastern Market MetroPark Pennsylvania Avenue, SE Washington, DC 20003

February 23, 2016

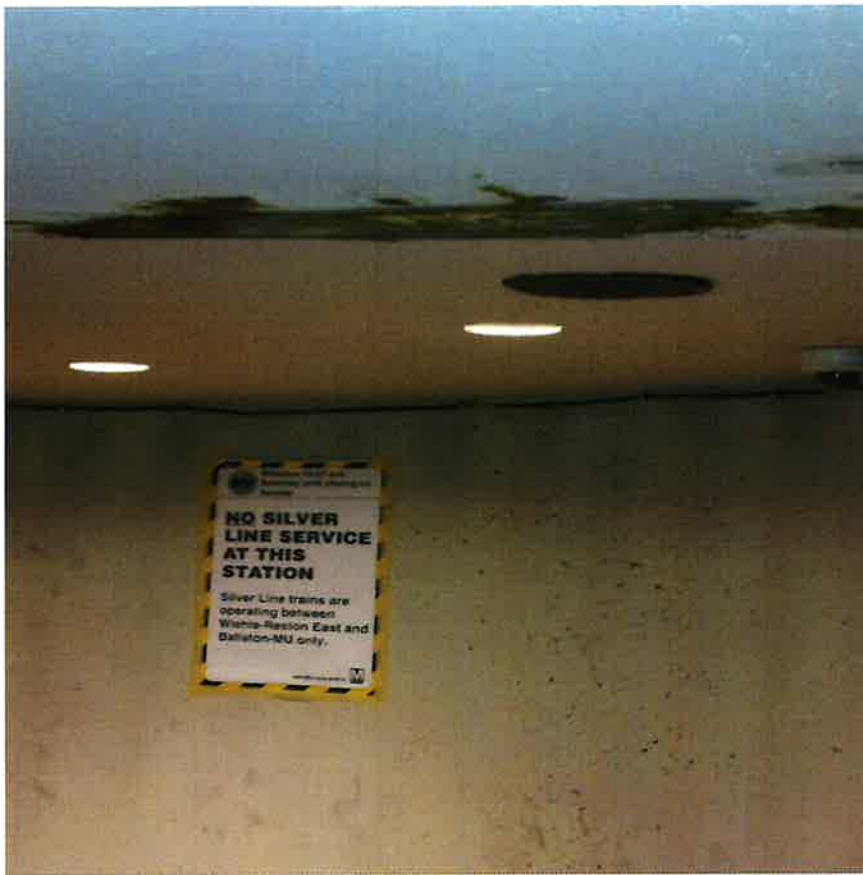
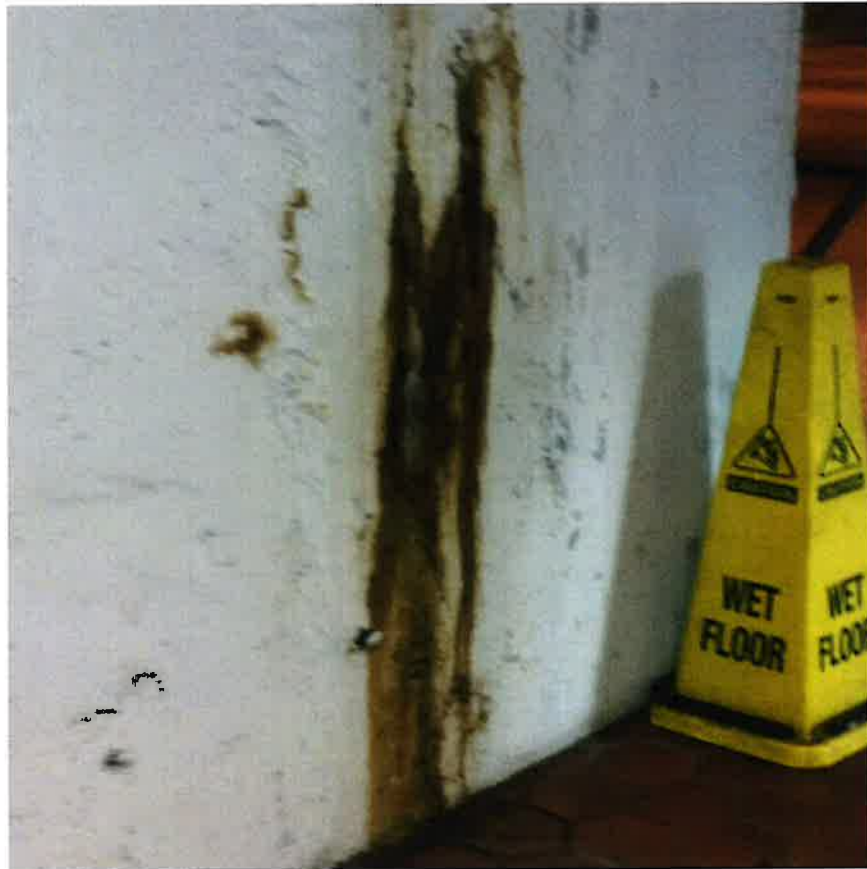
During our site visit, we observed mold on the wall and ceiling on the mezzanine platform of the lower level leading to the elevator (see Photos 2a & 2b).

Photos 2a and 2b – Mold on the wall and ceiling near the elevator entrance on the mezzanine platform to the lower-level. Note: the floor tile was used on the platform may contain ACBM.
