Addendum No. 3
To
Request for Proposals (“RFP”) No. DCAM-21-CS-RFP-0007
Construction Management At-Risk (“CMAR”) Services for Fort Dupont ICE Arena
Issued: April 26, 2021

REPORT OF HAZARDOUS MATERIALS SURVEY

**FORT DUPONT ICE ARENA
3779 ELY PLACE, SE
WASHINGTON, DC**

ECS PROJECT NO. 37:1405

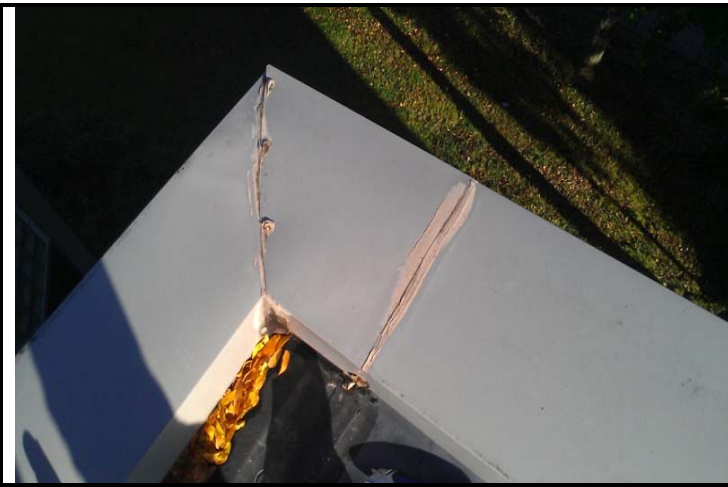
1. Roof by Hatch – View of Tan Caulk along Metal Coping (ACM), Samples # R01-R02

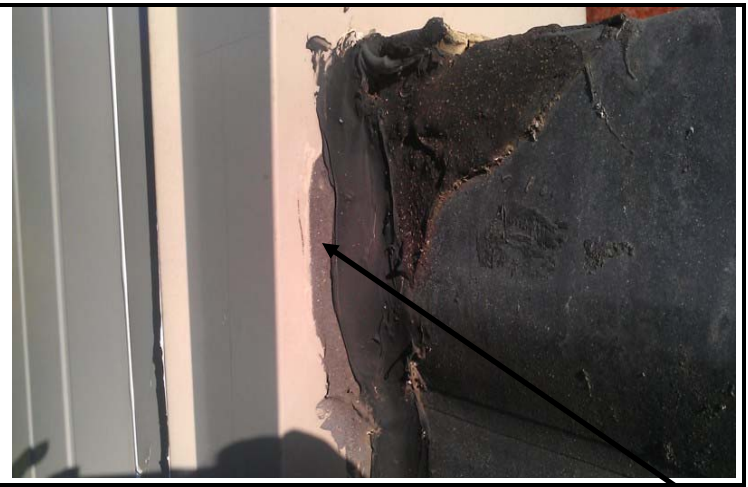
2. Roof by Hatch – View of Dark Gray Perimeter Caulk (ACM), Samples # R05-R06

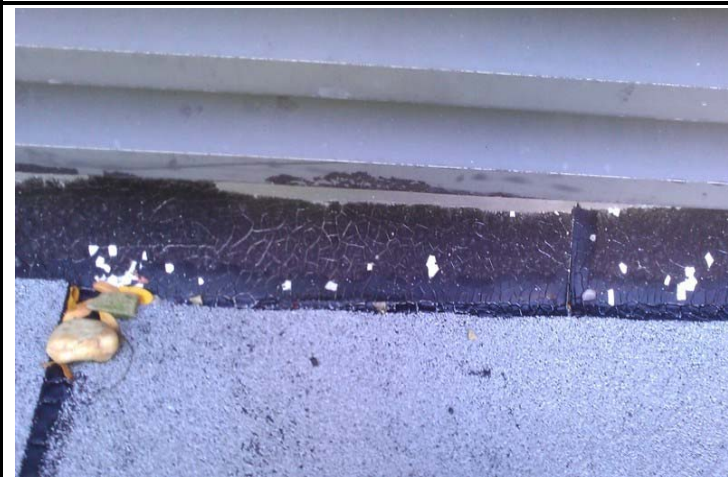
3. Roof of Lobby – View of Black Perimeter Flashing (ACM), Samples # R29-R30

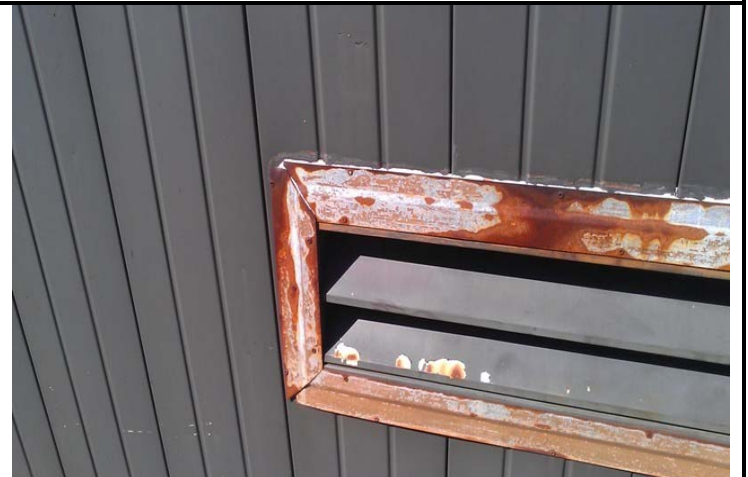
4. Built-up Roof #2 – View of White Caulk (ACM) along Vent, Samples # R43-44

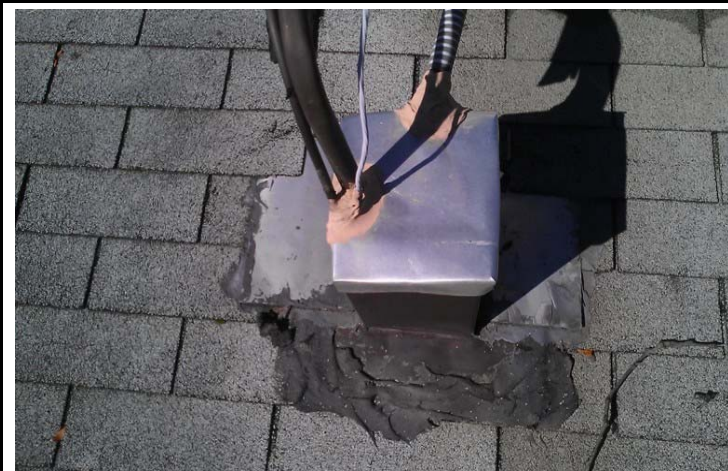
5. Built-up Roof #2 – View of Tar (ACM) By HVAC Unit, Samples # R45-R46

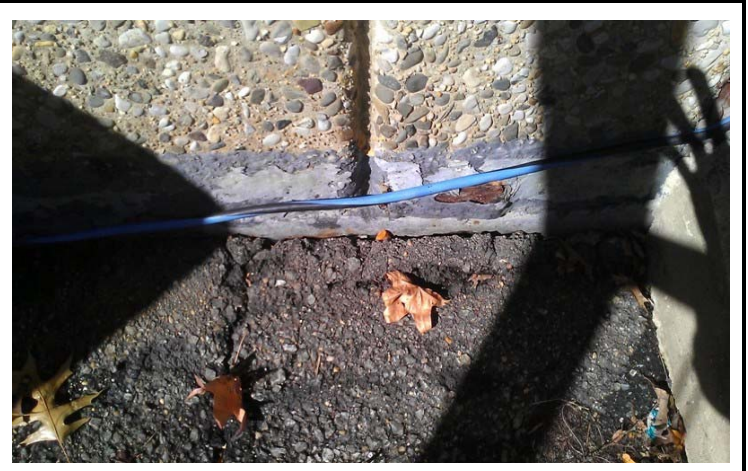
6. East Side of Building – View of Exterior Gray Waterproofing, Samples # E03-E04

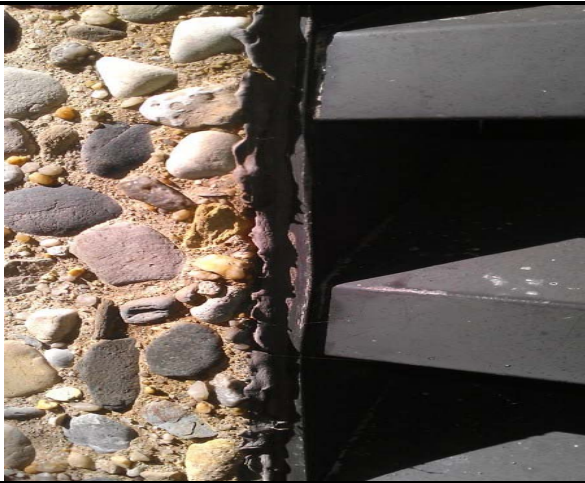
7. East Side of Building – View of Exterior Black Caulk (ACM) along Window & HVAC Vent, Samples #E05-E06

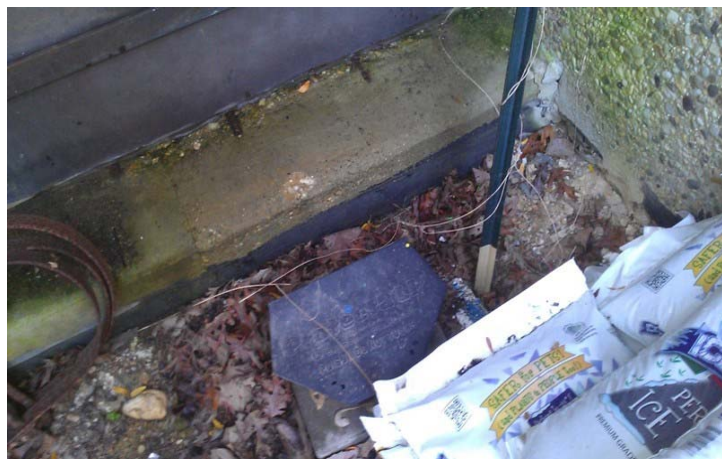
8. East Side of Building – View of Exterior Felt Paper Waterproofing (ACM), Samples #E07-E08

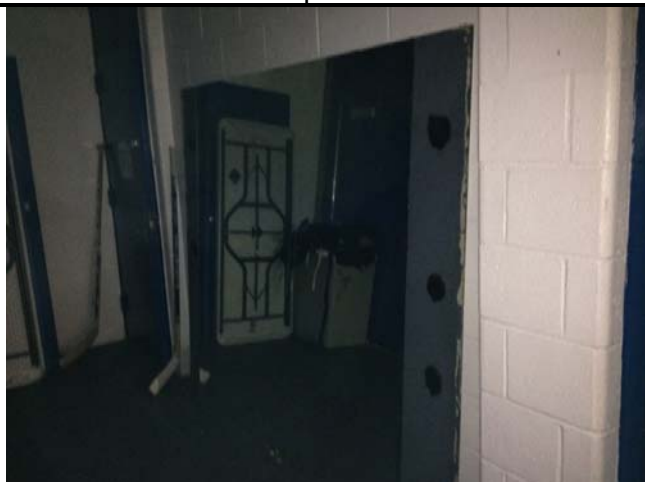
9. Interior of Building, 2nd Floor by Bleachers – View of Black Dot Mirror Mastic (ACM), Samples #07-08

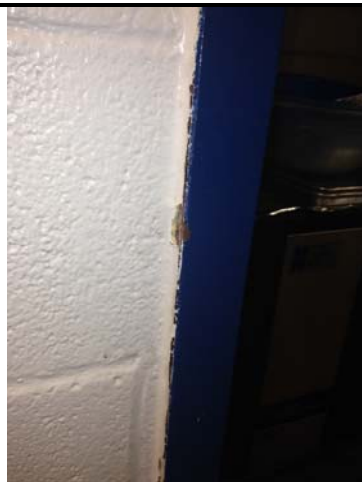
10. Interior of Building, 1st Floor – View of White Interior Door Caulk, Samples #21-22

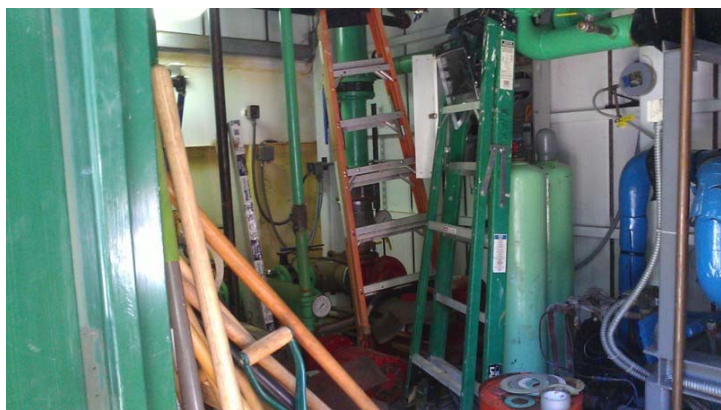
11. Exterior, Storage Room – Due to Safety Concerns, ECS Could Not Survey this Area

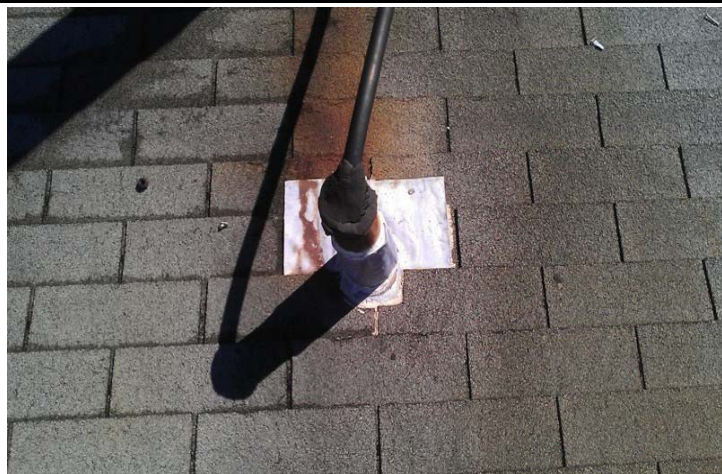
12. Built-up Roof #2 – View of Tar/Sealant on Electrical Supply Lines (Assumed ACM), Not Sampled Due to Safety Concerns

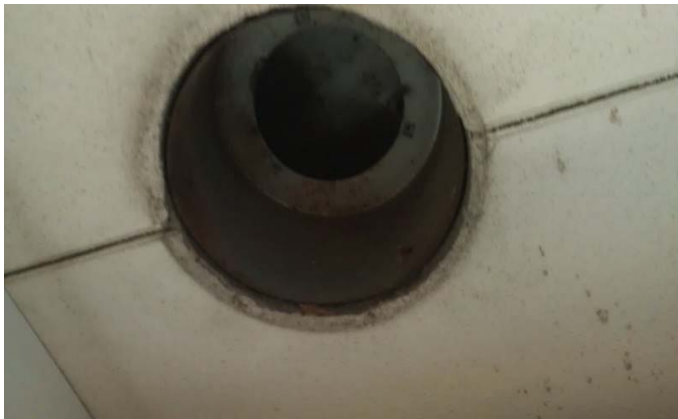
13. Assumed Asbestos-Containing Light Shields in Hallways. Not Sampled

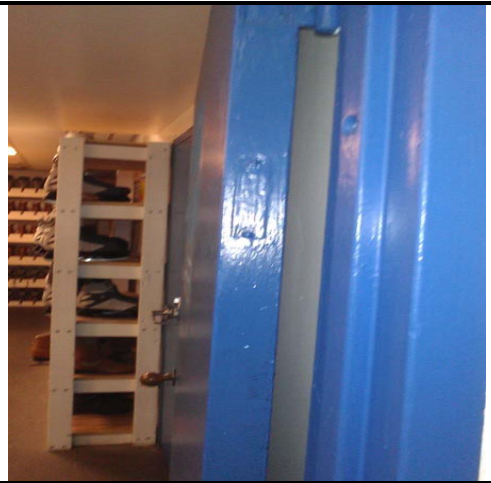
14. Assumed Asbestos-Containing Fire Door Insulation. Not Sampled.

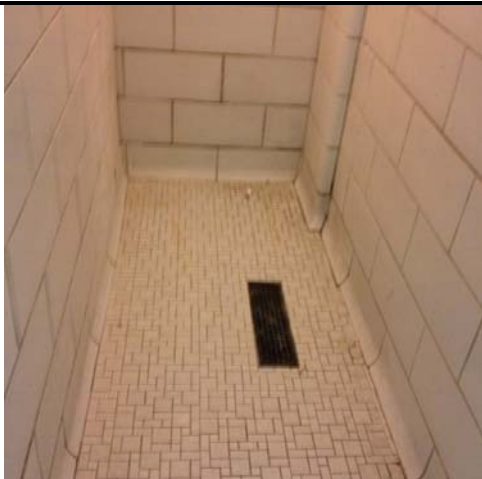
15. Assumed Asbestos-Containing Ceramic Floor Tile Mastic/Felt in the Bathrooms. Not Sampled.

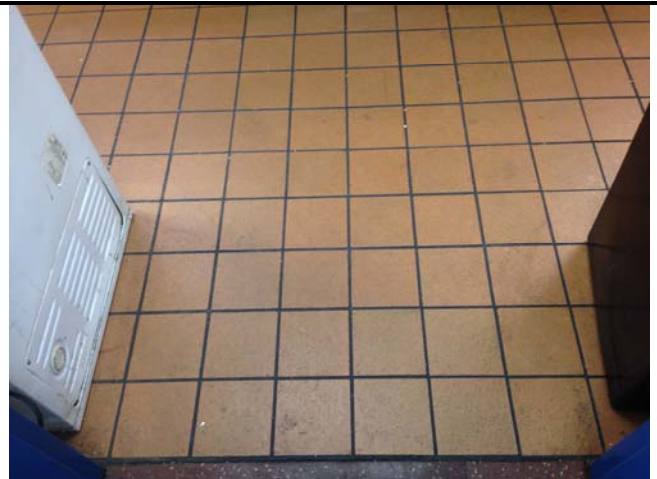
16. Assumed Asbestos-Containing Ceramic Floor Tile Mastic/Felt in the kitchen. Not Sampled.

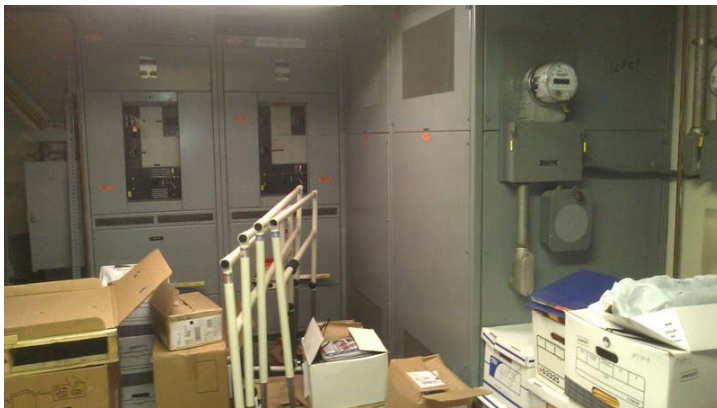
17. Assumed Asbestos-Containing Electric Panel Cement Components in Mechanical and Electrical Rooms. Not Sampled.

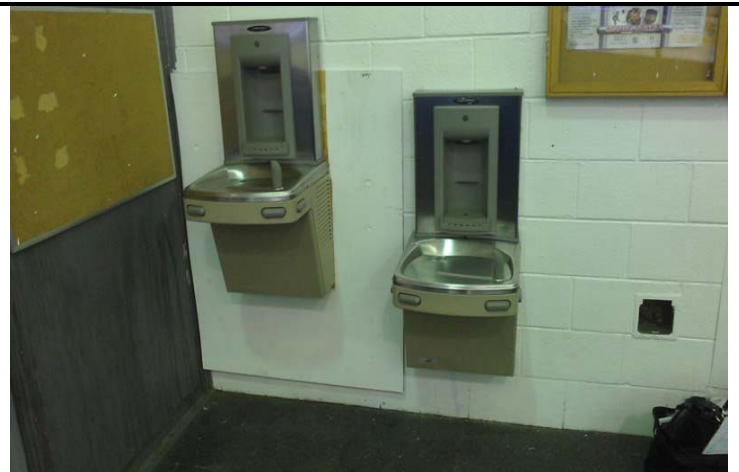
18. Assumed Asbestos-Containing Water Fountain Pipe Wrap. Not Sampled.

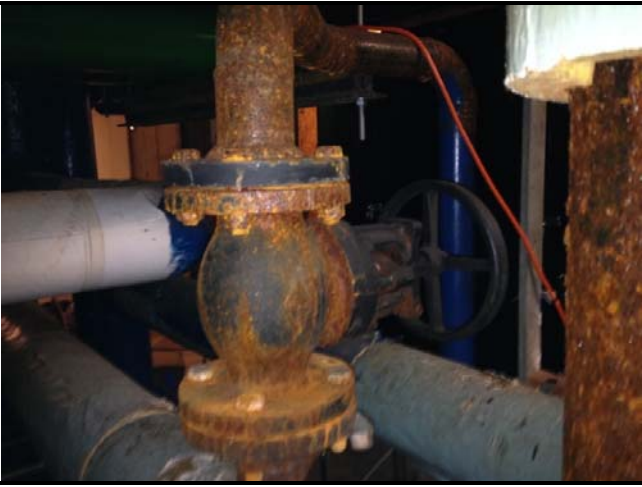
19. Assumed Asbestos-Containing Pipe Flange Gaskets in Heating and Plumbing Systems. Not Sampled.

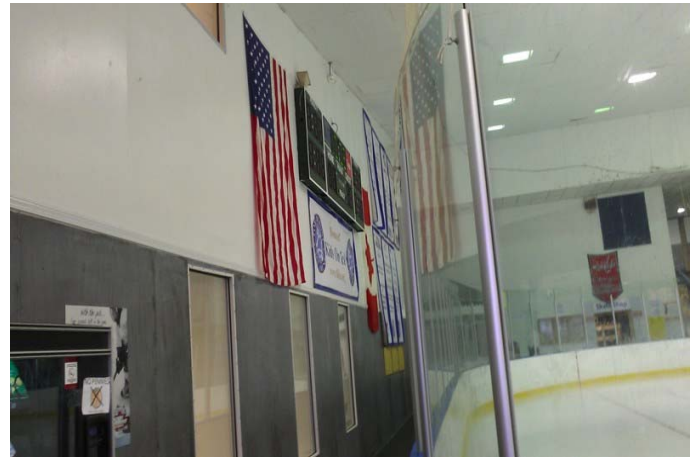
20. Assumed Asbestos-Containing Mastics Behind Scoreboard. Not Sampled.

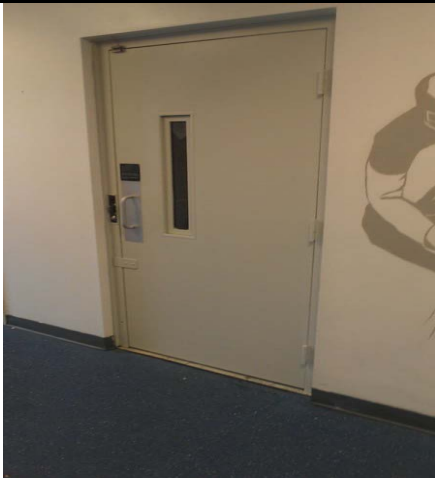
21. Assumed Asbestos-Containing Elevator Lift: Components. Not Sampled.

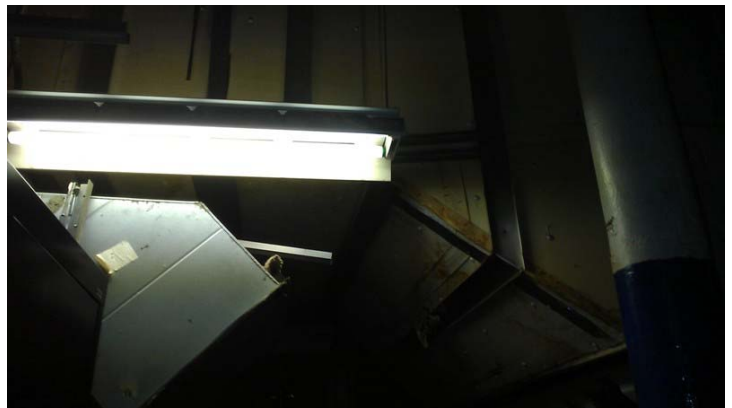
22. Assumed Asbestos-Containing Air Handler Unit: Interior Components. Not Sampled.

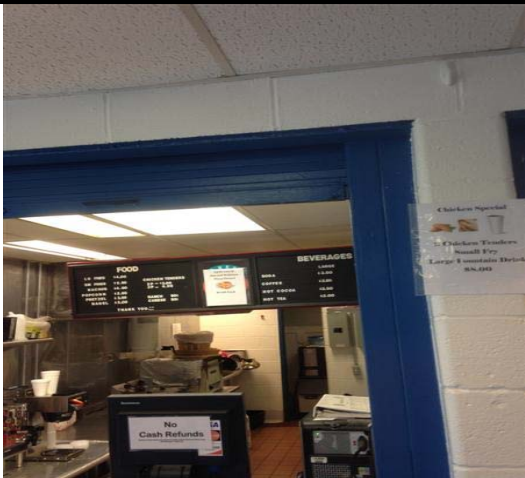
23. Lead-Based Paint on Blue Metal Window Casing Located in Snack Bar – Rollup. Reading No. 45.

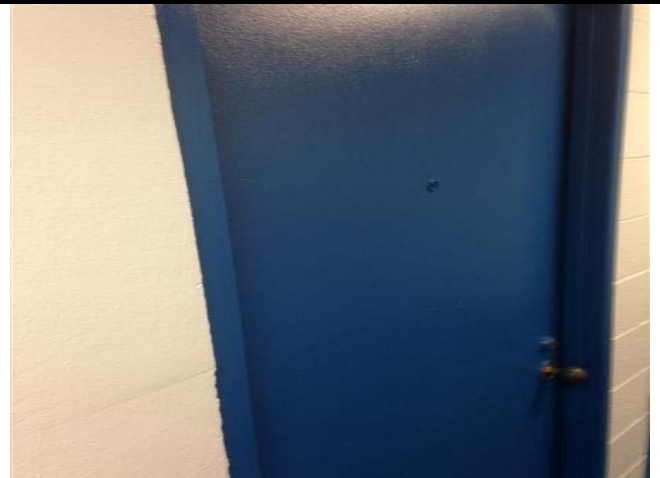
24. Lead-Based Paint on Blue Metal Window Door and Door Casing Located in Snack Bar – Rollup. Reading No. 49, 50 and 51.

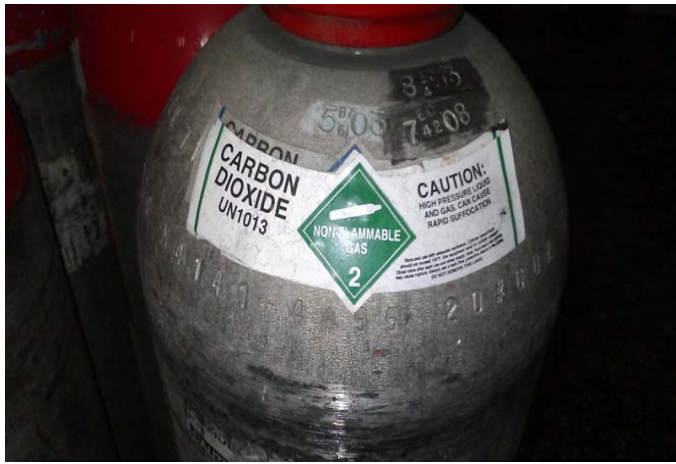
25. View of Carbon Dioxide Tanks within the First Floor Storage Closet.

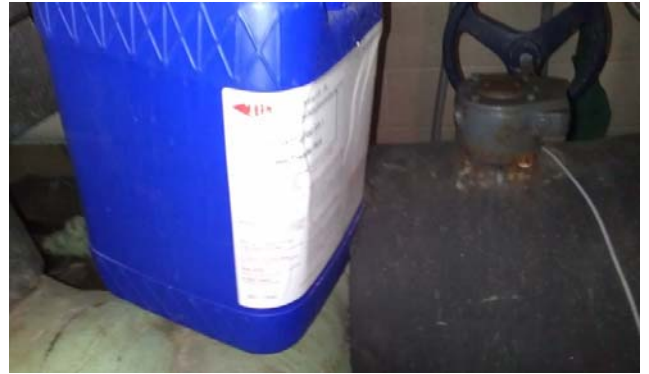
26. View of Three Open Blue Containers Containing a label of "Heat Transfer Fluid" within the First Floor Mechanical Room.

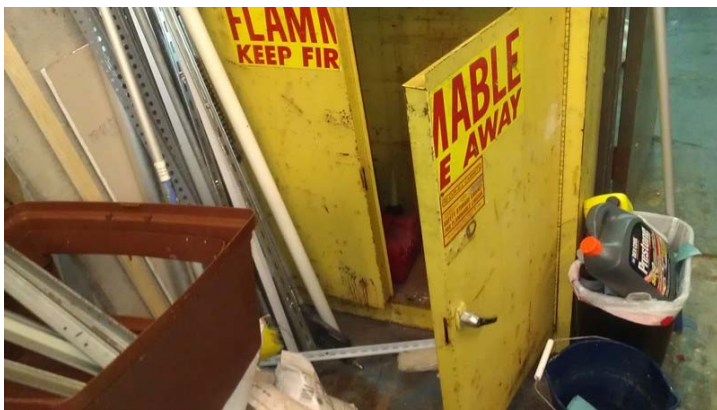
27. View of Yellow Cabinet containing Flammable Products.

Several drums, paints, solvents, and other chemicals were observed at the site. If the products will not be utilized they should be appropriately removed from the site for recycling purposes.

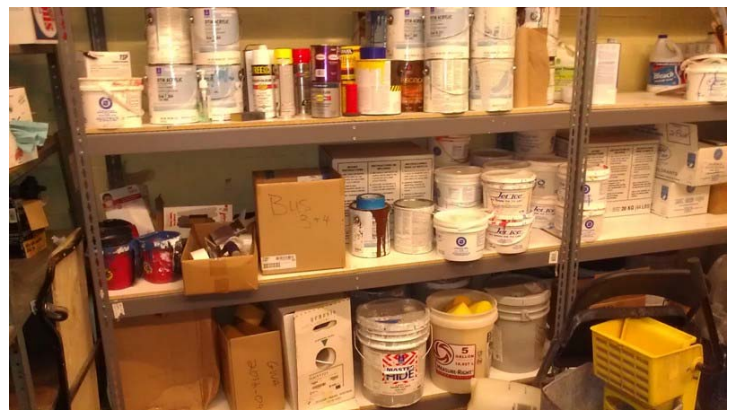
28. View of Paints and Chemicals within the Ice Rink Area.

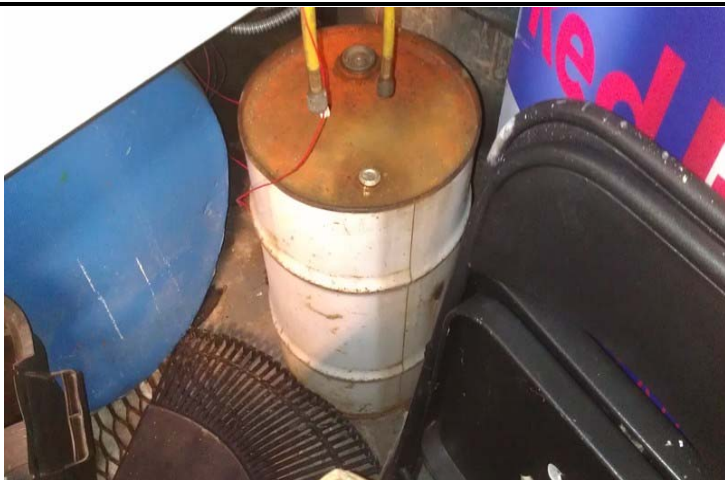
One white 55-gallon drum of unknown content was observed in the second floor mechanical equipment room. Two black 55-gallon drums of unknown content were observed in the cooling tower which is accessed from the second floor mechanical equipment room and area likely associated with water treatment system. Two water treatment 55-gallon drums were observed along the exterior (east side) of the building.

29. View of White Drum of Unknown Content within the Second Floor Mechanical Equipment Room

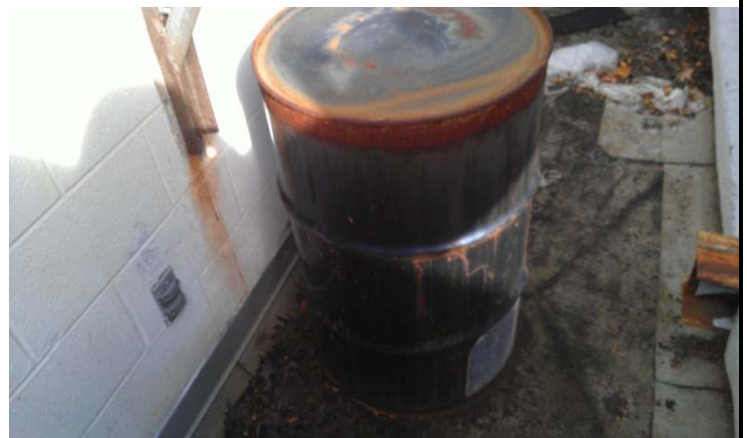
30. View of Black Drums of Unknown Content within the Second Floor Cooling Tower.

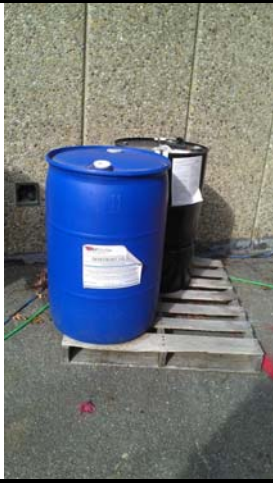
31. View of Container for Water Treatment along the East Side of the Building Exterior.

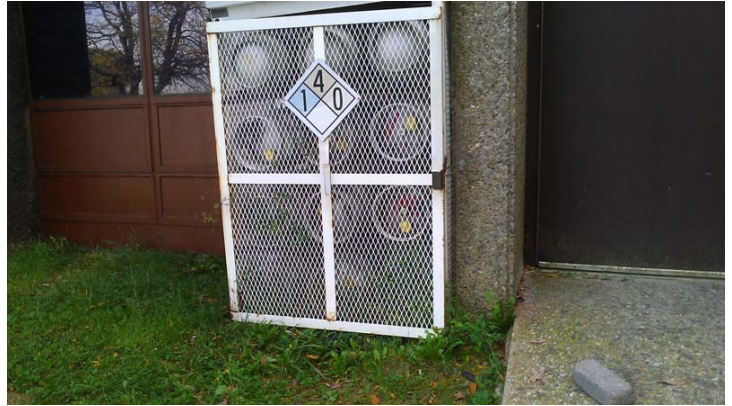
32. View of Propane Tanks along the West Side of the Building Exterior.

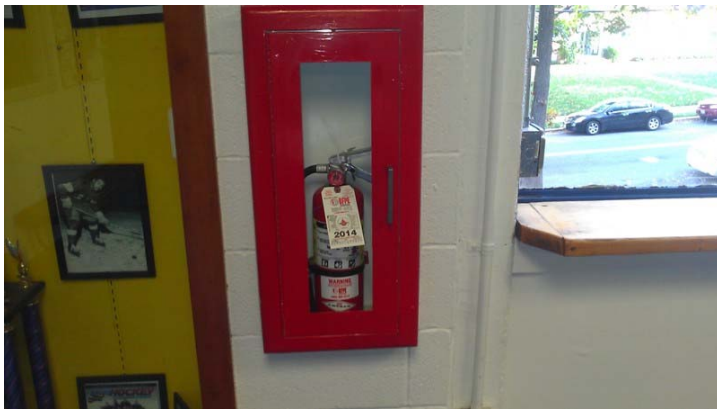
33. View of Fire Extinguisher

Refrigerants in chillers, refrigerators, and other equipment should be reclaimed and disposed of properly. The EPA requires that any equipment dismantled on-site prior to disposal must have its refrigerant recovered in accordance with EPA's Refrigerant Recycling Rules (Section 608). However, equipment that typically enters the waste stream during demolition with the charge intact (e.g. air conditioners, refrigerators, and water fountains) is subject to special safe disposal requirements. Under the EPA requirements, the final party in the disposal chain (e.g. scrap metal recycler or landfill owner) is responsible for ensuring that refrigerants are recovered from equipment prior to final disposition. However, refrigerants can also be evacuated prior to disposal provided proper documentation of the evacuation is provided to the disposal facility.

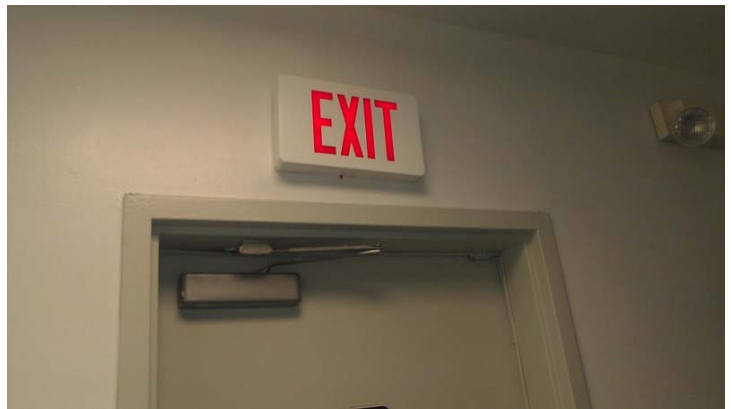
34. View of Exit Sign Assumed to Contain Lead-Acid Battery.

Lamp ballasts, mercury containing switches, lead-acid batteries and other regulated waste materials must be segregated and disposed of as universal waste as required by the EPA and District of Columbia. If any of these materials are observed to be leaking or otherwise damaged prior to disposal they must be disposed of as hazardous waste in accordance with EPA and District of Columbia regulations. Handling, packaging, labeling, and disposal of hazardous materials should be performed in accordance with EPA and District of Columbia regulations. The District of Columbia will require the buildings' owner (referred to as the "generator") to obtain an EPA Generator ID number in order to dispose of hazardous waste materials. A copy of the EPA Generator ID number application has been enclosed with this report. It should be completed and submitted to DDOE to obtain a number prior to the removal of any hazardous or universal waste materials from the site.
