May 3, 2019

Subject: Lead Survey
Janney Elementary School
4130 Albemarle Street NW
Washington, DC 20016

Attachment A
Screening Locations

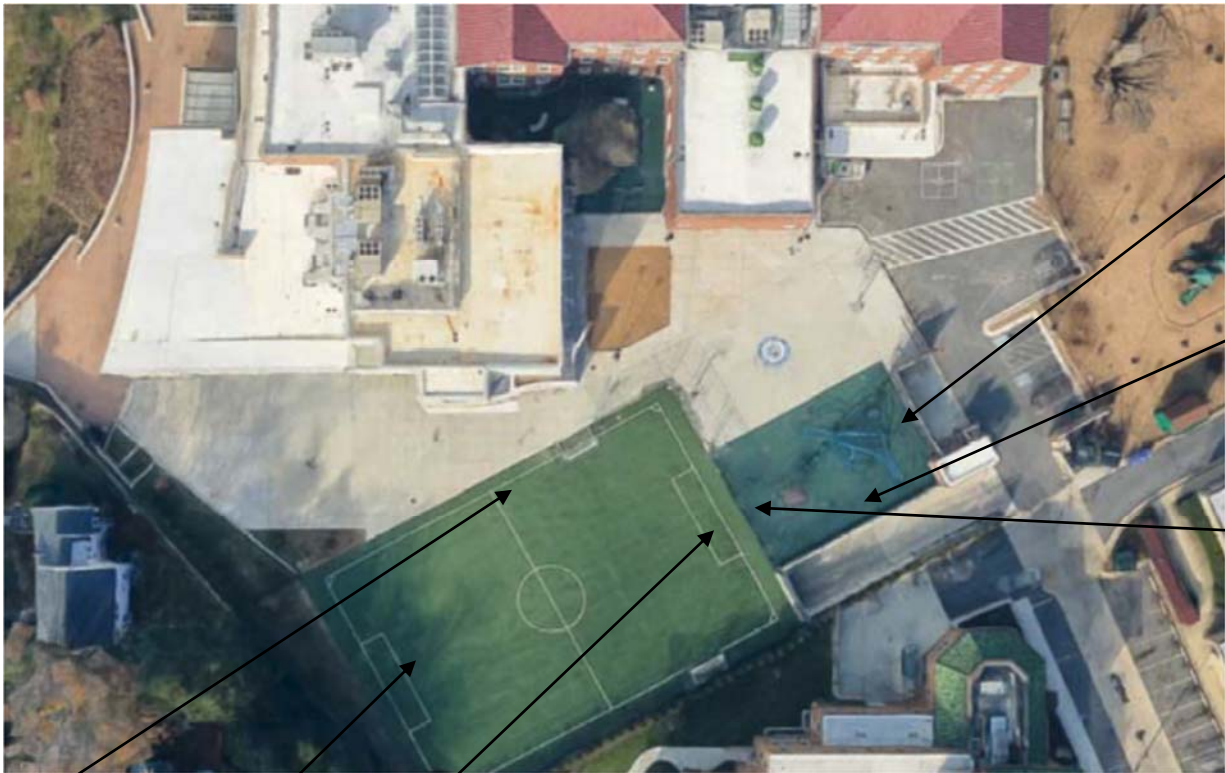
A total of six XRF readings were taken of the Playground PIP and the adjacent synthetic field. All the surfaces were negative for the presence of lead. Six (6) bulk samples of the Playground PIP and the Synthetic Turf have been submitted for lead analyzation.
