Task 2: Investigation of the Existing Conditions for Compliance

TECHNICAL MEMO 2 - RECOMMENDATIONS

PROJECT: Kalorama Park (Volkert No. 230405.60)

DATE OF REPORT: June 29, 2012

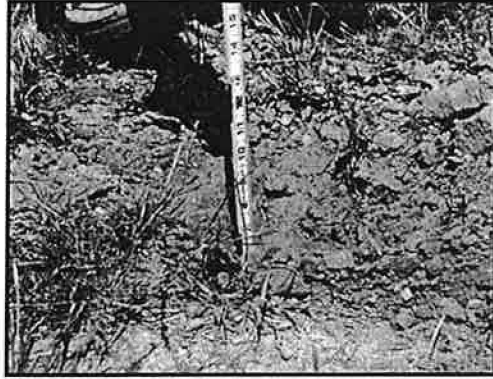
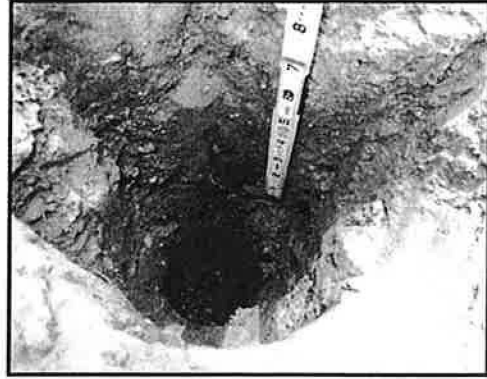
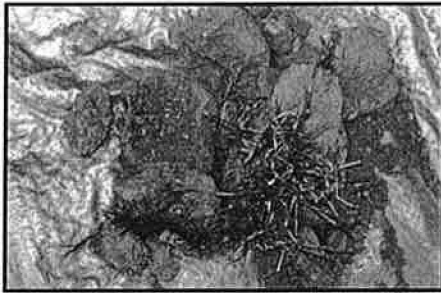
TP#1: 0"-12"

The top layer of test pit #1 consists of clay like medium that appears to be bonded together. Grass has not established to a satisfactory condition and appears in only small patches. At 6" we encountered a slightly loamy sand mix.

OBSERVATION	INITIAL RECOMMENDATIONS
See Above.	Remove top 12" of material and provide suitable mix.

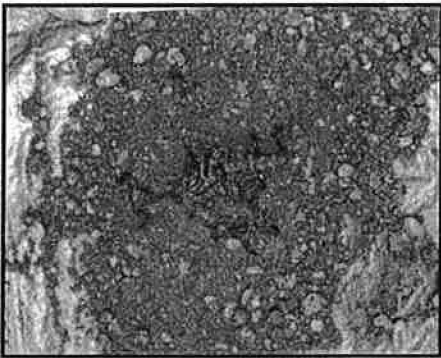
TP#1: 12"-18"

At 12 to 18 inches, we encountered layers of sand and construction debris, such as filter fabric. The filter fabric layer was found at 18" between two layers of sand. The sand layers were 2"-3" thick each.

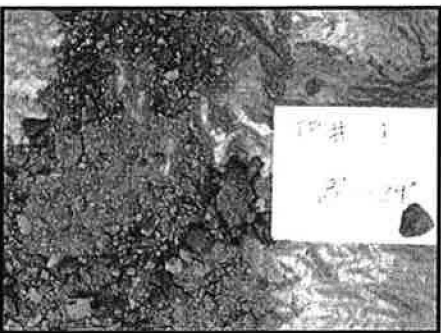
TP#1: 18"-24"

At 18 to 24 inches, we encountered sandy soil and construction debris. The construction debris consisted of pieces of concrete, asphalt, brick, and filter fabric.

As the boring process continued it was clear the layer of sand mixed with construction debris extended throughout the area around TP#1.

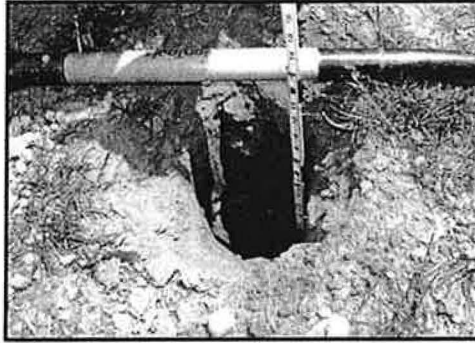
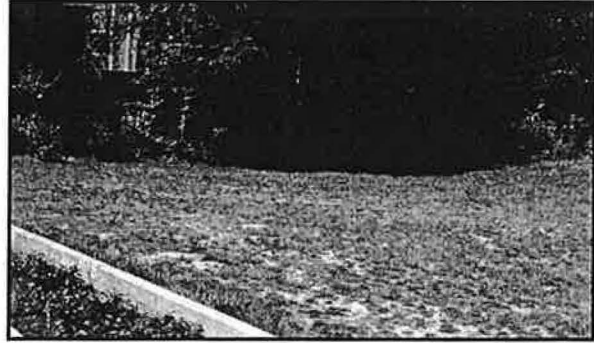
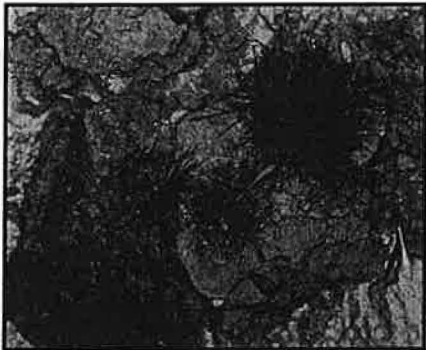
TP#2: 0"-12"

The top layer of test pit #2 consists of clay like medium that appears to be bonded together. Grass has not established to a satisfactory condition and appears in only small patches. At 6" we encountered a slightly loamy sand mix.

- Remove top 12" of material and provide suitable mix.
- Treat with sod or seed.

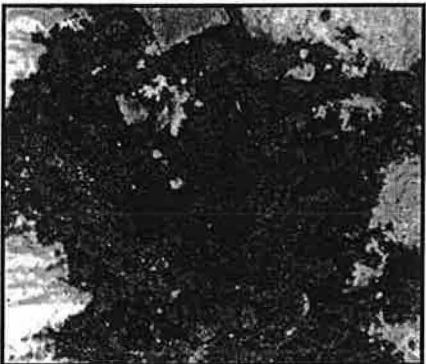
TP#2: 12"-18"

At 12 to 18 inches, we encountered layers of sand and construction debris, such as filter fabric. The filter fabric layer was found at 18" between two layers of sand. The sand layers were 2"-3" thick each.

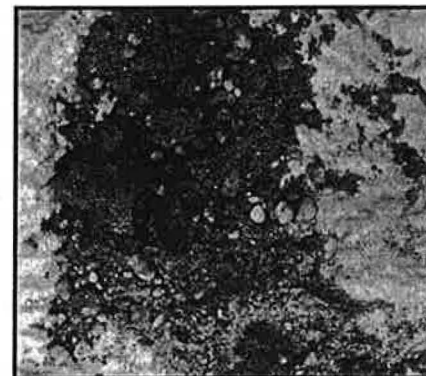
TP#2: 18"-24"

At 18 to 24 inches we encountered sandy soil and construction debris. The construction debris consisted of pieces of concrete, asphalt, brick, and filter fabric.

As the boring process continued it was clear the layer of sand mixed with construction debris extended throughout the area around TP#2.

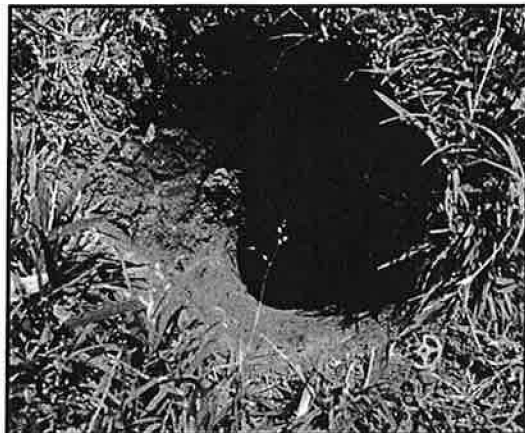
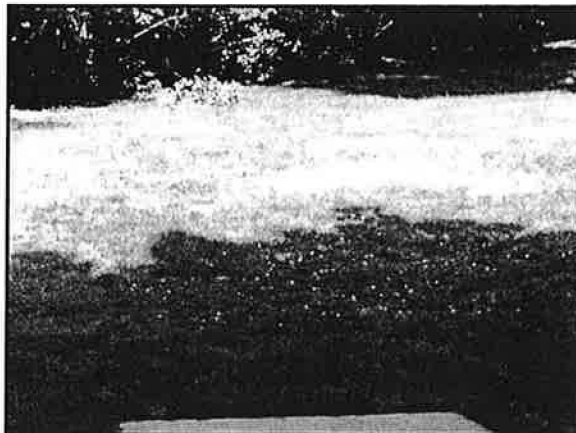
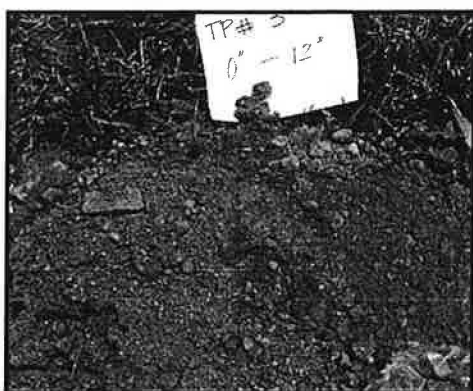
TP#3: 0"-12"

At the top layer of test pit #3 the grass seemed to have taken normally. However, the grass mix appeared to contain weeds. At 2 to 12 inches we encountered natural soil with some small rocks.

OBSERVATION	INITIAL RECOMMENDATIONS
See Above.	a. Remove top 6" of material and provide suitable mix. b. Treat with sod or seed.

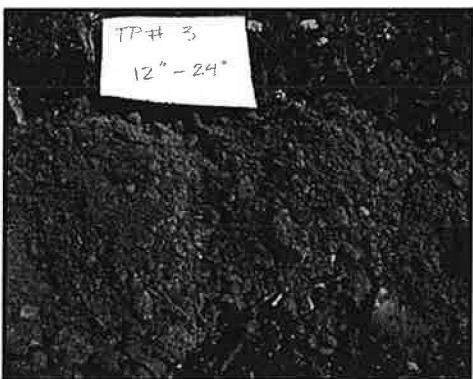
TP#3: 12"-24"

At 18 to 24 inches we encountered a slightly sandy medium with some small rocks. The soil moisture appeared suitable.

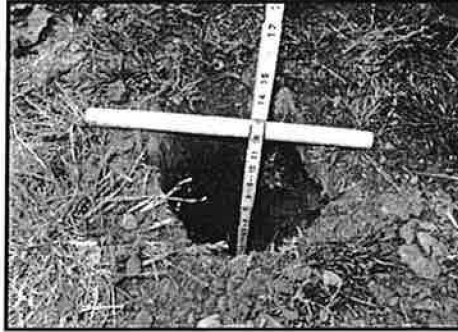
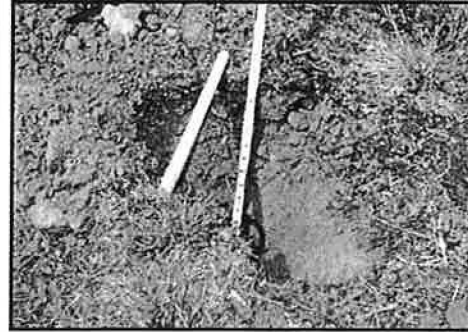
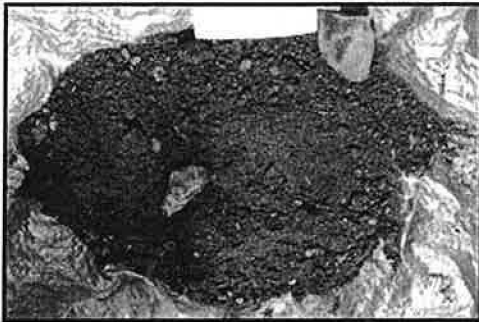
TP#4: 0"-12"

At 0 to 12 inches we encountered soil mixed with sand, clay and construction entrance debris. Soil excavation was hindered by numerous stones and hard soil.

Review of the construction drawings indicates that this area was a construction entrance during the construction of the site improvements. The stones and the hard subsurface encountered may be the result of improper removal of the construction entrance material.

- Remove top 36" of material and provide suitable mix.
- Treat with sod or seed.

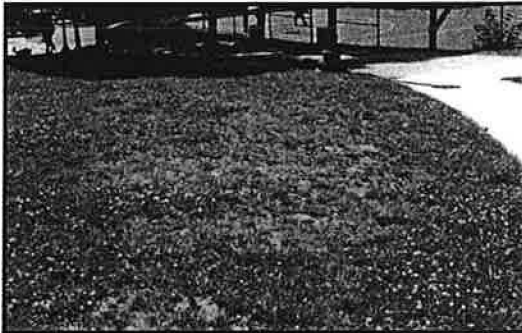
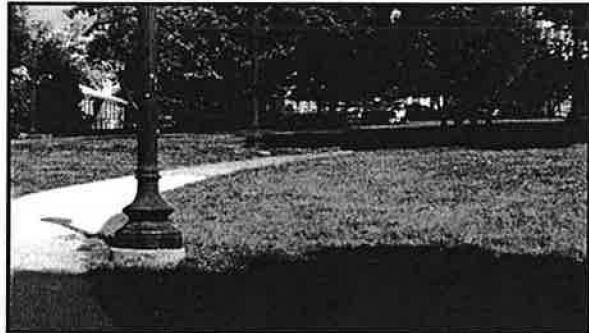
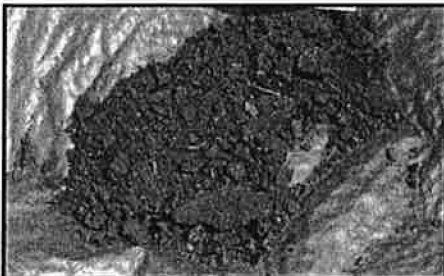
TP#5: 0"-12"

At 0 to 12 inches we encountered natural soil. Soil appeared to be slightly dryer than expected, but otherwise acceptable.

- Remove top 6" of material and provide suitable mix.

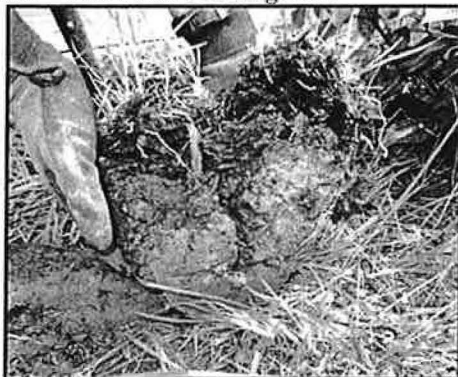
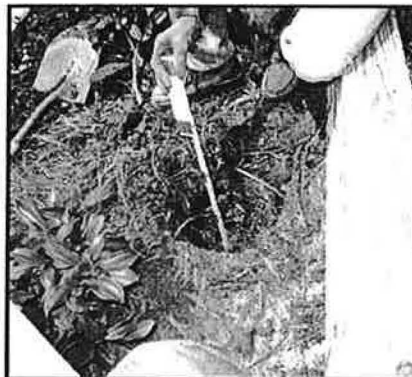
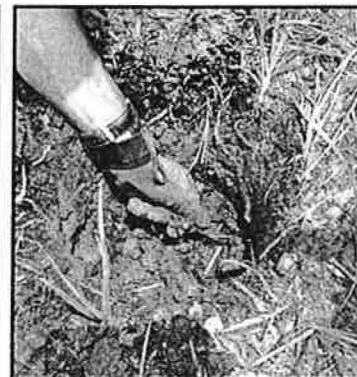
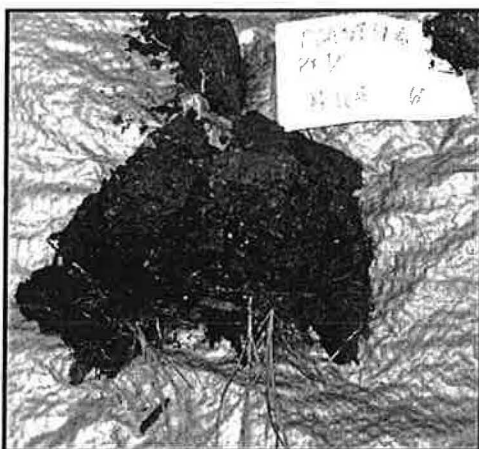
**TP: 0"-6"****TP#6: 0"-6"**

At 0 to 6 inches we encountered a layer of mulch on wet soil. The clay like medium appeared to be inadequate. However, the plants appeared healthy. Roots of shrubs have spread through the planting medium. Weeds are abundant. Roots of weeds remain on the top 1 inch of the planting soil.

Remove weeds (Also see recommendations in the Plantings section).

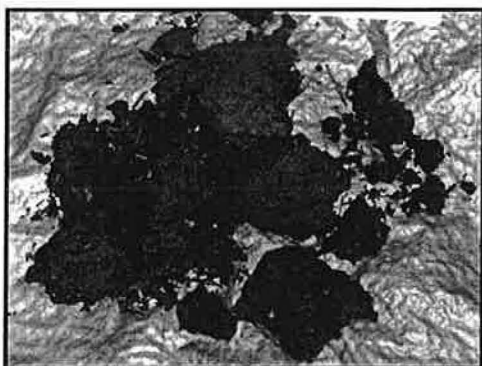
**TP: 6"-12"****TP#6: 6"-12"**

At 6 to 12 inches the soil medium was continuously moist with minor construction debris.

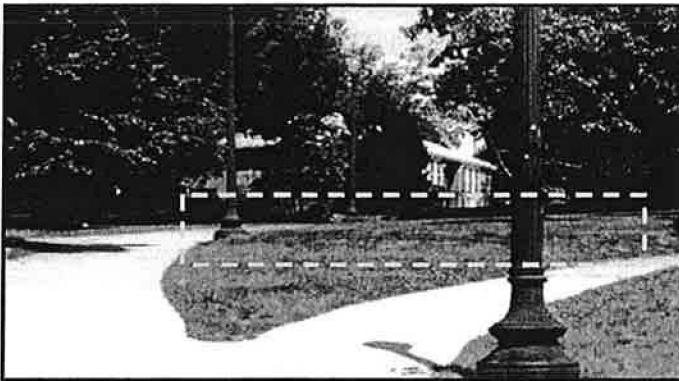
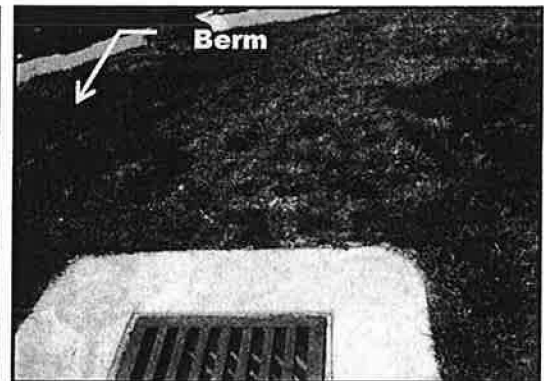
Berm B2

<i>OBSERVATION</i>	<i>INITIAL RECOMMENDATIONS</i>
<ul style="list-style-type: none">• Bioswale appears to be working normally.• Berm is mostly well covered with lawn. In some area, bare patches appear.• Catch basin at the end of bioswale is dry.	<ul style="list-style-type: none">a. Treat area with seed or sod.b. Flush catch basin and cleanout pipes.

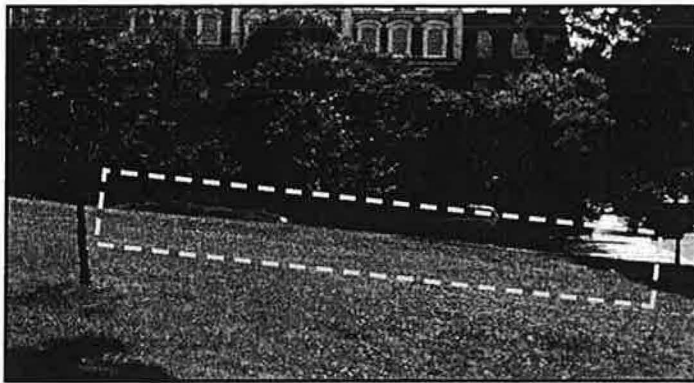
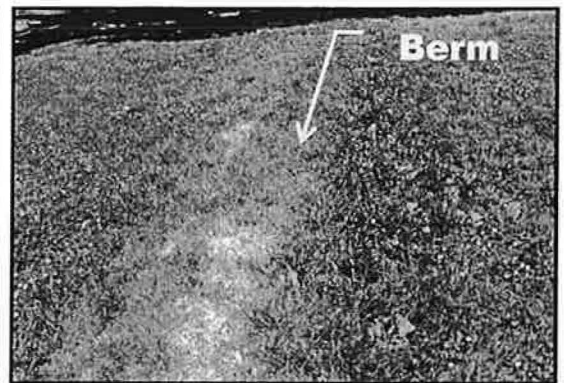
Berm B3

<i>OBSERVATION</i>	<i>INITIAL RECOMMENDATIONS</i>
<ul style="list-style-type: none">• Bioswale appears to be working normally.• Berm is mostly well covered with lawn. In some area, bare patches appear.• Catch basin at the end of bioswale has miscellaneous debris.	<ul style="list-style-type: none">a. Prepare bare areas around the catch basin for new lawn.b. Treat area with seed or sod.c. Remove debris in catch basin. Flush catch basin and cleanout pipes.

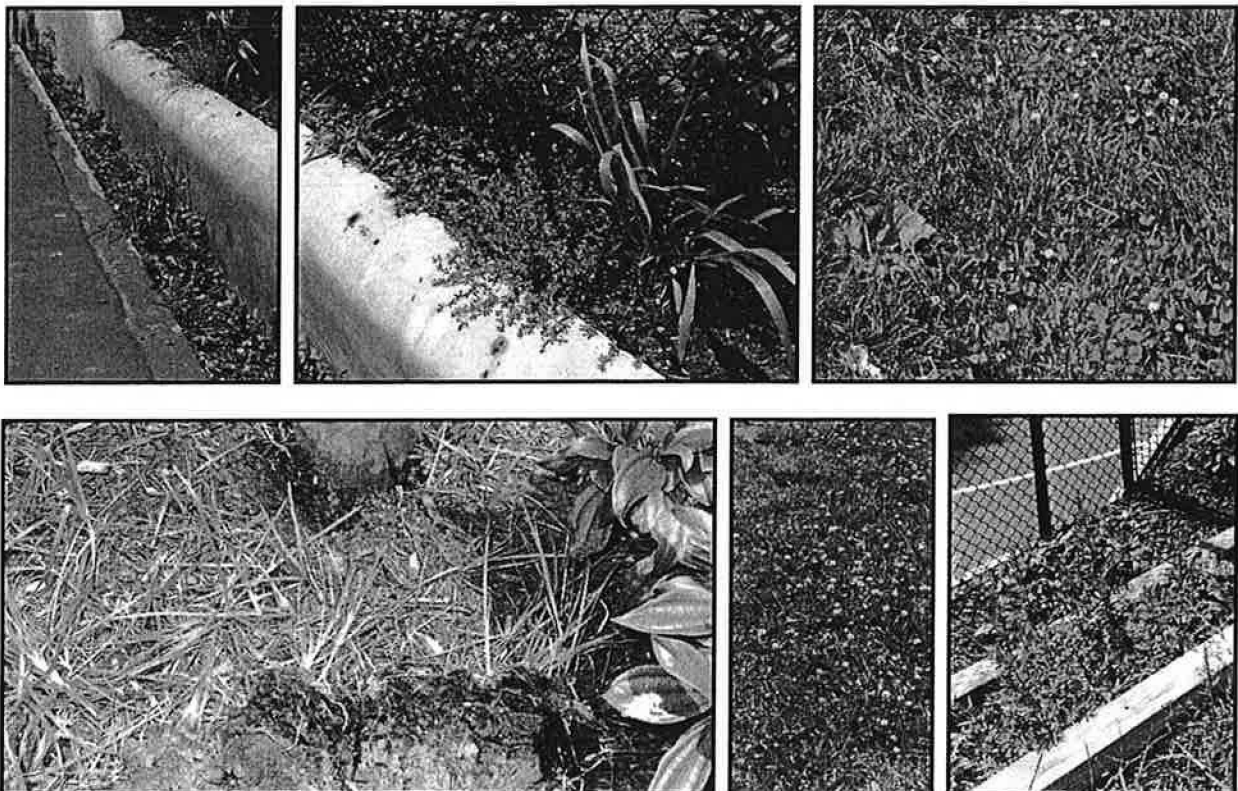
Weeds

There are weeds throughout the site.

a. Remove weeds.

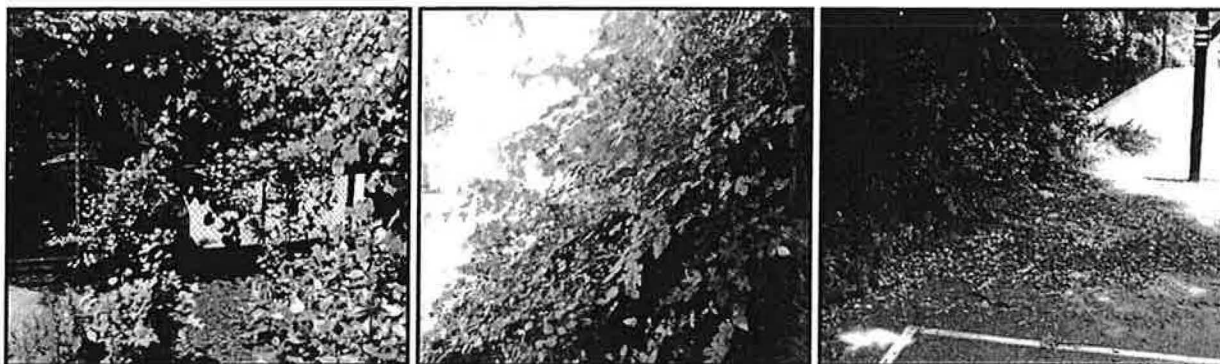
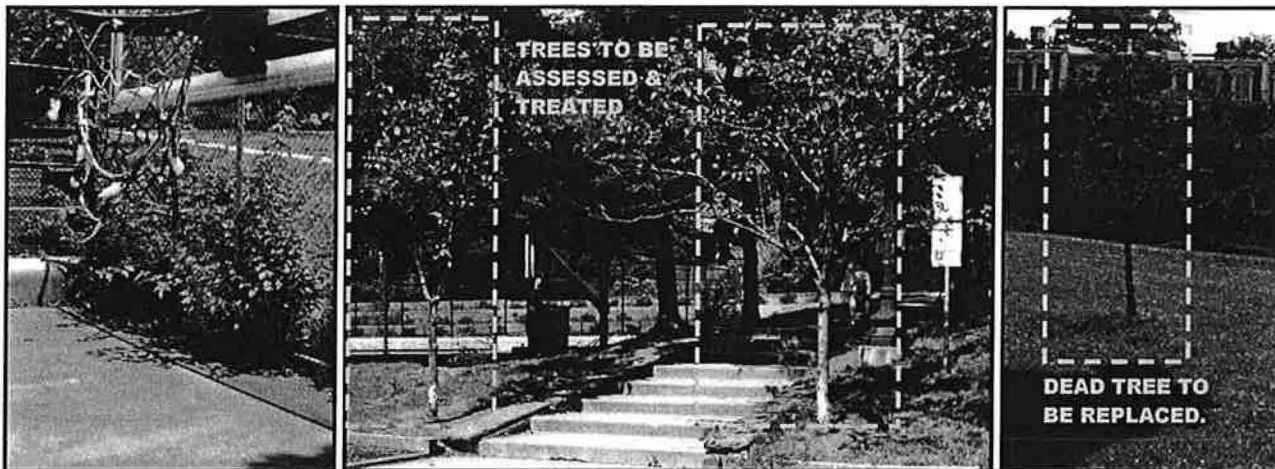
Pruning & Trees

OBSERVATION	INITIAL RECOMMENDATIONS
<ul style="list-style-type: none"> Vines and trees are hanging over planted materials and site features. Trees at the 19th Street NW entrance into the park appear to be in poor health. Roots may have been damaged from construction activity. 	<ol style="list-style-type: none"> Prune shrubs and ground cover. Have tree roots pruned and treated by arborist. Trees that are dead or dying should be replaced or treated as directed by arborist.

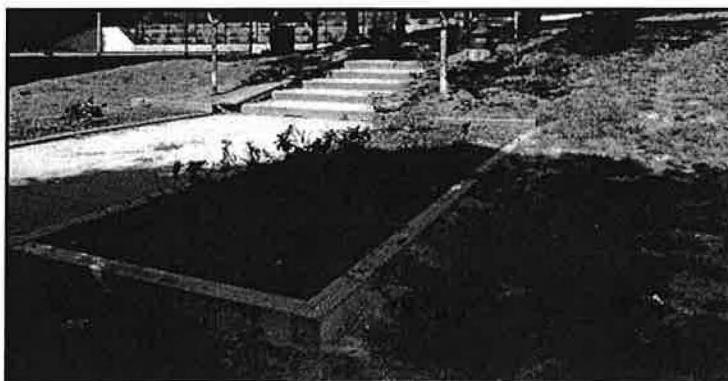
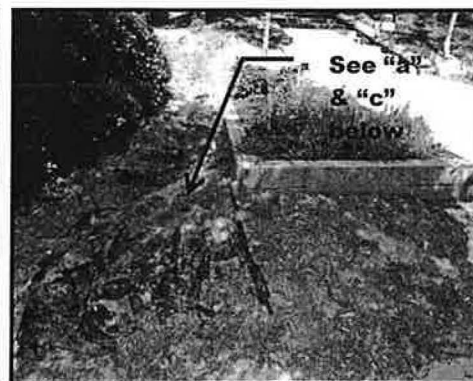
Shrubs and Groundcover at West Entrance

OBSERVATION	INITIAL RECOMMENDATIONS
<ul style="list-style-type: none"> Most shrubs and other plantings in the 19th Street entrance planters are in poor condition. Soil condition seems to be a loamy clay. Unlike the condition in Soil Test Pit Area 6, the plants in this area do not seem to have access to the moisture and are in decay. Planting beds at the west entrance of the park are full of weeds and grass. Grass adjacent to planters is in poor condition. Filter fabric and debris is exposed around planters. 	<ol style="list-style-type: none"> Remove filter fabric, debris, and weeds. Remove top 6" of soil in planter boxes and replace with planting soil. Install heavy duty filter fabric. Cut opening in fabric to allow shrubs to grow. Install a 3" thick layer of mulch to the top of timber plank. Shrubs should stay in place, undisturbed. Treat area around planter boxes with sod or seed.

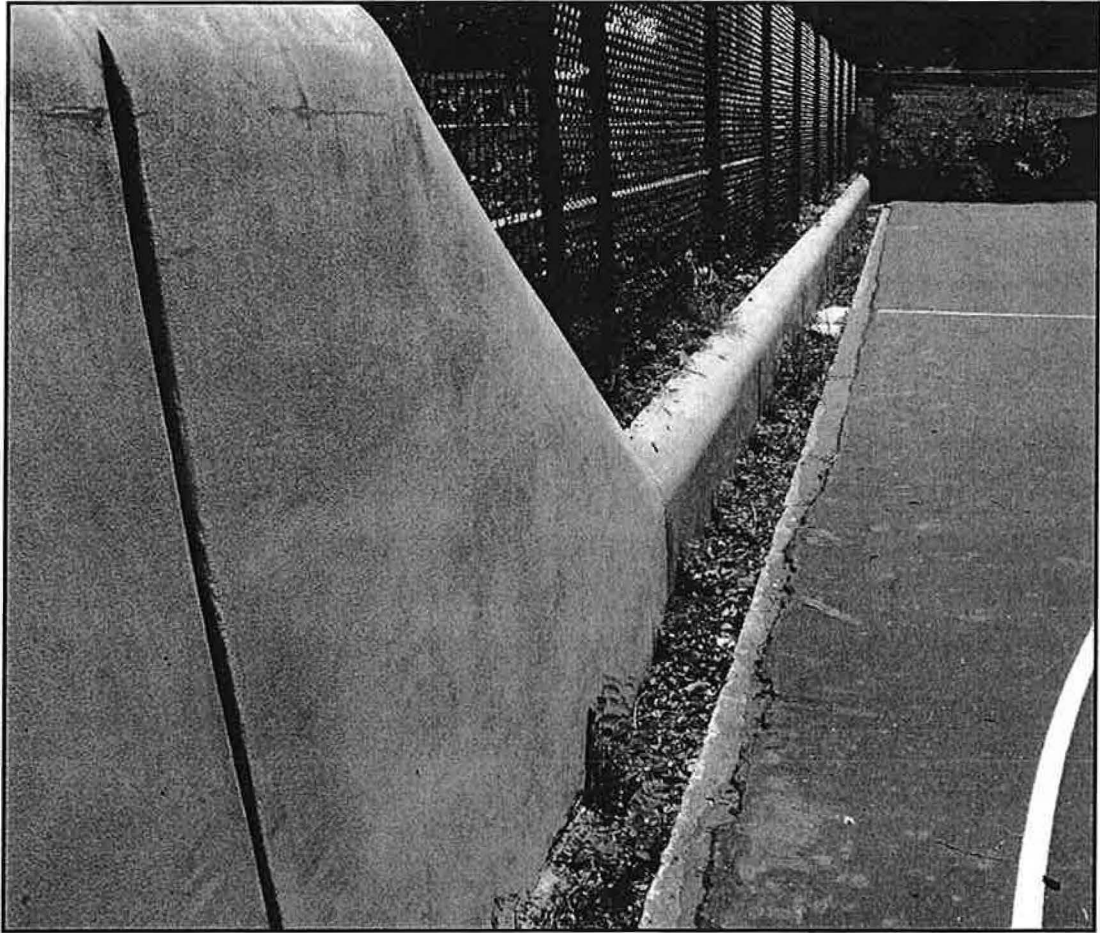
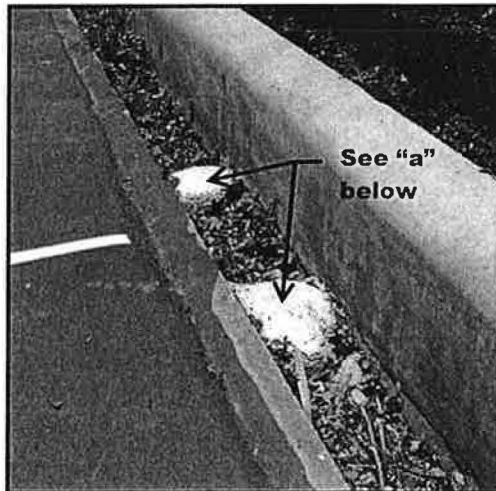
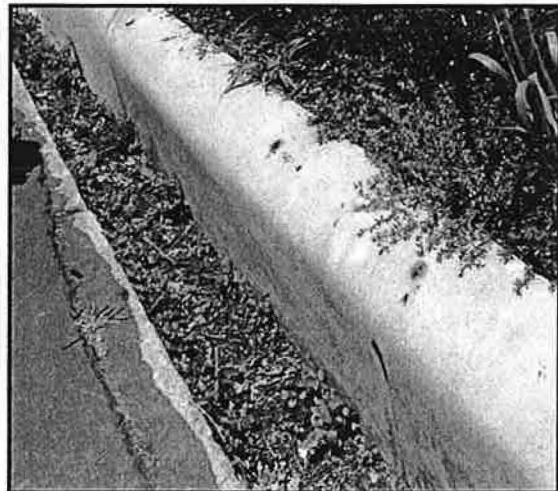
Concrete Wall and Paving

OBSERVATION	INITIAL RECOMMENDATIONS
<ul style="list-style-type: none">• Pavement between basketball court and retaining wall is missing and hazardous.• Foundation of previously existing basketball court remains in place, and is an obstruction to anyone using the court.	<ul style="list-style-type: none">a. Remove top 12" of old basket ball hoop concrete foundation.b. Install basketball court surface with a concrete base at gap between retaining wall and existing court. Provide a continuous expansion joint between wall and subbase.

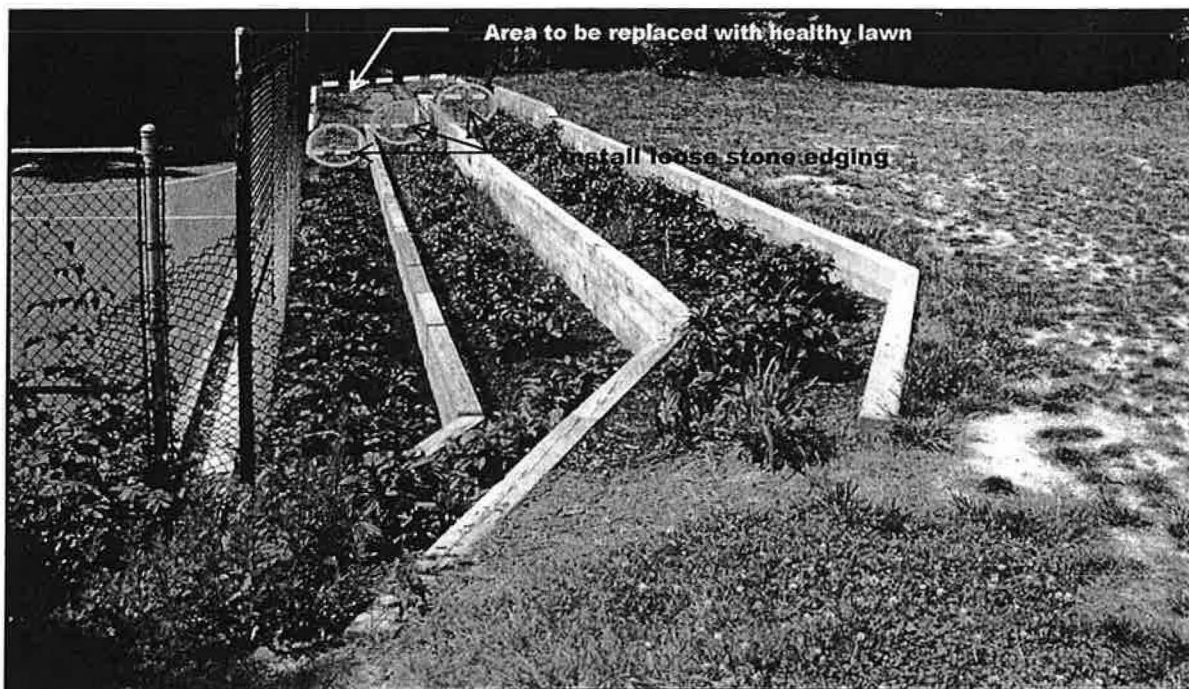
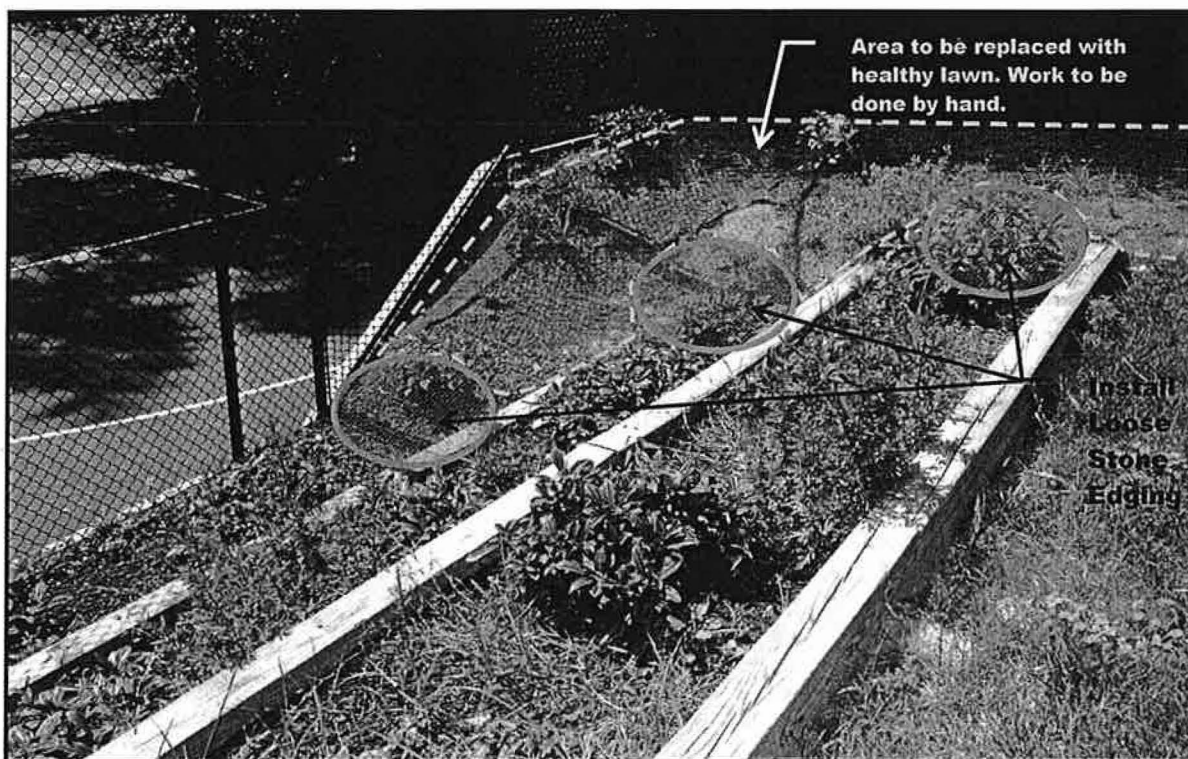
Terraced Timber Retaining Wall and Planter

OBSERVATION	INITIAL RECOMMENDATIONS
<ul style="list-style-type: none"> • Terraced wall was installed by second contractor without plans. Layout was coordinated with DPR. • Terraced planting bed at the north ends is eroding and existing filter fabric is falling apart. 	<p>a. Remove planting and filter fabric at the north end or the terraced planter and replace with sod or seed. Provide $\pm 18"$ dia. rounded loose stone edging between grass and planter to separate lawn from planting (see images above). There should be no digging past 12".</p>

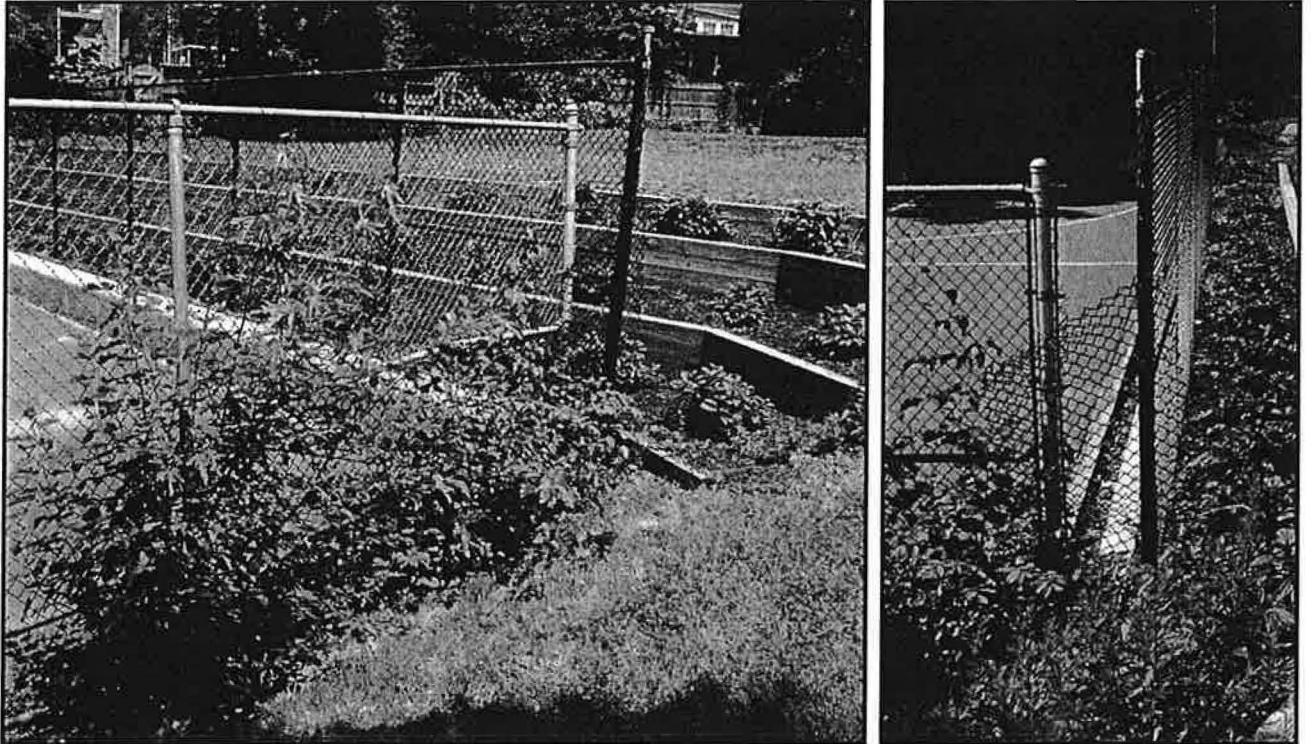
<i>OBSERVATION</i>	<i>INITIAL RECOMMENDATIONS</i>
<ul style="list-style-type: none">• New black fence and previously existing fence are poorly tied together with miscellaneous fence fabric.	<ol style="list-style-type: none">a. Correctly tie new fence fabric to fence posts.
