KALORAMA PARK

PHASE I

TECHNICAL MEMO 1 - SITE INVESTIGATION NOTES

TECHNICAL MEMO 2 - RECOMMENDATIONS

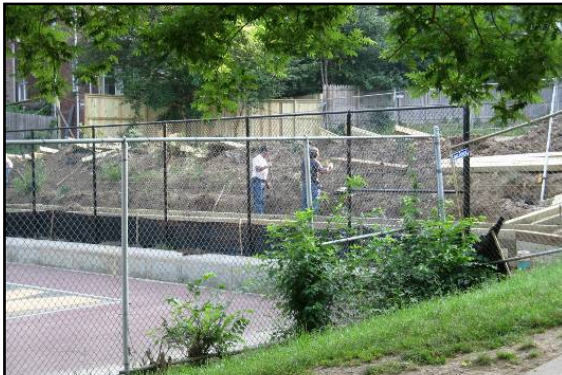
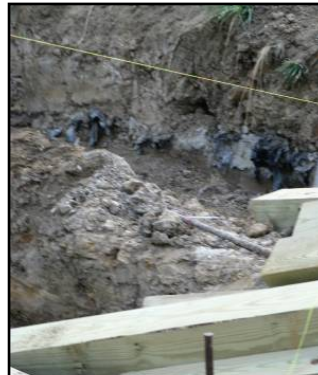
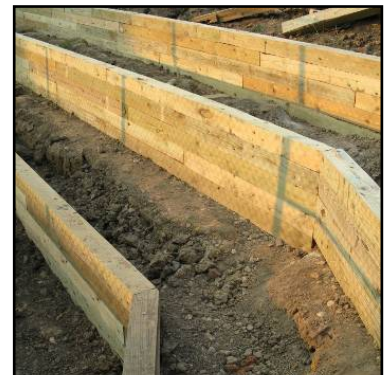
Photographs of construction of timber retaining wall.

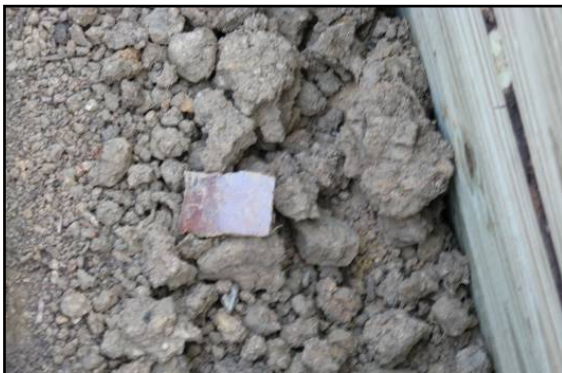
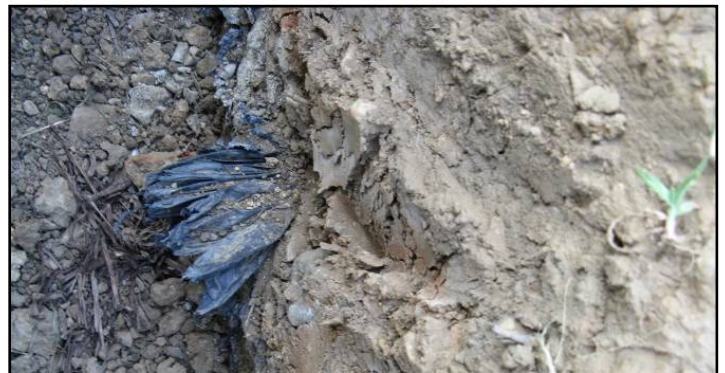
Photographs of construction debris and soil medium below lawn and planting areas.

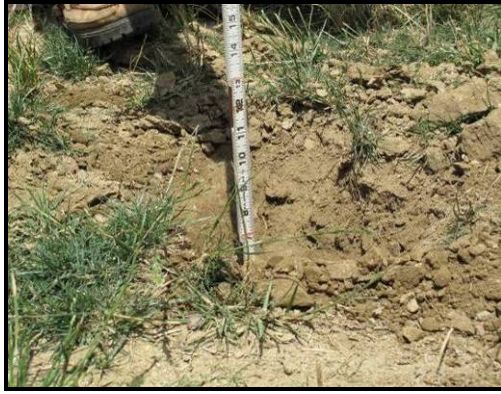
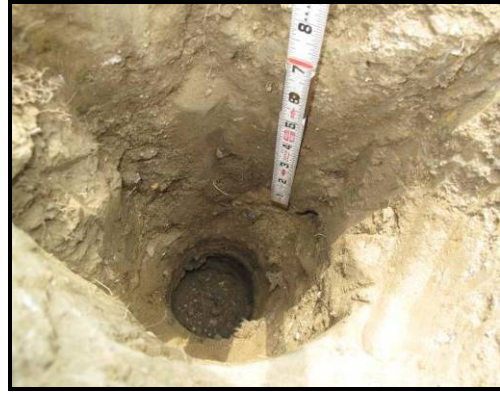
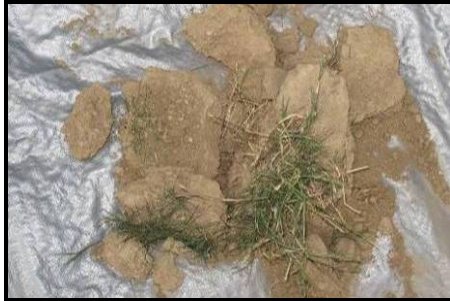
TP#1: 0"-12"

The top layer of test pit #1 consists of clay like medium that appears to be bonded together. Grass has not established to a satisfactory condition and appears in only small patches. At 6" we encountered a slightly loamy sand mix.

OBSERVATION	INITIAL RECOMMENDATIONS
See Above.	Remove top 12" of material and provide suitable mix.

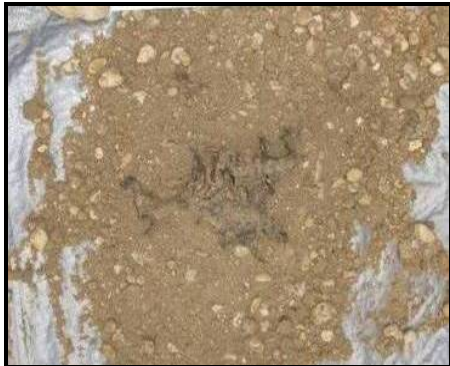
TP#1: 12"-18"

At 12 to 18 inches, we encountered layers of sand and construction debris, such as filter fabric. The filter fabric layer was found at 18" between two layers of sand. The sand layers were 2"-3" thick each.

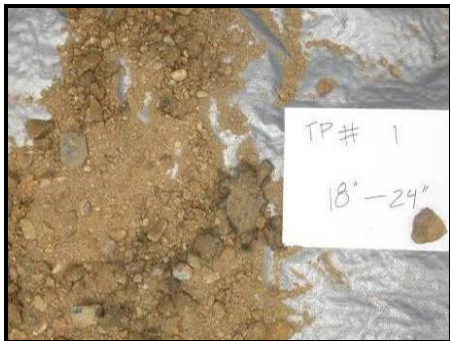
TP#1: 18"-24"

At 18 to 24 inches, we encountered sandy soil and construction debris. The construction debris consisted of pieces of concrete, asphalt, brick, and filter fabric.

As the boring process continued it was clear the layer of sand mixed with construction debris extended throughout the area around TP#1.

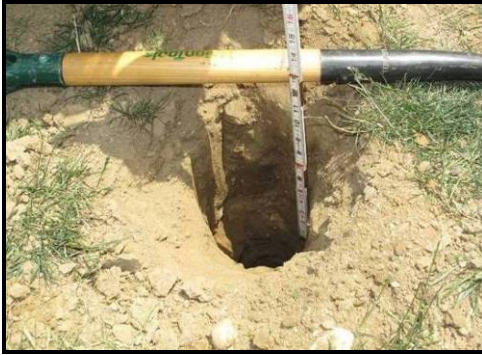
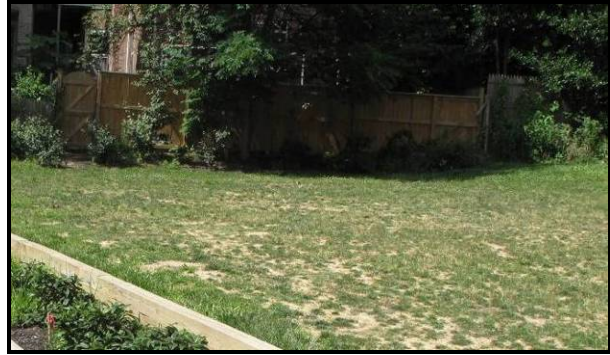
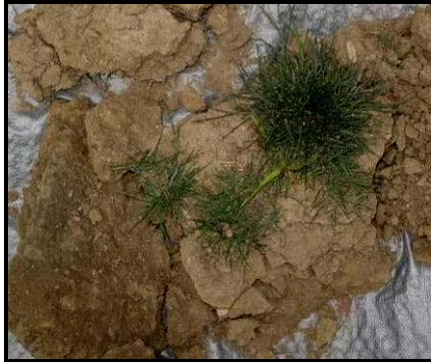
TP#2: 0"-12"

The top layer of test pit #2 consists of clay like medium that appears to be bonded together. Grass has not established to a satisfactory condition and appears in only small patches. At 6" we encountered a slightly loamy sand mix.

OBSERVATION	INITIAL RECOMMENDATIONS
See Above.	<ul style="list-style-type: none"> a. Remove top 12" of material and provide suitable mix. b. Treat with sod or seed.

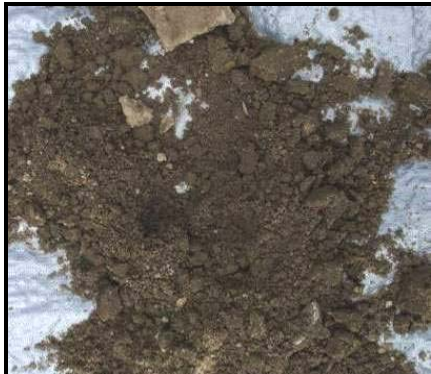
TP#2: 12"-18"

At 12 to 18 inches, we encountered layers of sand and construction debris, such as filter fabric. The filter fabric layer was found at 18" between two layers of sand. The sand layers were 2"-3" thick each.

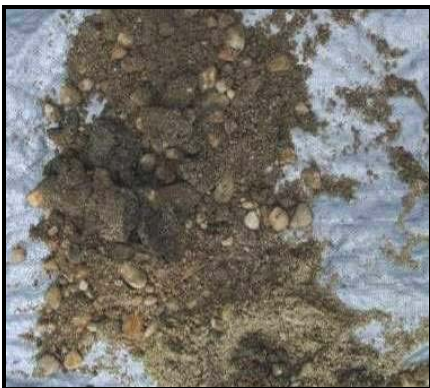
TP#2: 18"-24"

At 18 to 24 inches we encountered sandy soil and construction debris. The construction debris consisted of pieces of concrete, asphalt, brick, and filter fabric.

As the boring process continued it was clear the layer of sand mixed with construction debris extended throughout the area around TP#2.

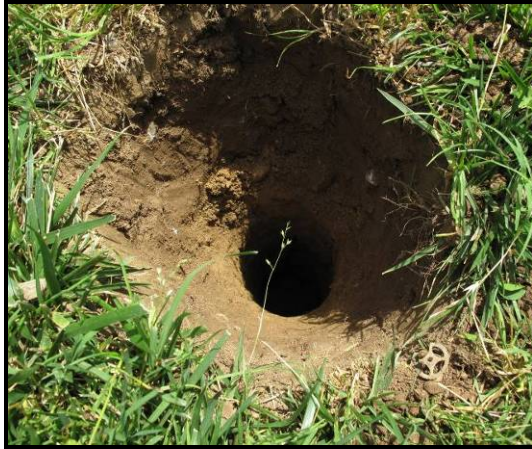
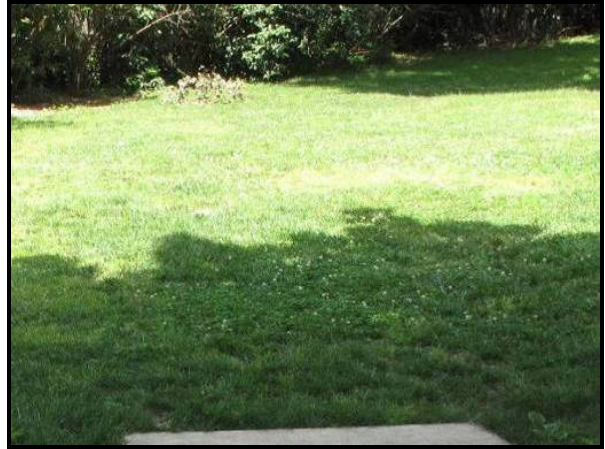
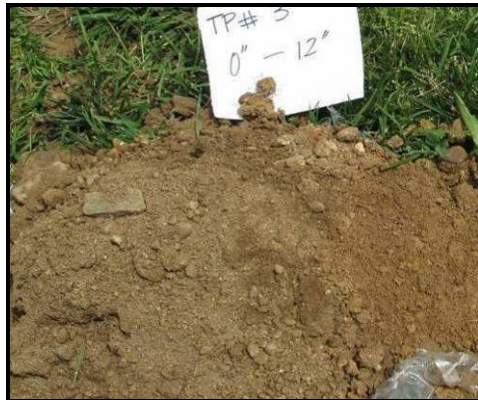
TP#3: 0"-12"

At the top layer of test pit #3 the grass seemed to have taken normally. However, the grass mix appeared to contain weeds. At 2 to 12 inches we encountered natural soil with some small rocks.

OBSERVATION	INITIAL RECOMMENDATIONS
See Above.	<ul style="list-style-type: none"> a. Remove top 6" of material and provide suitable mix. b. Treat with sod or seed.

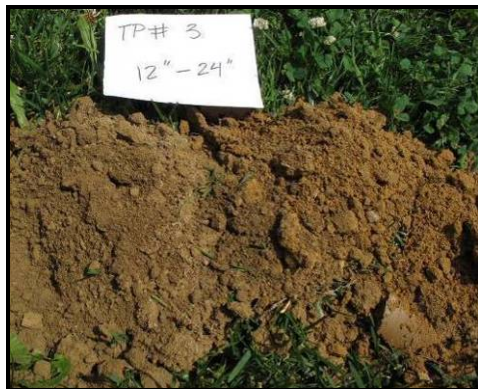
TP#3: 12"-24"

At 18 to 24 inches we encountered a slightly sandy medium with some small rocks. The soil moisture appeared suitable.

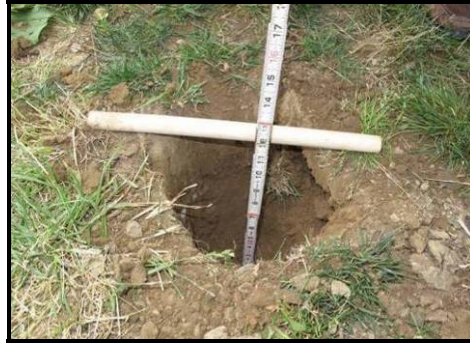
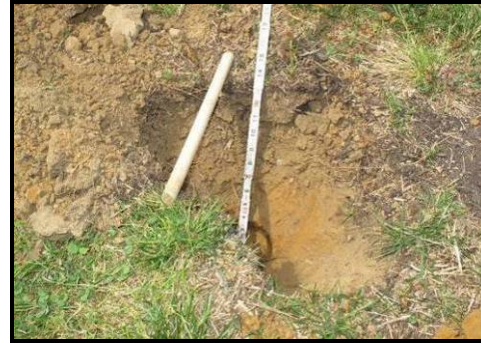
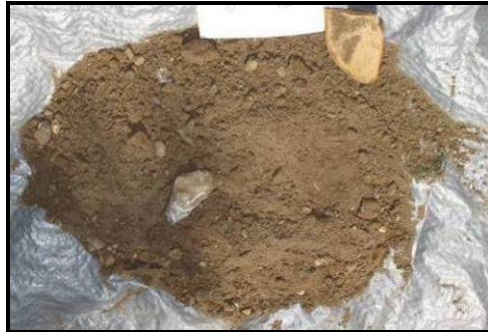
TP#4: 0"-12"

At 0 to 12 inches we encountered soil mixed with sand, clay and construction entrance debris. Soil excavation was hindered by numerous stones and hard soil.

Review of the construction drawings indicates that this area was a construction entrance during the construction of the site improvements. The stones and the hard subsurface encountered may be the result of improper removal of the construction entrance material.

OBSERVATION	INITIAL RECOMMENDATIONS
See Above.	<ul style="list-style-type: none"> a. Remove top 36" of material and provide suitable mix. b. Treat with sod or seed.

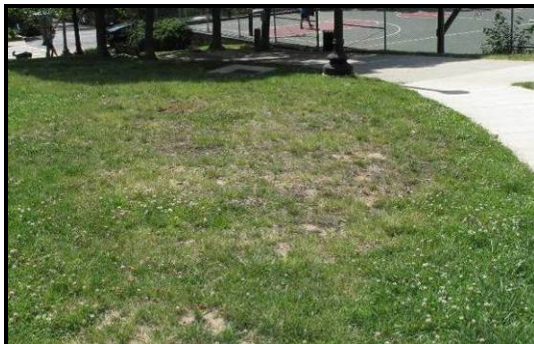
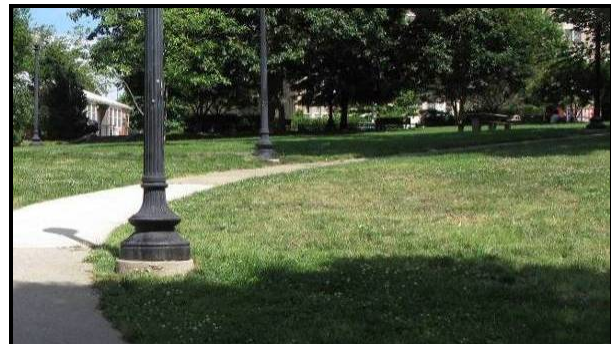
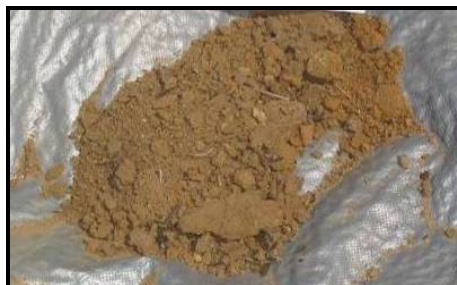
TP#5: 0"-12"

At 0 to 12 inches we encountered natural soil. Soil appeared to be slightly dryer than expected, but otherwise acceptable.

OBSERVATION	INITIAL RECOMMENDATIONS
See Above.	<ul style="list-style-type: none"> a. Remove top 6" of material and provide suitable mix.

b. Treat with sod or seed.

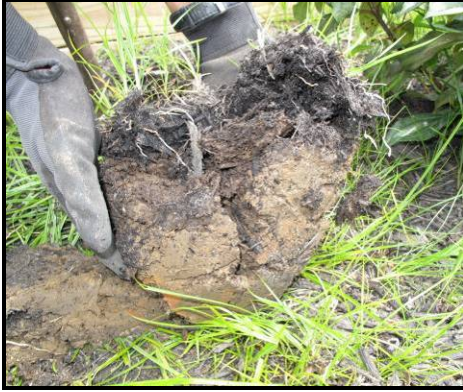
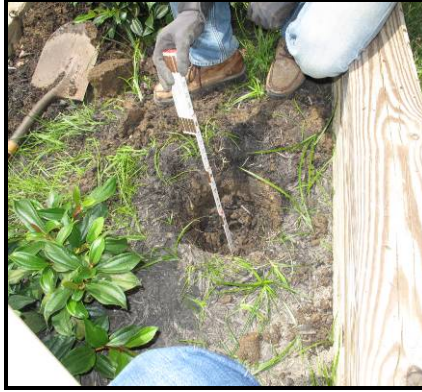
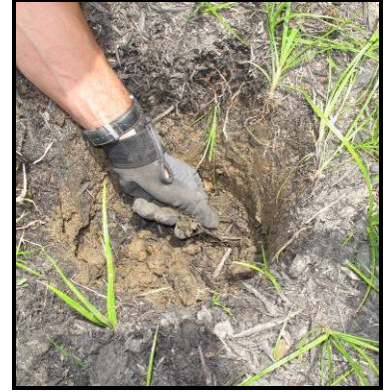
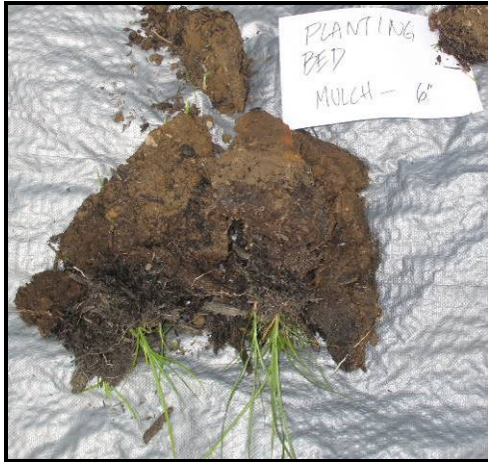
**TP: 0"-6"****TP#6: 0"-6"**

At 0 to 6 inches we encountered a layer of mulch on wet soil. The clay like medium appeared to be inadequate. However, the plants appeared healthy. Roots of shrubs have spread through the planting medium. Weeds are abundant. Roots of weeds remain on the top 1 inch of the planting soil.

Remove weeds (Also see recommendations in the Plantings section).

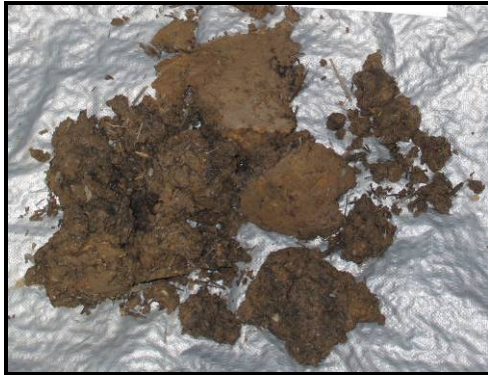
**TP: 6"-12"****TP#6: 6"-12"**

At 6 to 12 inches the soil medium was continuously moist with minor construction debris.

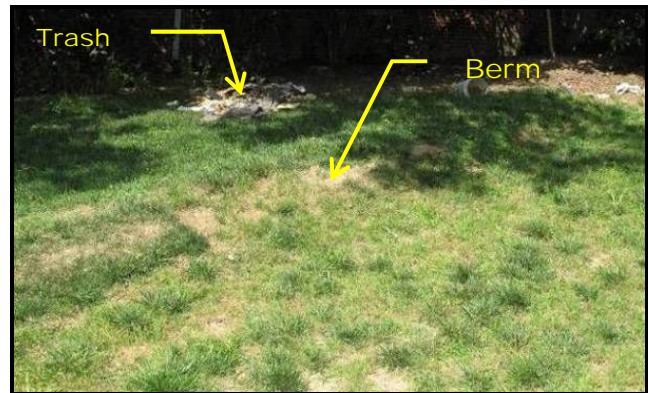
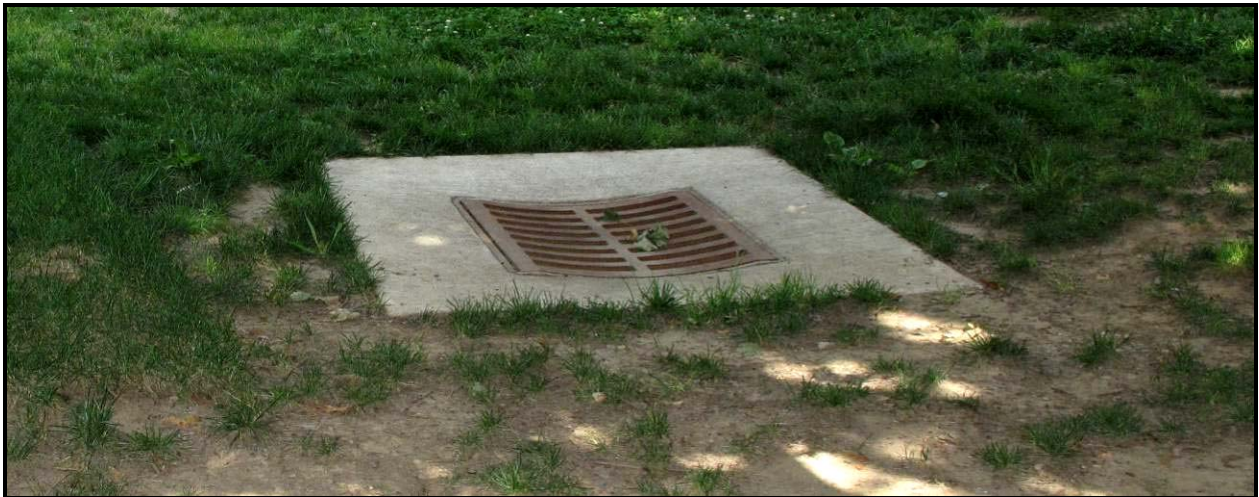
Berm B1

<i>OBSERVATION</i>	<i>INITIAL RECOMMENDATIONS</i>
<ul style="list-style-type: none"> • Bioswale appears to be working normally. • Berm is mostly well covered with lawn. In some area, bare patches appear. • Soil uphill of the berm appears to be adequate (See TP#3 above). • Catch basin at the end of bioswale has standing water. The outfall pipe appears to be clogged. 	<ul style="list-style-type: none"> a. Prepare bare areas around the catch basin for new lawn. b. Treat area with seed or sod. c. Flush catch basin and cleanout pipes.

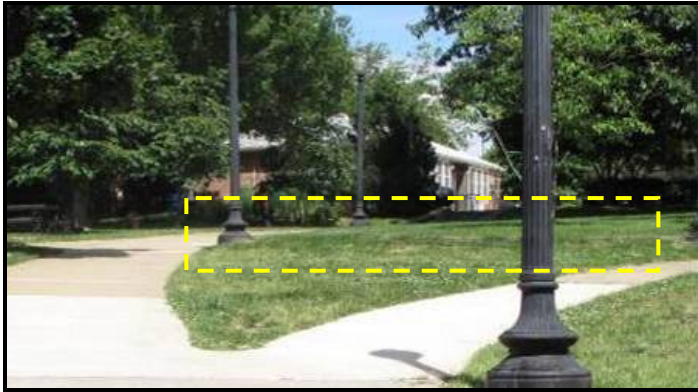
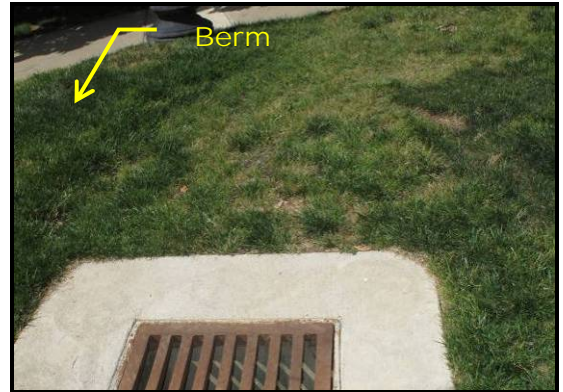
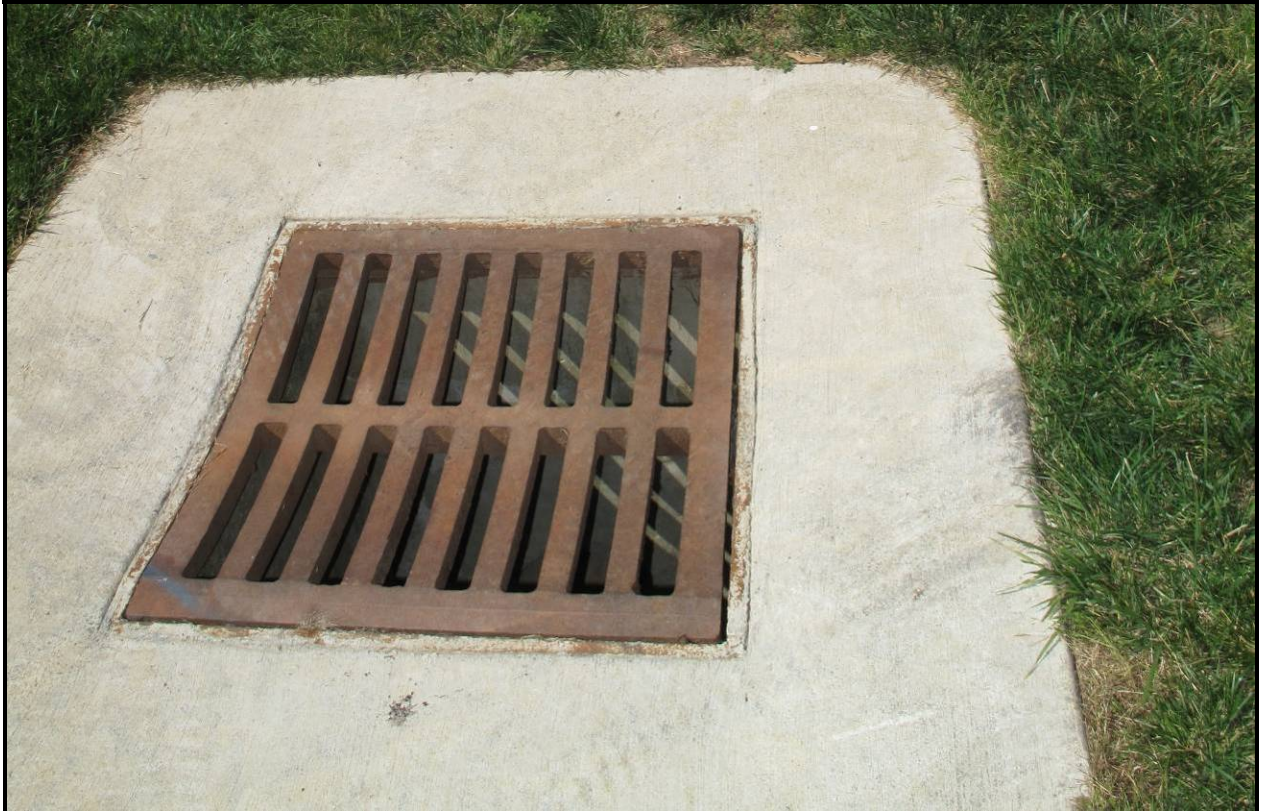
Berm B2

<i>OBSERVATION</i>	<i>INITIAL RECOMMENDATIONS</i>
<ul style="list-style-type: none"> • Bioswale appears to be working normally. • Berm is mostly well covered with lawn. In some area, bare patches appear. • Catch basin at the end of bioswale is dry. 	<ul style="list-style-type: none"> a. Treat area with seed or sod. b. Flush catch basin and cleanout pipes.

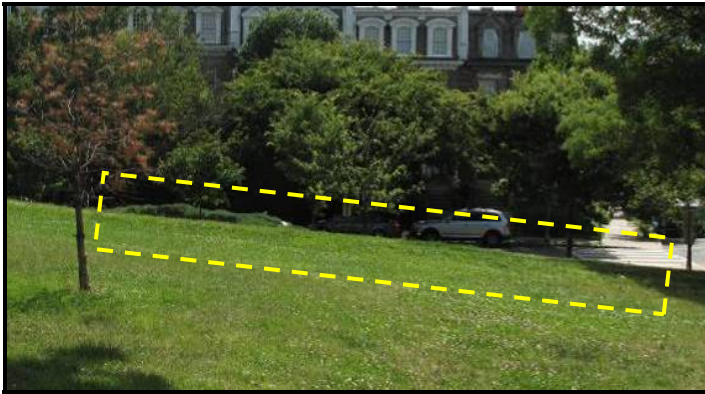
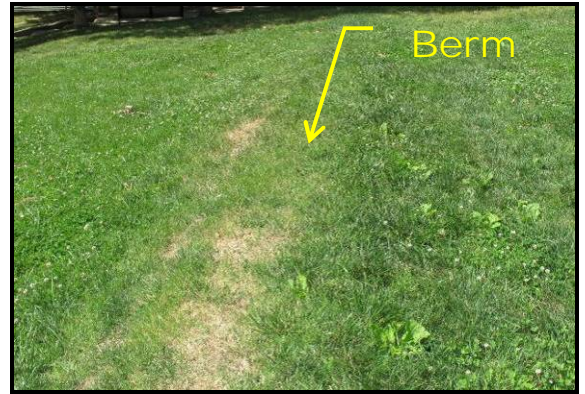
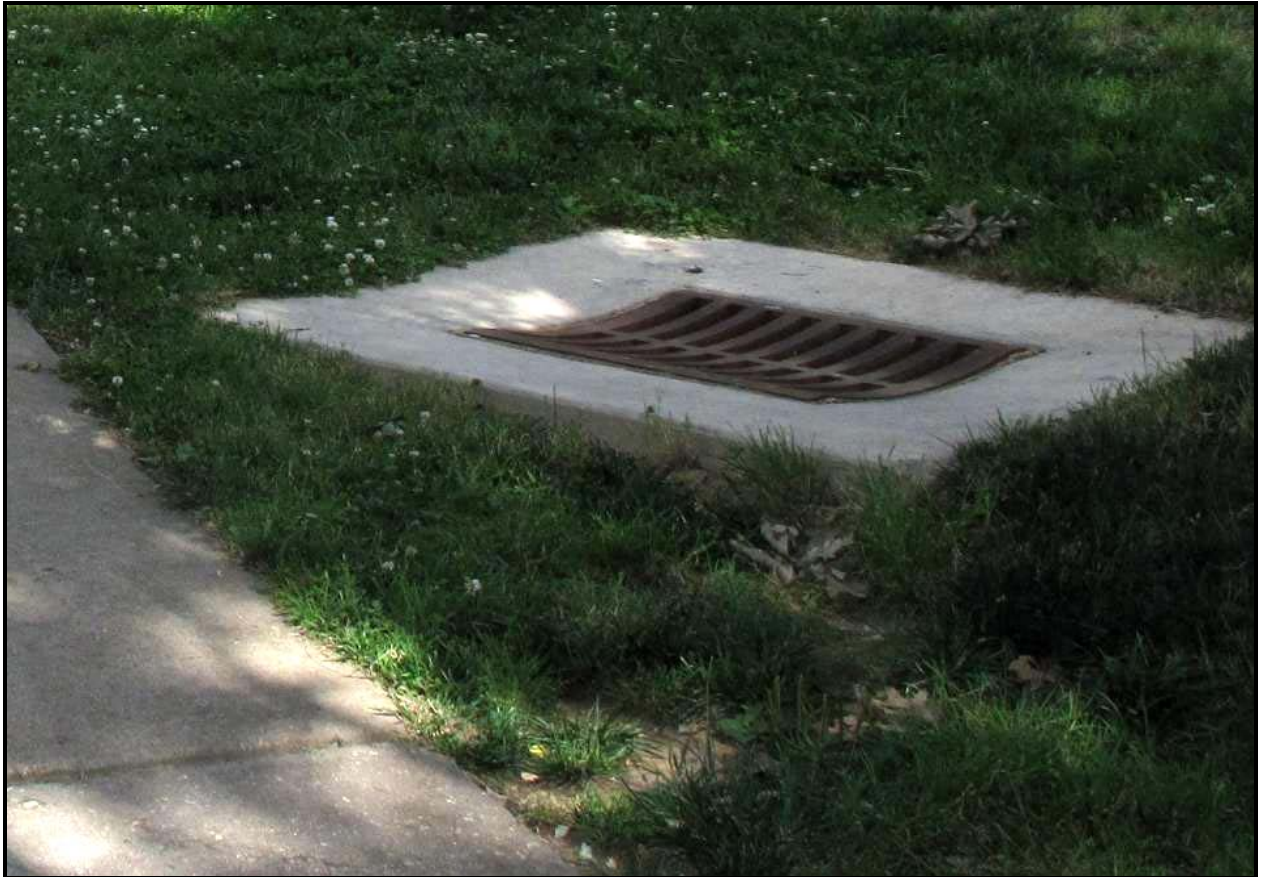
Berm B3

<i>OBSERVATION</i>	<i>INITIAL RECOMMENDATIONS</i>
<ul style="list-style-type: none"> • Bioswale appears to be working normally. • Berm is mostly well covered with lawn. In some area, bare patches appear. • Catch basin at the end of bioswale has miscellaneous debris. 	<ul style="list-style-type: none"> a. Prepare bare areas around the catch basin for new lawn. b. Treat area with seed or sod. c. Remove debris in catch basin. Flush catch basin and cleanout pipes.

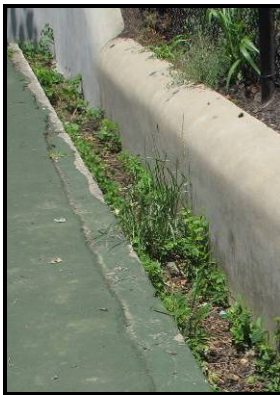
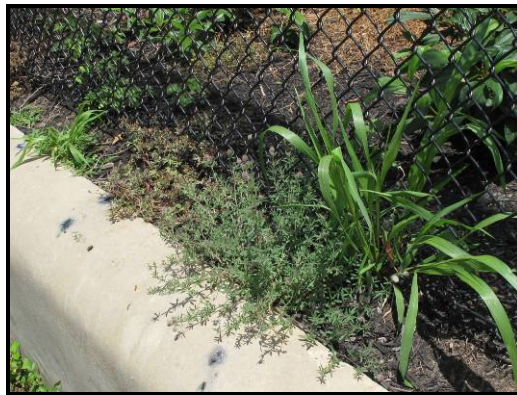
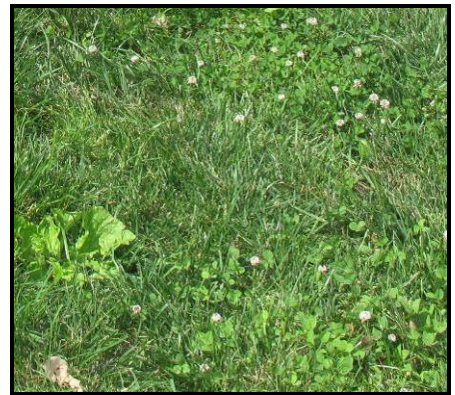
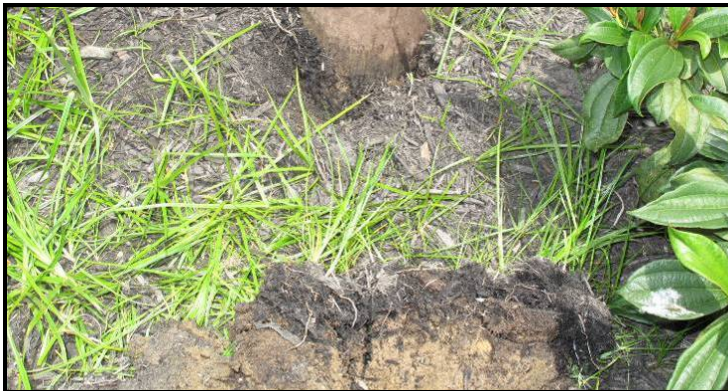
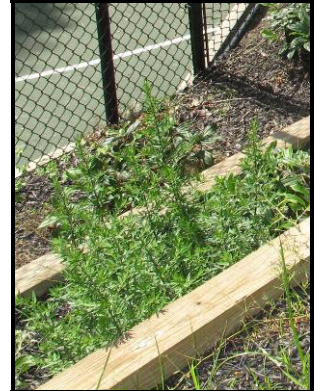
Weeds

<i>OBSERVATION</i>	<i>INITIAL RECOMMENDATIONS</i>
There are weeds throughout the site.	a. Remove weeds.

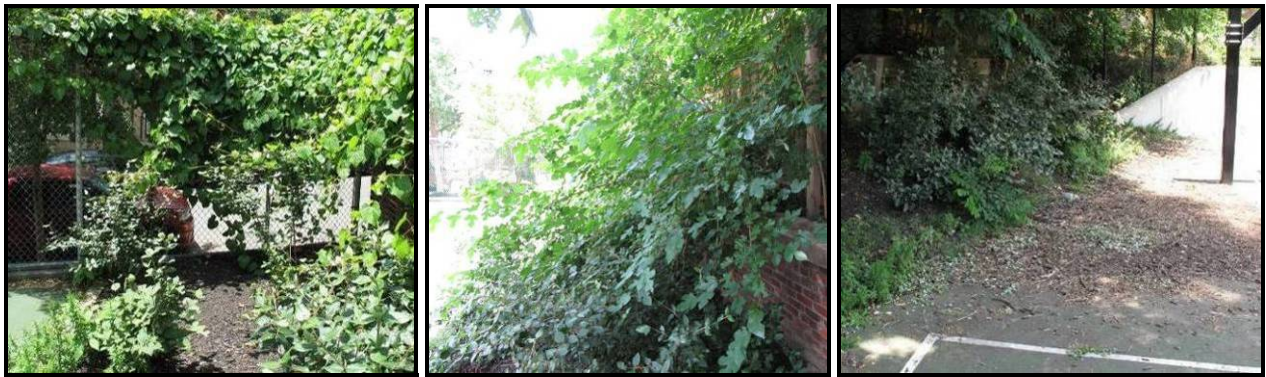
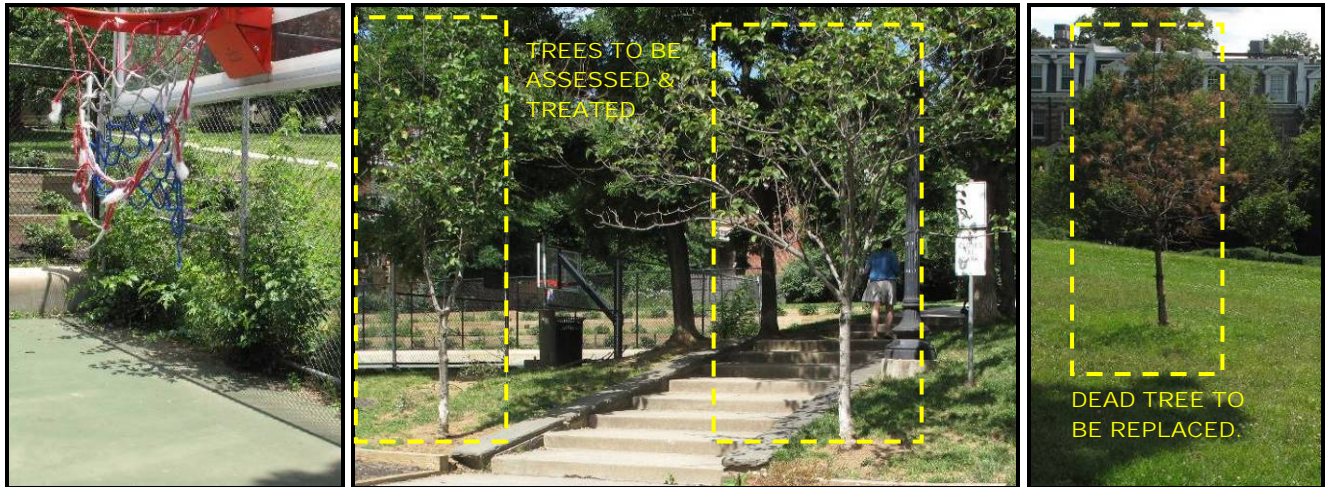
Pruning & Trees

OBSERVATION	INITIAL RECOMMENDATIONS
<ul style="list-style-type: none"> Vines and trees are hanging over planted materials and site features. Trees at the 19th Street NW entrance into the park appear to be in poor health. Roots may have been damaged from construction activity. 	<ol style="list-style-type: none"> Prune shrubs and ground cover. Have tree roots pruned and treated by arborist. Trees that are dead or dying should be replaced or treated as directed by arborist.

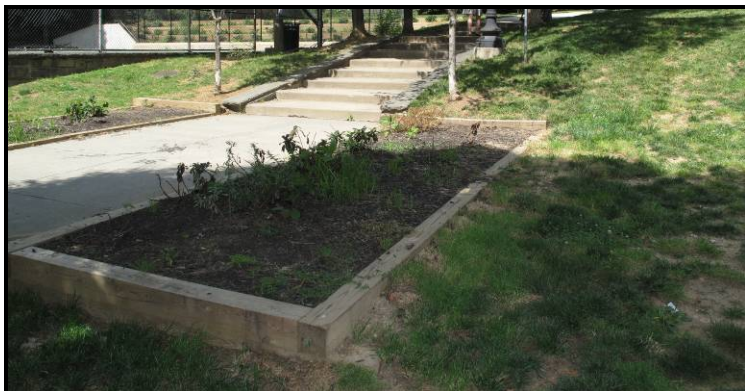
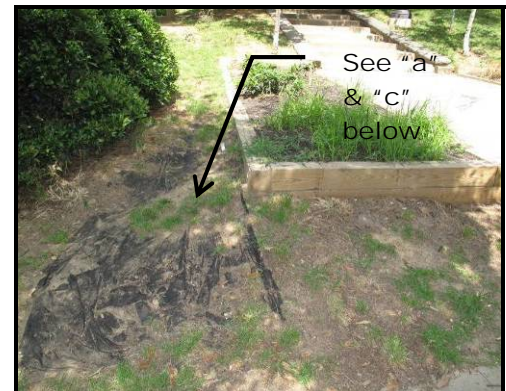
Shrubs and Groundcover at West Entrance

OBSERVATION	INITIAL RECOMMENDATIONS
<ul style="list-style-type: none"> Most shrubs and other plantings in the 19th Street entrance planters are in poor condition. Soil condition seems to be a loamy clay. Unlike the condition in Soil Test Pit Area 6, the plants in this area do not seem to have access to the moisture and are in decay. Planting beds at the west entrance of the park are full of weeds and grass. Grass adjacent to planters is in poor condition. Filter fabric and debris is exposed around planters. 	<ol style="list-style-type: none"> Remove filter fabric, debris, and weeds. Remove top 6" of soil in planter boxes and replace with planting soil. Install heavy duty filter fabric. Cut opening in fabric to allow shrubs to grow. Install a 3" thick layer of mulch to the top of timber plank. Shrubs should stay in place, undisturbed. Treat area around planter boxes with sod or seed.

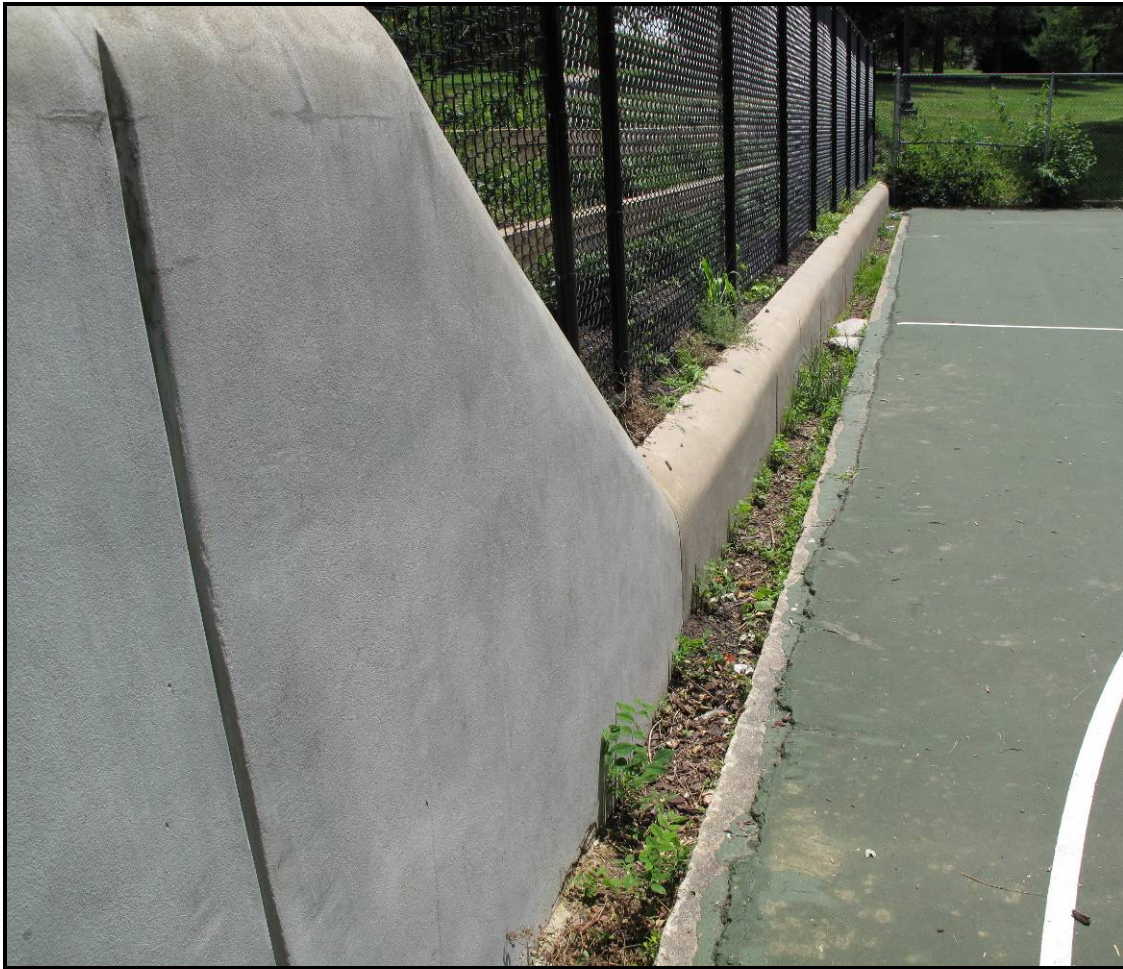
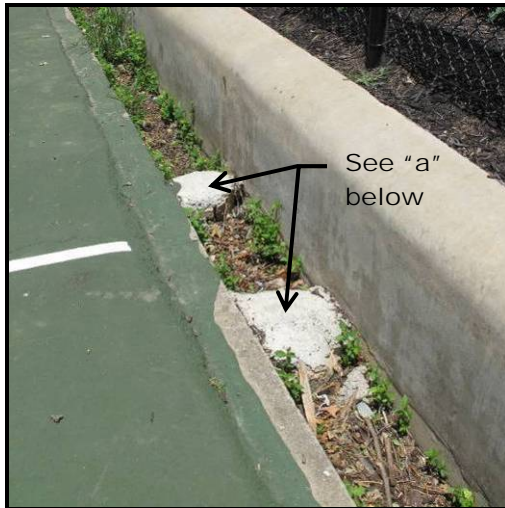
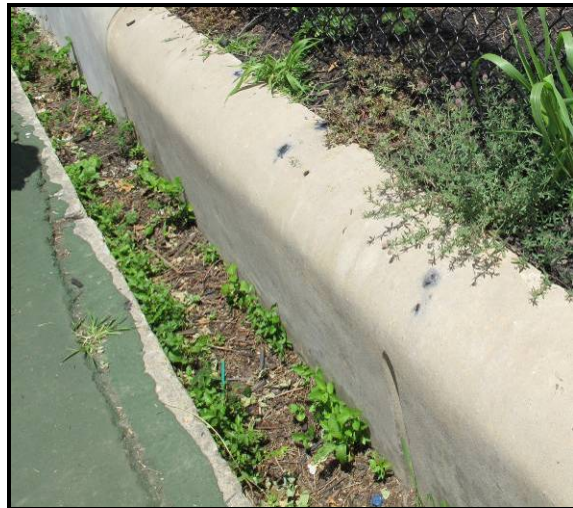
Concrete Wall and Paving

OBSERVATION	INITIAL RECOMMENDATIONS
<ul style="list-style-type: none"> • Pavement between basketball court and retaining wall is missing and hazardous. • Foundation of previously existing basketball court remains in place, and is an obstruction to anyone using the court. 	<ul style="list-style-type: none"> a. Remove top 12" of old basket ball hoop concrete foundation. b. Install basketball court surface with a concrete base at gap between retaining wall and existing court. Provide a continuous expansion joint between wall and subbase.

Pavement between basketball court and retaining wall is missing and presents a hazardous condition.
Foundation of previously existing basketball court remains in place, and is an obstruction to anyone using the court.

1. Remove top 12" from the top of old basket ball hoop concrete foundation.
2. Install basketball court surface and a concrete base along the gap between retaining wall and existing court. Provide a continuous expansion joint between wall and subbase.

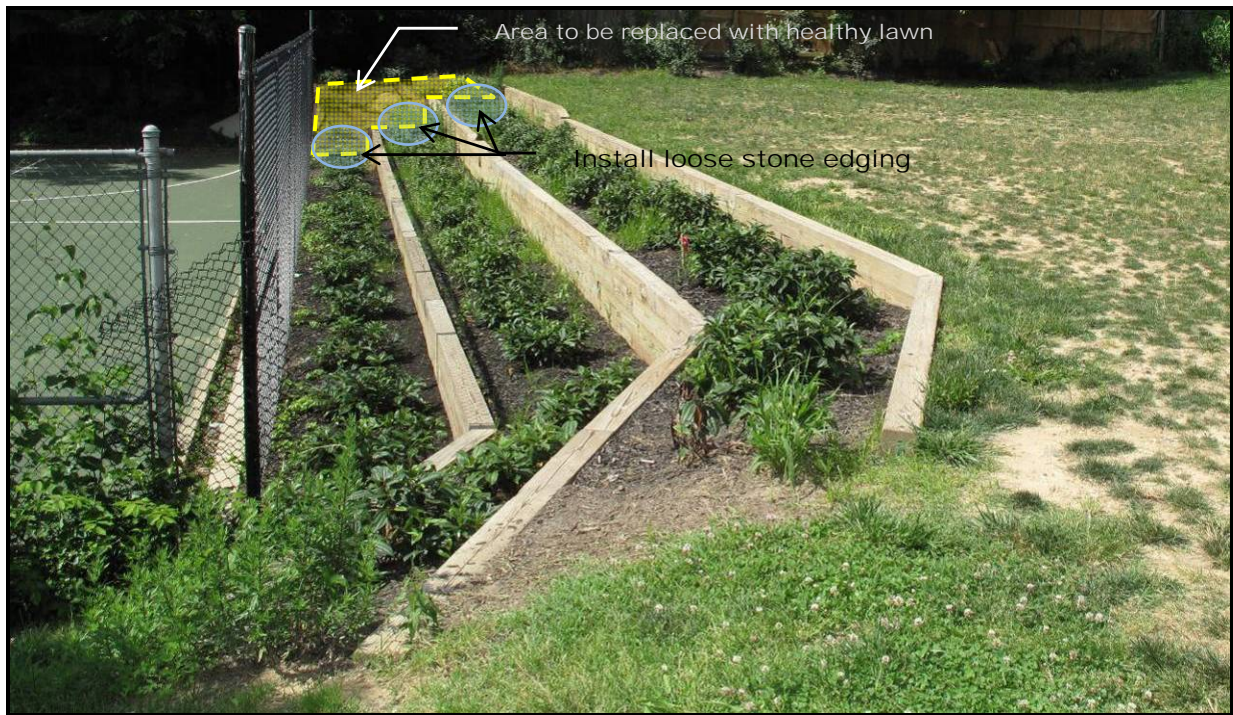
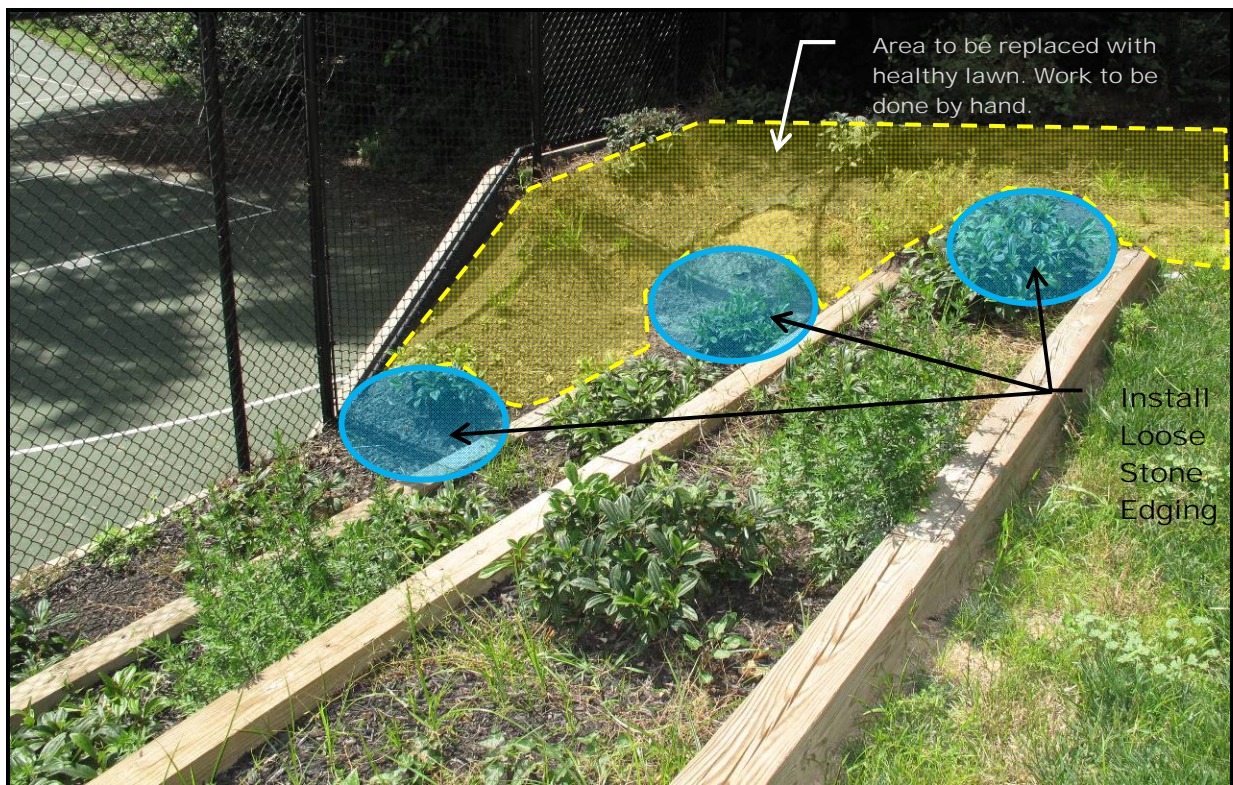
Terraced Timber Retaining Wall and Planter

OBSERVATION	INITIAL RECOMMENDATIONS
<ul style="list-style-type: none"> Terraced wall was installed by second contractor without plans. Layout was coordinated with DPR. Terraced planting bed at the north ends is eroding and existing filter fabric is falling apart. 	<p>a. Remove planting and filter fabric at the north end of the terraced planter and replace with sod or seed. Provide $\pm 18''$ dia. rounded loose stone edging between grass and planter to separate lawn from planting (see images above). There should be no digging past 12".</p>

4. At the north end of the terraced timber wall area, the contractor shall remove plants outside the planter and install sod. Install $\pm 18"$ dia. rounded loose stone edging between grass and terraced timber wall to separate new lawn from planter.

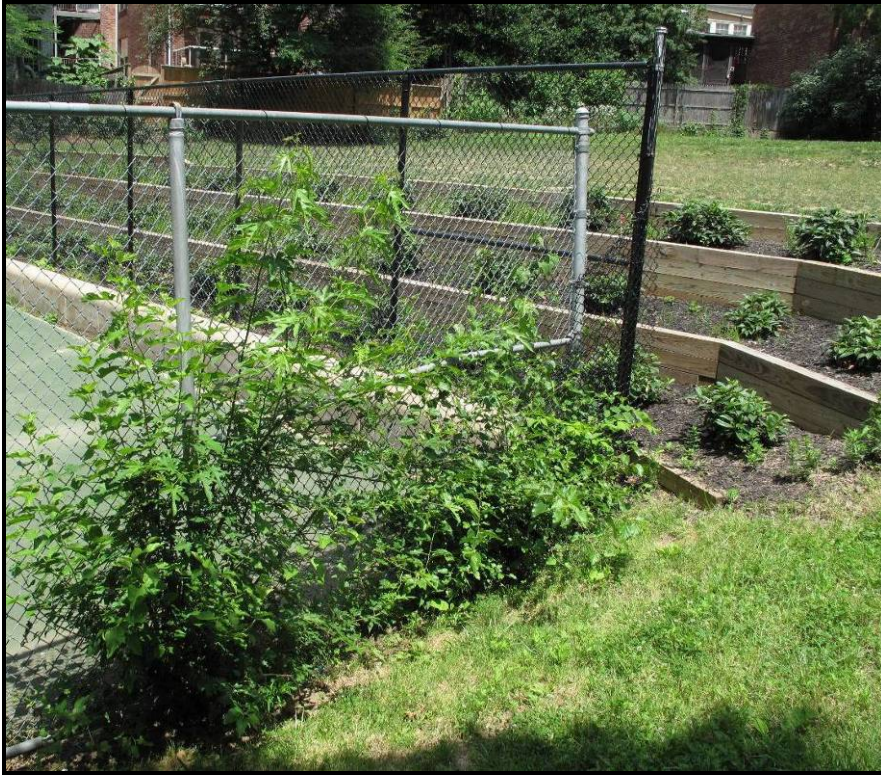
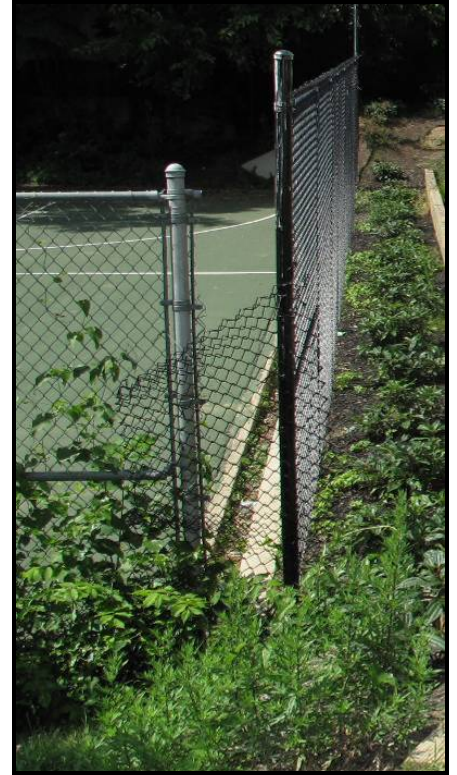
F. Fencing

<i>OBSERVATION</i>	<i>INITIAL RECOMMENDATIONS</i>
<ul style="list-style-type: none">• New black fence and previously existing fence are poorly tied together with miscellaneous fence fabric.	<ul style="list-style-type: none">a. Correctly tie new fence fabric to fence posts.
