GOVERNMENT OF THE DISTRICT OF COLUMBIA
Department of Energy and Environment

March 22, 2018

Re: Stormwater Runoff Assessment for Lafayette Recreation Center

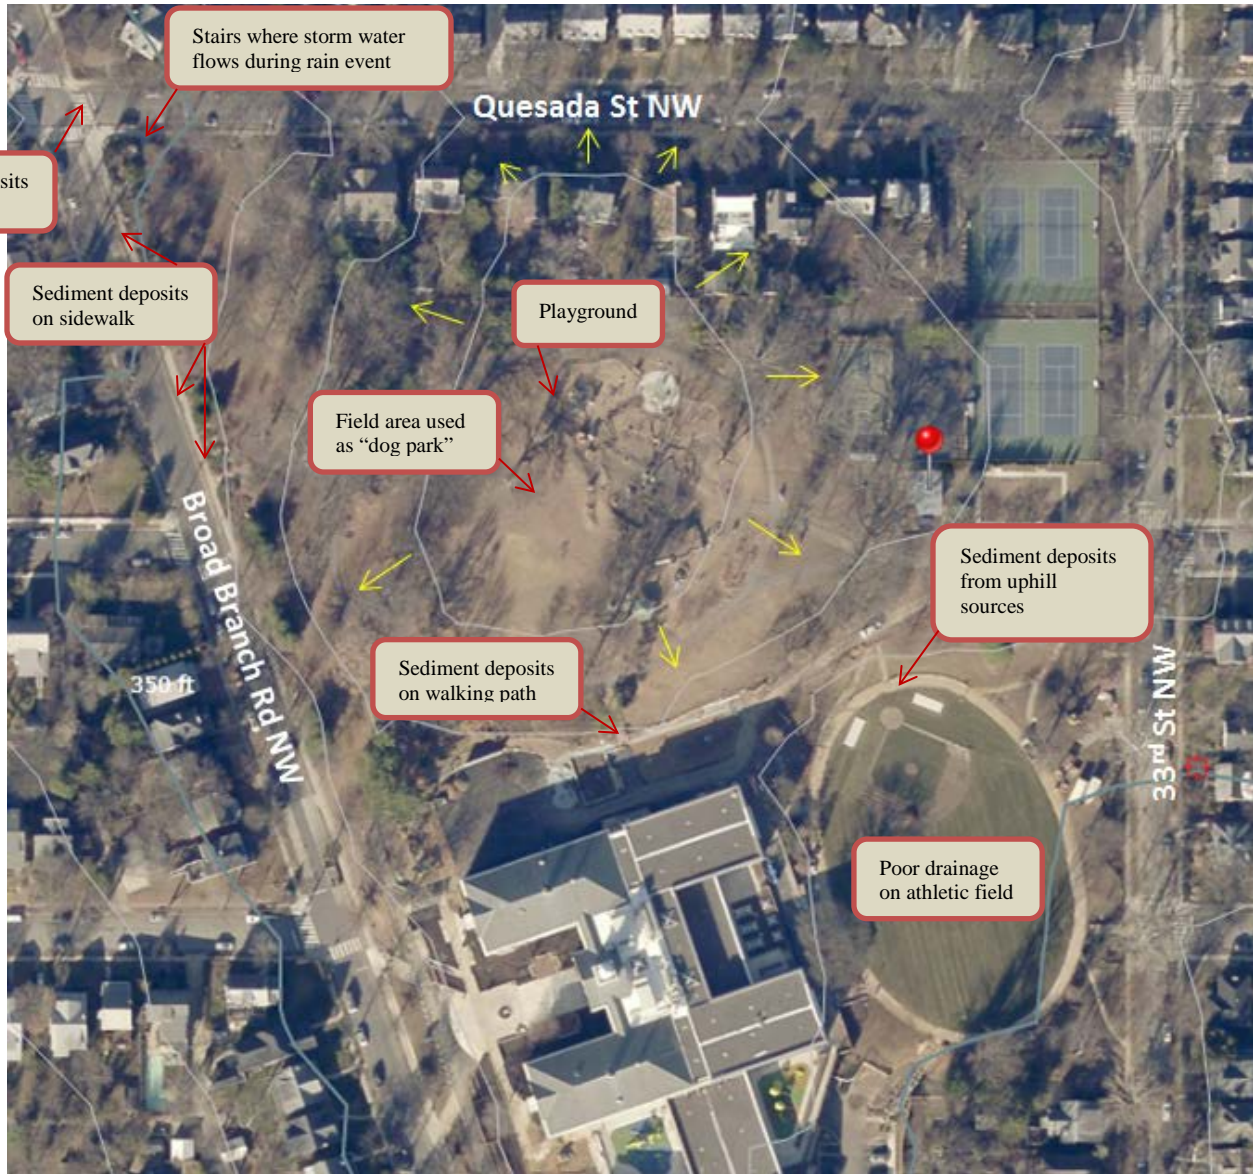
Lafayette Recreation Center is a steeply sloped site that falls within the Municipal Separate Storm Sewer System (MS4) sewershed area of the District. The highest elevation on this site is at the playground and extending to some of the field adjacent to it. These steep slopes create conditions for stormwater to gather momentum as it makes its way downhill causing erosion, stripping the trees of protective soil at the roots, creating gulleys, eroding and compromising the asphalt walking paths, and depositing sediment and debris in drainage grates throughout the site.

Figure 1. Existing Conditions at Lafayette Recreation Center

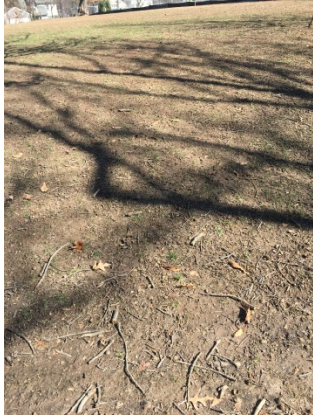
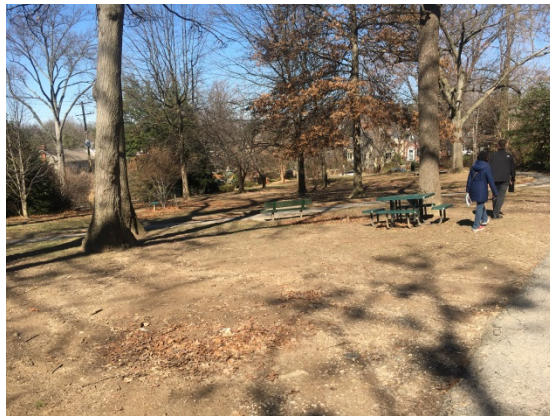
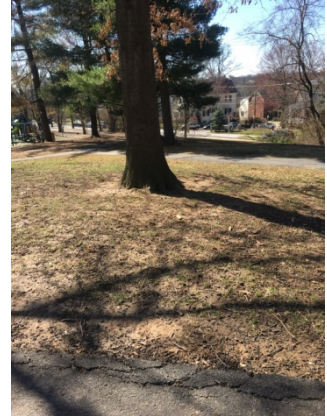
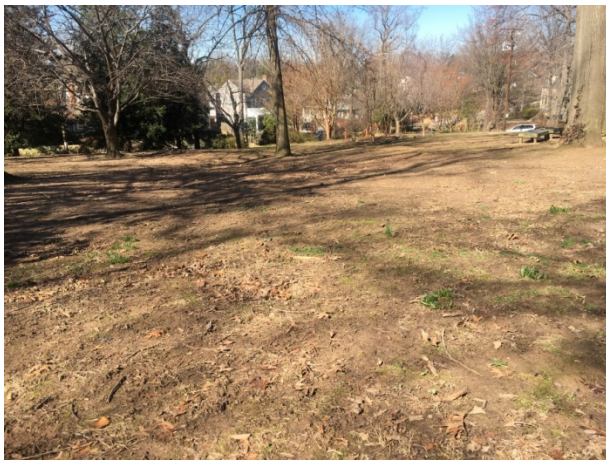
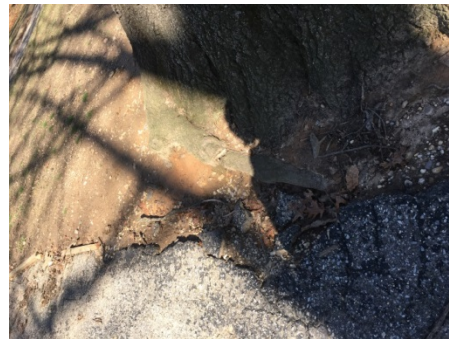
The existence of multiple mature trees throughout the site and the heavy play use of the park make it difficult for grass to grow consistently. Additionally the neighborhood frequently uses the top field as an unofficial dog park and the stakeholders expressed the residents' desire for it to remain as such.

Figure 2. Pictures of erosion and bare ground on upper fields

- Stakeholders indicated that the uphill area adjacent to the playground is frequently used by residents as an informal dog park and would like it to remain as such. As such, DOEE recommends the use of mulch and other natural materials to create a series of low berms that would a) slow down the stormwater, and b) direct and contain it in areas for slow infiltration and irrigation for the surrounding trees. Strategically placed berms at this uphill location would help stabilize the hillsides and help prevent the extensive erosion. This system has been used at Takoma Recreation Center, a site that had similar conditions and challenges, at a relatively low cost. It is important to note that although up to date this solution at Takoma Recreation Center has been working well, DOEE's use of this technique is fairly new and therefore still in an experimental stage.

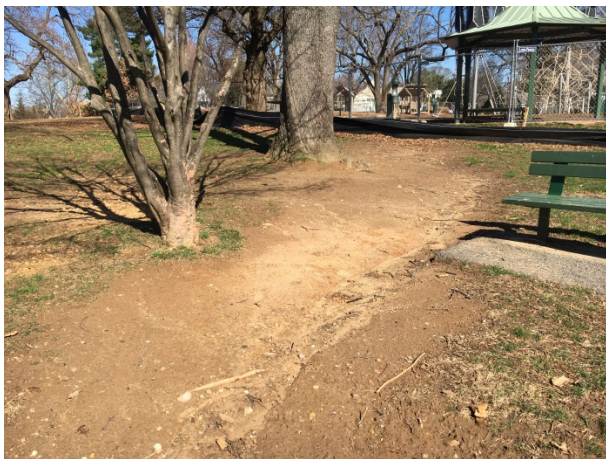
Figure 3. Picture of a gully south of the playground

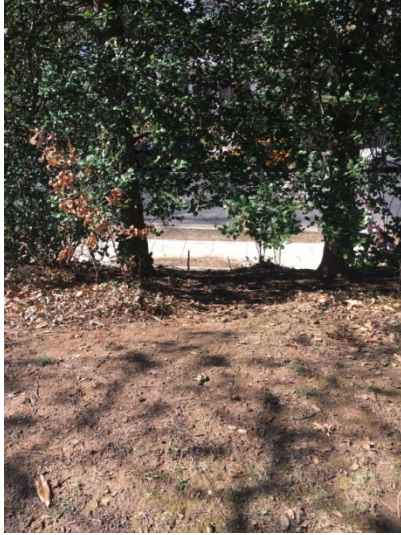
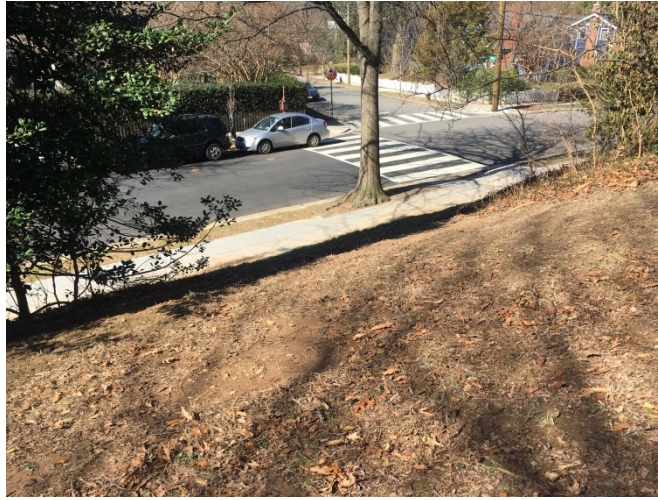
In the north-west corner of the site, this downhill rush of stormwater results in a concentrated flow at the stairs descending to the sidewalk on Quesada Street. The erosive forces of the flow result in sediment being deposited on the sidewalk adjacent to Broad Branch Road.

Figure 4. Pictures of sediment deposit on Broad Branch Road

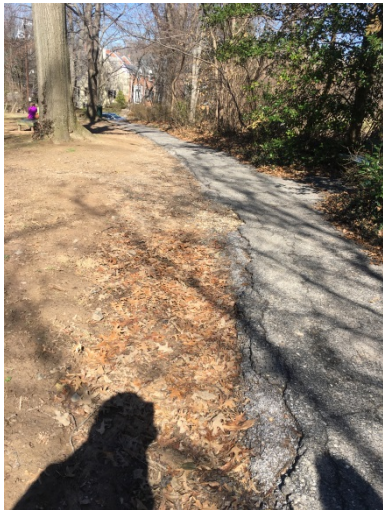
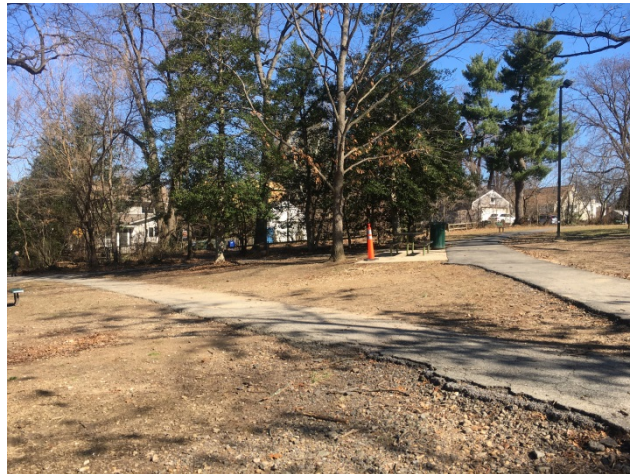
Figure 5. Pictures of destabilized walkways

DOEE believes that due to the large volume of stormwater that comes through this project's proposed work area, this end of pipe solution will not offset the damage to the asphalt walkways because the vast erosion uphill will quickly clog the proposed system. The solution of creating berms throughout the field, from uphill to down, will slow down the water that has been causing the destabilization of the walkways.

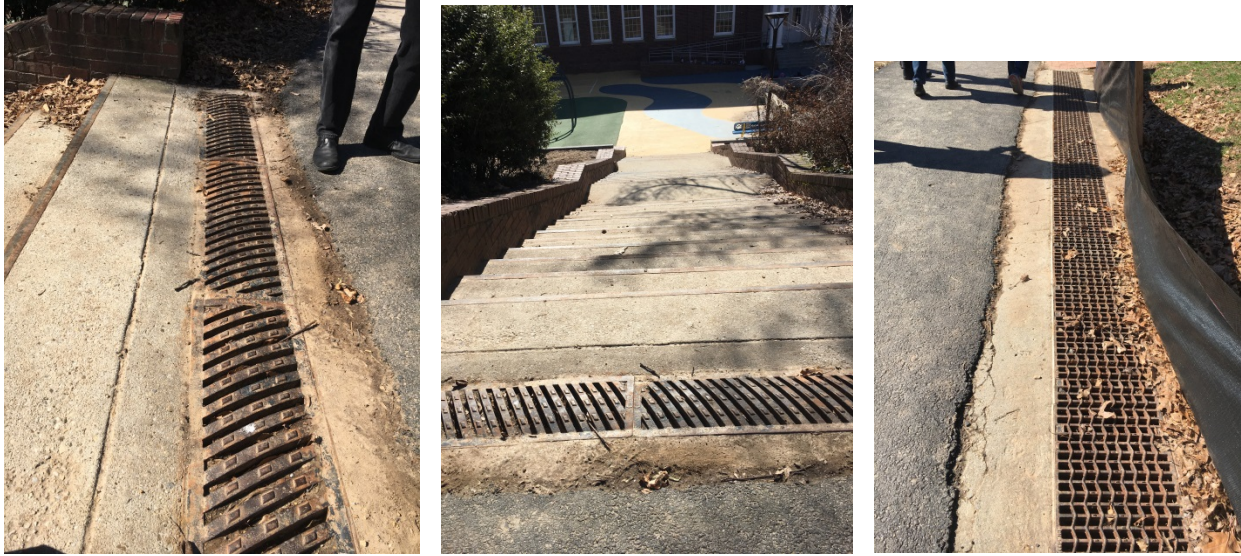
Figure 6. Pictures of sediment and debris deposit at drainage grates

DOEE proposes that DGS clean out the drainage grates to get them back to functioning order in conjunction with uphill site stabilization to prevent further sediment clogging from occurring.

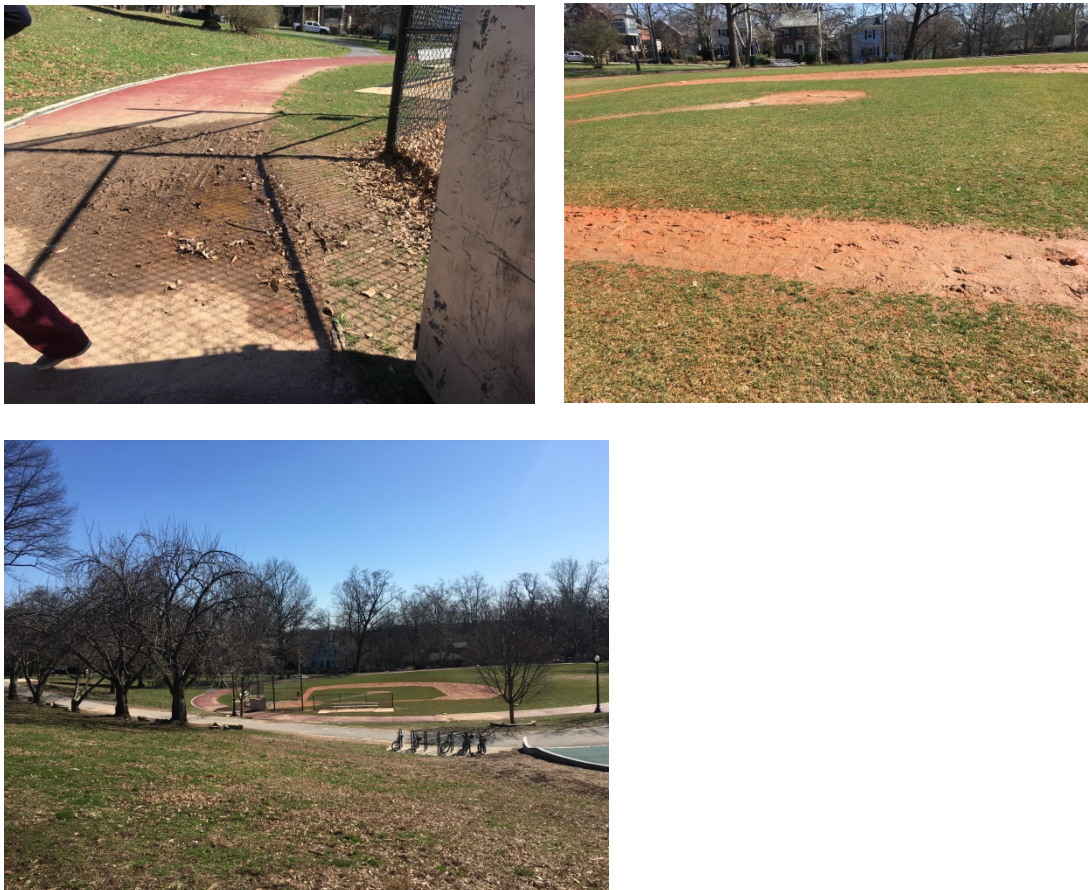
On the athletic field, drainage is poor and the field remains soaked well after a rain event.

Figure 7. Pictures of sediment deposit on athletic track, the saturated athletic field and the driveway which stakeholders desire to be removed.

However, as the site visit revealed, the northern half of the field remained saturated over 40 hours beyond a storm event, and again sediment had accumulated on the north track abutting DPR land. DOEE suggests that stakeholders have a conversation with DCPS to address these concerns. Possible areas for review may include verification of the grading on that drainage area to ensure that it was indeed sloped sufficiently enough to convey stormwater towards the disconnection per the design intention.

A cleaning of the trench drains should alleviate the problem of the uphill stormwater, but this would have to be done periodically.

Lastly, DOEE notes that based on our assessment above, at least some of the problem on the athletic field will persist unless the site uphill is stabilized. DOEE's suggestion of implementing a bioretention in the place of the driveway should aid towards this solution.

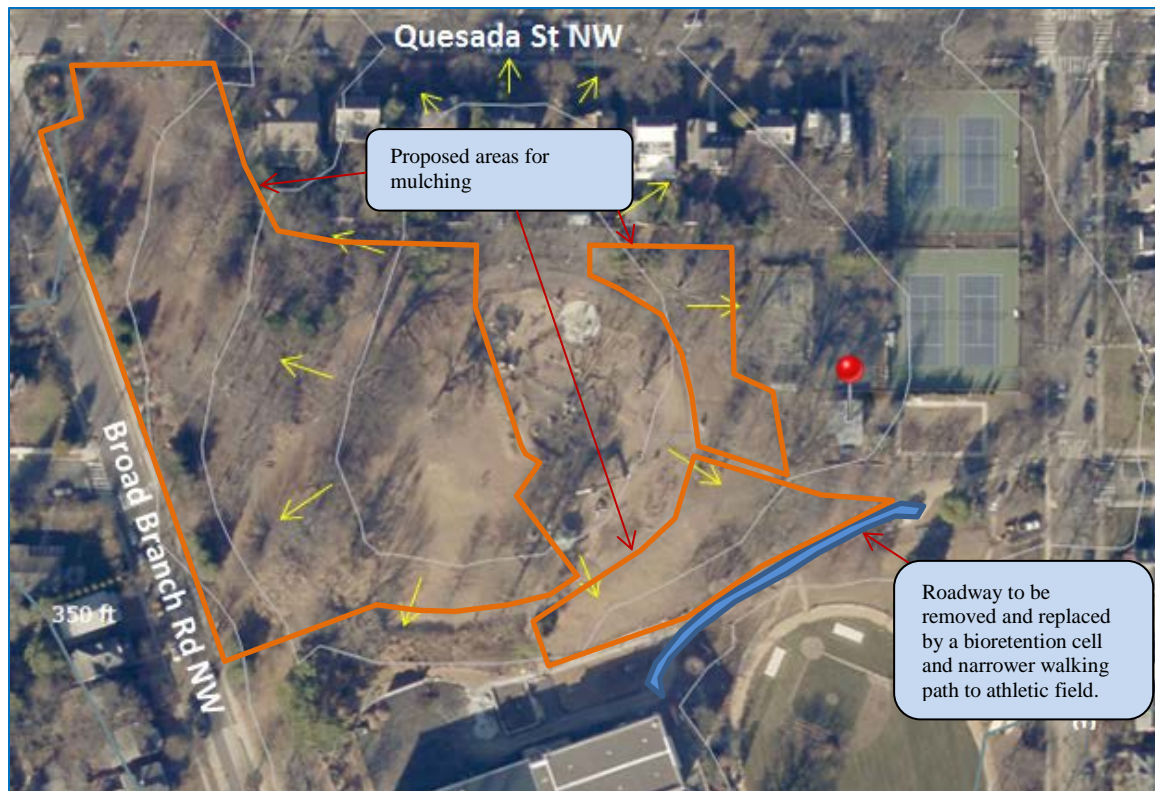
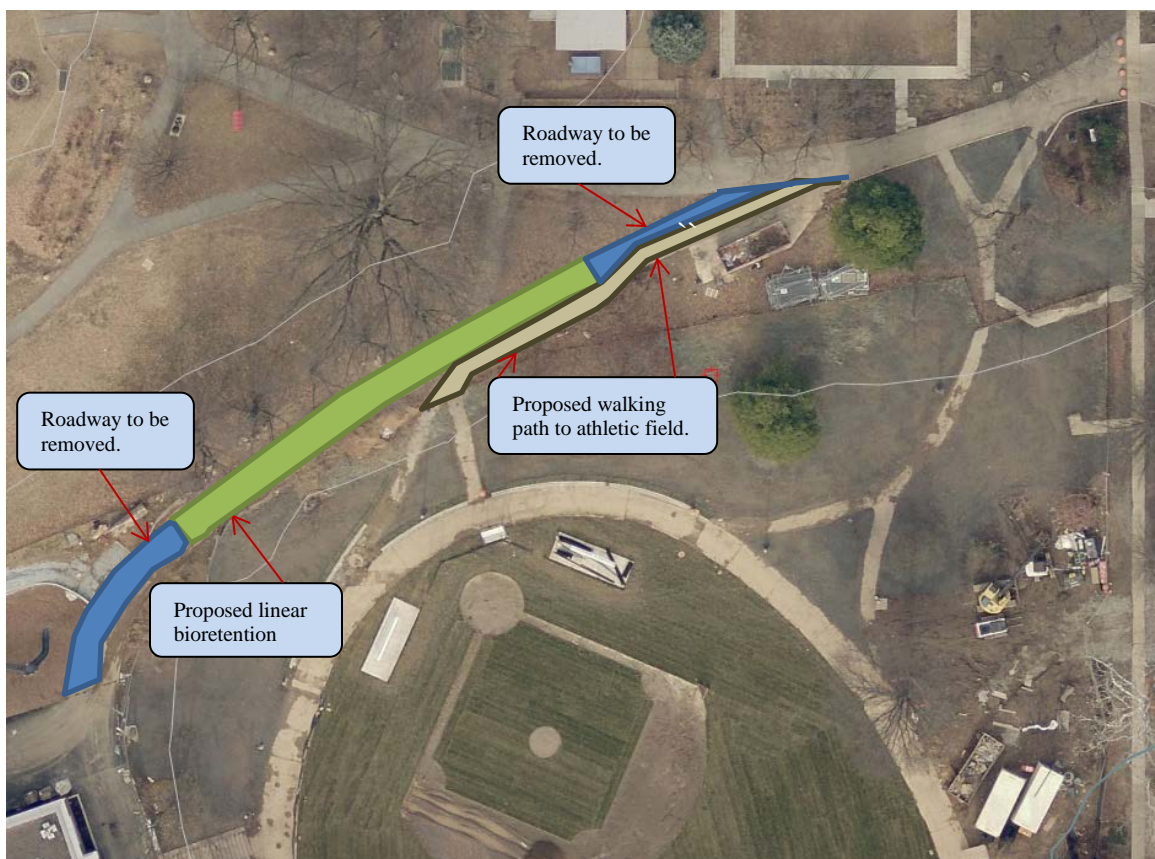
Figure 8: Proposed solutions at Lafayette Recreation Center

The stakeholders have expressed that they would like to remove the portion of the road that begins at 33rd Street and curves around the athletic field leading to the school. Removal of this impervious cover and adding in its place stormwater practices such as

bioretention will help capture some of the stormwater that would have otherwise gone to the athletic field.

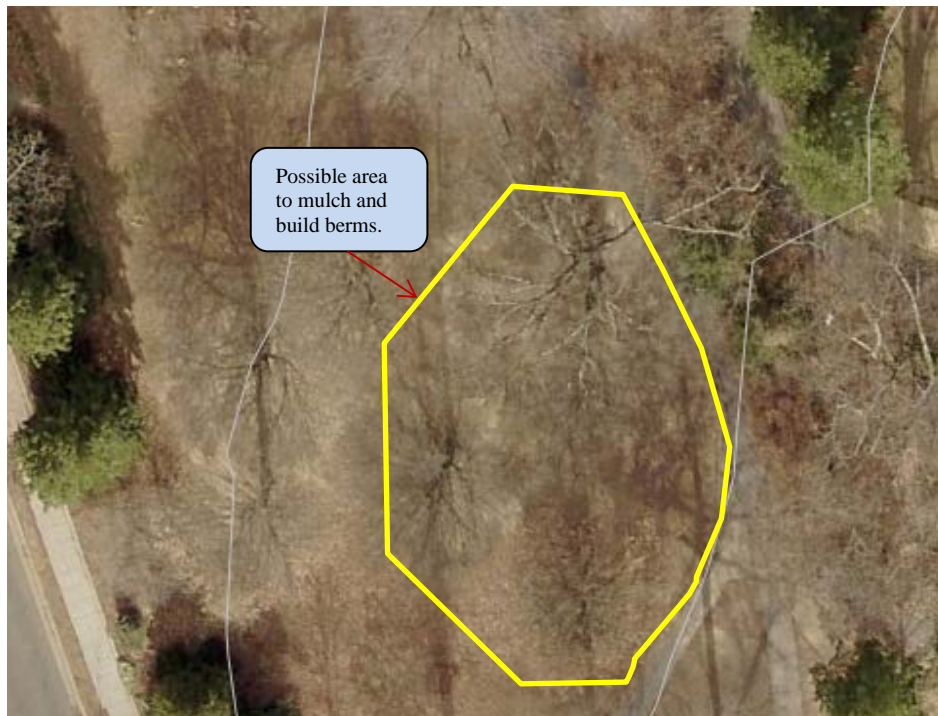
Figure 9. Possible project alternative for Eagle Scout

As an alternate project, the resident might work with the landscape designer to employ DOEE's proposed mulch and berm solution at a smaller scale. Mulching the area adjacent to the walking path and building low berms perpendicular to the flow path may help mitigate future damage to the walking path and offer protection and irrigation for the trees in the project area. Please note that this would only be a temporary solution since the practice would be demolished when a comprehensive solution to the area is being worked on.
