GOVERNMENT OF THE DISTRICT OF COLUMBIA  
DEPARTMENT OF GENERAL SERVICES  
CAPITAL CONSTRUCTION SERVICES

## Earthquake Initiatives – Phase II

### Scope of Work:

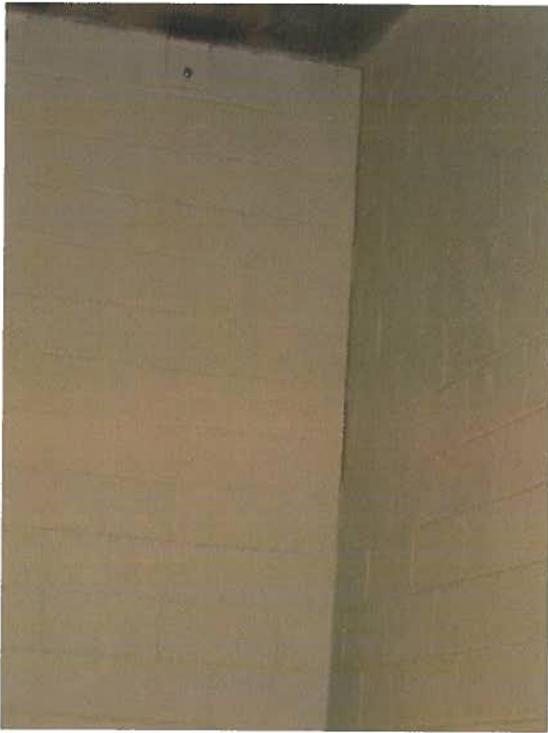
016 item 1.jpg

1. Cracks at mortar joints of CMU and joint with concrete roof slab: Re-point and paint, scaffolding required.

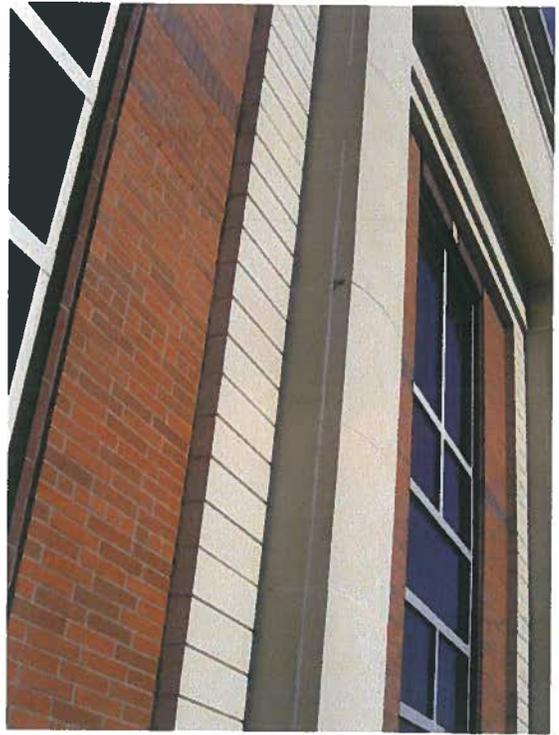
016 item 2.jpg

2. Missing mortar from pre-cast panels of pilaster and damage to edge of pre-cast panel: Re-point with color mortar, scaffolding required for access.

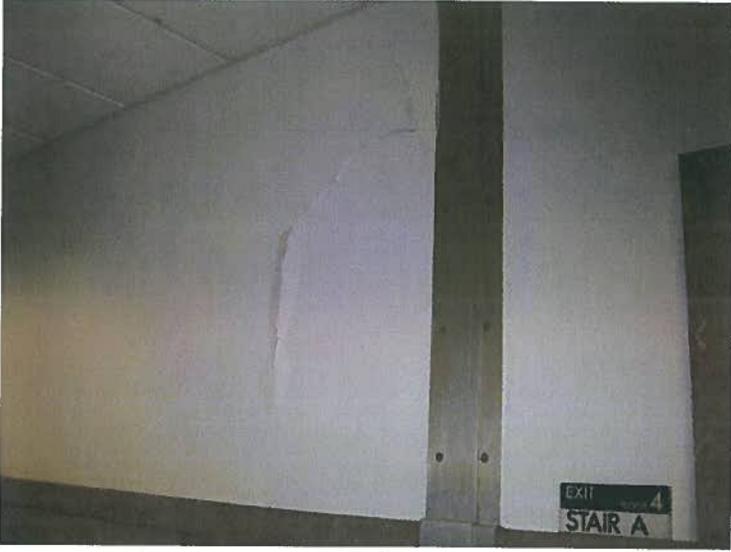
019-1.JPG

| 4 <sup>th</sup> Floor Corridor, adjacent to Stair A | 1. Cracked wall adjacent expansion joint, potential for lead based paint, see HAZMAT: Patch plaster and re-paint. |

- Items 1, 2, 3, 4, 5, and 6: Cracking of interior painted plaster walls in multiple building areas. Painted plaster walls suspected of being coated with LBP due to construction date (1942) of building. Some locations showed evidence of past water intrusion and may be unrelated to EQ. Minor Suspect mold growth was noted on wood baseboard on Stair A, 1<sup>st</sup> Floor area (Item 4.)

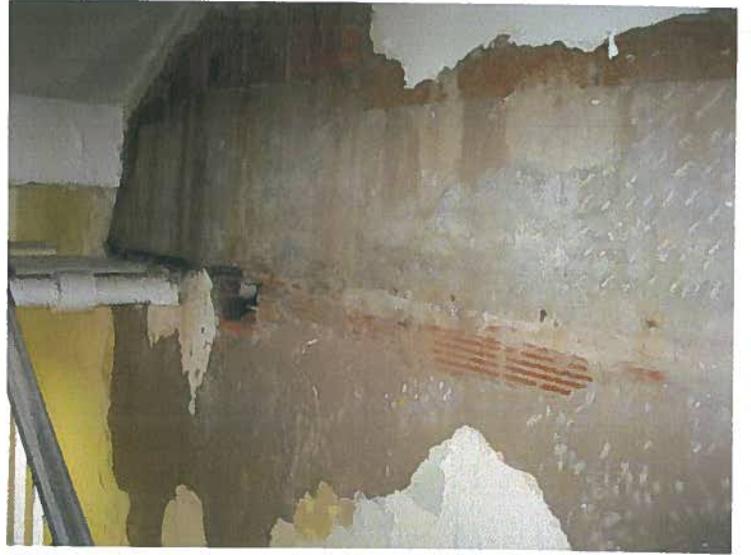
019-4.JPG

| Stair A, Basement to Level 2 | 4. Water damage to plaster from pipes, not earthquake-related. Potential for lead based paint, see HAZMAT. |

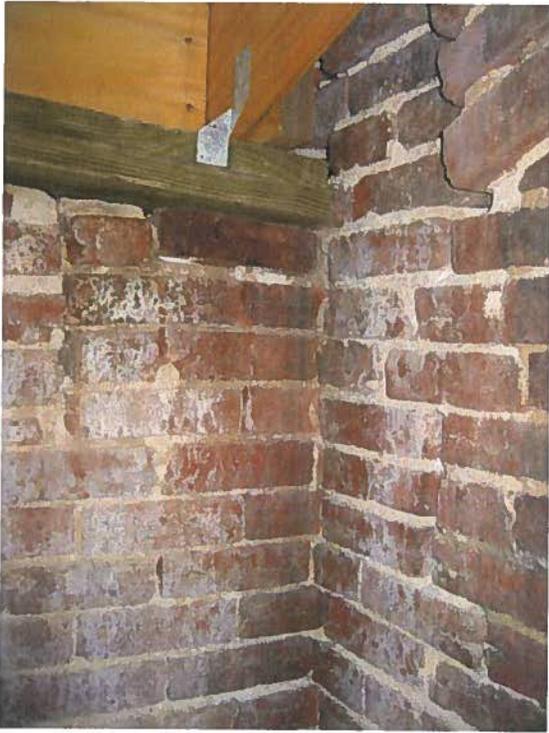
032-3.JPG

1. Pre-existing crack in brick, not earthquake-related.
2. Crack in brick wall: Tuck point.
3. Crack in brick wall: Tuck point.
4. Pre-existing mis-aligned cap block, not earthquake-related.

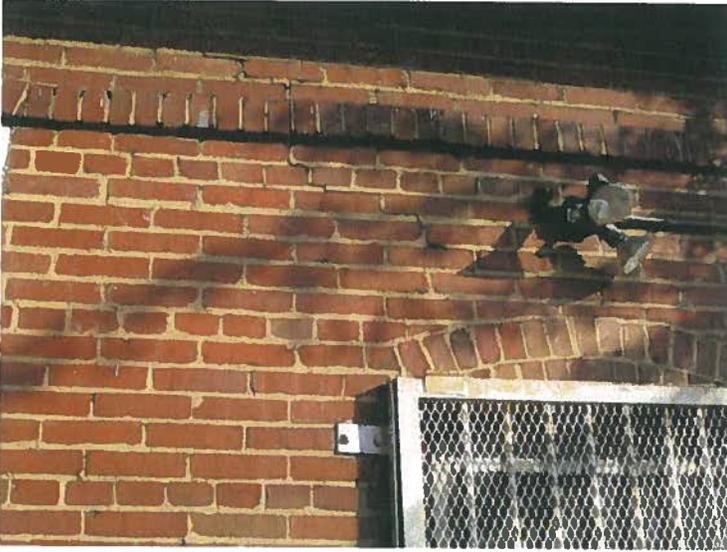
022 Item 1.jpg

1. Cracking at brick mortar joints: Tuck point area.
2. Cracking at brick mortar joints, and displacement: Tuck point area and monitor.

- Item 1: Exterior crack in unpainted brick wall on south side of building above Head Start entrance. Disturbance of potential hazardous materials not anticipated.

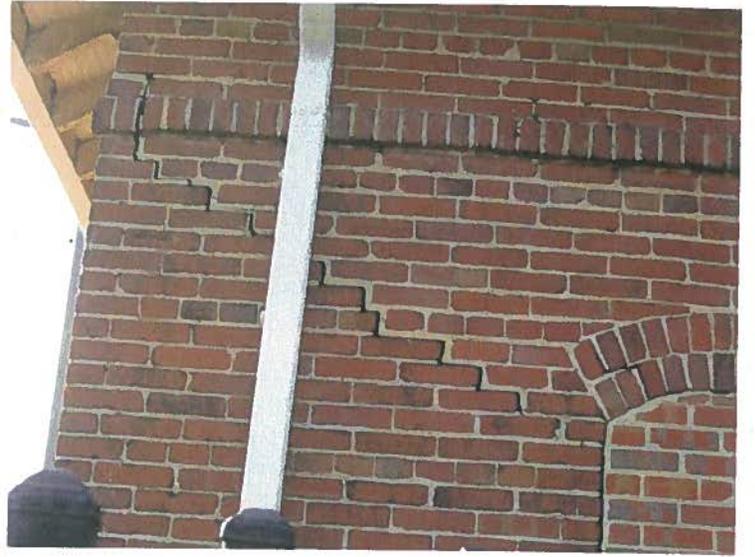
022 Item 2.jpg

- Item 2: Exterior crack in unpainted brick wall on northeast corner of building. Disturbance of potential hazardous materials not anticipated.
- Item 3: Cracking on interior painted south brick wall in Main Entrance Foyer. Brick wall suspected of being coated with LBP due to construction date (1930s) of building. Extra care during abatement/stabilization may be warranted due to child occupied facility.

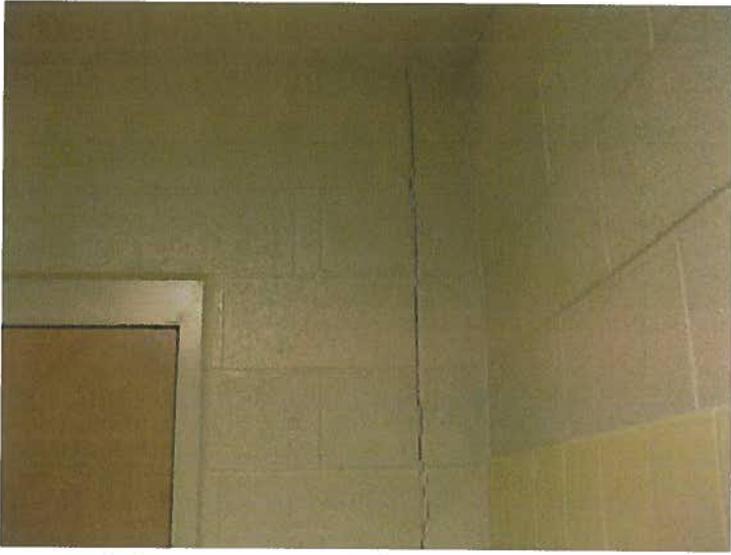
034-1.jpg

1. North & east walls separation in caulk seam: Re-caulk vertical control joints in CMU. North wall, missing grout in wall tile: Replace grout. West wall, vertical crack in CMU: Tuck point.

- Item 1: Separation at wall caulk seam in 1<sup>st</sup> Floor Men's Room. No hazardous materials are anticipated due to recent construction date (2007/2008) of building.

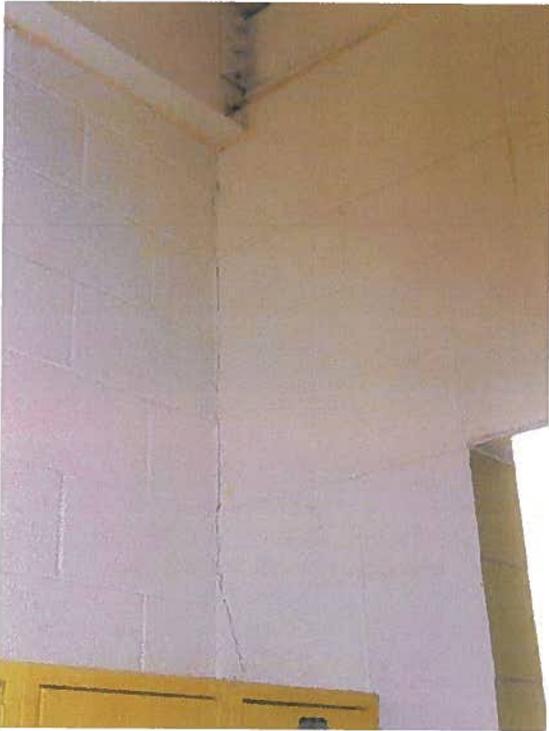
035 item1.jpg

| Locker Room | 1. Southwest and northeast corners, CMU wall cracks: Tuck point & re-paint. |

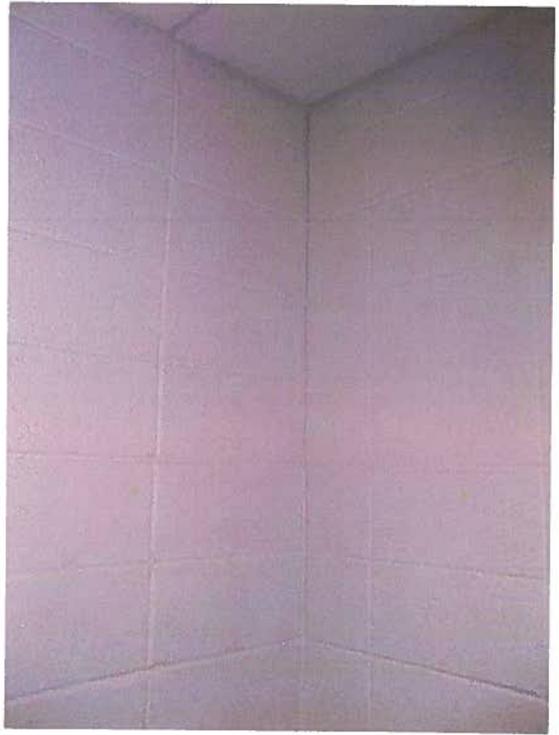
035 item 8.jpg

| Men's room vestibule (2 <sup>nd</sup> floor) | 8. CMU crack at southwest corner: Tuck point & re-paint. |

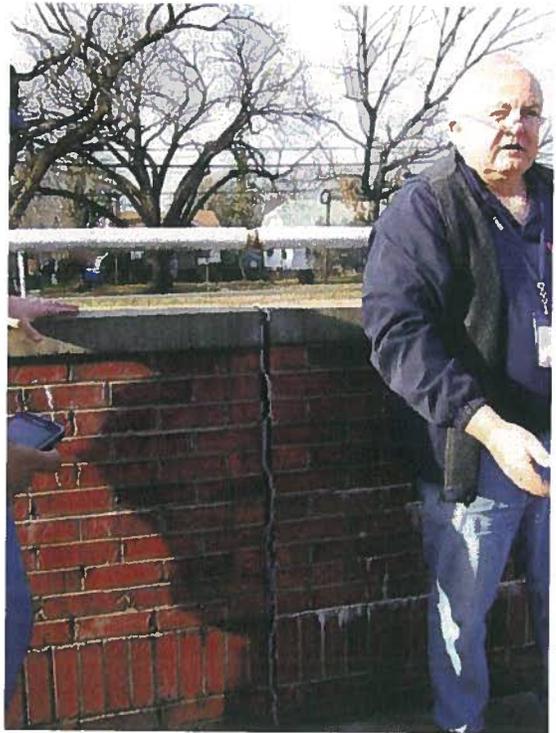
083 item 4.jpg

4. Expansion joint in north patio wall has widened and adjacent slab cracked: Fill the expansion joint in patio wall with mortar. Fill crack in slab with epoxy grout.
