# **KALORAMA PARK**

# PHASE I

DATE OF REPORT: June 18, 2012

# **TECHNICAL MEMO 2 - RECOMMENDATIONS**

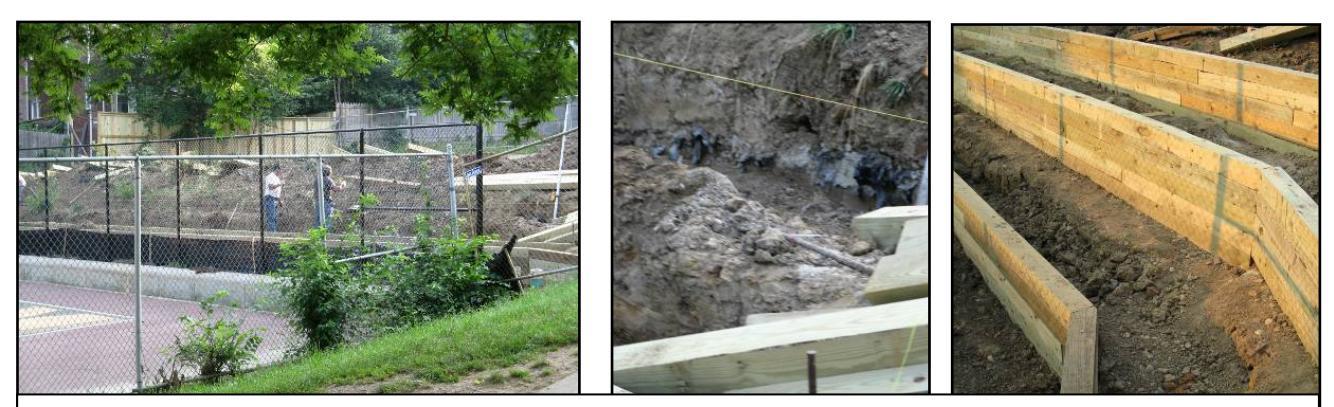
Photographs of construction of timber retaining wall.

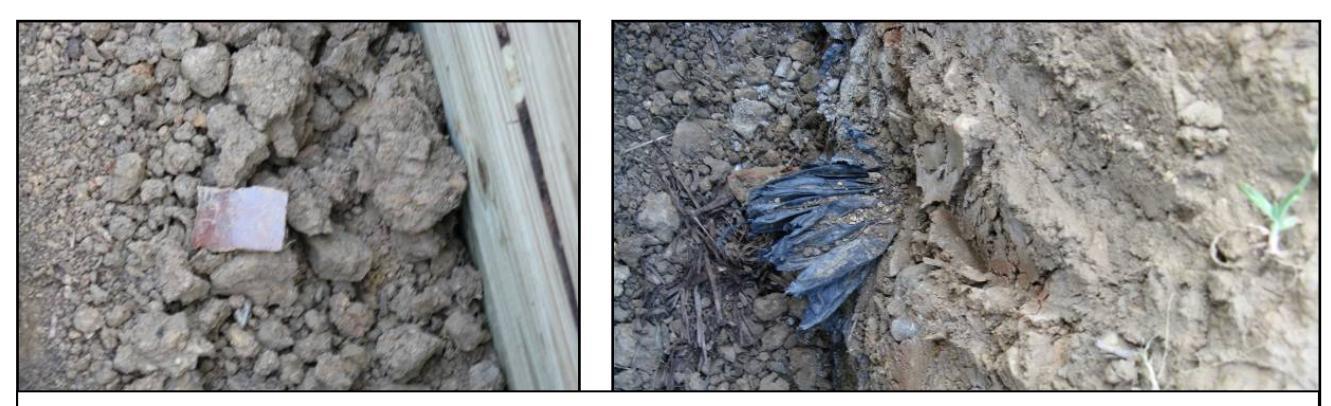
Photographs of construction debris and soil medium below lawn and planting areas.

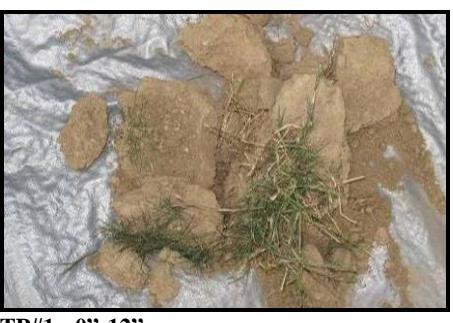
TP#1: 0"-12"

The top layer of test pit #1 consists of clay like medium that appears to be bonded together. Grass has not established to a satisfactory condition and appears in only small patches. At 6" we encountered a slightly loamy sand mix.

OBSERVATION	INITIAL RECOMMENDATIONS
See Above.	Remove top 12" of material and provide suitable
	mix.

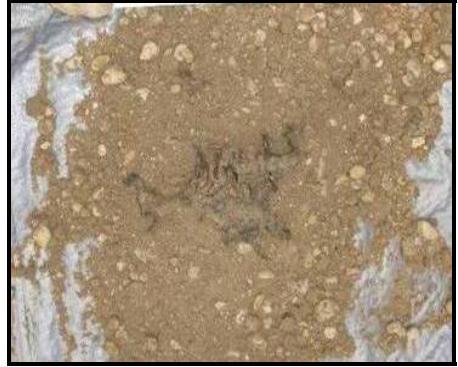
#### TP#1: 12"-18'

At 12 to 18 inches, we encountered layers of sand and construction debris, such as filter fabric. The filter fabric layer was found at 18" between two layers of sand. The sand layers were 2"-3" thick each.

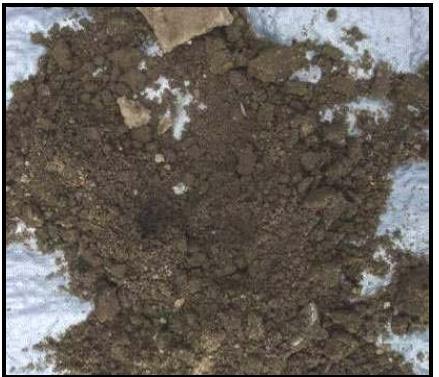
The top layer of test pit #2 consists of clay like medium that appears to be bonded together. Grass has not established to a satisfactory condition and appears in only small patches. At 6" we encountered a slightly loamy sand mix.

OBSERVATION	INITIAL RECOMMENDATIONS
See Above.	a. Remove top 12" of material and provide
	suitable mix.
	b. Treat with sod or seed.

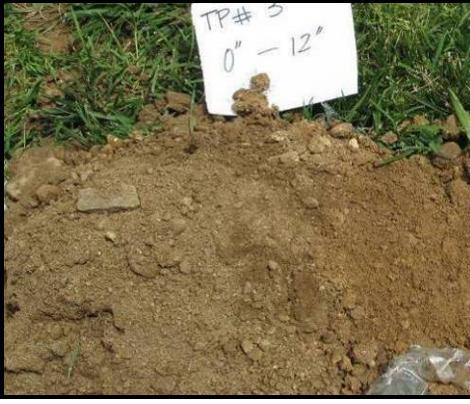
#### TP#3: 0"-12"

**TP#3: 0"-12":** At the top layer of test pit #3 the grass seemed to have taking normally. However, the grass mix appeared to contain weeds. At 2 to12 inches we encountered natural soil with some small rocks. **TP#3: 12"-24":** At 18 to 24 inches we encountered a slightly sandy medium with some small rocks. The soil moisture appeared suitable.

OBSERVATION	INITIAL RECOMMENDATIONS
See Above.	a. Remove top 6" of material and provide
	suitable mix.
	b. Treat with sod or seed.

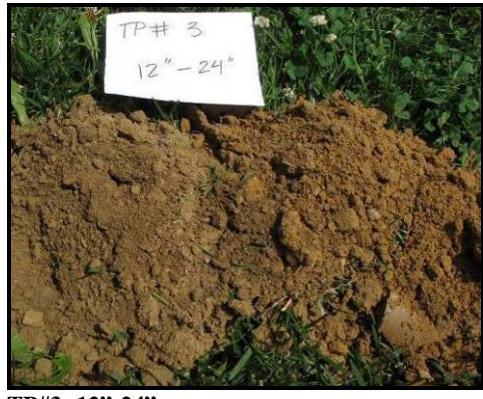
#### TP#3: 12"-24"

At 18 to 24 inches we encountered a slightly sandy medium with some small rocks. The soil moisture appeared suitable.

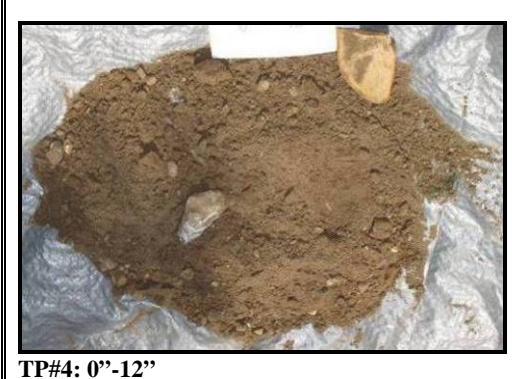
**TP#4: 0"-12"**

At 0 to 12 inches we encountered soil mixed with sand, clay and construction entrance debris. Soil excavation was hindered by numerous stones and hard soil.

Review of the construction drawings indicates that this area was a construction entrance during the construction of the site improvements. The stones and the hard subsurface encountered may be the result of improper removal of the construction entrance material.

OBSERVATION	INITIAL RECOMMENDATIONS
See Above.	a. Remove top 36" of material and provide
	suitable mix.
	b. Treat with sod or seed.

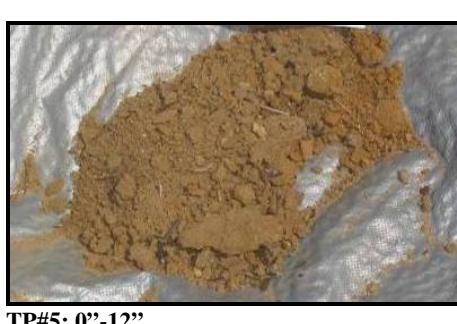
TP#5: 0"-12"

**TP#5: 0"-12"** At 0 to 12 inches we encountered natural soil. Soil appeared to be slightly dryer than expected, but otherwise acceptable.

OBSERVATION	INITIAL RECOMMENDATIONS
See Above.	a. Remove top 6" of material and provide suitable mix

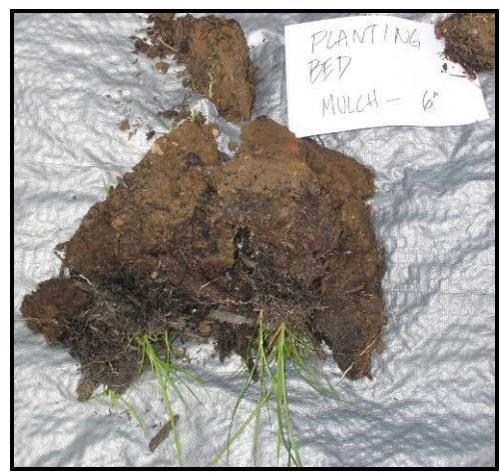
## TP#6: 0"-6"

At 0 to 6 inches we encountered a layer of mulch on wet soil. The clay like medium appeared to be inadequate. However, the plants appeared healthy. Roots of shrubs have spread through the planting medium. Weeds are abundant. Roots of weeds remain on the top 1 inch of the planting soil.

OBSERVATION	INITIAL RECOMMENDATIONS
See Above.	Remove weeds (Also see recommendations in
	the Plantings section).

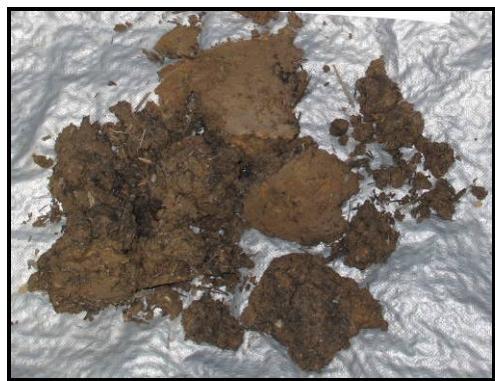
TP: 6"-12"

At 6 to 12 inches the soil medium was continuously moist with minor construction debris.

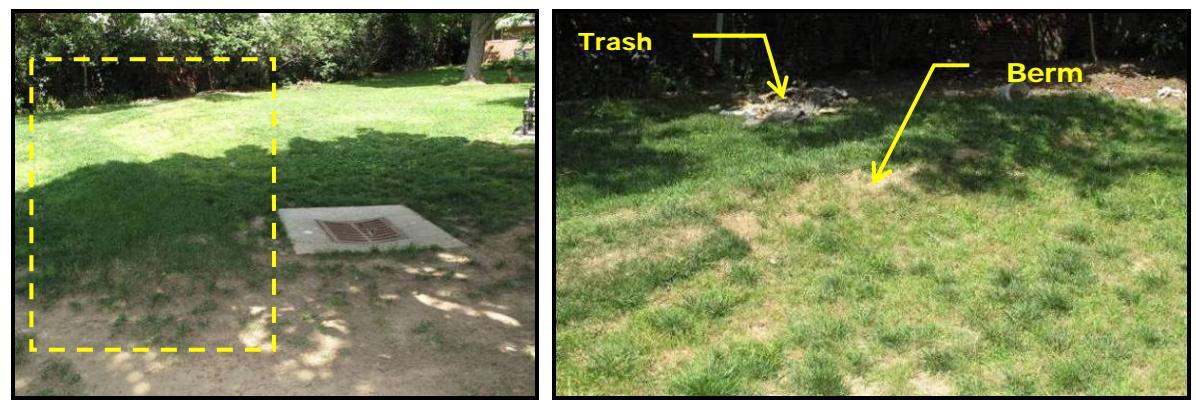
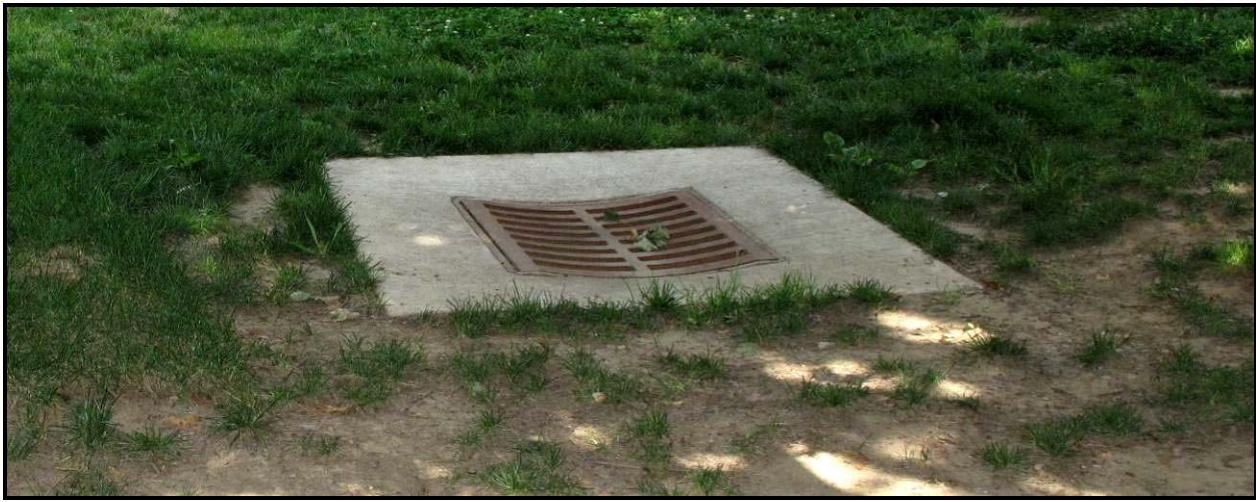
Berm B1

OBSERVATION	INITIAL RECOMMENDATIONS
• Bioswale appears to be working normally.	a. Prepare bare areas around the catch basin for
• Berm is mostly well covered with lawn. In some area, bare patches	new lawn.
appear.	b. Treat area with seed or sod.
• Soil uphill of the berm appears to be adequate (See TP#3 above).	c. Flush catch basin and cleanout pipes.
• Catch basin at the end of bioswale has standing water. The outfall pipe	
appears to be clogged.

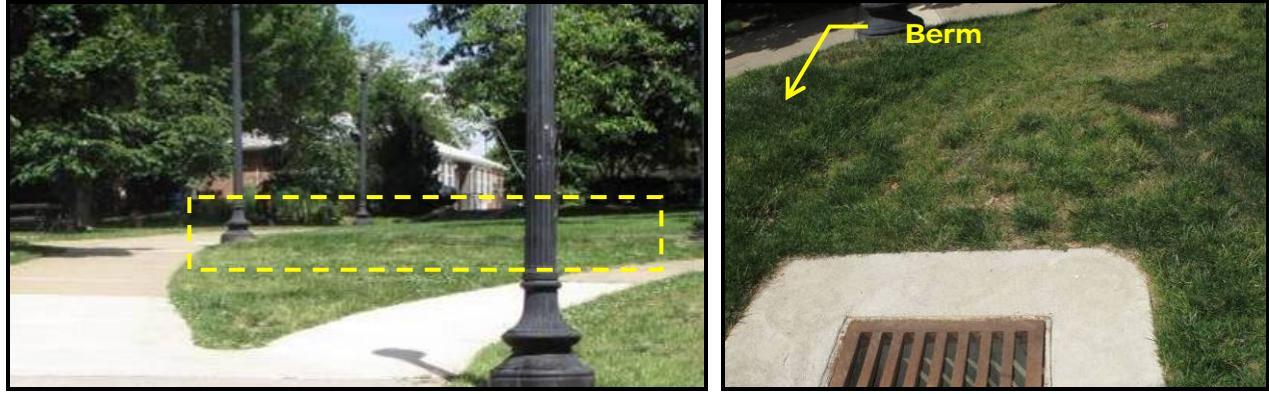
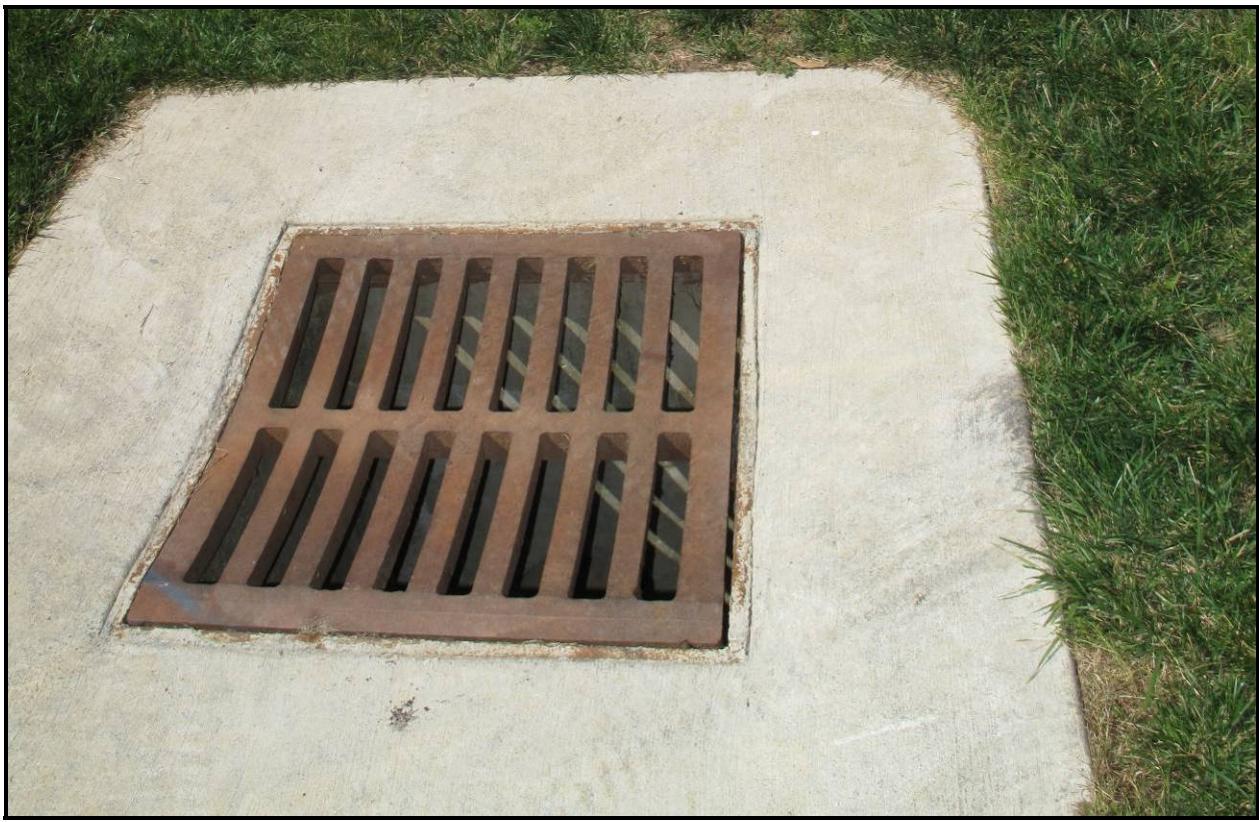
Berm B2

OBSERVATION	INITIAL RECOMMENDATIONS
• Bioswale appears to be working normally.	a. Treat area with seed or sod.
• Berm is mostly well covered with lawn. In some area, bare patches	b. Flush catch basin and cleanout pipes.
appear.	
• Catch basin at the end of bioswale is dry.

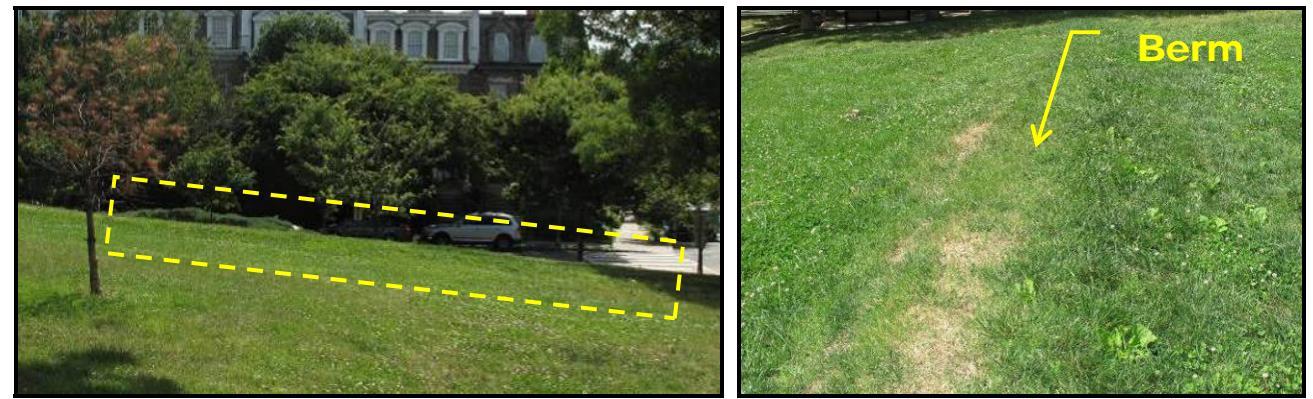
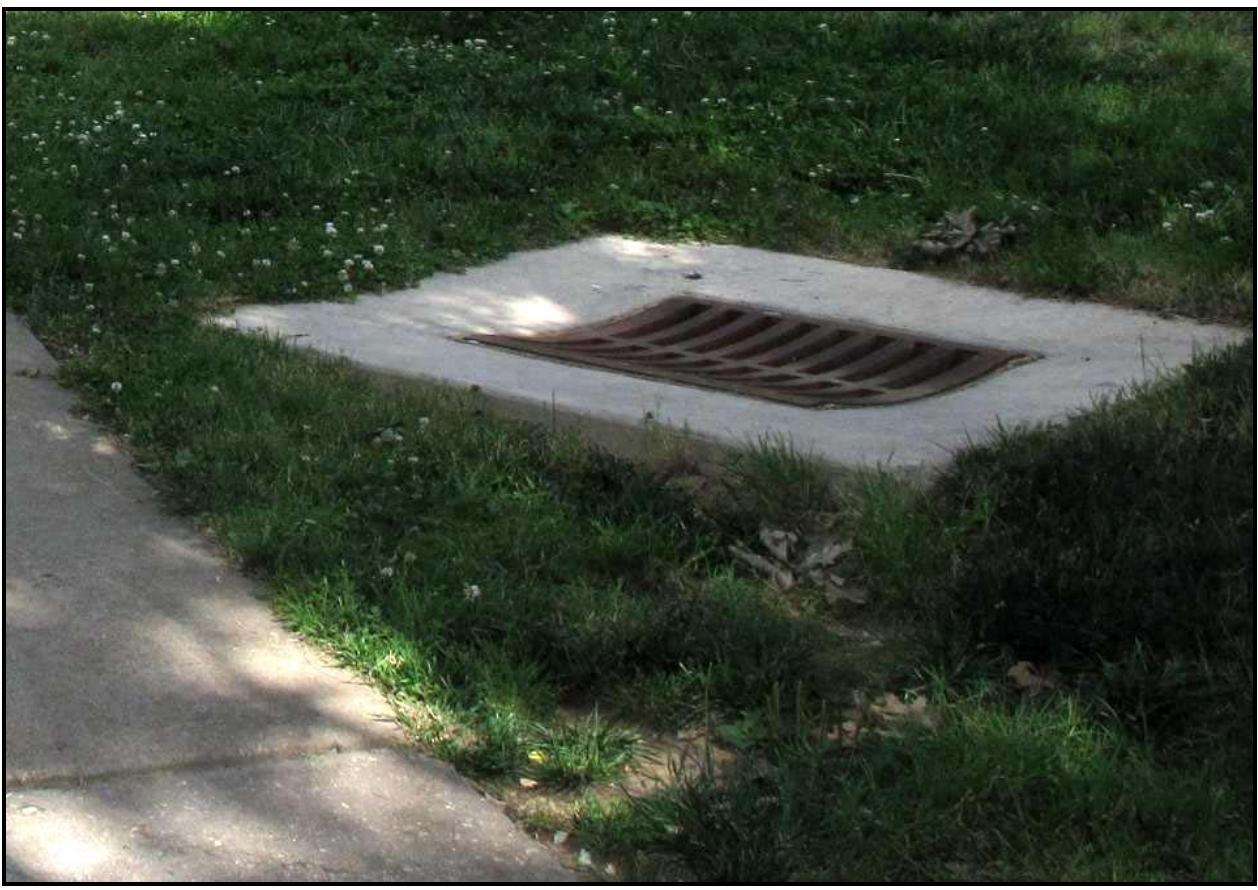
Berm B3

OBSERVATION	INITIAL RECOMMENDATIONS
• Bioswale appears to be working normally.	a. Prepare bare areas around the catch basin for
• Berm is mostly well covered with lawn. In some area, bare patches	new lawn.
appear.	b. Treat area with seed or sod.
• Catch basin at the end of bioswale has miscellaneous debris.	c. Remove debris in catch basin. Flush catch
	basin and cleanout pipes.

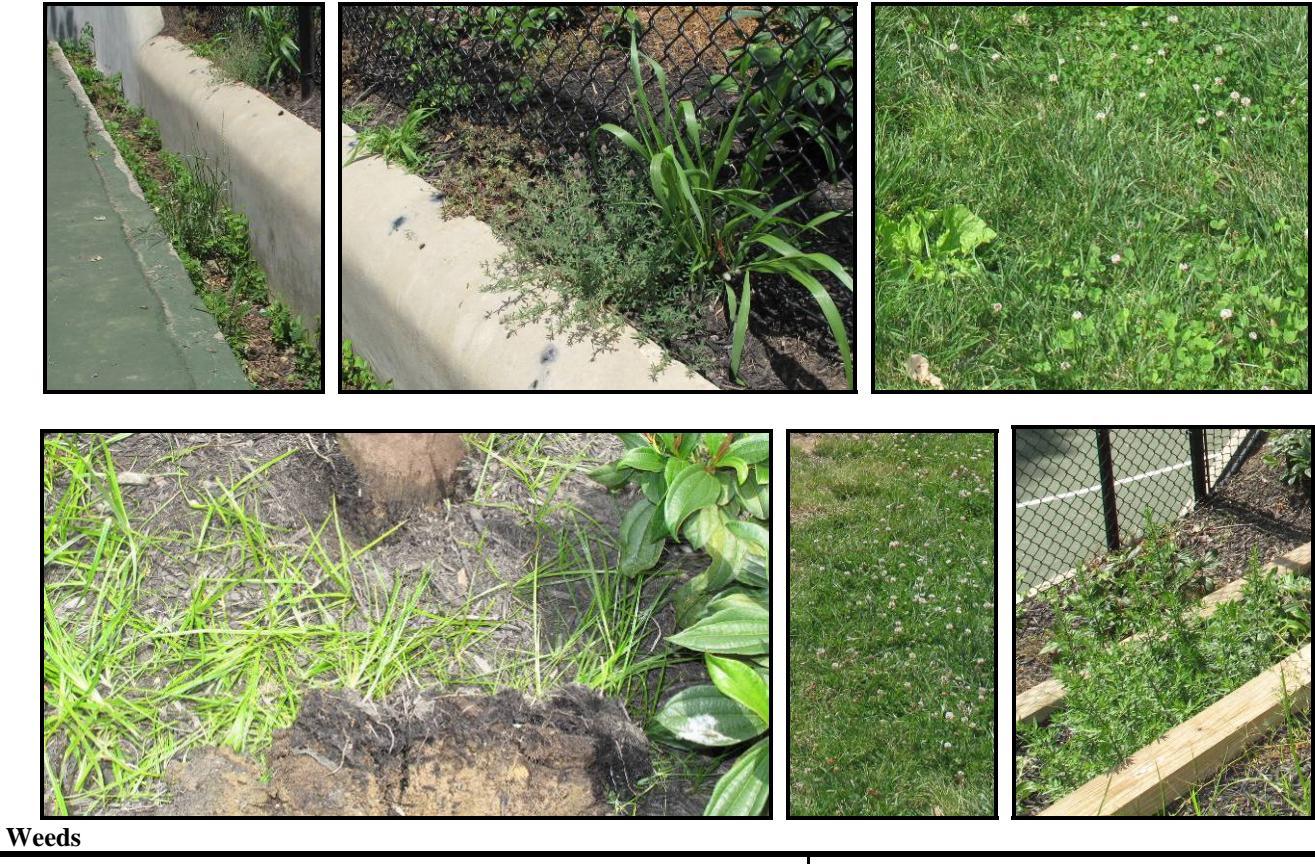
OBSERVATION	INITIAL RECOMMENDATIONS
There are weeds throughout the site.	a. Remove weeds.

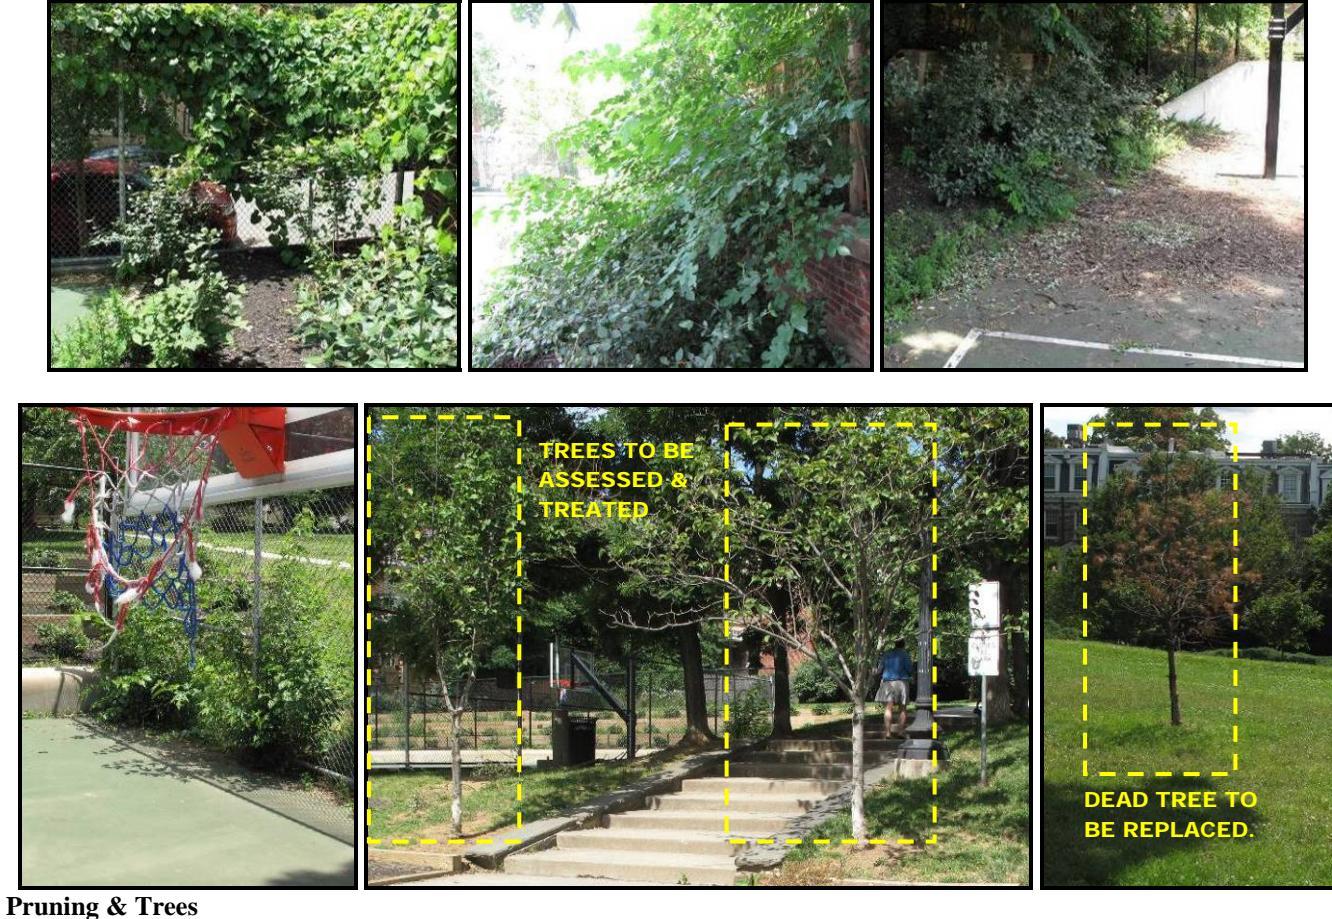
- Vines and trees are hanging over planted materials and site features. •
- Trees at the 19<sup>th</sup> Street NW entrance into the park appear to be in • poor health. Roots may have been damaged from construction activity.

Prune shrubs and ground cover. a.

- Have tree roots pruned and treated by b. arborist.
- Trees that are dead or dying should be c. replaced or treated as directed by arborist.

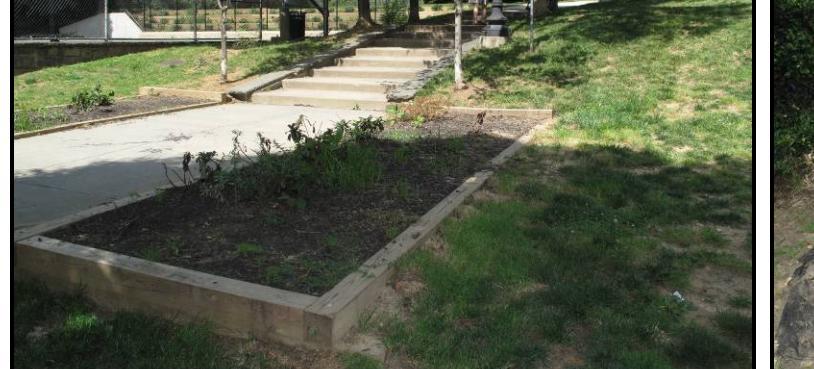
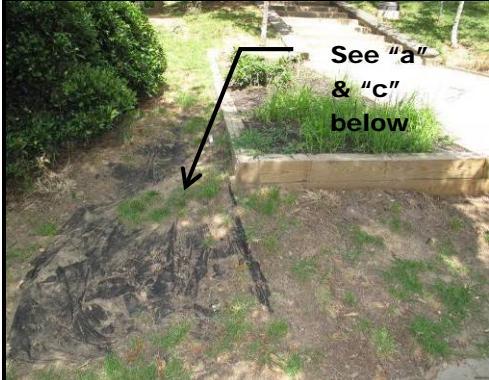
## Shrubs and Groundcover at West Entrance

OBSERVATION	INITIAL RECOMMENDATIONS
• Most shrubs and other plantings in the 19 <sup>th</sup> Street entrance planters are	a. Remove filter fabric, debris, and weeds.
in poor condition. Soil condition seems to be a loamy clay. Unlike the	b. Remove top 6" of soil in planter boxes and
condition in Soil Test Pit Area 6, the plants in this area do not seem to	replace with planting soil. Install heavy duty
have access to the moisture and are in decay. Planting beds at the west	filter fabric. Cut opening in fabric to allow
entrance of the park are full of weeds and grass. Grass adjacent to	shrubs to grow. Install a 3" thick layer of
planters is in poor condition. Filter fabric and debris is exposed	mulch to the top of timber plank. Shrubs
around planters.	should stay in place, undisturbed.
-	c. Treat area around planter boxes with sod or
	seed

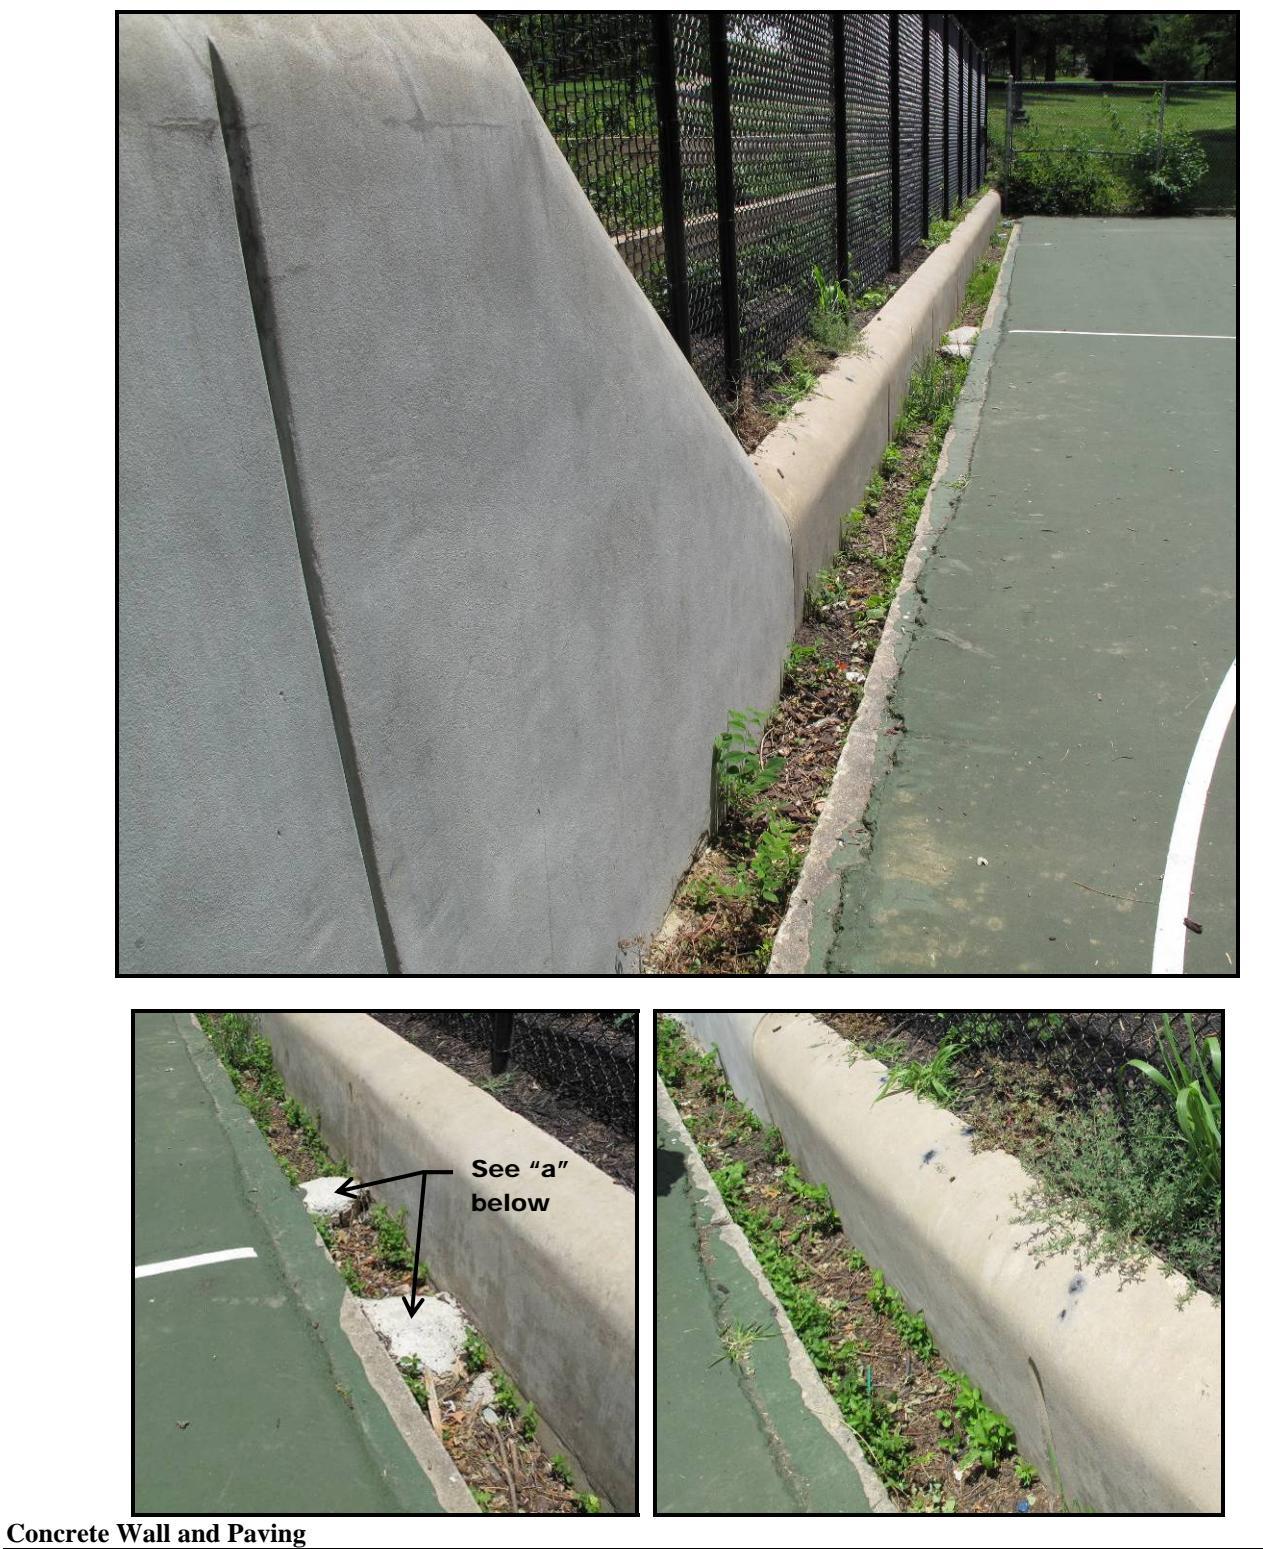
0	BSERVATION	INITIAL RECOMMENDATIONS	
•	Pavement between basketball court and retaining wall is missing and hazardous. Foundation of previously existing basketball court remains in place,	a. b.	Remove top 12" of old basket ball hoop concrete foundation. Install basketball court surface with a
	and is an obstruction to anyone using the court.		concrete base at gap between retaining wall and existing court. Provide a continuous expansion joint between wall and subbase.

Pavement between basketball court and retaining wall is missing and presents a hazardous condition. Foundation of previously existing basketball court remains in place, and is an obstruction to anyone using the court.

- 1. Remove top 12" from the top of old basket ball hoop concrete foundation.
- 2. Install basketball court surface and a concrete base along the gap between retaining wall and existing court. Provide a continuous expansion joint between wall and subbase.

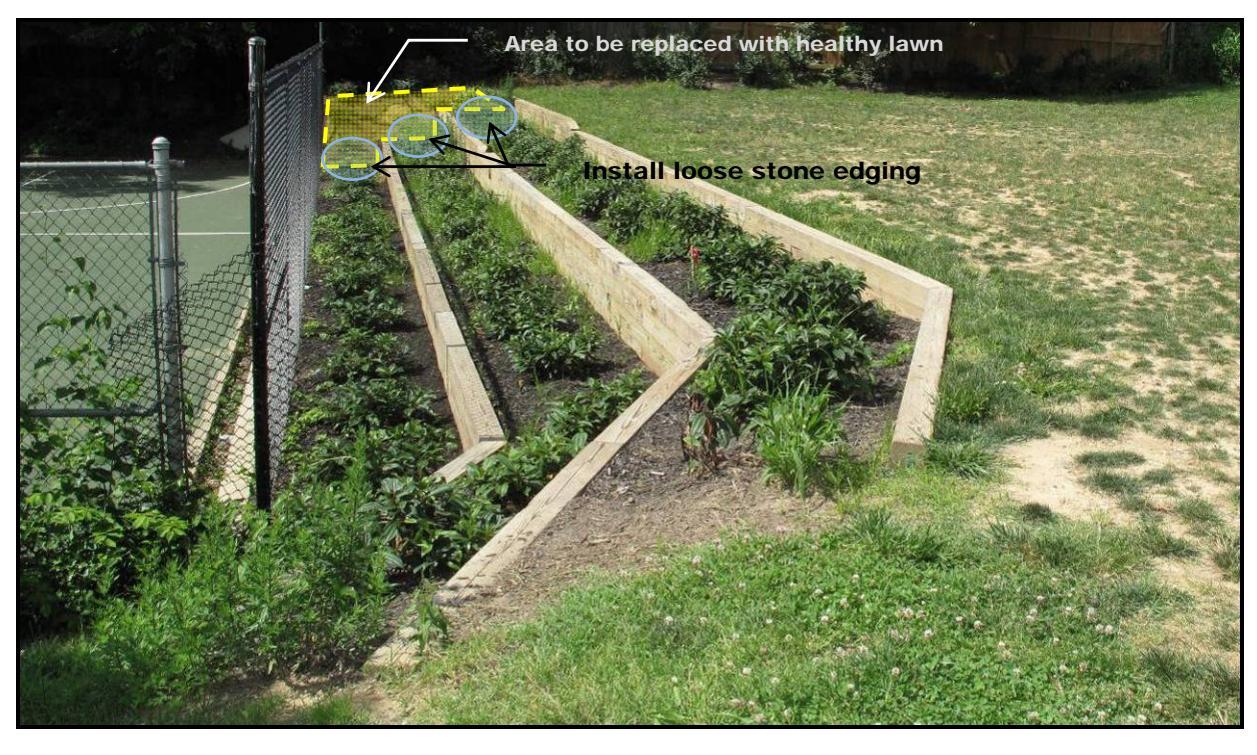
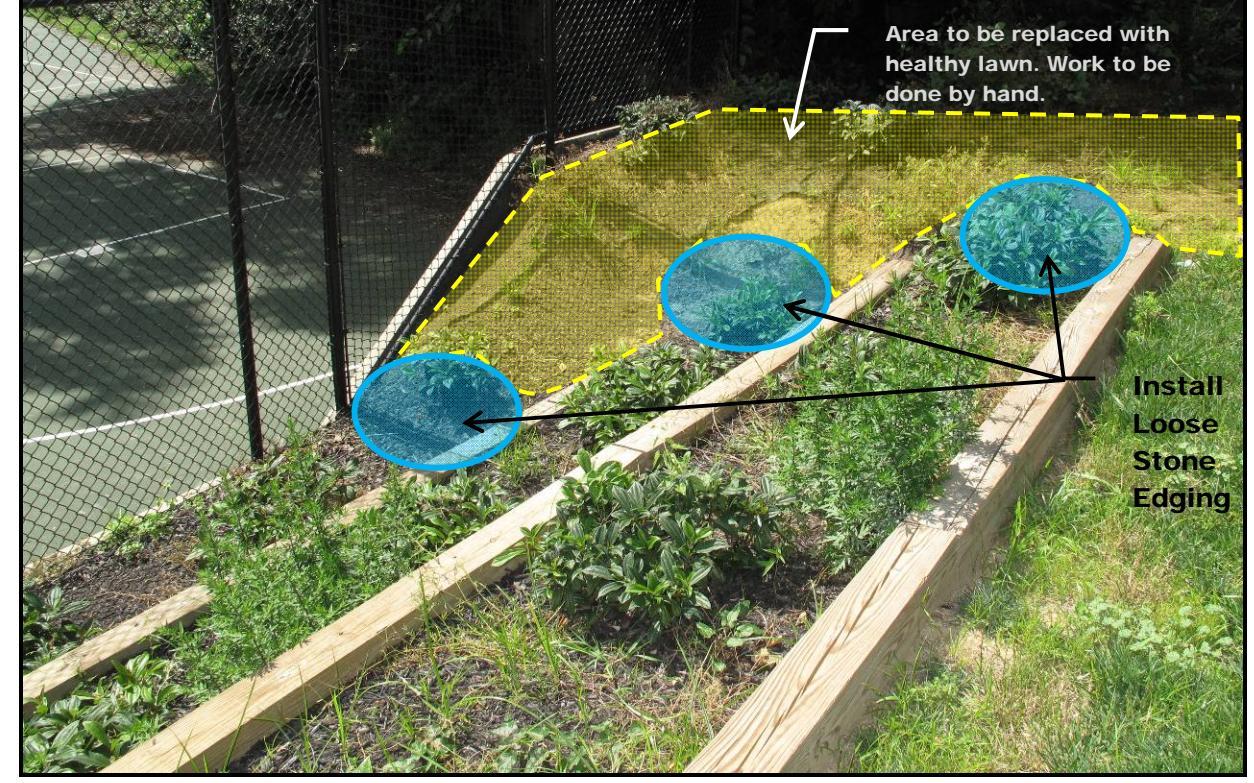
Terraced Timber Retaining Wall and Planter				
OBSERVATION		INITIAL RECOMMENDATIONS		
•	Terraced wall was installed by second contractor without plans.	a. Remove planting and filter fabric at the north		
•	Terraced planting bed at the north ends is eroding and existing filter	sod or seed. Provide $\pm 18$ " dia. rounded loose		
	fabric is falling apart.	stone edging between grass and planter to separate lawn from planting (see images		
		above). There should be no digging past 12".

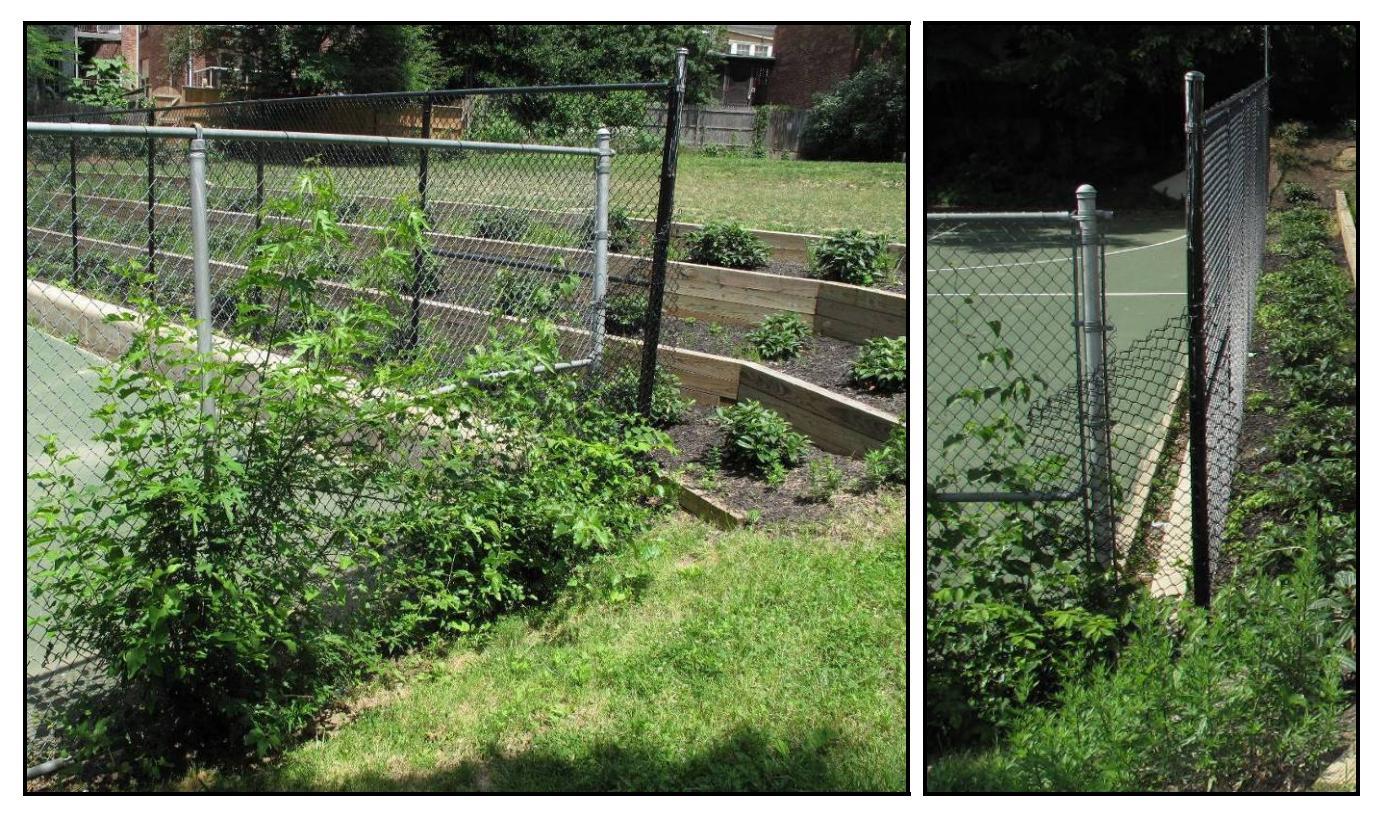
0	BSERVATION	INITIAL RECOMMENDATIONS
•	New black fence and previously existing fence are poorly tied	a. Correctly tie new fence fabric to fence posts.
	together with miscellaneous fence fabric.
