## G-MAX TEST REPORT

2019

Date 06-18-2019

**Project Name – Deal Middle School – Soccer Field**

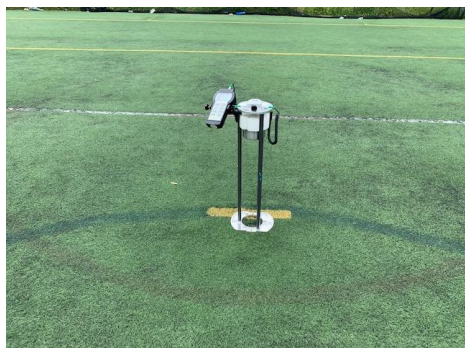
Location #1

Test Location	Drop 1		Drop 2		Drop 3		Gmax Average	Infill Depth (mm)	Field Temp (°F)
	Gmax	HIC	Gmax	HIC	Gmax	HIC			
1	186	498	201	563	208	577	204.50	7	102
2	154	479	164	526	164	535	164.00	30	102
3	144	279	116	283	115	277	115.50	39	102
4	123	328	131	358	129	350	130.00	37	102
5	170	493	177	501	168	545	172.50	25	102
6	114	279	119	298	120	299	119.50	37	102
7	126	327	134	353	130	332	132.00	36	102
8	162	449	169	476	169	474	169.00	35	102
9	119	283	127	310	136	404	131.50	36	102
10	141	380	144	385	144	381	144.00	41	102
							148	Overall Average G-max

Location	Specific Location Description
1	W Penalty Kick at Center of the Field
2	W Goal area at center of field
3	SW Corner of White Lines
4	SW Approx 25 yd line 30 ft from midfield
5	Center of field
6	NE Approx 25 yd line at the numbers
7	E Center of field at White Arc
8	E Soccer Goal Area at center of field
9	SE Corner kick white line
10	South sideline at midfield
