# Public Facilities Environmental Safety Act Community Meeting

Mike McLaughlin, DGS External Affairs

August 16, 2023

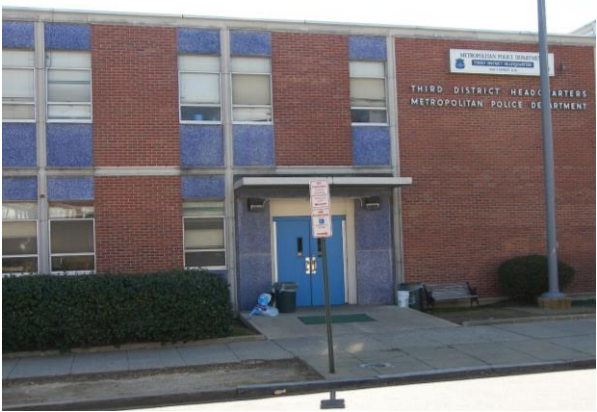
# 3<sup>rd</sup> District (MPD) – Ward 1

Environmental risk(s) found	Location(s) of finding	Acceptable threshold	Next steps
Mold & mildew	Men’s and women’s locker rooms and bathrooms; first floor lobby; boiler room pipes	Interior < exterior	Repaired leaks and replaced ceiling tiles
Pests	Burrows along the exterior of the building	None	Treated and closed burrows; installed bait, catch and release stations
Dust	Boiler room; 108 µg/m3	< 50 µg/m3	Determined dust source and cleaned as appropriate

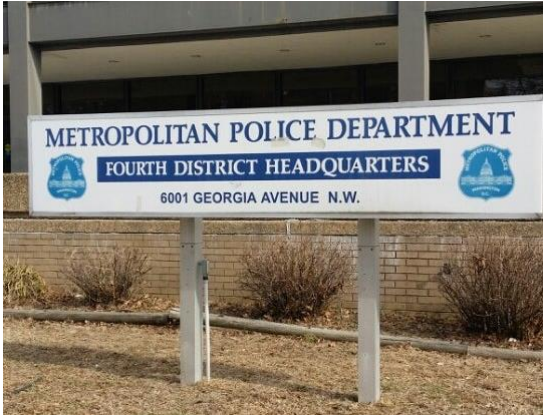
# 4<sup>th</sup> District (MPD) – Ward 4

Environmental risk(s) found	Location(s) of finding	Acceptable threshold	Next steps
Dust	Boiler room; 216 µg/m <sup>3</sup>	< 50 µg/m <sup>3</sup>	Cleaned to address excess particulate matter
Asbestos	Basement floor tile; 2 <sup>nd</sup> floor hallway tile; 5%	<1% of material	Remove asbestos-containing material
Mold & mildew	Women’s bathroom; stairwell; basement vents	Interior < exterior	Replaced ceiling tiles and drywall; disinfected basement vents; seal roof

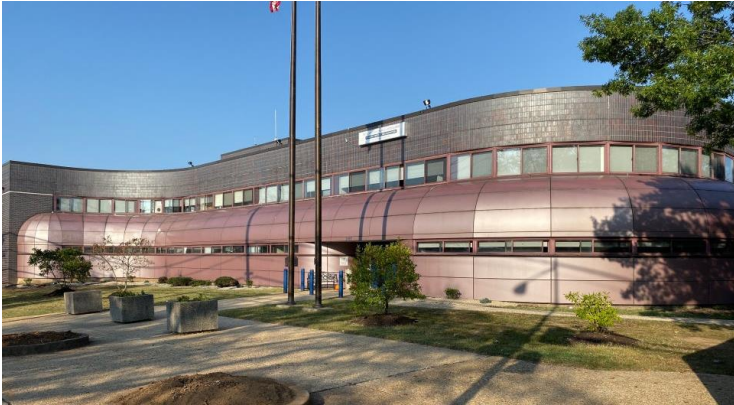
Environmental risk(s) found	Location(s) of finding	Acceptable threshold	Next steps
Mold & mildew	Mechanical hallway ceiling tile and vents	Interior < exterior	Ceiling tile replaced and vents cleaned
Groundwater	Leaking backup generator	None	Repair or remove source leaking generator and treat any groundwater contamination
Dust	Boiler room; 105 µg/m3	< 50 µg/m3	Clean to address excess particulate matter

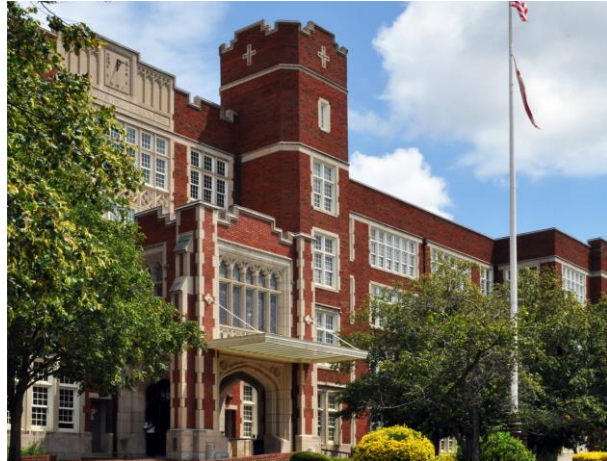
# Eastern High School – Ward 7

Environmental risk(s) found	Location(s) of finding	Acceptable threshold	Next steps
Dust	Band room; 70 $\mu\text{g}/\text{m}^3$ ; Boiler room 139 $\mu\text{g}/\text{m}^3$	< 50 $\mu\text{g}/\text{m}^3$	Determined dust source and cleaned as appropriate

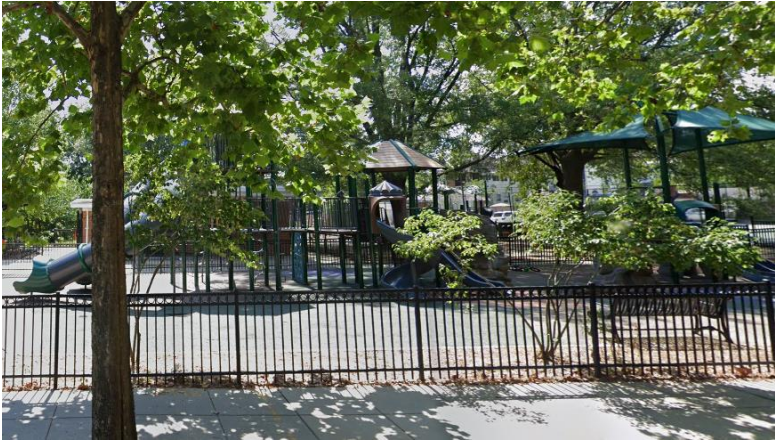
# Hamilton Recreation Center – Ward 4

Environmental risk(s) found	Location(s) of finding	Acceptable threshold	Next steps
Deteriorating lead-based paint	Exterior soffit/facia board; 1.3%	<1mg/cm <sup>2</sup> or 0.5% by weight	Execute remediation design by removing paint from the surface, HEPA vacuuming, and repainting

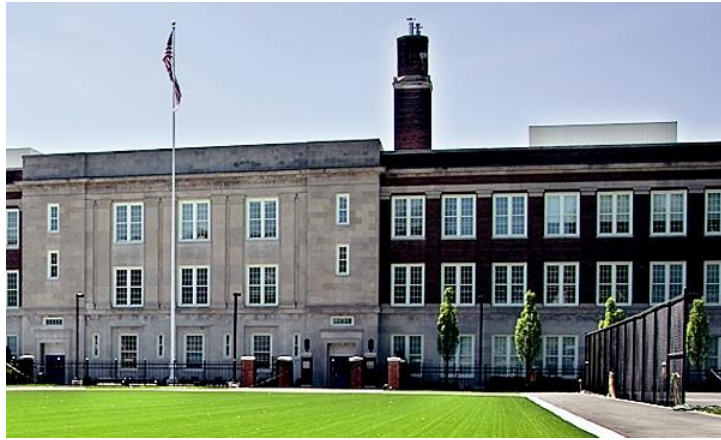
# Hardy Middle School – Ward 3

Environmental risk(s) found	Location(s) of finding	Acceptable threshold	Next steps
Mold & mildew	Boiler room	Interior < exterior	Ceiling tiles replaced
Pests	Rodent burrows along the outside of the building	None	Treat and close burrows; rebait bait boxes
Dust	Boiler room; 75 µg/m3	< 50 µg/m3	Determine dust source and clean as appropriate

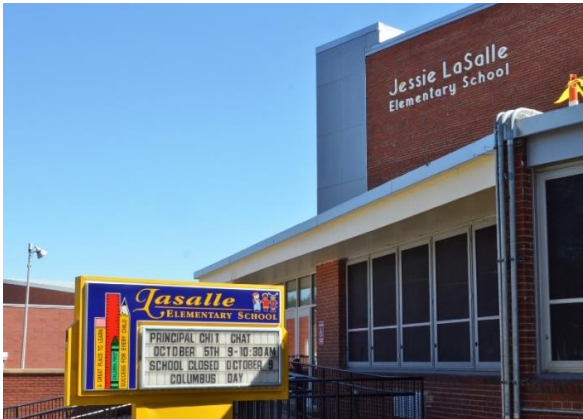
# LaSalle-Backus Education Campus – Ward 4

Environmental risk(s) found	Location(s) of finding	Acceptable threshold	Next steps
Mold & mildew	Theater room (only moisture currently)	Interior < exterior	Reseal northwest side of roof
Dust	Boiler room; 48 µg/m3	< 35 µg/m3	Determine dust source and clean as appropriate

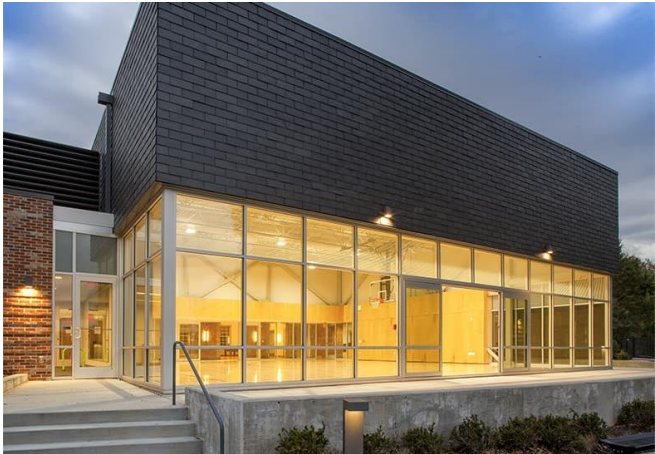
# Palisades Recreation Center – Ward 3

Environmental risk(s) found	Location(s) of finding	Acceptable threshold	Next steps
Mold & mildew	Basement; lobby window	Interior < exterior	Replace missing roof shingles; treat identified basement mold
Deteriorating lead-based paint	Basement janitor closet; basement storage room; 1.04-4.92%	<1mg/cm <sup>2</sup> or 0.5% by weight	Execute remediation design by removing paint from the surface, HEPA vacuuming, and repainting
Pests	Basement	None	Treat basement and close points of entry

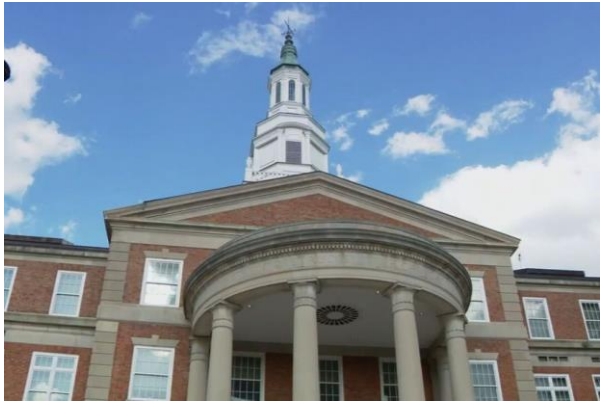
# Roosevelt STAY High School at Garnet-Patterson – Ward 1

Environmental risk(s) found	Location(s) of finding	Acceptable threshold	Next steps
Mold & mildew	Main office ceiling; stairwell behind auditorium	Interior < exterior	Replace ceiling tiles
Dust	Boiler room; 50 µg/m3	< 50 µg/m3	Determine dust source and clean as appropriate

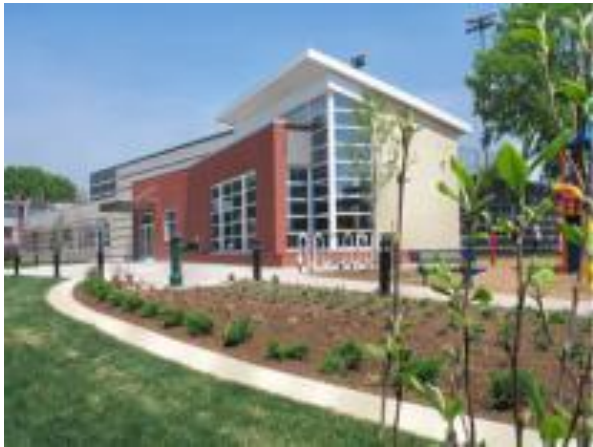
# Trinidad Recreation Center – Ward 5

Environmental risk(s) found	Location(s) of finding	Acceptable threshold	Next steps
Pests	Outside near garbage receptacles	None	Treat and close burrows
Dust	Boiler room; 122 µg/m <sup>3</sup>	< 50 µg/m <sup>3</sup>	Determine dust source and remediate as appropriate

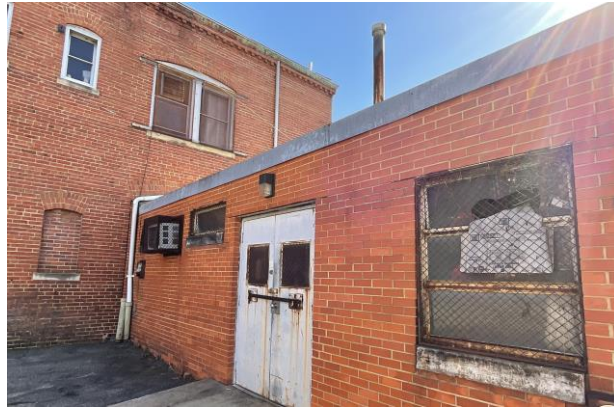
# TSA Sign Shop (DDOT) – Ward 6

Environmental risk(s) found	Location(s) of finding	Acceptable threshold	Next steps
Asbestos	Metal window glazing; 2%	<1% of material	Complete an assessment, develop a remediation project design and execute
VOCs/Ventilation	Print shop; 5000	<500 µg/m3	Repair exhaust fans
Deteriorating lead-based paint	Boiler room support column; 18%	<1mg/cm <sup>2</sup> or 0.5% by weight	Design a remediation project and execute
Toxic Chemicals and Hazardous Waste	Print shop	None	Properly store or dispose of material
Pests	Building exterior and storage space	None	Treat and close rodent burrows
Mold & mildew	Second floor hallway	Interior < exterior	Replace ceiling tiles

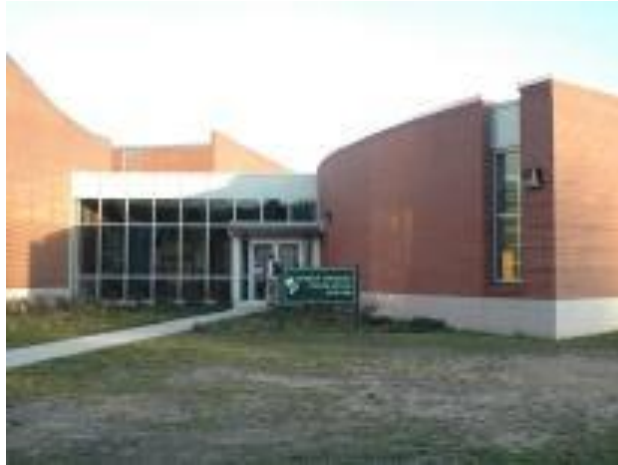
# Turkey Thicket Aquatic Center – Ward 5

Environmental risk(s) found	Location(s) of finding	Acceptable threshold	Next steps
Mold & mildew	Table tennis room; gym; lobby	Interior < exterior	Address sources of moisture and repair
Pests	Kitchen	None	Treat and close exterior burrows; treat interior as appropriate
