Public Facilities Environmental Safety Act Community Meeting

Ivania Esquivel, DGS Facilities

October 11, 2023

Public buildings with actionable results (1 of 2)

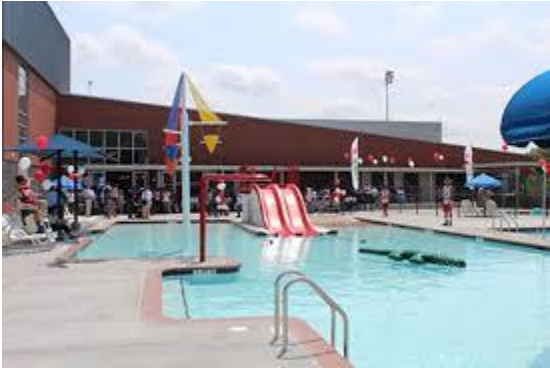
Lincoln Capper Children’s Pool– Ward 6

Environmental risk(s) found	Location(s) of finding	Acceptable threshold	Next steps
Pests	Burrows along the exterior of the building	None	Treated and closed burrows; installed bait, catch and release stations
Dust	Boiler room; 108 µg/m3	< 50 µg/m3	Determined dust source and cleaned as appropriate

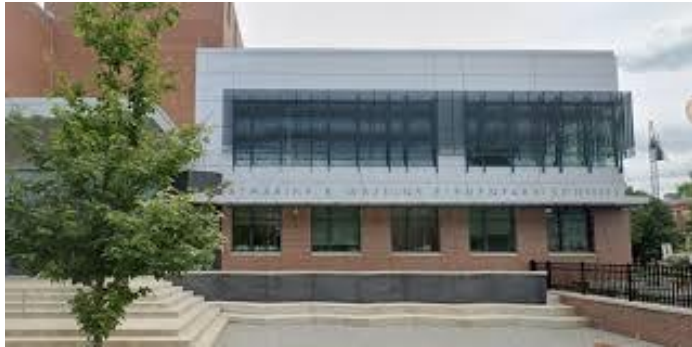
Watkins Elementary School – Ward 6

Environmental risk(s) found	Location(s) of finding	Acceptable threshold	Next steps
Water intrusion	Mechanical hallway ceiling tile and vents	None	Ceiling tile replaced
Dust	Boiler room; 105 µg/m3	< 50 µg/m3	Clean to address excess particulate matter

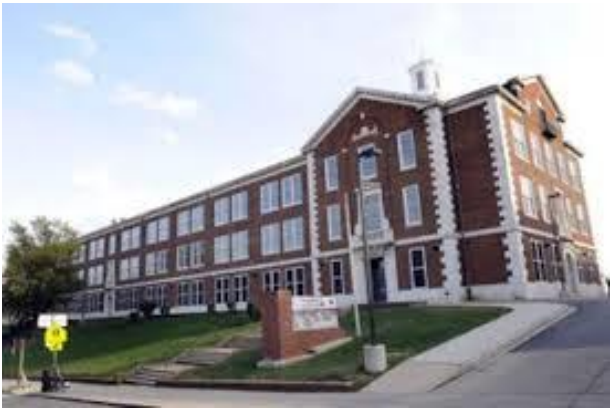
McKinley Middle School – Ward 5

Environmental risk(s) found	Location(s) of finding	Acceptable threshold	Next steps
Dust	Band room; 70 µg/m ³ ; Boiler room 139 µg/m ³	< 50 µg/m ³	Determined dust source and cleaned as appropriate
Deteriorating lead-based paint	Exterior soffit/facia board; 1.3%	<1mg/cm ² or 0.5% by weight	Execute remediation design by removing paint from the surface, HEPA vacuuming, and repainting

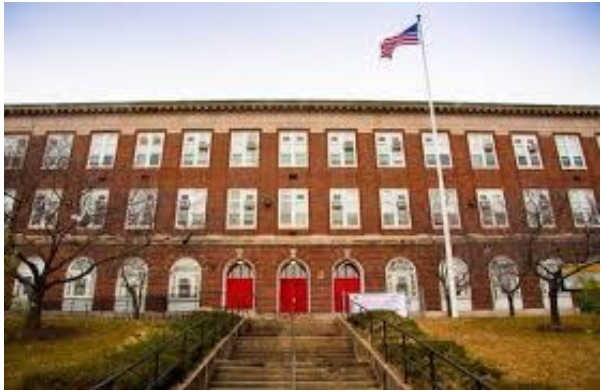
Browne Education Campus – Ward 5

Environmental risk(s) found	Location(s) of finding	Acceptable threshold	Next steps
Water intrusion	Mechanical hallway ceiling tile and vents	None	Ceiling tile replaced
Dust	Boiler room; 105 µg/m3	< 50 µg/m3	Clean to address excess particulate matter
