G-MAX TEST REPORT

Date 06-18-2019

Project Name – Palisades Spray Park – Turf Field

Test Type - Onsite G-max Test - 10 Locations

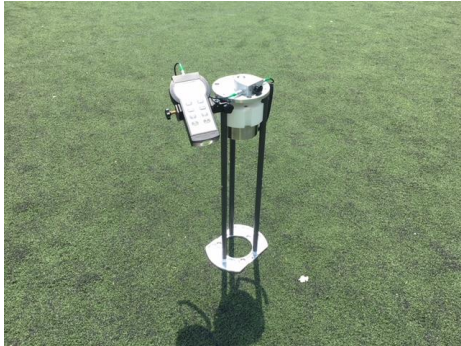
Location #1

Location	Specific Location Description
1	E Penalty Kick at Center of the Field
2	E Goal area at center of field
3	SE Corner of White Lines
4	SE Approx 25 yd line 30 ft from midfield
5	Center of field
6	NW Approx 25 yd line at the numbers
7	W Center of field at White Arc
8	W Soccer Goal Area at center of field
9	NW Corner kick white line
10	North sideline at midfield
