# G-MAX TEST REPORT

**Project Name – Riggs Recreation Football Field**

**Test Type** - Onsite G-max Test - 10 Locations

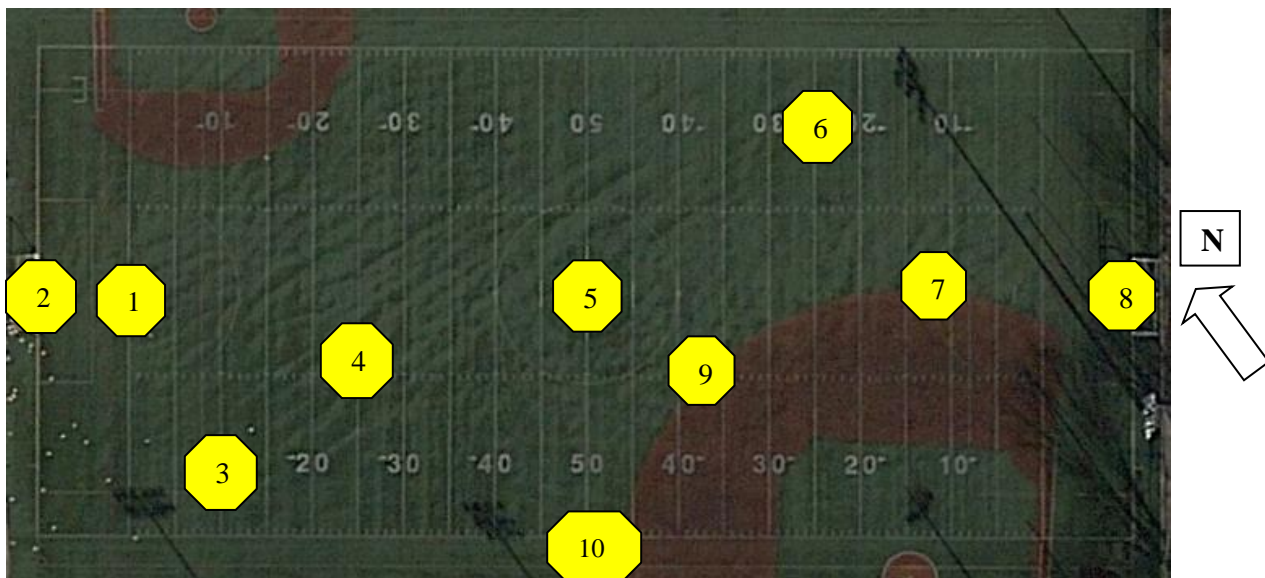
Location	Specific Location Description
1	W goal line center of the field
2	W Soccer Goal area at center of field
3	SW 10yd line at the numbers
4	SW 25yd line at the hashes
5	Midfield at Centerfield
6	NE 25 yd line at the numbers
7	E center of the LAX circle
8	E Soccer Goal area at center of field
9	SE 37yd line at the hashes
10	South sideline at midfield
