G-MAX TEST REPORT

Project Name – Tubman Elementary School
Site address - 3103 13th St NW, Washington, DC 20010
Test Type - Onsite G-max Test - 10 Locations
Field Type - Soccer (Sand/Rubber)

**Tubman ES - Synthetic Turf Field
Overall G-max = 196**

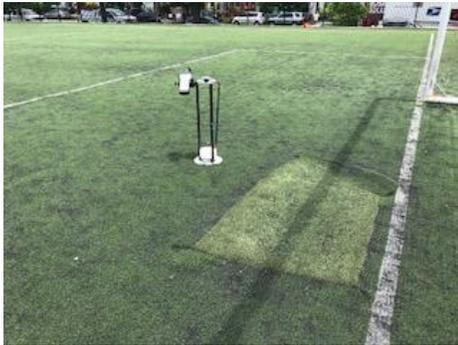
Location #1

Location	Specific Location Description
1	S Penalty Kick at Center of the Field
2	S Goal area at center of field
3	SE Corner of White Lines
4	SE Approx 25 yd line 30 ft from midfield
5	Center of field
6	NW Approx 25 yd line at the numbers
7	N Center of field at White Arc
8	N Soccer Goal Area at center of field
9	NE Corner kick white line
10	West sideline at midfield
