**Addendum No. 1**

**Solicitation Number: DCAM-23-AE-RFP-0001**

**ARCHITECTURAL/ENGINEERING SERVICES FOR  
RANDALL RECREATION CENTER**

# ADA Master Plan for the District of Columbia

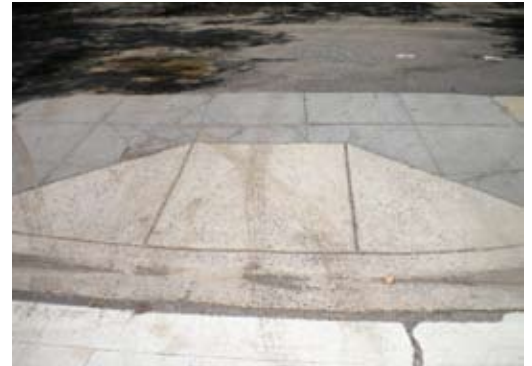
Picture 4

- Curb cuts are provided at site entrance, but no required truncated domes are included (Picture 4).

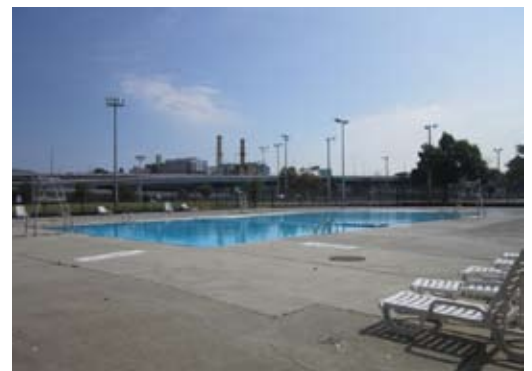
Picture 5

- The outdoor swimming pool is located within a fenced area and is accessed through the pool bathhouse building. The pool has more than 300 linear feet of water wall but does not have the required accessible means of entry (Picture 5).

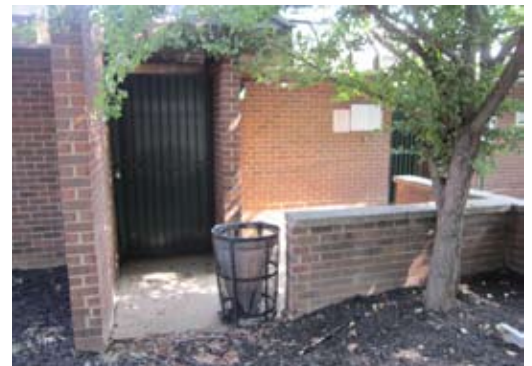
Picture 6

2-412	404.2.9	<b>Opening Force</b>						
	404.2.9	Opening Force, non-fire rated doors	No requirement for exterior doors					Entrance doors require an opening force that may prevent an accessible entry. Action: Repair / replace door closer to comply with the DOJ accessibility regulations for persons with disabilities.
2-415	302 / 404.2.4.1 / 404.2.4.2 / 404.2.4.3 / 404.2.4.4 / 404.2.6	<b>Maneuvering Clearances at doors</b>	Floor or ground surface within required maneuvering clearances shall comply with 302. Changes in level not permitted.					Layout and configuration of building entrance for Men's and Women's changing rooms is not ADA compliant (Picture 6, 19). Action: Significant demolition and restructuring is required to provide required clearances.

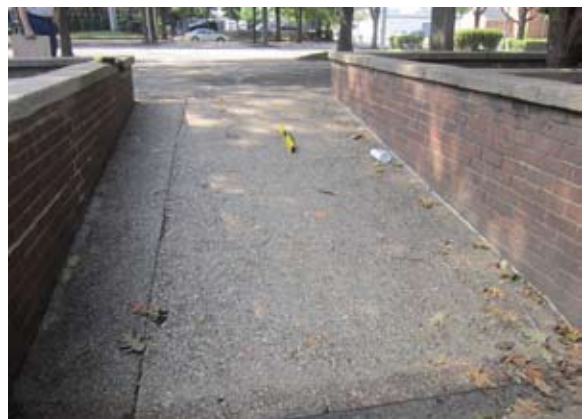
Picture 18

2-205	405.8	Handrail required if more 6"rise	Railings (top 34" to 38" H)					Required handrails are not provided (Picture 18). Action: Provided and install ADA compliant handrails with extensions.
2-206		Top and bottom landings	12" area extension beyond edges					
2-207	405.9	Edge Protection						
2-208	405.1	Curb or Barrier Curb Protection	Barrier located 4" AFF at Rail					
2-209	405.4 / 302	Floor or Ground Surfaces	Floor and ground surfaces shall be stable, firm, and slip resistant and shall comply with 302.

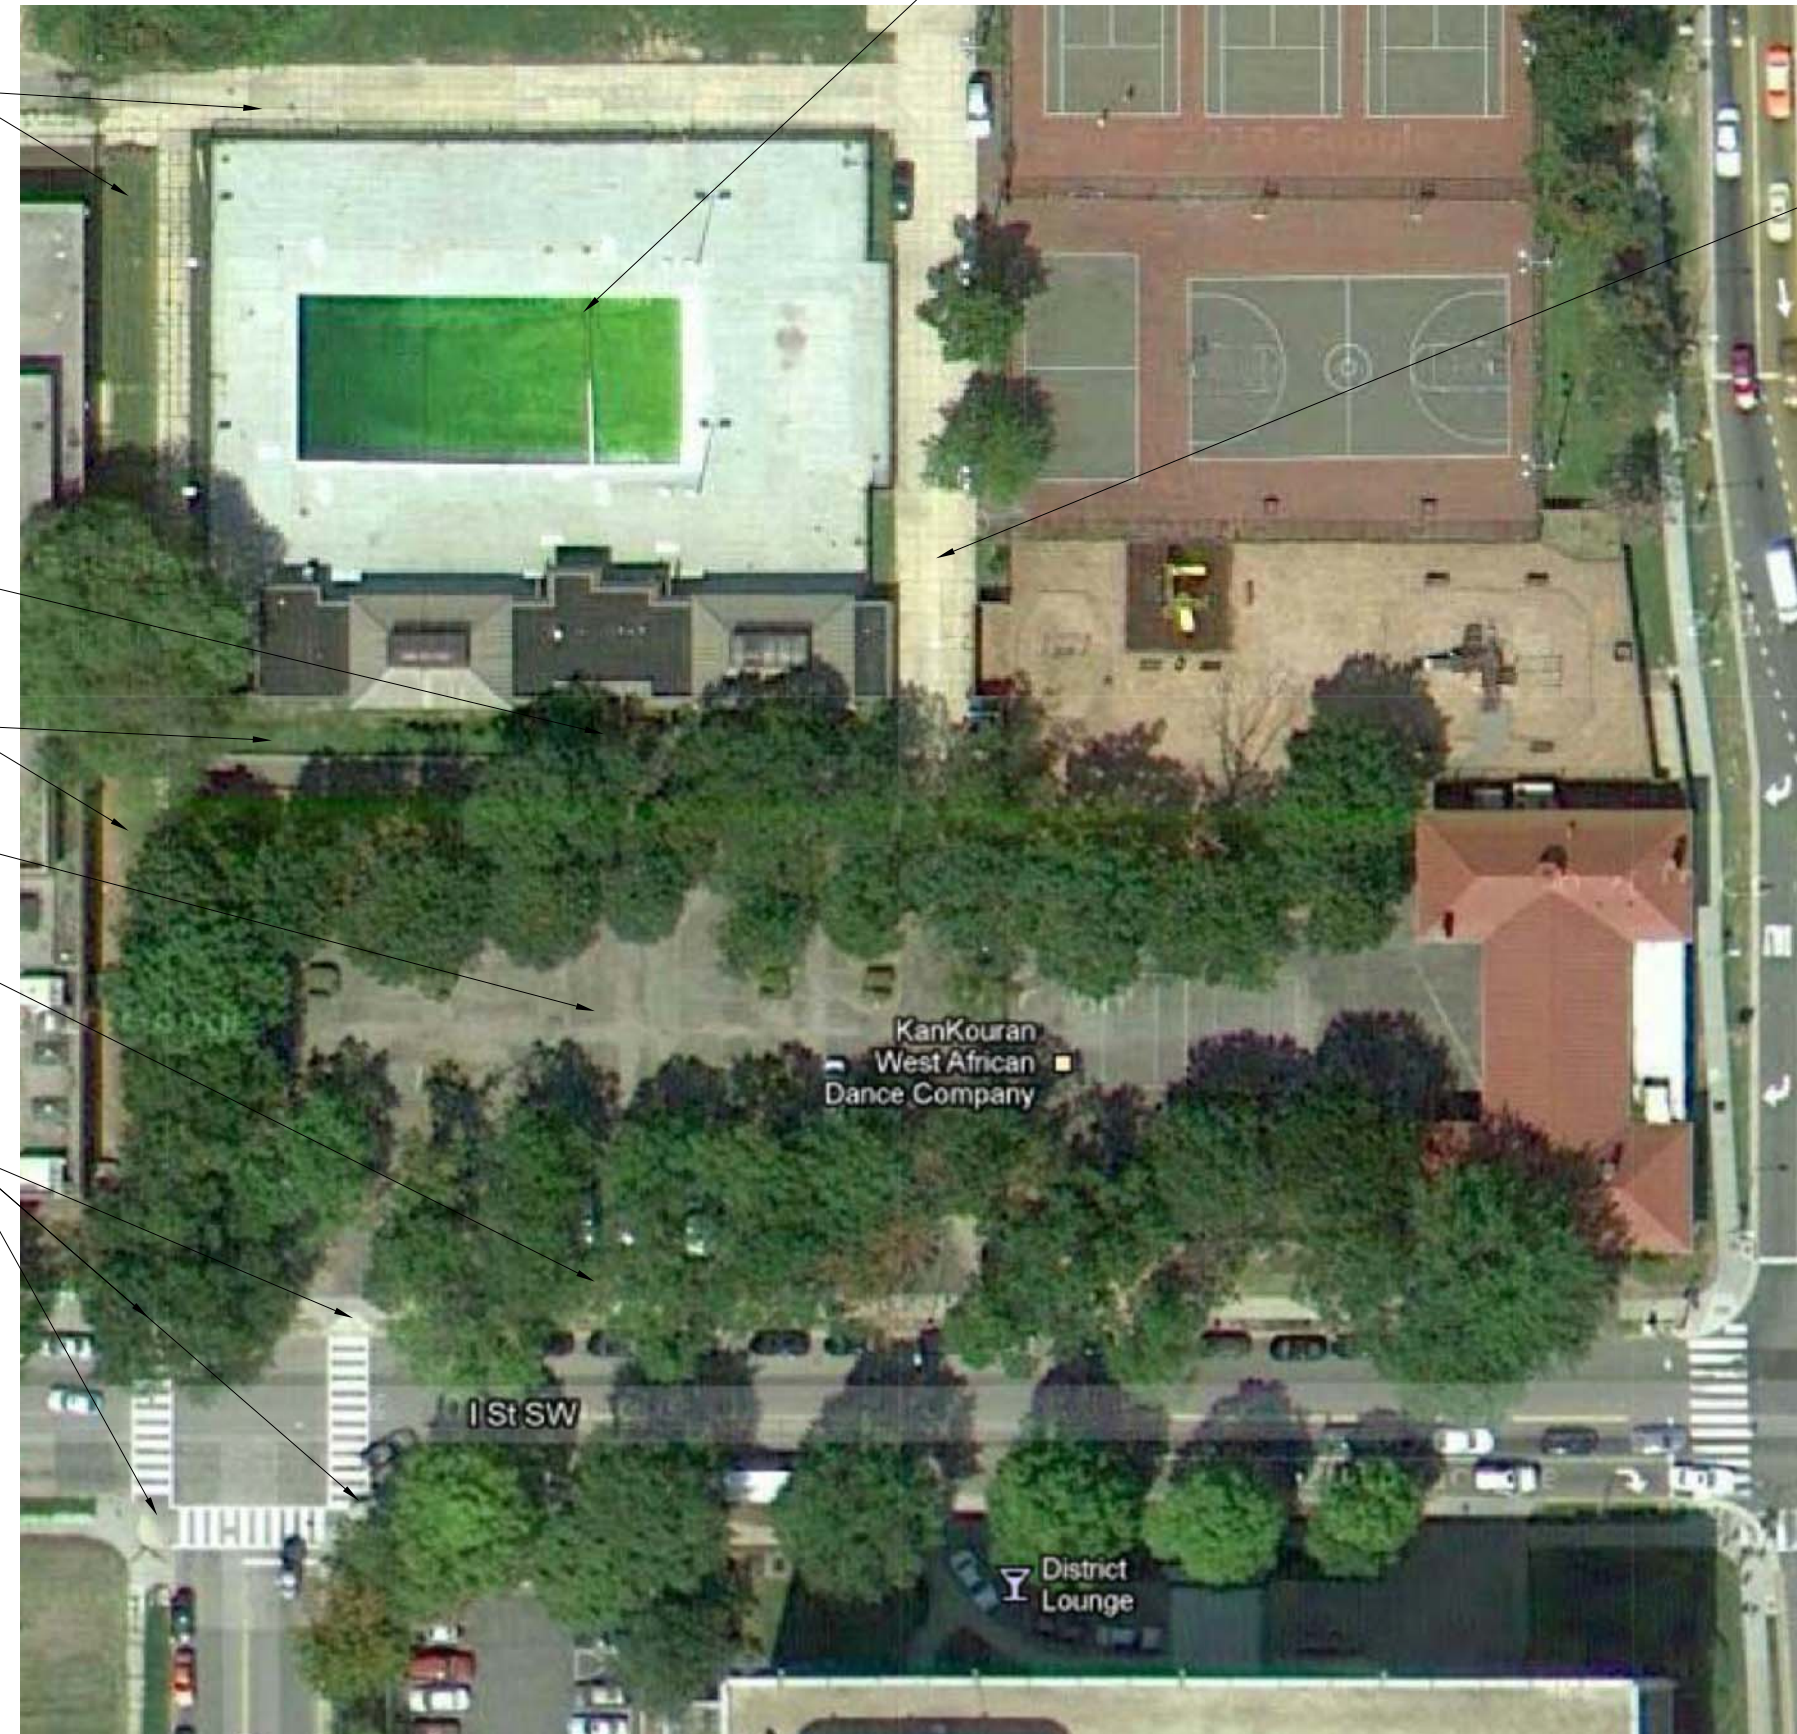
**SITE PLAN**

- 1] WHERE NOTE 1] IS SHOWN ON PLAN, FLOOR PLAN IS AT VARIANCE WITH OBSERVED FIELD CONDITIONS AS OF SURVEY DATE.
- 2] [X-XXX] ANNOTATION OF BUILDING ELEMENTS AS DESCRIBED IN THE ADA ANALYSIS CHECKLIST
- 3] WHERE NOTE 3] IS SHOWN ON PLAN, ACCESS HAS NOT BEEN PROVIDED TO AREA AT TIME OF SURVEY
