Property Condition Report

**OB / GYN - Building 9
1900 Massachusetts Ave SE
Washington, DC**

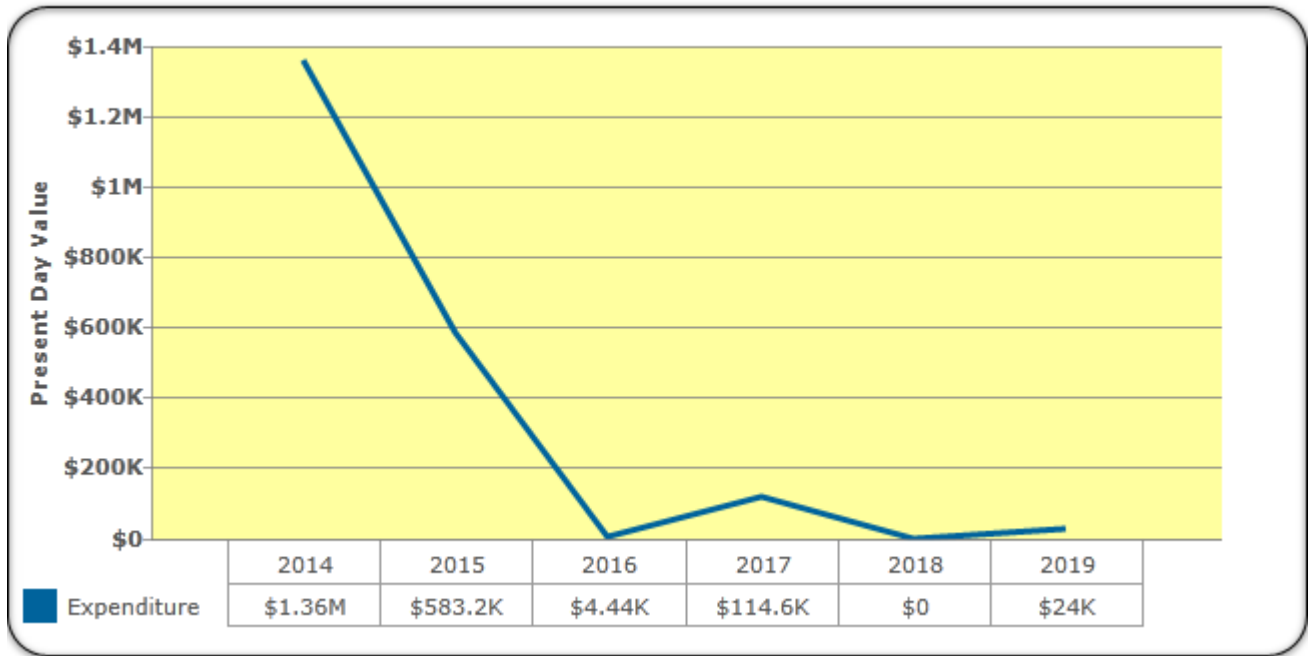
1.7 FACILITY CONDITION INDEX

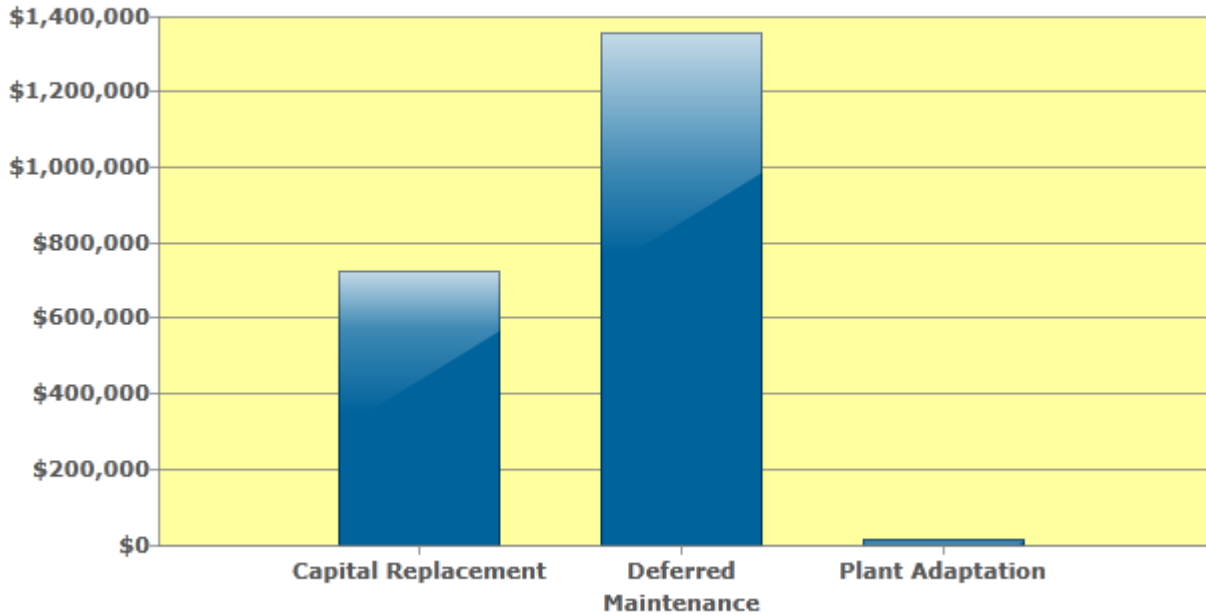
Plan Types	Total Cost
Deferred Maintenance	\$1,356,925
Plant Adaptation	\$11,830
Capital Replacement	\$726,230
Total	\$2,094,985

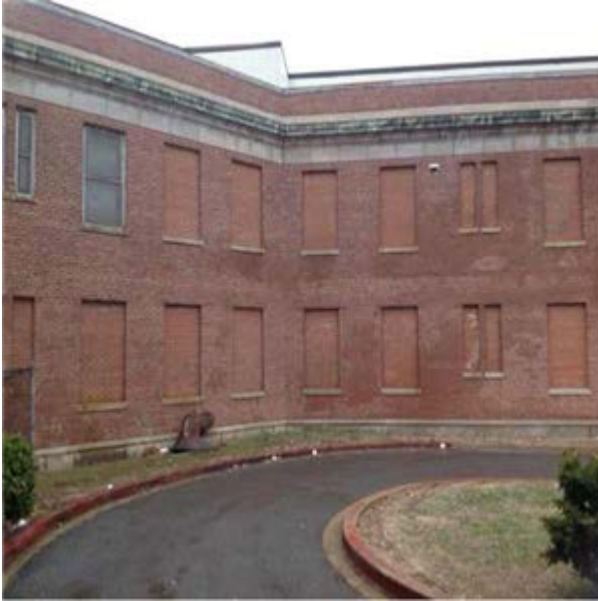
Exterior Wall Clay Brick

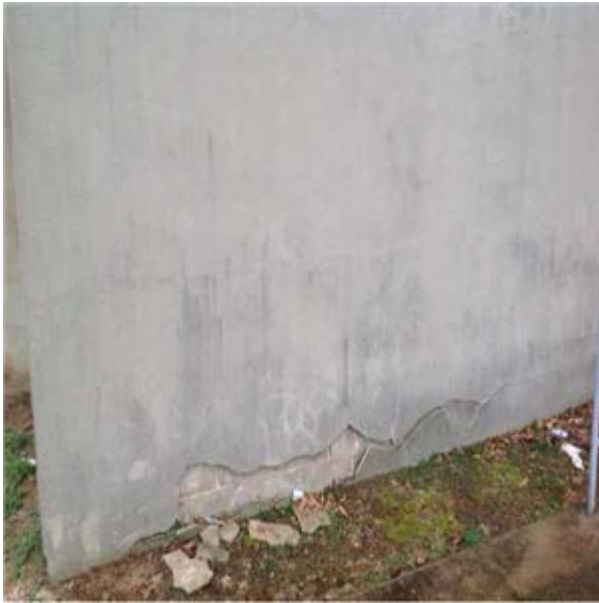
Exterior Wall Stucco Finish

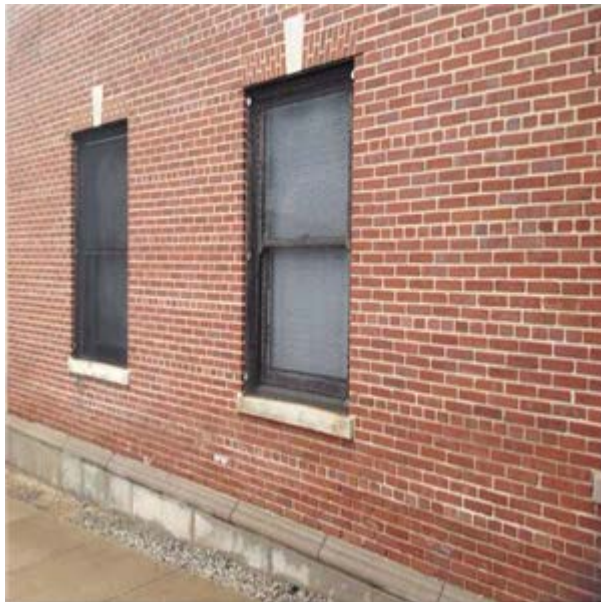
Operable Wood Windows

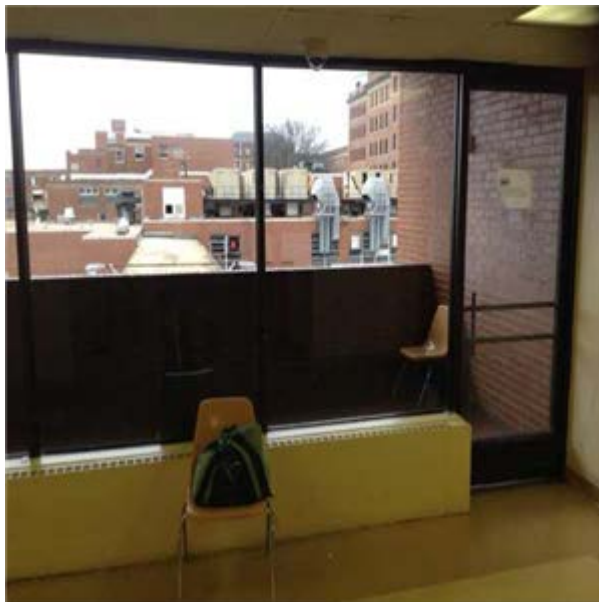
Aluminum Storefront At Patio Area

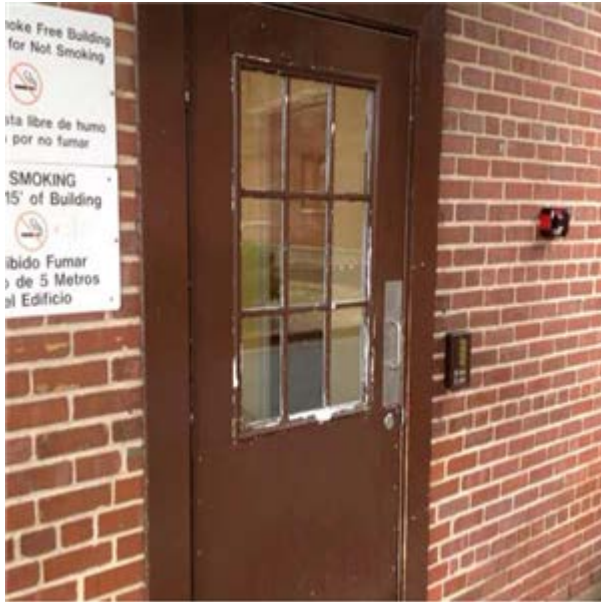
Exterior Painted Metal Door

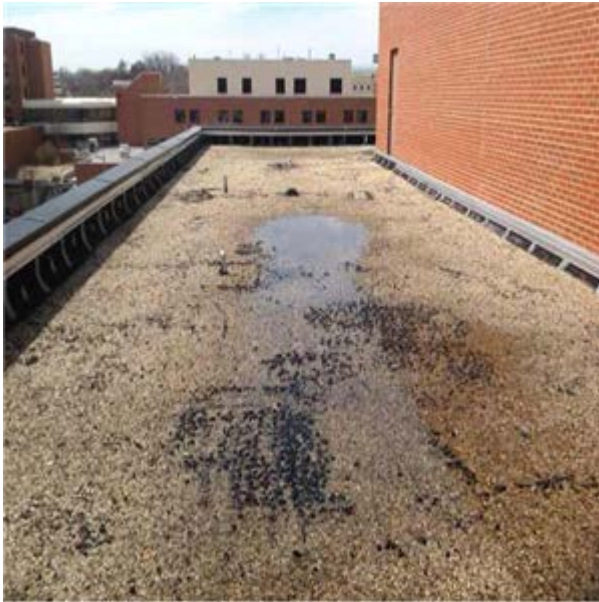
Low Slope Built Up Asphalt Roof

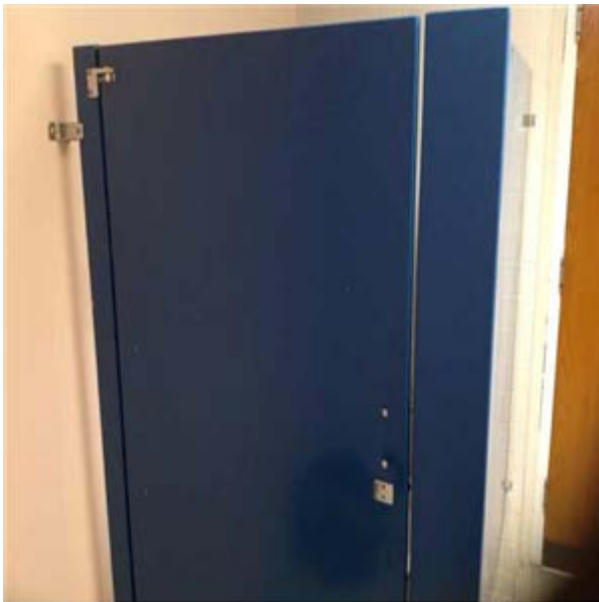
Bathroom Toilet Partion

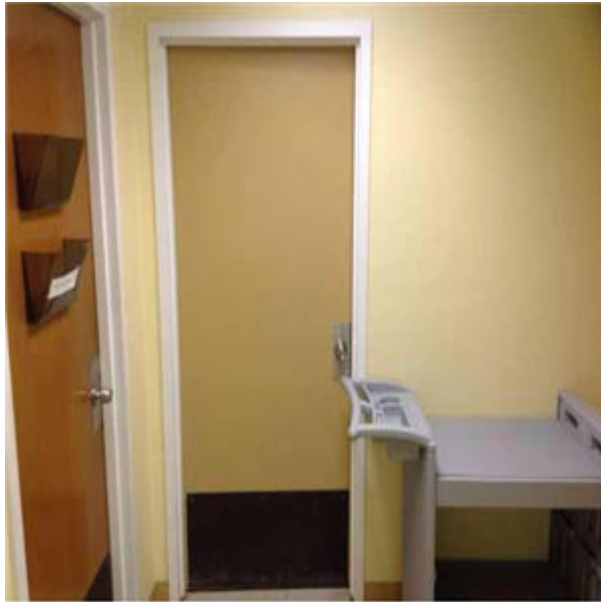
Interior Painted Steel Door

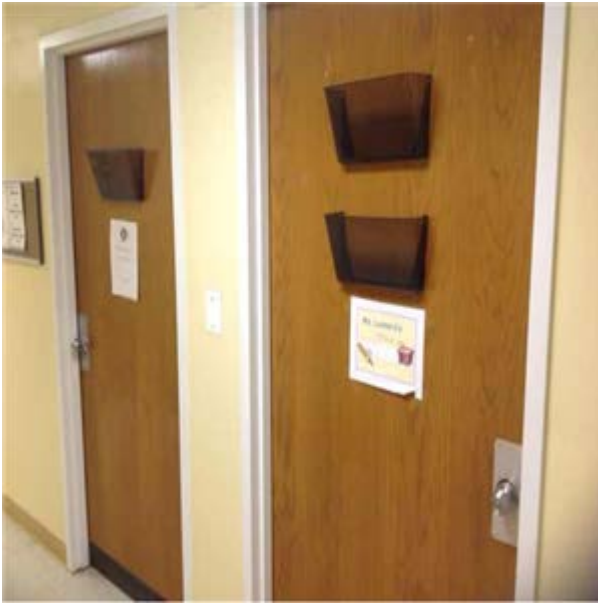
Interior Stained Solid Core Wood Doors

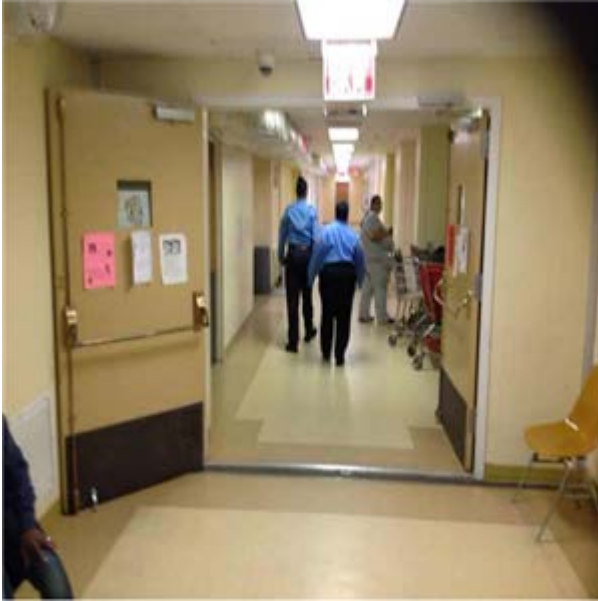
Painted Steel Interior Double Doors

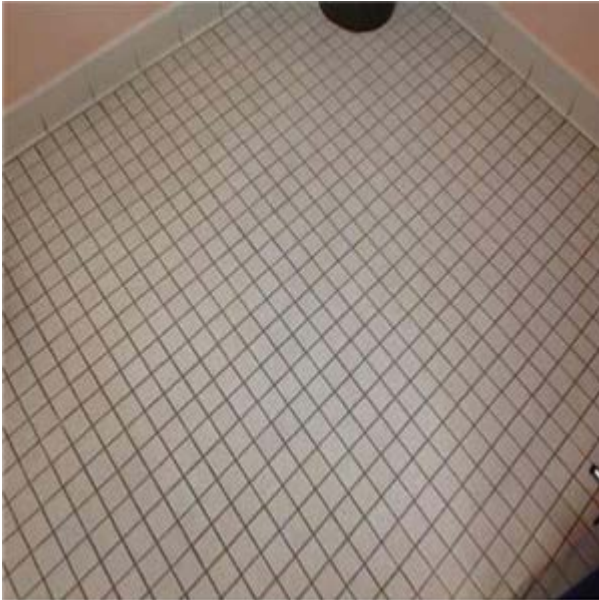
Quantity	2590
Unit of Measure	Sq Ft
Unit Cost	\$13.49

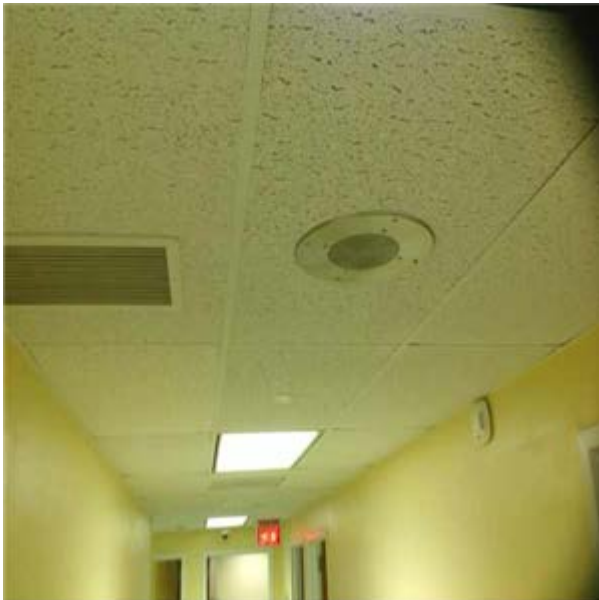
Suspended Acoustical Ceiling Tile

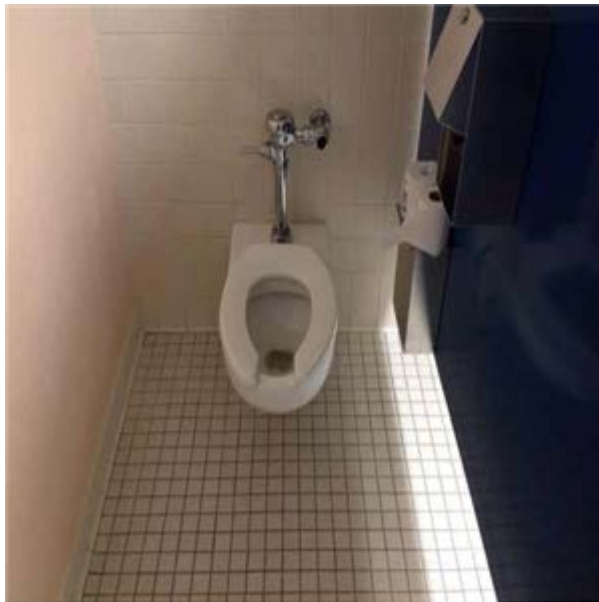
Tankless Water Closet

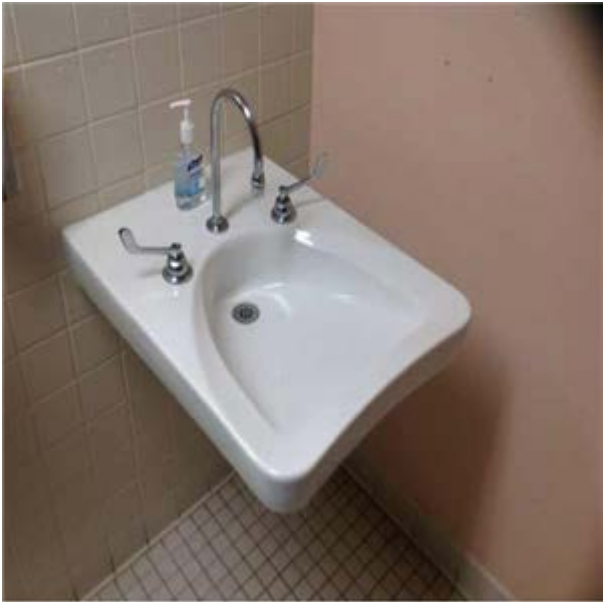
Plan Type	Capital Replacement
Quantity	9
Unit of Measure	Each
Unit Cost	\$468.21

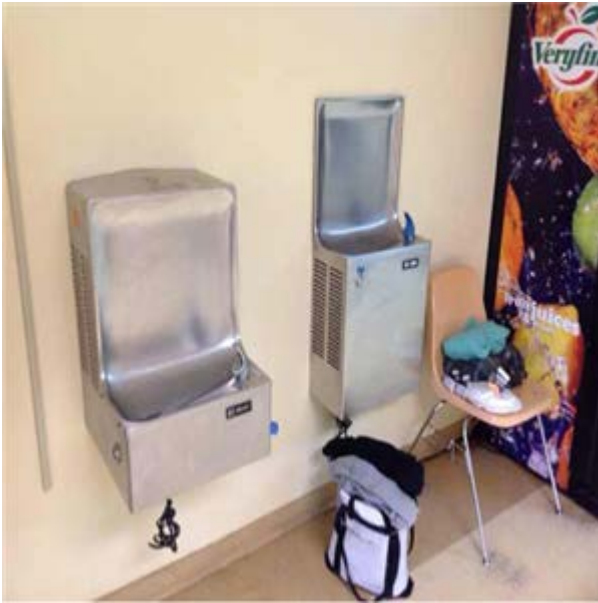
Refrigerated Drinking Fountains

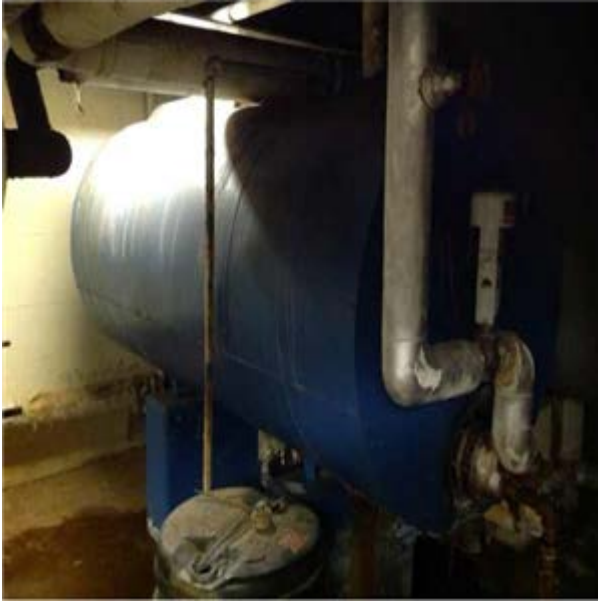
Domestic Hot Water Storage Tank

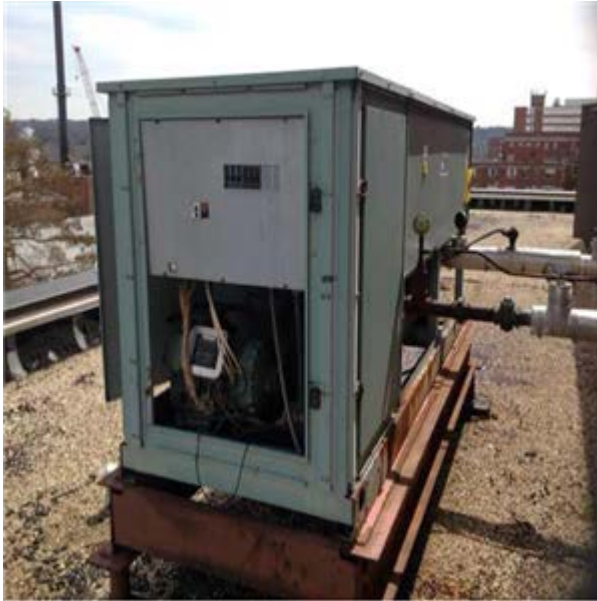
Carrier Rooftop Chiller - Not Operational

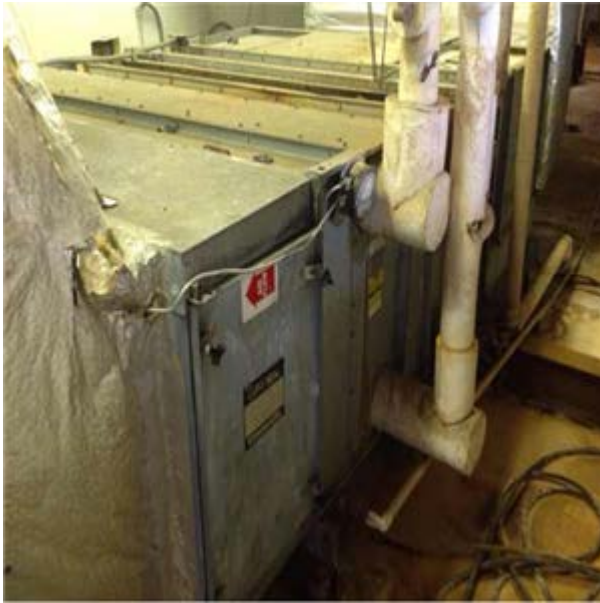
Carrier Rooftop Penthouse Air Handler

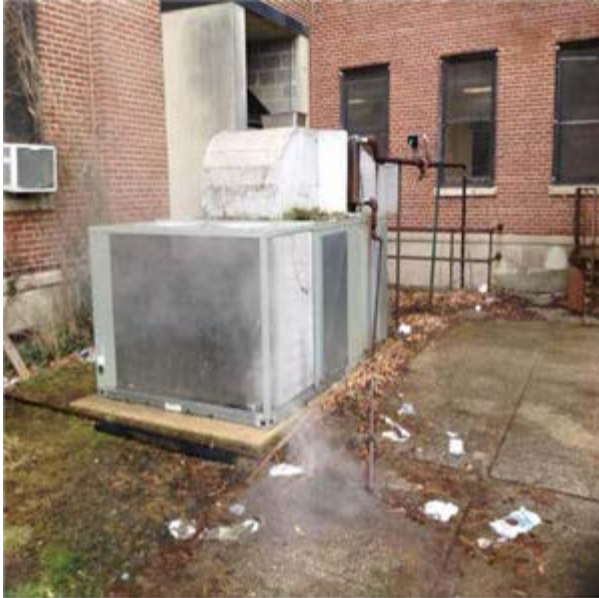
Pad Mounted Trane Package Unit

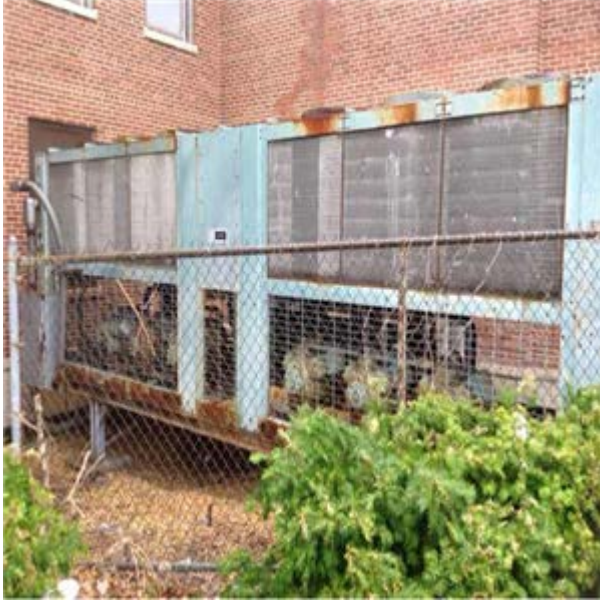
Carrier Pad Mounted Packaged Unit

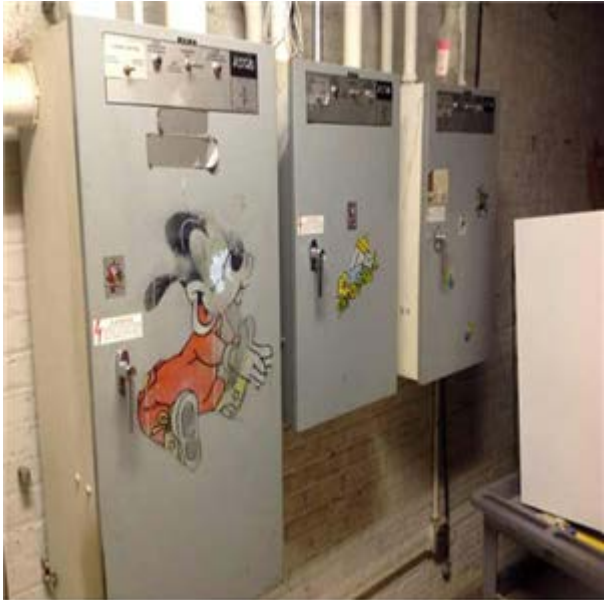
Generator Transfer Switch

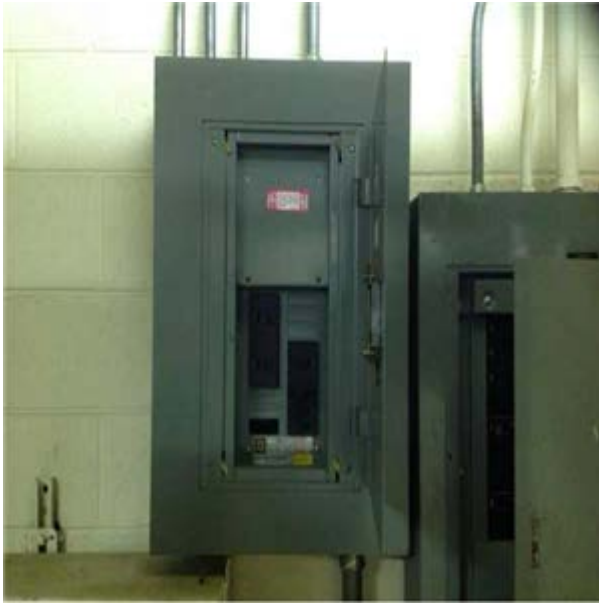
Rooftop Penthouse Circuit Breaker Panel

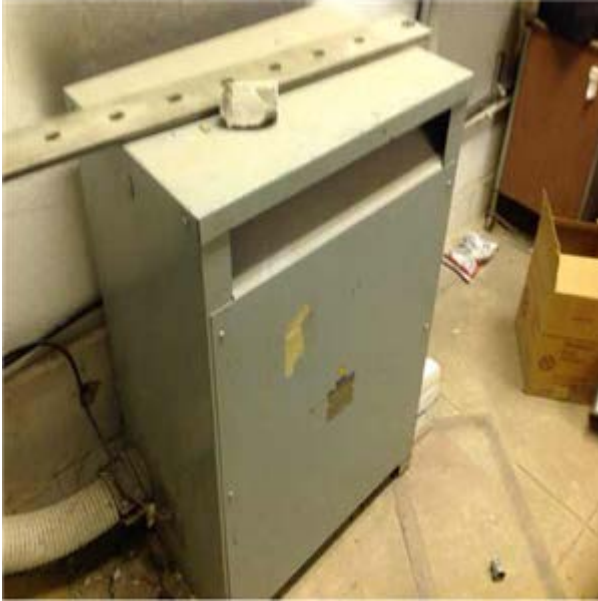
Basement Electric Room Secondary Transformer

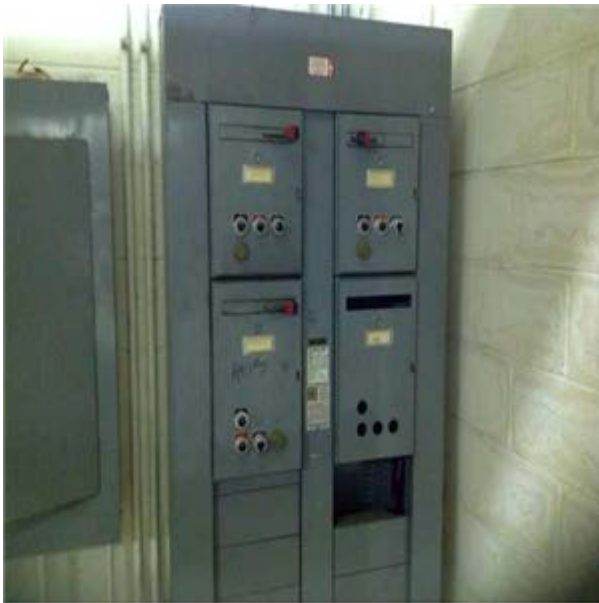
Rooftop Penthouse Air Handler Distribution Panel

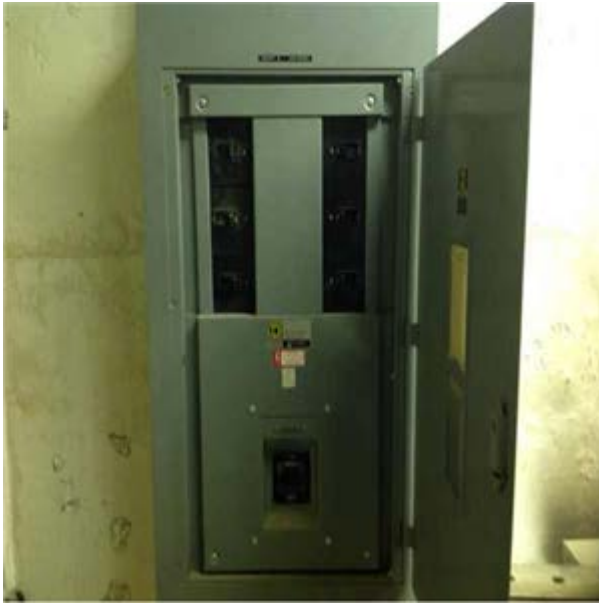
400 Amp Circuit Breaker Panel

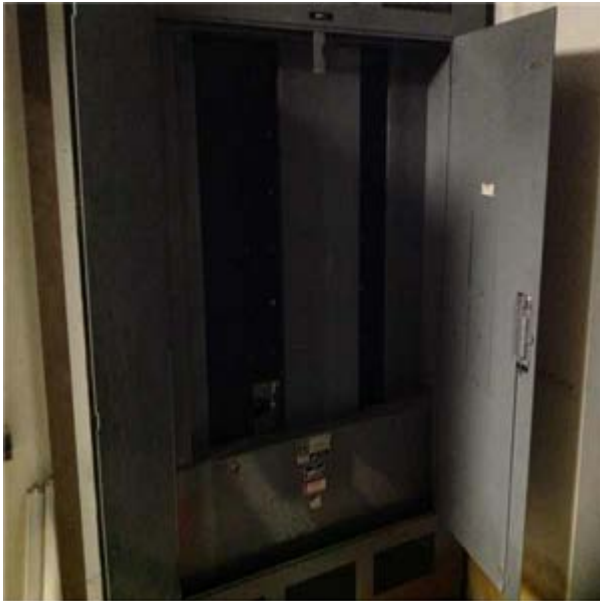
Basement Electric 1200 Amp Circuit Breaker Panel

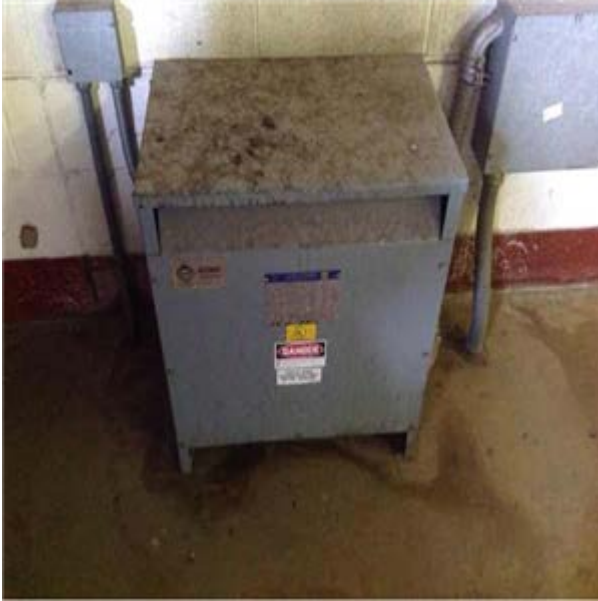
Rooftop Penthouse Transformer

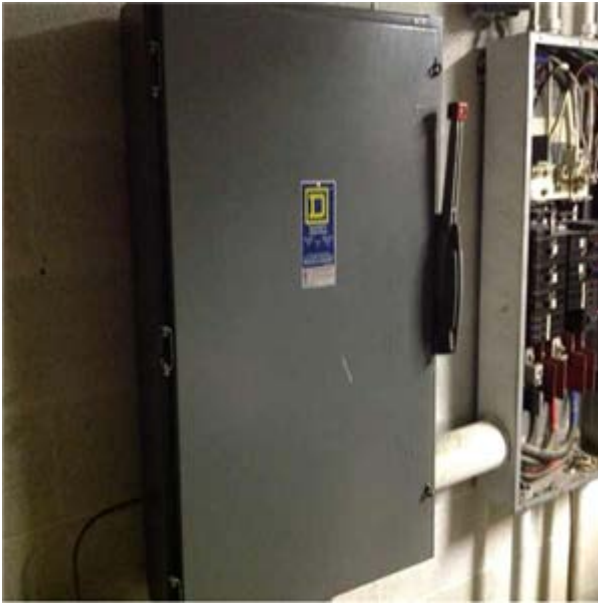
Basement Level Electrical Disconnect Switch

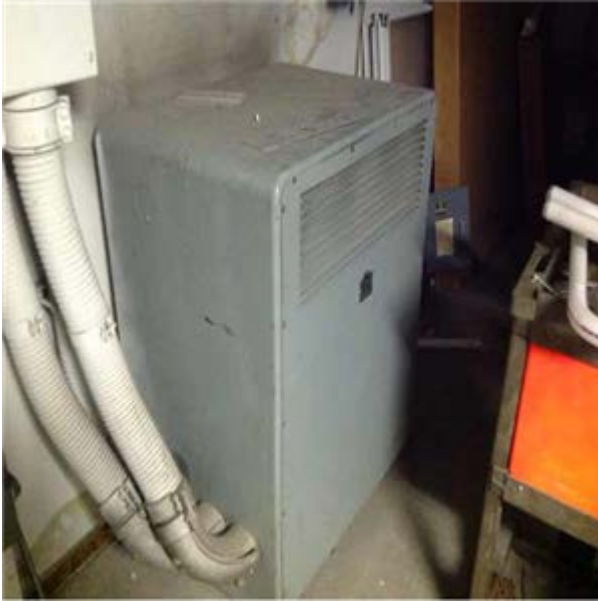
Basement Level Electric Secondary Transformer

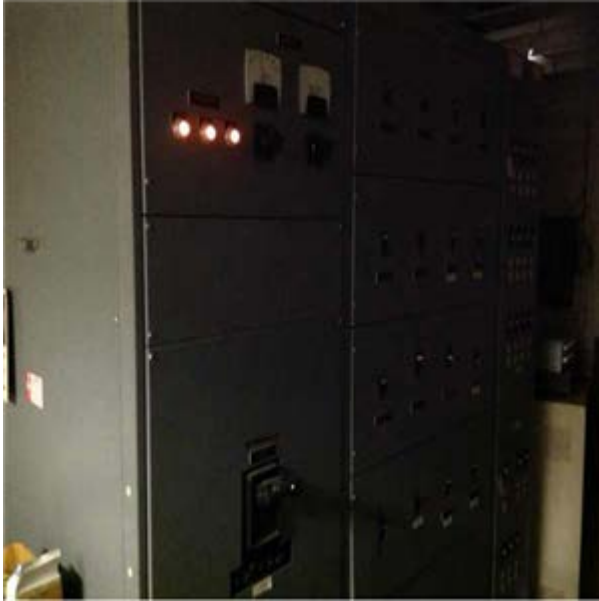
Basement Level Main Electric Disconnect

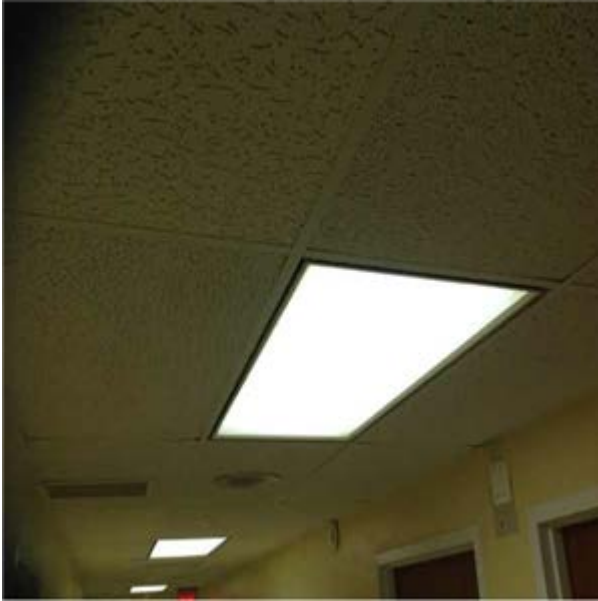
Recessed Ceiling Mounted Fluorescent Light Fixture

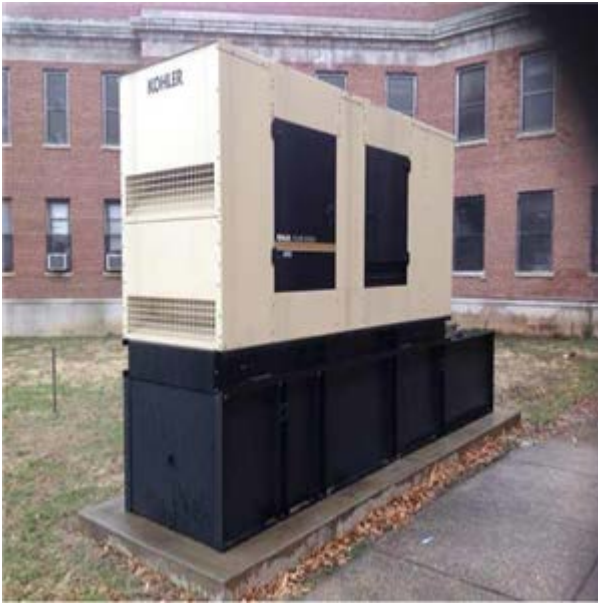
Kohler Pad Mounted Generator

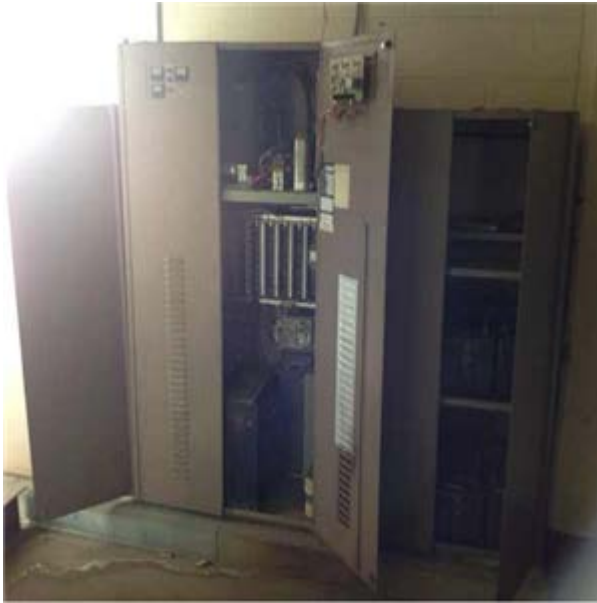
Rooftop Penthouse UPS

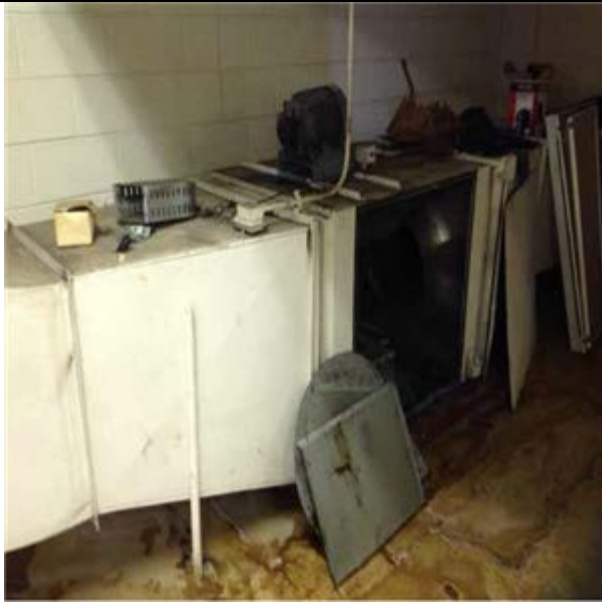
Abandoned Rooftop Penthouse Air Handler

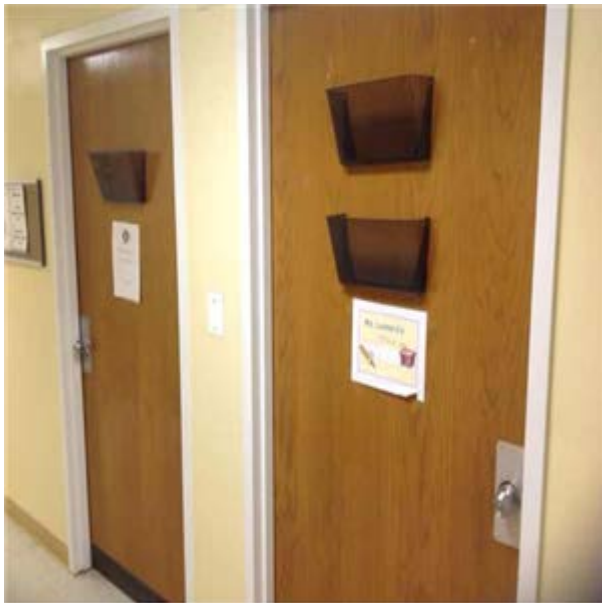
Wood, Solid Core, Painted, Interior Door :- Interior Stained Solid Core Wood Doors

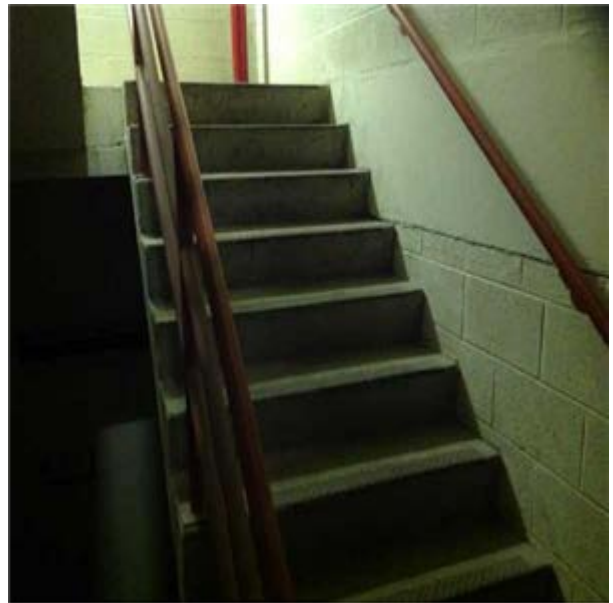
Concrete, Interior Stairs:- Concrete Interior Stair

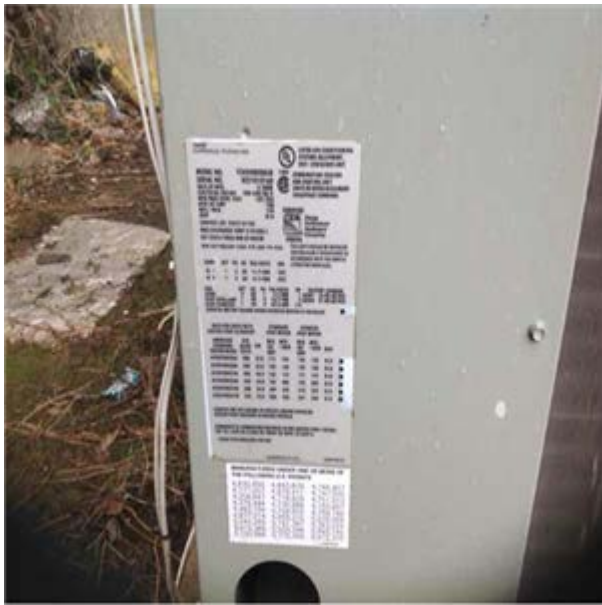
Air Conditioner Multizone Variable Volume 25 Ton :- Pad Mounted Trane Package Unit Nameplate

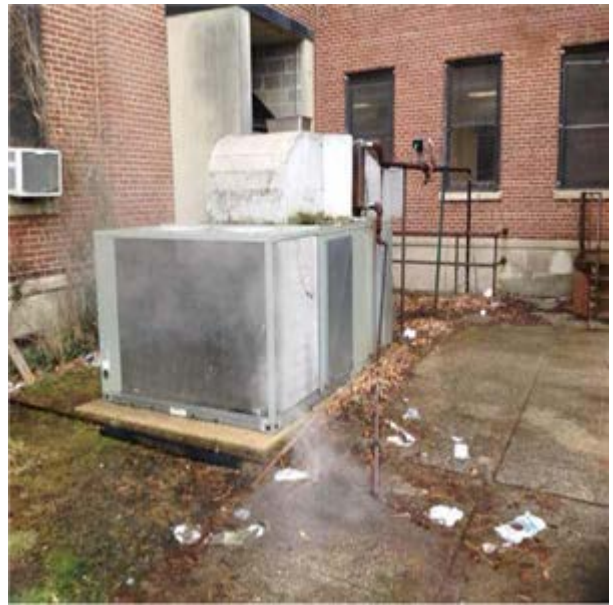
Air Conditioner Multizone Variable Volume 25 Ton:- Pad Mounted Trane Package Unit

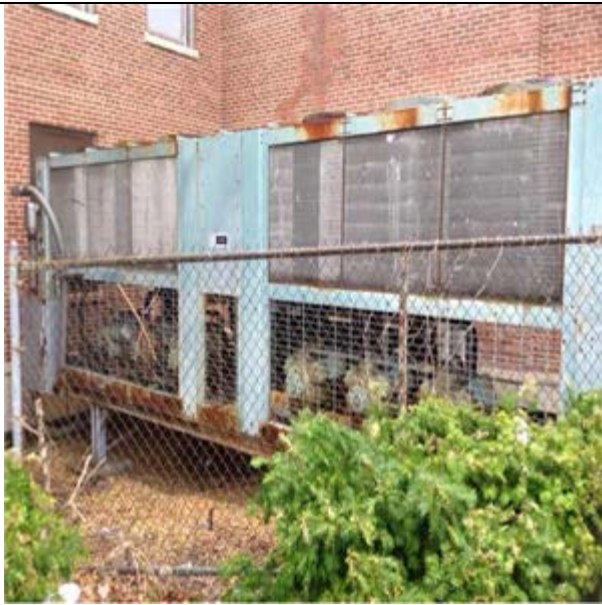
Air Conditioner Multizone Variable Volume 50 Ton
:- Carrier Pad Mounted Packaged Unit

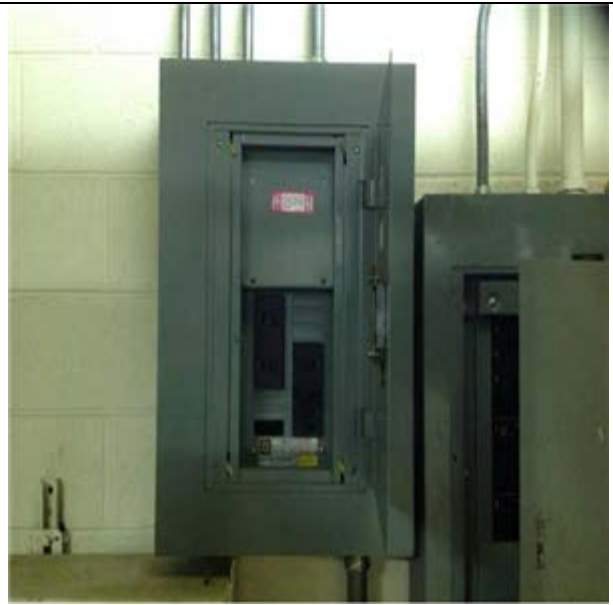
Circuit Breaker, 3 Ph., 600 V, 100 Amp:- Rooftop
Penthouse Circuit Breaker Panel

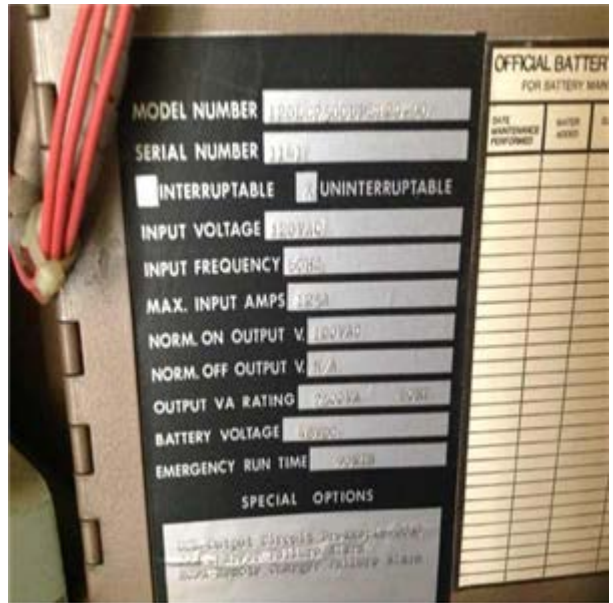
Uninterruptible Power Supply, 80 kVA:- UPS Nameplate
