Property Condition Report

**One Judiciary Square
441 4th St NW
Washington, DC**

**Comprehensive Facility Condition Assessment
And Space Utilization Study
DCAM-13-NC-0162**

October 15, 2014

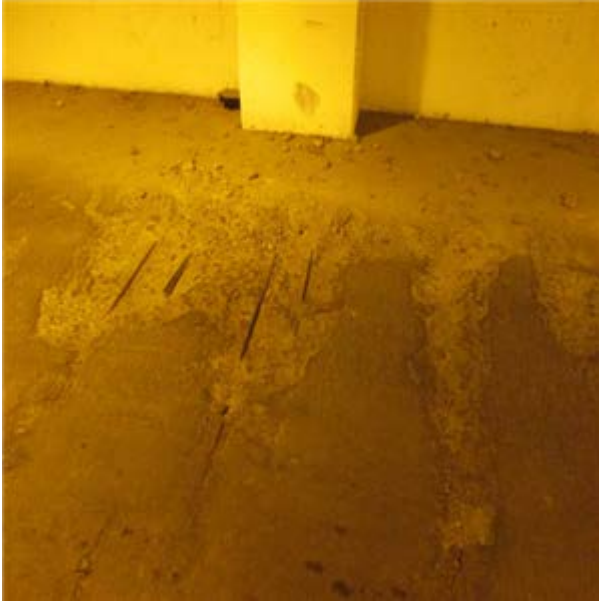
The concrete slab within the below grade parking garage was observed to be in fair to poor condition. There are several areas throughout the slab where the concrete is spalling or damaged. The damaged areas require repair.

Damaged concrete slab

Type	Component Description	Plan Type	Year	Expenditures (\$)
A1031	Repair slab on grade	Deferred Maintenance	2014	\$87,500

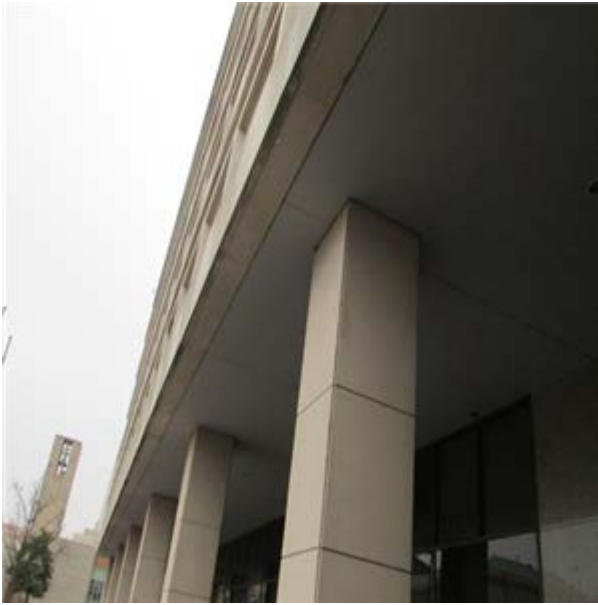
The buildings superstructure is concrete structural frame and is in good condition. No signs of deflection were observed.

Concrete column

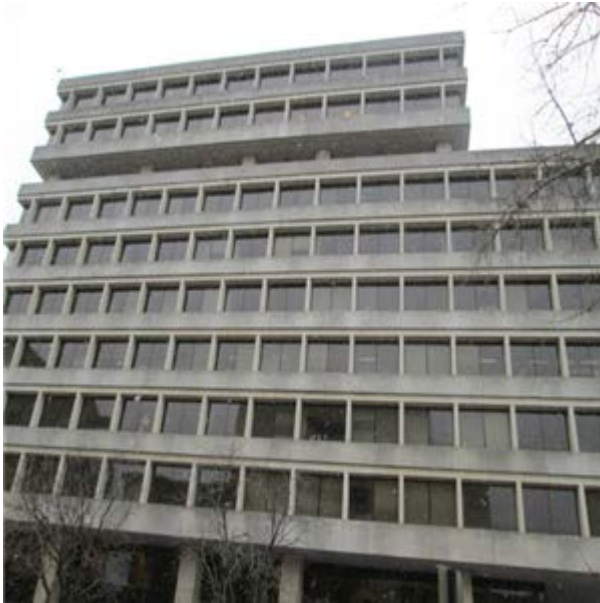
The precast concrete exterior walls are in fair to good condition. No signs of deterioration or cracking was observed. The exterior walls will require routine maintenance over the assessment period. Preventative maintenance should be performed on the exterior building control joints in order to control and prevent any future exterior leaks and infiltration.

Exterior Wall

Type	Component Description	Plan Type	Year	Expenditures (\$)
B2011	Replace joint sealant	Deferred Maintenance	2014	\$580,932

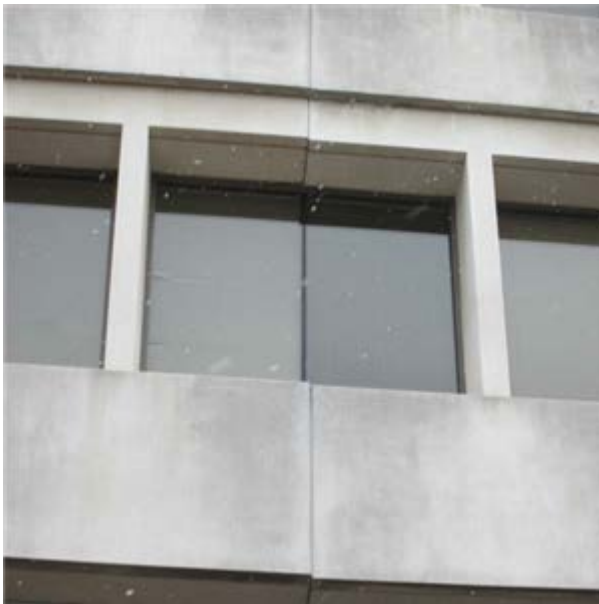
The exterior windows observed to be in fair condition. The windows are original to the building. No signs of broken seals or condensation was observed. Based on the age of the exterior windows they will require replacement over the assessment period.

Fixed exterior window

Type	Component Description	Plan Type	Year	Expenditures (\$)
B2021	Replace Alum Fixed Therm Break, Dbl Glaz, Gas 3 Stry, 12SF	Capital Replacement	2019	\$451,129

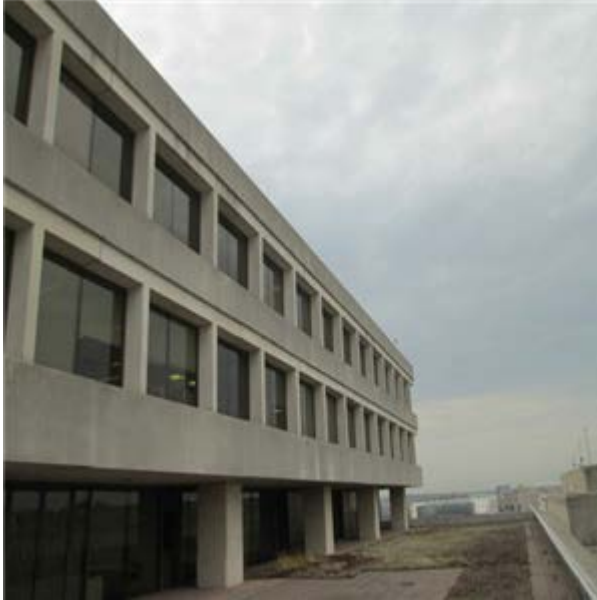
The exterior windows observed to be in fair condition. The windows are original to the building. No signs of broken seals or condensation was observed. Based on the age of the exterior windows they will require replacement over the assessment period.

Exterior windows

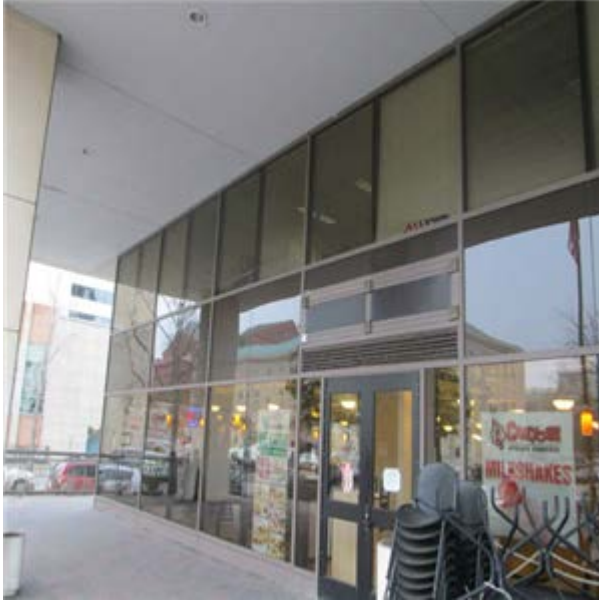
The curtain walls were observed to be in good condition. Based on their age they will require replacement over the assessment period.

Curtain wall

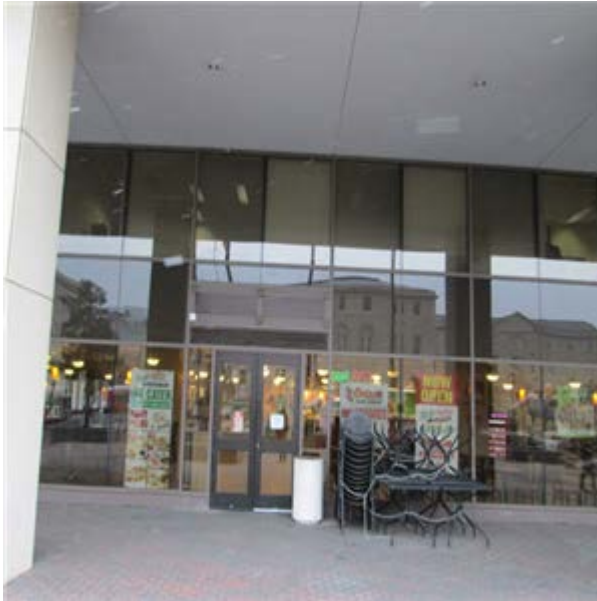
The exterior doors are in good condition and will require replacement during the reserve term.

Glazed exterior doors

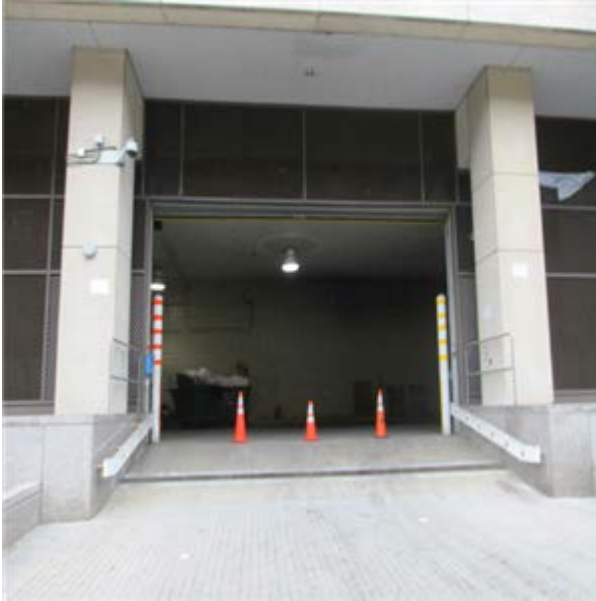
The steel roll-up doors service the maintenance loading docks and the below grade garage. The doors are in fair condition requiring routine maintenance over the assessment period.

Overhead door

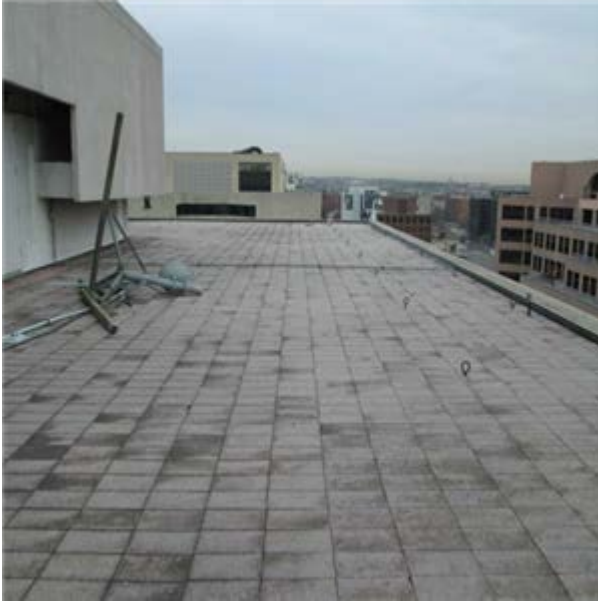
The roof consists of a single-ply membrane and is finished with cast stone pavers. No active roof leaks were reported by the building maintenance personnel. Previous roof leaks were reported to have been resolved. The roof is original and only minor roof repairs have been performed. The roof is beyond its estimated Remaining Useful Life (RUL) however, it has been well maintained. Replacement will be required during the assessment period.

Roof overview

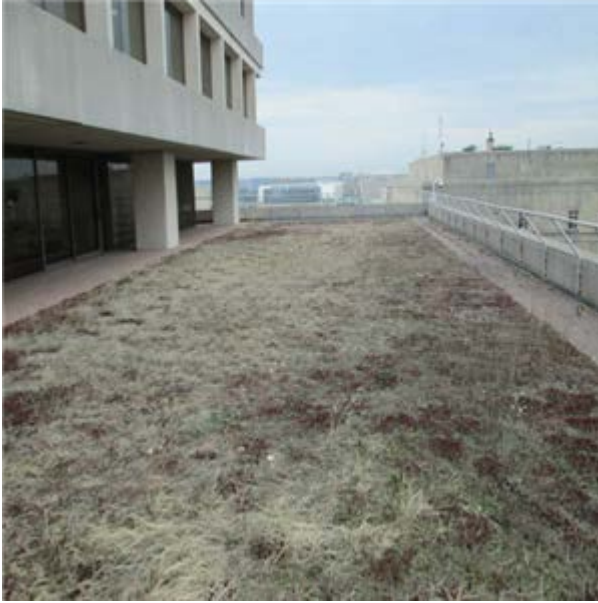
The ninth floor roof is finished with a green vegetative roof. The roof has been well maintained and is in good condition. The roof will require routine maintenance during the assessment period.

Green roof

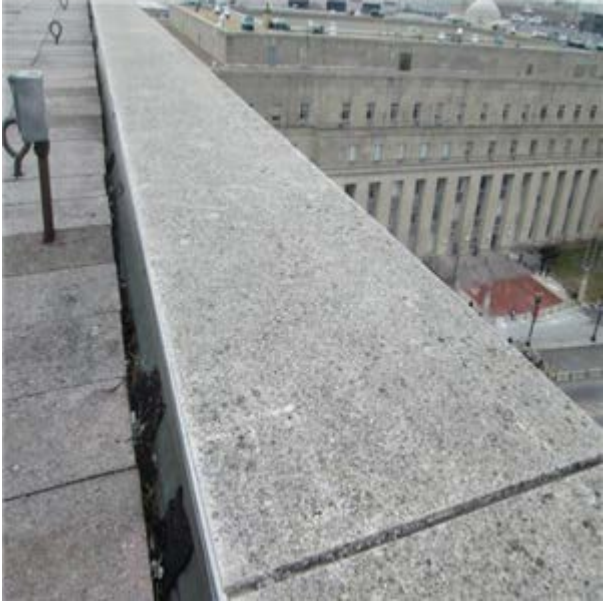
The perimeter roof coping is finished with precast stone. The copings are in good condition and will require routine maintenance over the assessment period.

Stone roof coping

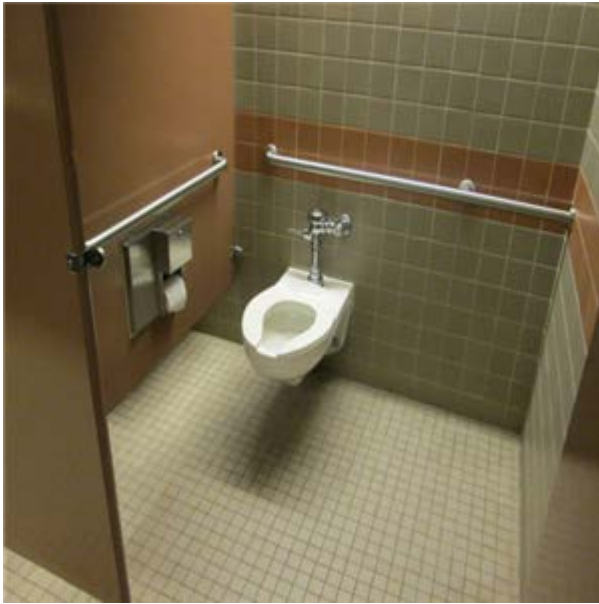
The ceramic tile is located in the restrooms throughout the building. The ceramic tile is in good condition showing no signs of damaged or missing tile. The ceramic floor tile will require routine maintenance over the assessment period.

Ceramic floor tile

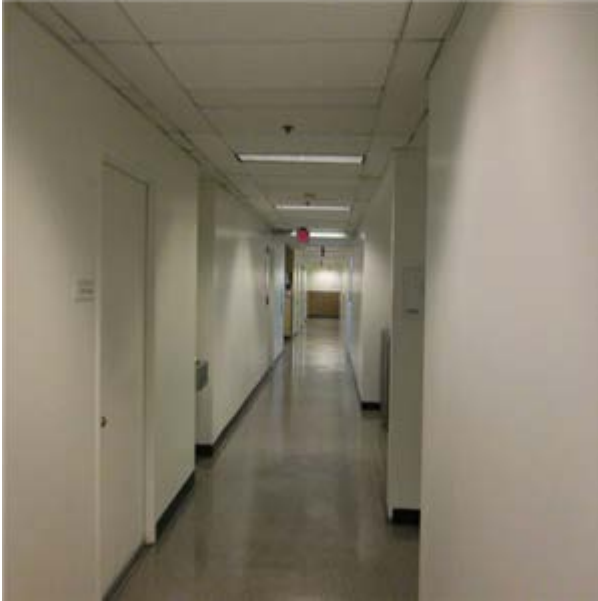
The vinyl tile flooring is located throughout the building service areas. The vinyl tile is in fair condition and will require replacement during the reserve term.

Vinyl tile

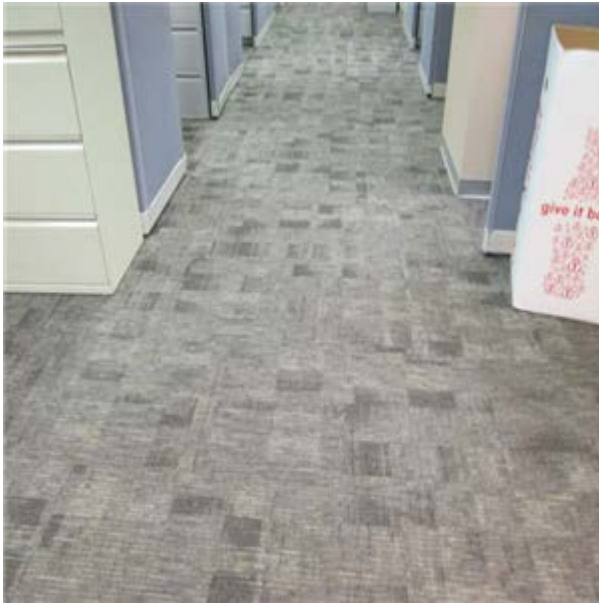
The main interior floor finish is carpeting. The carpet flooring was observed to be in fair to good condition. The age of the carpet throughout the building varies since the interior appearance of each department is the responsibility of that respective department. All of the carpeting will require replacement over the assessment period.

Carpet flooring

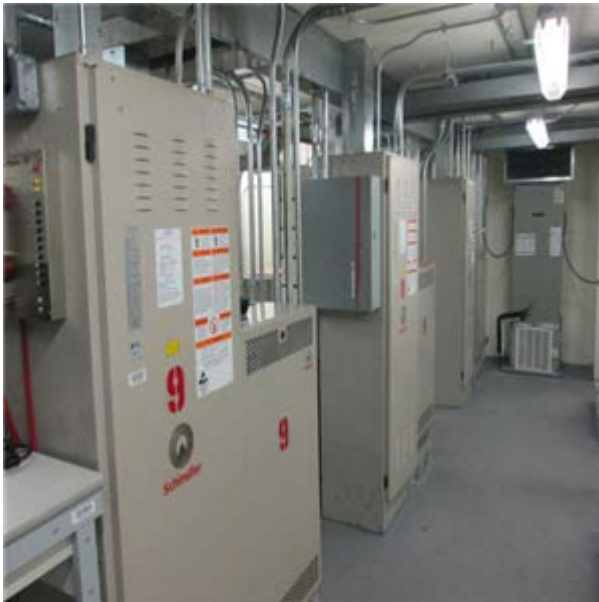
Traction elevators are in good condition. The elevators and machinery underwent a modernization in 2014.

Elevator equipment

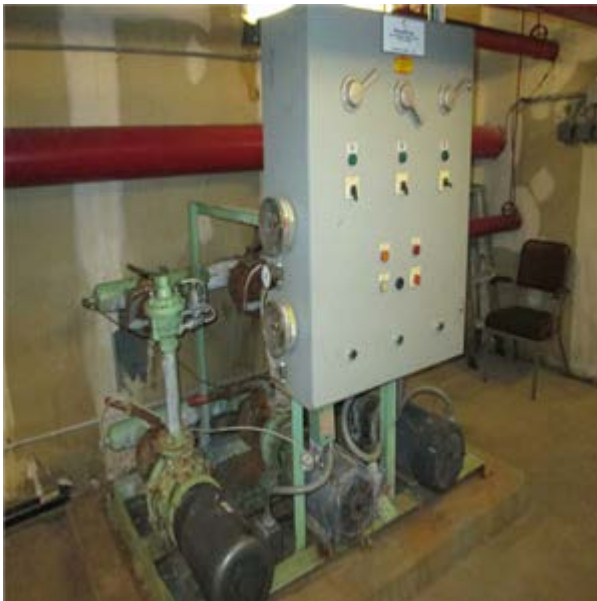
The water pressure booster pumps are in poor condition. The booster pumps display a significant amount of rust and corrosion. The pumps have reached the end of their useful life and will require replacement over the assessment period.

Booster pumps

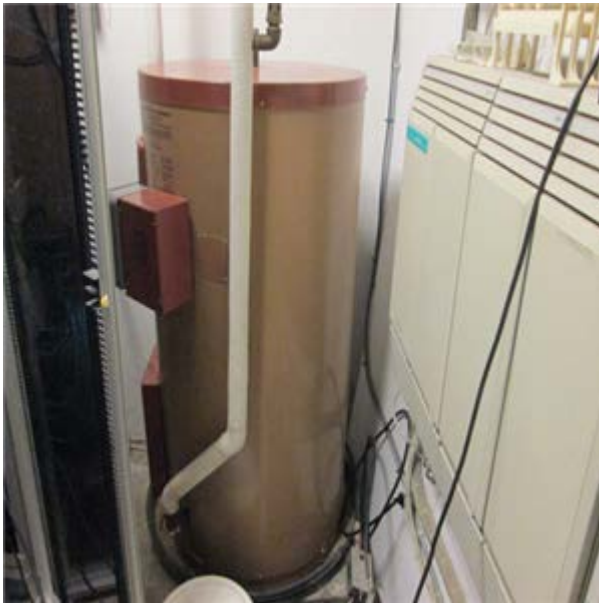
Domestic hot water for the building is provided by electric water heaters located adjacent to the restrooms. The domestic water heater is approximately ten years old. Based on the age of the equipment it will require replacement over the assessment period.

Electric water heater

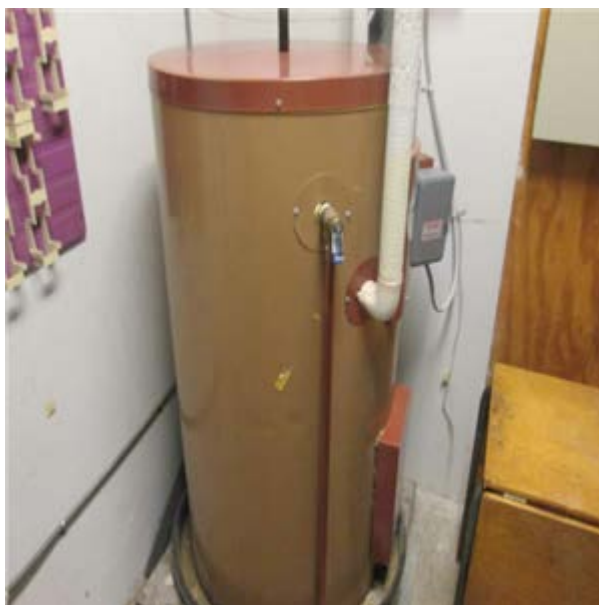
Domestic hot water for the building is provided by electric water heaters located adjacent to the restrooms. The domestic water heater is approximately ten years old. Based on the age of the equipment it will require replacement over the assessment period.

Electric water heater

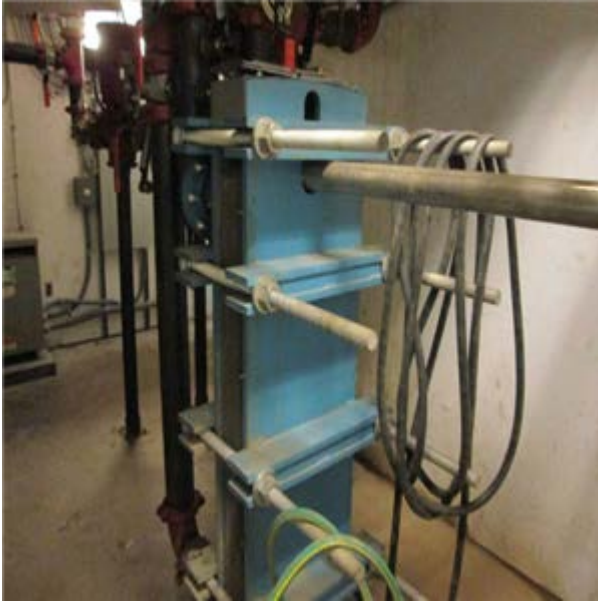
The water to water plate heat exchanger was observed to be in fair condition. The equipment is 22 years old. It will not require replacement over the assessment period however, maintenance is expected based on the age of the equipment.

Plate heat exchanger

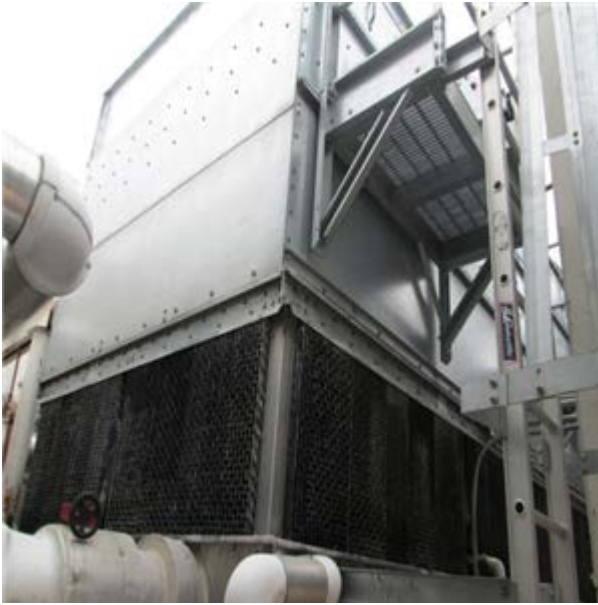
It was reported by the building maintenance staff that the cooling towers are three years old. Cooling towers were observed to be in good condition.

Cooling tower

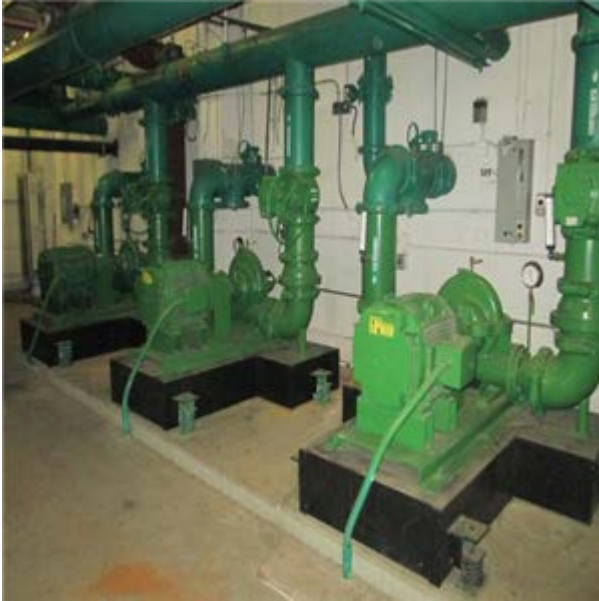
The chilled water pumps are in good condition and will require routine maintenance.

Chilled water pumps

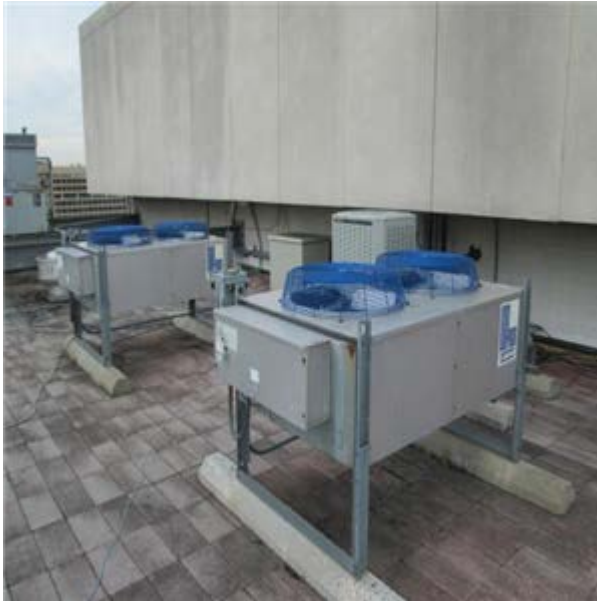
The direct drive air cooled condenser was observed to be in fair condition. The condenser services the penthouse server room and is not maintained by the building maintenance personnel. The air cooled condenser will require replacement over the assessment period.

Direct drive air cooled condenser

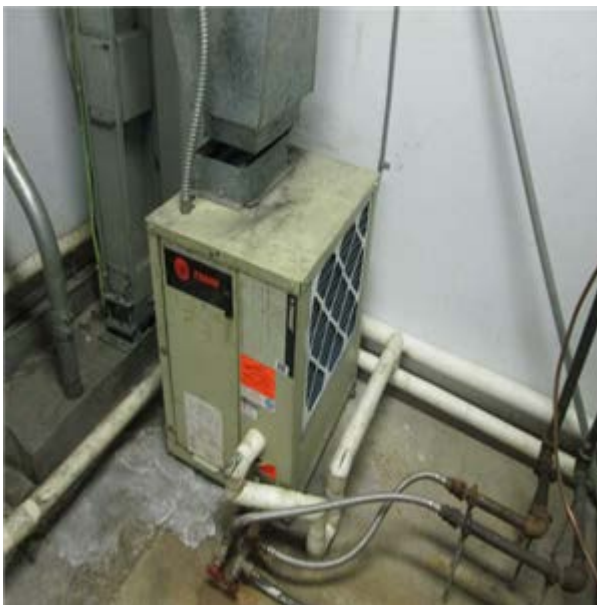
The air handling unit is in fair to poor condition. The unit does not appear to have been well maintained over the course of its life. Based on the age of the equipment replacement will be required over the assessment period.

Air handler

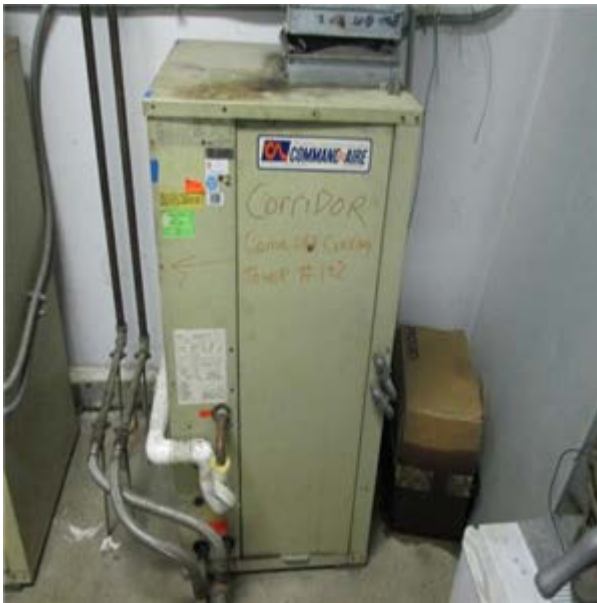
The air handler is in fair condition and appears to have been fairly maintained. Based on the observed condition and it's estimated useful life, the unit will require replacement over the assessment period.

Air handler

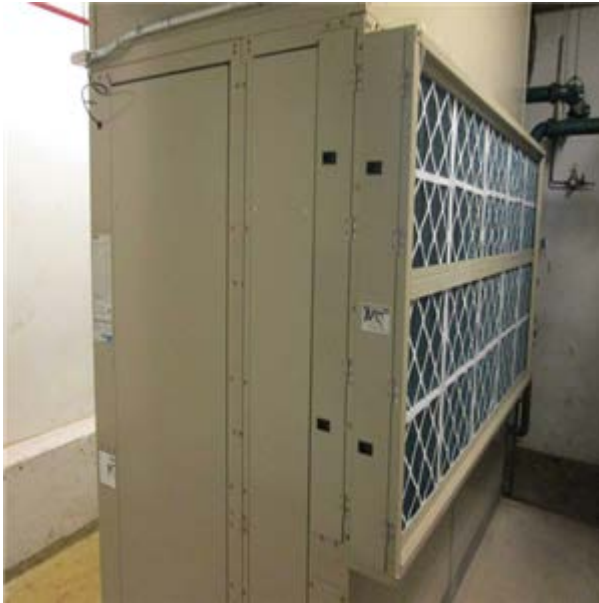
Four self contained fan coil units are located on each floor. Each unit is labeled either north, north-central, south-central, or south. Each 40-ton unit is equipped with heating and cooling coils in order to provide conditioned air to the VAV boxes throughout the interior spaces. Based on the the age of the equipment it will require routine maintenance during the reserve term.

Self contained fan coil

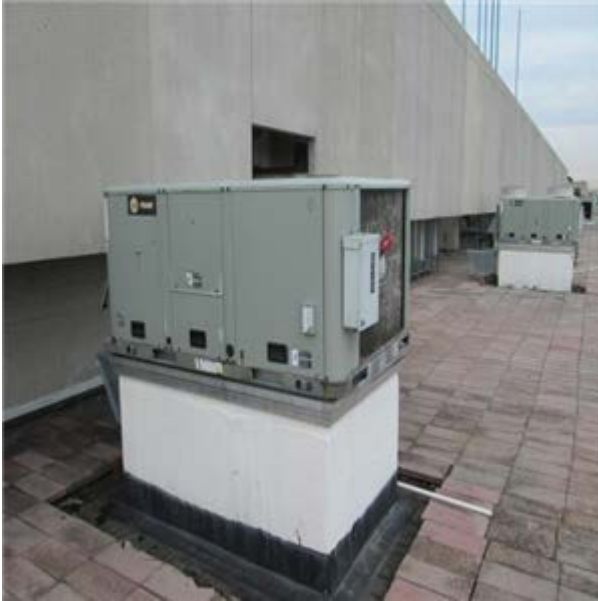
The packaged rooftop unit was observed to be in fair condition. The equipment is 12 years old and will require replacement over the assessment period.

Packaged rooftop unit

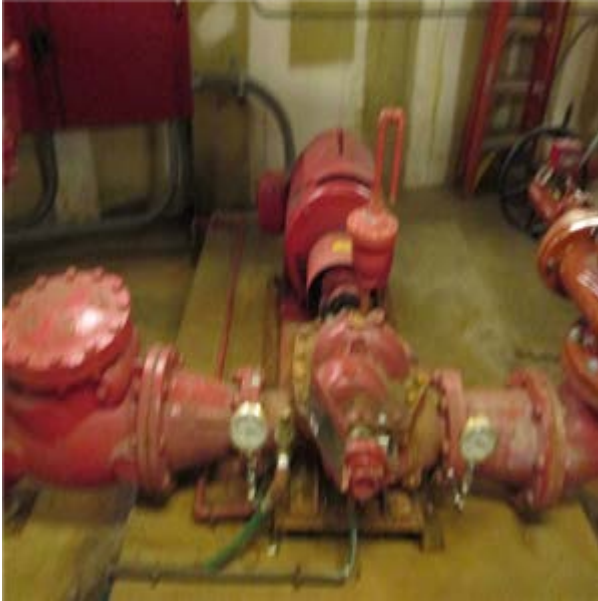
The sprinkler system 75 horsepower fire pump is original to the property and is in fair condition. Base on the age of the pump it will require replacement during the assessment period.

Sprinkler fire pump

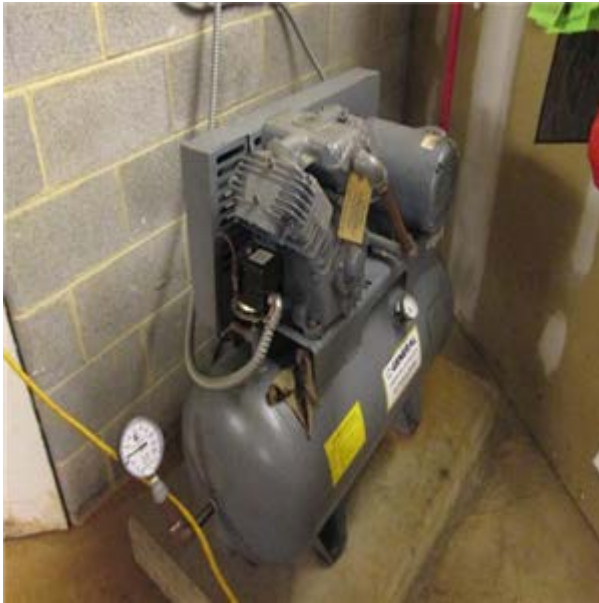
The parking garage and unconditioned spaces of the building are equipped with a dry sprinkler system. The dry sprinkler system is equipped with a one horsepower air compressor. The compressor is in good condition requiring routine maintenance during the assessment period.

Dry sprinkler air compressor

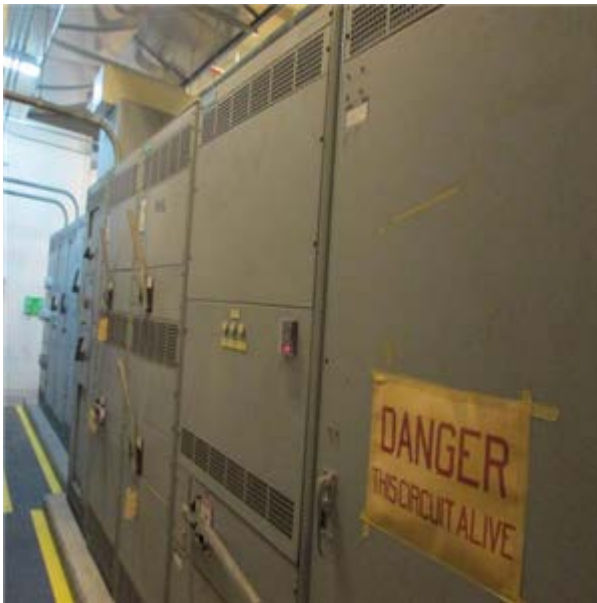
The main electrical service to the property was reported to be adequate. The main electrical switchgear is original to the building. Although the main switchgear has reached its useful life it was observed to be in good condition and replacement is not recommended. Routine maintenance will be required over the assessment period.

Electrical switchgear

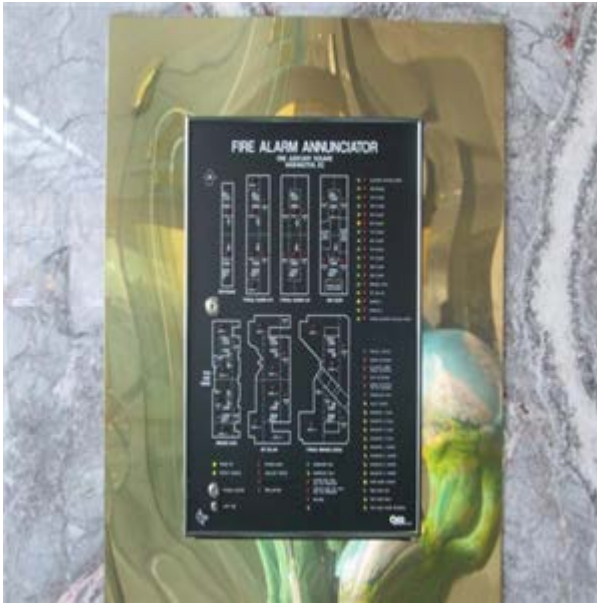
The annunciation panel was found to be in fair condition and will require replacement during the assessment period.

Annunciation panel

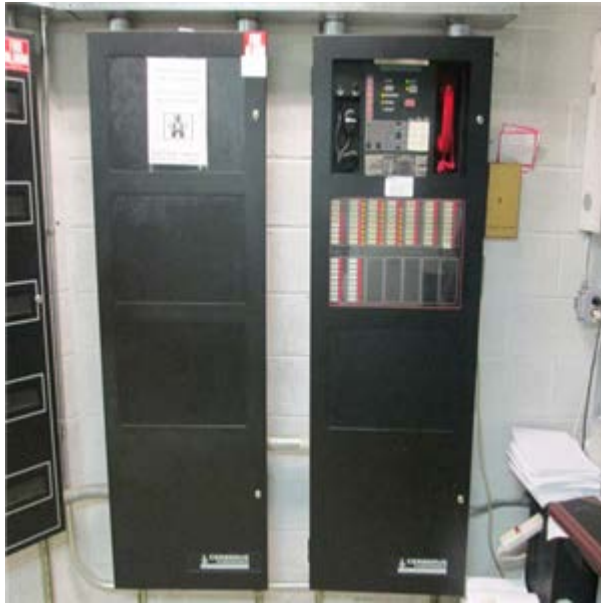
The fire alarm system devices are original to the building and has not been upgraded or modernized. The system devices were observed to be in good condition. Based on the age of the equipment replacement is recommended during the assessment period.

Fire alarm equipment

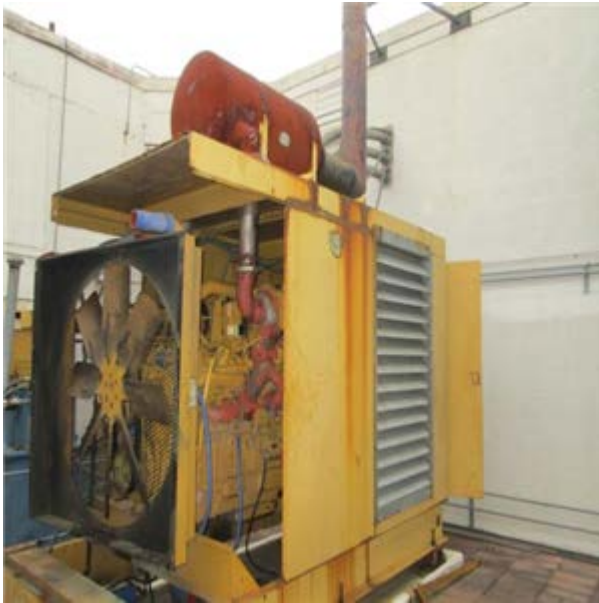
The building's main generator was observed to be in fair to poor condition. The generator was being serviced during the time of the assessment due to a radiator problem. Based on the observed condition the estimated age of the generator replacement is recommended during the assessment period.

Emergency generator

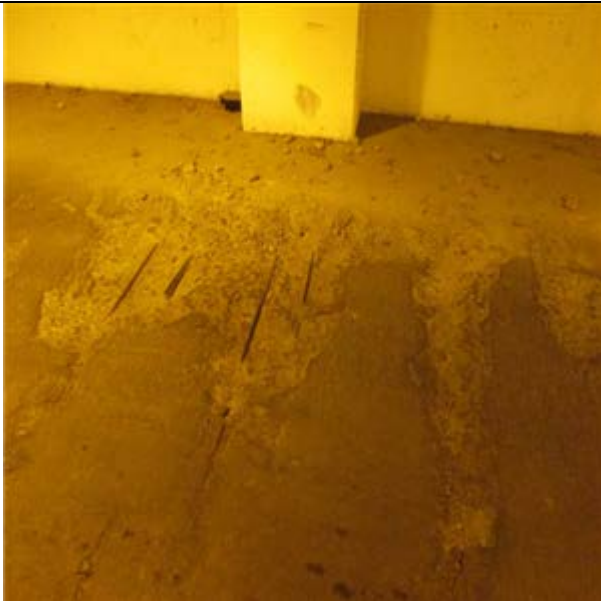
Concrete Slab :- Damaged concrete slab

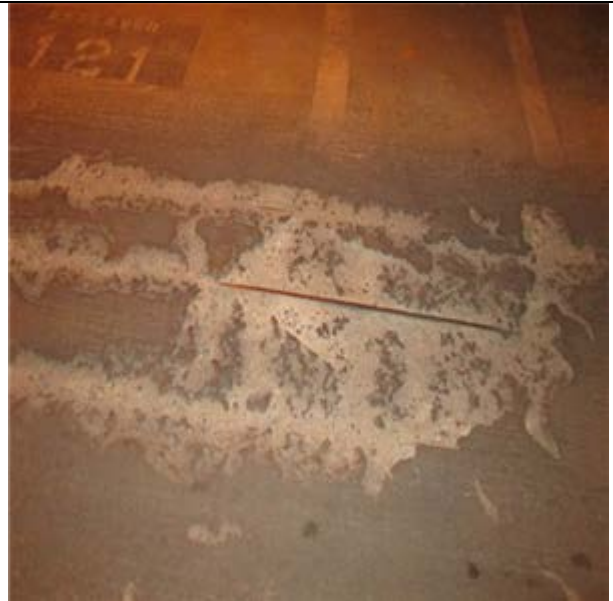
Concrete Slab:- Damaged concrete slab

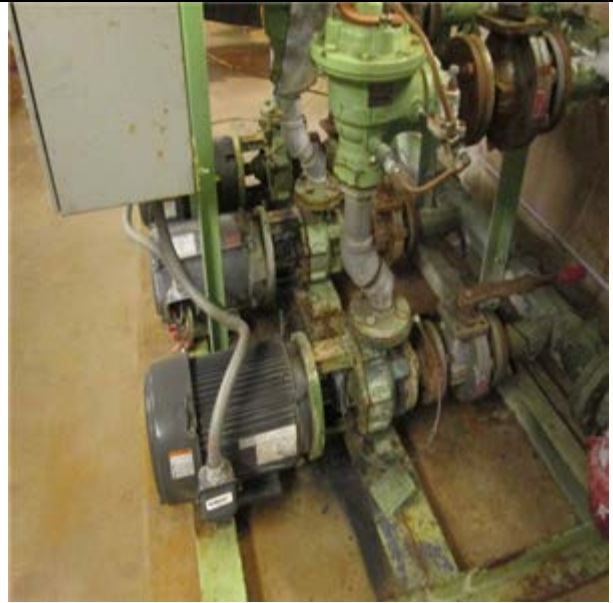
Booster Pump, 7.500 HP:- Corrosion at booster pumps
