Property Condition Report

**4th District Headquarters
6001 Georgia Ave
Washington, DC**

**Comprehensive Facility Condition Assessment
And Space Utilization Study
DCAM-13-NC-0162**

October 15, 2014

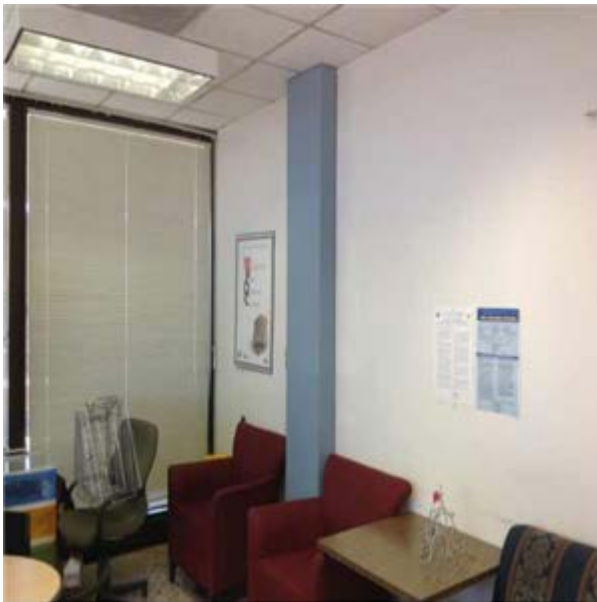
Item	Description
B1032 Concrete frame Structure	concrete Columns and Beams Frame
Condition	Good
RUL	30
Plan Type	Capital Replacement
Quantity	47439
Unit of Measure	SF
Unit Cost	\$8.15

Concrete column

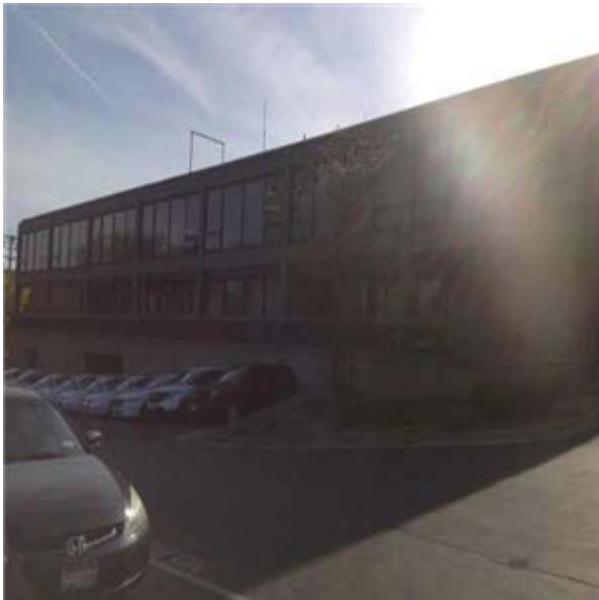
Item	Description
B2011 Exterior Wall Construction	Brick Veneer, Exterior, 1 Story

Condition	Fair - Good
RUL	30
Plan Type	Capital Replacement
Quantity	3020
Unit of Measure	Sq Ft
Unit Cost	\$30.93

At rear elevation

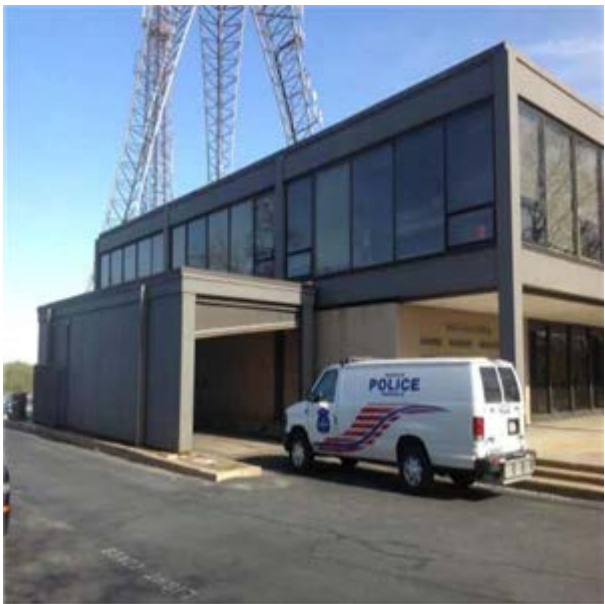
Side elevation

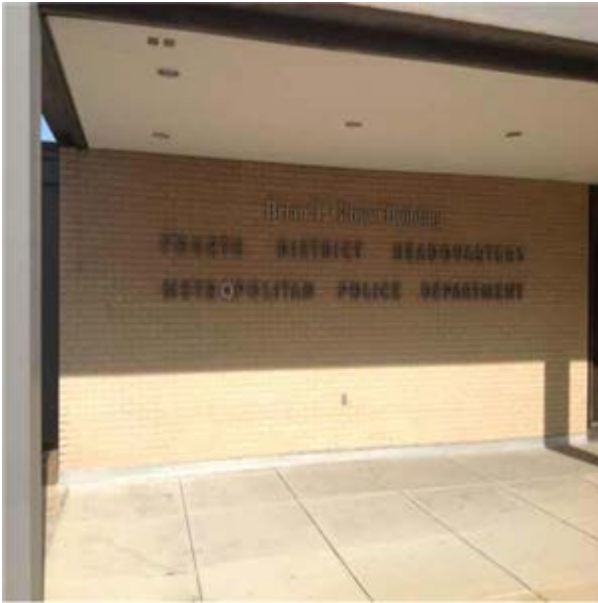
At front of building

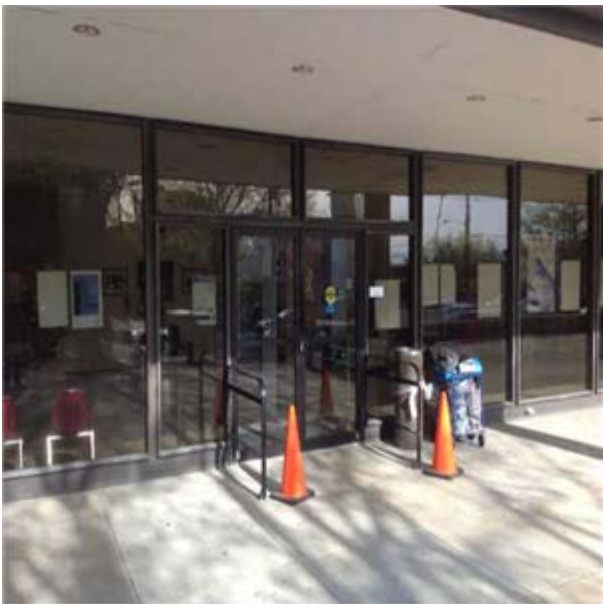
Item	Description
B2023 Storefronts	Glazed Aluminum Framed with Swing Doors
Condition	Good
RUL	30
Plan Type	Capital Replacement
Quantity	7368
Unit of Measure	SF
Unit Cost	\$29.96

Main entrance

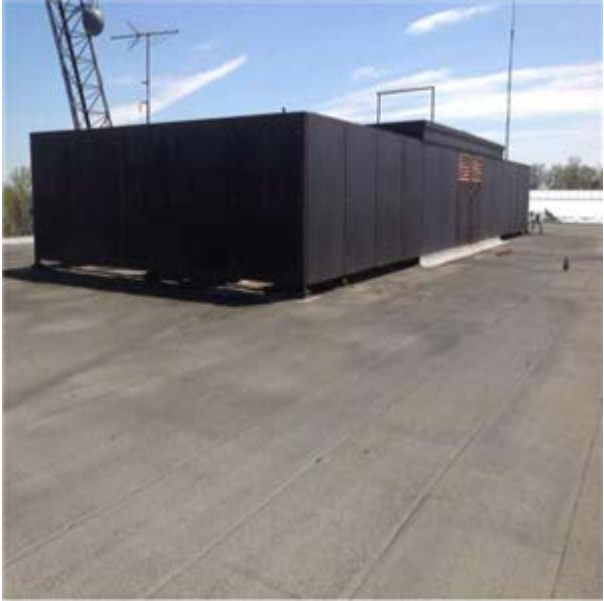
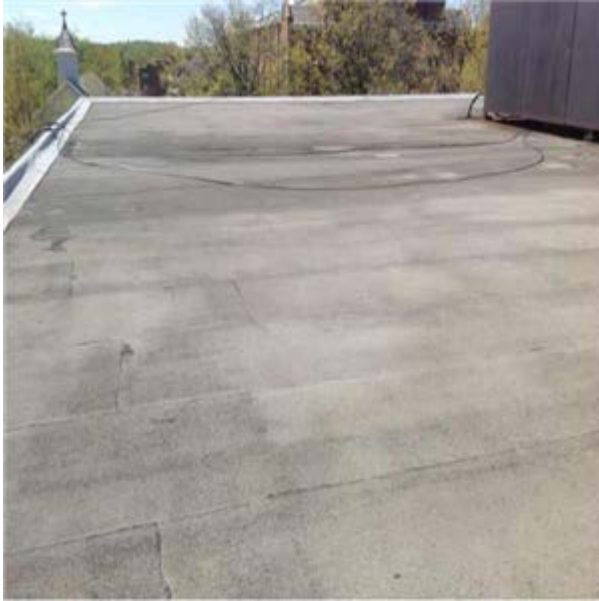
Item	Description
B3011 Roof Finishes	Built-up Roof
Condition	Poor
RUL	0
Plan Type	Capital Replacement
Quantity	19584
Unit of Measure	Sq Ft
Unit Cost	\$10.46

Type	Component Description	Plan Type	Year	Expenditures (\$)
B3011	Replace Built-up Roof	Capital Replacement	2014	\$204,751

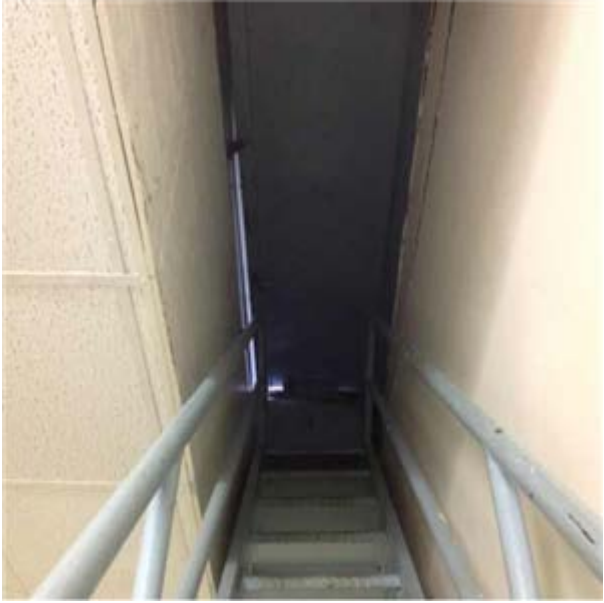
Item	Description
B3022 Roof Hatches	Roof Hatch, Aluminum
Condition	Fair - Good
RUL	36
Plan Type	Capital Replacement
Quantity	1
Unit of Measure	Each
Unit Cost	\$1,131.61

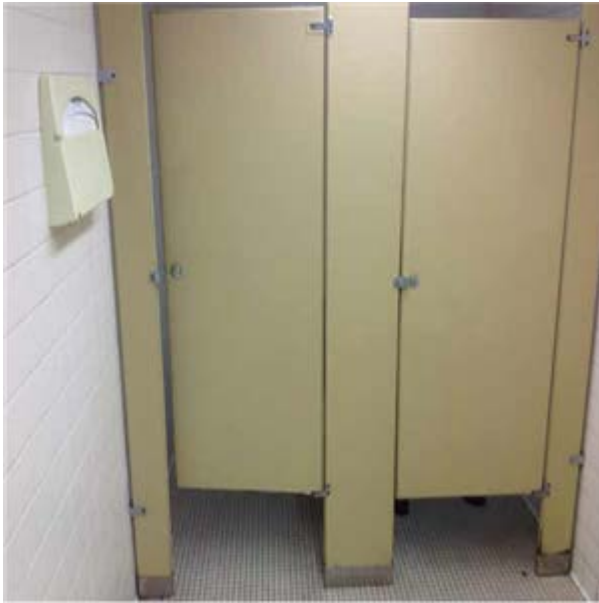
Item	Description
C1014 Site Built Toilet Partitions	Site Built Toilet Partitions
Condition	Fair - Good
RUL	11
Plan Type	Capital Replacement
Quantity	20
Unit of Measure	
Unit Cost	\$500

Metal toilet partitions

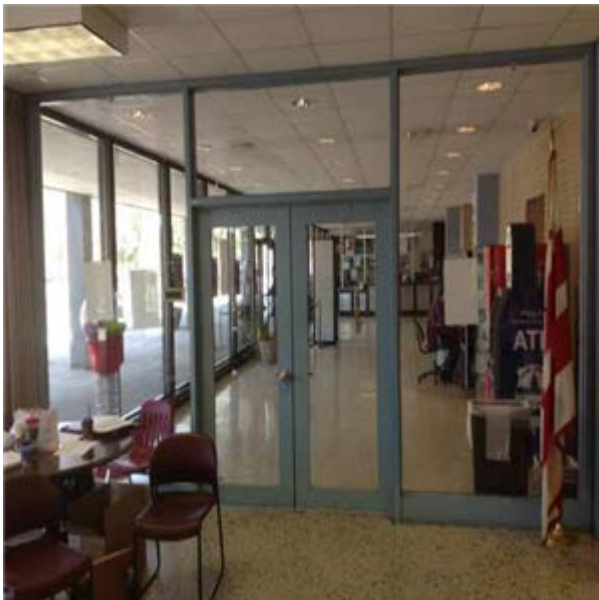
Item	Description
C1017 Interior Windows & Storefronts	Interior Windows & Storefronts
Condition	Fair - Good
RUL	11
Plan Type	Capital Replacement

Quantity	7
Unit of Measure	Each
Unit Cost	\$2,500

Interior hm storefront

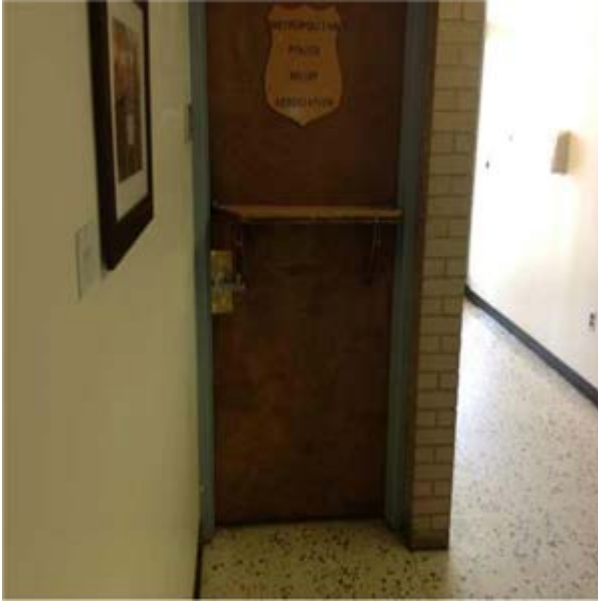
Item	Description
C1021 Interior Doors	Wood, Solid Core, Painted, Interior Door
Condition	Fair - Good
RUL	26
Plan Type	Capital Replacement
Quantity	5
Unit of Measure	Each
Unit Cost	\$1,343.55

Wood door

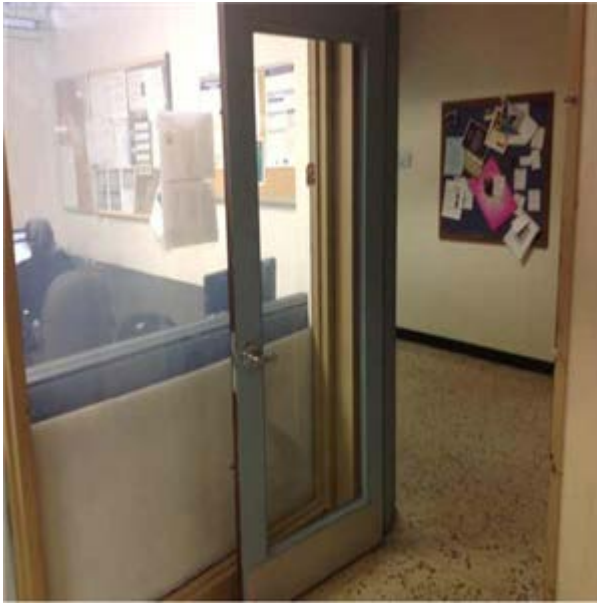
Item	Description
C1021 Interior Doors	Steel, Painted, w/ Safety Glass, Interior Door
Condition	Fair - Good
RUL	30
Plan Type	Capital Replacement
Quantity	5
Unit of Measure	Each
Unit Cost	\$1,195.66

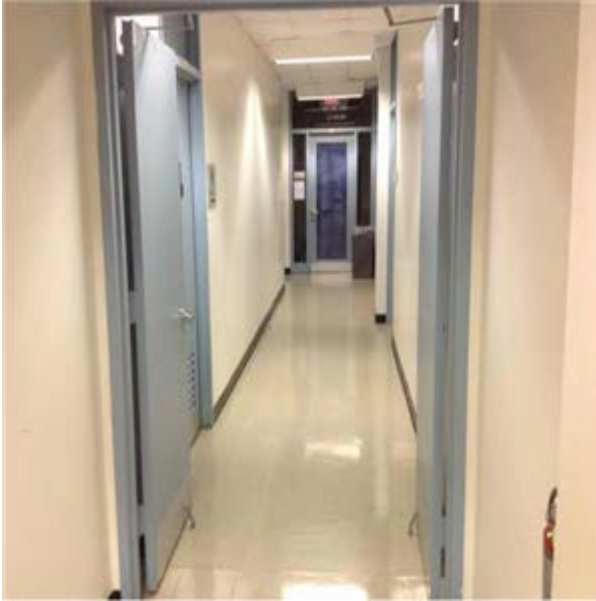
Item	Description
C1021 Interior Doors	Steel, Painted, Interior Double Door
Condition	Fair - Good
RUL	30
Plan Type	Capital Replacement
Quantity	16
Unit of Measure	Each
Unit Cost	\$1,857.80

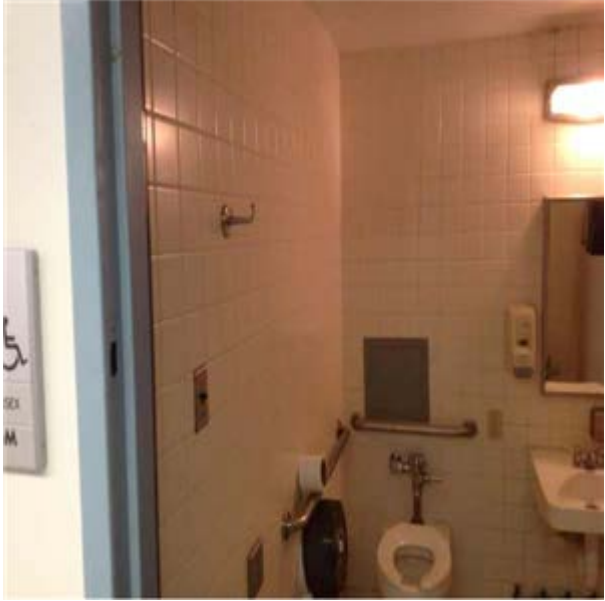
Item	Description
C3012 Wall Finishes to Interior Walls	Ceramic Tile, Interior Wall Finish, 16 Sq In
Condition	Good

RUL	30
Plan Type	Capital Replacement
Quantity	2851
Unit of Measure	Sq Ft
Unit Cost	\$12.70

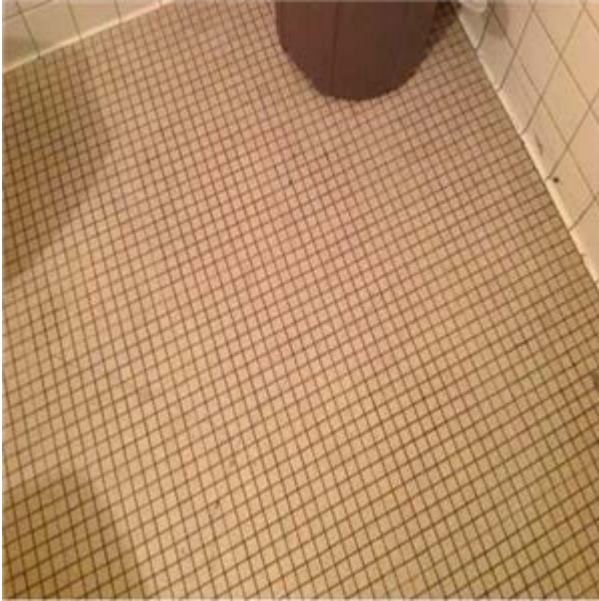
Item	Description
C3024 Flooring	Ceramic Tile Flooring
Condition	Fair - Good
RUL	26
Plan Type	Capital Replacement
Quantity	1381
Unit of Measure	Sq Ft
Unit Cost	\$13.49

Bathroom flooring

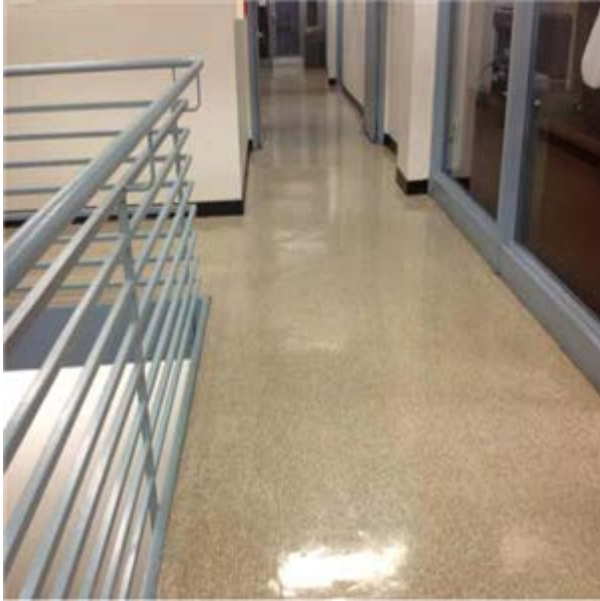
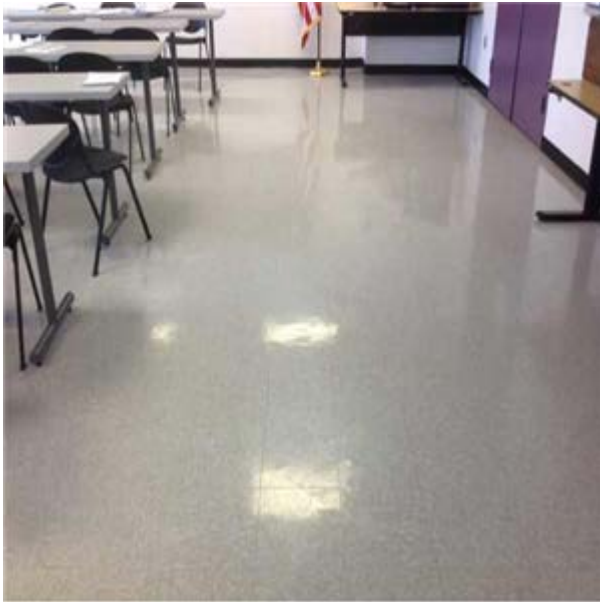
Item	Description
C3024 Flooring	Vinyl Tile Flooring
Condition	Fair
RUL	4
Plan Type	Capital Replacement
Quantity	25230
Unit of Measure	Sq Ft

Unit Cost	\$3.04
-----------	--------

2nd floor vct

Type	Component Description	Plan Type	Year	Expenditures (\$)
C3024	Replace Vinyl Tile Flooring	Capital Replacement	2018	\$76,699

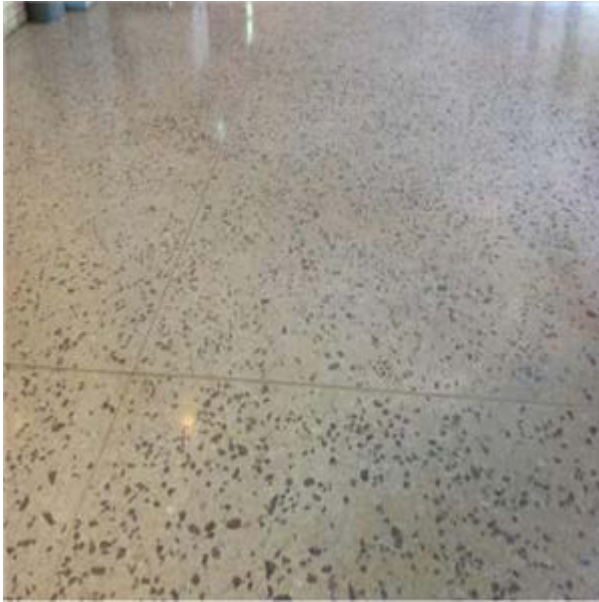
Item	Description
C3024 Flooring	Terrazzo Flooring
Condition	Fair - Good
RUL	30
Plan Type	Capital Replacement
Quantity	6356

Unit of Measure	Sq Ft
Unit Cost	\$9.75

Lobby floor

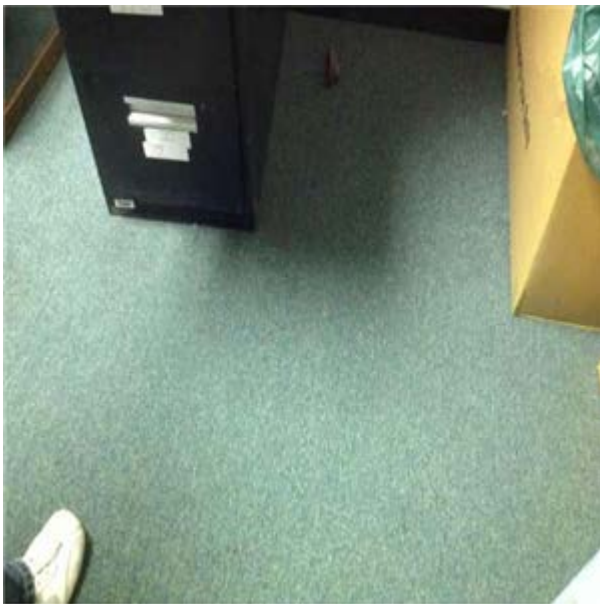
Cut pile carpeting

Type	Component Description	Plan Type	Year	Expenditures (\$)
C3025	Replace Carpet, Nylon, High Traffic, 20 oz	Capital Replacement	2017	\$18,825

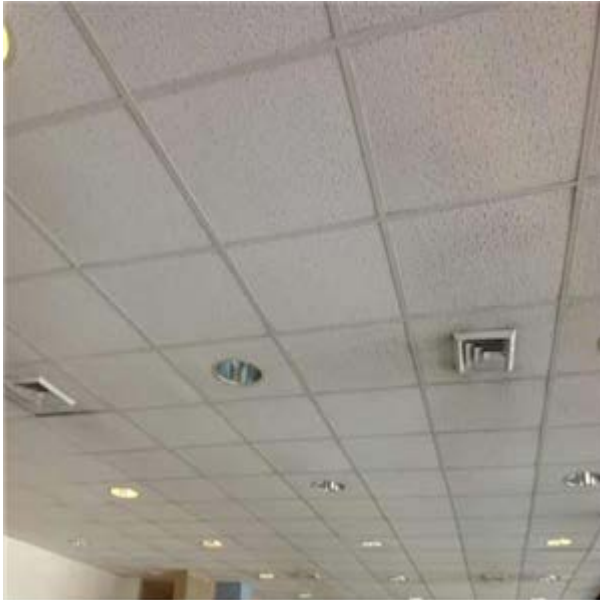
Item	Description
C3032 Suspended Ceilings	Acoustical Tile, Dropped Ceiling
Condition	Fair - Good
RUL	11
Plan Type	Capital Replacement

Quantity	35417
Unit of Measure	Sq Ft
Unit Cost	\$2.97

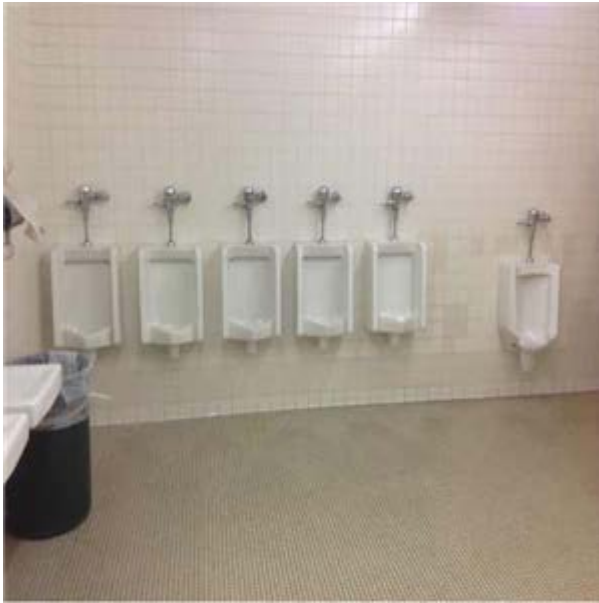
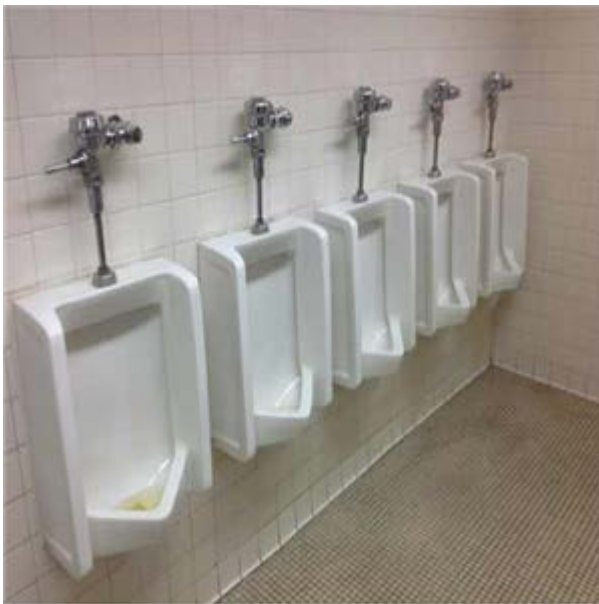
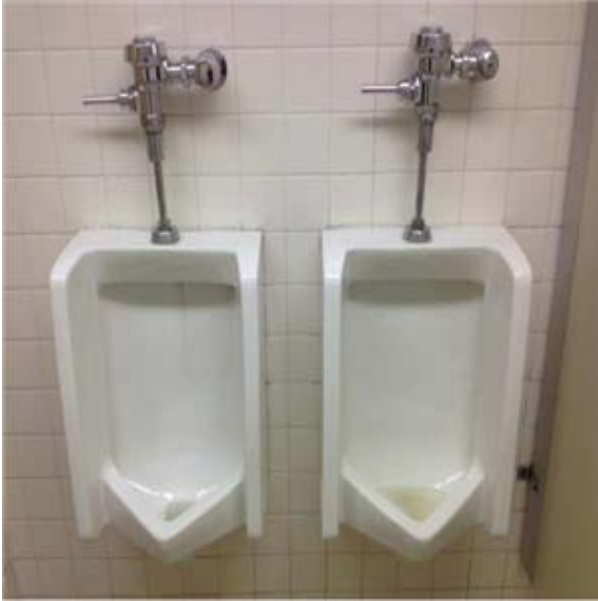
Item	Description
D2012 Urinals	Urinal, Vitreous China
Condition	Fair - Good
RUL	21
Plan Type	Capital Replacement
Quantity	13
Unit of Measure	Each
Unit Cost	\$888.54

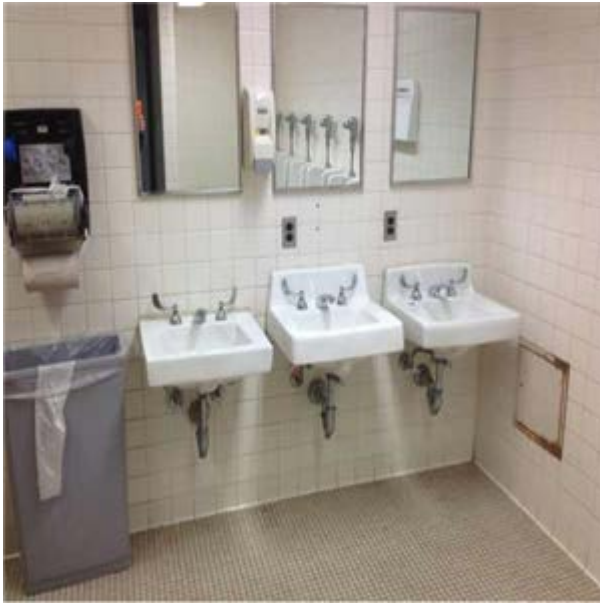
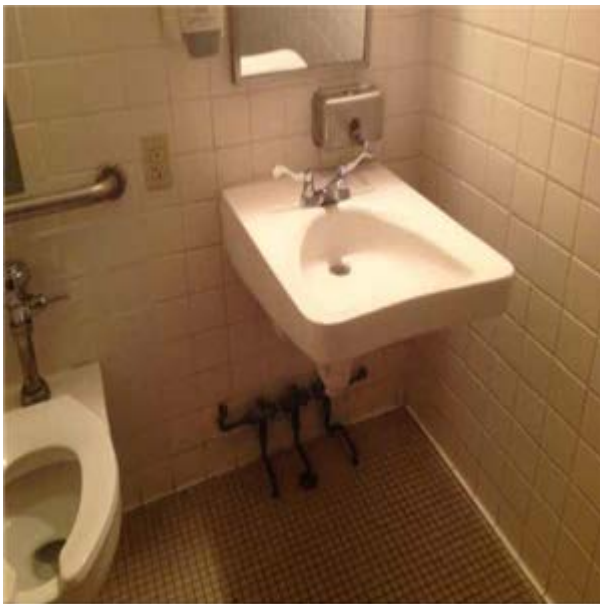
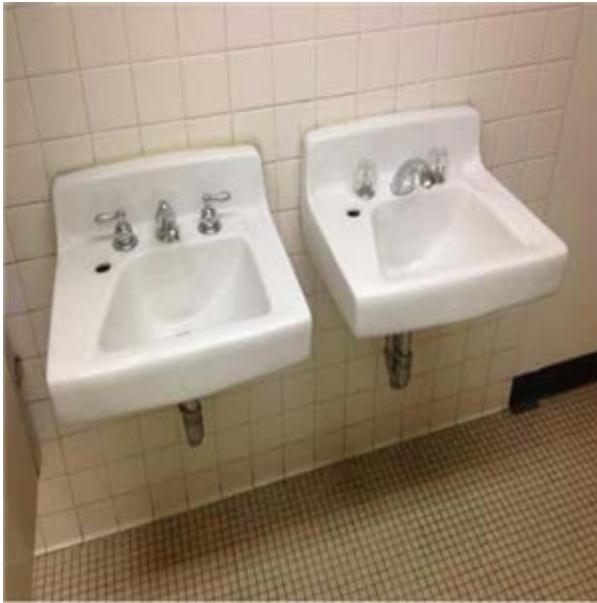
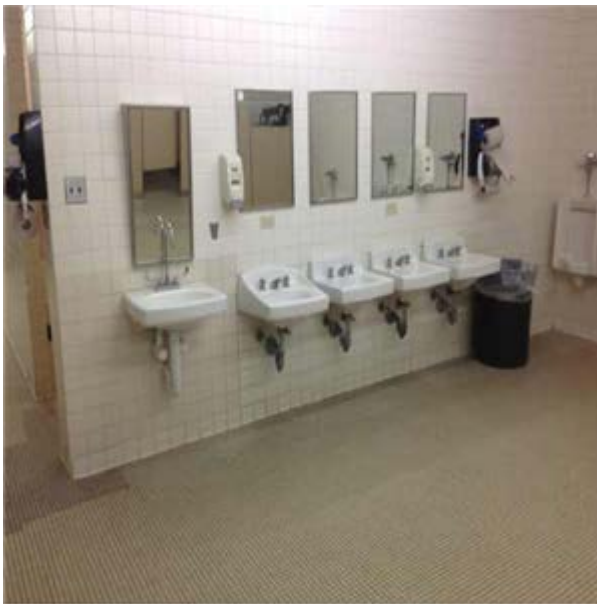
Item	Description
D2013 Lavatories	Lavatories
Condition	Good
RUL	21
Plan Type	Capital Replacement
Quantity	19
Unit of Measure	Each
Unit Cost	\$468.21

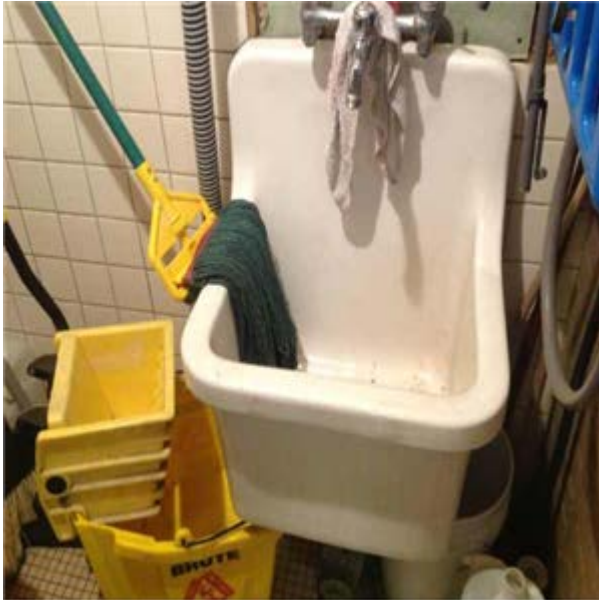
Item	Description
D2014 Sinks	Service Sink, Iron, Enamel
Condition	Fair - Good
RUL	21
Plan Type	Capital Replacement

Quantity	5
Unit of Measure	Each
Unit Cost	\$1,012.39

Mop sink

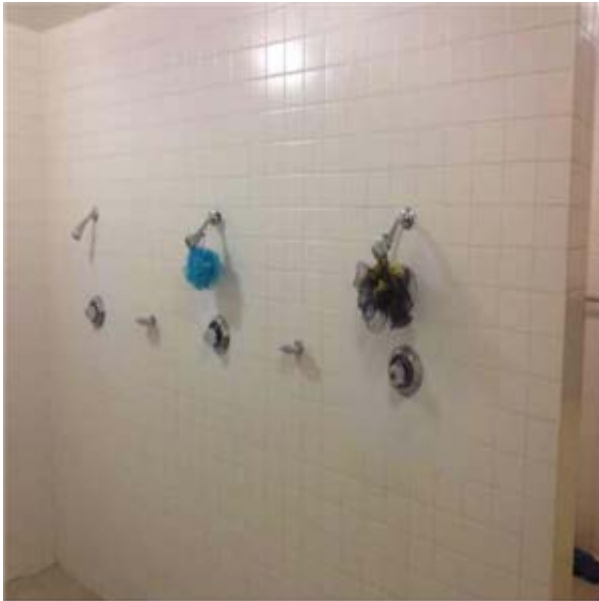
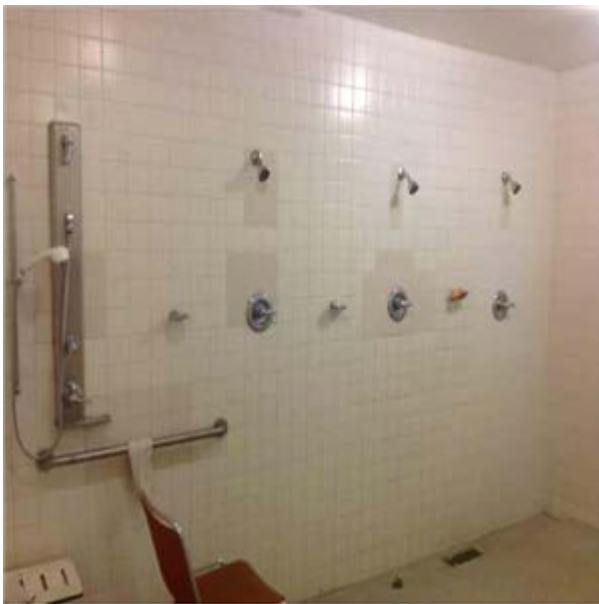
Item	Description
D2017 Showers	Shower, Ceramic Tile
Condition	Fair - Good
RUL	16
Plan Type	Capital Replacement
Quantity	11
Unit of Measure	Each
Unit Cost	\$1,398.32

Locker rooms

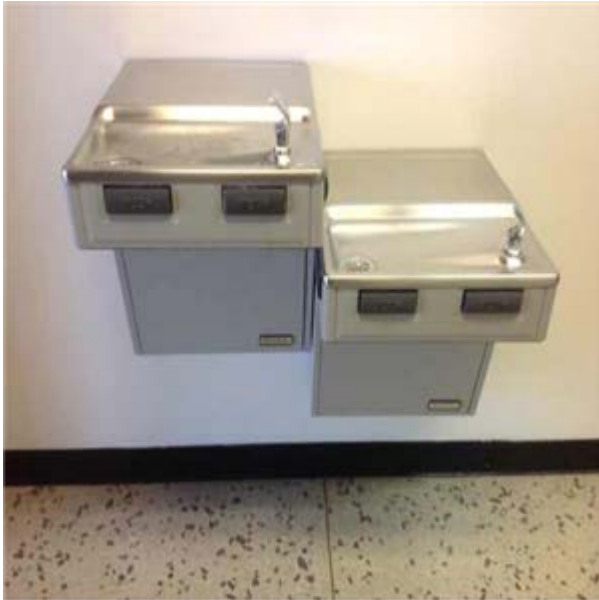
Item	Description
D2018 Drinking Fountains and Coolers	Drinking Fountain, Refrigerated
Condition	Fair - Good
RUL	6
Plan Type	Capital Replacement

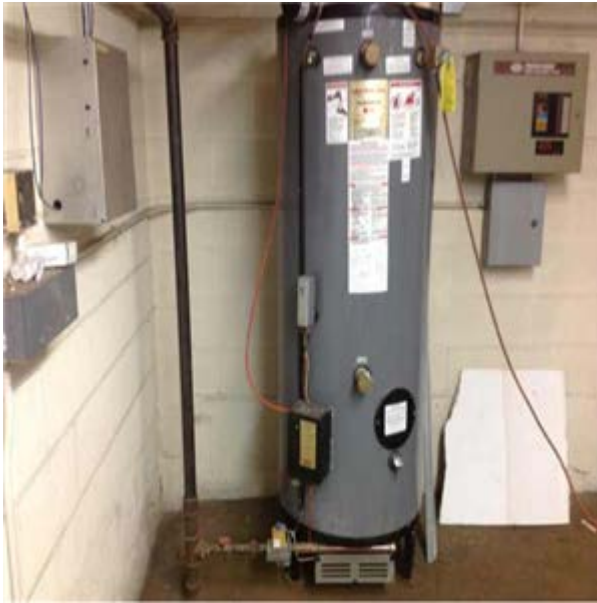
Item	Description
D2022 Hot Water Service	Domestic Hot Water Heater - Gas
Condition	Fair - Good
RUL	5
Plan Type	Capital Replacement
Quantity	1
Unit of Measure	Each
Unit Cost	\$3,000
Make	Rheem
Model	G91-200

91 Gallons, 199,900 Btu

Type	Component Description	Plan Type	Year	Expenditures (\$)
D2022	Replace Domestic Hot Water Heater - Gas	Capital Replacement	2019	\$3,000

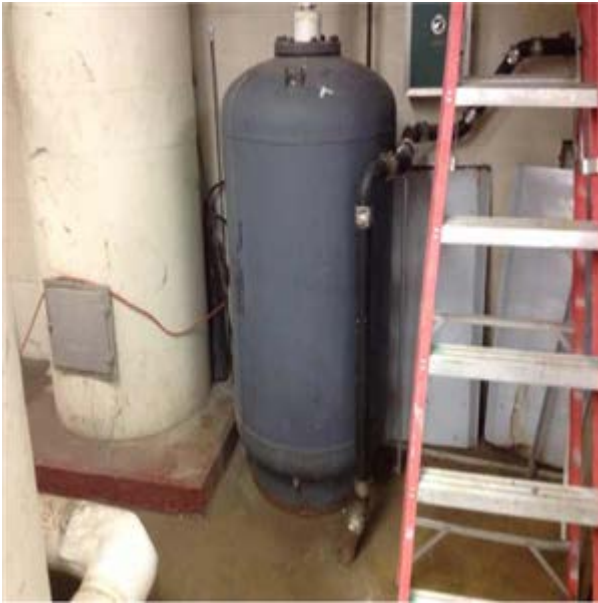
Item	Description
D2023 Domestic Water Supply Equipment	boiler bag tank
Condition	Fair - Good
RUL	16
Plan Type	Capital Replacement
Quantity	1
Unit of Measure	
Unit Cost	\$3,000
Make	John Wood Co.
Model	NONE

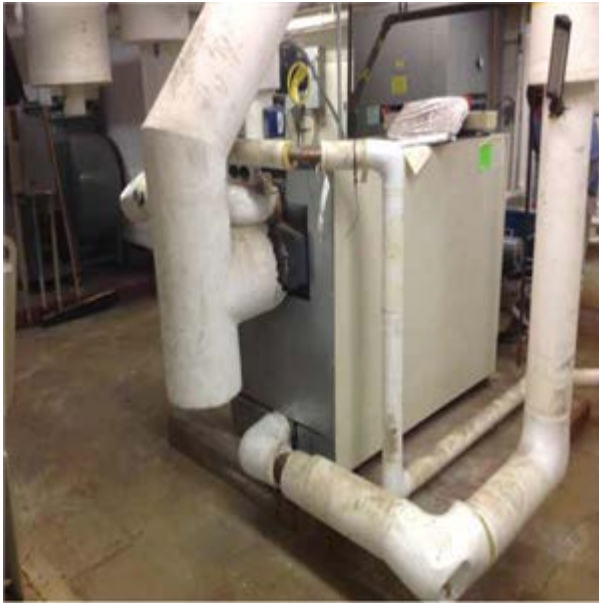
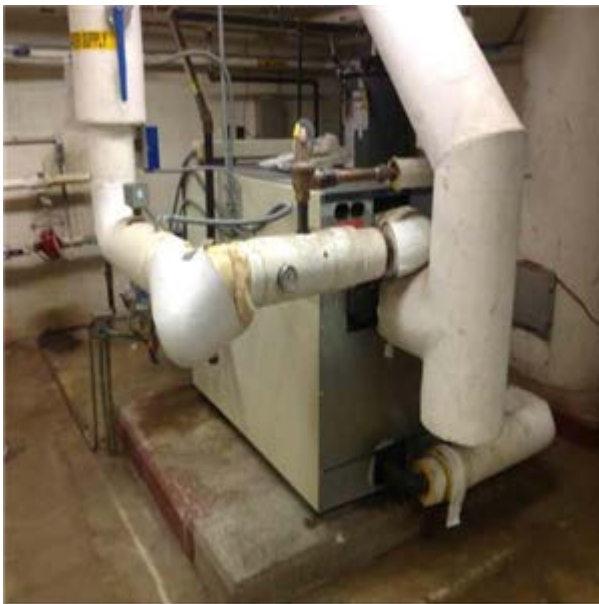
Item	Description
D3021 Boilers	Boiler, Gas, 1,000 Mbh
Condition	Good
RUL	12
Plan Type	Capital Replacement
Quantity	2
Unit of Measure	Each
Unit Cost	\$23,259.16
Make	De Dietrich
Model	GT309A

Comments
1999 Install

One of two boilers

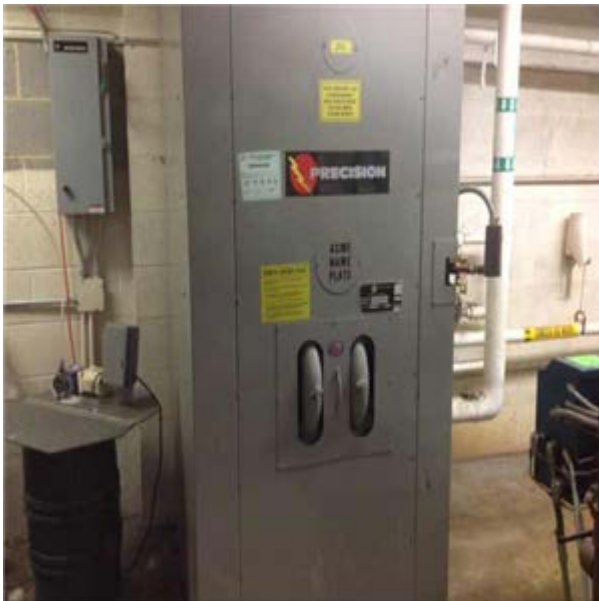
Item	Description
D3021 Boilers	Boiler, Gas, 1,000 Mbh
Condition	Good
RUL	12
Plan Type	Capital Replacement

1999 Install

3rd boiler

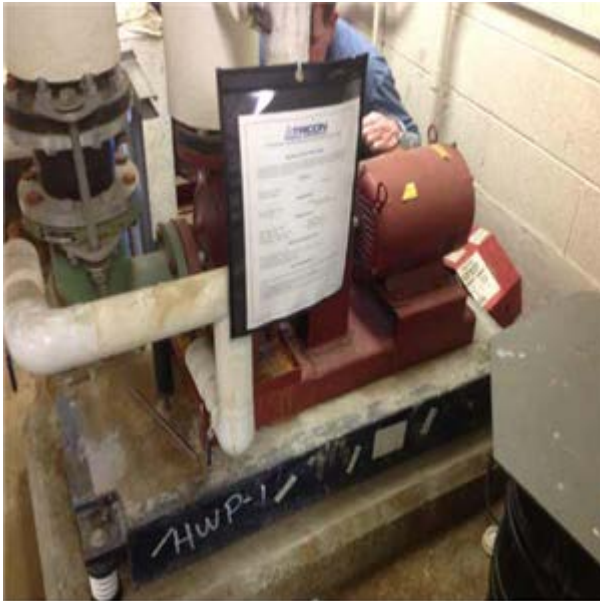
Item	Description
D3022 Boiler Room Piping & Specialties	Circulation Pump, Hot Water, 7.500 HP
Condition	Fair
RUL	3
Plan Type	Capital Replacement
Quantity	1
Unit of Measure	Each
Unit Cost	\$4,473.70
Make	Baldor

Model	N3311T
--------------	--------

Type	Component Description	Plan Type	Year	Expenditures (\$)
D3022	Replace Circulation Pump, Hot Water, 7.500 HP	Capital Replacement	2017	\$4,474

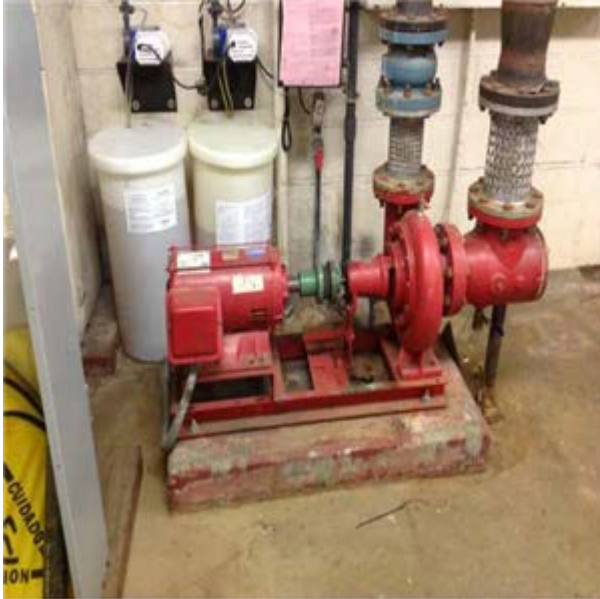
Item	Description
D3022 Boiler Room Piping & Specialties	Circulation Pump, Hot Water, 15.000 HP
Condition	Fair
RUL	3
Plan Type	Capital Replacement
Quantity	1
Unit of Measure	Each
Unit Cost	\$4,719.92
Make	Magnetek

Model	7-850099-01-OJ
--------------	----------------

Type	Component Description	Plan Type	Year	Expenditures (\$)
D3022	Replace Circulation Pump, Hot Water, 15.000 HP	Capital Replacement	2017	\$4,720

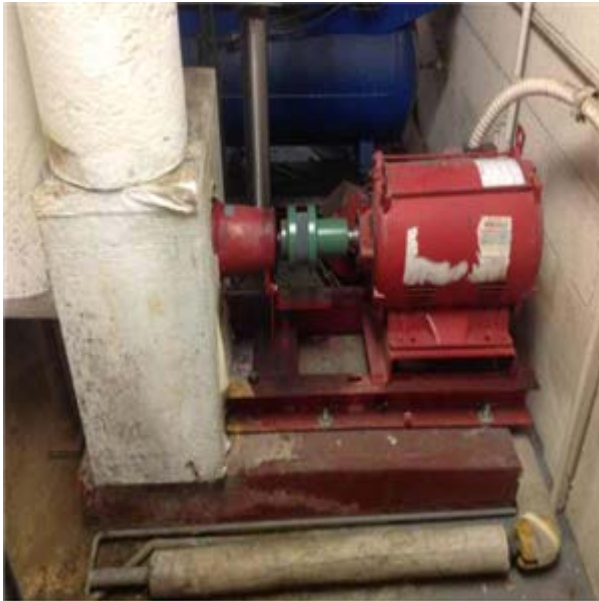
Item	Description
D3022 Boiler Room Piping & Specialties	Circulation Pump, Hot Water, 25.000 HP
Condition	Fair
RUL	3
Plan Type	Capital Replacement
Quantity	1
Unit of Measure	Each
Unit Cost	\$9,328.28
Make	Magnetek

Model	7-850003-01-OJ
--------------	----------------

Type	Component Description	Plan Type	Year	Expenditures (\$)
D3022	Replace Circulation Pump, Hot Water, 25.000 HP	Capital Replacement	2017	\$9,328

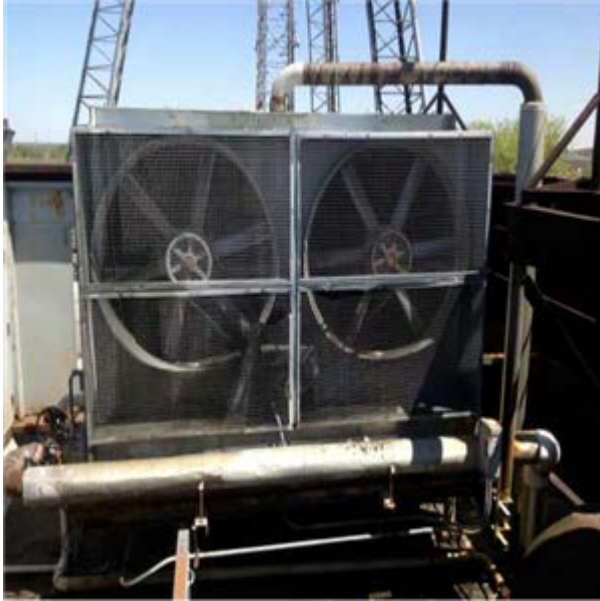
Item	Description
D3031 Chilled Water Systems	Cooling Tower, 50 Ton
Condition	Poor
RUL	1
Plan Type	Capital Replacement
Quantity	1
Unit of Measure	Each
Unit Cost	\$100,000
Make	Baltimore Aircoil Company

Model	FXT-192
--------------	---------

Chiller on rooftop

Type	Component Description	Plan Type	Year	Expenditures (\$)
D3031	Replace Cooling Tower, 50 Ton	Capital Replacement	2015	\$100,000

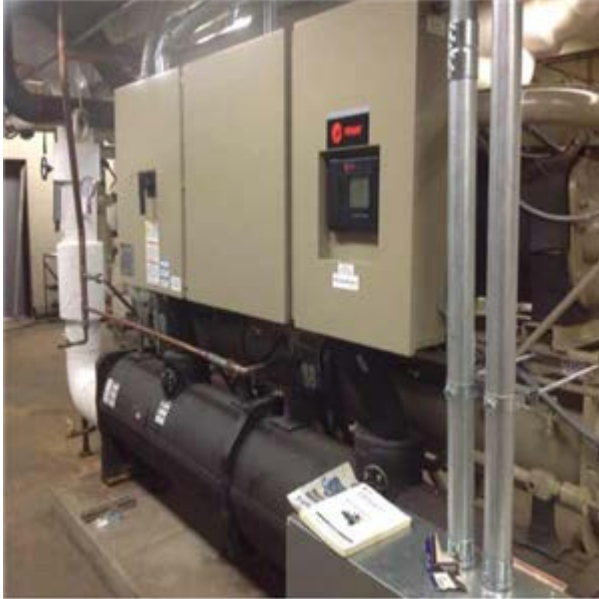
Item	Description
D3031 Chilled Water Systems	Chiller, Absorption, 50 Ton
Condition	Fair - Good
RUL	6
Plan Type	Capital Replacement
Quantity	1
Unit of Measure	Each
Unit Cost	\$90,856.77
Make	Trane

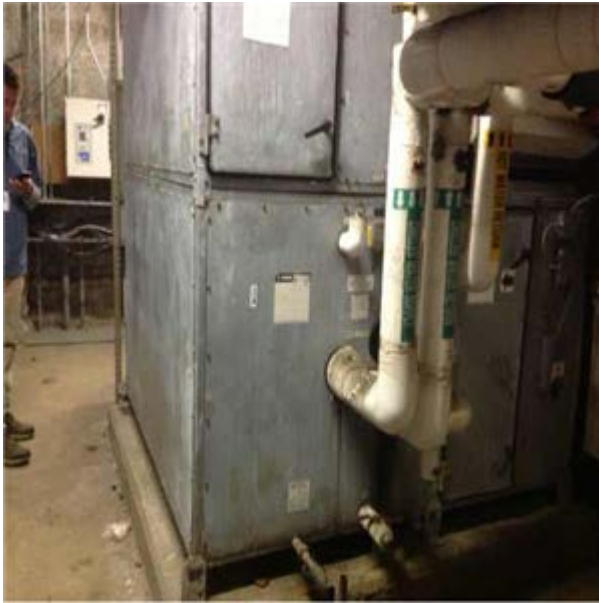
Item	Description
D3041 Air Distribution Systems	Air Handler, Multizone, 20,000 Cfm
Condition	Fair
RUL	3
Plan Type	Capital Replacement
Quantity	4
Unit of Measure	Each
Unit Cost	\$47,329.17
Make	Trane
Model	MCCA017CAK0B0C0A0000000

Air Handler Cam Not Identified

Ahu-1

Type	Component Description	Plan Type	Year	Expenditures (\$)
D3041	Replace Air Handler, Multizone, 20,000 Cfm	Capital Replacement	2017	\$189,317

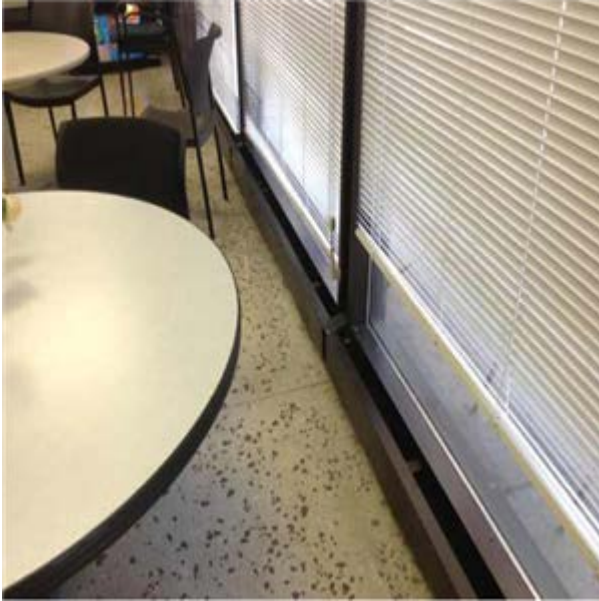
Item	Description
D3044 Hot Water Distribution	Radiator, Finned, Wall
Condition	Fair
RUL	6
Plan Type	Capital Replacement
Quantity	127
Unit of Measure	Each
Unit Cost	\$213.94

Measured In 6 Foot Sections

Baseboard hot water fin tube radiators

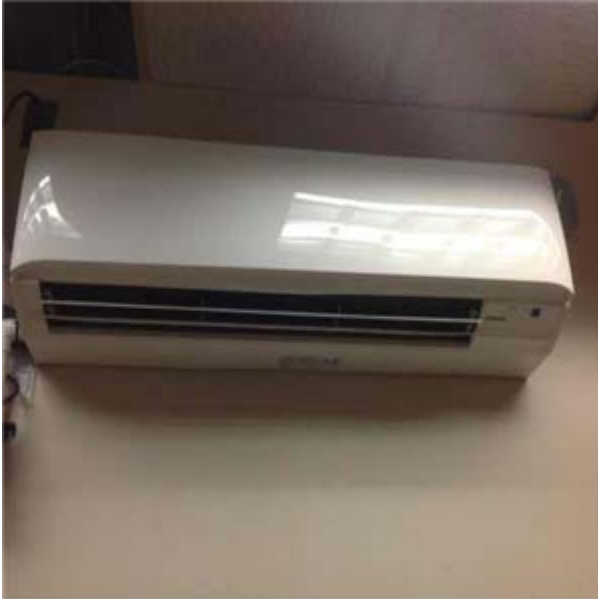
Item	Description
D3053 Split-Systems	Indoor Unit Only - Cooling, Heating Coils and Circulation Fan
Condition	Fair
RUL	6
Plan Type	Capital Replacement
Quantity	1
Unit of Measure	TON
Unit Cost	\$500
Make	Panasonic
Model	CS-KS30NKUA

Mini Split Indoor Unit

Mini split indoor unit

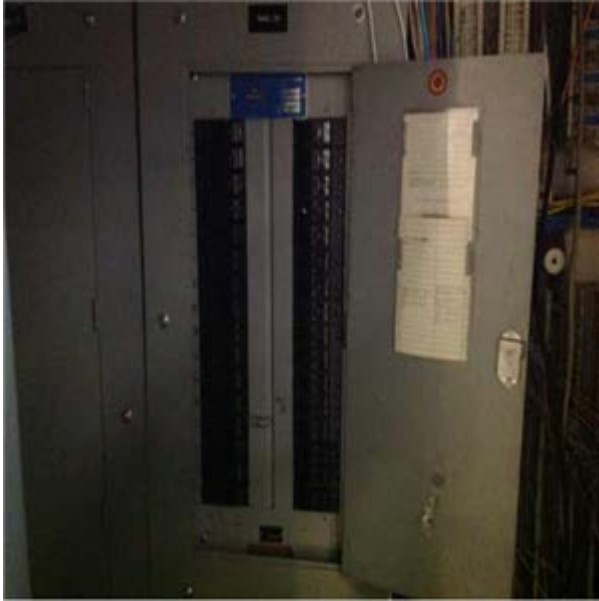
Item	Description
D5012 Low Tension Service & Dist.	Power Panel Board, 208 Y, 120 V, 100 Amp
Condition	Fair - Good
RUL	16
Plan Type	Capital Replacement
Quantity	2
Unit of Measure	Each
Unit Cost	\$4,224.27

100 Amp Panel

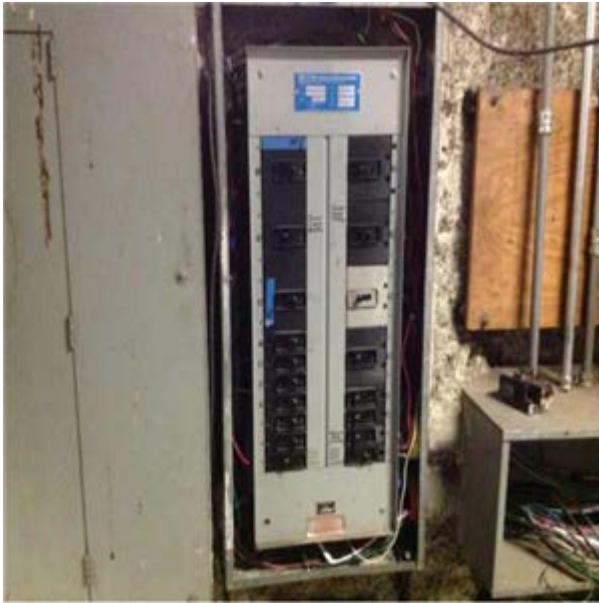
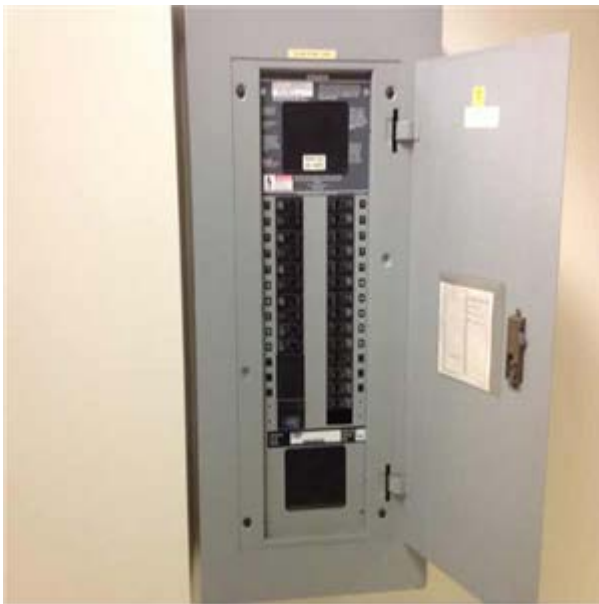
Item	Description
D5012 Low Tension Service & Dist.	Power Panel Board, 208 Y, 120 V, 125 Amp
Condition	Fair - Good
RUL	16
Plan Type	Capital Replacement
Quantity	2
Unit of Measure	Each
Unit Cost	\$4,224.27

Power Panel Board, 208 Y, 120 V, 125 Amp

In penthouse

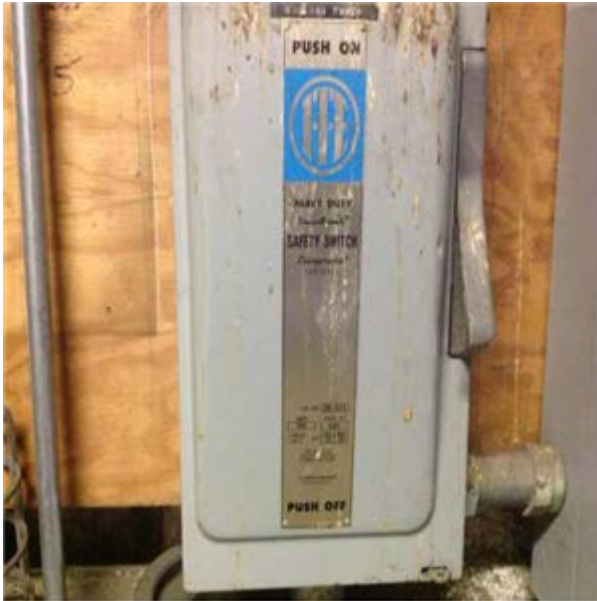
Item	Description
D5012 Low Tension Service & Dist.	Safety Switch, Fused, 100 Amp, 3 Ph
Condition	Fair
RUL	11
Plan Type	Capital Replacement

Safety Switch, Fused, 100 Amp, 3 Ph

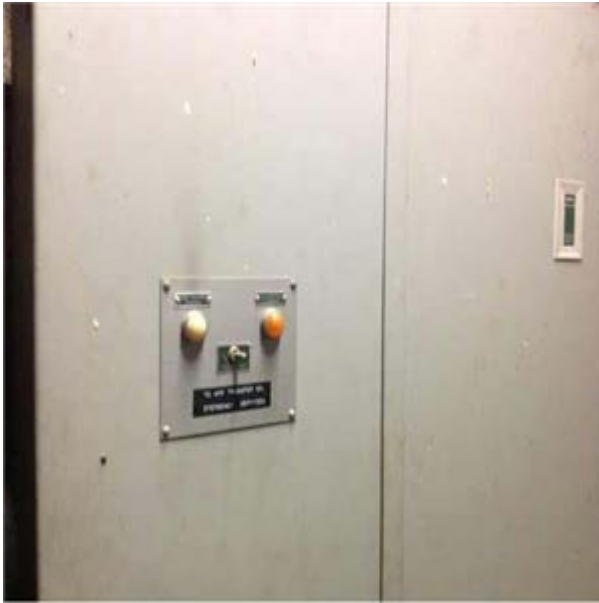
Item	Description
D5012 Low Tension Service & Dist.	Transfer Switch, Auto, 600 V, 70 Amp
Condition	Fair
RUL	8
Plan Type	Capital Replacement
Quantity	1
Unit of Measure	Each
Unit Cost	\$6,168
Make	Asca

Transfer Switch, Auto, 600 V, 70 Amp

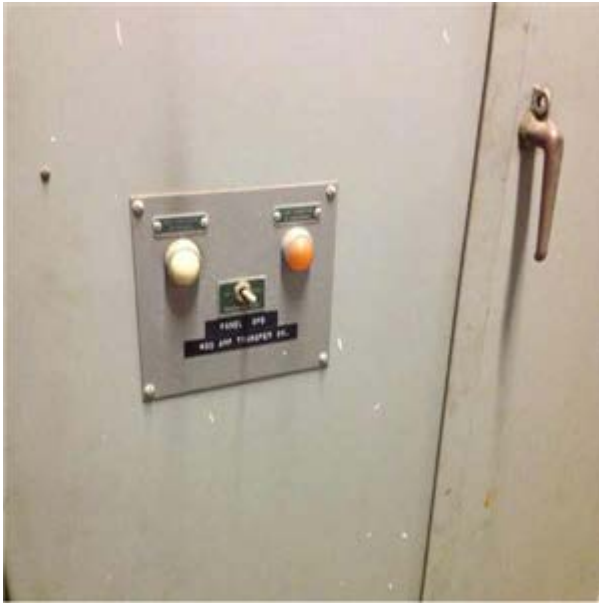
Item	Description
D5012 Low Tension Service & Dist.	Transfer Switch, Auto, 600 V, 400 Amp
Condition	Fair
RUL	8
Plan Type	Capital Replacement
Quantity	1
Unit of Measure	Each
Unit Cost	\$10,669.08
Make	Asca

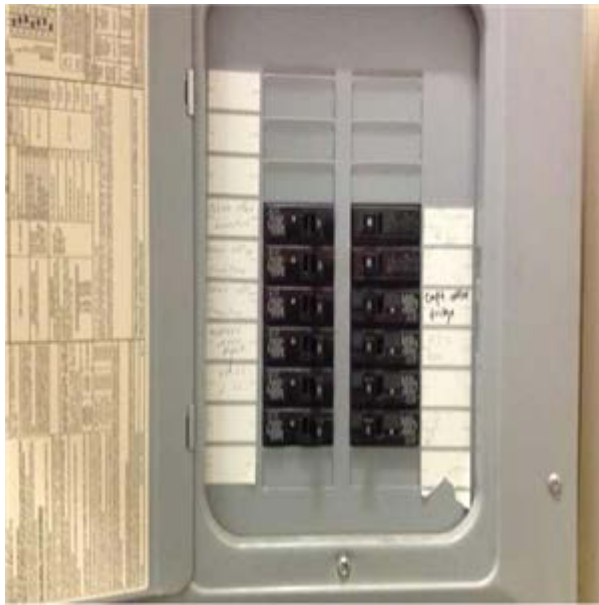
Item	Description
D5012 Low Tension Service & Dist.	Power Panel Board, 480 Y, 277 V, 100 Amp
Condition	Fair - Good
RUL	16
Plan Type	Capital Replacement
Quantity	1
Unit of Measure	Each
Unit Cost	\$5,914.17

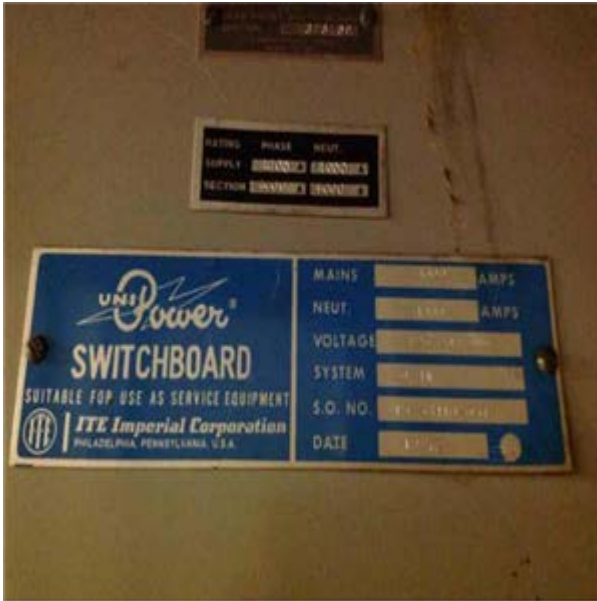
Item	Description
D5012 Low Tension Service & Dist.	Main Switchgear, 480 Y, 277 V, 4,000 Amp
Condition	Fair - Good
RUL	6
Plan Type	Capital Replacement
Quantity	1
Unit of Measure	Each
Unit Cost	\$392,210.47
Make	ITE Imperial

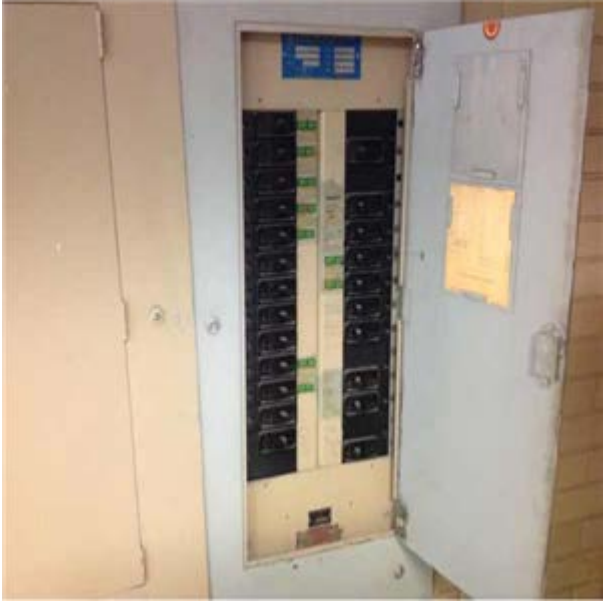
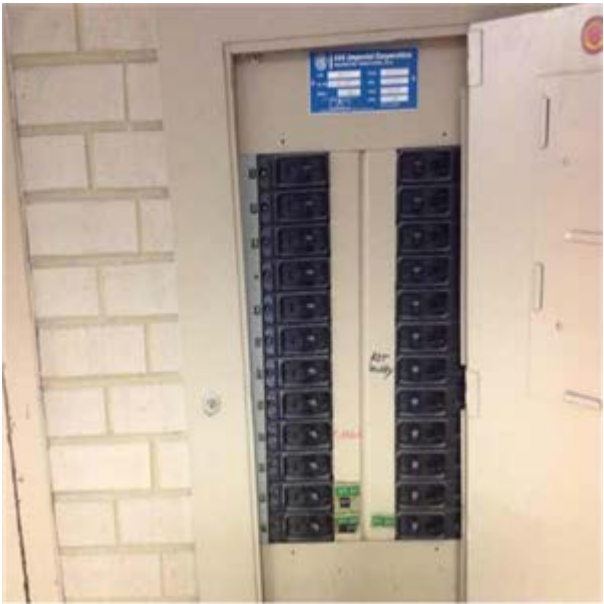
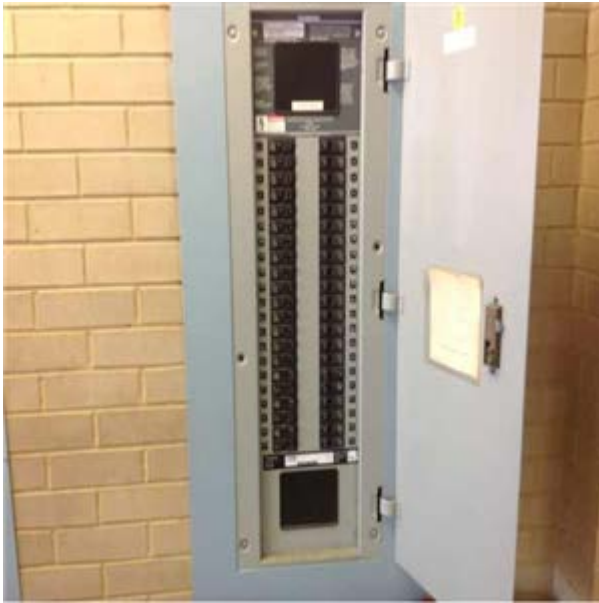
Item	Description
D5012 Low Tension Service & Dist.	Power Panel Board, 208 Y, 120 V, 225 Amp
Condition	Fair - Good
RUL	16
Plan Type	Capital Replacement
Quantity	10
Unit of Measure	Each
Unit Cost	\$6,379.29

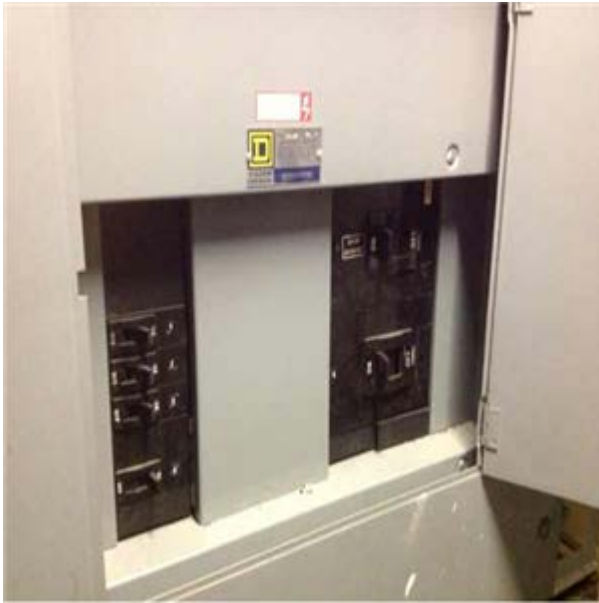
Item	Description
D5012 Low Tension Service & Dist.	Power Panel Board, 208 Y, 120 V, 400 Amp
Condition	Fair - Good
RUL	16
Plan Type	Capital Replacement
Quantity	3
Unit of Measure	Each
Unit Cost	\$7,601.26
Make	Square D
