Property Condition Report

**4th District Headquarters
6001 Georgia Ave
Washington, DC**

**Comprehensive Facility Condition Assessment
And Space Utilization Study
DCAM-13-NC-0162**

October 15, 2014

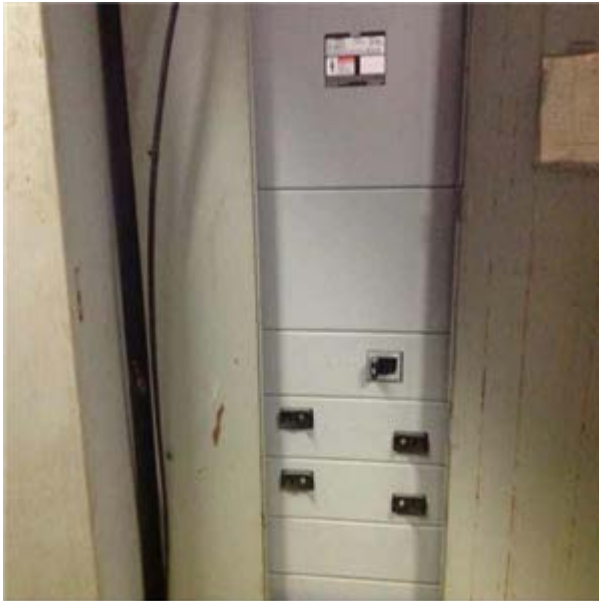
Item	Description
D5012 Low Tension Service & Dist.	Power Panel Board, 208 Y, 120 V, 600 Amp
Condition	Fair - Good
RUL	16
Plan Type	Capital Replacement
Quantity	1
Unit of Measure	Each
Unit Cost	\$7,601.26

Power Panel Board, 208 Y, 120 V, 600 Amp

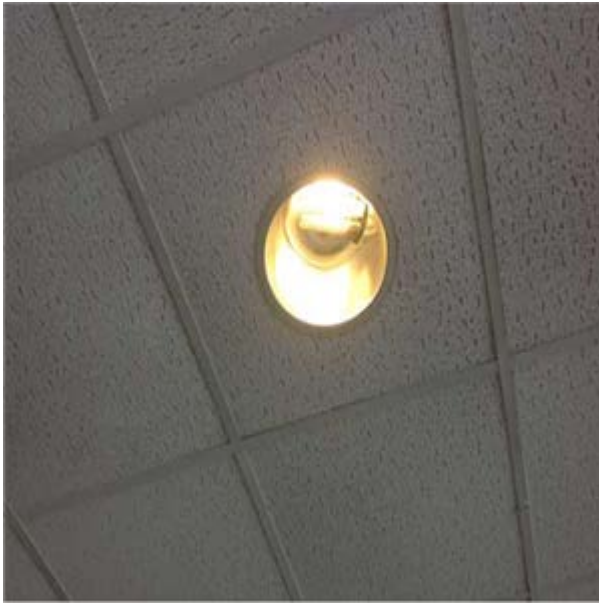
Item	Description
D5022 Lighting Equipment	Compact Fluorescent Lighting Fixture Ballast 32 W
Condition	Fair
RUL	6
Plan Type	Capital Replacement
Quantity	42
Unit of Measure	Each
Unit Cost	\$102.14

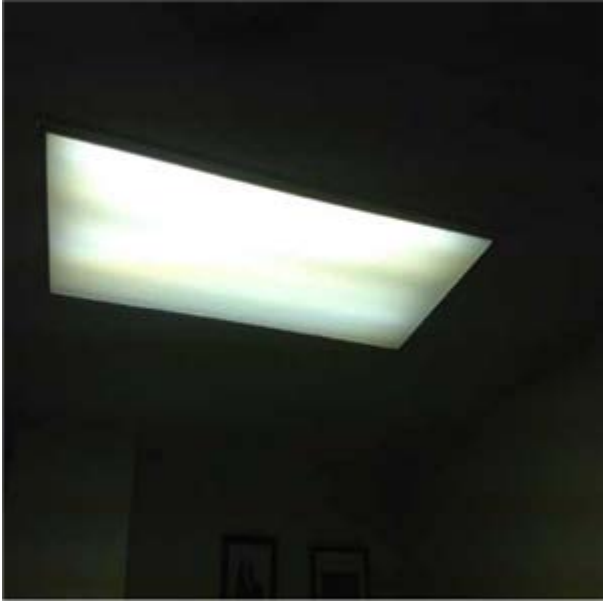
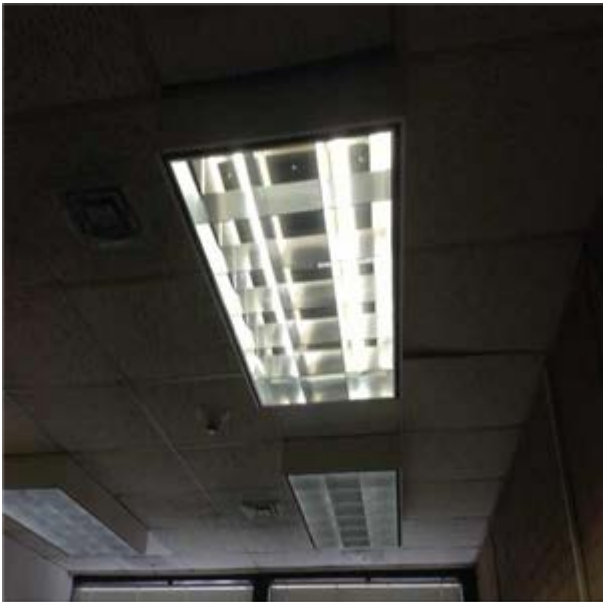
Item	Description
D5022 Lighting Equipment	Fluorescent Lighting Fixture, T8, 32w
Condition	Fair - Good
RUL	6
Plan Type	Capital Replacement
Quantity	565
Unit of Measure	Each
Unit Cost	\$178.94

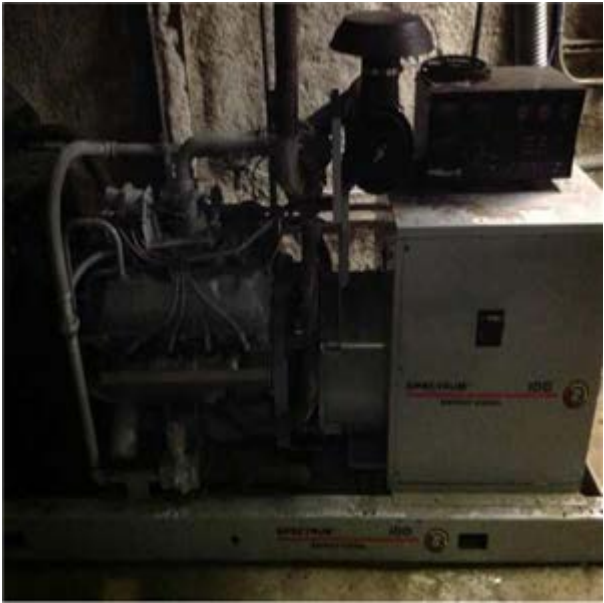
Item	Description
D5092 Emergency Light & Power Systems	Generator, natural gas, 125 kW
Condition	Good
RUL	11
Plan Type	Capital Replacement
Quantity	1
Unit of Measure	Each
Unit Cost	\$92,066.39
Make	Spectrum
Model	100GS

Generator, Natural Gas, 125 Kw -Not Diesel

Generator, natural gas, 125 kW

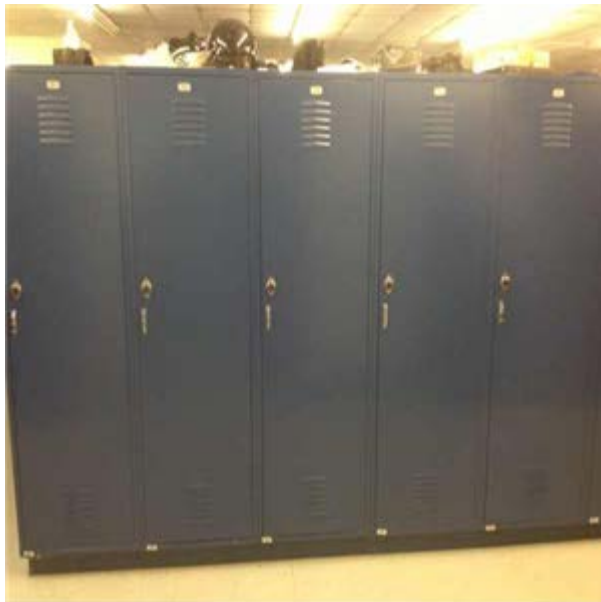
Item	Description
E10 Equipment	Lockers
Condition	Good
RUL	11
Plan Type	Capital Replacement
Quantity	742
Unit of Measure	
Unit Cost	\$200

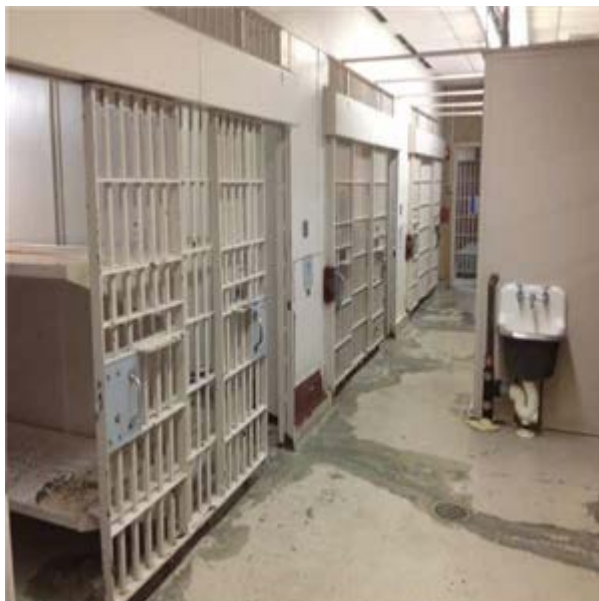
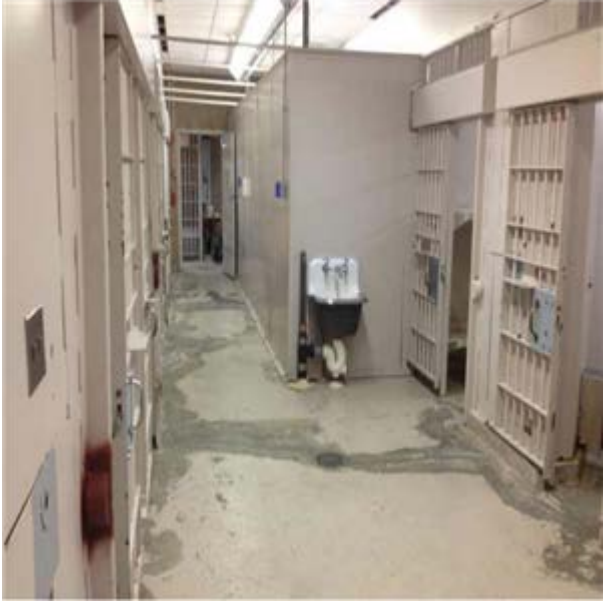
Item	Description
E1026 Detention Equipment	Detention Doors & Hardware
Condition	Fair - Good
RUL	30
Plan Type	Capital Replacement
Quantity	14
Unit of Measure	Each
Unit Cost	\$2,942.14

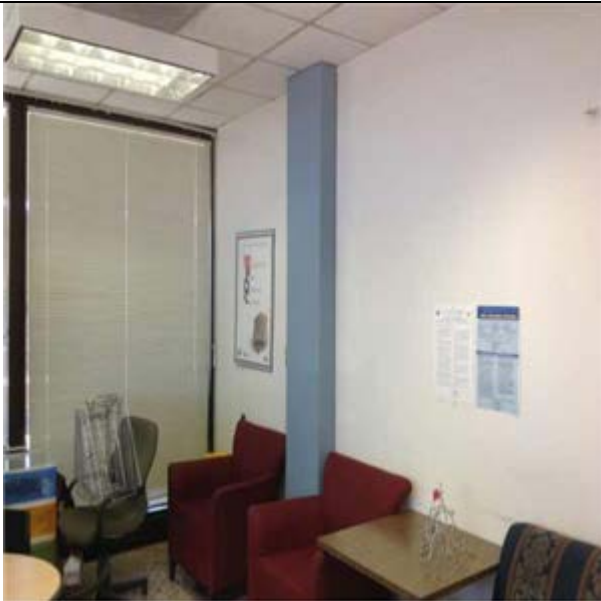
concrete Columns and Beams Frame :- concrete column

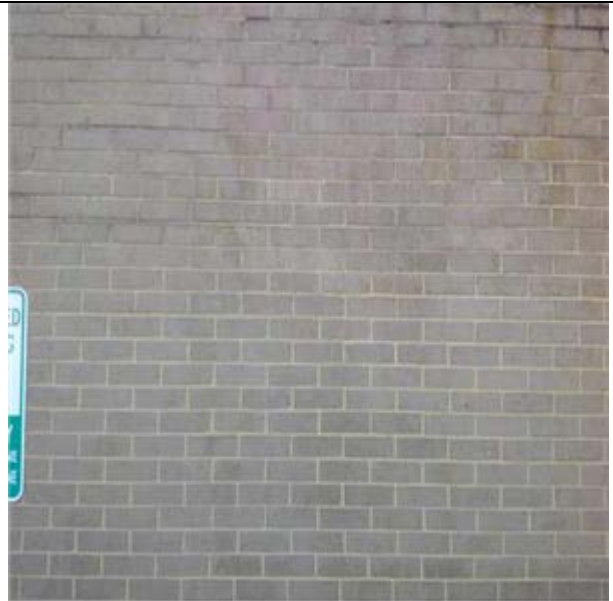
Brick Veneer, Exterior, 1 Story:- (null)

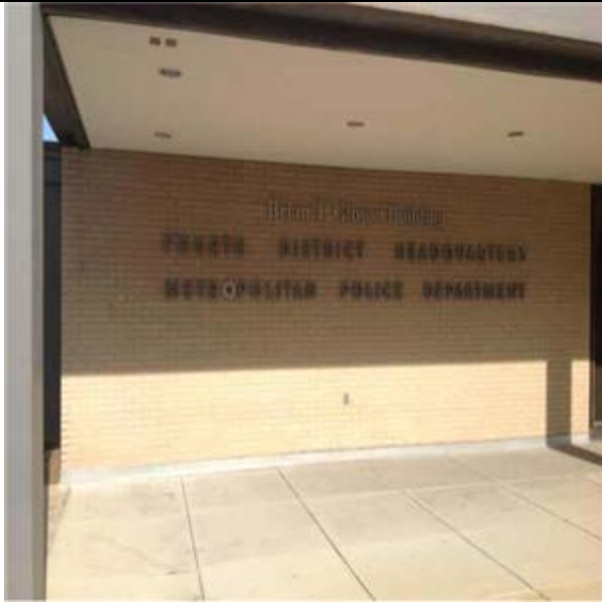
Brick Veneer, Exterior, 1 Story :- at front of building

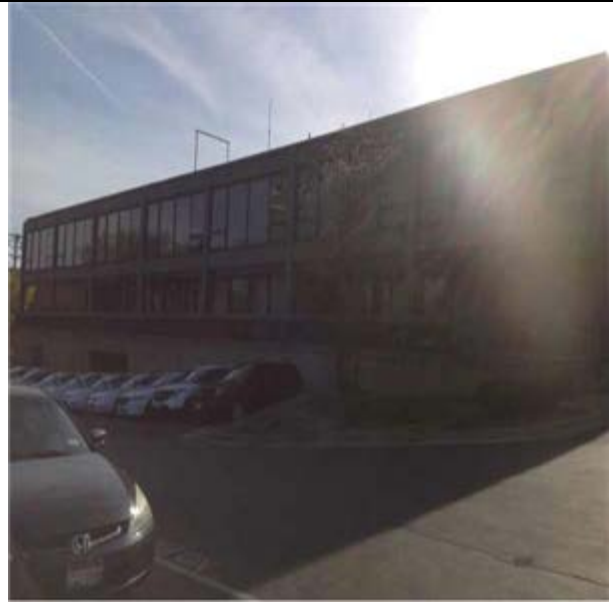
Brick Veneer, Exterior, 1 Story:- at rear elevation

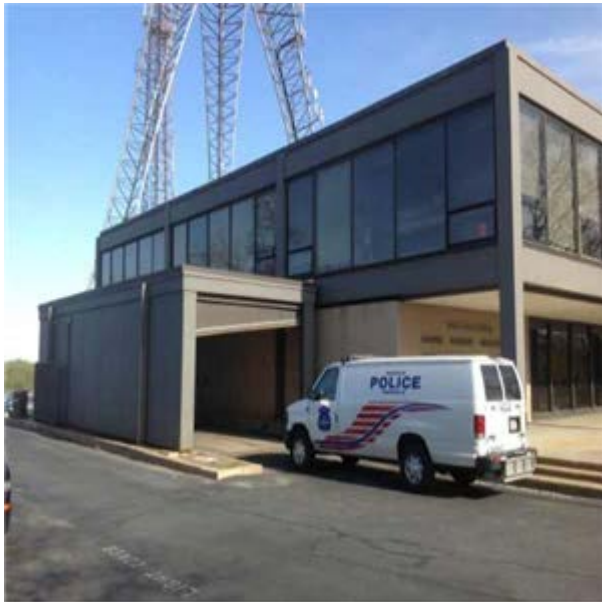
Brick Veneer, Exterior, 1 Story :- Side elevation

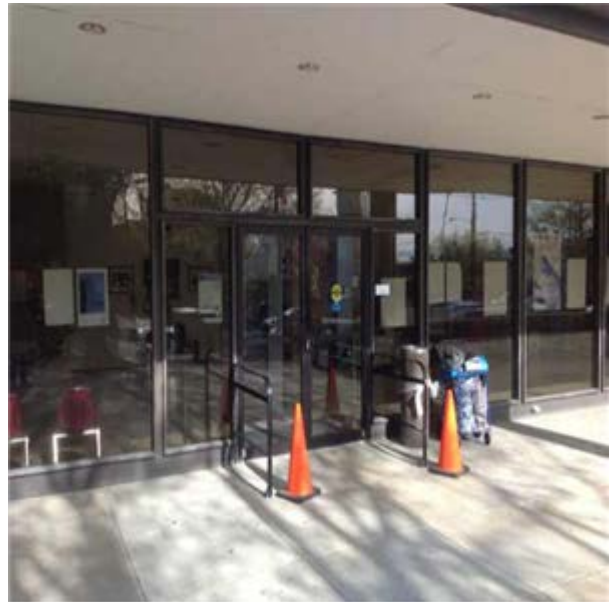
Glazed Aluminum Framed with Swing Doors:- main entrance

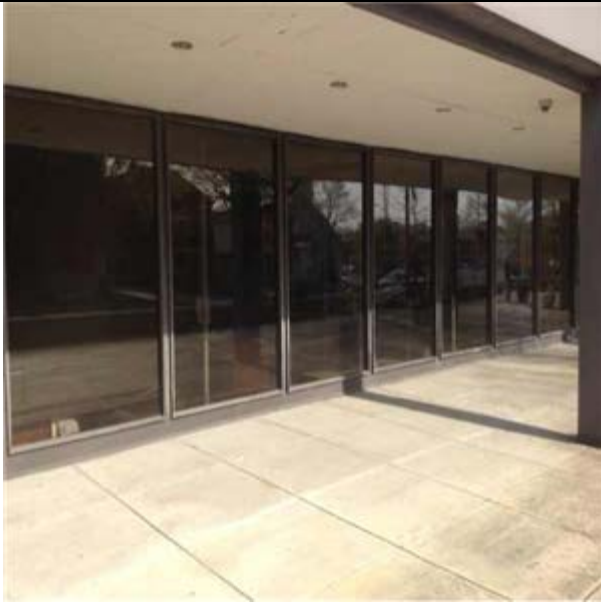
Glazed Aluminum Framed with Swing Doors :-
(null)

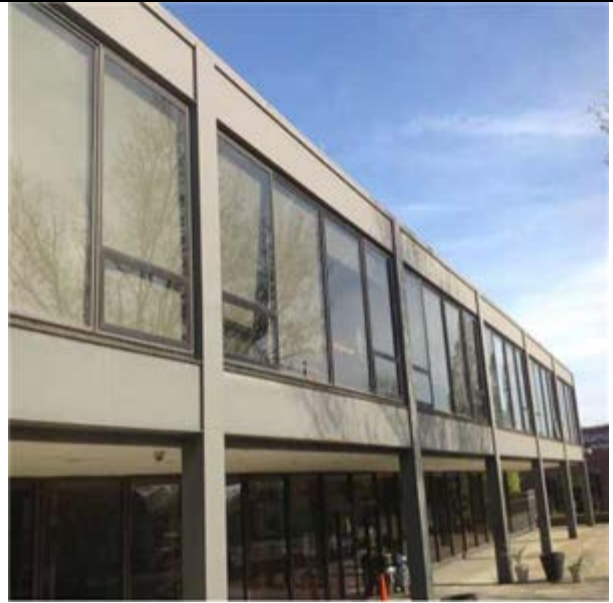
Glazed Aluminum Framed with Swing Doors:- (null)

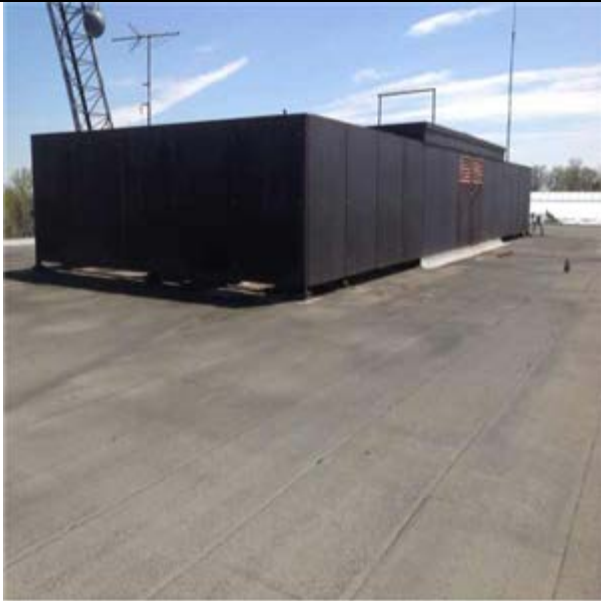
Capital Replacement	Poor	B30 Roofing	Built-up Roof	19,584.00	Sq Ft	10.46	204,750.72	2	10.00	99%	1.99	9.95		
							205,882.33	10			2.03	10.00	80%	Poor
C10 Interior Construction														
Capital Replacement	Fair - Good	C10 Interior Construction	Steel, Painted, Interior Double Door	16.00	Each	1,857.80	29,724.78	8	10.00	22%	1.78	2.23		
Capital Replacement	Fair - Good	C10 Interior Construction	Wood, Solid Core, Painted, Interior Door	5.00	Each	1,343.55	6,717.74	8	10.00	5%	0.40	0.50		
Capital Replacement	Fair - Good	C10 Interior Construction	Interior Windows & Storefronts	7.00	Each	2,500.00	17,500.00	8	10.00	13%	1.05	1.31		
Capital Replacement	Fair - Good	C10 Interior Construction	Steel, Painted, Interior Door	74.00	Each	857.53	63,457.15	8	10.00	48%	3.81	4.76		
Capital Replacement	Fair - Good	C10 Interior Construction	Steel, Painted, w/ Safety Glass, Interior Door	5.00	Each	1,195.66	5,978.30	8	10.00	4%	0.36	0.45

Built-up Roof :- (null)

A. SUBSTRUCTURE															
A. SUBSTRUCTURE SUB-TOTALS									\$0	\$0	\$0	\$0	\$0	\$0	\$0
B. SHELL															
B30	ROOFING														
B3011	Replace Built-up Roof	Poor	30	0	19,584.00	Sq Ft	\$10.46	Capital Replacement	\$204,751						\$204,751

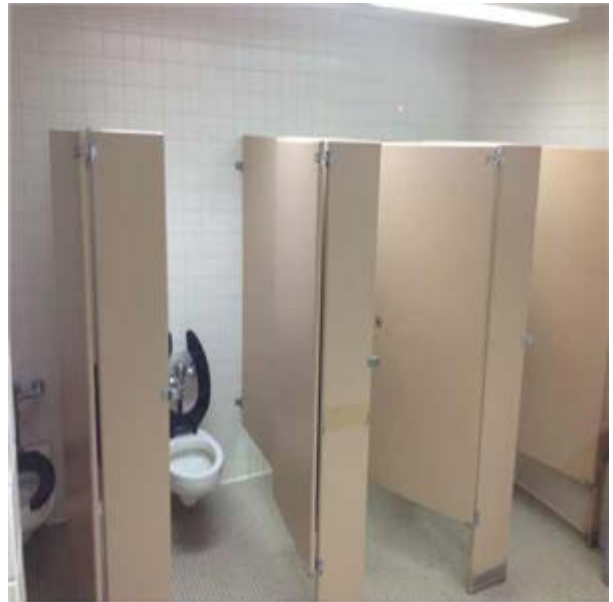
Site Built Toilet Partitions :- metal toilet partitions

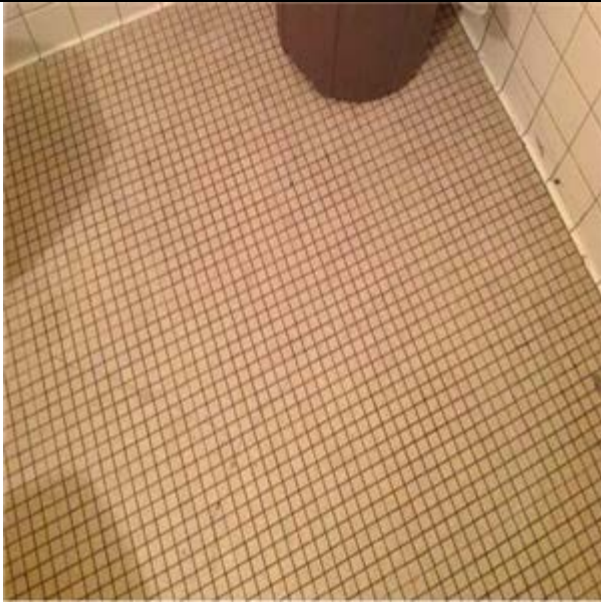
Ceramic Tile Flooring :- bathroom flooring

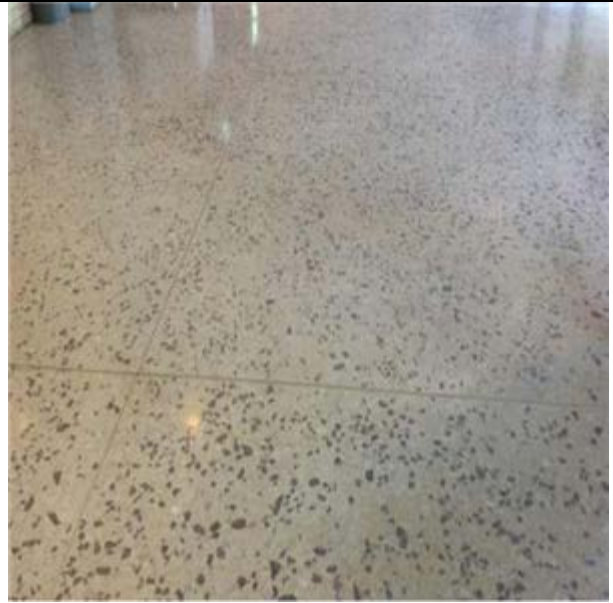
Terrazzo Flooring:- lobby floor

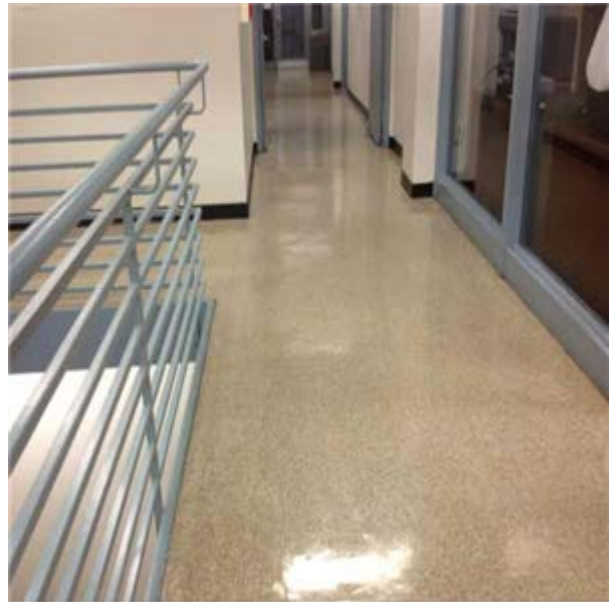
Vinyl Tile Flooring:- 2nd floor vct

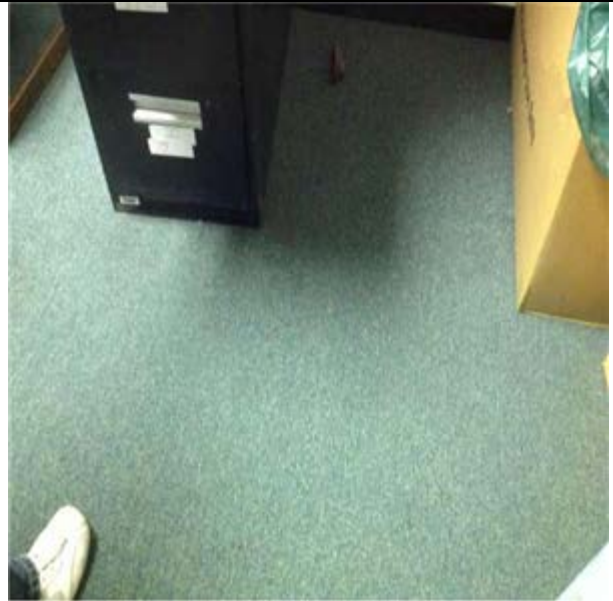
Carpet, Nylon, High Traffic, 20 oz:- cut pile carpeting

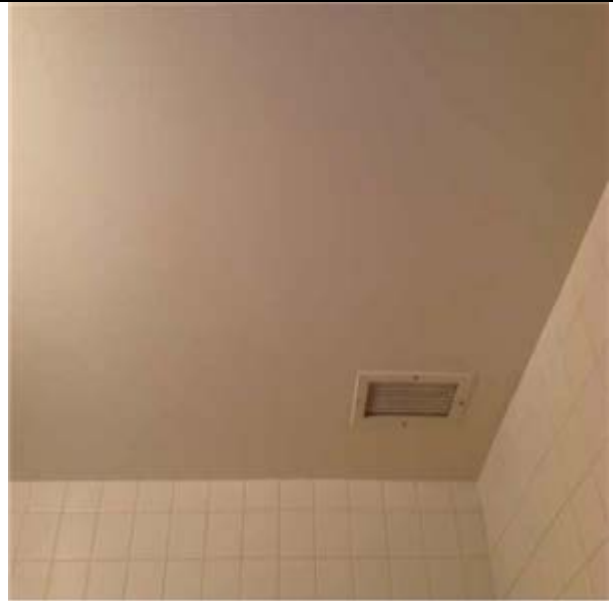
Plaster Ceiling:- plaster ceiling

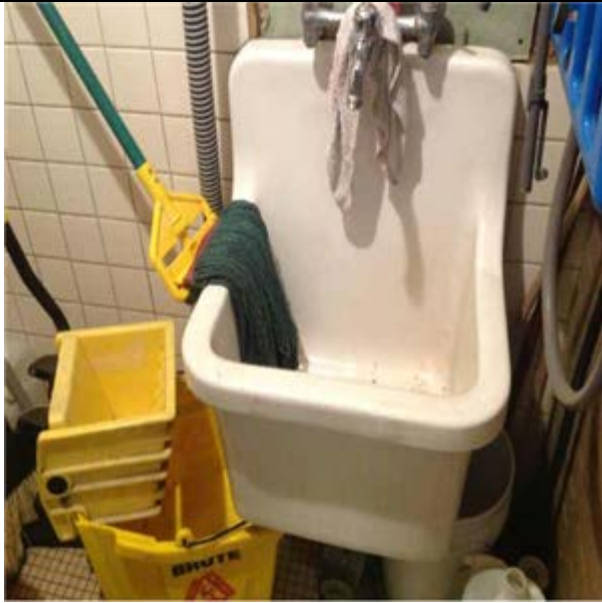
Service Sink, Iron, Enamel :- mop sink

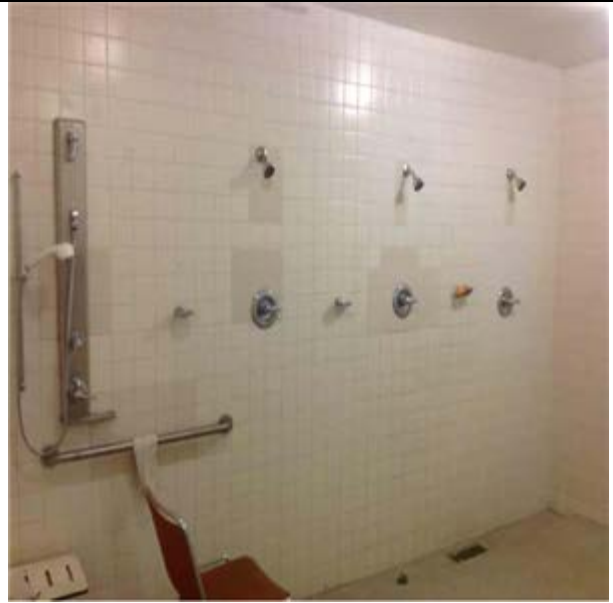
Shower, Ceramic Tile:- locker rooms

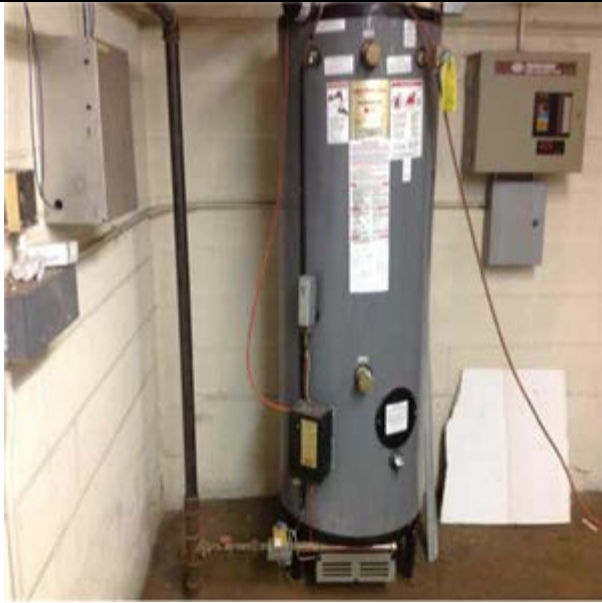
Domestic Hot Water Heater - Gas :- (null)

Capital Replacement	Fair - Good	D20 Plumbing	Domestic Hot Water Heater - Gas	1.00	Each	3,000.00	3,000.00	8	10.00	4%	0.33	0.41		
Capital Replacement	Fair - Good	D20 Plumbing	Shower, Ceramic Tile	11.00	Each	1,398.32	15,381.51	8	10.00	21%	1.69	2.11		
Capital Replacement	Good	D20 Plumbing	Lavatories	19.00	Each	468.21	8,895.95	10	10.00	12%	1.22	1.22		
Capital Replacement	Fair - Good	D20 Plumbing	Service Sink, Iron, Enamel	5.00	Each	1,012.39	5,061.93	8	10.00	7%	0.56	0.69		
Capital Replacement	Fair - Good	D20 Plumbing	Urinal, Vitreous China	13.00	Each	888.54	11,551.05	8	10.00	16%	1.27	1.59		
Capital Replacement	Fair - Good	D20 Plumbing	Drinking Fountain, Refrigerated	10.00	Each	988.98	9,889.83	8	10.00	14%	1.09	1.36		
							72,865.04	68			8.69	10.00	13%	Good
D30 HVAC														
Capital Replacement	Fair	D30 HVAC	Circulation Pump, Hot Water, 15.000 HP	1.00	Each	4,719.92	4,719.92	6	10.00	1%	0.06	0.10		
Capital Replacement	Fair	D30 HVAC	Circulation Pump, Hot Water, 7.500 HP	1.00	Each	4,473.70	4,473.70	6	10.00	1%	0.05	0.09

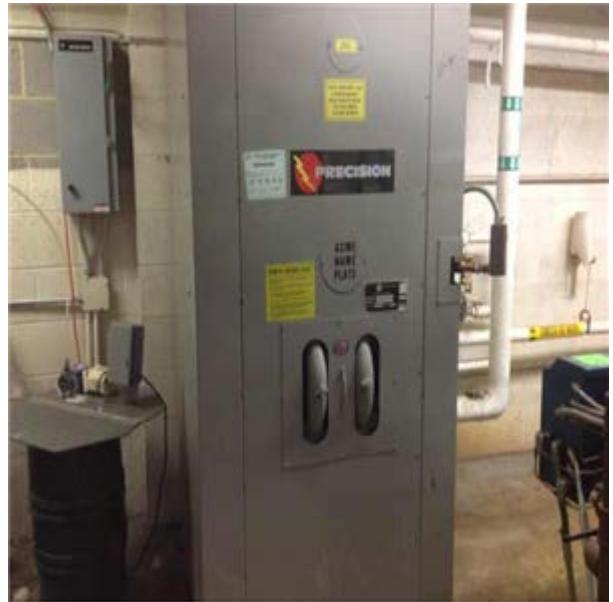
Boiler, Gas, 1,000 Mbh:- 3rd boiler

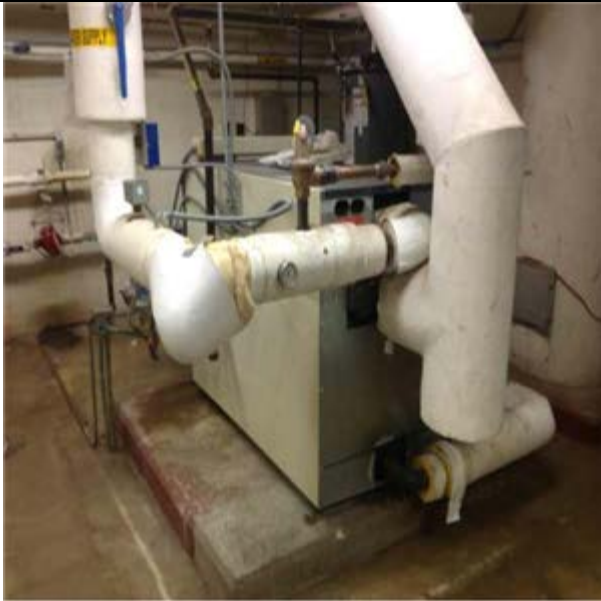
Boiler, Gas, 1,000 Mbh :- one of two boilers

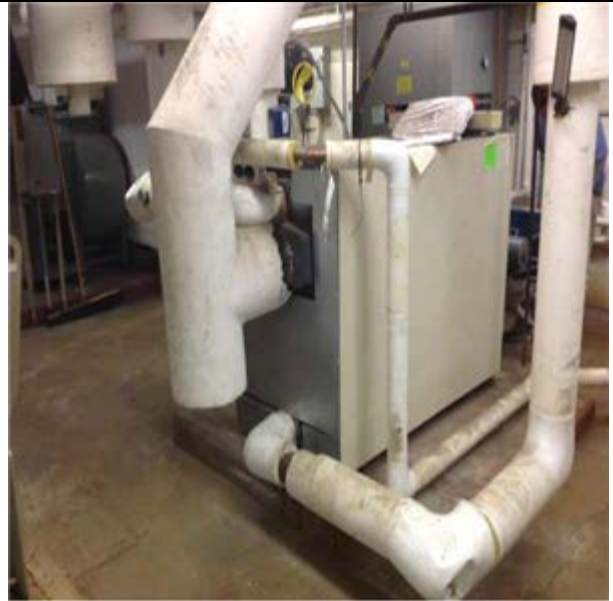
Boiler, Gas, 1,000 Mbh:- one of two boilers

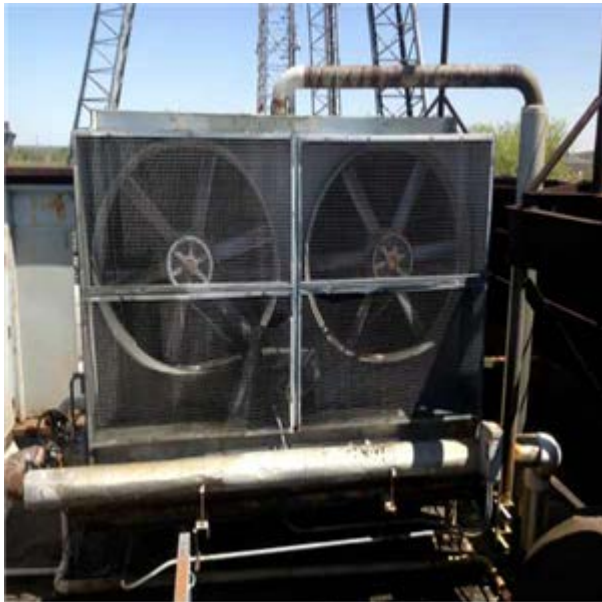
Cooling Tower, 50 Ton :- chiller on rooftop

Capital Replacement	Poor	D30 HVAC	Cooling Tower, 50 Ton	1.00	Each	100,000.00	100,000.00	2	10.00	20%	0.40	2.02

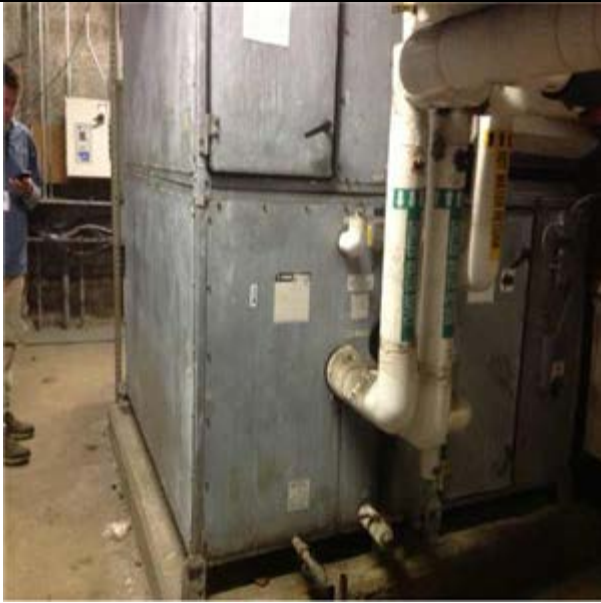
Air Handler, Multizone, 20,000 Cfm :- ahu-1

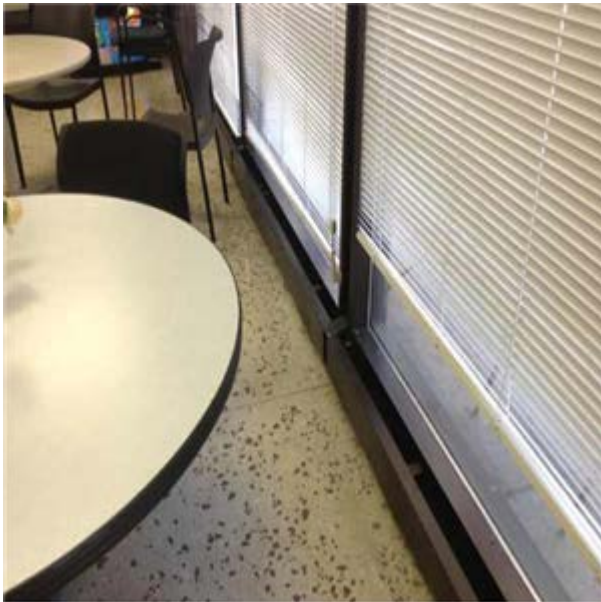
Radiator, Finned, Wall :- baseboard hot water fin tube radiators

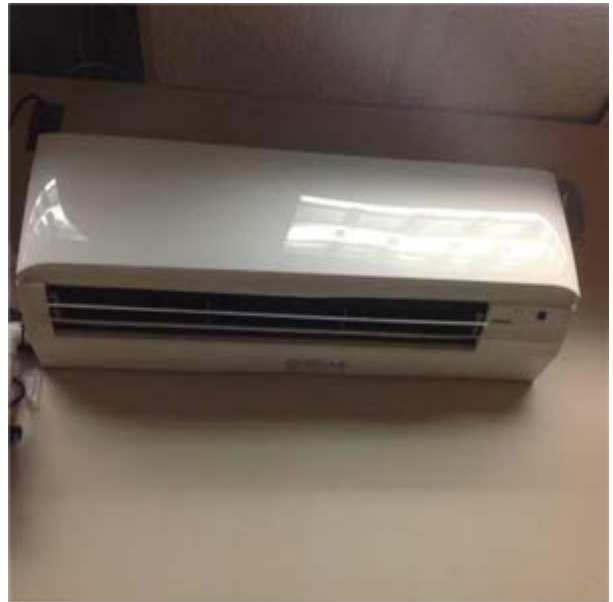
Indoor Unit Only - Cooling, Heating Coils and Circulation Fan:- mini split indoor unit

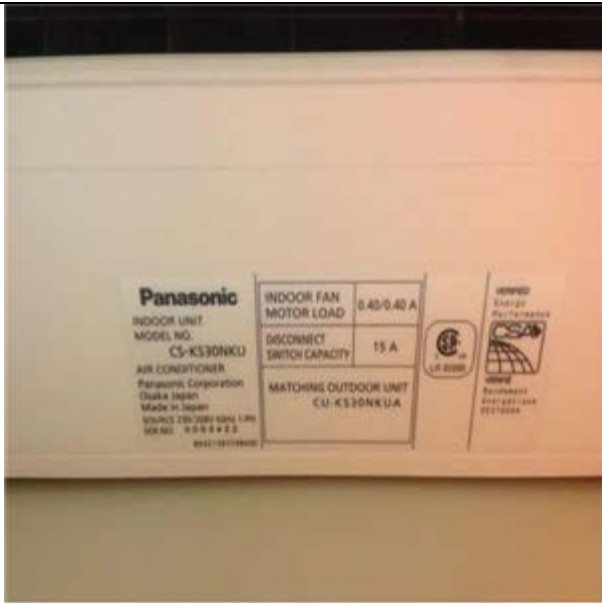
Indoor Unit Only - Cooling, Heating Coils and Circulation Fan :- mini split indoor unit

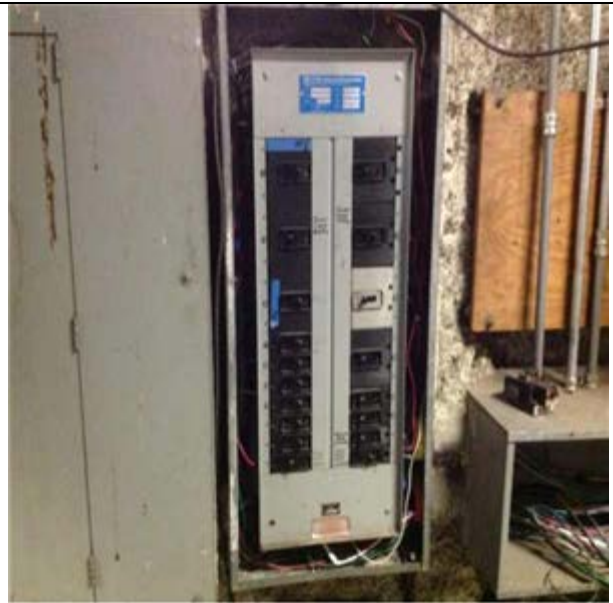
Power Panel Board, 208 Y, 120 V, 125 Amp:- in penthouse

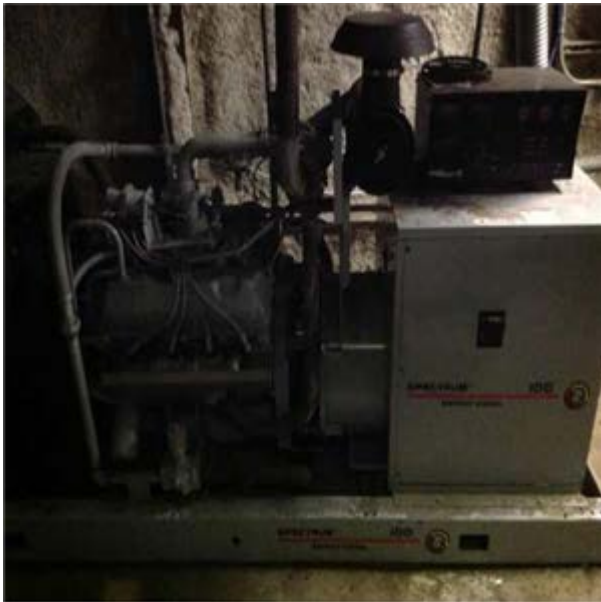
Generator, natural gas, 125 kW :- Generator,
natural gas, 125 kW

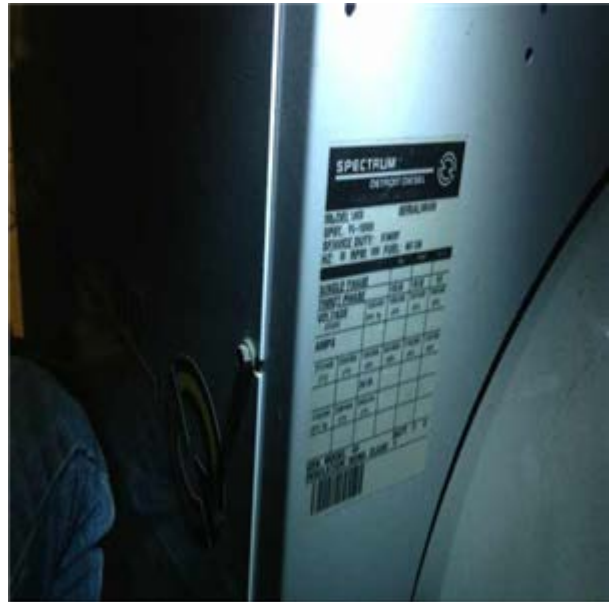
Generator, natural gas, 125 kW:- (null)

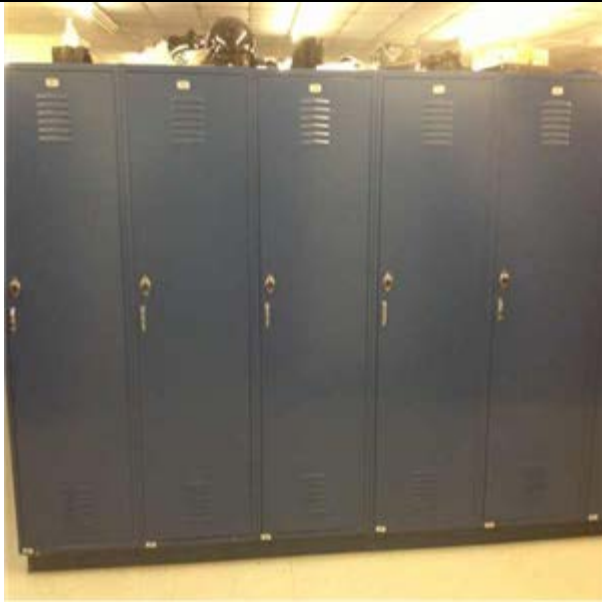
Lockers :- (null)

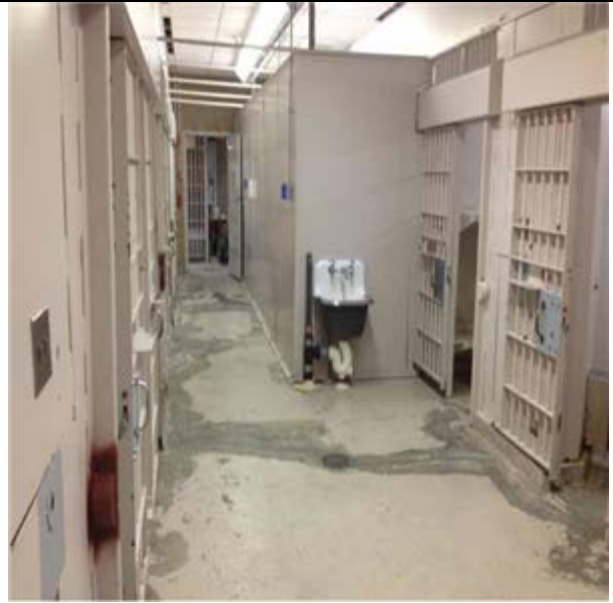
Detention Doors & Hardware:- (null)

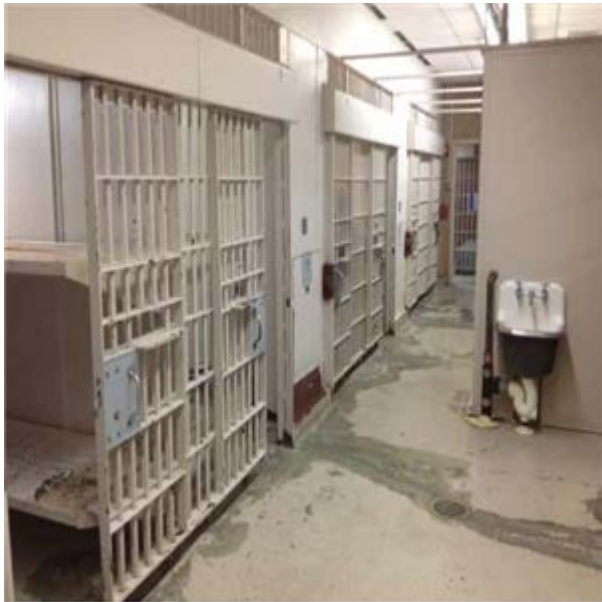
Detention Doors & Hardware :- (null)
