**Property Condition Report**

**5th District Headquarters  
1805 Bladensburg Rd  
Washington, DC**

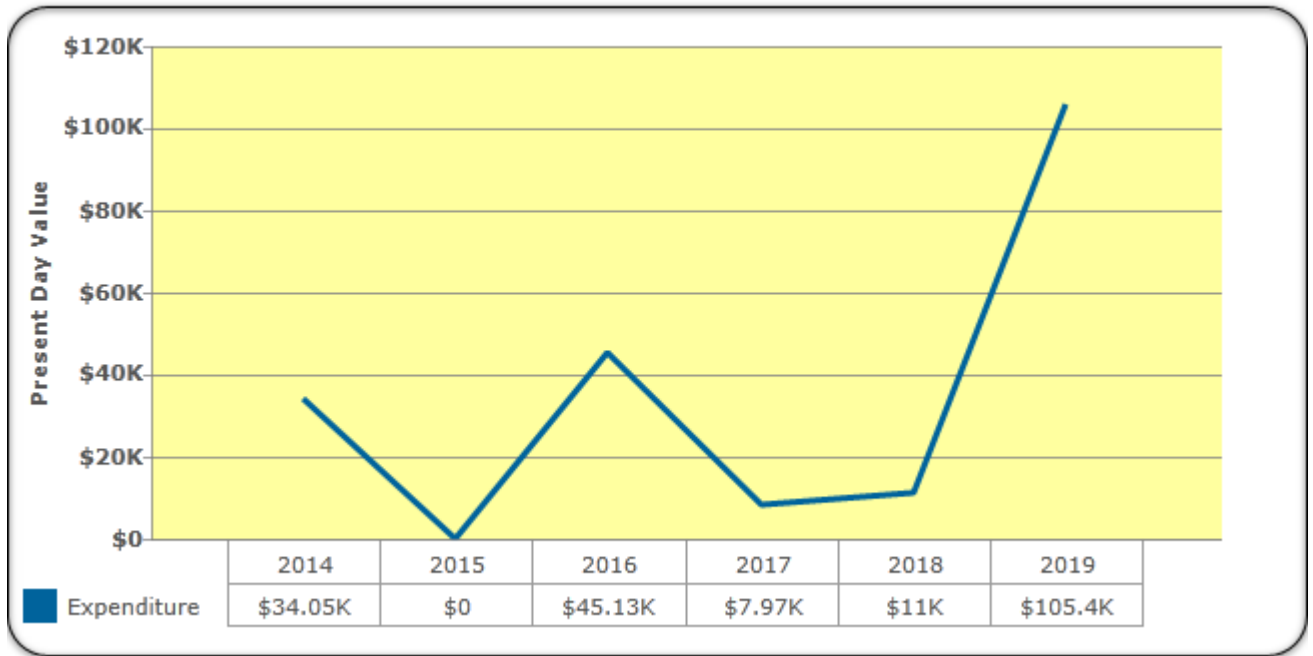
## 1.7 FACILITY CONDITION INDEX

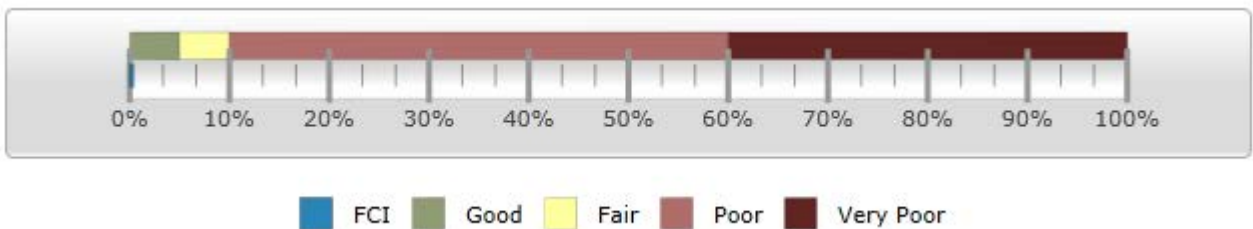
**5th District Headquarters**  
**Current Year FCI = 0.37%**

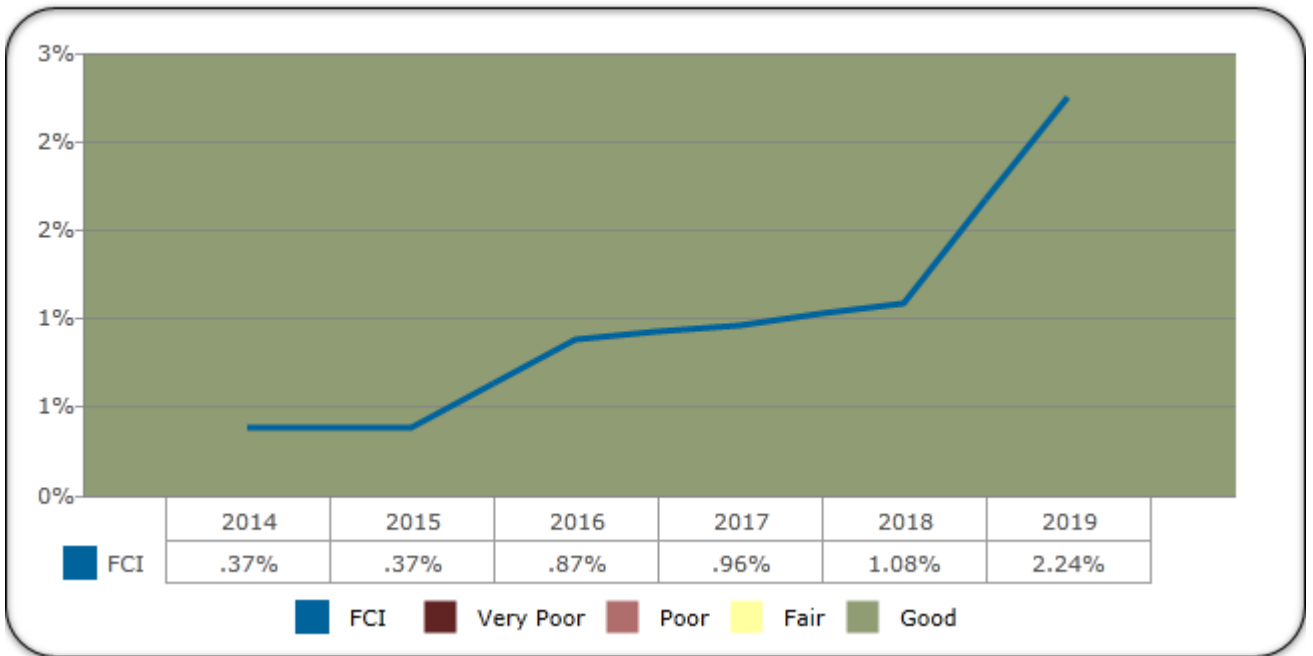
**1.8 PLANNING HORIZON CATEGORY NEEDS: CURRENT YEAR TO YEAR 6**

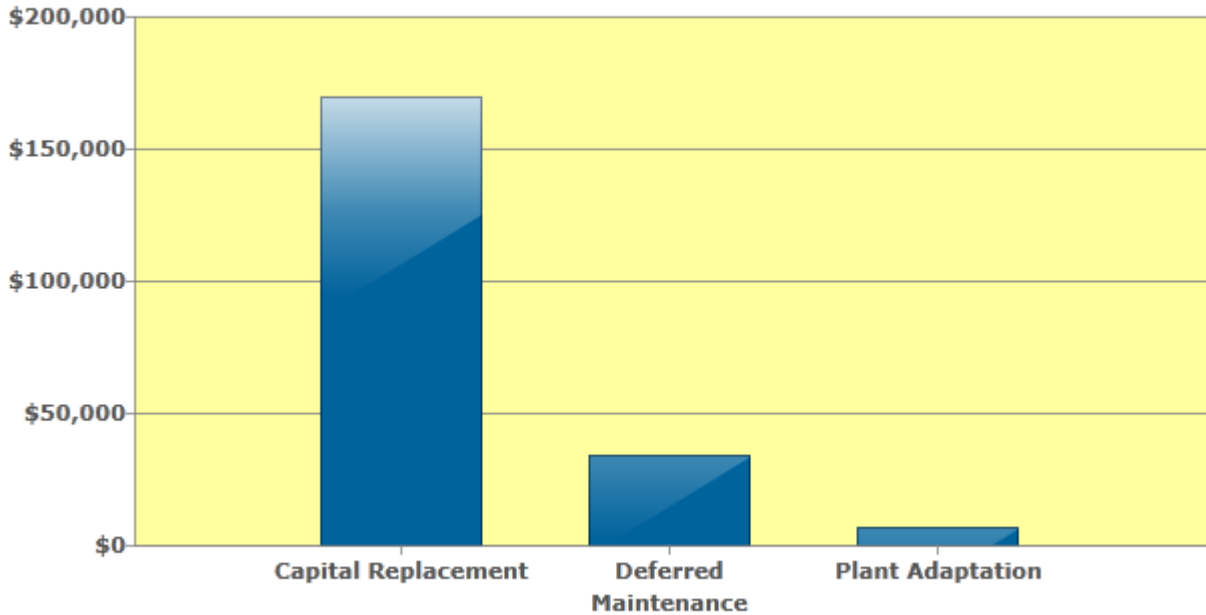
Plan Types	Total Cost
Deferred Maintenance	\$34,051
Plant Adaptation	\$6,205
Capital Replacement	\$169,501
<b>Total</b>	<b>\$209,757</b>

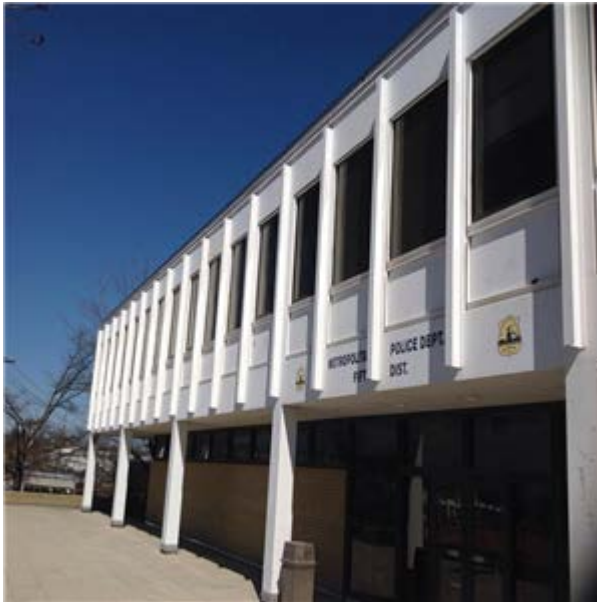
Exterior Wall Steel Panel Finishes

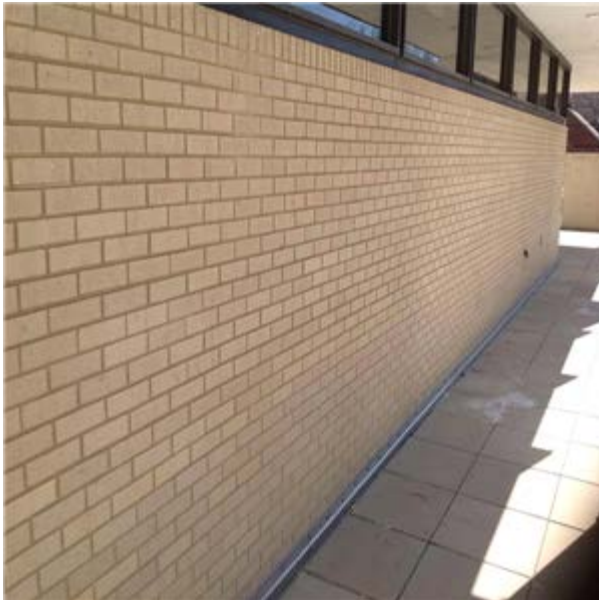
Exterior Wall First Floor Brick Veneer

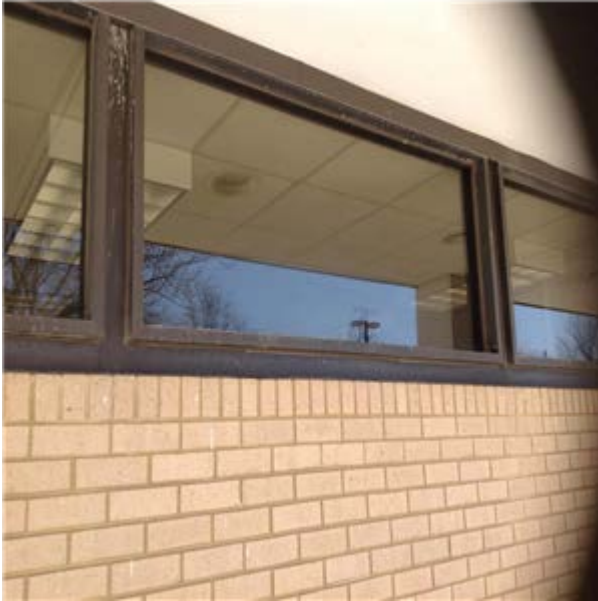
First Floor Aluminum Fixed Pane Window

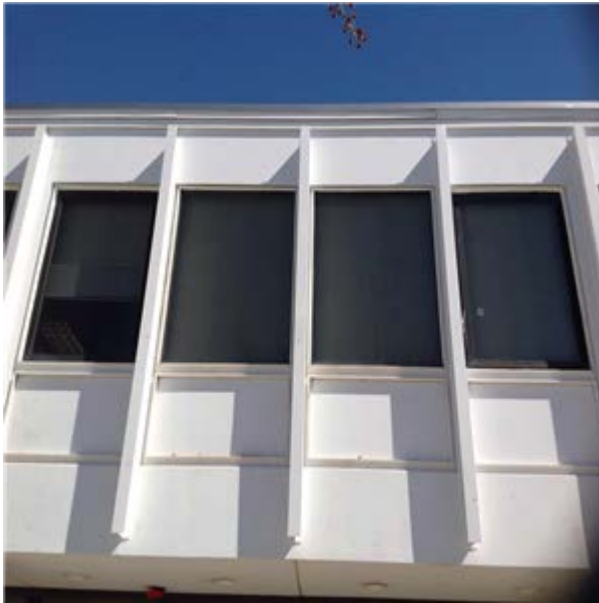
Operable Aluminum Windows

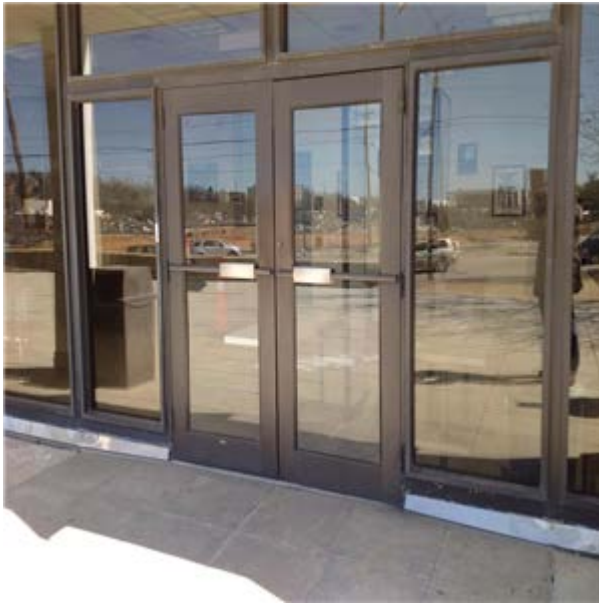
AluminumStorefront Entry Door

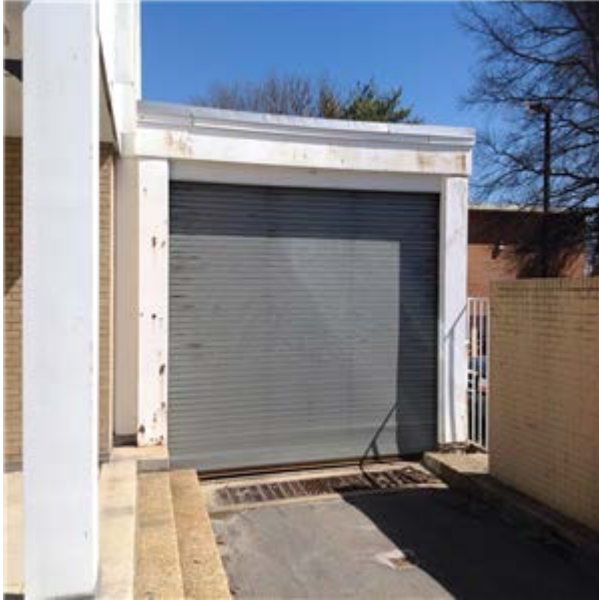
Aluminum Roll-Up Door

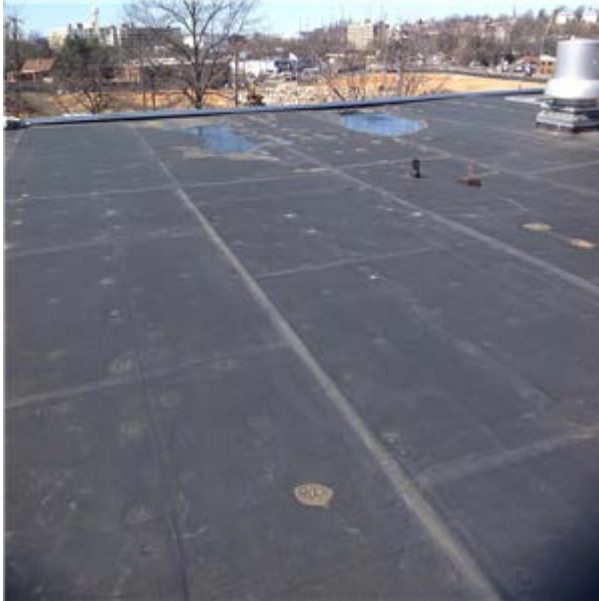
Main Roof EPDM Membrane

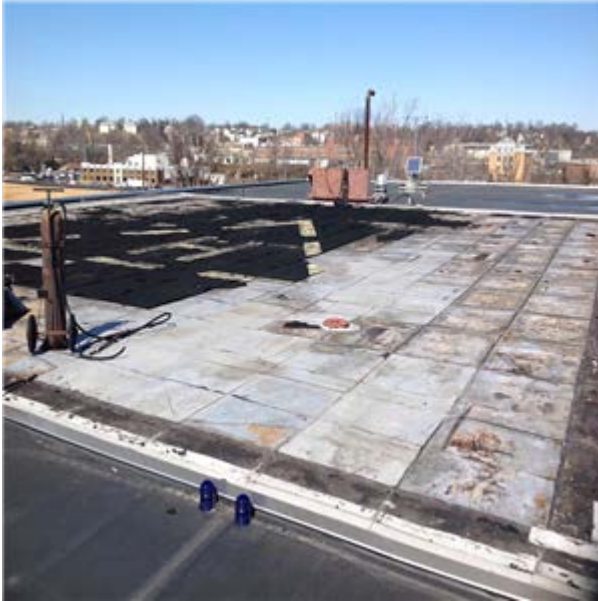
Main Roof Modified Bitumen Membrane

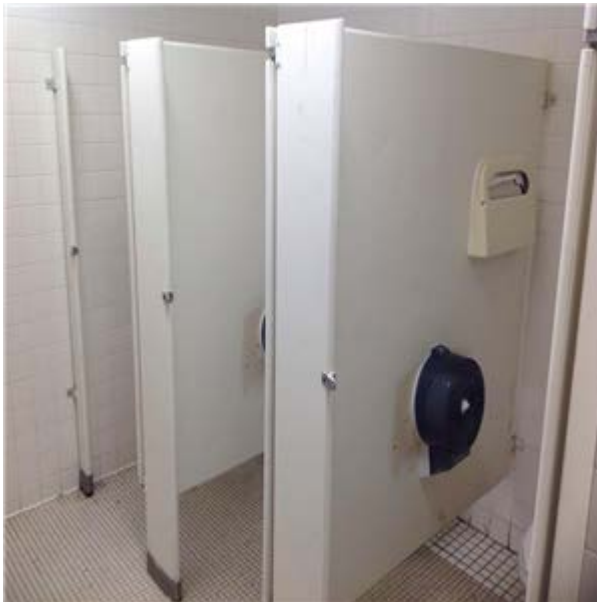
Locker Room Metal Toilet Partitions

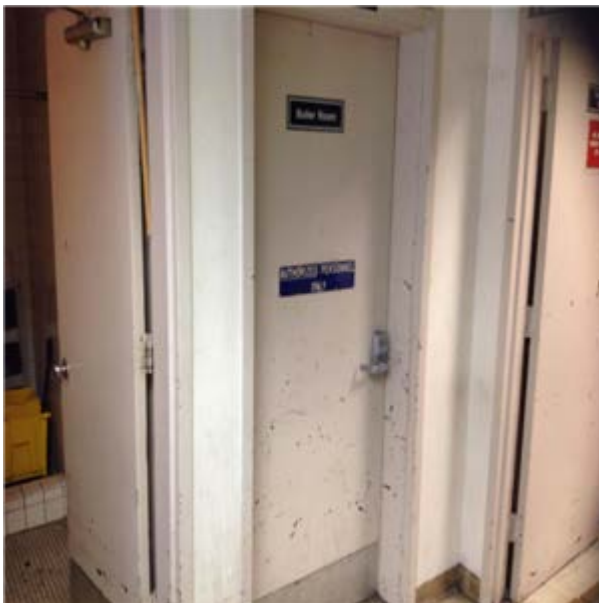
Interior Door, Single, Steel

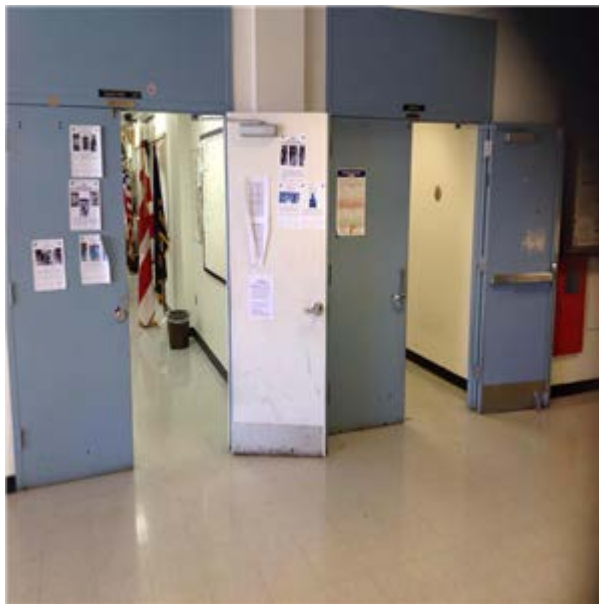
Interior Door, Double, Steel

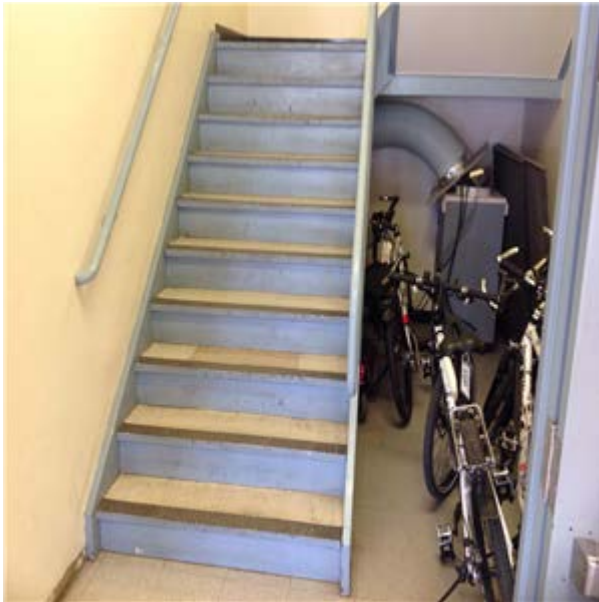
Steel Framed Interior Stair

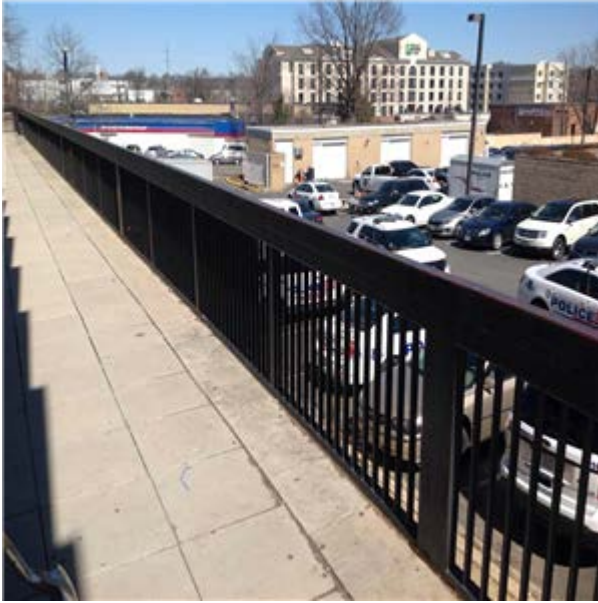
Steel Railing At Rear Patio Area

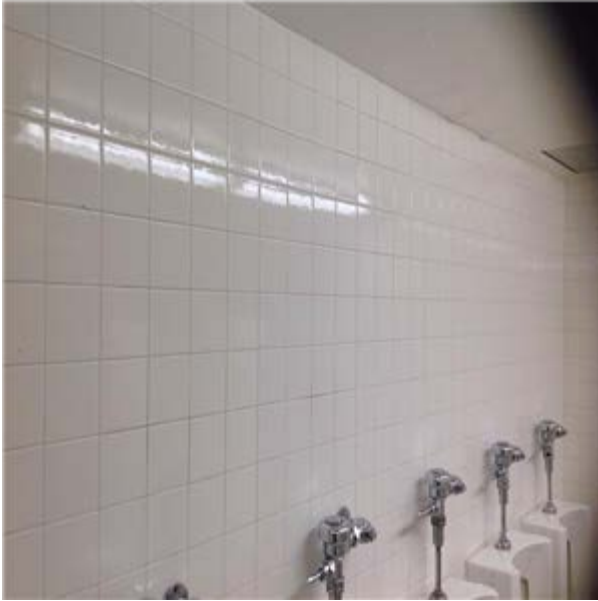
Locker Room Ceramic Tile Wall Finish

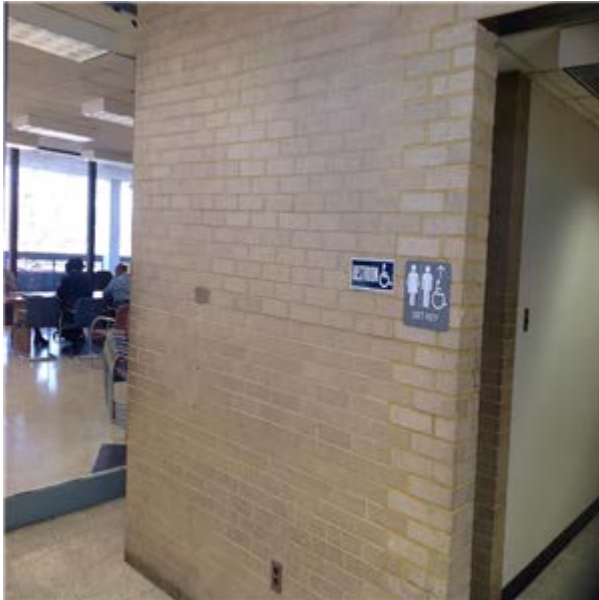
Interior Wall Brick Finish

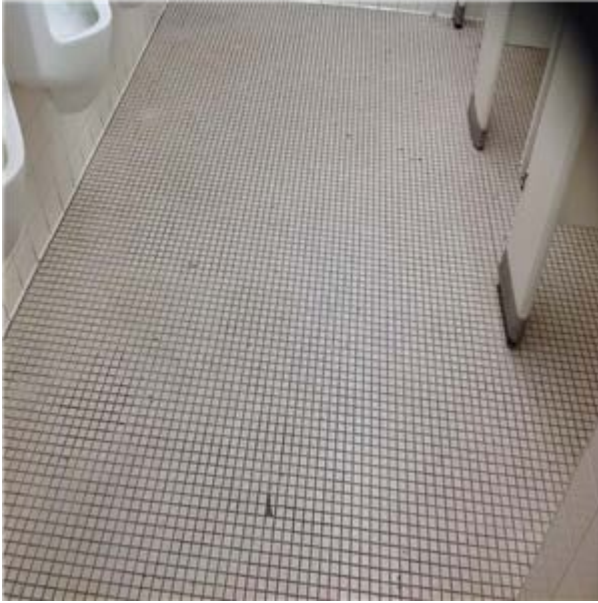
Ceramic Tile Flooring

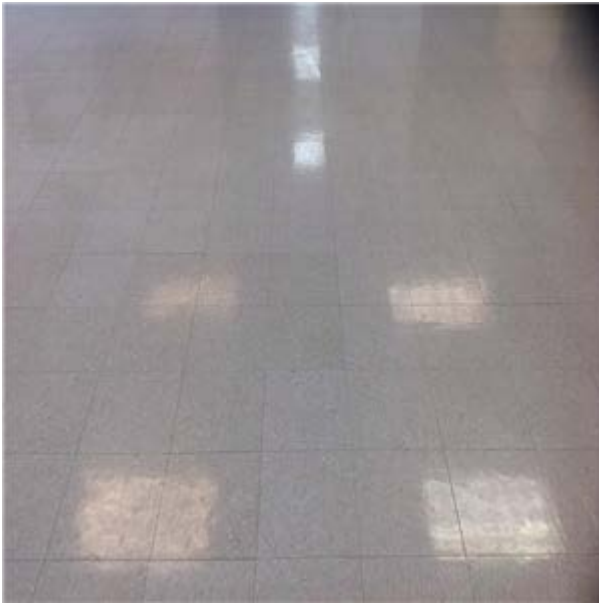
Item	Description
C3024 Flooring	Vinyl Tile Flooring
Condition	Fair
RUL	6
Plan Type	Capital Replacement
Quantity	14000
Unit of Measure	Sq Ft
Unit Cost	\$3.04

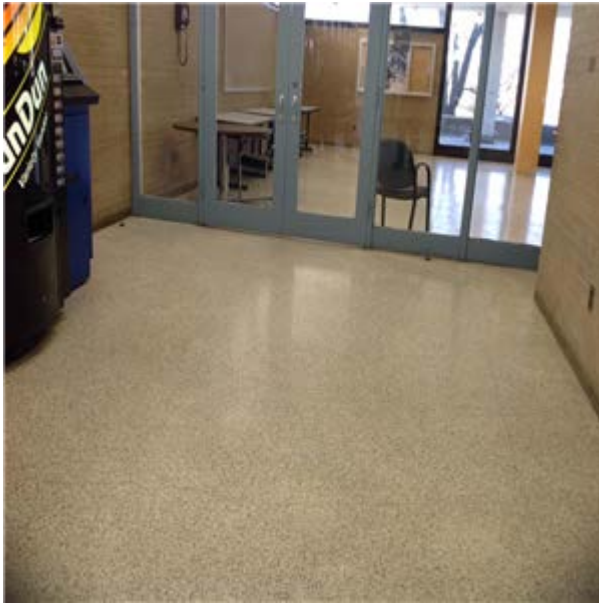
Item	Description
C3024 Flooring	Terrazzo Flooring
Condition	Fair - Good
RUL	30
Plan Type	Capital Replacement
Quantity	28000
Unit of Measure	Sq Ft
Unit Cost	\$9.75

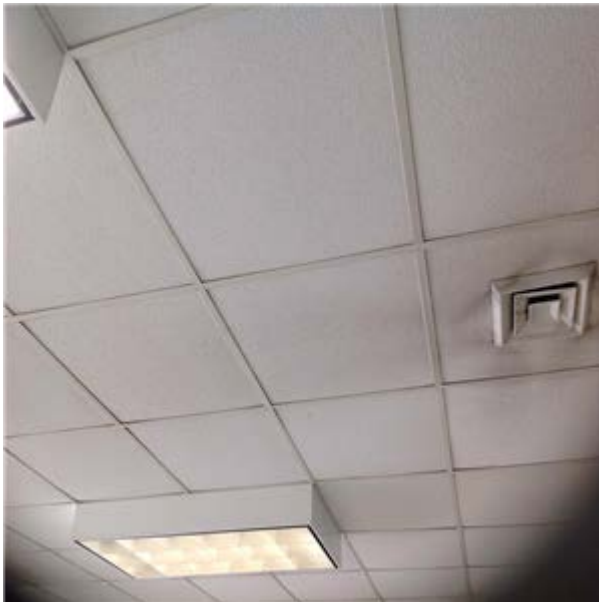
2' x 2 Acoustic Ceiling Tile

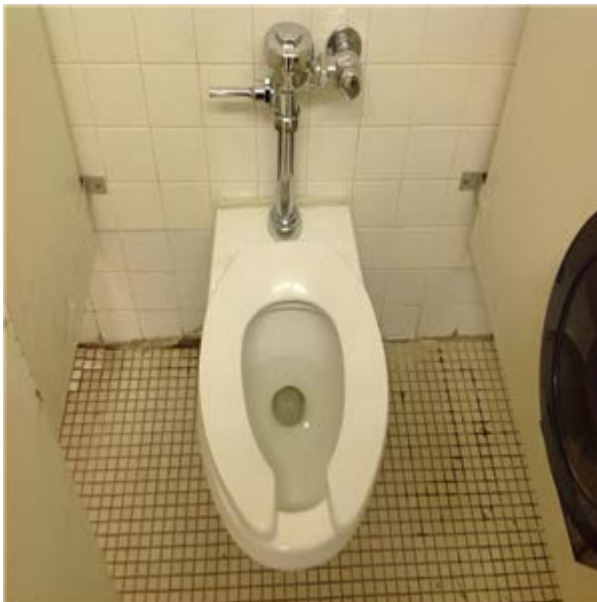
Locker Room Water Closet

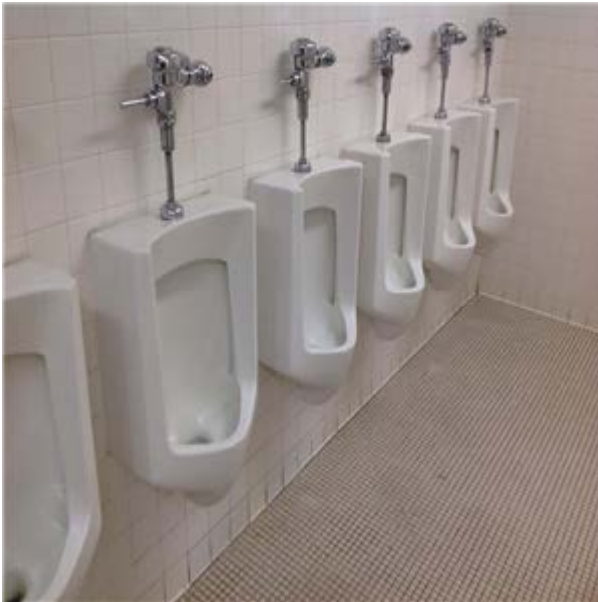
<b>Plan Type</b>	Capital Replacement
<b>Quantity</b>	18
<b>Unit of Measure</b>	EACH
<b>Unit Cost</b>	\$1,235

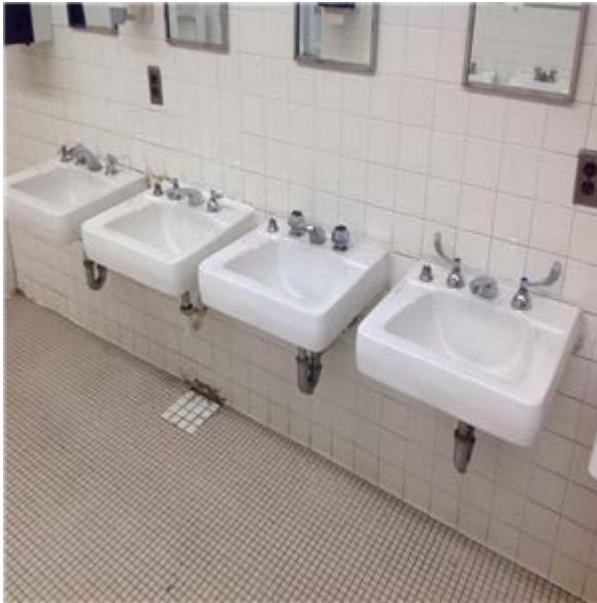
Wall Hung Lavatories

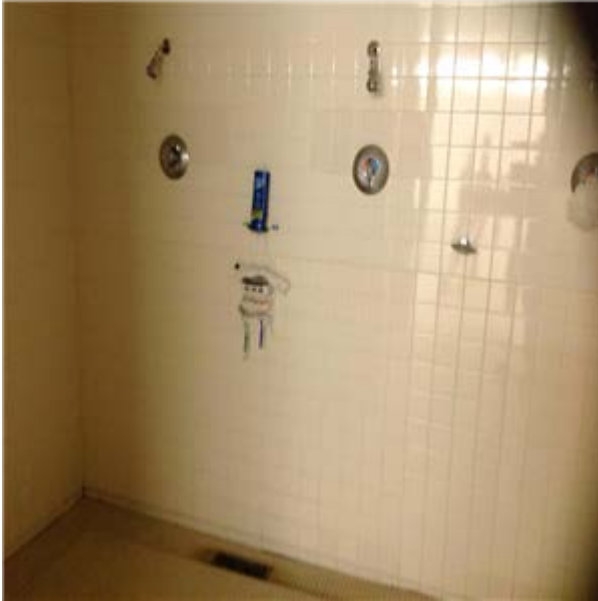
Communal Shower - Locker Room

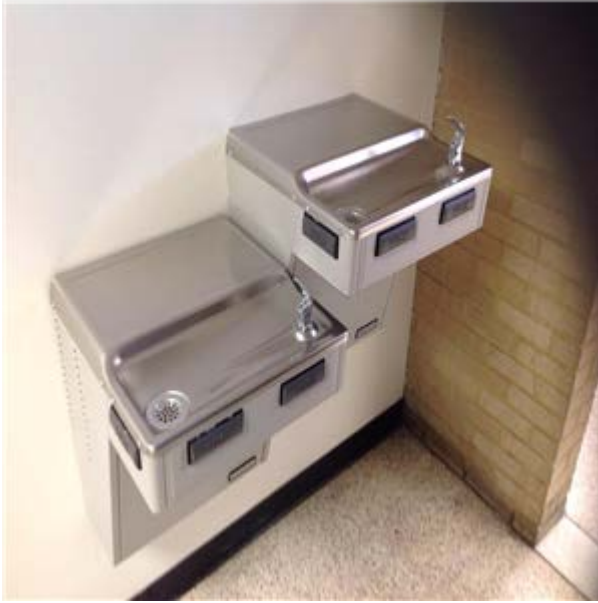
Wall Mounted Drinking Fountain

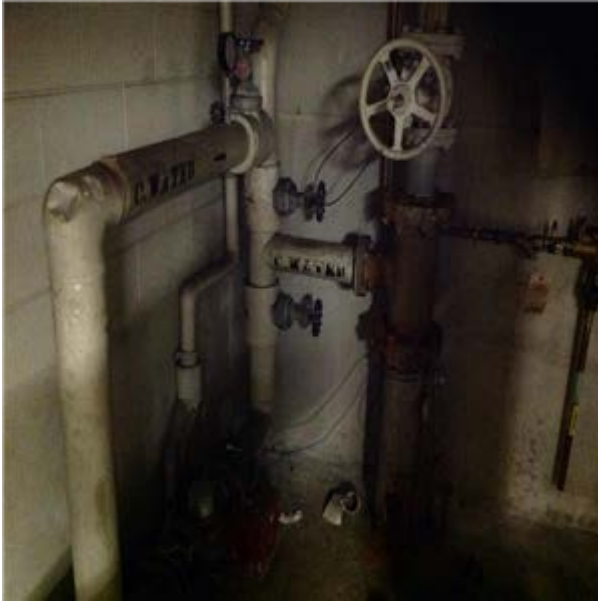
Item	Description
D2021 Cold Water Service	Domestic Water Main
Condition	Fair - Good
RUL	15
Plan Type	Capital Replacement
Quantity	1
Unit of Measure	EACH
Unit Cost	\$25,000

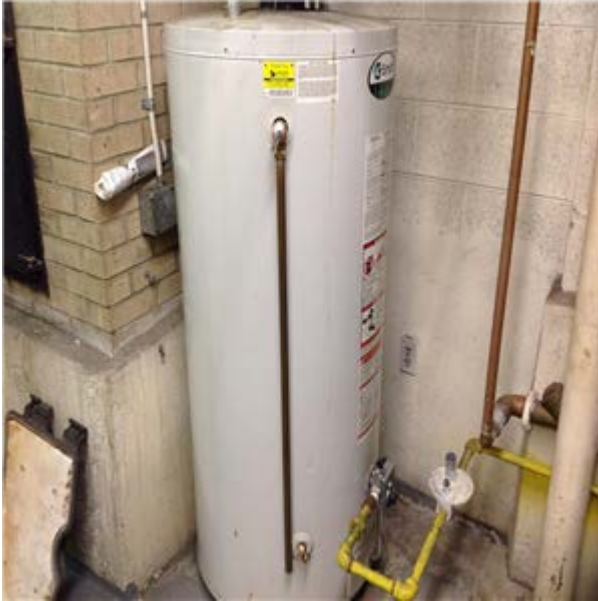
Domestic Water Heater

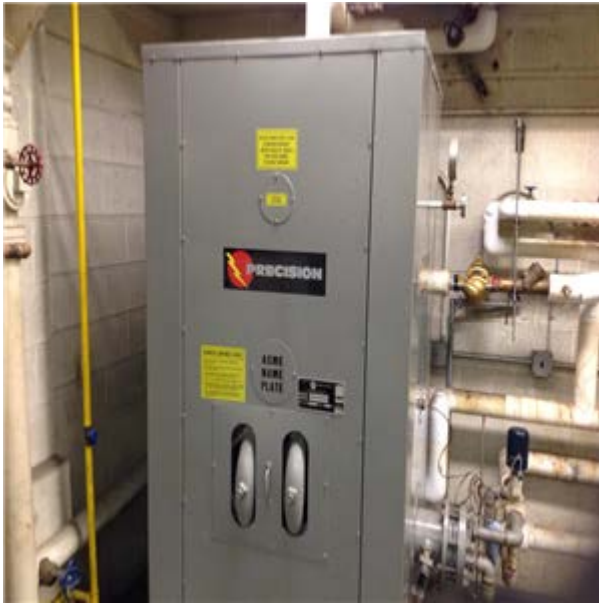
Domestic Hot Water Boiler

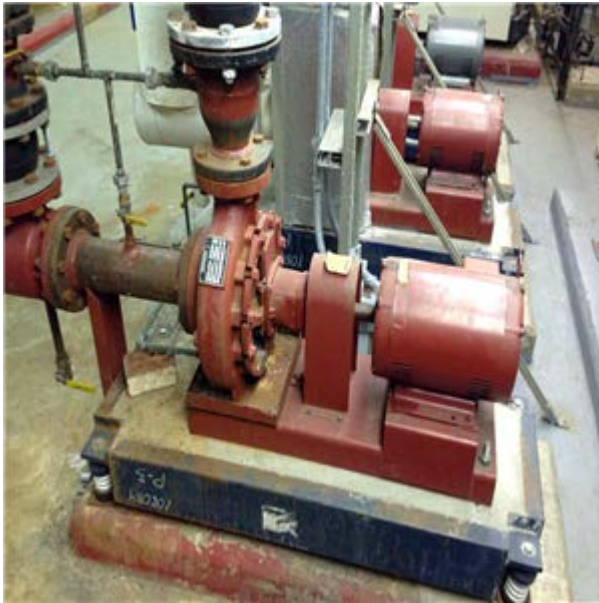
Domestic Hot Water Booster Pump

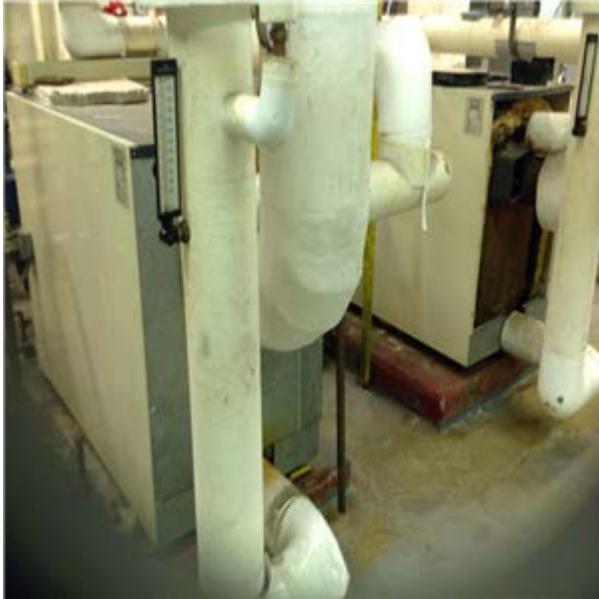
Duel Fuel Heating Boilers

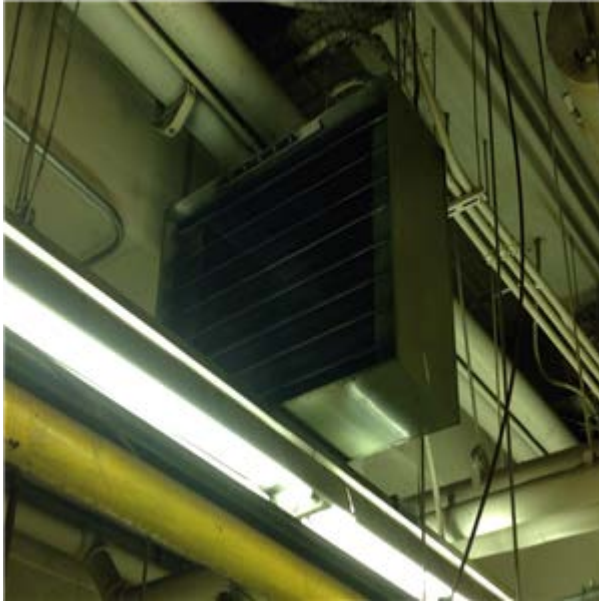
Boiler Room Unit Heater

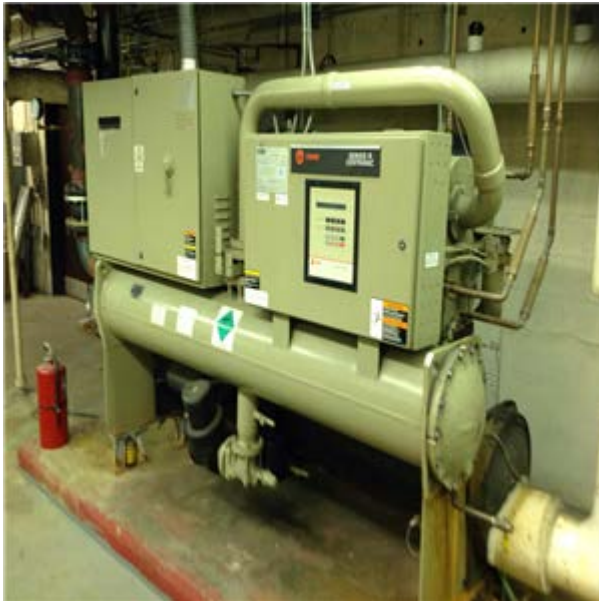
Trane Series R Centravac Chiller

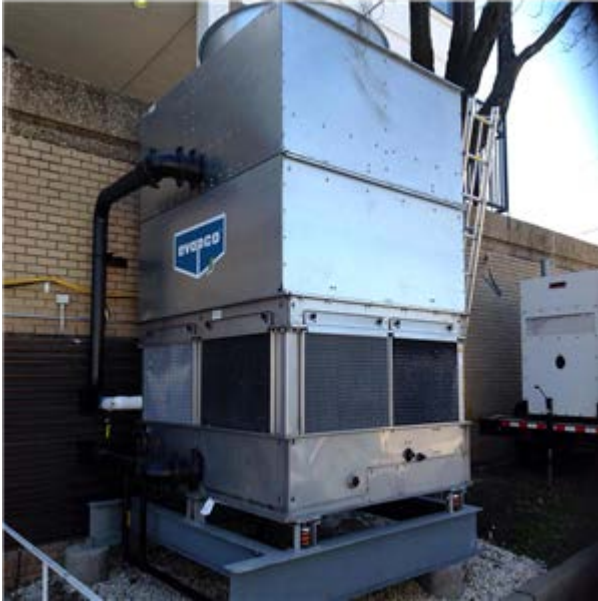
Evapco Cooling Tower

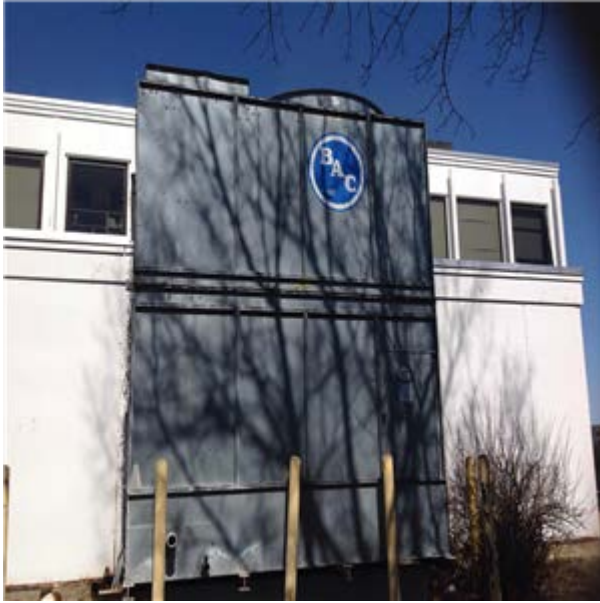
Pad Mounted BAC Cooling Tower

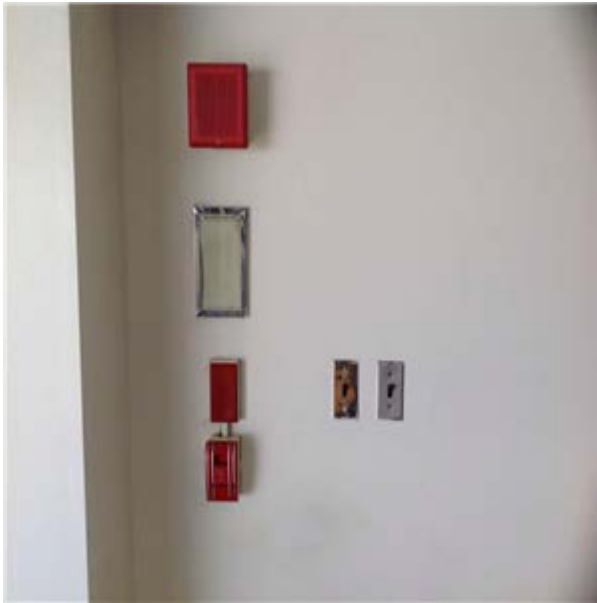
Central Fire Alarm System Components

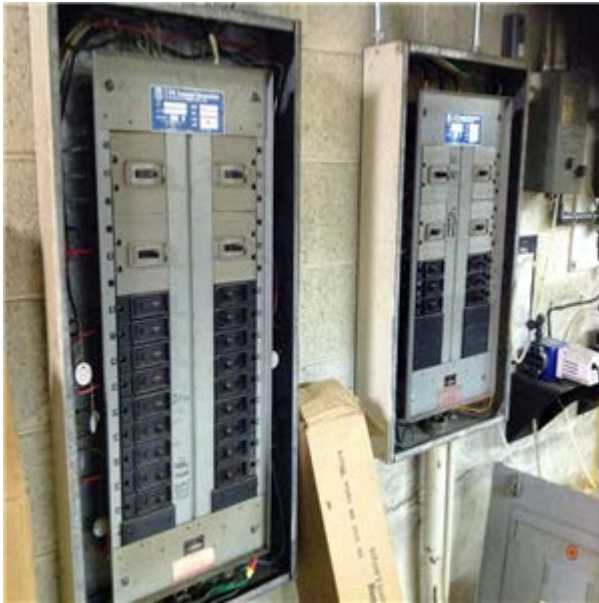
100 Amp Breaker Panels

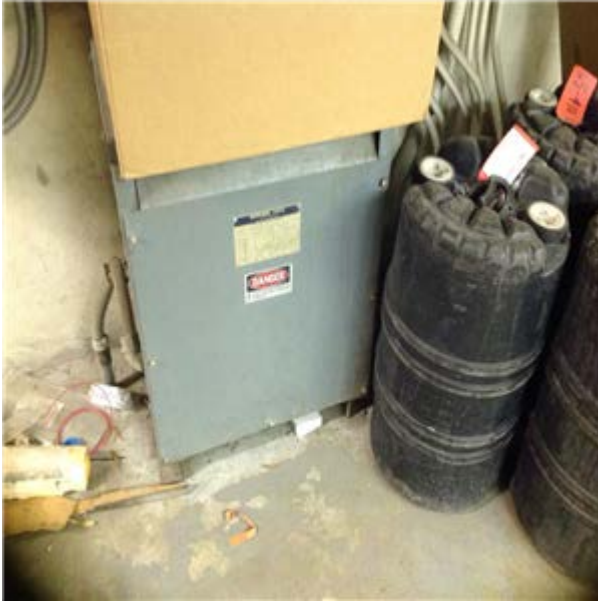
Secondary Transformer

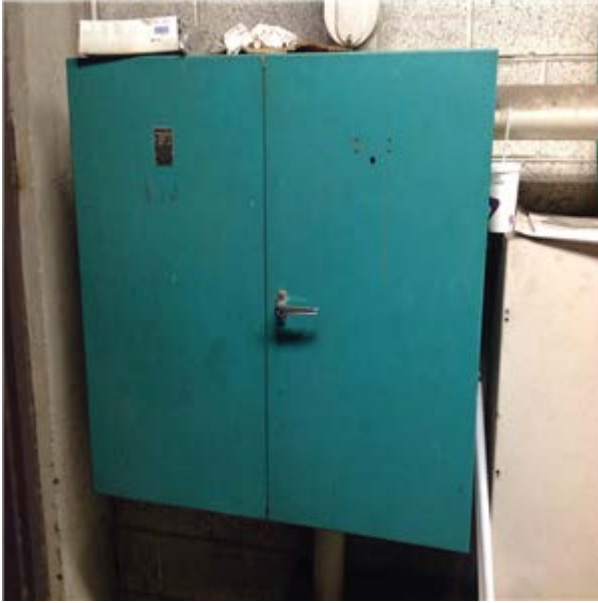
400 Amp Electric Disconnect

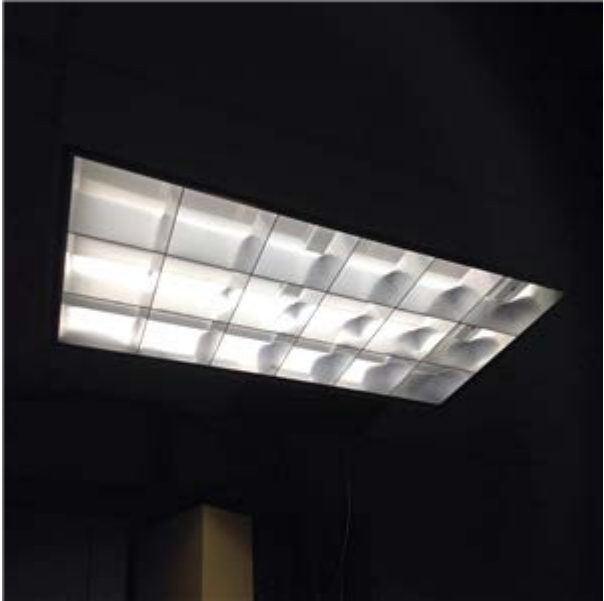
T8 Fluorescent Light Fixture

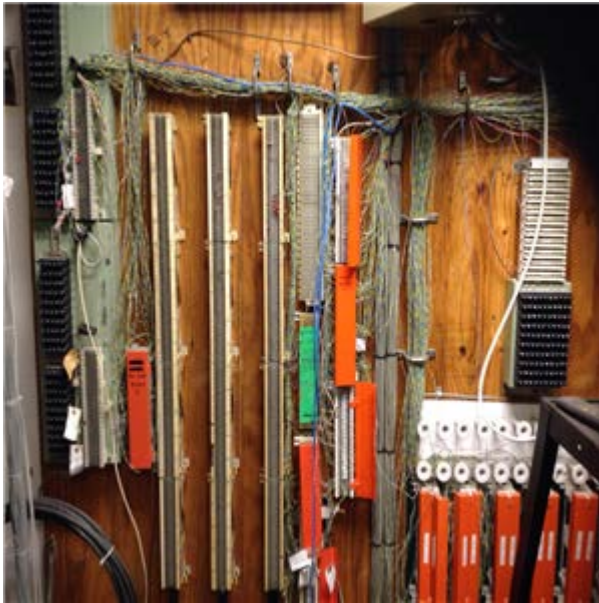
Telephone Distribution

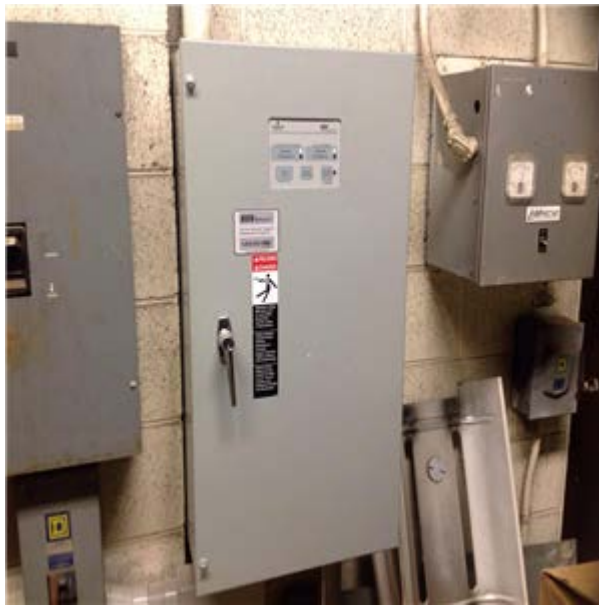
Generator Transfer Switch

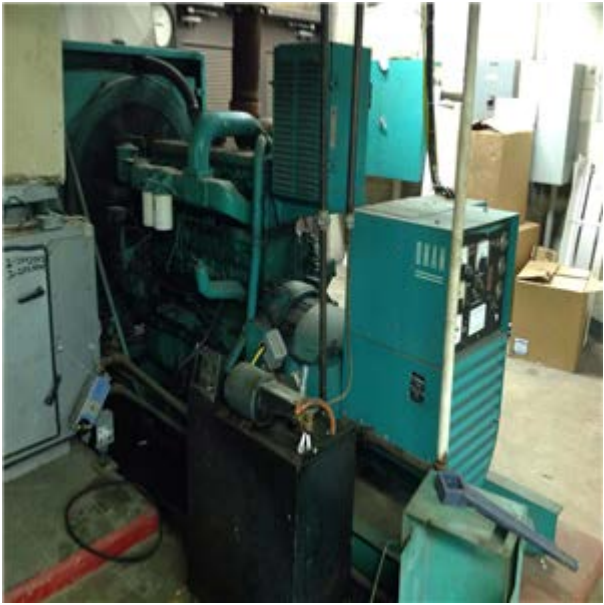
Item	Description
D5092 Emergency Light & Power Systems	Generator, Diesel, 125 kW
Condition	Fair - Good
RUL	15
Plan Type	Capital Replacement
Quantity	1
Unit of Measure	Each
Unit Cost	\$85,000
Make	Onan
Model	1750DYD15R/12880a

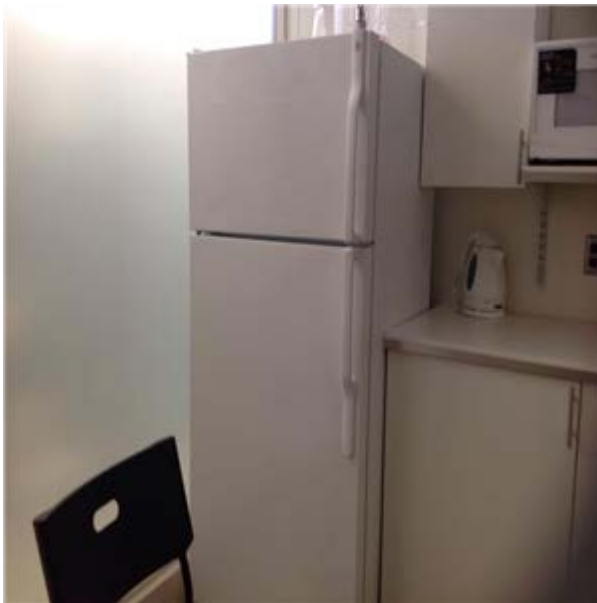
Break Room Refrigerator

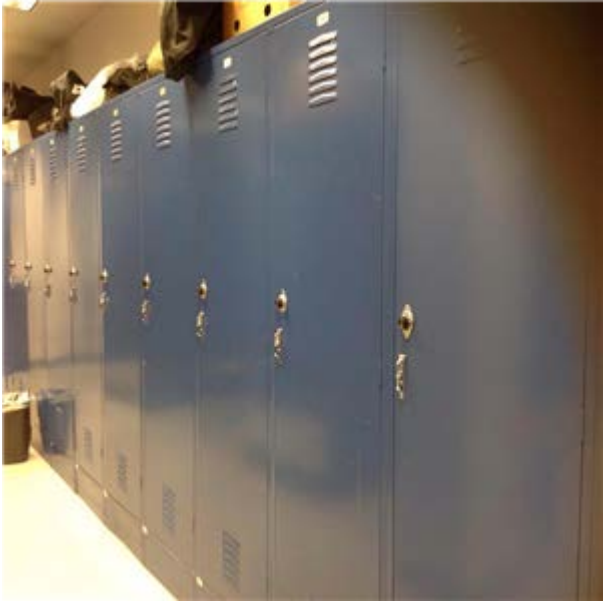
Metal Storage Lockers
