Property Conditions Report

**2nd District Headquarters  
3320 Idaho Ave NW  
Washington, DC**

**Comprehensive Facility Condition Assessment  
And Space Utilization Study  
DCAM-13-NC-0162**

**October 15, 2014**

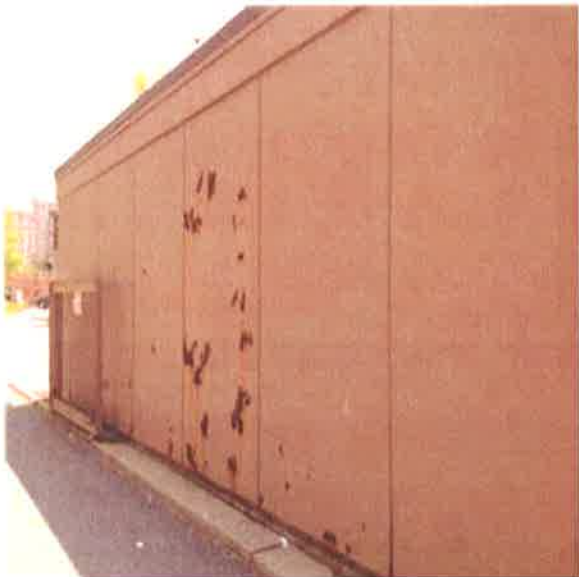
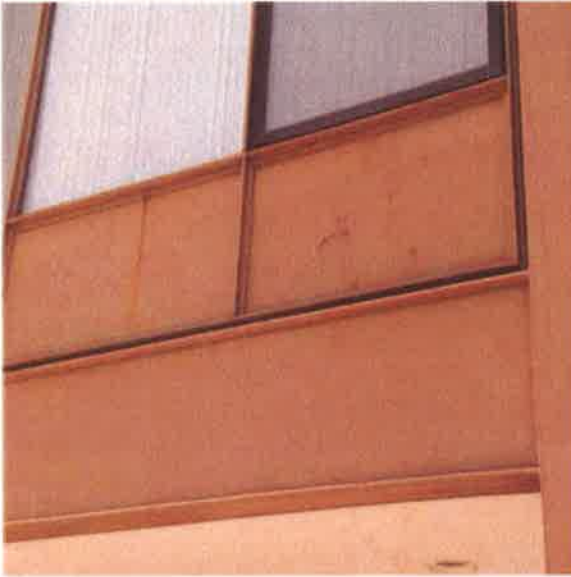
Item	Description
<b>B2011 Exterior Wall Construction</b>	Steel, Exterior, 2 Stories
<b>Condition</b>	Poor

Exterior Steel Paint Recommended; Surface Oxidation Observed Throughout

Typical Deteriorated Paint and Oxidation at Exterior Steel

Typical Deteriorated Paint and Oxidation at Exterior Sterl

Type	Component Description	Plan Type	Year	Expenditures (\$)
B2011	Replace Steel, Exterior, 2 Stories	Deferred Maintenance	2014	\$15,300

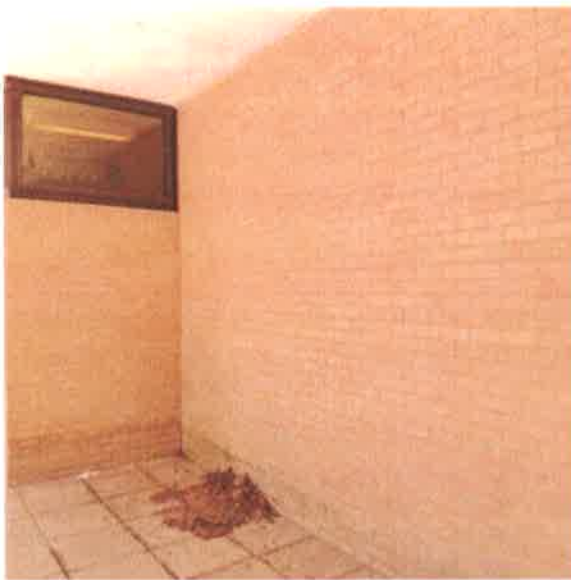
Item	Description
B2011 Exterior Wall Construction	Brick Veneer, Exterior, 1 Story
Condition	Fair - Good
RUL	30
Plan Type	Capital Replacement
Quantity	3195
Unit of Measure	Sq Ft
Unit Cost	\$30.93

Brick Veneer Along 1st Floor

First Floor Exterior Brick Veneer

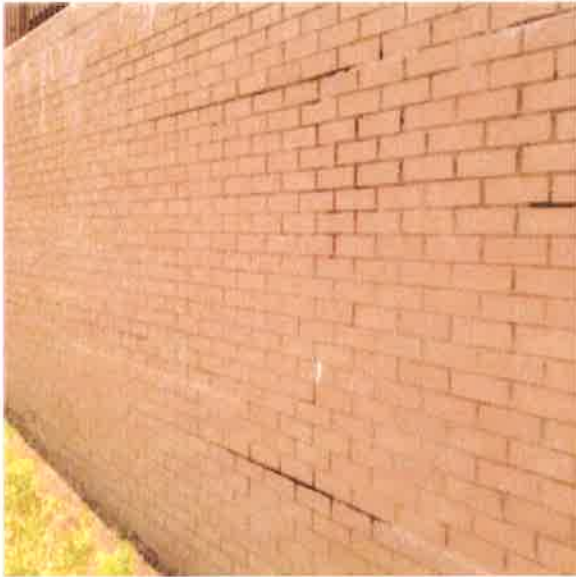
Item	Description
B2011 Exterior Wall Construction	Brick Veneer, Exterior, 1 Story
Condition	Poor
RUL	0
Plan Type	Deferred Maintenance

Brick Pointing Recommended; Cracking And Mortar Joint Deterioration Observed

Typical Exterior Brick Mortar Deterioration

Type	Component Description	Plan Type	Year	Expenditures (\$)
B2011	Replace Brick Veneer, Exterior, 1 Story	Deferred Maintenance	2014	\$7,988

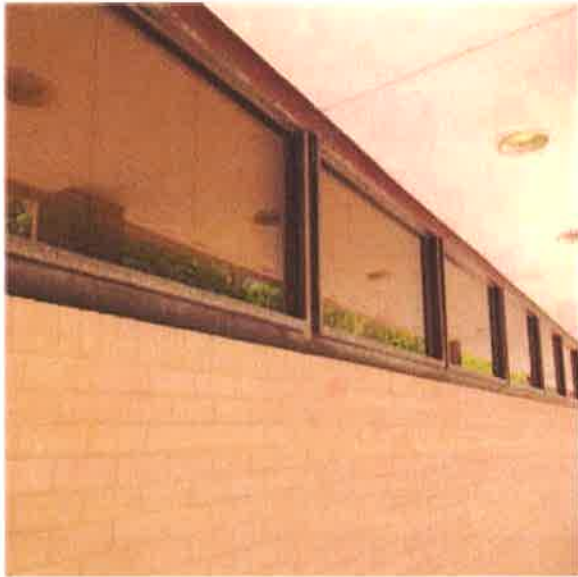
Item	Description
B2021 Windows	Alum Fixed Thermal Break, Double Glazing, 1 Story, 12SF
Condition	Fair - Good
RUL	20
Plan Type	Capital Replacement

First Floor Aluminum Framed Windows

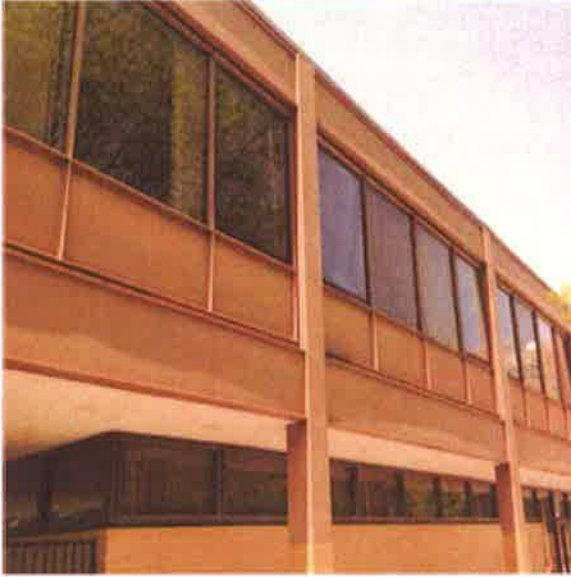
Item	Description
B2021 Windows	Alum Fixed Thermal Break, Double Glazing, 2 Story, 24SF
Condition	Fair - Good
RUL	20
Plan Type	Capital Replacement
Quantity	63
Unit of Measure	Each
Unit Cost	\$699.02

Second Floor Aluminum Framed Windows and Painted Steel Exterior

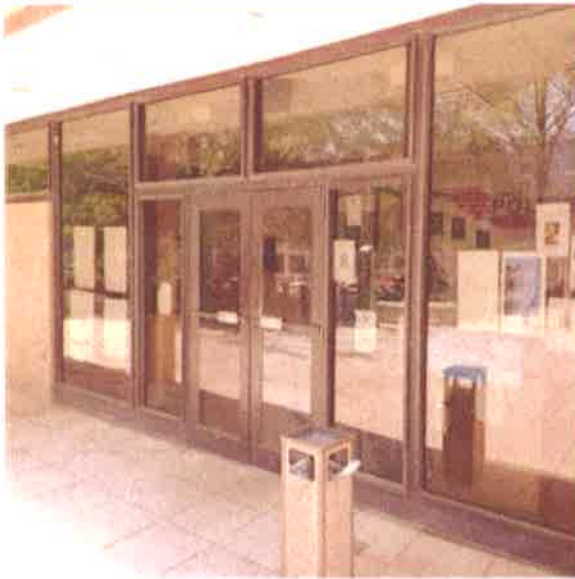
Item	Description
<b>B2023 Storefronts</b>	Glazed Aluminum Framed with Swing Doors
<b>Condition</b>	Fair
<b>RUL</b>	30
<b>Plan Type</b>	Capital Replacement
<b>Quantity</b>	1330
<b>Unit of Measure</b>	SF
<b>Unit Cost</b>	\$29.96

Main Building Entry Storefront

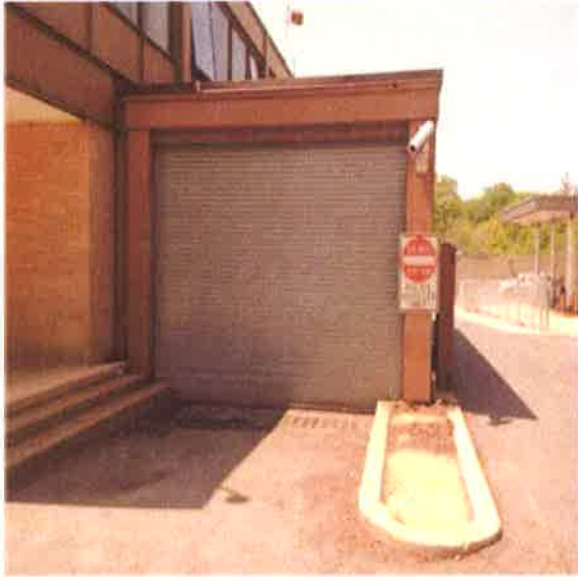
Item	Description
<b>B2034 Overhead Doors</b>	Aluminum Single, Painted, Roll-up Door, 144 Sq Ft
<b>Condition</b>	Fair - Good
<b>RUL</b>	20
<b>Plan Type</b>	Capital Replacement
<b>Quantity</b>	2
<b>Unit of Measure</b>	Each
<b>Unit Cost</b>	\$3,772.46

Typical Aluminum Roll Up Door

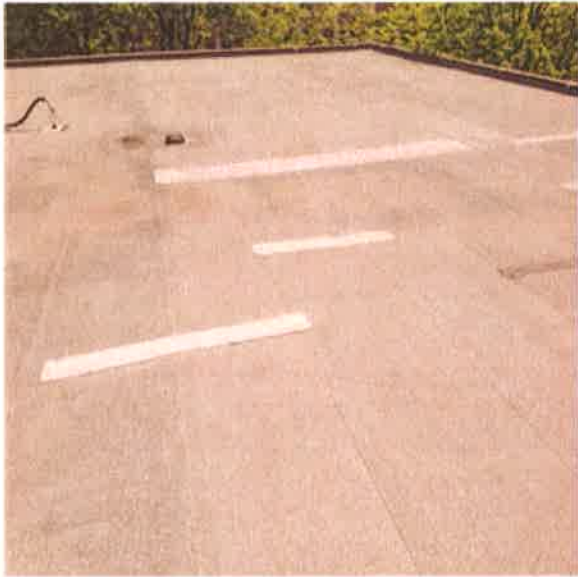
Item	Description
B3011 Roof Finishes	Modified Bitumen - Single Ply
Condition	Fair
RUL	8
Plan Type	Capital Replacement
Quantity	12750
Unit of Measure	SF
Unit Cost	\$5.90

**Modified Bitumen Roof Coverings**

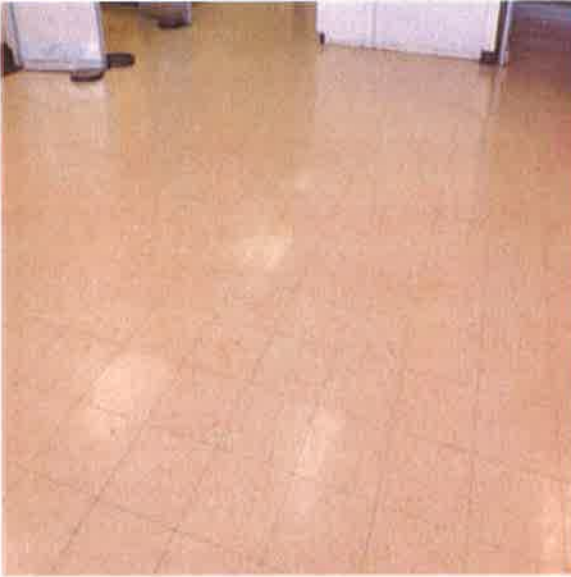
Item	Description
<b>C3024 Flooring</b>	Vinyl Tile Flooring
<b>Condition</b>	Fair
<b>RUL</b>	6
<b>Plan Type</b>	Capital Replacement
<b>Quantity</b>	21727
<b>Unit of Measure</b>	Sq Ft
<b>Unit Cost</b>	\$3.04

Typical Vinyl Floor Tile

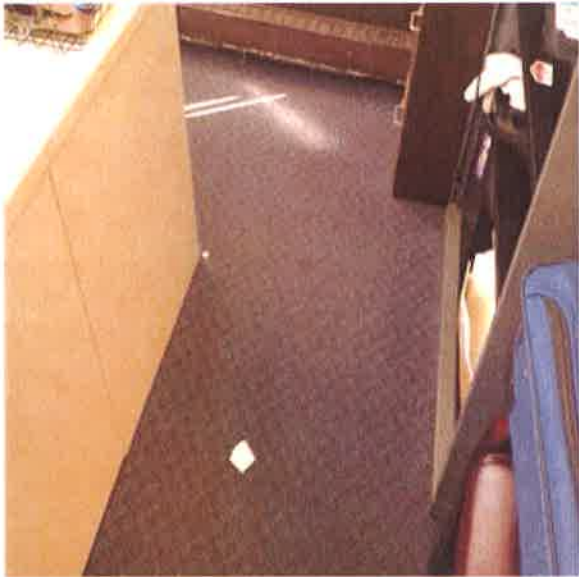
Item	Description
C3025 Carpeting	Carpet, Nylon, High Traffic, 20 oz
Condition	Fair
RUL	3
Plan Type	Capital Replacement
Quantity	2969
Unit of Measure	Sq Ft
Unit Cost	\$5.98

Typical Carpet Flooring

Type	Component Description	Plan Type	Year	Expenditures (\$)
C3025	Replace Carpet, Nylon, High Traffic, 20 oz	Capital Replacement	2017	\$17,749

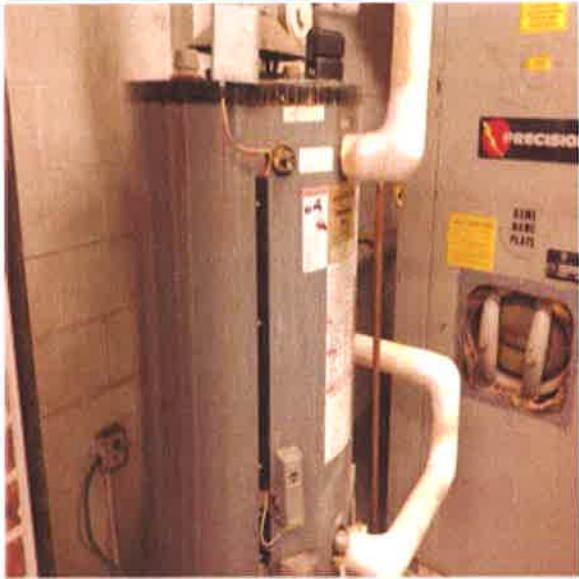
Rheem 76 Gallon Gas Fired Domestic Hot Water With Storage Tank

Domestic Hot Water Storage Tank

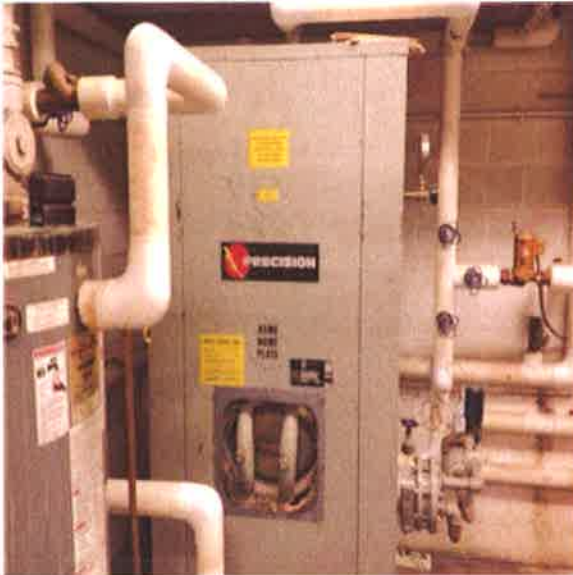
Precision Brand Domestic Hot Water Gas Boiler; Capacity Not Determined; Installed 1999

Domestic Hot Water Boiler

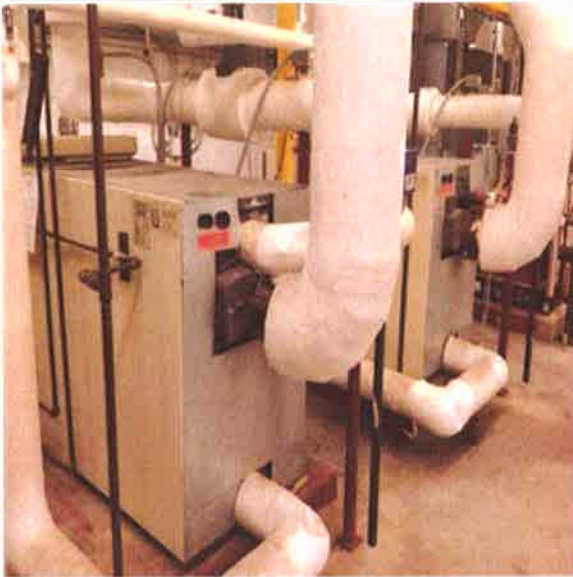
Dietrich 1,154 Btu/Hr Gas Fired Hot Water Boiler; Installed 1999

Central Heating Boilers

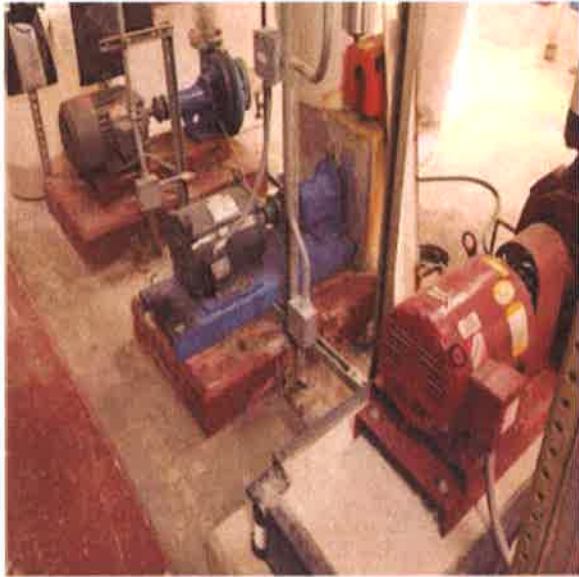
7.5 Hp Conditioned Water Circulation Pumps

Conditioned Water Circulation Pumps

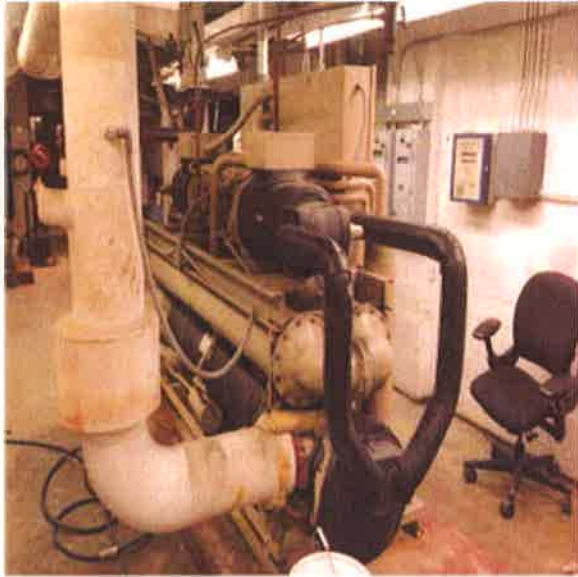
Trane Central Chiller Unit

Central Chiller Unit

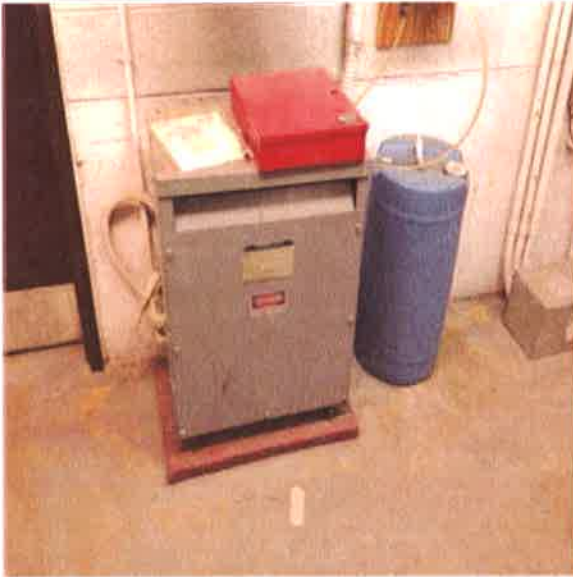
Item	Description
D5012 Low Tension Service & Dist.	Secondary Transformer, Dry, 30 kVA
Condition	Fair
RUL	15
Plan Type	Capital Replacement
Quantity	3
Unit of Measure	Each
Unit Cost	\$4,899.35

Secondary Transformer

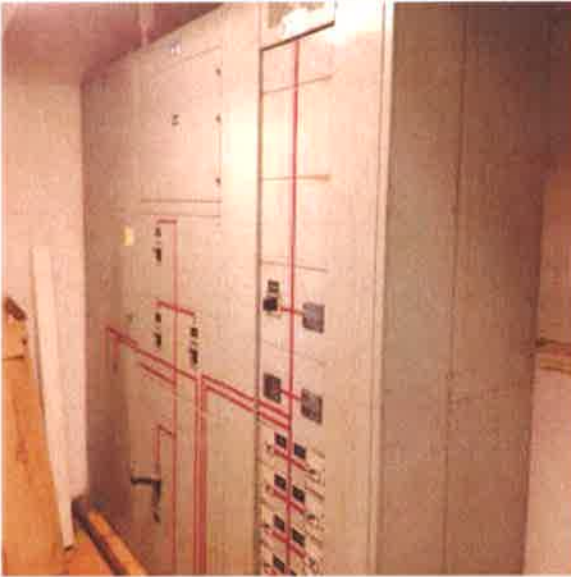
ITE 2,000 Amp, 120/208 Volt, 3 Phase, 4 Wire Main Switchgear

Main Electric Service Switchgear

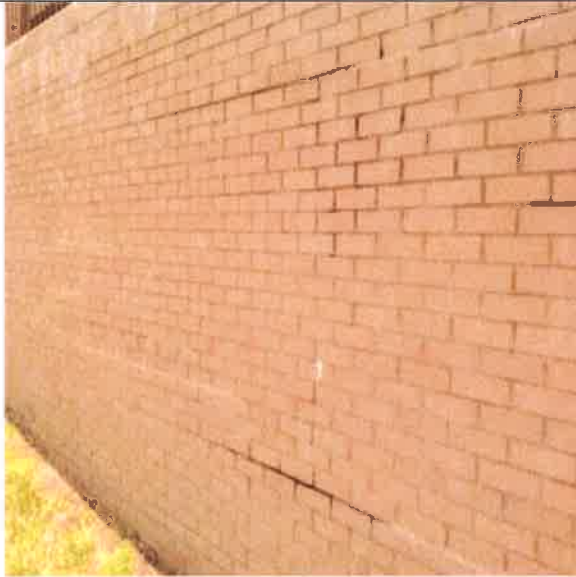
Brick Veneer, Exterior, 1 Story :- Typical Exterior  
Brick Mortar Deterioration

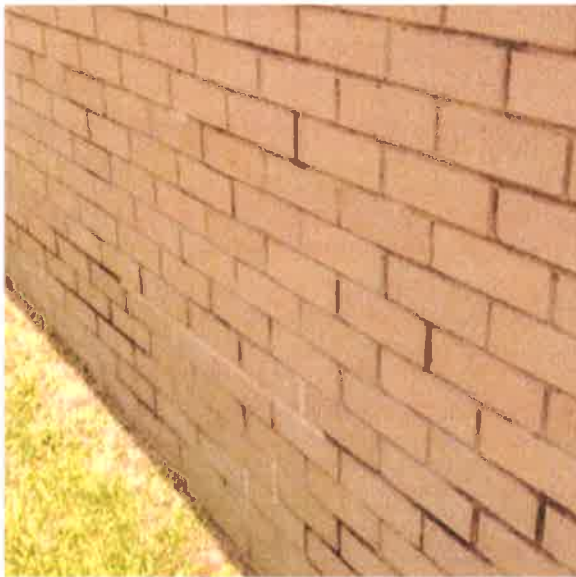
Brick Veneer, Exterior, 1 Story :- Typical Exterior  
Brick Mortar Deterioration

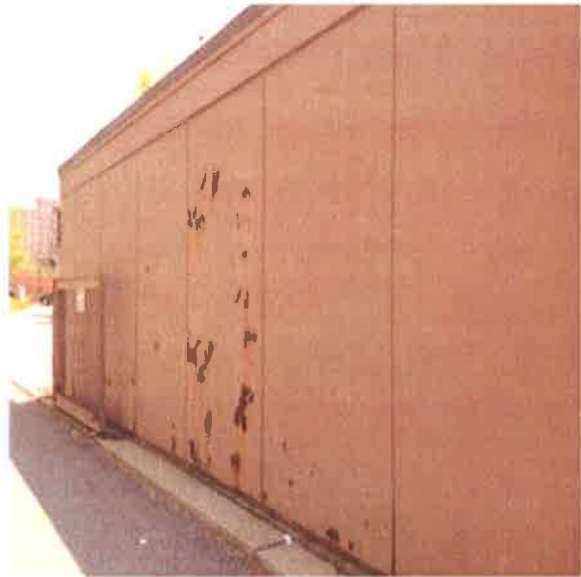
Steel, Exterior, 2 Stories:- Typical Deteriorated  
Paint and Oxidation at Exterior Steel

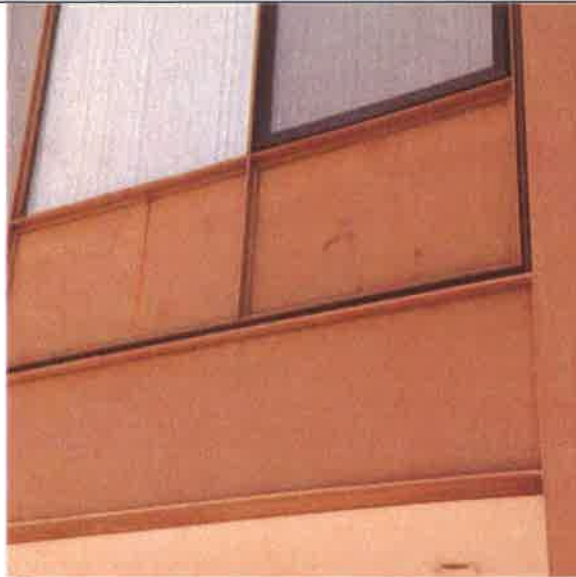
Steel, Exterior, 2 Stories :- Typical Deteriorated Paint and Oxidation at Exterior Steel
