HEARST PARK AND POOL

CONSTRUCTION UPDATE: DECEMBER 2022

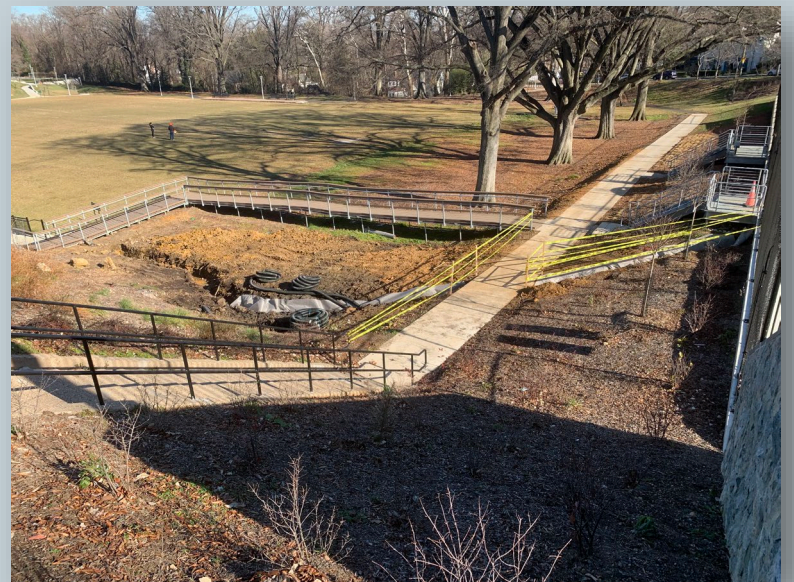
Trench has been dug for French drain.

- A contractor (Dennison Landscaping, Inc.) will excavate a trench outside the Critical Root Zone (CRZ) of the surviving heritage oak.
- The trench will be lined with filter fabric and the base will be layered with gravel with a positive downhill slope.
- Perforated drainpipes will be installed in the trench
- The drainpipes will be wrapped in a sleeve and covered by additional gravel
- The trench will be covered with filter fabric, topsoil and mulch
- The perforated drainpipes will be connected to solid pipes and connected to the existing storm-sewer system onsite.
- Two swales will be installed and a new surface drain to assist the surface water that has been standing in the CRZ's south of the field after rain events.

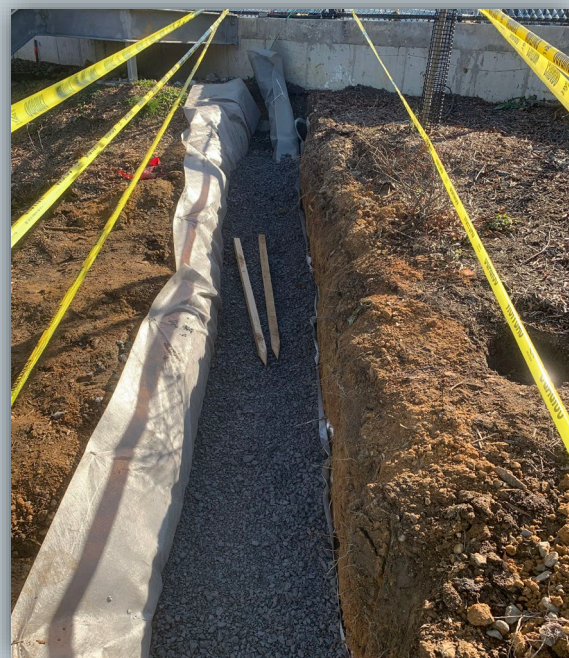
The base of the trench lined with filter fabric.

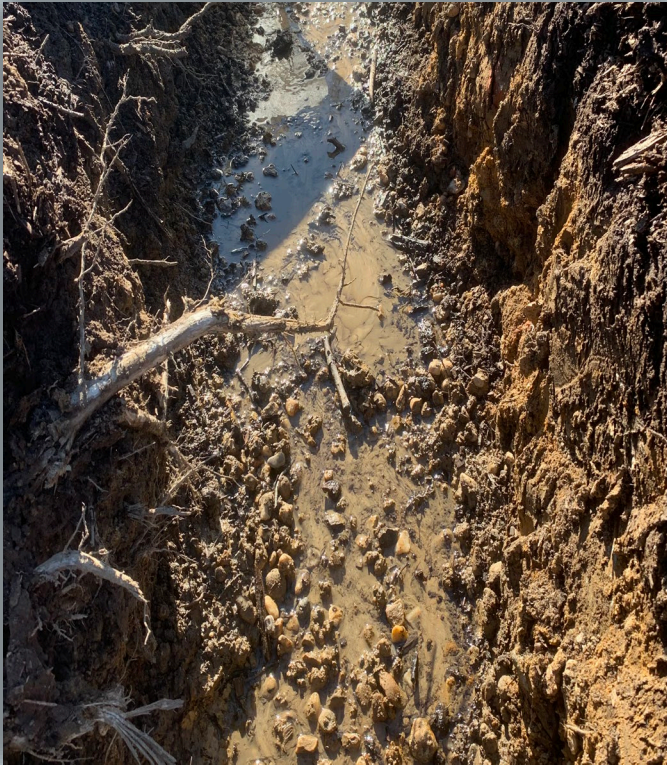
Groundwater visible and flowing in the trench from the higher elevations at southwest to the field to the north.

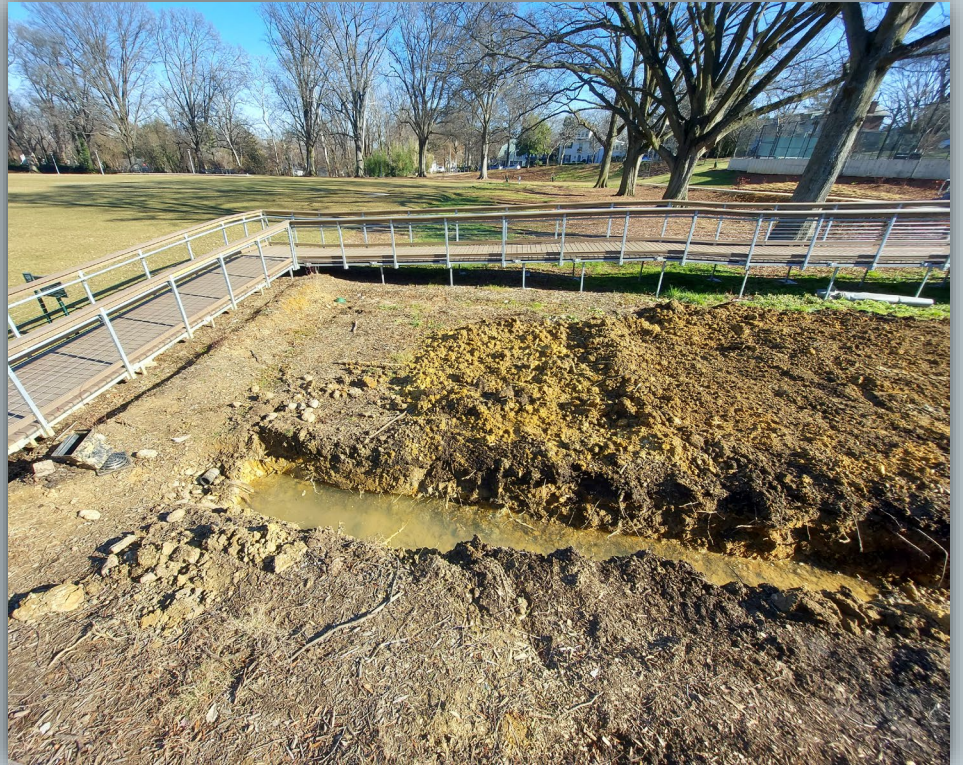
Water backed-up in the incomplete trench higher than the field as it flows down from the hill to the south to the field to the north.

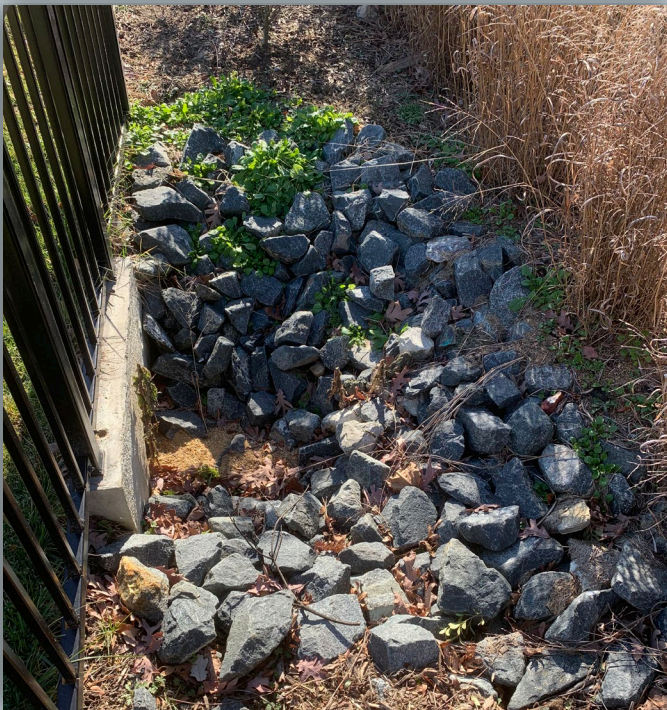
Bioretention Area lower than the field is dry

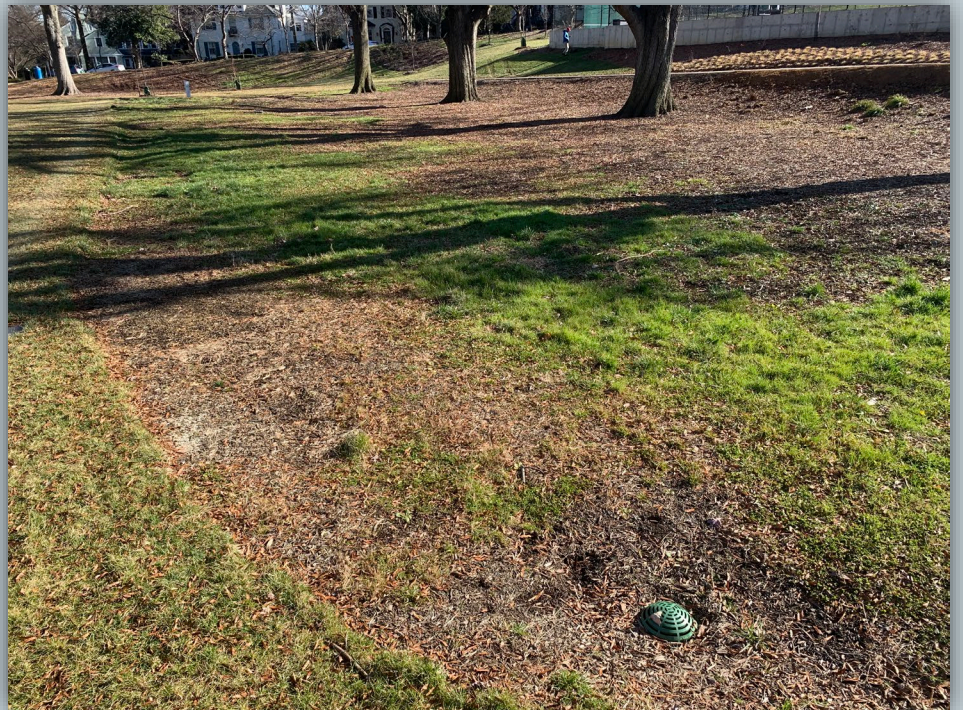
Areas within the Critical Root Zone of the heritage trees where the surface swales will be installed are dry after over 2" of rain last week.
