**Center for Therapeutic Recreation Program
Development and Associated Services**

3030 G Street SE
Washington, DC 20019

Building Conditions Assessment Report

December 10, 2014

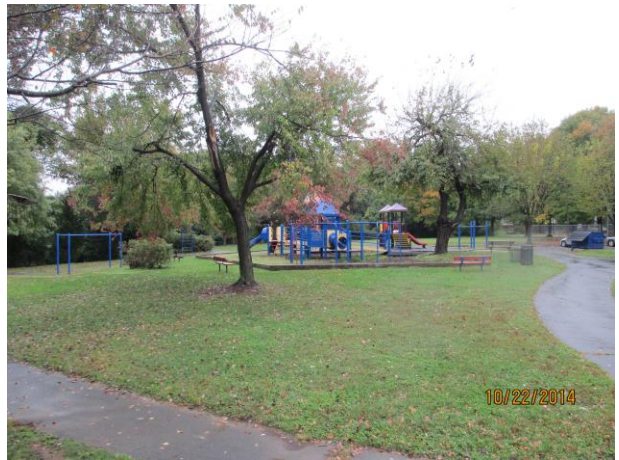
The playground surface should be updated based on current standards being utilized by DCPS for new / updated playgrounds at schools. Upgrade to the path surface that connects to playgrounds is also needed. The playground equipment appears to be in fair condition.

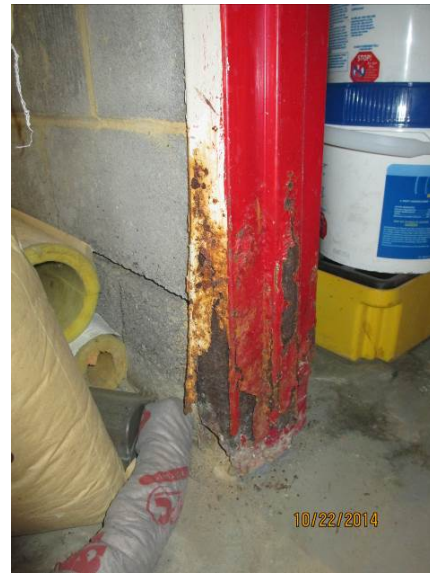
Door Frame in Mechanical Space

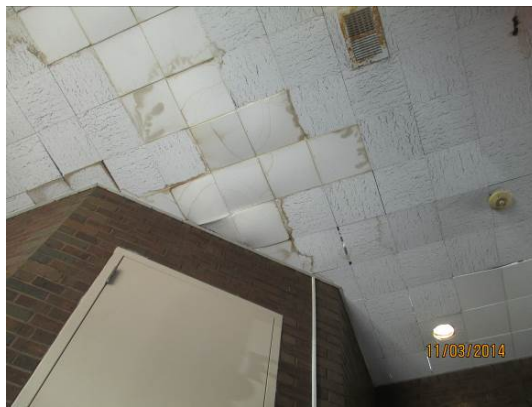
Ceilings are recommended to be replaced in its entirety. The wall partitions require paint as there are walls with peeling paint in most places. Besides time, the biggest factor in the deterioration of the building is due to water infiltration from flooding in the basement, due to storm drain backing up, as evident of rust on the door frames to stains on the ceiling tiles. Though the roof has been recently replaced identifying the location of the leak(s) was not possible. The moisture levels in the pool area are not controlled as evident from the rust on the metal deck and structural support system in the storage room. The joist system above the pool has been repainted in recent years.

Ceiling in Senior Center

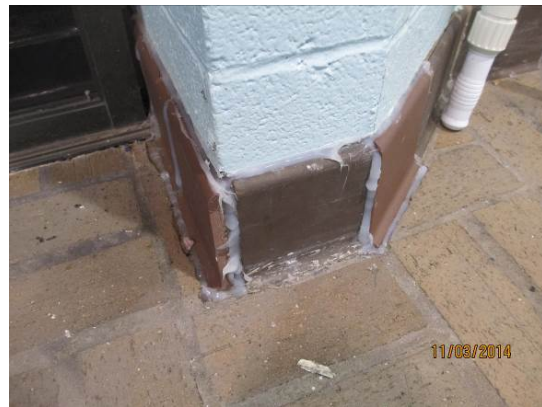
Base in pool

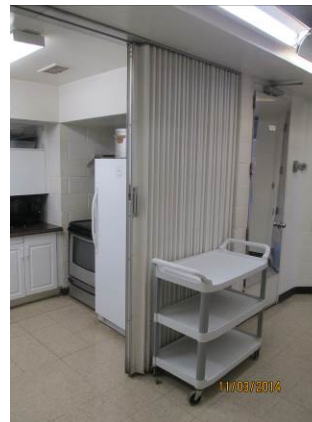
Kitchenette

The galley kitchenette has been upgraded in recent years, but high frequency of use has worn out the residential surfaces and equipment. Currently the space contains a residential grade electric stove and oven, dishwasher, microwave, and stackable washing machine and dryer. There is an exhaust hood but it is not vented. All kitchenette equipment is in need of an upgrade. The layout is rather disorganized with very little preparation surface. The P-lam is worn on the countertop and beginning to delaminate; the cabinet doors are missing hardware and some doors need to be tightened. The VCT flooring should be replaced around the work area. The pantry around the corner has shelves for storage, but adds to the chaotic layout by not being accessible for food preparation. Finally, the kitchen space has a ceiling mounted accordion door that further separates the open space adjacent to it.

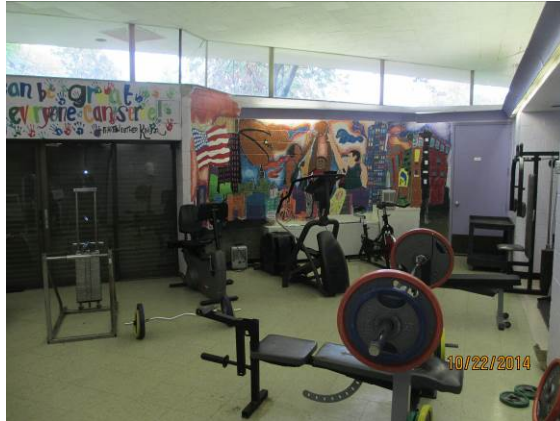
Weight Room

There are several activity rooms that house numerous functions year round. The rooms serve the following needs; art room, computer lab, weight exercise room and library. Upgrades to the room finishes for these spaces are needed as well as adequate lighting. In general the storage rooms are awkwardly sized and full to capacity. Most of the floor spaces in the various activity rooms are used to stored items thus rendering the space more inefficient.

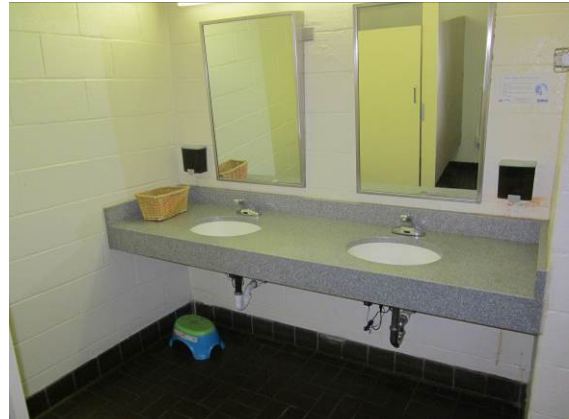
View of Sink

The main men's and women's toilets that serve both buildings are not ADA compliant. The accessible stalls do not have sufficient clearance for transfer to the toilet seat. The spaces do not meet the required circulation for wheel chair maneuverability as well as appropriate grab bar supports. Thermal insulation is not provided under the sink to avoid a scald hazard to wheelchair bound persons. The finishes in these areas are worn and need updating.

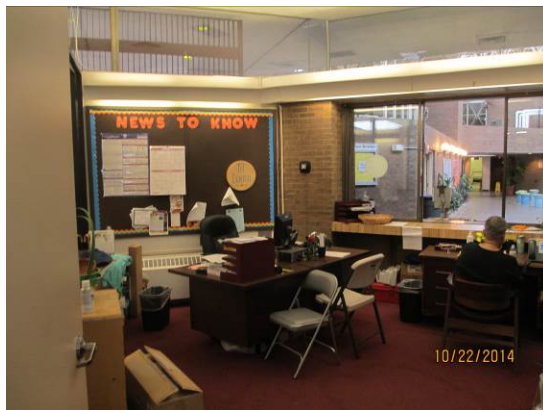
View from Front Desk

The administration offices are similar to the other classroom and activity spaces. The spaces reflect an outdated function. More space is needed to adequately meet the TR Center's current full time staff and projected staffing. More common space for general and secure storage, along with a meeting room, is needed. Regarding finishes, the wood panel walls are outdated and carpet should be replaced. Greater visibility to the outside as well as better a position to view major spaces including entry and lobby is requested for the front desk.

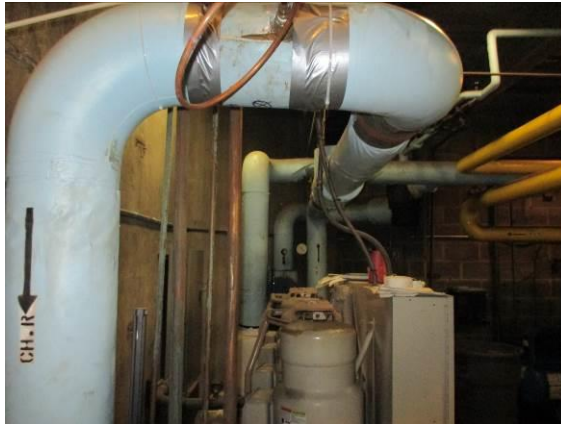
Photo 3.5.2-1: Chiller

The majority of the existing chilled water system is in average condition, including chiller and associated air cooled condenser, chemical feeder, expansion tank, and air separator. The existing chilled water pump appears to be in poor condition. The existing chilled water system is approximately 13 years old.

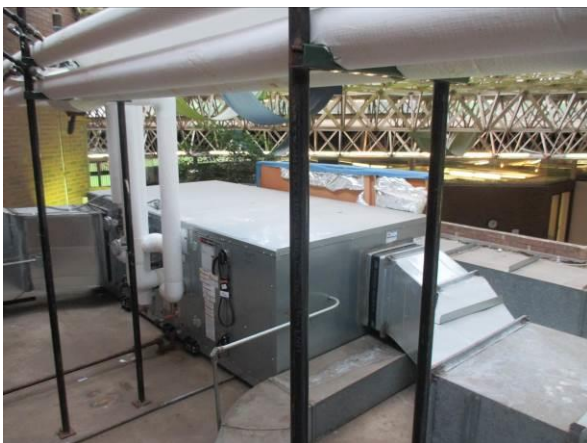
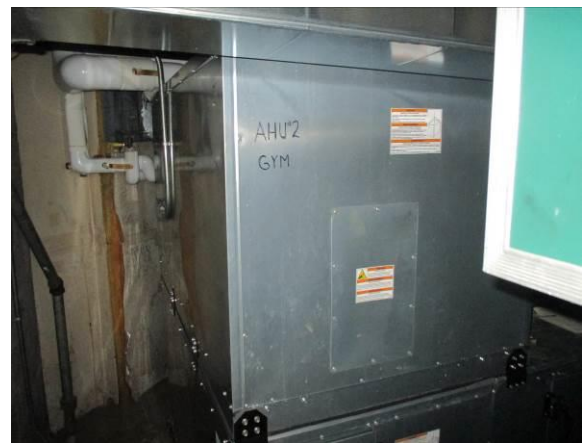
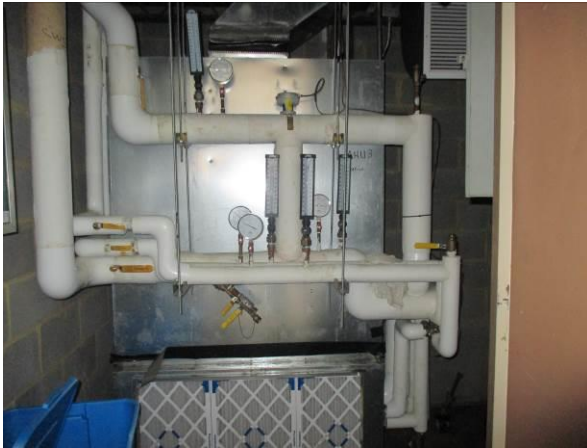
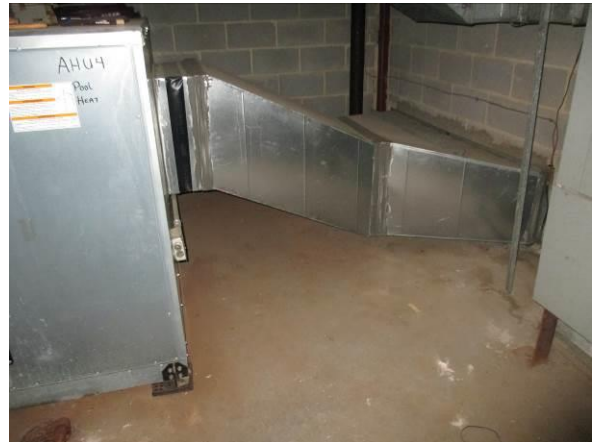
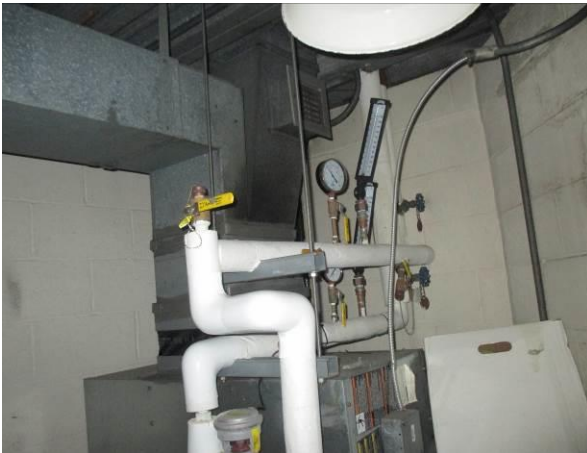
The existing air handling units are in good condition, and the existing roof top unit is in poor condition. The existing air handling units are approximately four (4) years old, and the existing rooftop unit is approximately 15 years old.

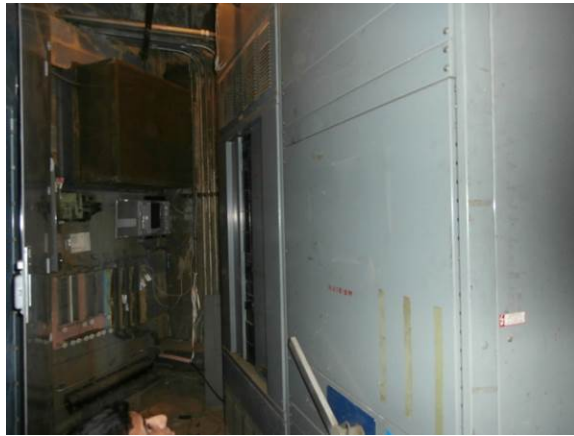
Photo 3.6.1-1: Main Switchboard and Distribution Section

The main electric room is in violation of the current code (NFPA 70-Article 110.26), as the number of entrances to working spaces for equipment rated 1200 amperes or more and over 6 feet wide. The required working clearance in front of the switchboard is also in violation of NFPA 70-Article 110.26.

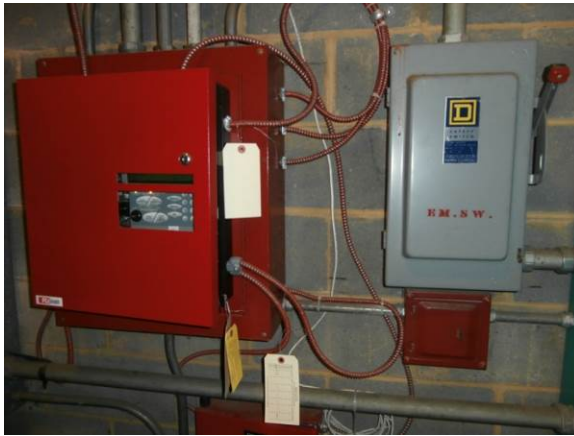
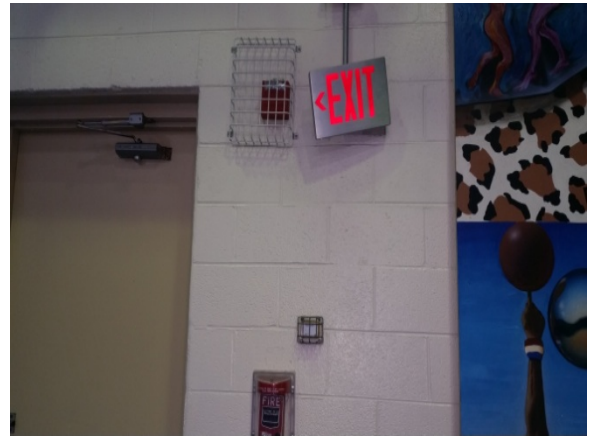
Photo 3.6.1-7 & 8: Existing Fire Alarm Control Panel, Manual Pull Station and Audio Visual Device

The existing fire alarm control panel is located in the Main Electrical Room. The system appears to be in a fairly good condition and well maintained compared to rest of the systems. Fire alarm audio-visual devices and manual pull stations are installed. However, fire alarm devices are not installed throughout and it does not meet the coverage which is a violation per code requirements.

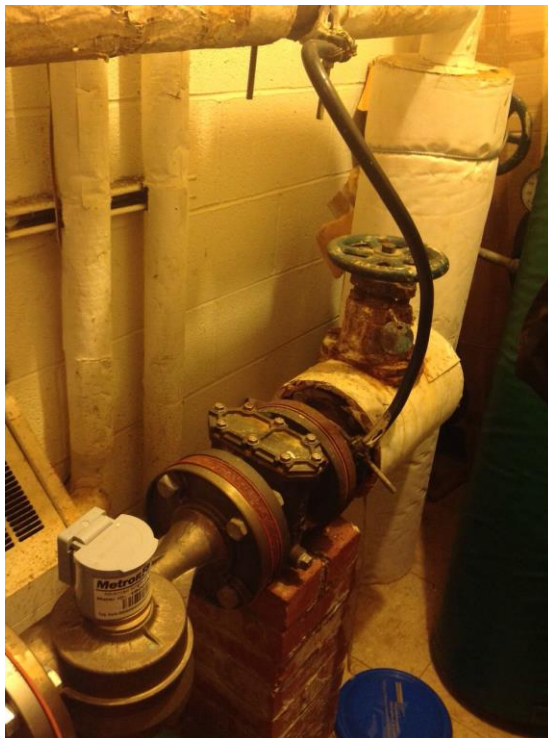
Photo 3.7.1-1: Water Meter

The existing Domestic cold water system at the main building is a 2-inch water service with meter that enters the water service room #124 at the front of the building. There is not a backflow preventer device installed. The domestic cold water system serves all plumbing fixtures within the building including external hose bibs. All domestic cold water piping is copper tubing with wrought copper fittings. All domestic cold water piping is insulated but there is damaged insulation in some areas.

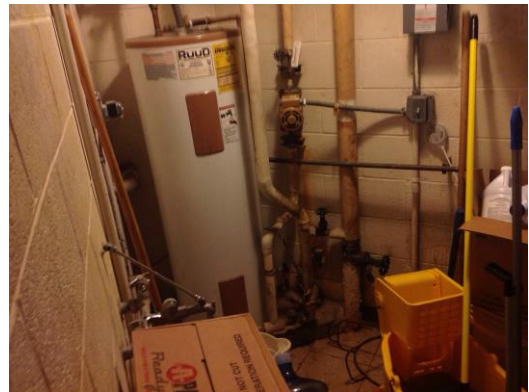
Photo 3.7.2-2: Water Heaters Small Building

The small building is equipped with a water heater in Room 171. This water heater is outdated.

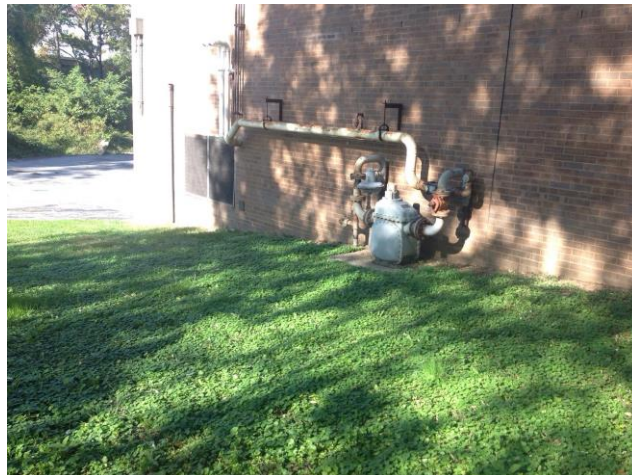
Photo 3.7.5-1: Natural Gas Meter

The existing natural gas system serves boilers, water heaters, and HVAC equipment. The existing natural gas system consists of schedule 40 black steel piping with welded fittings for 3-inch pipe and above, and screwed fittings for 2-inch pipe and below. The existing natural gas piping does not show significant wear and damage. The majority of the gas piping is not painted yellow. The gas meter is located on the south side of the building.

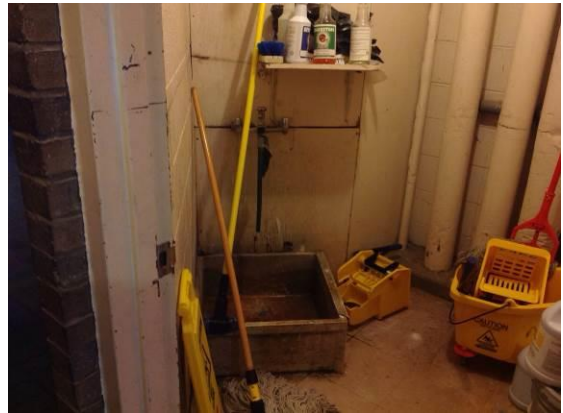
Photo 3.7.6-4: Typical Janitor's Sink

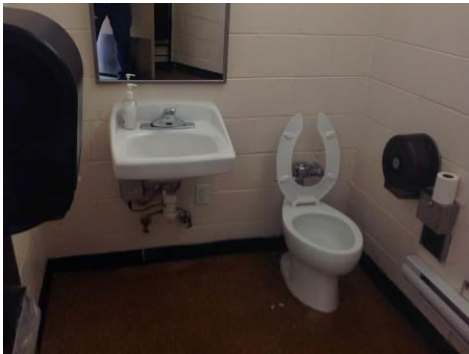
Photo 3.7.6-5: Bathrooms 166 & 167

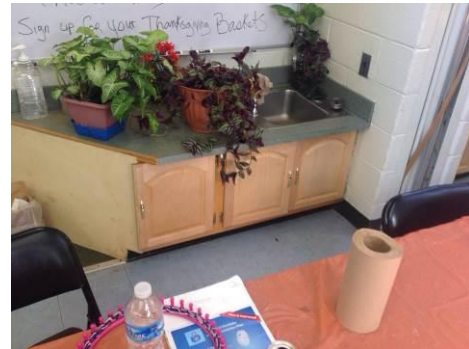
Photo 3.7.6-6: Classroom Sink

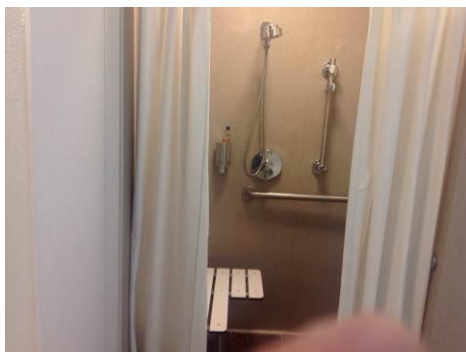
Photo 3.7.6-7: Typical Shower

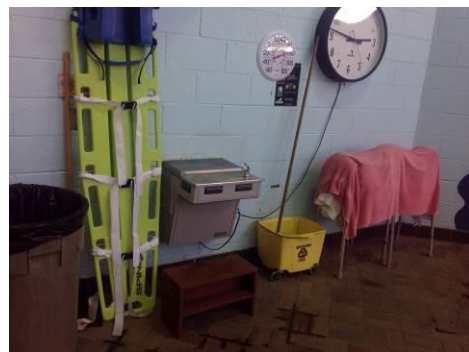
Photo 3.7.6-8: Drink Fountain

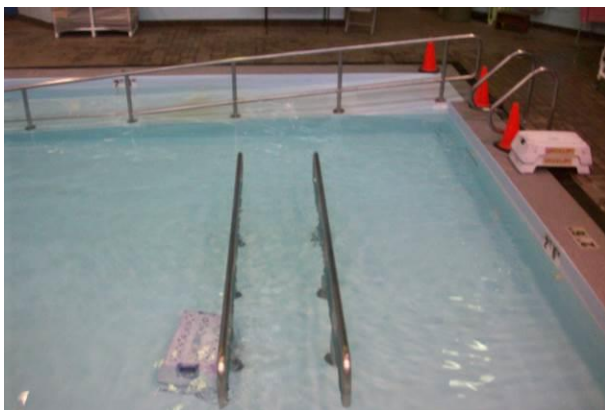
Sloped Entry and Parallel Bars

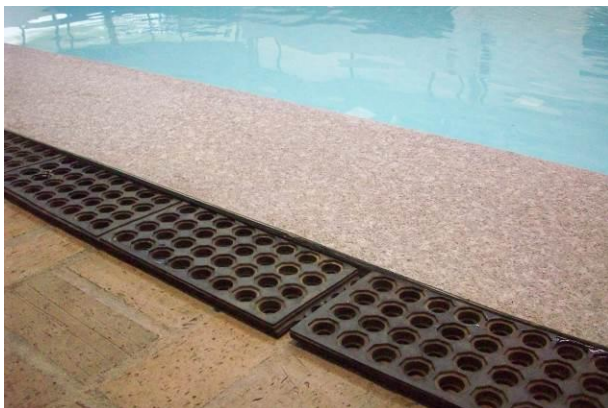
The vinyl liner system has historically had a life of approximately 7 years. The current liner has been in place 7 years and has delaminated in places, been repaired in places, and all of the markings are severely faded. The existing pool vinyl liner system has reached the end of its life.

Pool Liner – Non Compliant ADA Pool Edge

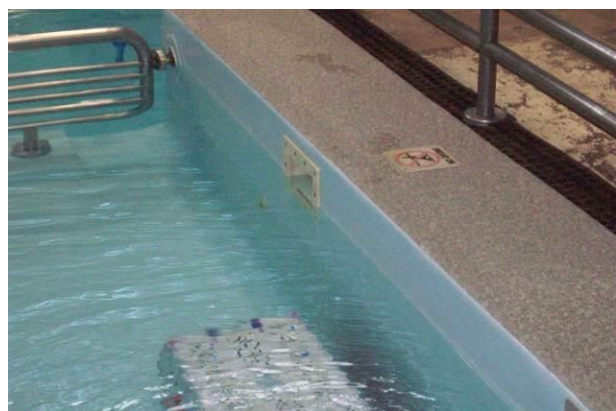
Skimmer Overflow – One of Two

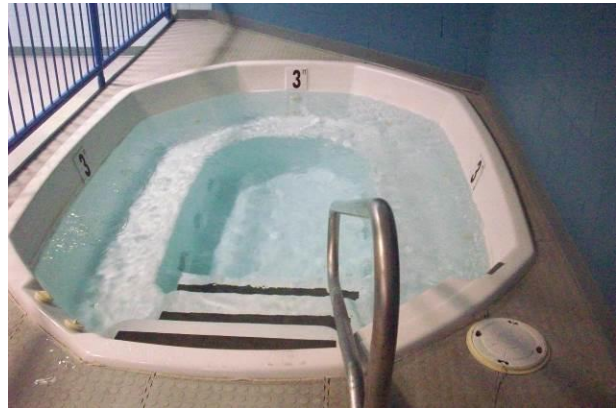
The spa is a fiberglass spa which is not a typical materials selection for a community recreation facility and the spa itself does not provide for ADA accessibility into the spa.

Fiberglass Spa Structure

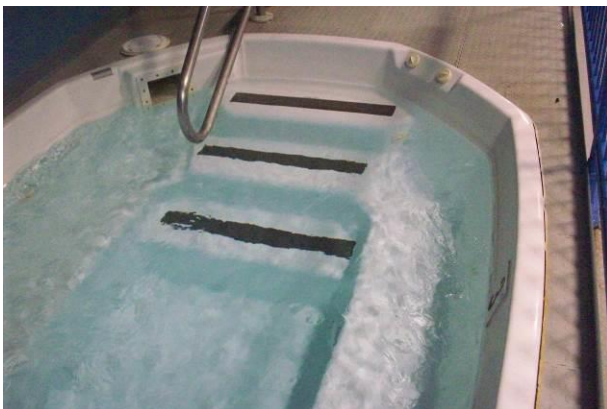
Depth markings for the spa are located vertically on the interior surface of the spa, but are not located on the adjacent deck as required by code.

No Deck Space, No Deck Markings

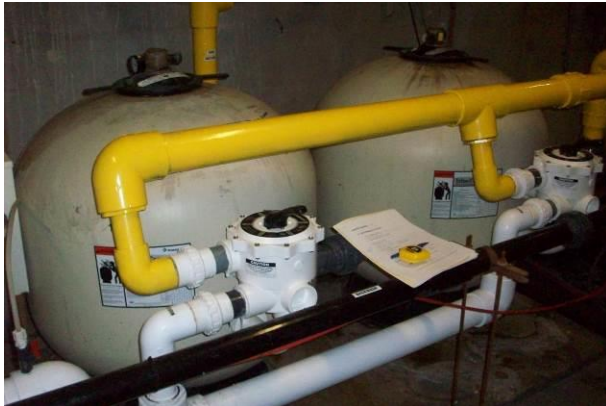
A high rate sand filtration system, two Pentair Triton TR140C filters, is utilized for the pool. The filters are in good condition as they had the sand replaced in 2013 and any laterals that were broken were replaced at that time as well. The filters utilize multi-port valves and the backwash goes to sanitary sewer through an air gap. The backwash line does not have a flow meter which is industry standard and would monitor the flow rate of the backwash process.

Swimming Pool Filters

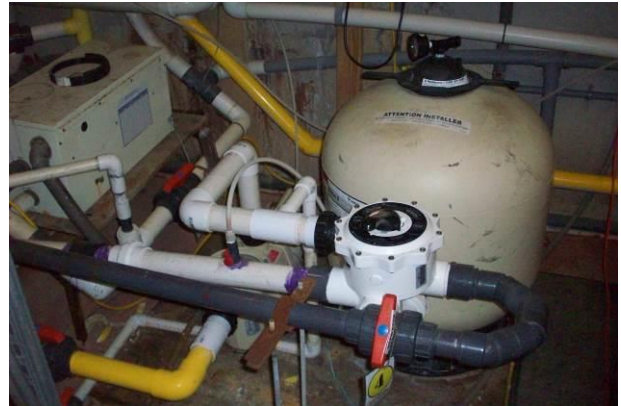
The spa has a 3 hp Pentair Challenger recirculation pump and a 2 hp Pentair Whisperflow pump for the hydrotherapy jets. Both pumps are in good condition.

A high rate sand filtration system, a Pentair Triton TR60 filter, is utilized for the pool. The filter is in good condition as it had the sand replaced in 2013 and any laterals that were broken were replaced at that time as well. The filter utilizes a multi-port valve and the backwash goes to sanitary sewer through an air gap. The backwash line does not have a flow meter which is industry standard and would monitor the flow rate of the backwash process.

Spa Recirculation Pump and Filter

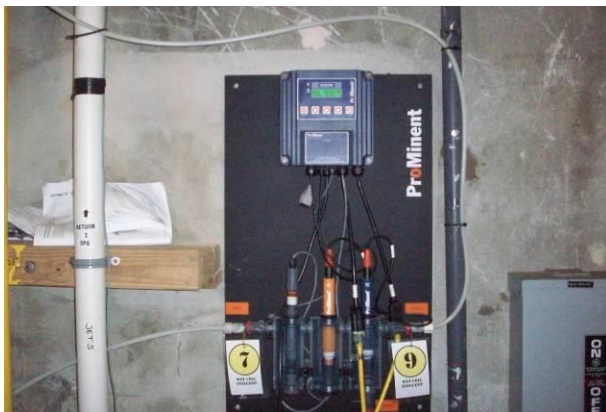
The two water chemistry controllers are new within the last year and are in excellent condition. There was a discrepancy in the measured water temperatures and the water temperatures displayed by the water chemistry controllers. It is recommended that all water parameters on the controllers be calibrated.

Water Chemistry Controller – New Equipment

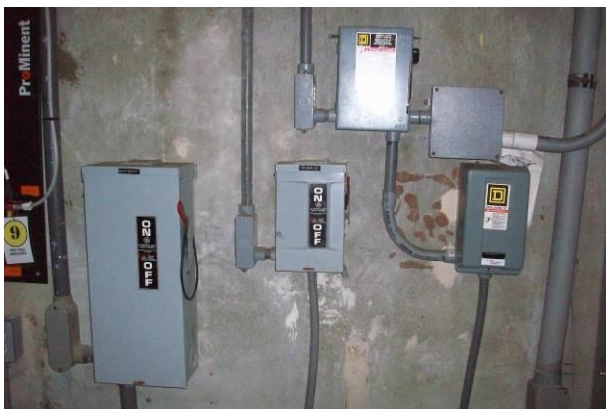
Electrical Power Panels

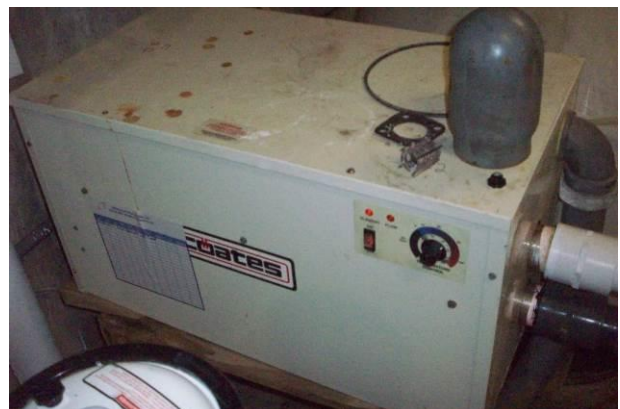
Both the pool and spa are heated by Coates electric pool heaters of which both are in good condition. Electric heaters are an expensive way to heat the pool and spa water. Both electric heaters are in good condition and have been added in an update to the heating systems. Overhead piping remains in place that indicates pool and spa heating was originally provided through water to water heating systems.

Electric Heaters for Both Pool and Spa

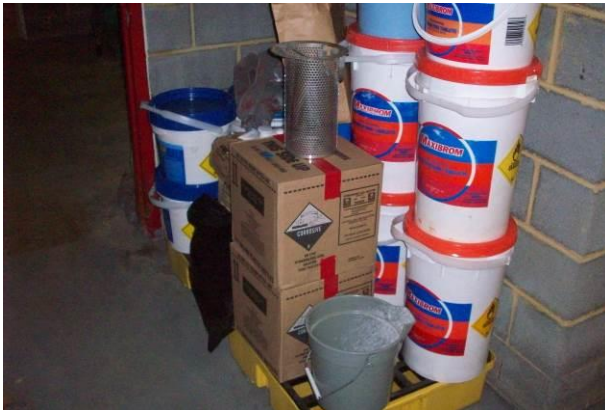
Chemical Storage on Pallet
