D.C. DEPARTMENT OF GENERAL SERVICES
WASHINGTON, D.C.

BUILDING ASSESSMENT

LINCOLN THEATRE
1215 U STREET, N.W.
WASHINGTON, D.C.

MARCH 7, 2012

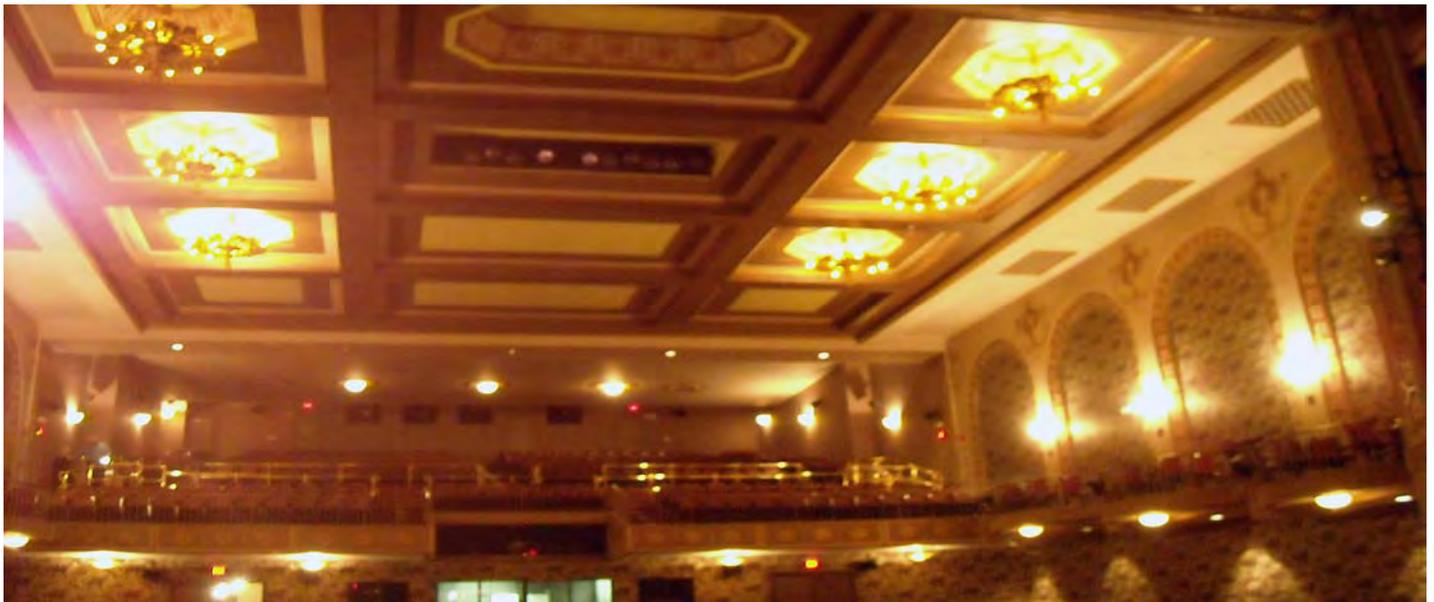
Supply air is discharged into the main theater through six ceiling mounted decorative grilles located three deep on each side of the theater and through two supply registers in front of the stage. These decorative grilles are lacking any air distribution/dispersion features resulting in a very limited dispersion pattern which is further accentuated by the reduced air velocities necessary for sound reduction. See Pic 1.1, 1.2.

Pic 1.1- Theatre - Supply Air Decorative Grilles

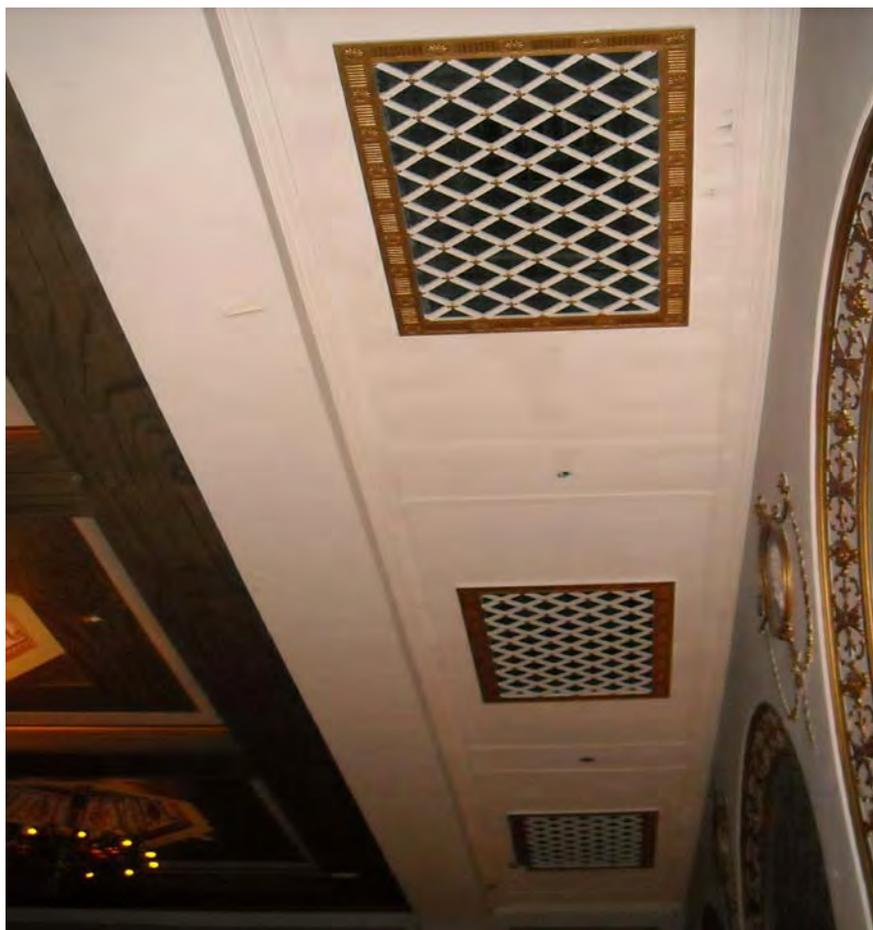
Pic 1.2- Theatre - Supply Air Decorative Grilles

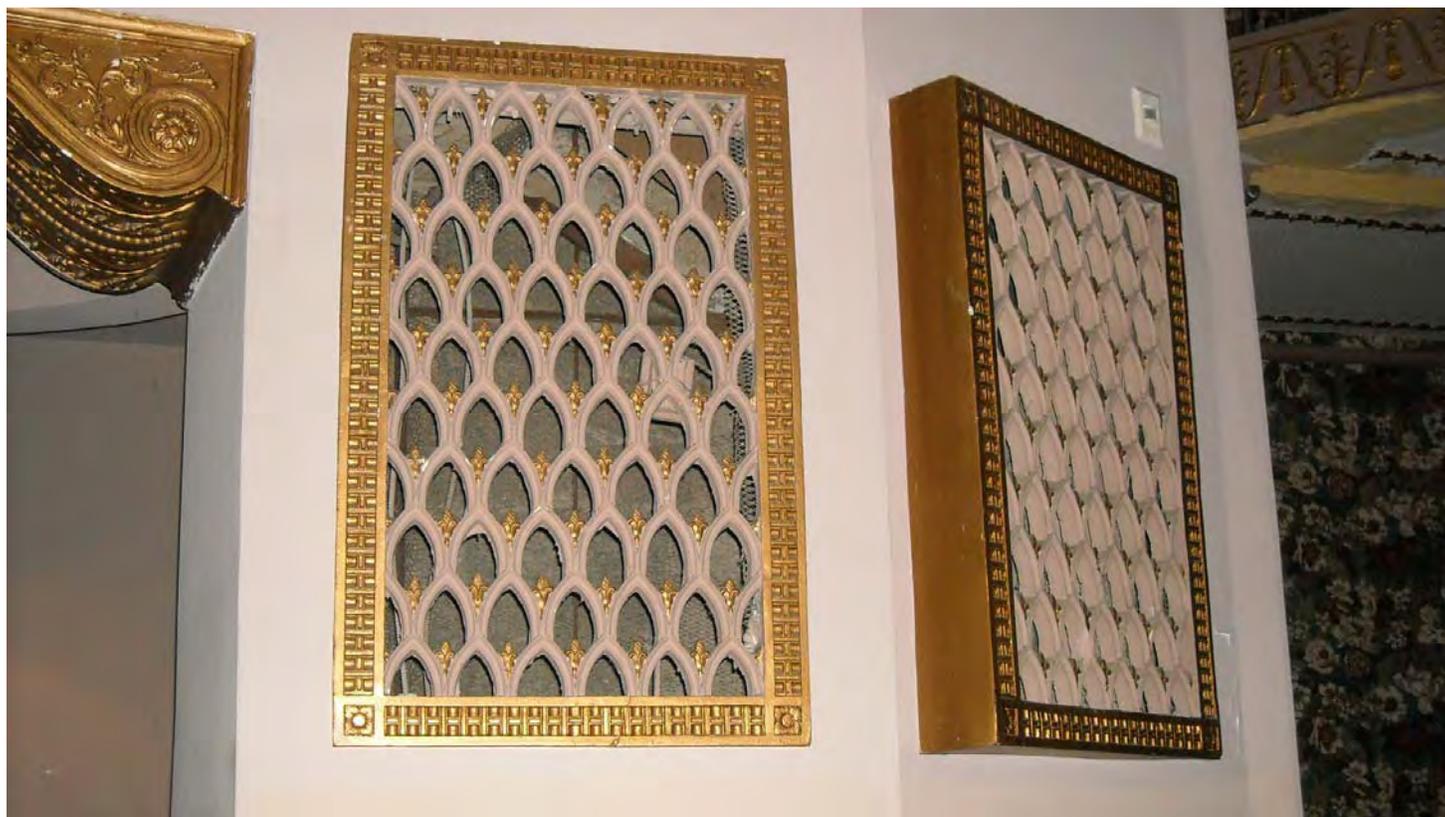
There appears to be four major return air inlets covered by decorative grilles matching in appearance with the supply air decorative grilles. The return air grilles are located on the walls in close proximity to the stage and about 6 feet above the finished floor. See Pic 3. Our inspection revealed that the return air grilles are placed on an unlined shaft open to building cavities. See Pic 4.1, 4.2. As direction of airflow follows the path of least resistance, an unconfined return air shaft allows the potential of extreme and uncontrolled infiltration from points closer to the connections of the main duct at the ceiling levels rather than introduction of return air closer to the floor level where the grilles are located. This enhances even further the stratification discussed previously because of not being able to “pull” the air downwards to dilute stratification and isothermals.

Pic 3- Decorative Return Air Grilles

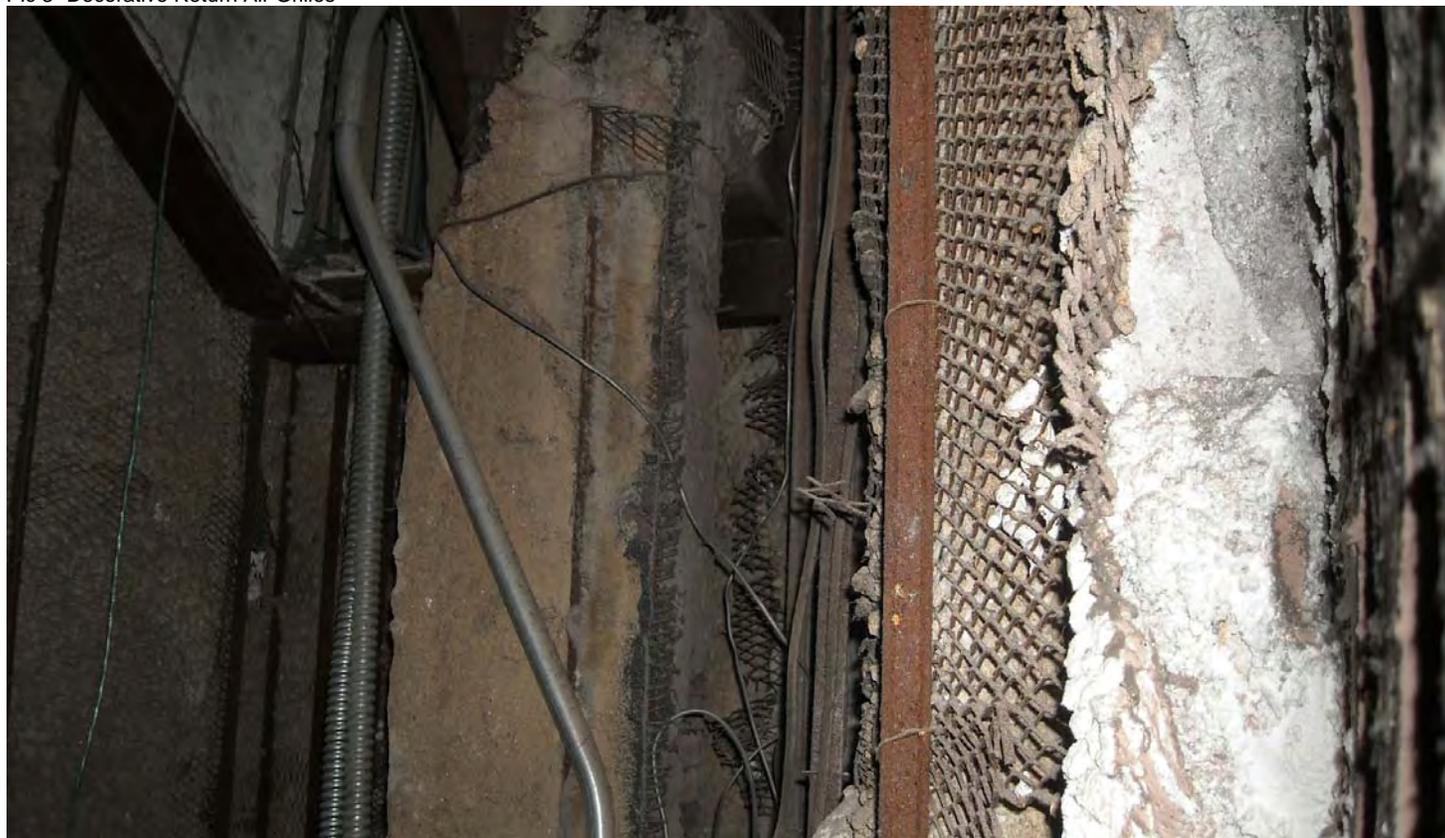
Pic 4.1- Return Air Shaft, Theatre

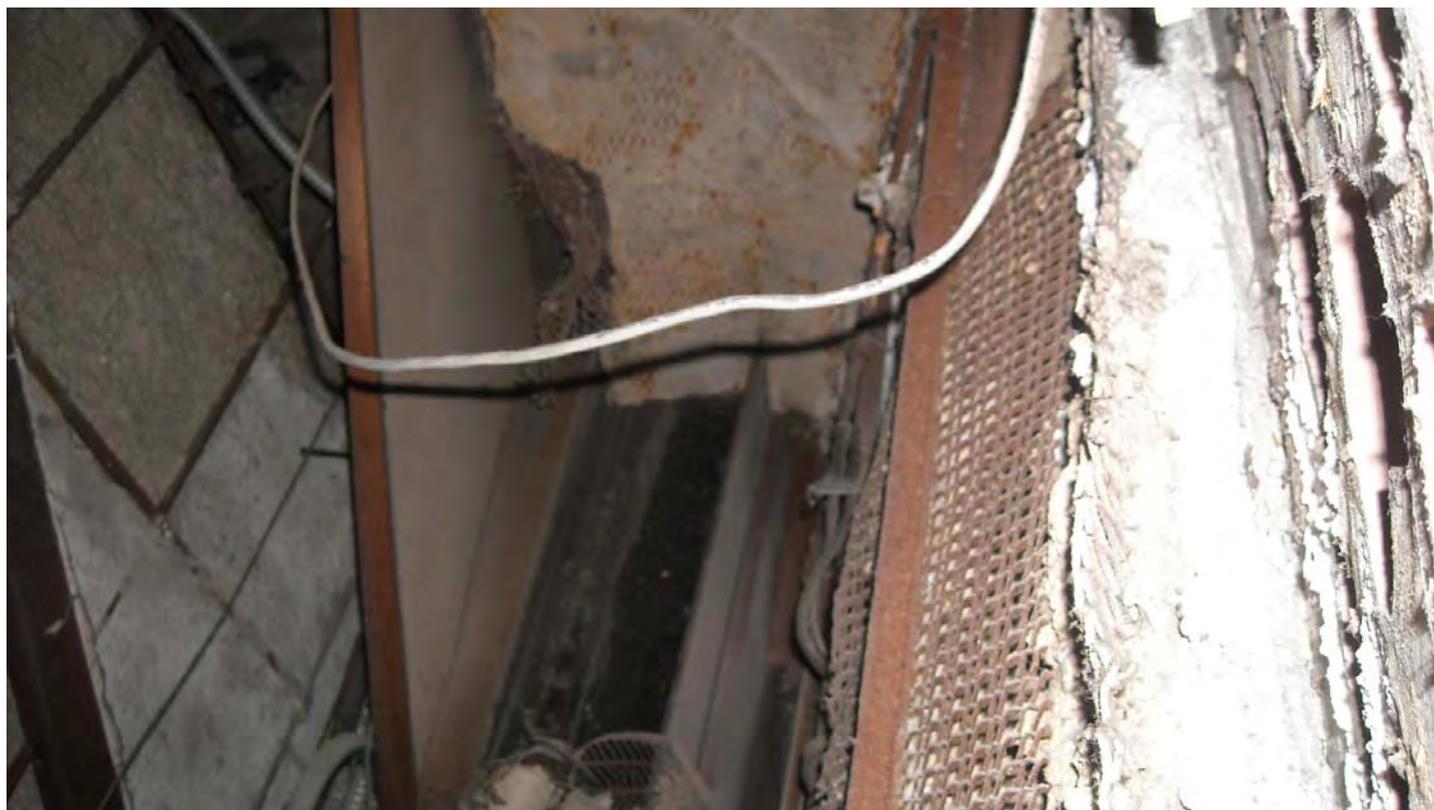
Pic 4.2- Return Air Shaft, Theatre

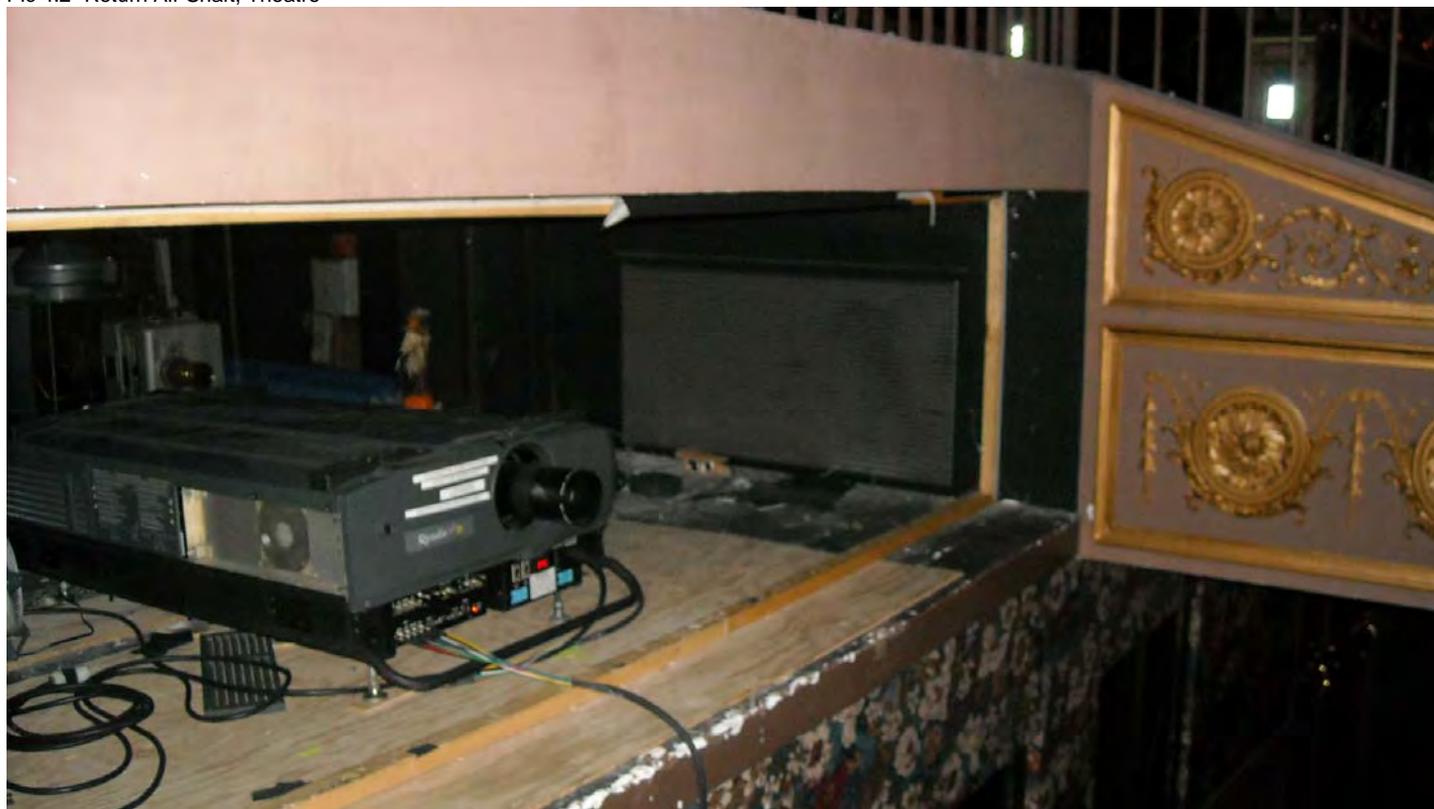
Subsequent designs eliminated the ceiling grilles from underneath the balcony and replaced them with two wall grilles, alongside the low projector at the front of the balcony. See Pic5.

Pic 5- Return Air Grille Below Balcony
