Building and Site Repairs at 2601 & 2603 Naylor Road SE

Solicitation No.: DCAM-16-CS-0087

**Amendment No. 3
Issued: March 18, 2016**

Naylor Road Evaluation

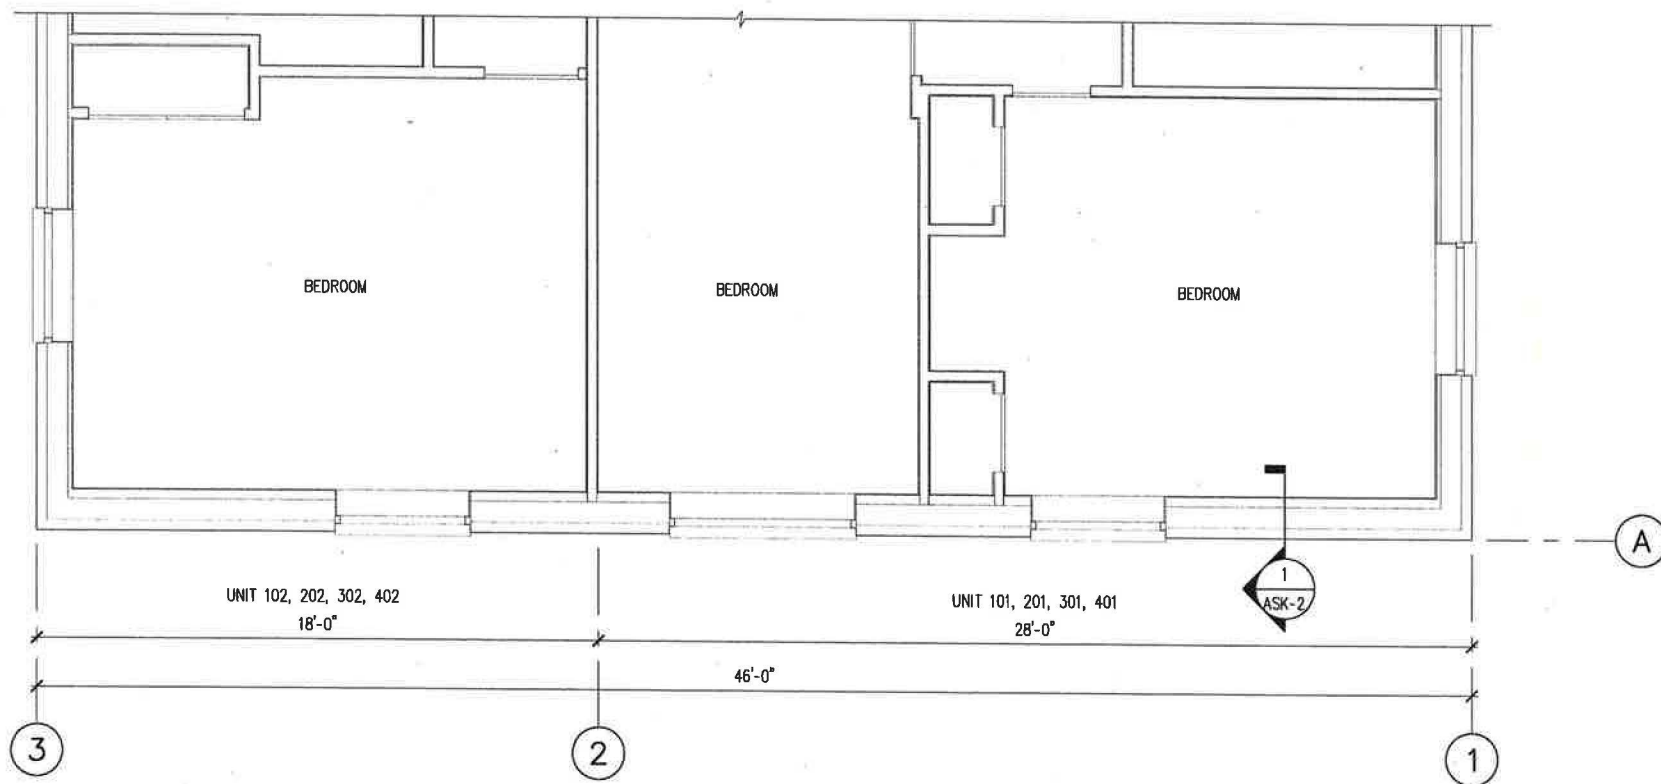
2. PARTIAL TYPICAL FLOOR PLAN

The following pages show a partial floor plan and partial section created to communicate with DGS personnel about probe locations. These are followed by annotated photographs of existing conditions with the missing downspouts highlighted. This report is concluded with Robert Silman Associates' detailed structural evaluation report.

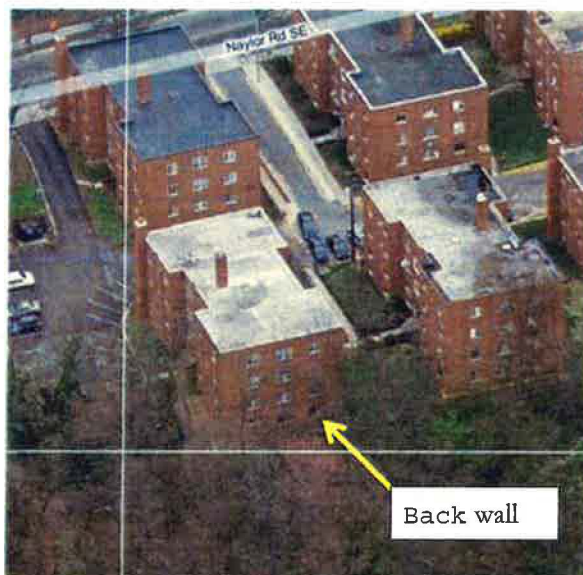
Photo 1: Aerial View of 2603 Naylor Rd (Bing.com)
